# Midtown Parking Garage

Condition Survey

December 2010

**LABELLA**  
Associates, P.C.

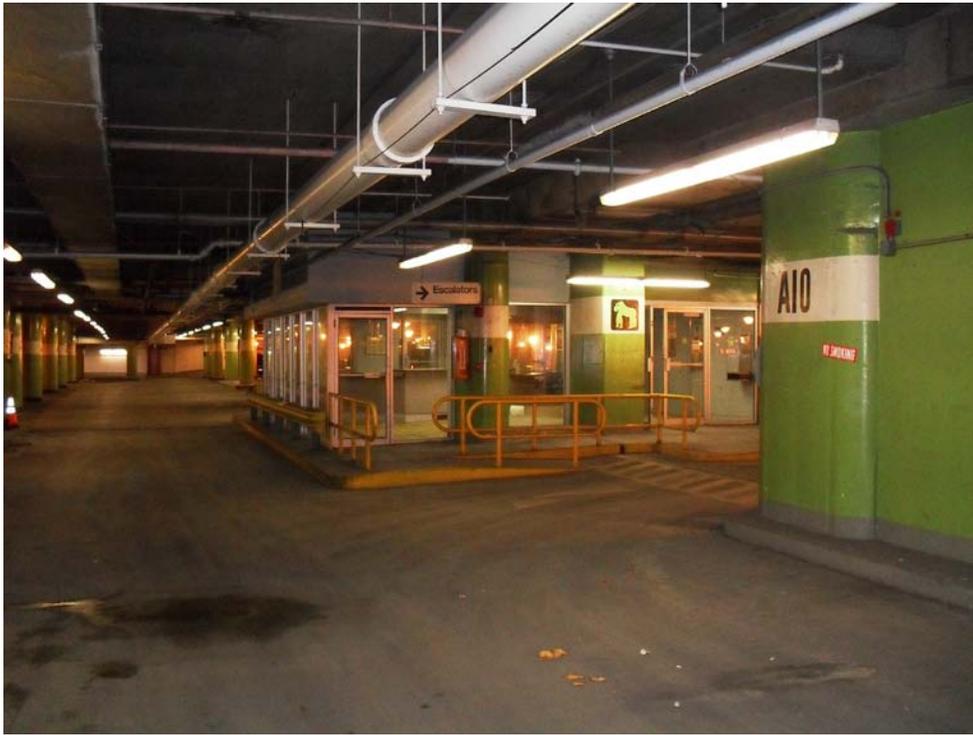
Level A & B. As part of the rehabilitation work in the mid-1980's, the Level A and B structural concrete floor slabs were topped with a concrete overlay and traffic grade membrane system (see Photo 1). The traffic topping is in various degrees of deterioration. In the main drive and recirculation aisles, widespread areas of the membrane system is worn and disintegrated, exposing the concrete overlay (see Photos 5, 7 & 8). The remainder of the membrane system in these aisles exhibits random cracks and isolated debonded or worn areas. Isolated cracks were observed in the exposed concrete overlay (see Photo 6).

1. Level A: Main Drive Aisle

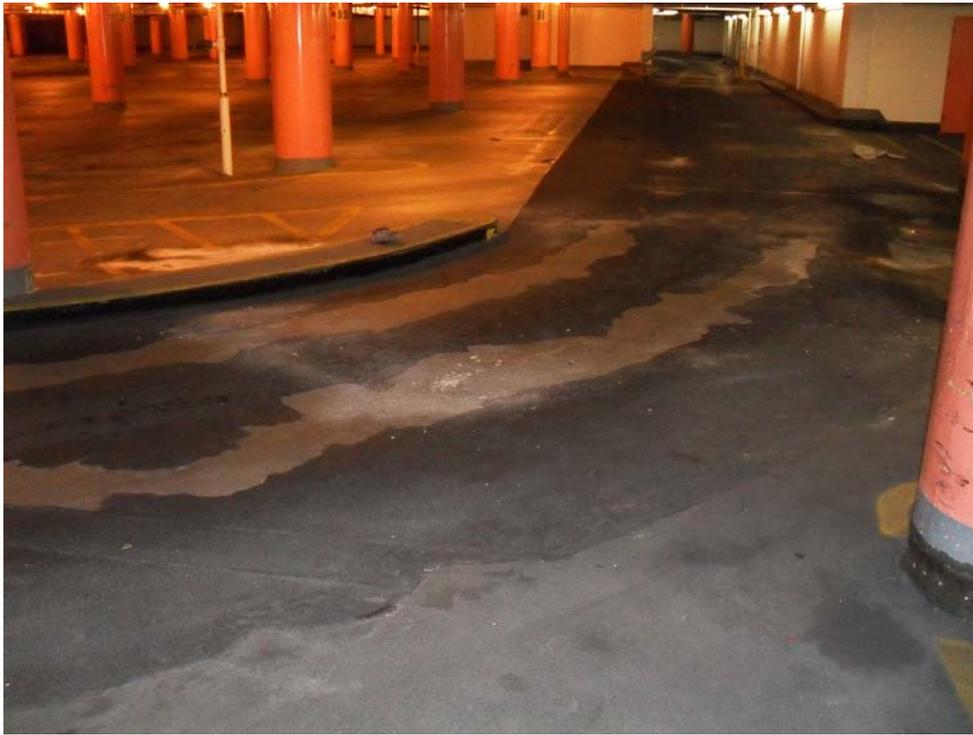
5. Level B: Worn Traffic Membrane and Ceiling Scaling Deposits on Floor

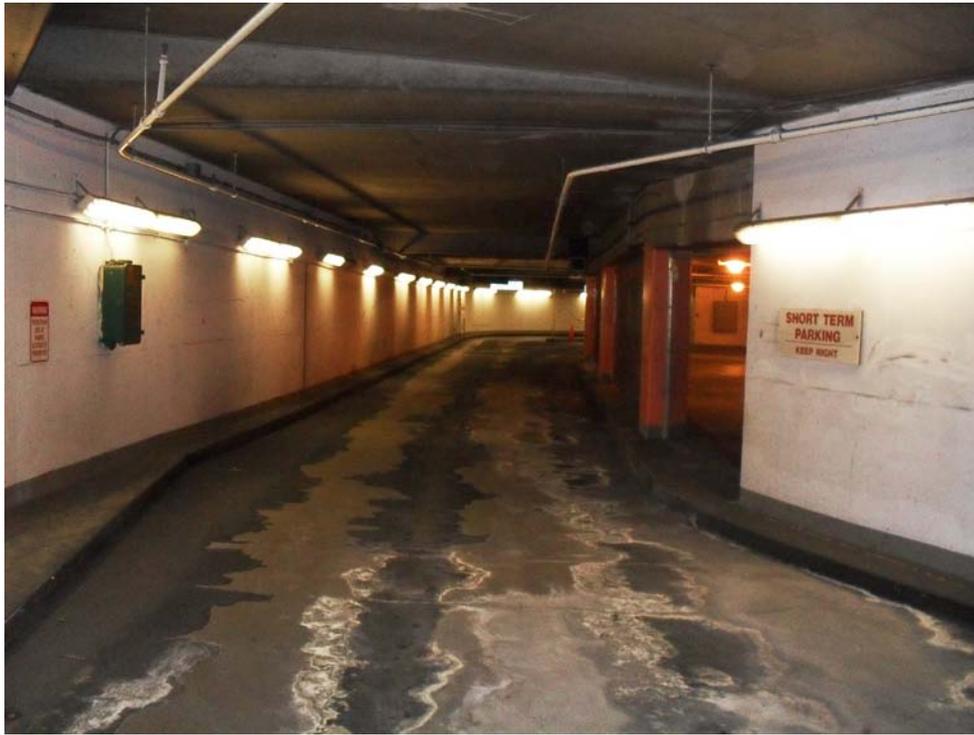
7. Level B: Worn Traffic Membrane in Recirculation Aisle

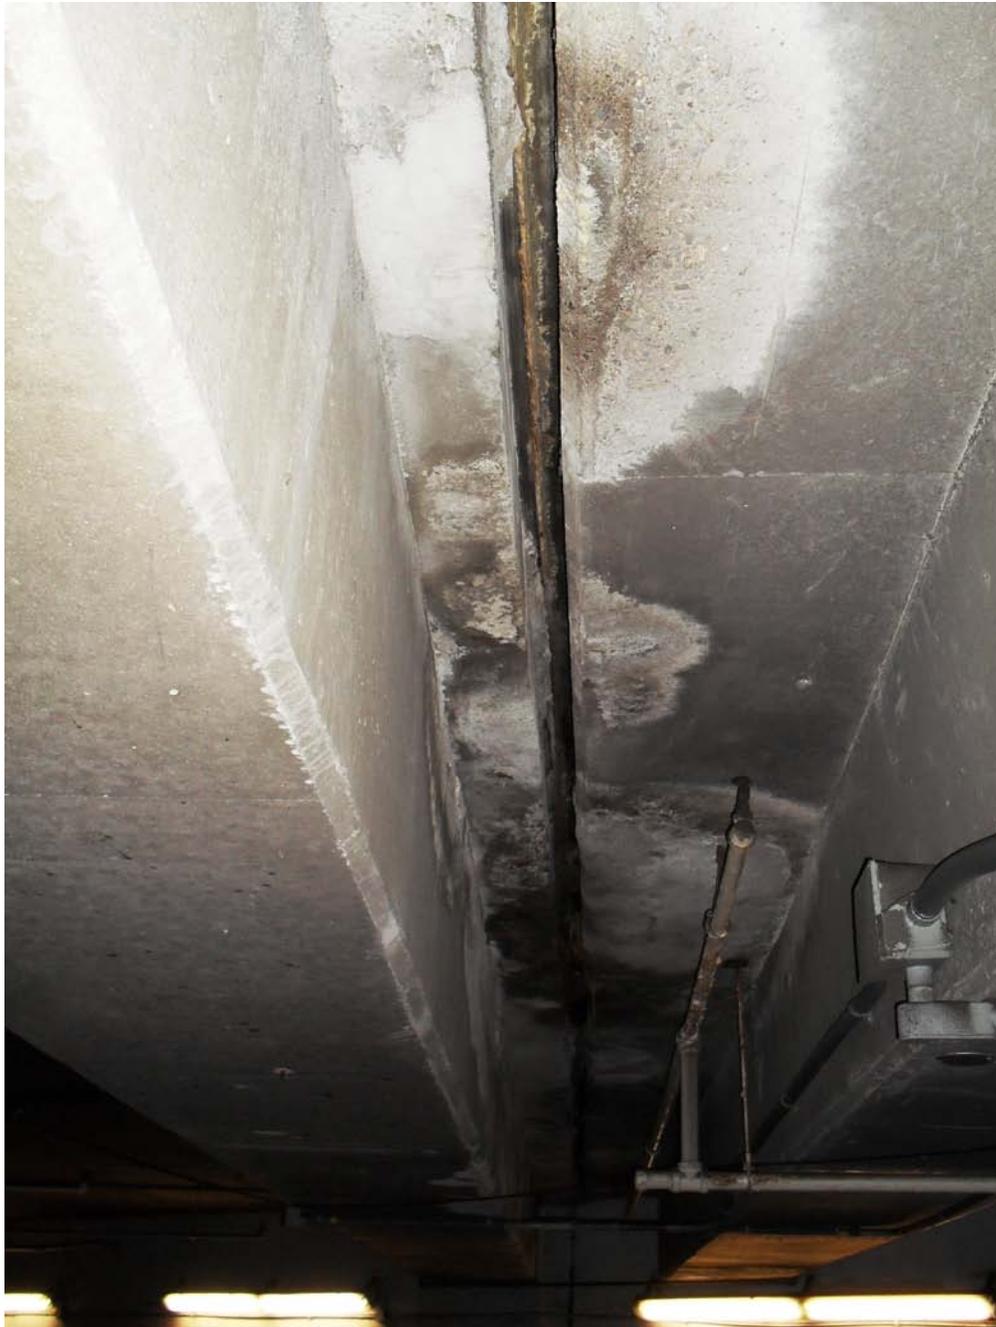
11. Level A: Ceiling Deterioration at Leaking Expansion Joint

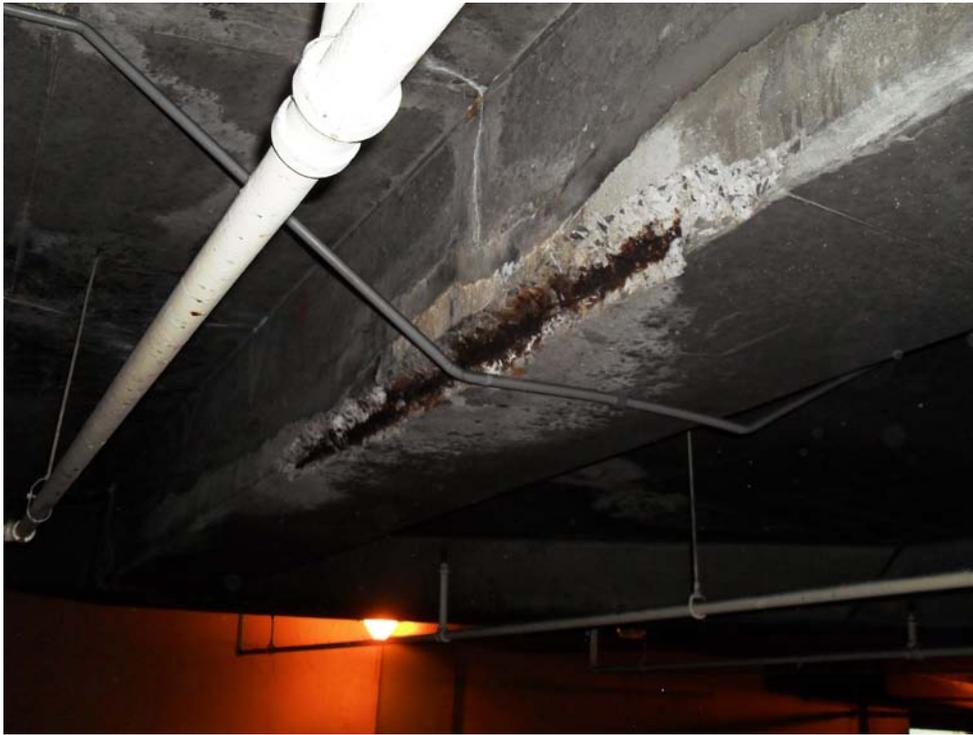
12. Level A: Beam Bottom Deterioration

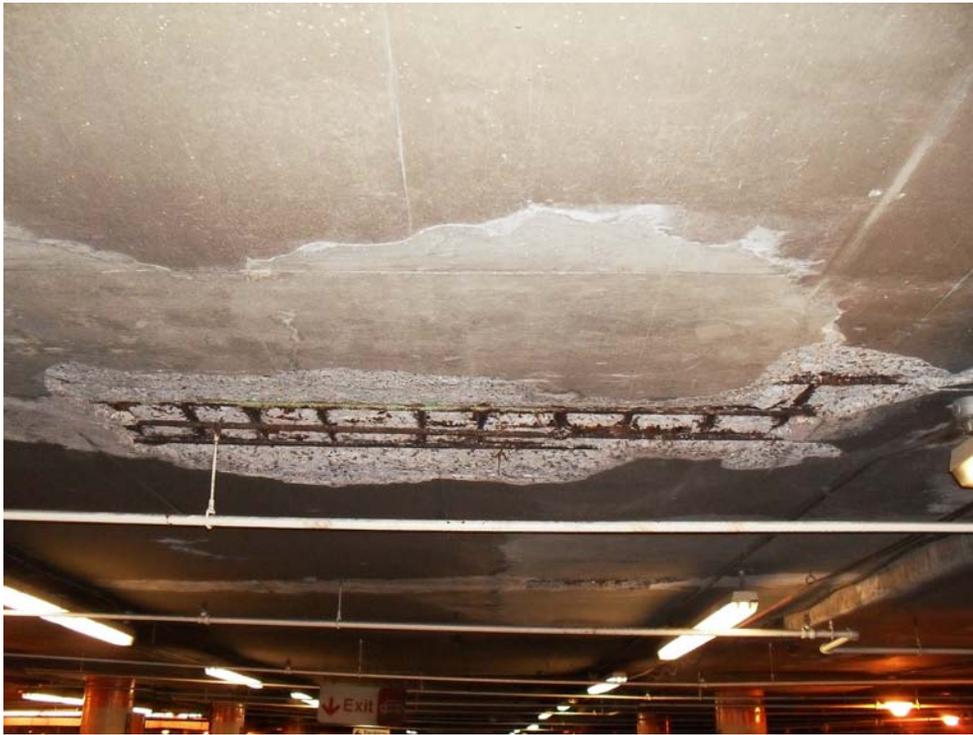
14. Level B: Ceiling Deterioration Adjacent to Previous Patch

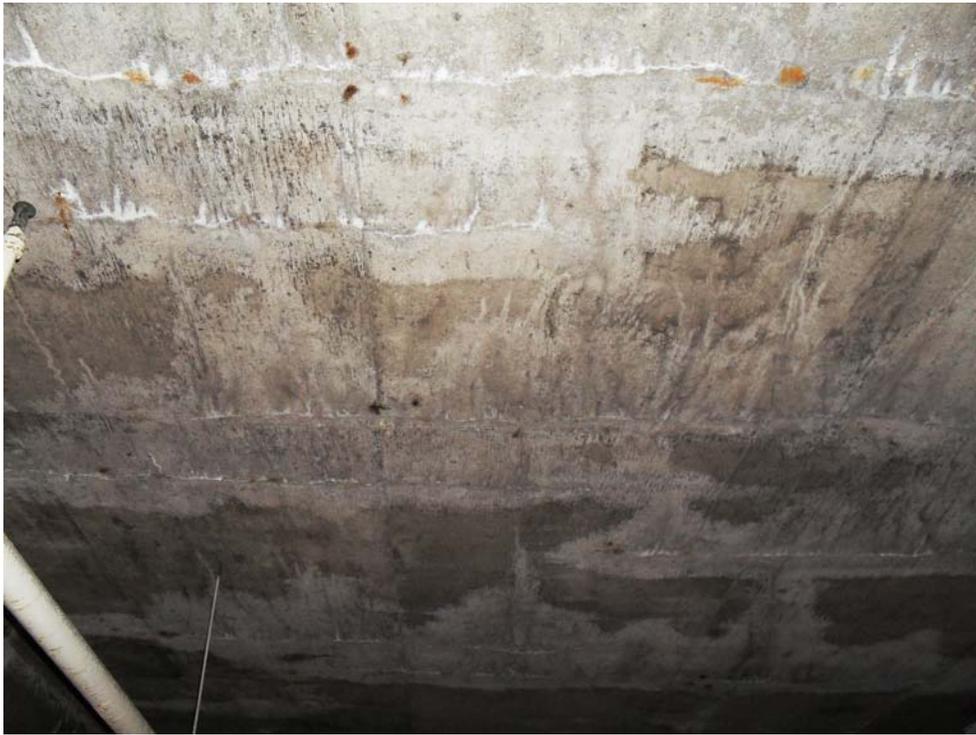
The underside of the Level A and B slabs, especially under the drive aisles, exhibit numerous efflorescence stained and delaminated areas, scaled concrete, and spalled concrete exposing corroded slab reinforcement (see Photos 15, 16 & 19). The majority of the slab deterioration is in the southern half of the garage, with the southwest quadrant the worst. Most scaled and spalled concrete areas have deposited an outline of the deterioration on the floor below (see Photos 6 & 17).

16. Level B: Ceiling Deterioration

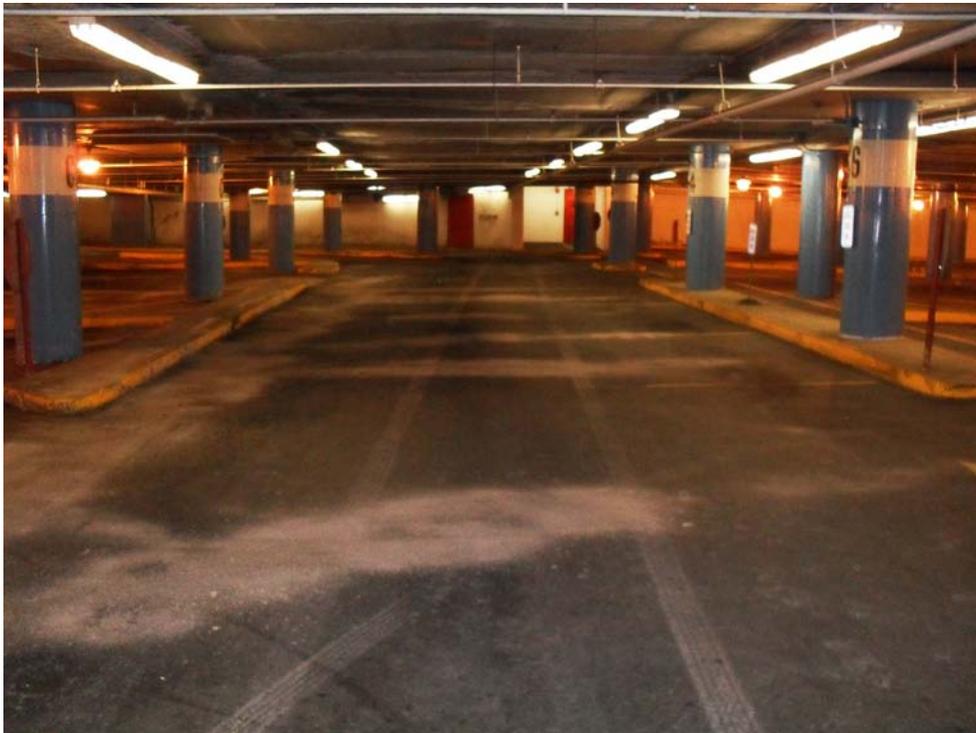
17. Level C: Ceiling Scaling Deposits on Main Drive Aisle

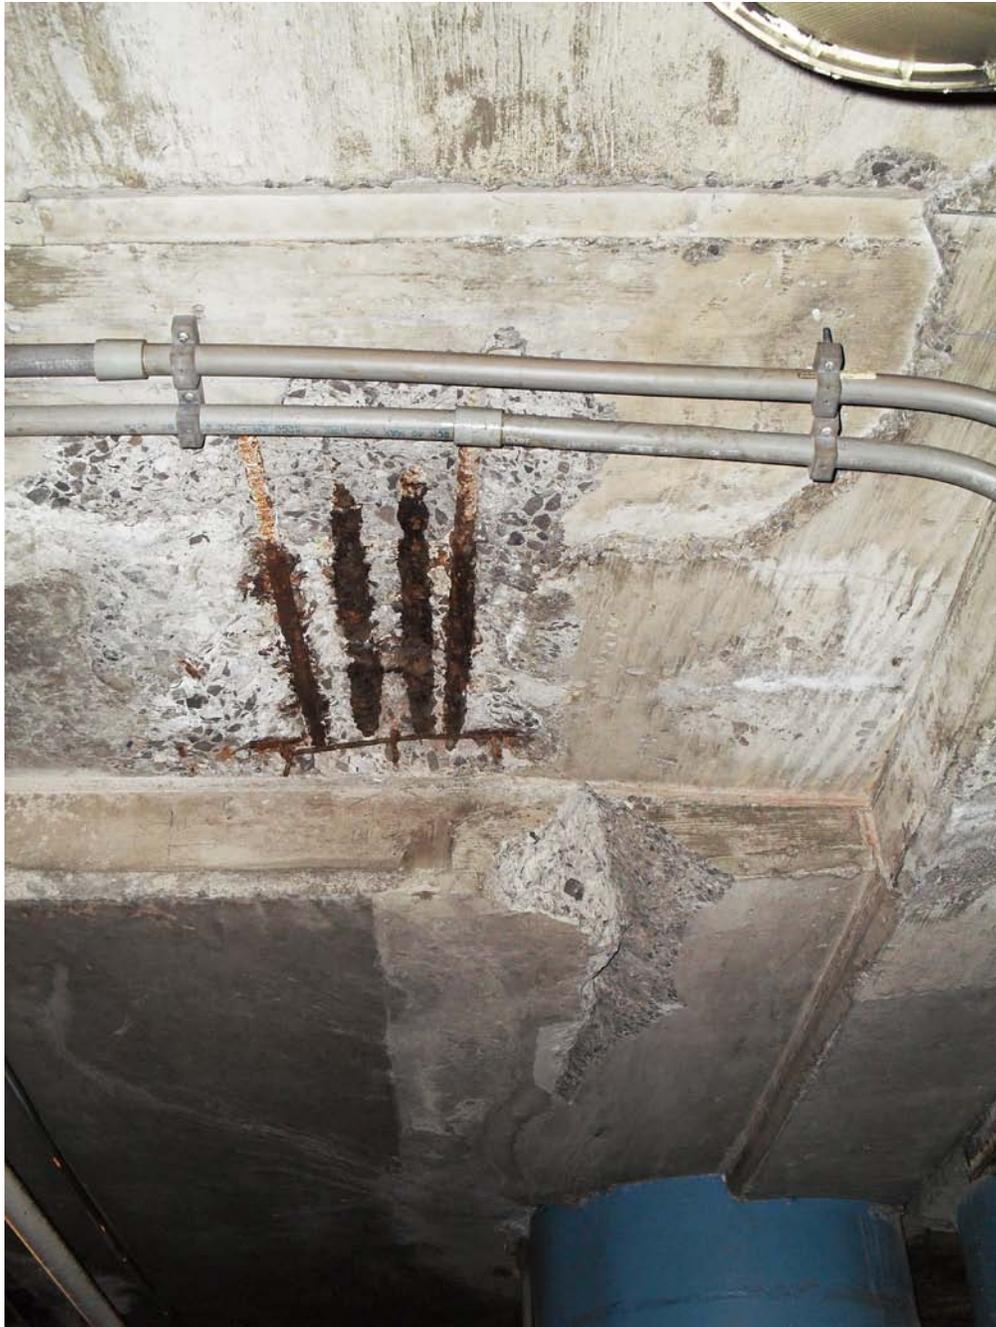
On Level C at Column 8-H, an efflorescence stained and spalled concrete area with exposed corroded reinforcement in the slab underside is adjacent to a crack and spall in the column drop panel (see Photo 18).

18. Level C: Column 8-H Drop Panel Spall and Crack

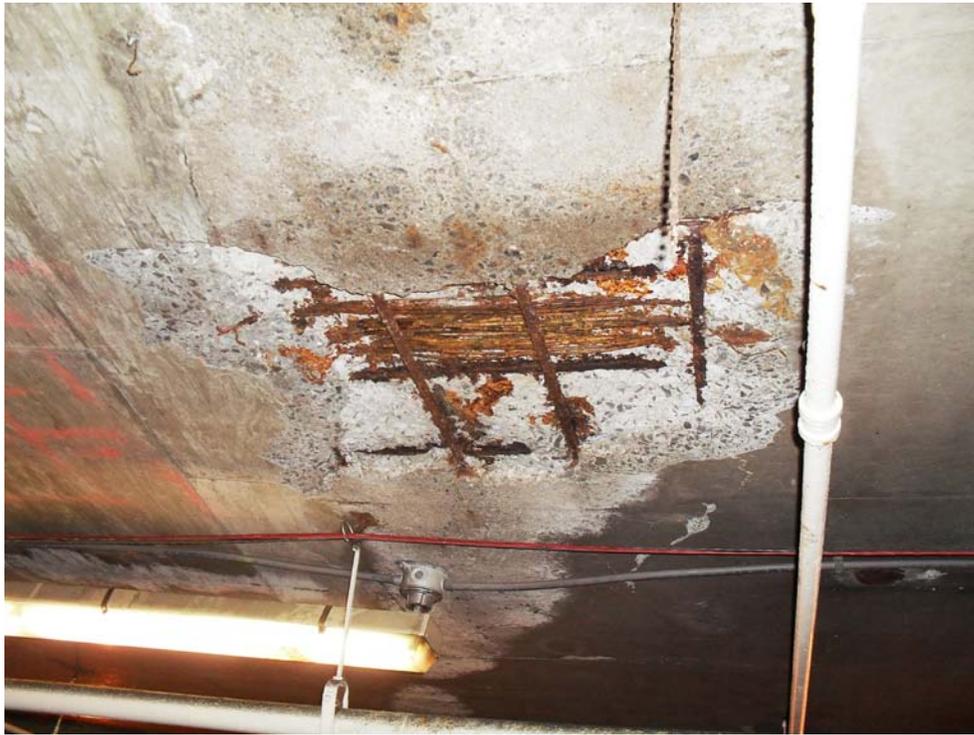
19. Level C: Ceiling Deterioration

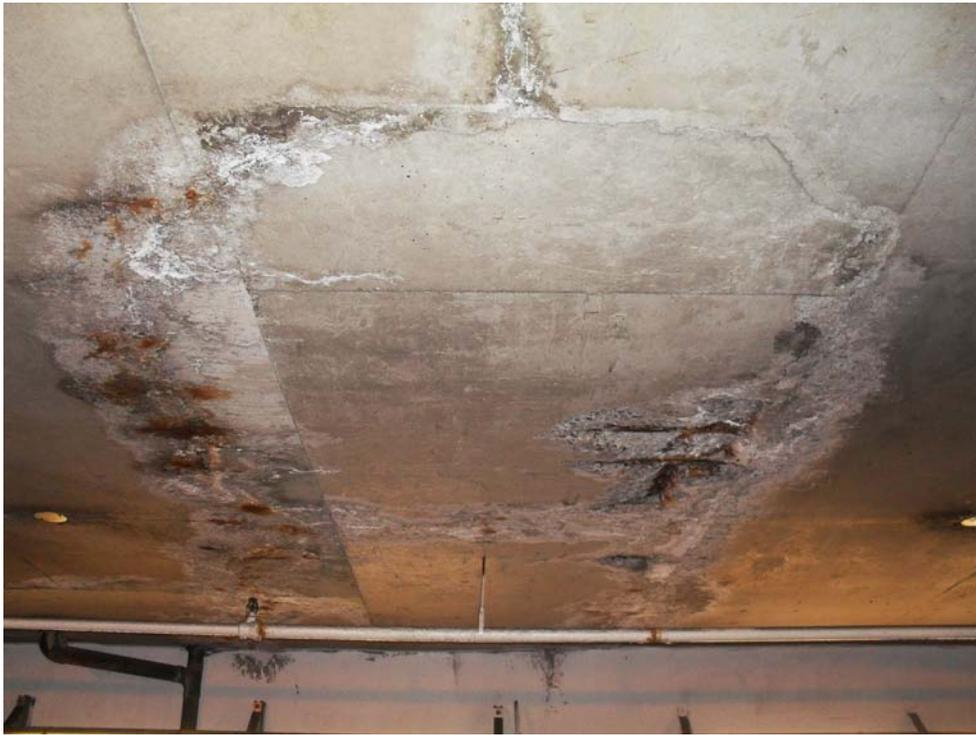
21. Level C: Ceiling Deterioration Around Previous Patch

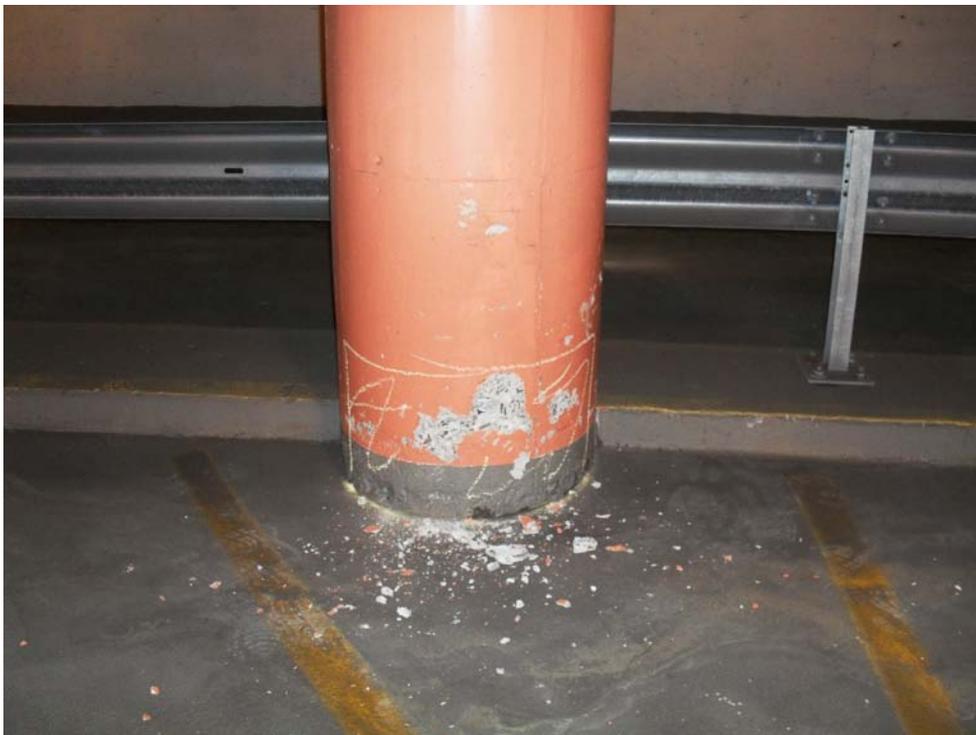
Columns on Level A and B typically exhibit isolated concrete delamination and spalls at the floor line (see Photo 22). Level C columns are in worse condition; exhibiting concrete delamination and spalls on the majority of the columns at the floor line (see Photo 23).

22. Level B: Typical Deterioration at Column Base

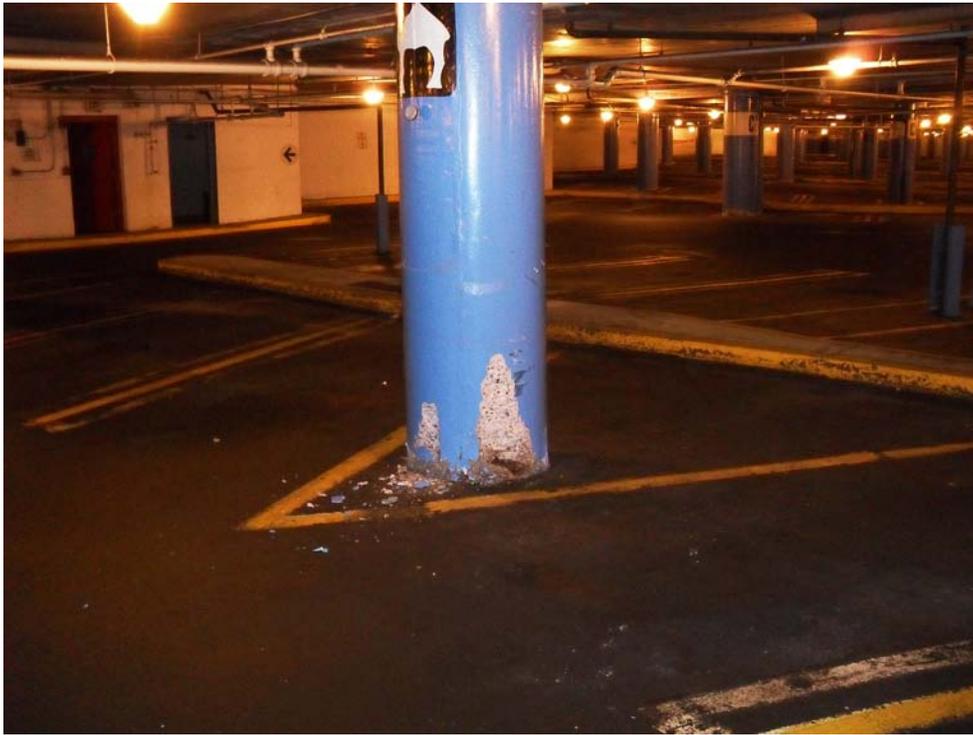
23. Level C: Typical Deterioration at Column Base

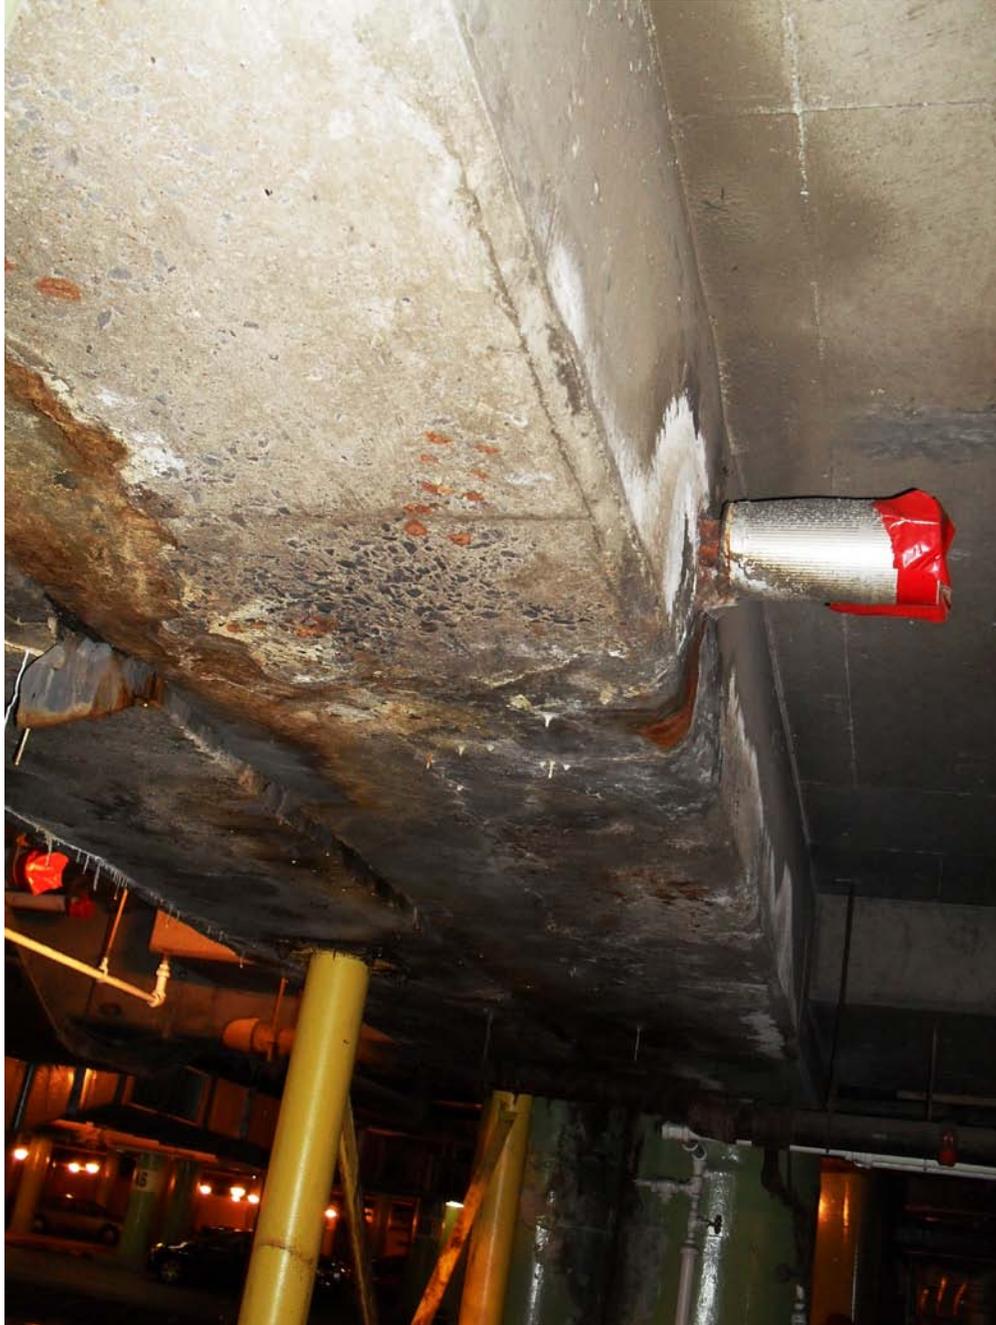
25. Level A: Beam Deterioration at Leaking Expansion Joint

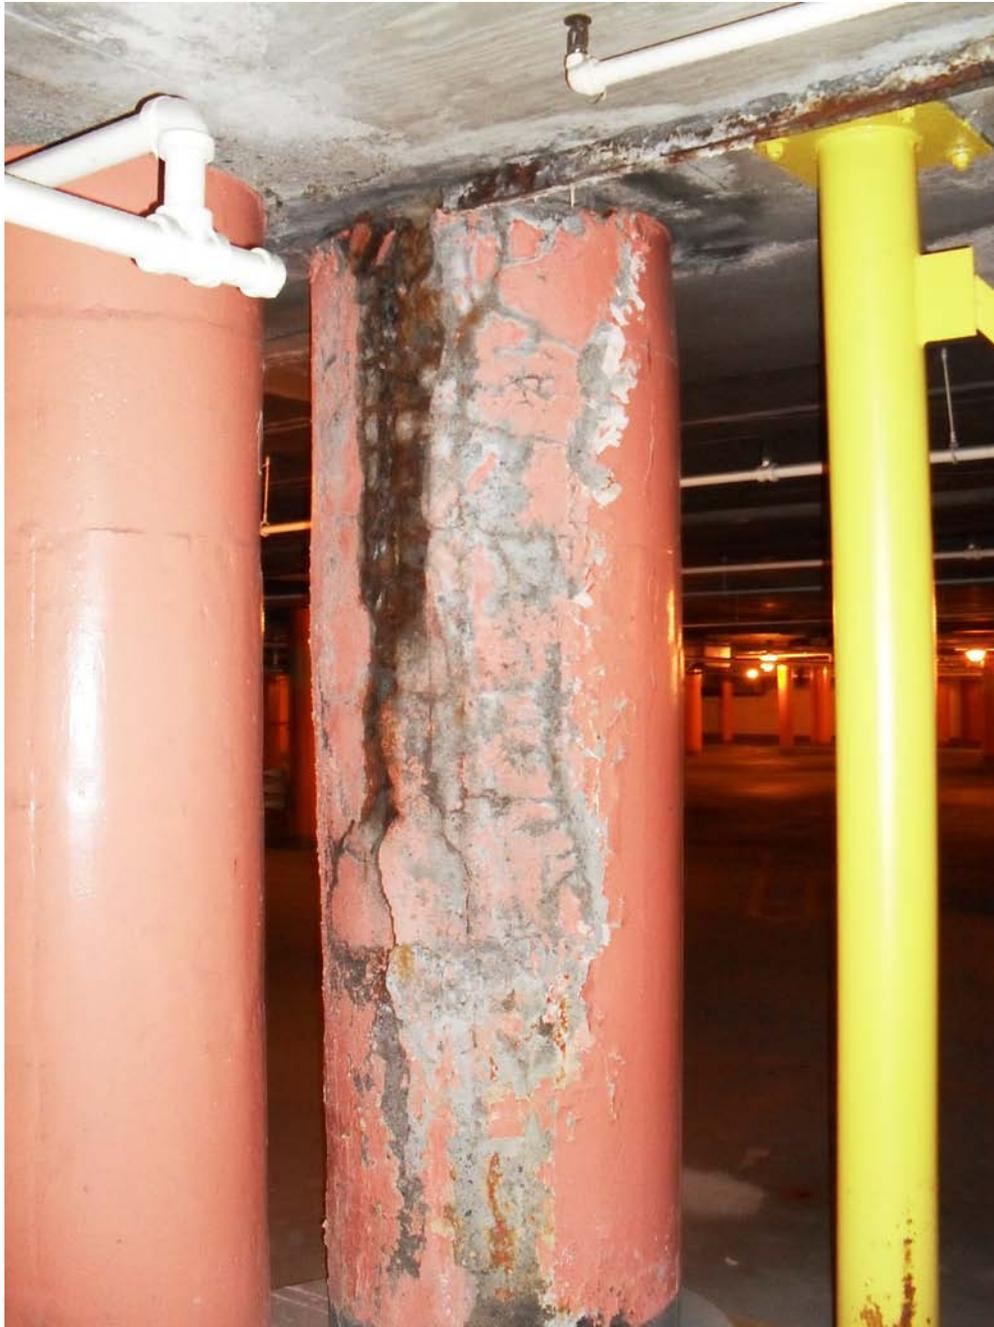
At the leaking Mall Level north/south expansion joint that extends under Broad Street, the columns at 5-H, 5-H.1, 6-H & 6-H.1 exhibit severe concrete deterioration; significant map cracking, delamination, spalls, rust stains and exposed, corroded reinforcement. This deterioration carries down to all three garage levels (see Photos 24, 26 & 27). In 2008, temporary steel bents were installed in this column bay in the event the columns’ structural load carrying capacity is compromised by the active deterioration.

26. Level B: Column 5-H Deterioration at Leaking Expansion Joint

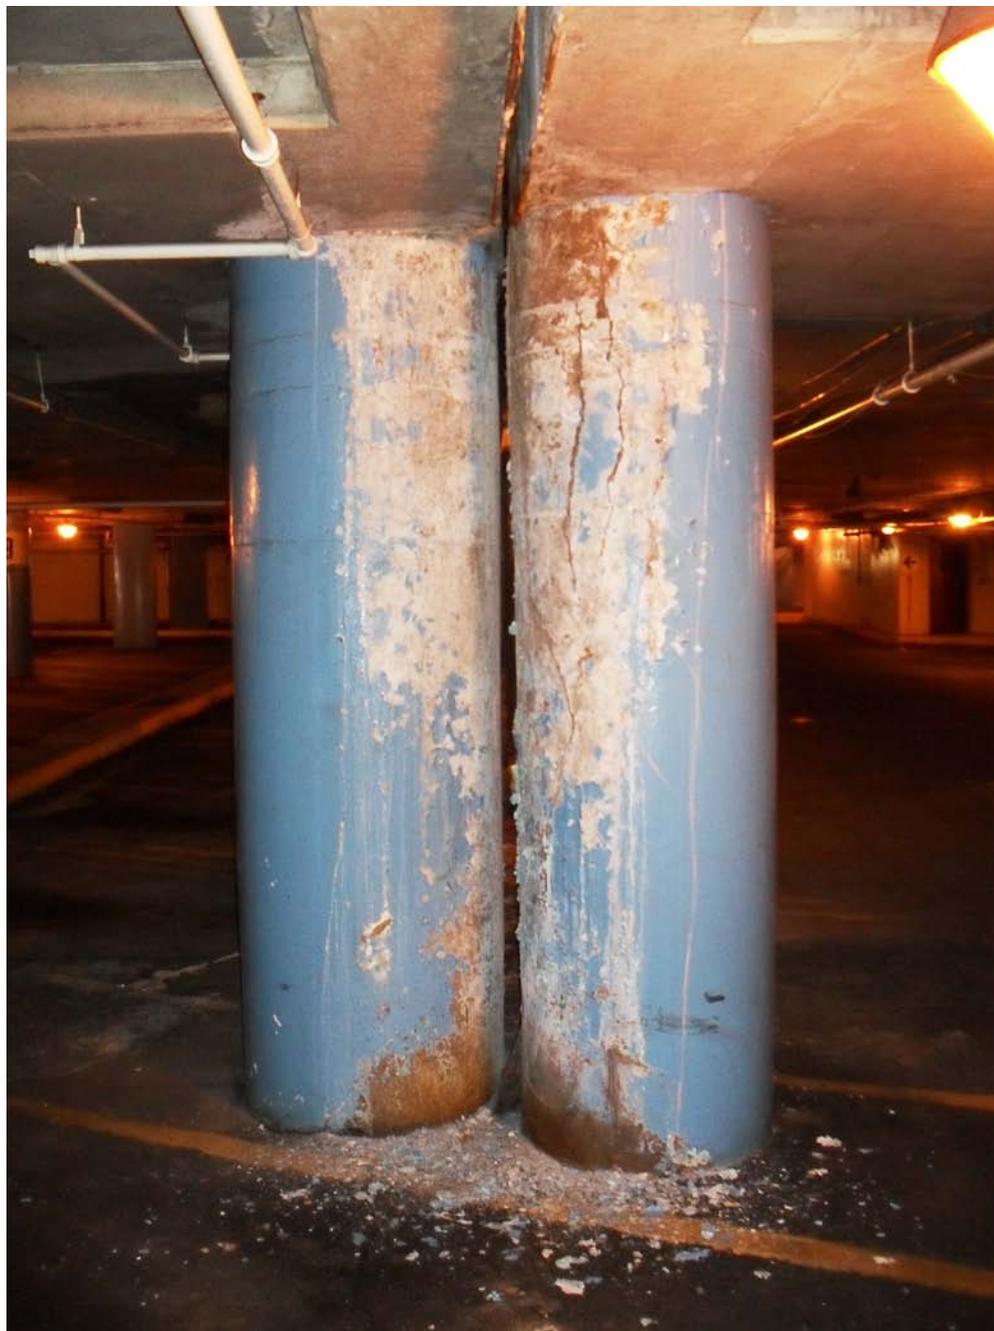
27. Level C: Columns 6-H/H.1 Deterioration at Leaking Expansion Joint

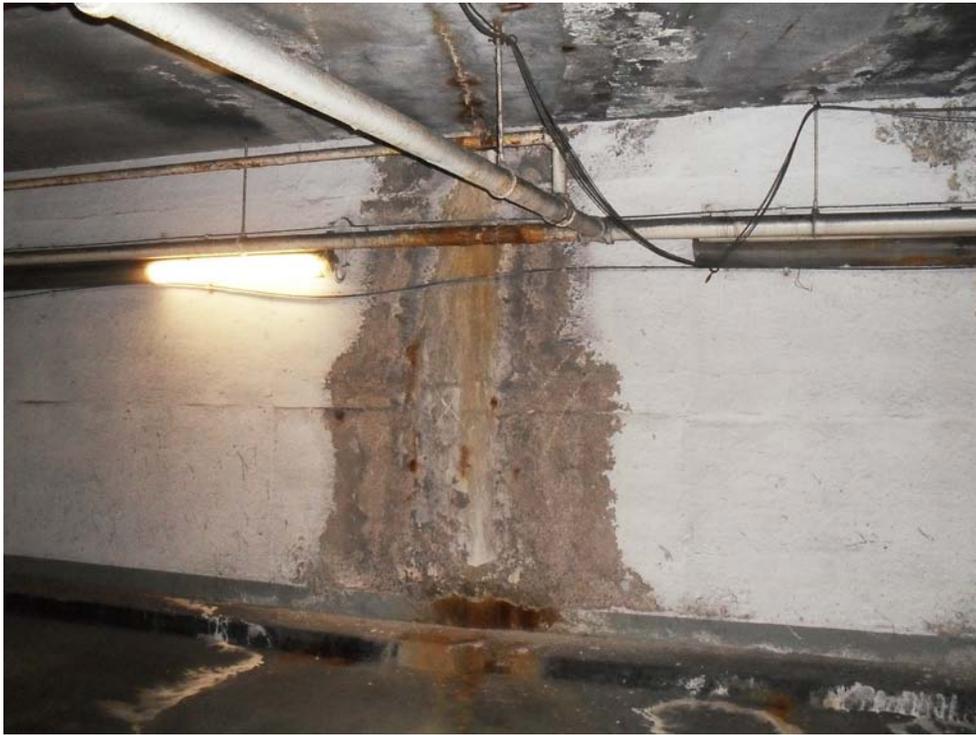
On Level A, evidence of leakage through the south exterior perimeter wall was observed (see Photo 28). This leakage has resulted in an extensive efflorescence build-up on the floor (see Photo 29).

28. Level A: Exit to Court Street Wall Leakage

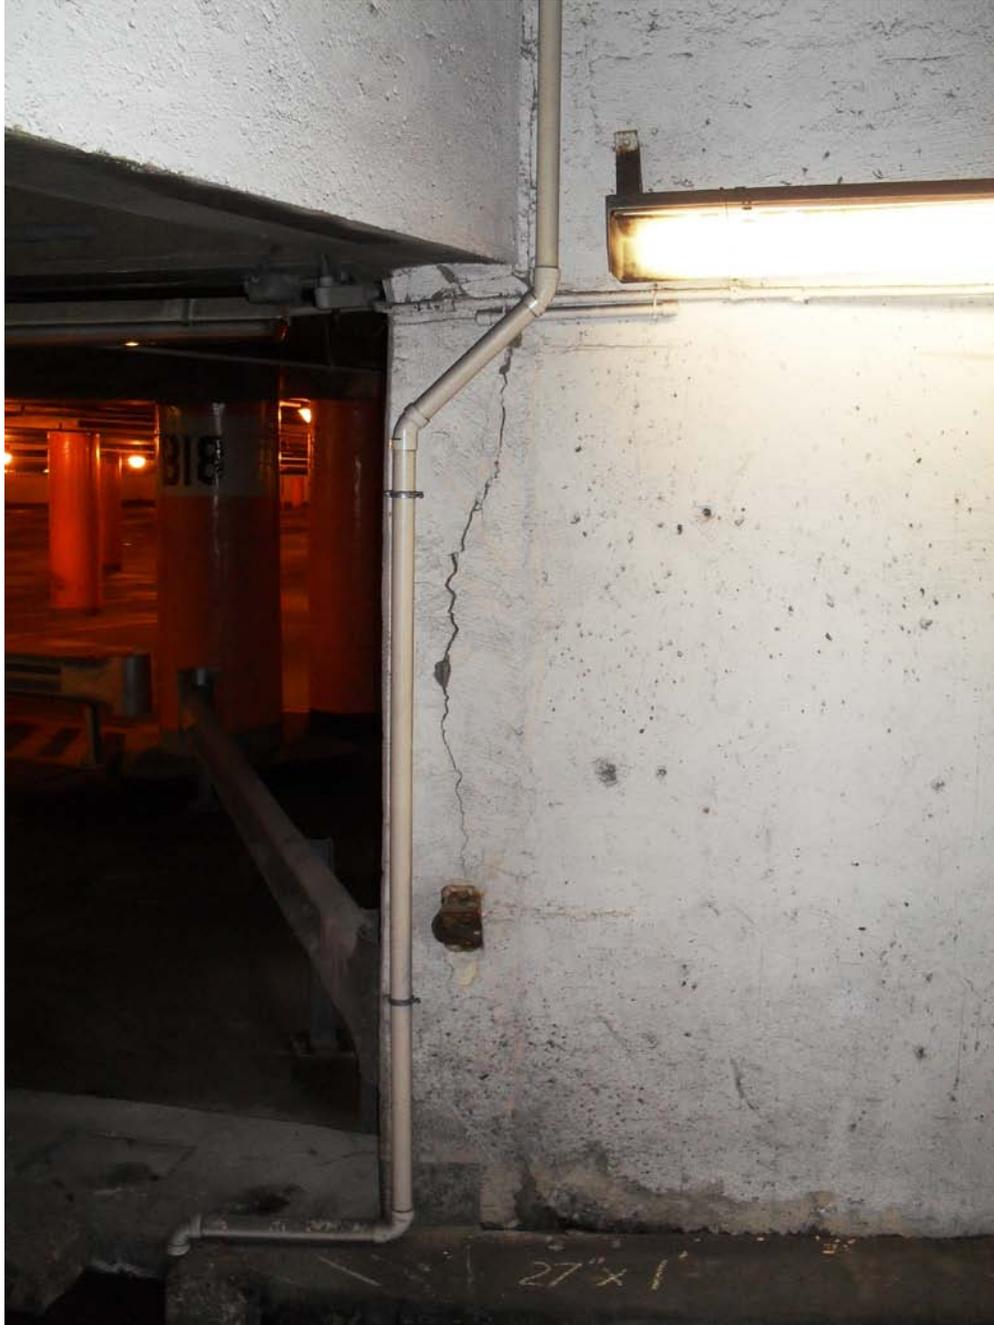
30. Level B: 3/16" Wide Wall Crack Under Beam

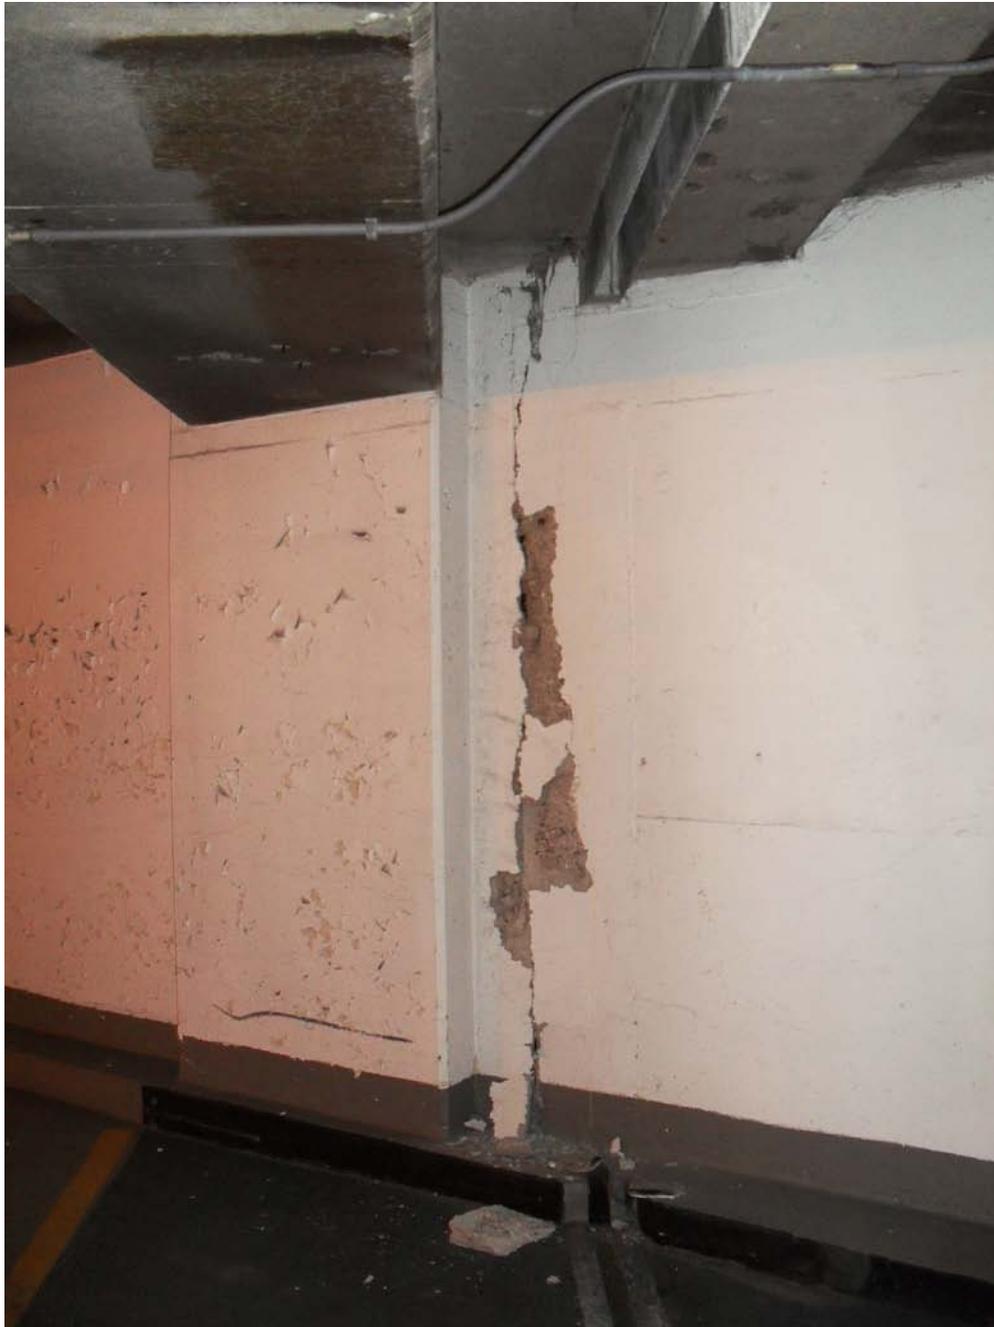
On Level B, a vertical wall crack and spall at the east/west expansion joint at Ramp R-4 (exit ramp to Chestnut Street) was observed (see Photo 31). Also on Level B, the wall ends at two locations exhibit severe cracking under a Level A slab floor beam. At Ramp R-4, the wall end exhibits a 3/16" wide diagonal crack on both sides of the wall (see Photo 30). At Stair Tower S-9, the wall end exhibits a diagonal crack and concrete spall (see Photos 32 & 33).

31. Level B: Wall Crack and Spall at Expansion Joint

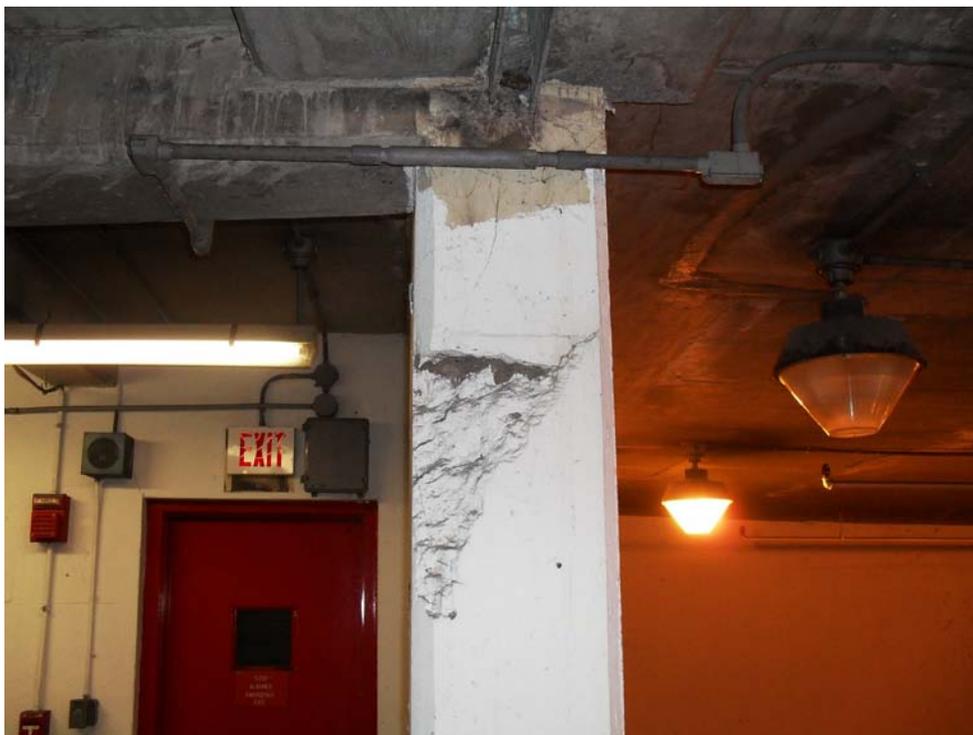
32. Level B: Spall Under Beam at Stair S-9

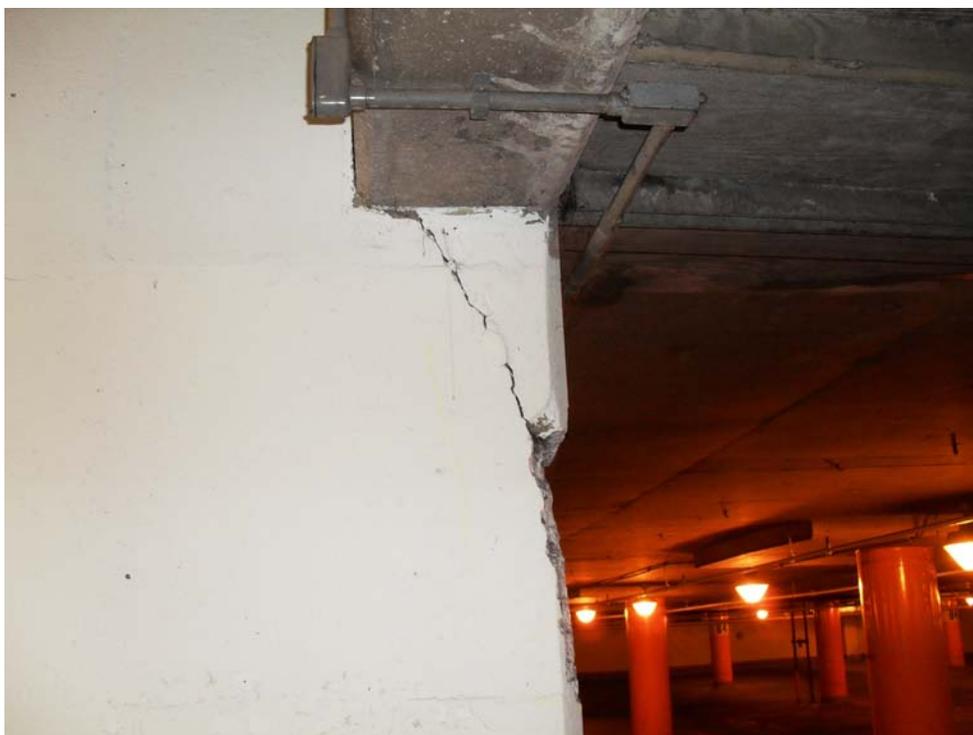
33. Level B: Diagonal Crack and Spall Under Beam at Stair S-9

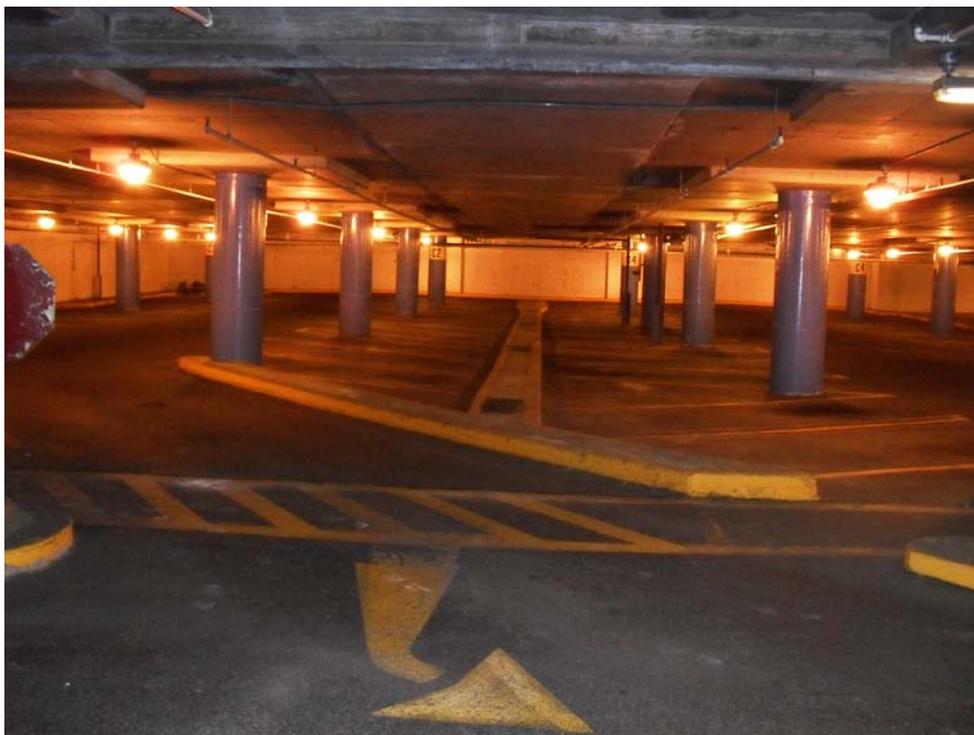
36. Level C: Typical Curb Layout Between Parking Rows

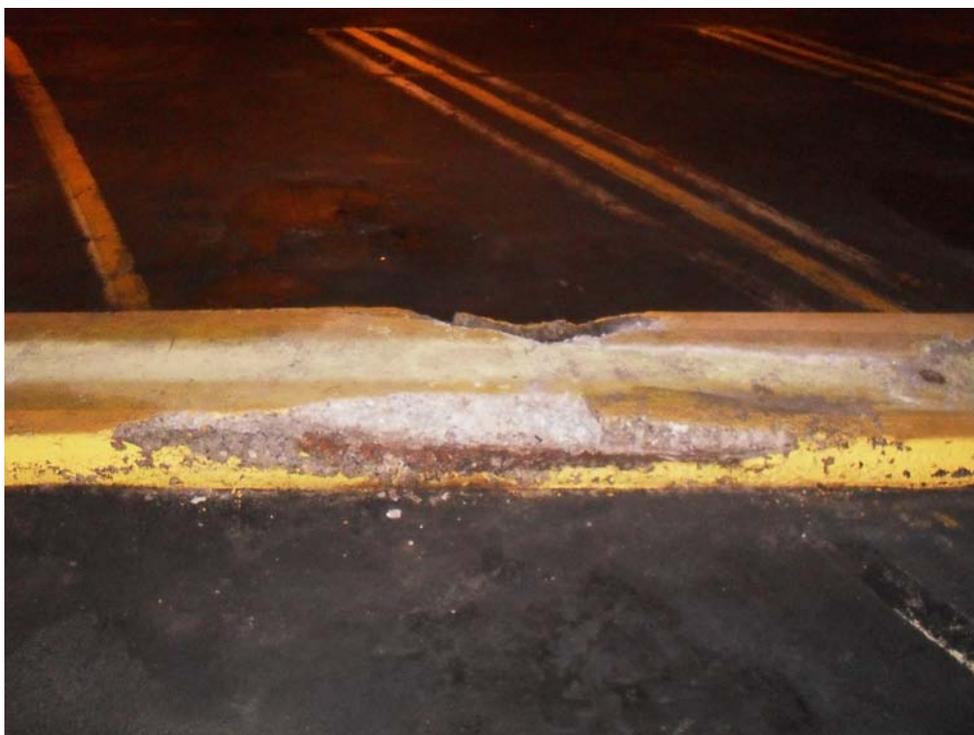
Delaminated concrete sections and spalled areas with exposed, corroded reinforcement were observed, predominately along drive aisles (see Photos 35, 37 & 38). On Level C, extensive areas of scaled concrete were observed on the topside of the curbs.

37. Level C: Typical Curb Spalls

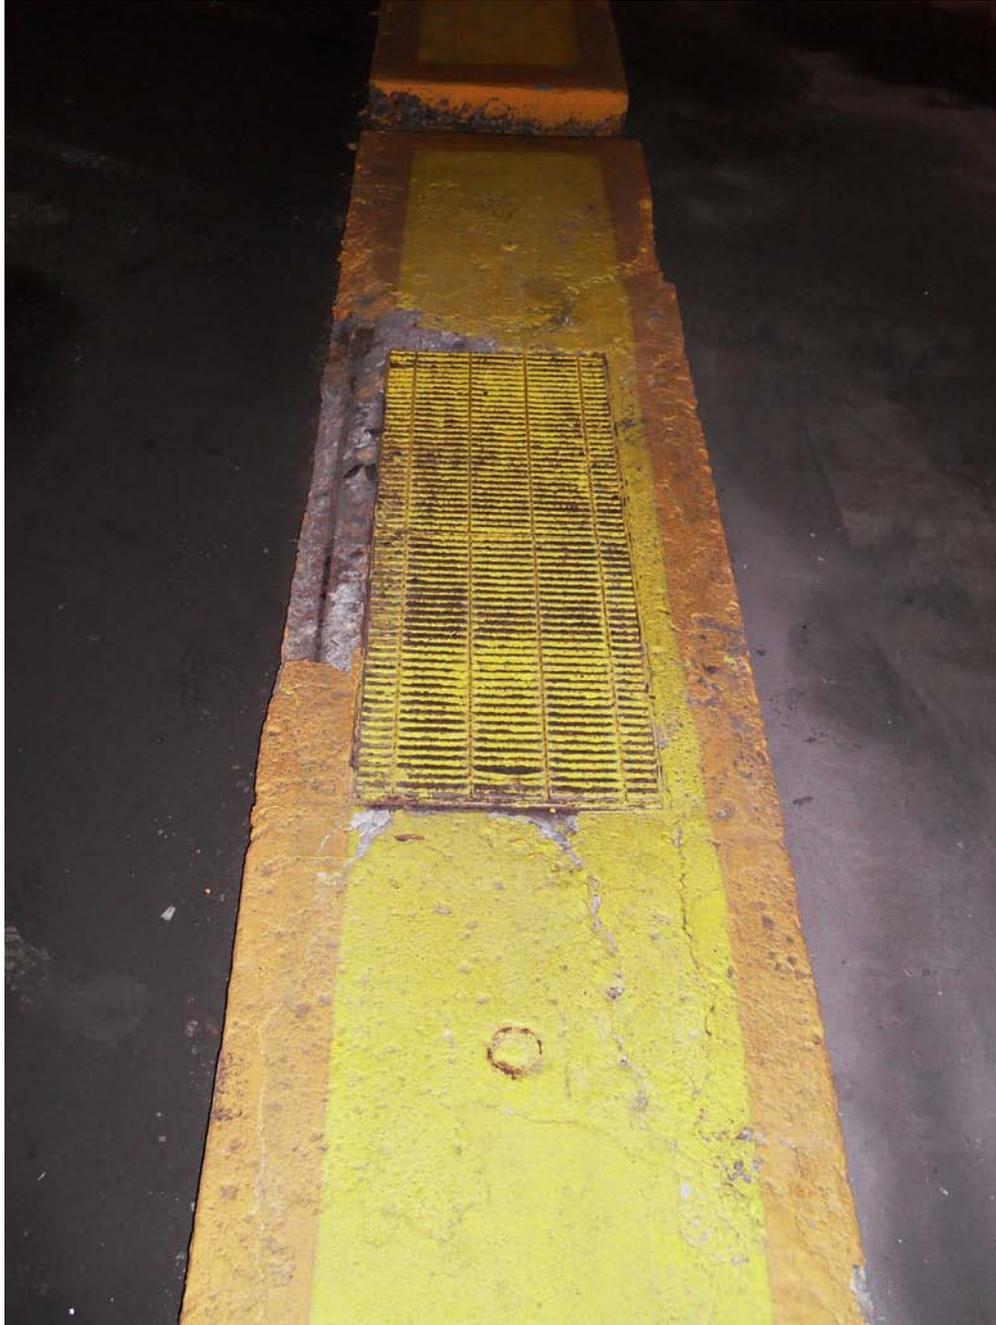
38. Level C: Typical Curb Scaling and Spall at Ventilation Grill
