# Midtown Parking Garage

Condition Survey

December 2010

**LABELLA**  
Associates, P.C.

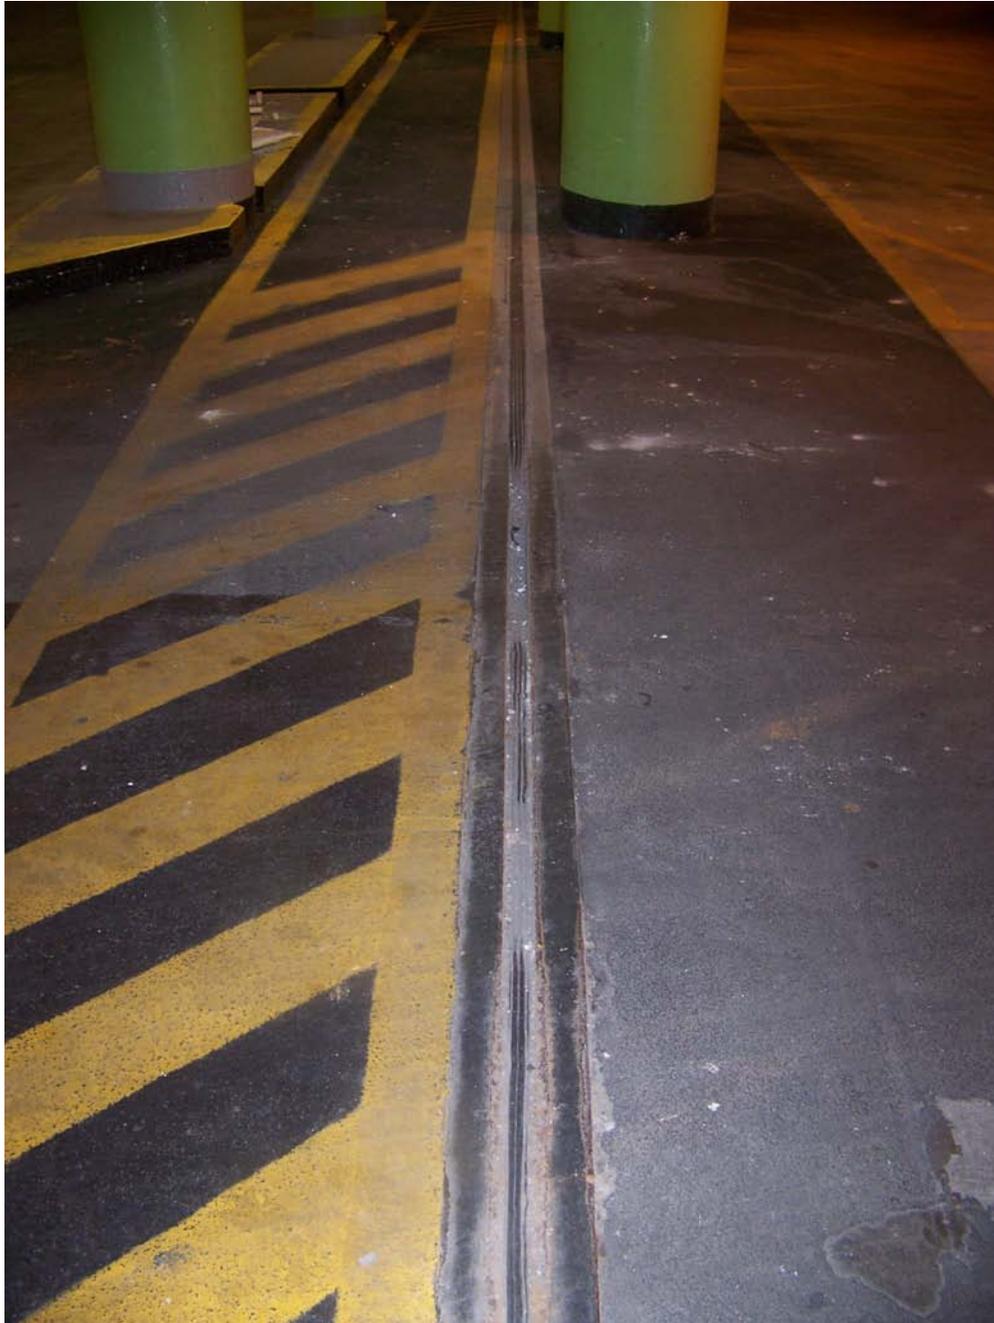
39. Level A: East/West Expansion Joint

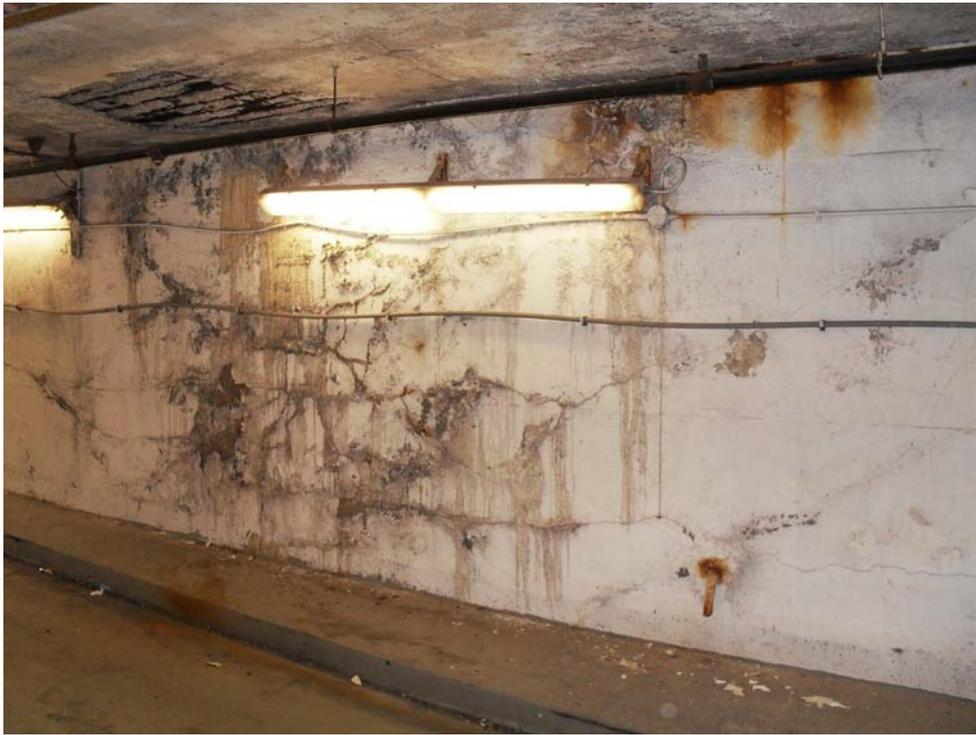
41. Clinton Avenue Entry: Wall and Ceiling Deterioration
