City of Rochester

Running Track Bridge

**August 2020 Inspection
Representative Photos**

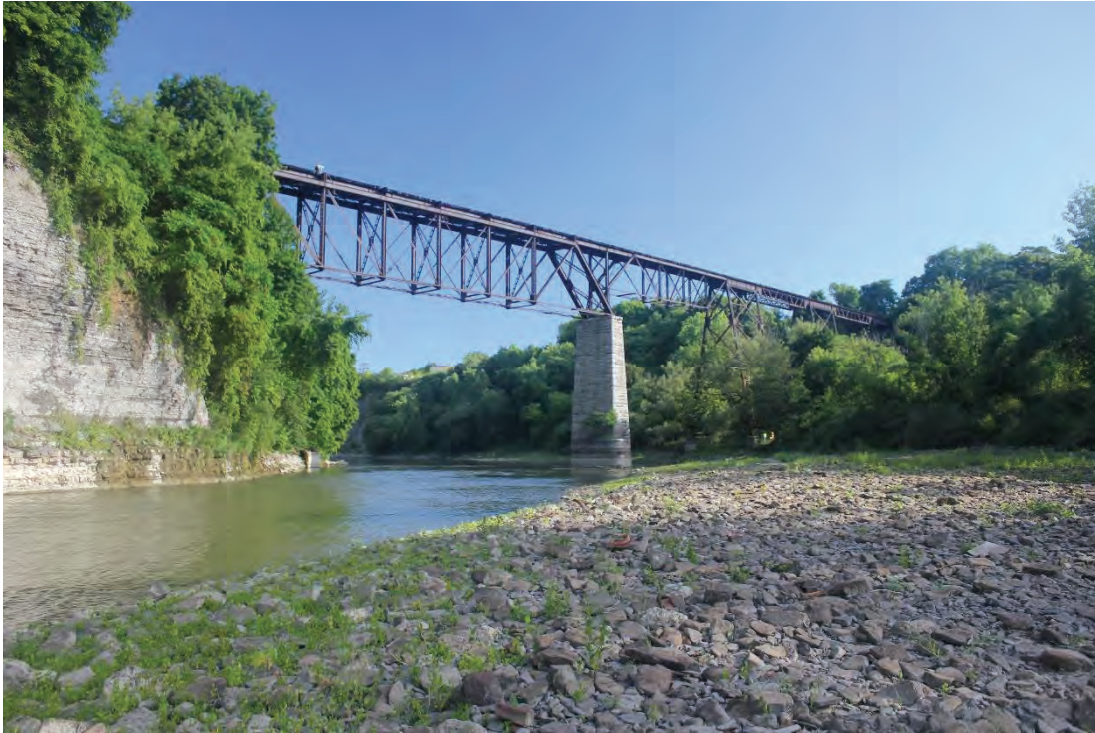
Rochester Running Track Bridge looking northeast

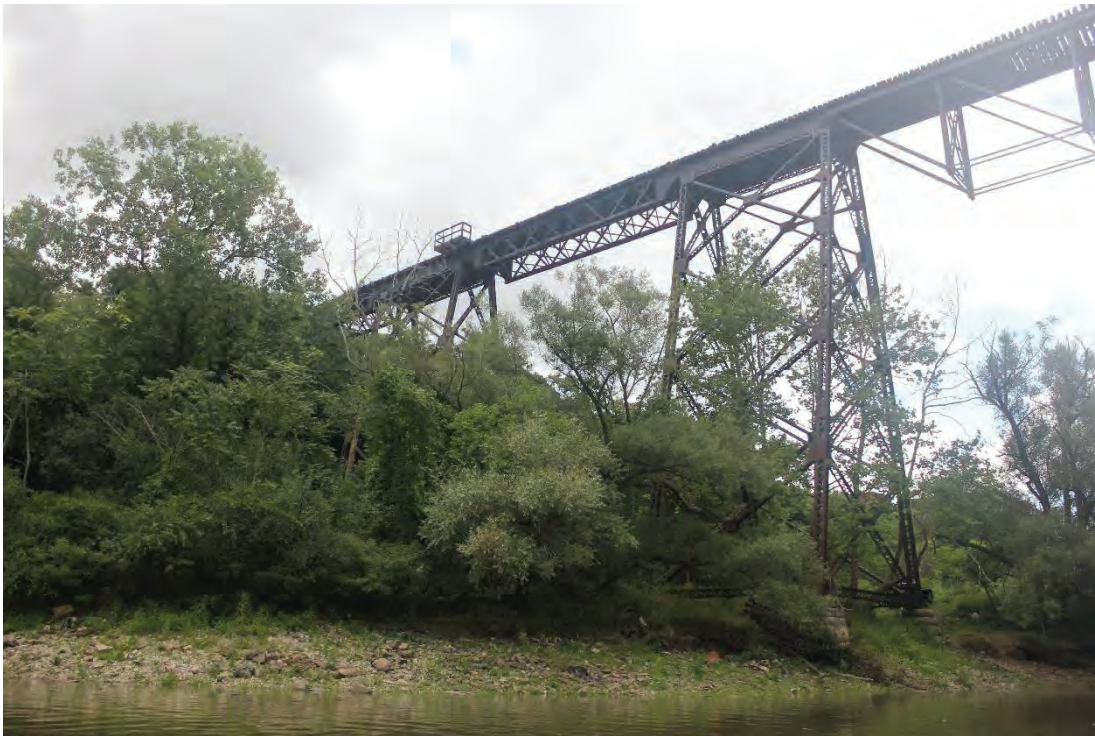
Rochester Running Track Bridge looking southeast

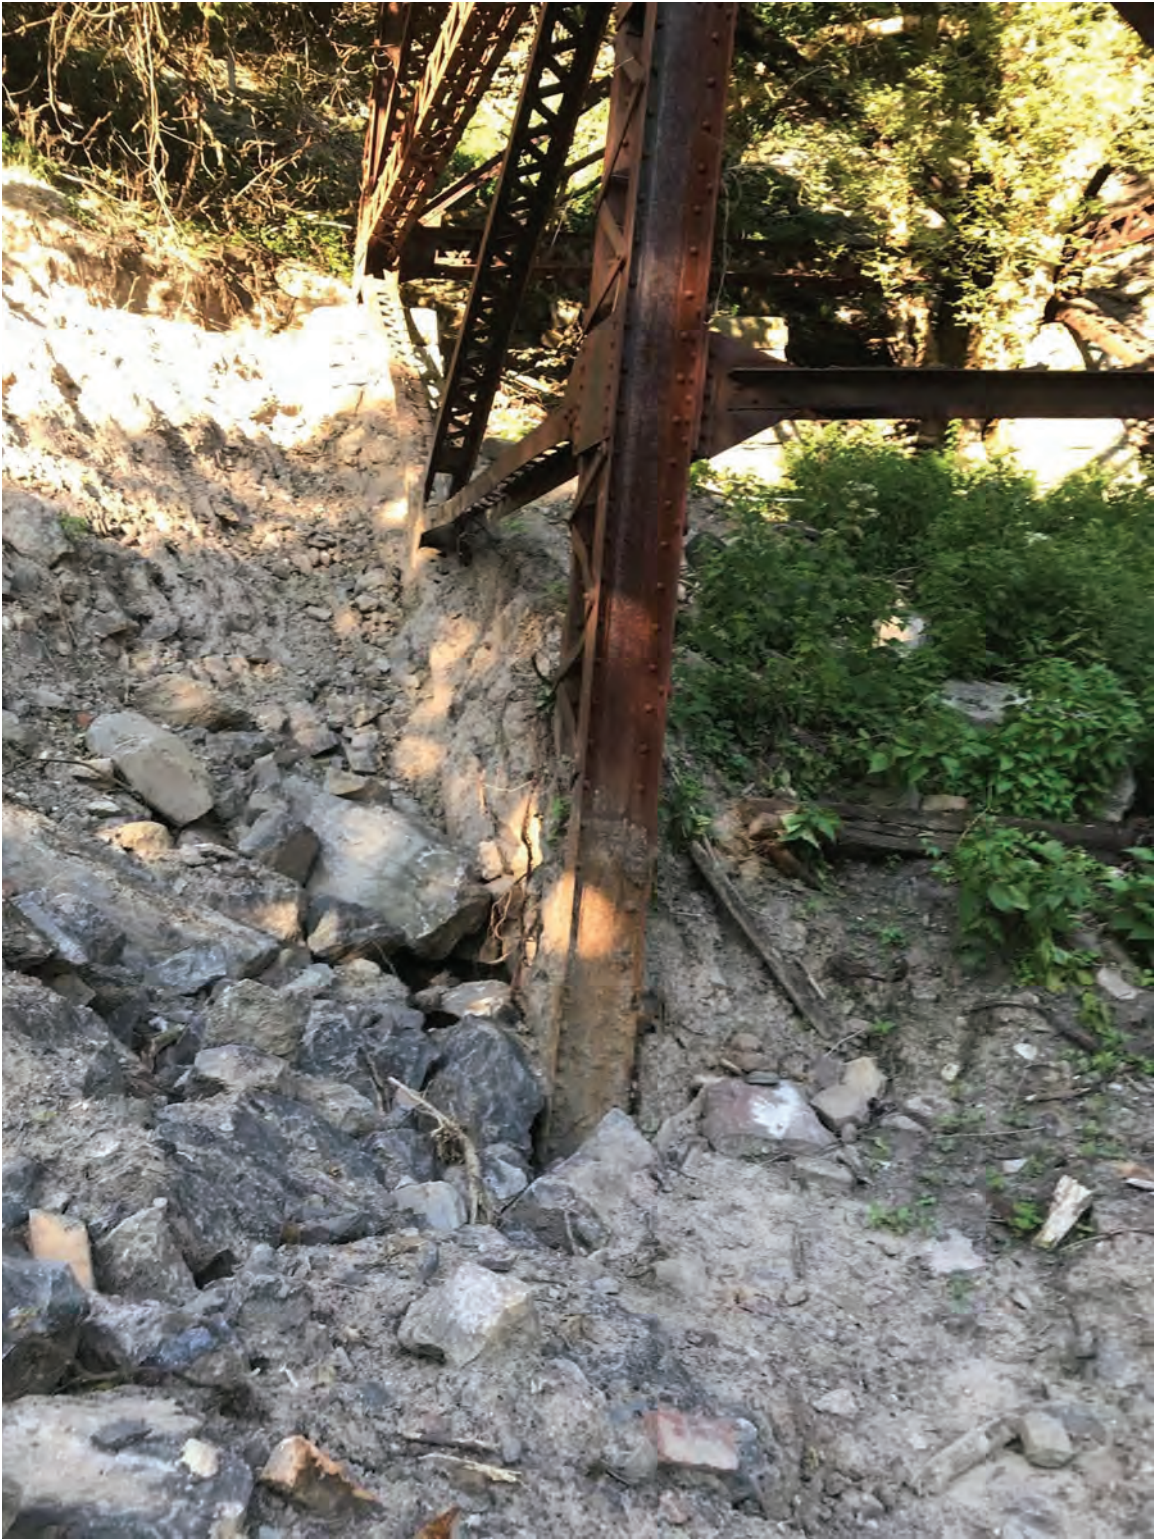
Bent B, North Tower Leg – post excavation and visual inspection

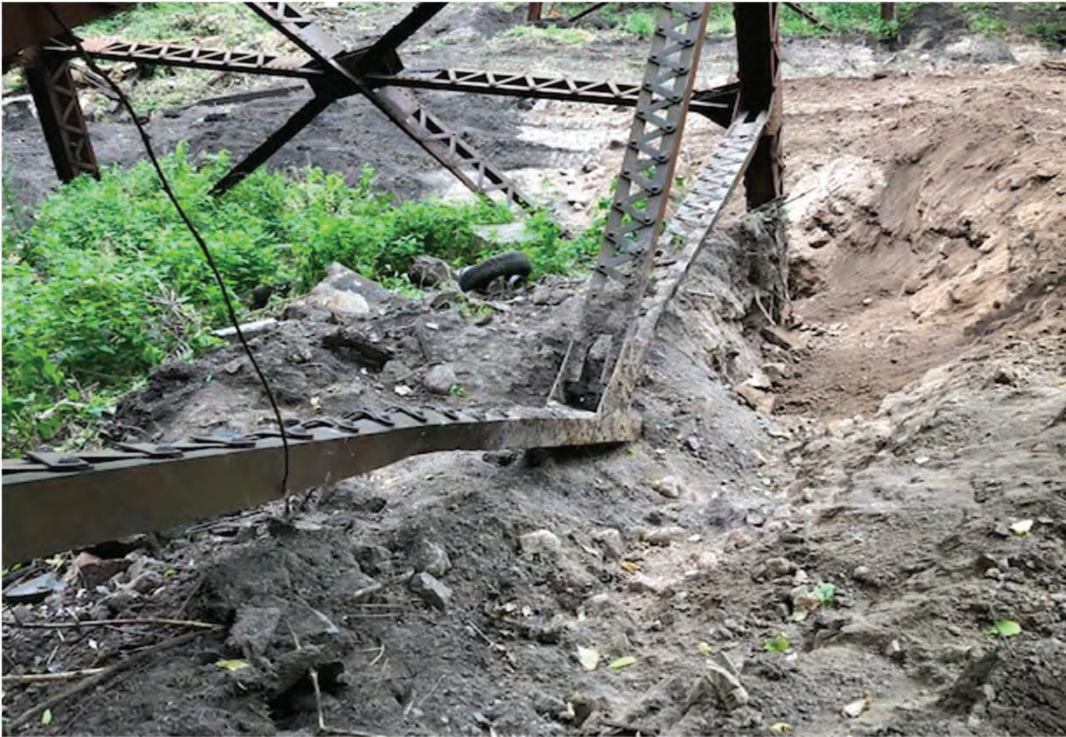
During excavation/inspection: North side Bent A-B bracing (looking SW)

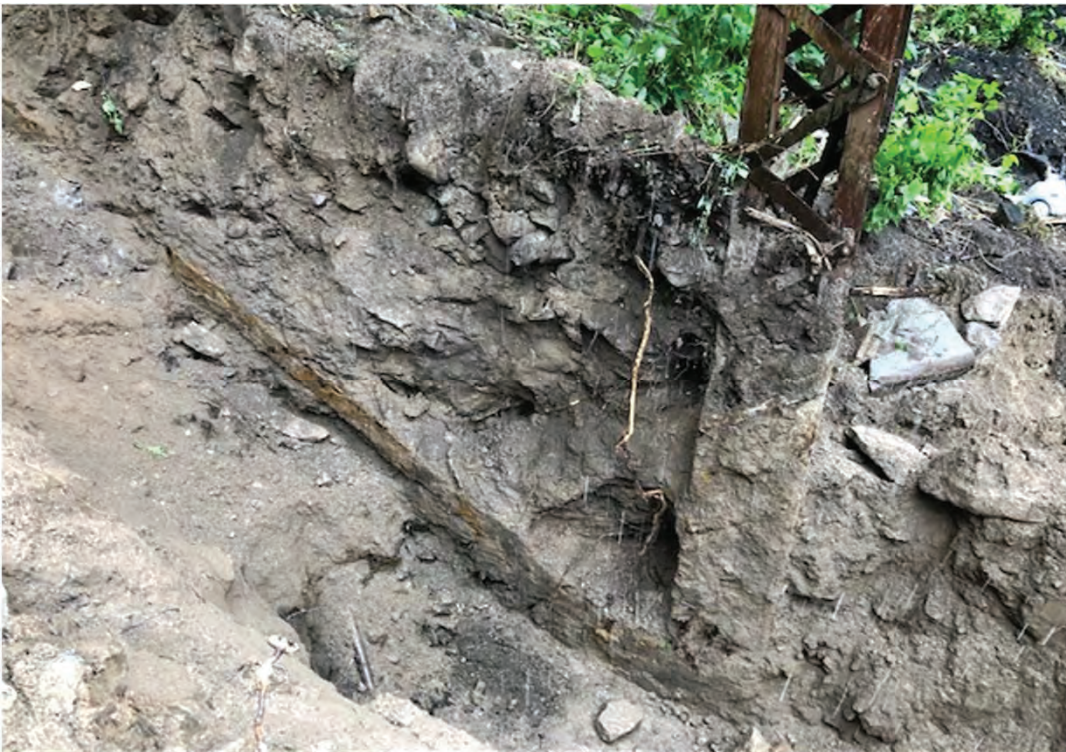
During excavation/inspection: Bent B north column (looking south)

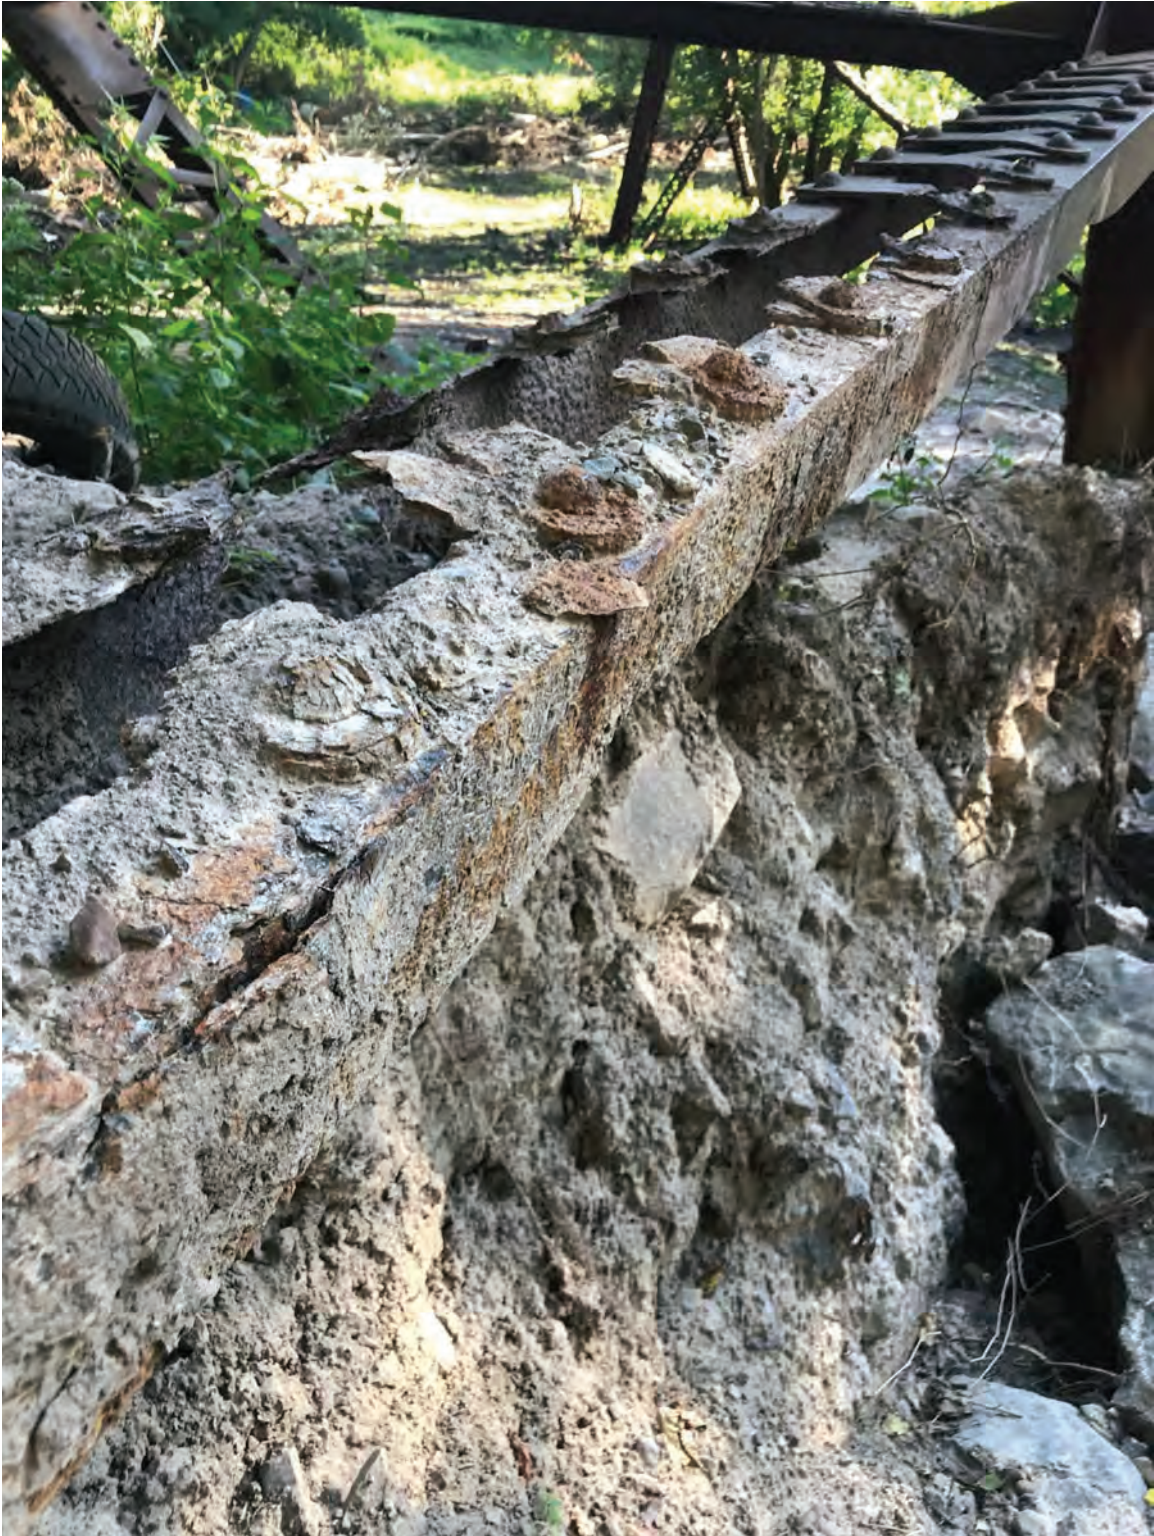
Bent A – Bent B North side longitudinal brace near groundline

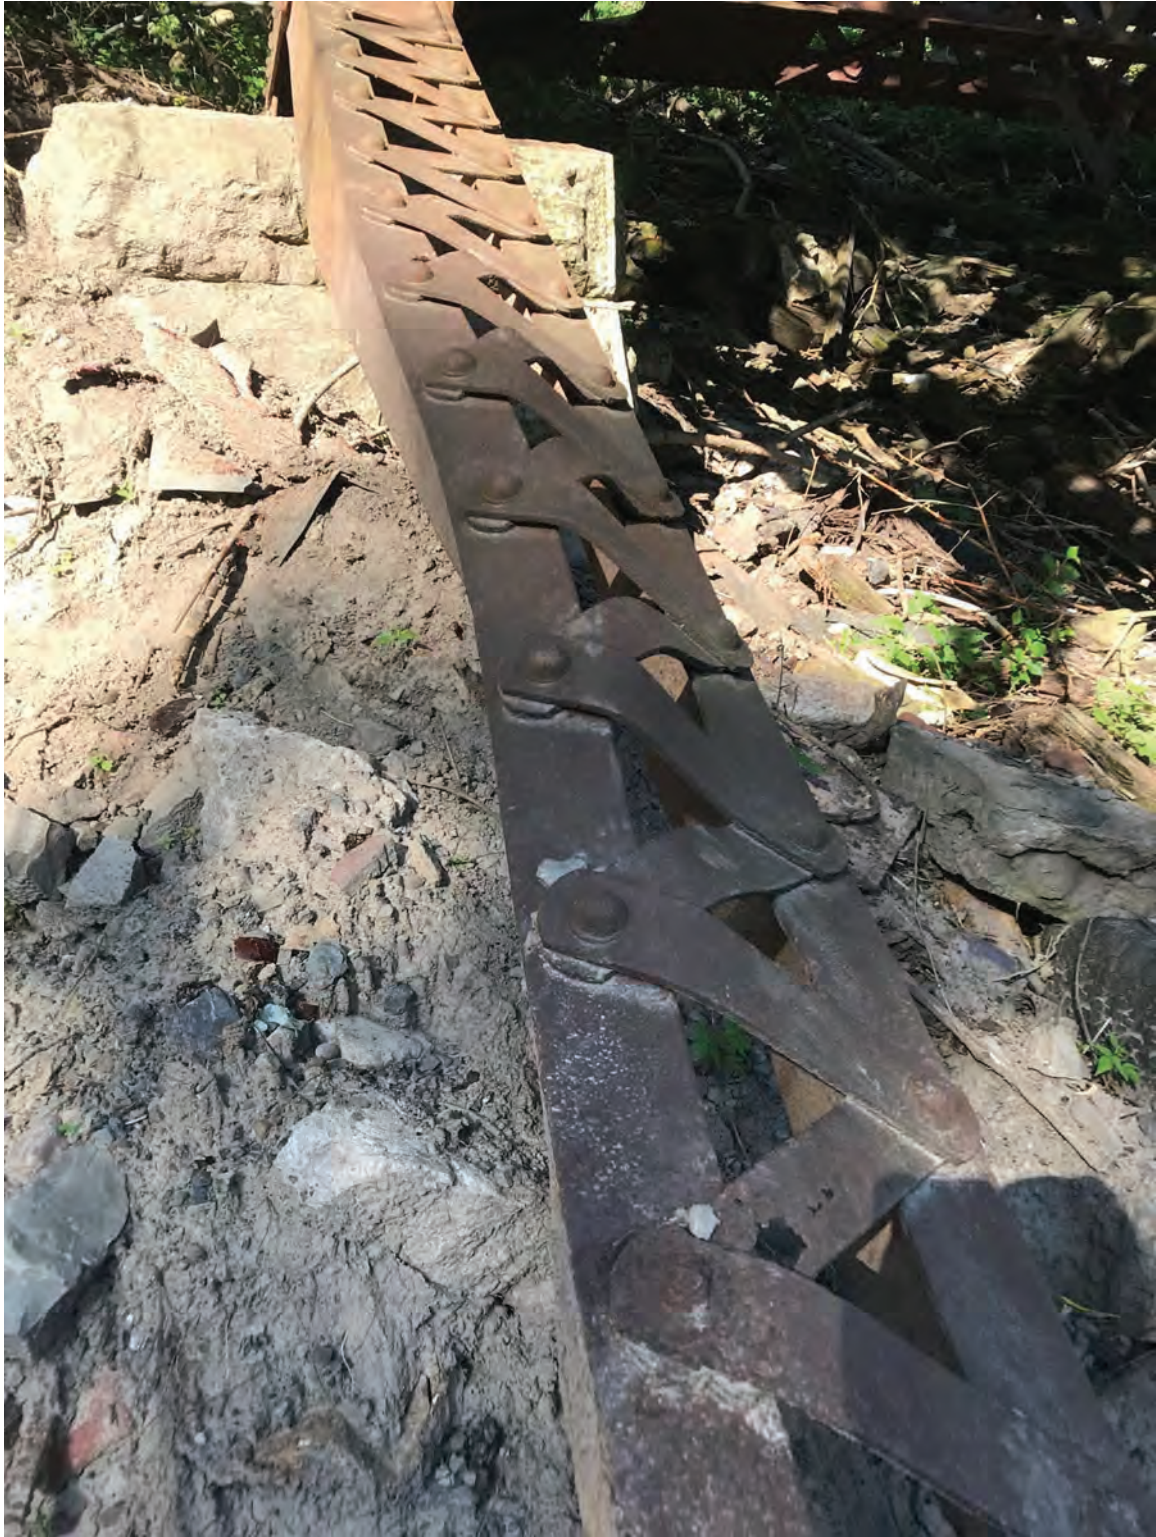
Bent A – Bent B North side diagonal brace near groundline

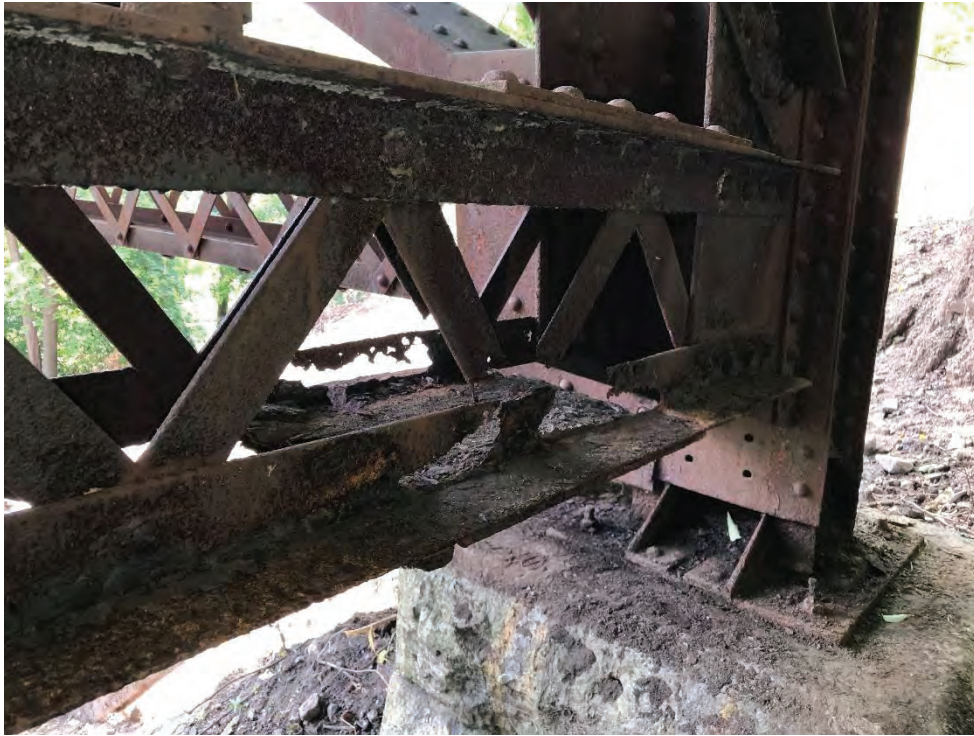
Bent A lower transverse strut at North column (east face)

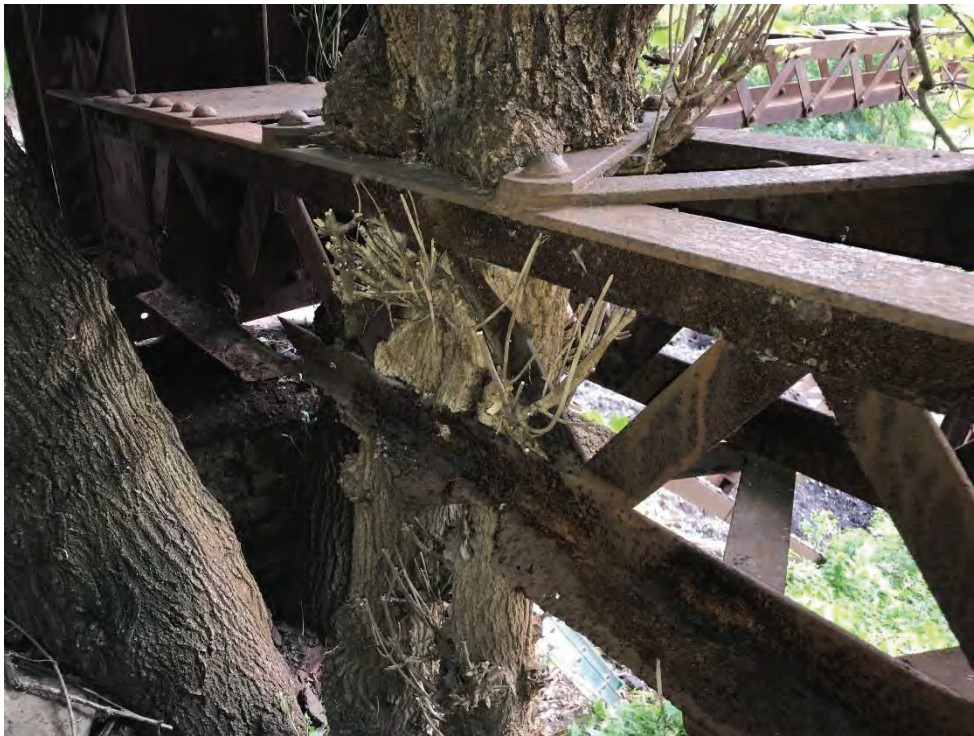
Bent A lower transverse strut at South column (east face)

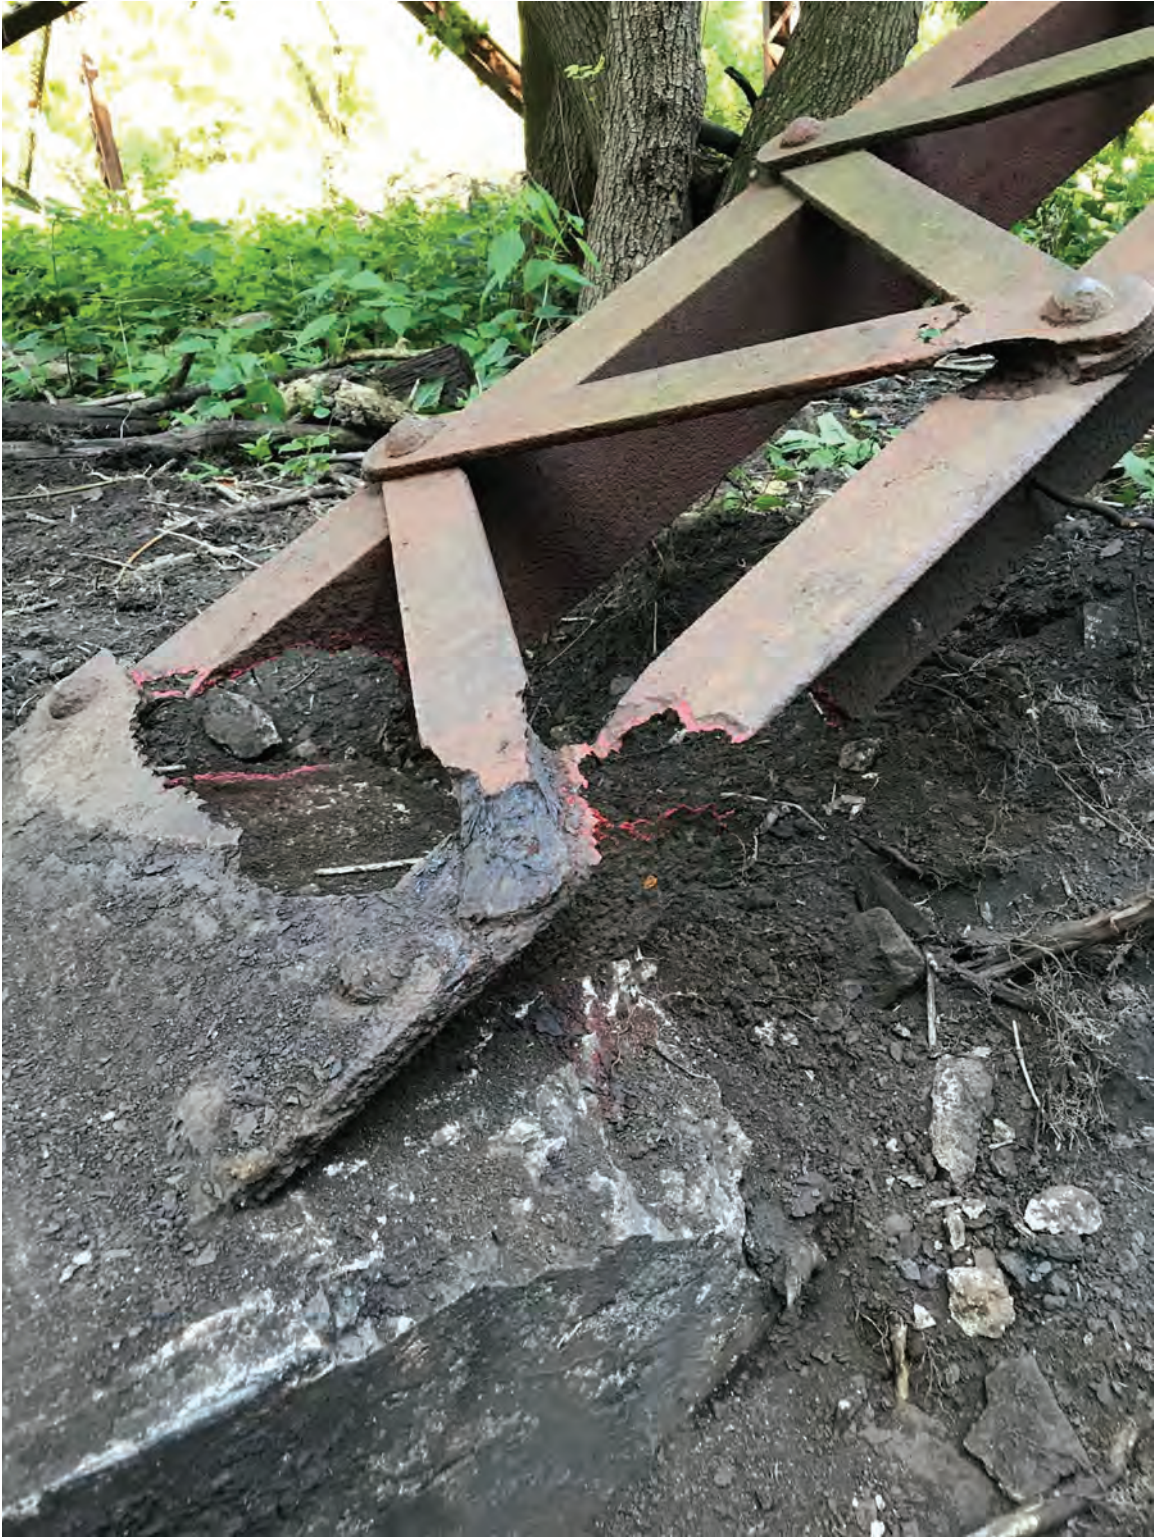
Bent C diagonal transverse brace at South column (east face)

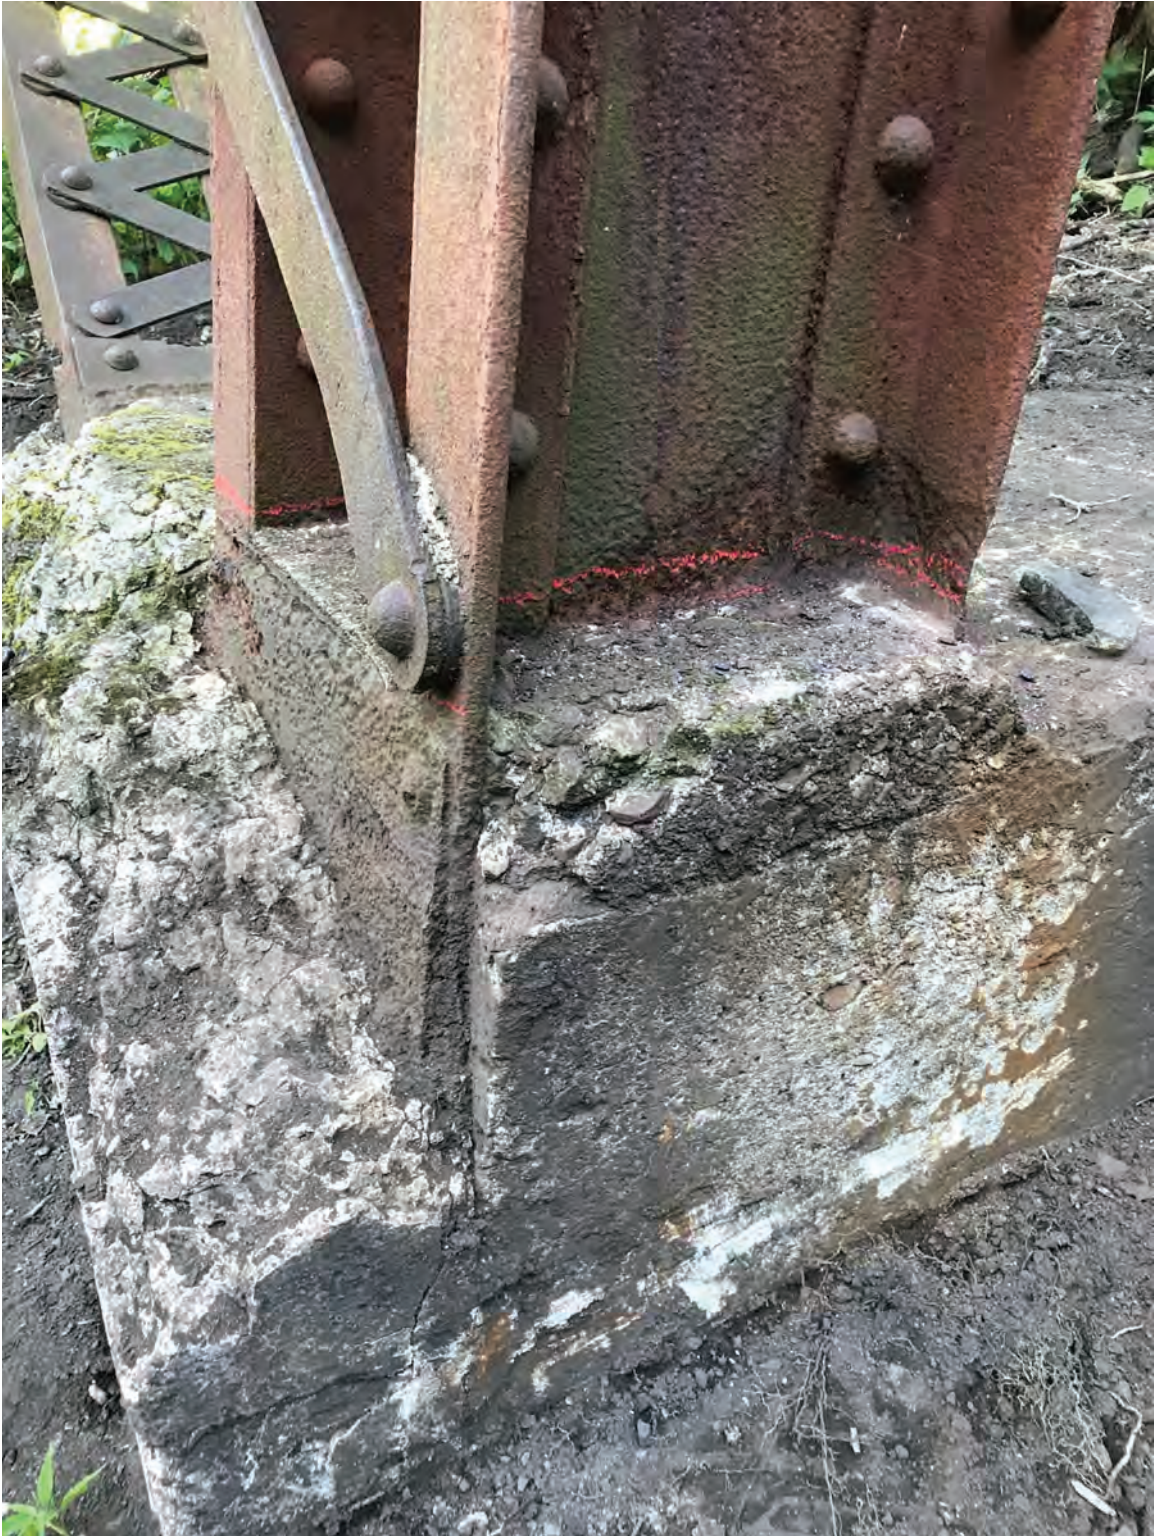
Bent C South column

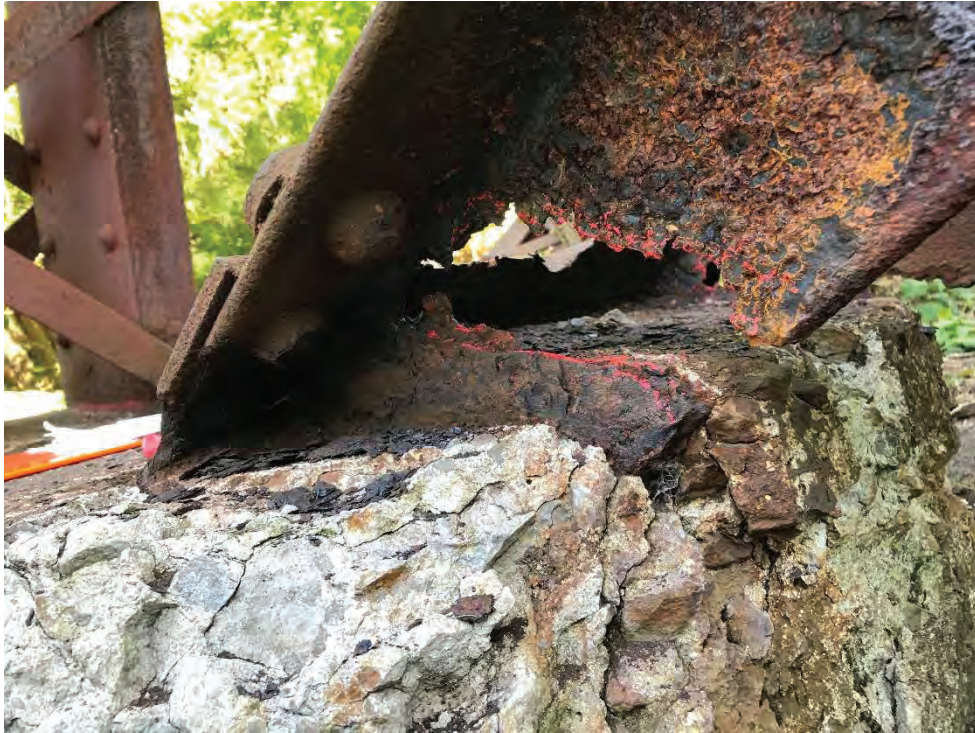
Bent D diagonal transverse brace at North column (looking northeast)

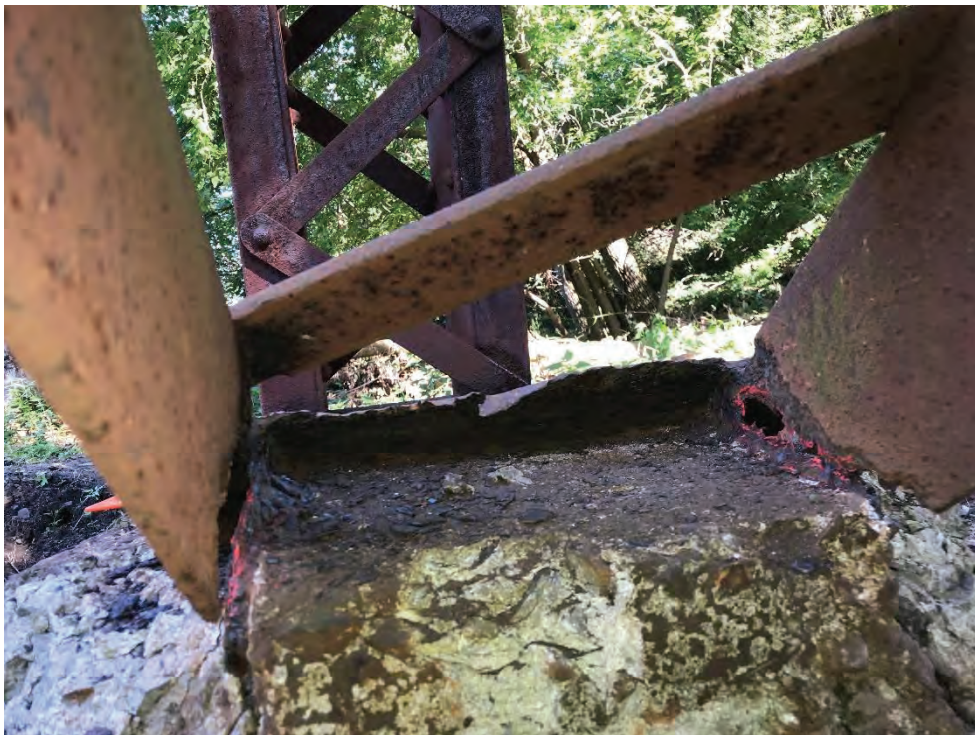
Bent D diagonal transverse brace at North column (looking north)

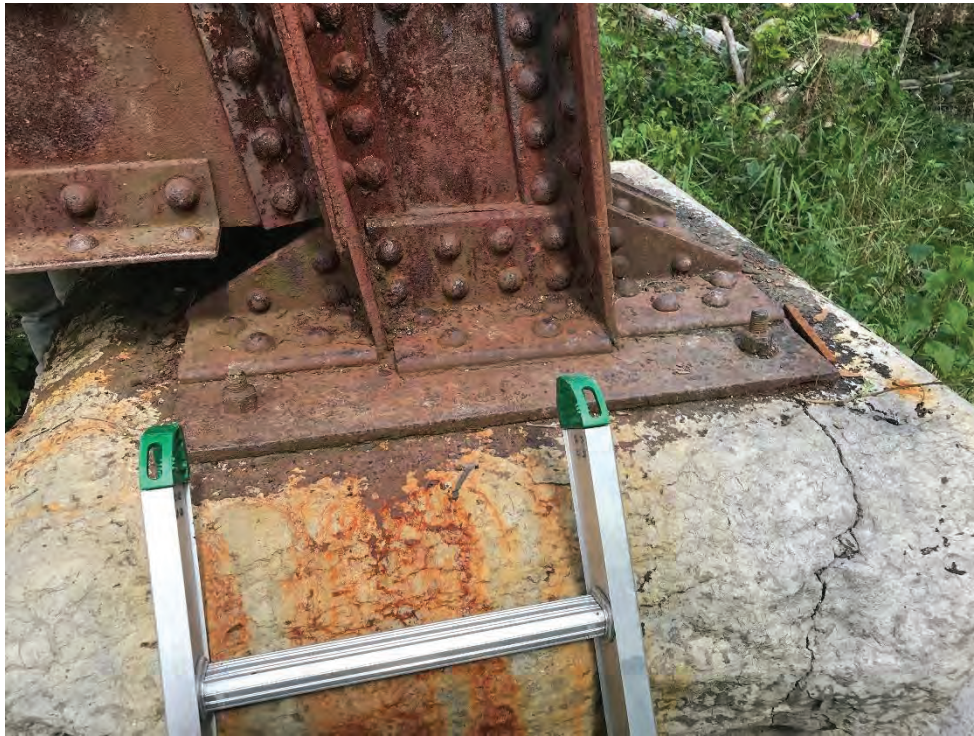
Bent F South column – cracked masonry at anchor bolt

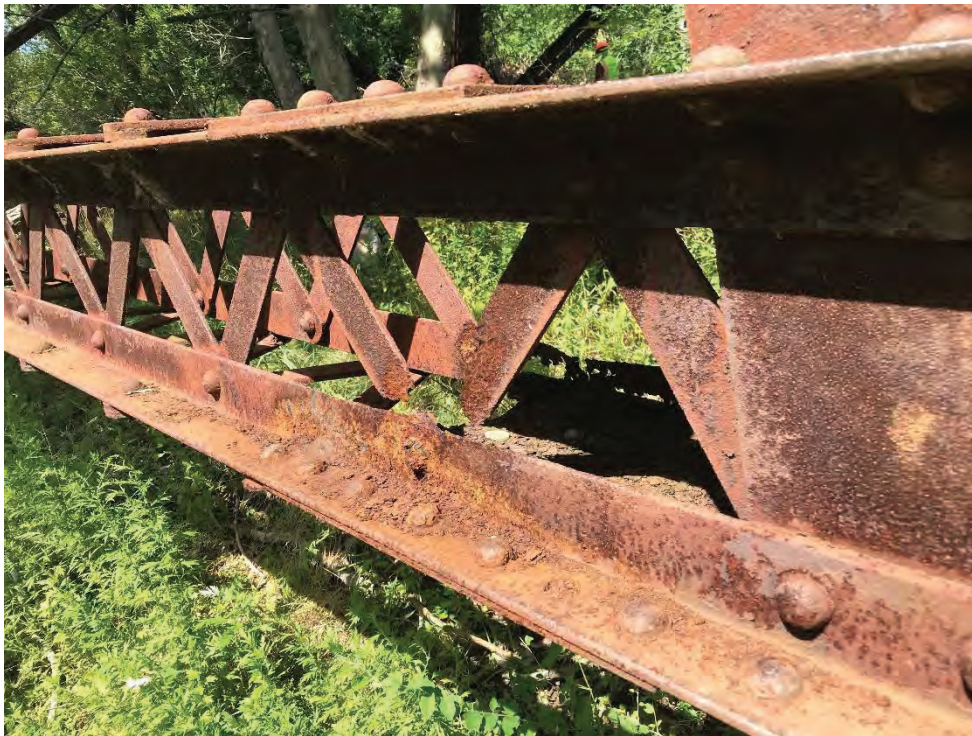
Bent F lower transverse strut (looking north)

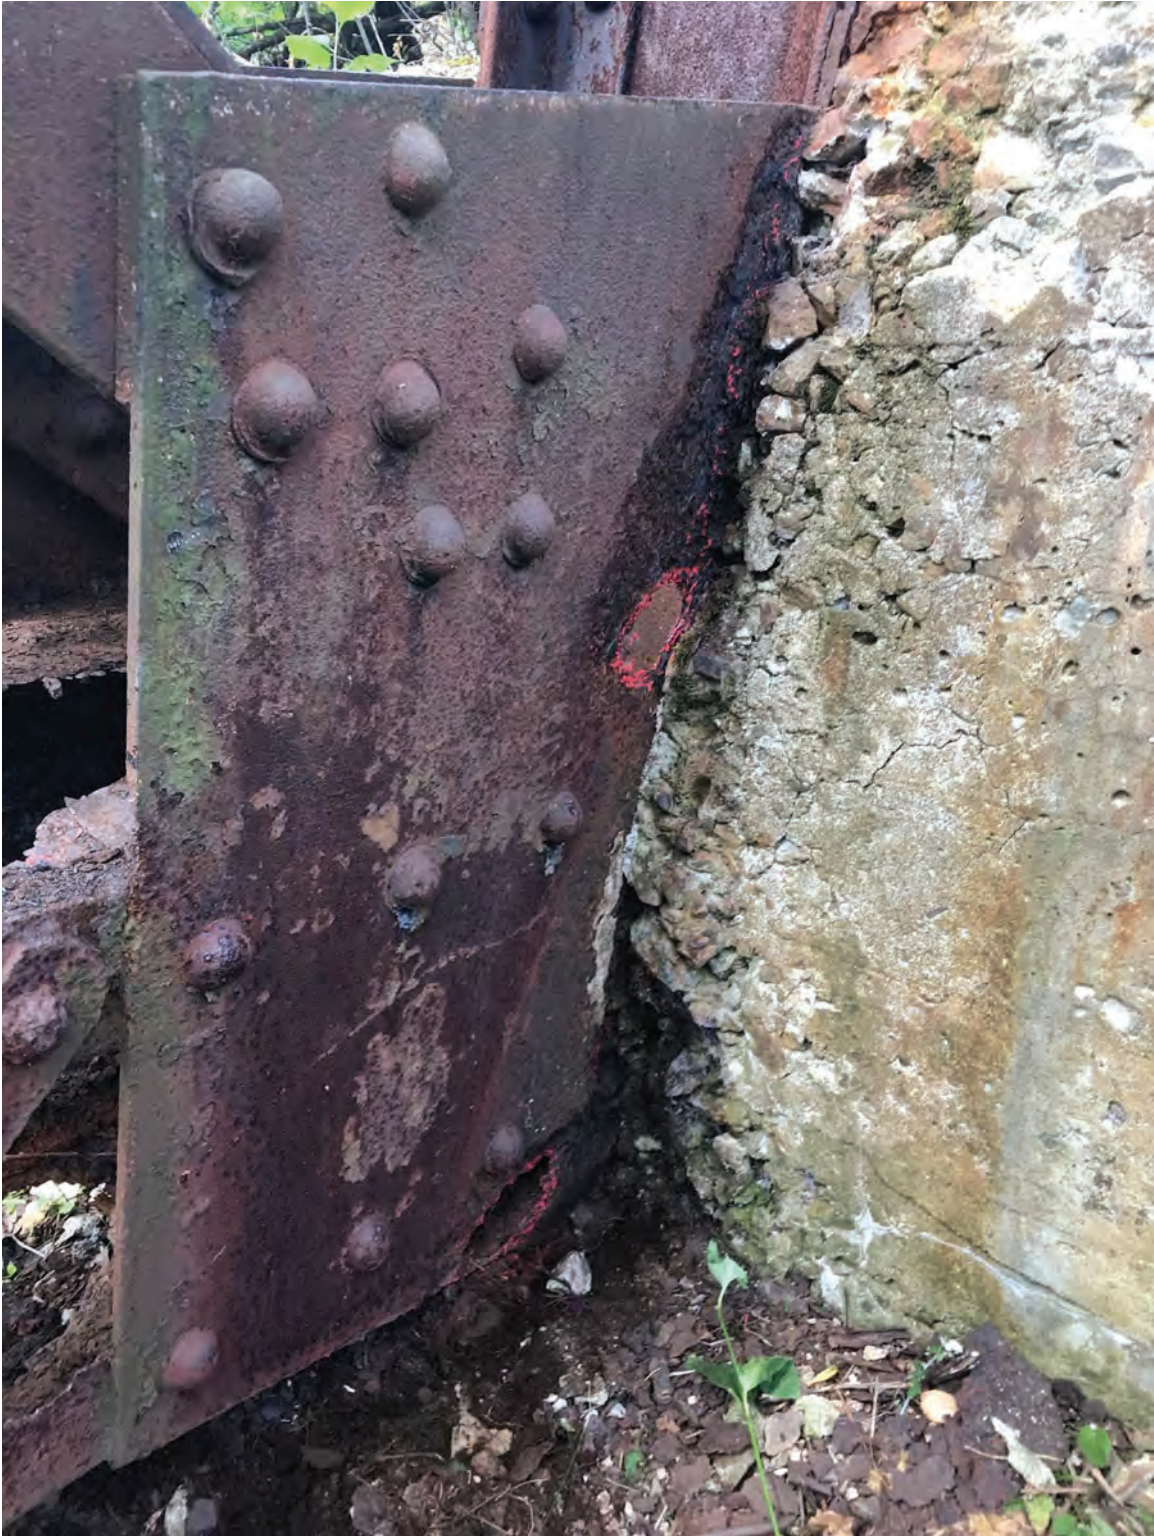
Bent E North column – lateral brace and diagonal brace gusset plate

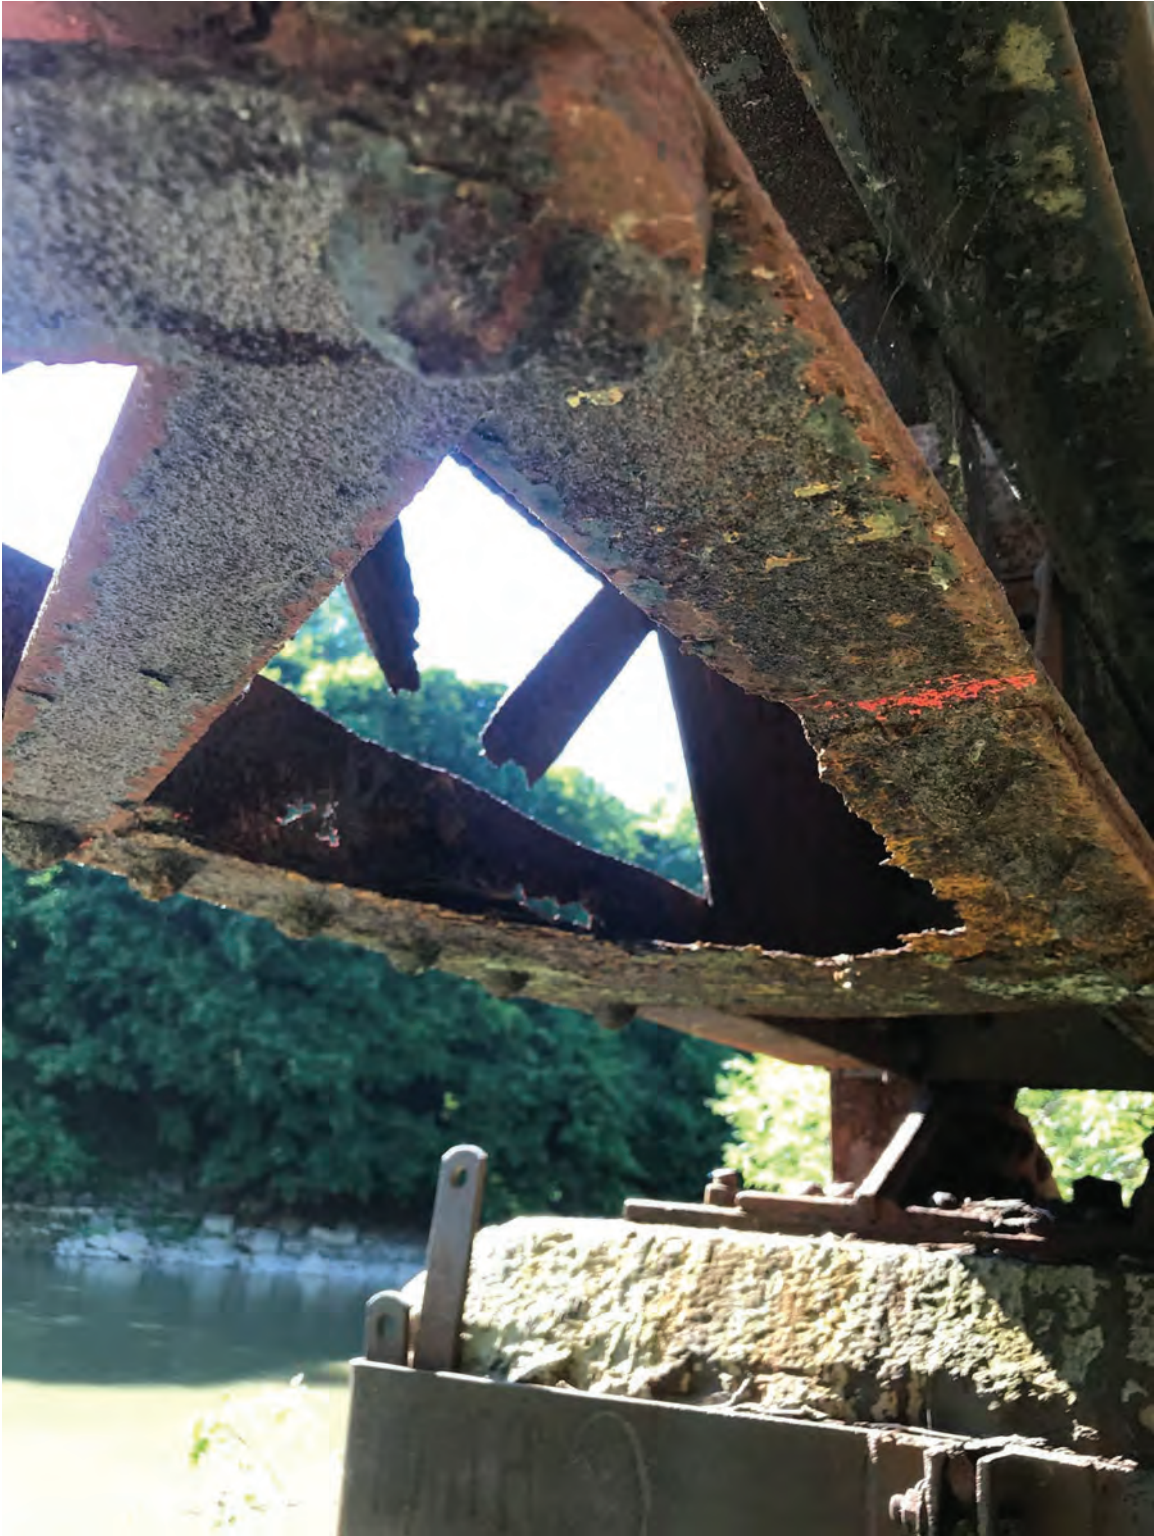
Bent F lower transverse strut at North column (looking northwest)

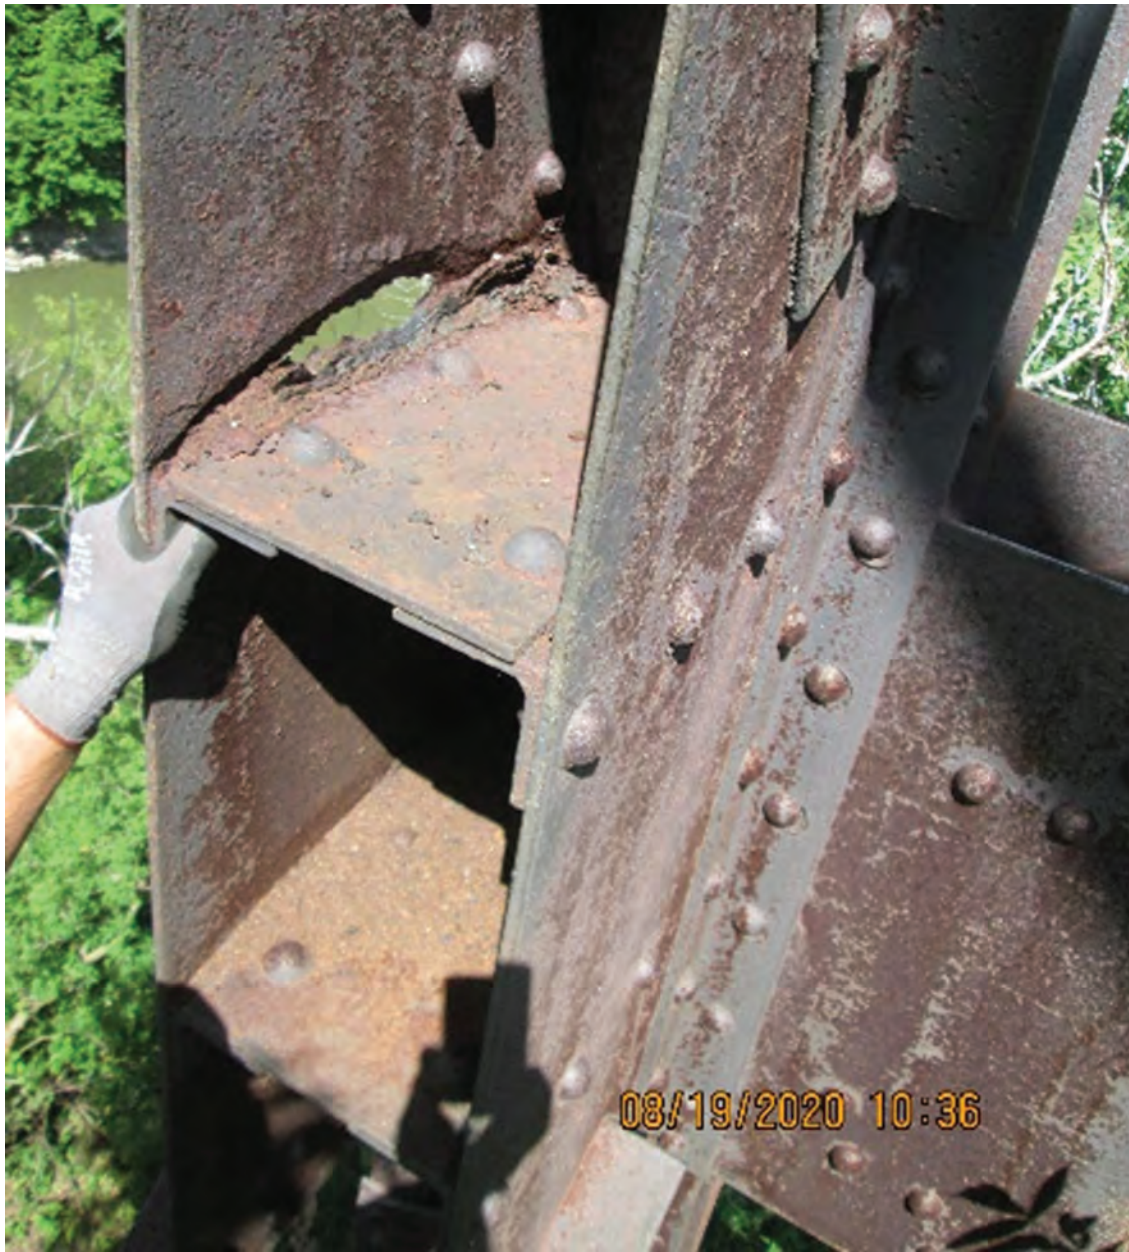
Bent D North column vertical gusset plate (similar section loss at other loc.)

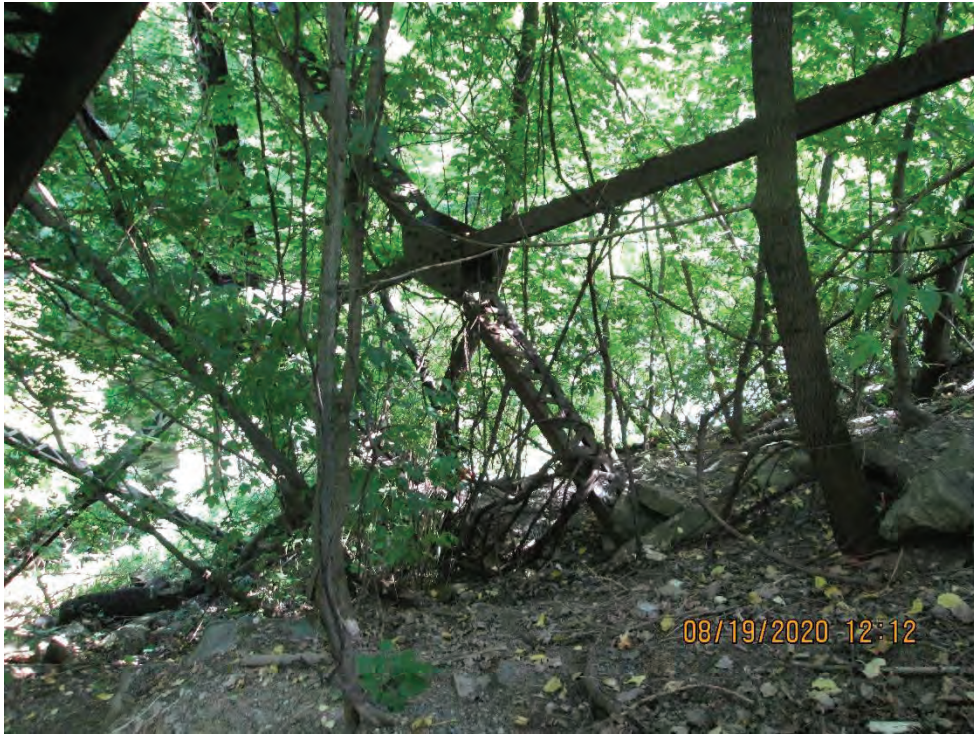
Bent G/Bent H longitudinal bracing on south side of tower (looking south)

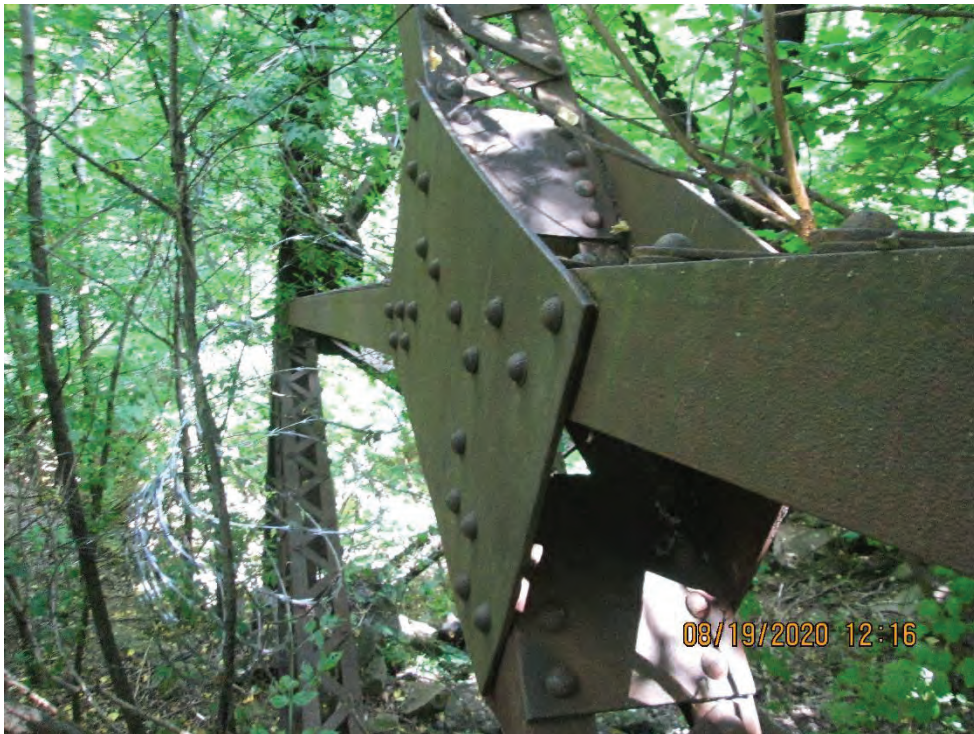
Bent G/Bent H longitudinal bracing on north side of tower (looking east)
