City of Rochester

Running Track Bridge

**August 2020 Inspection
Representative Photos**

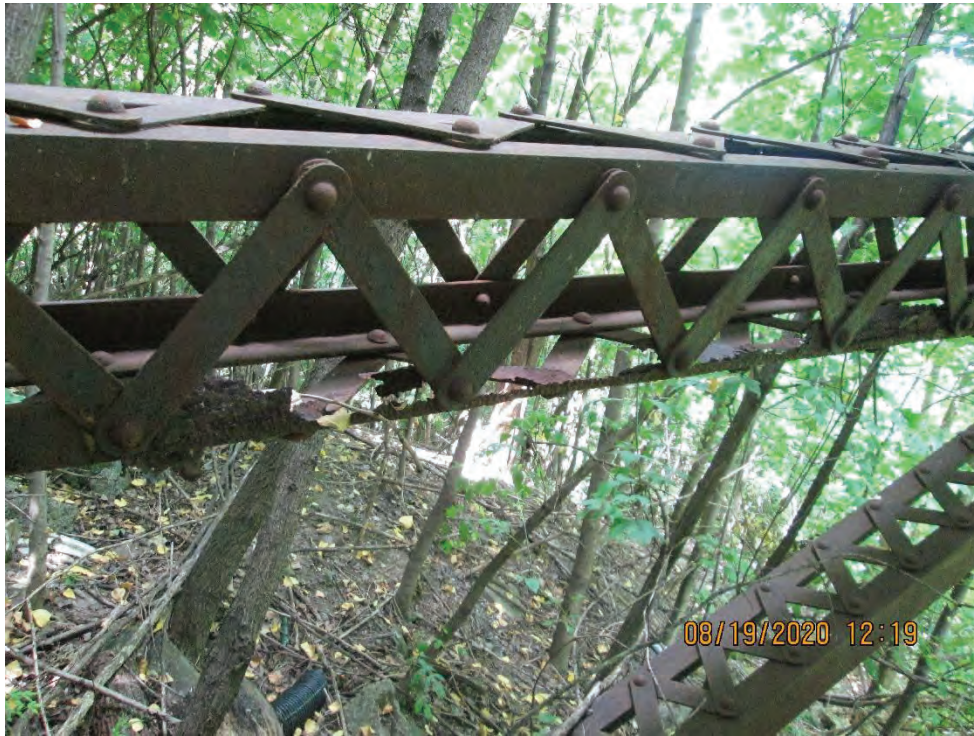
Bent G/Bent H longitudinal bracing on north side of tower

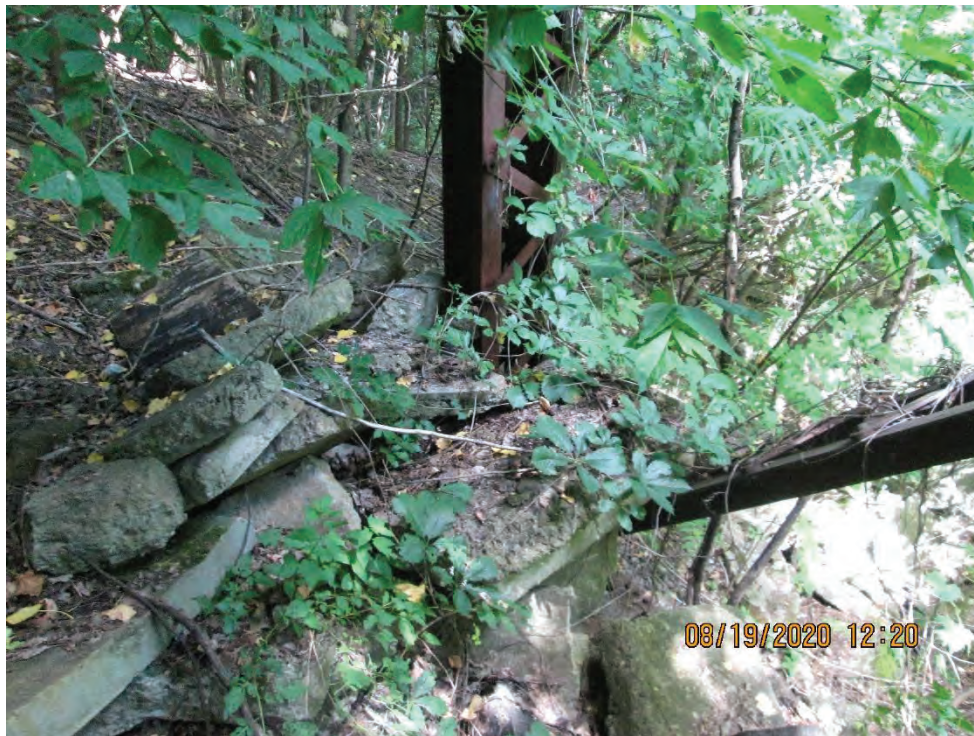
Bent G/Bent H buried tower leg and diagonal bracing

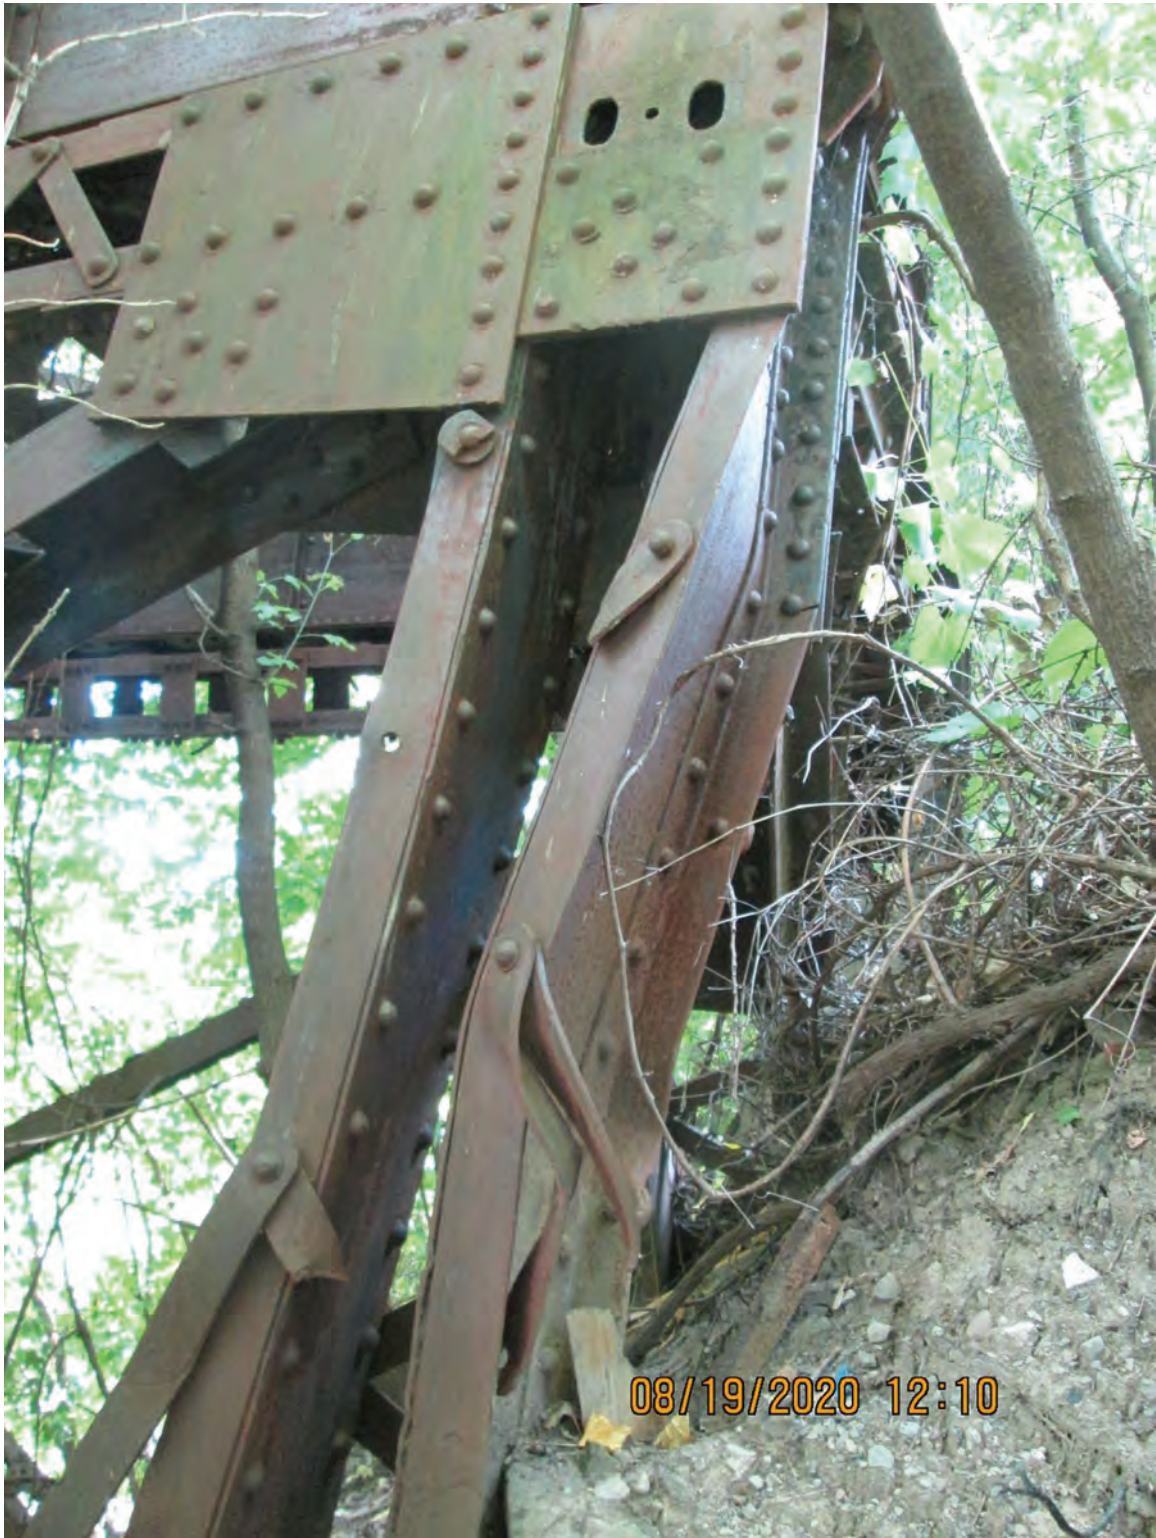
Bent H North Tower Leg (looking south)

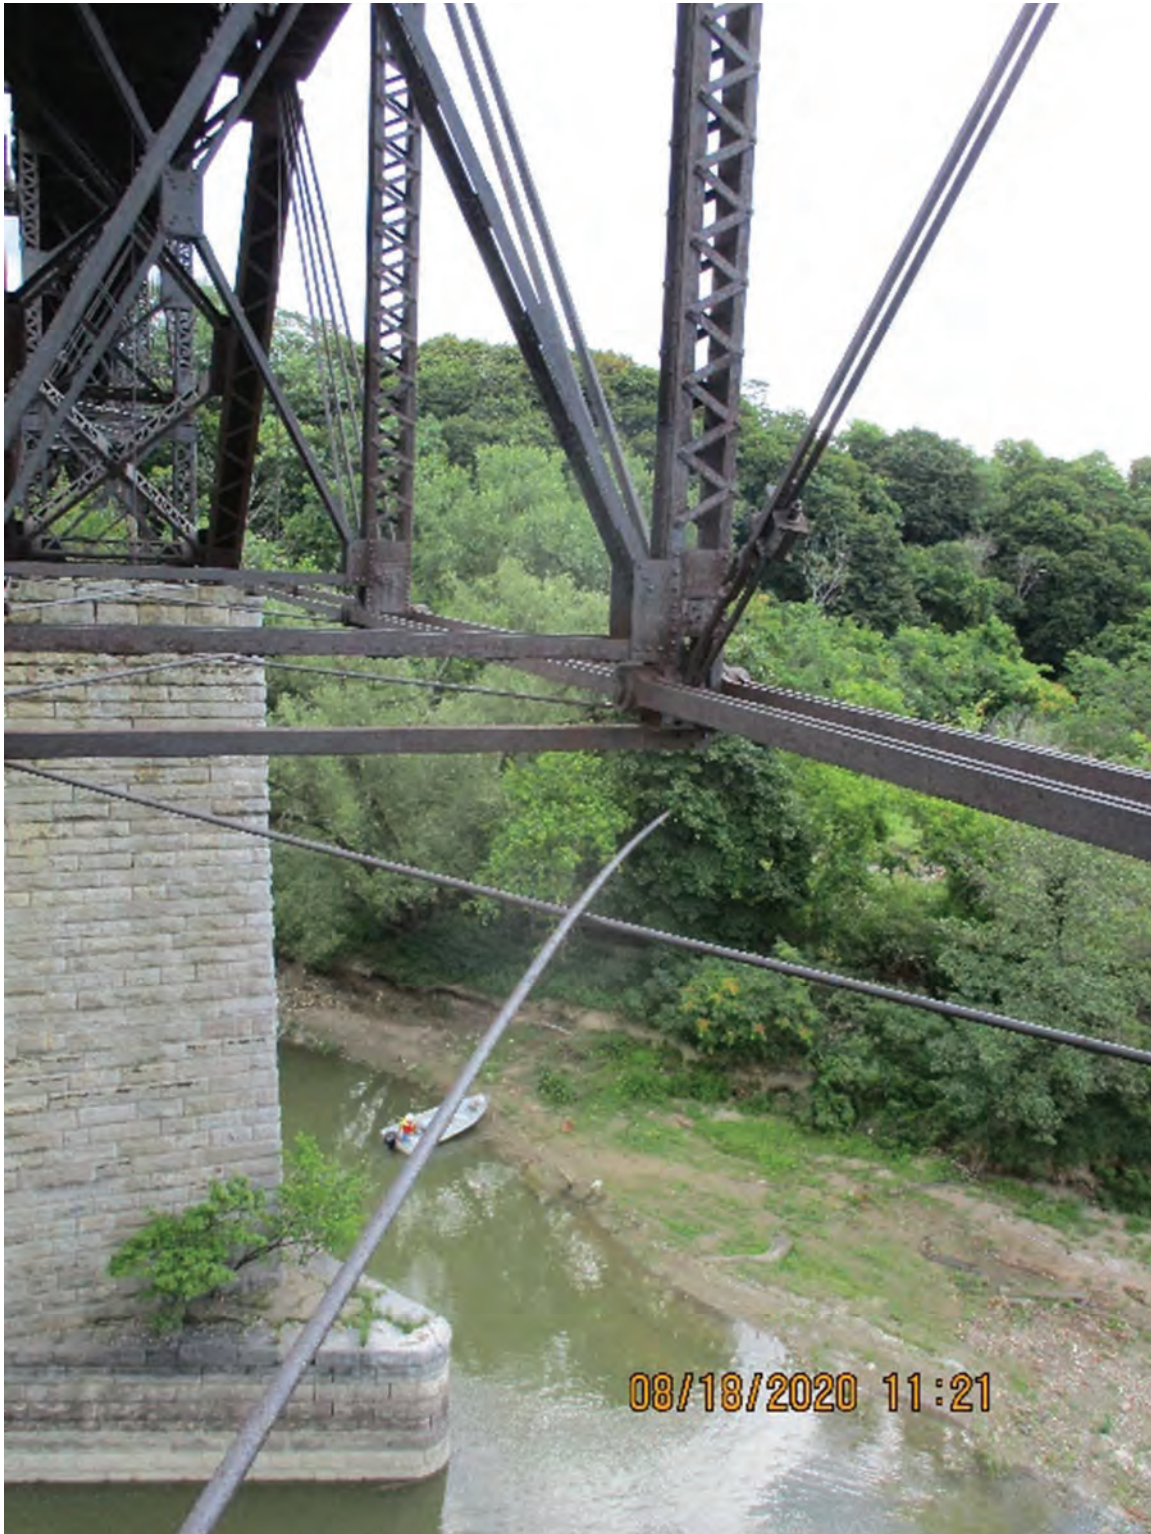
200' Truss Span – Fractured bottom lateral bracing at panel point 4, south side
(similar at south side panel point 5)

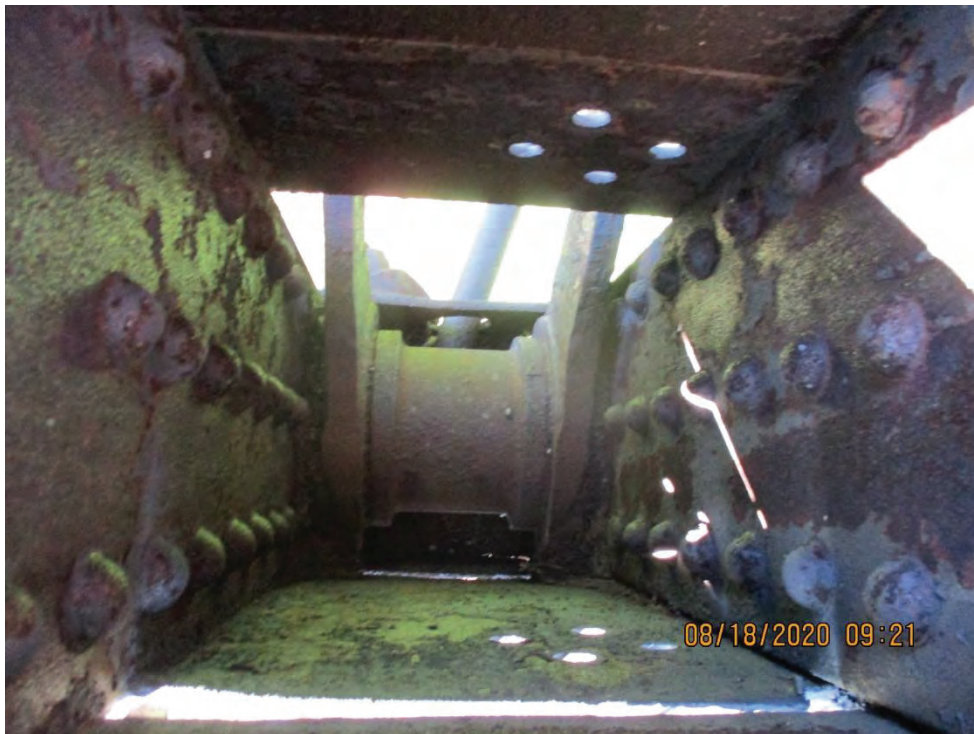
Typical bottom panel point connection on 200' truss (looking down) –
moisture and pack rust build-up at bottom

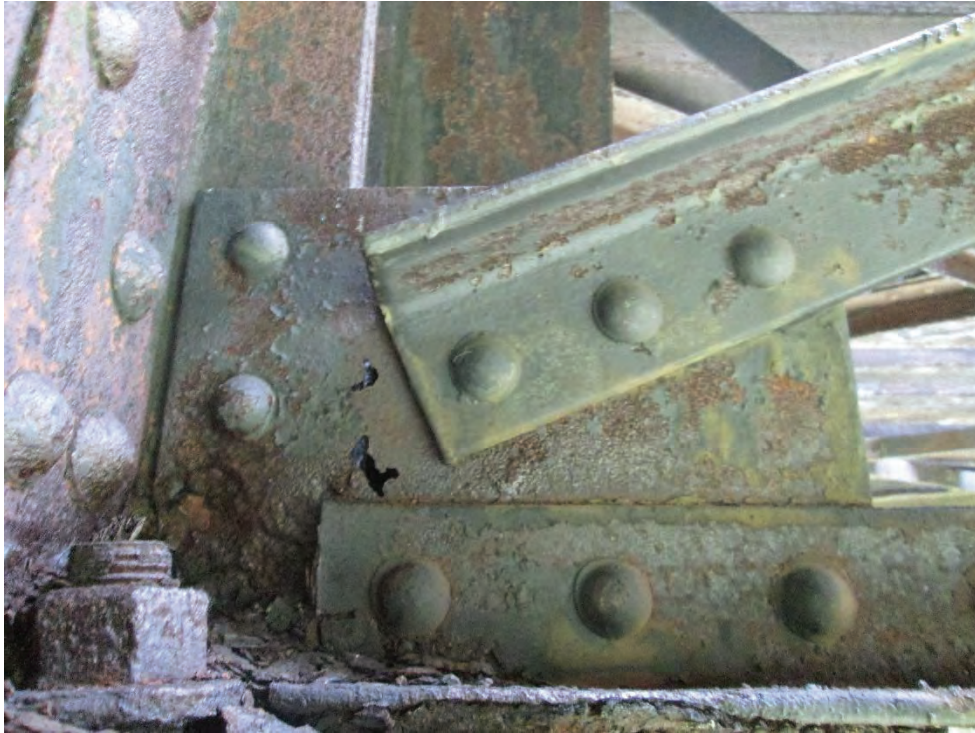
End bracing running N-S above Bent E – corroded gusset plate for BTB angles

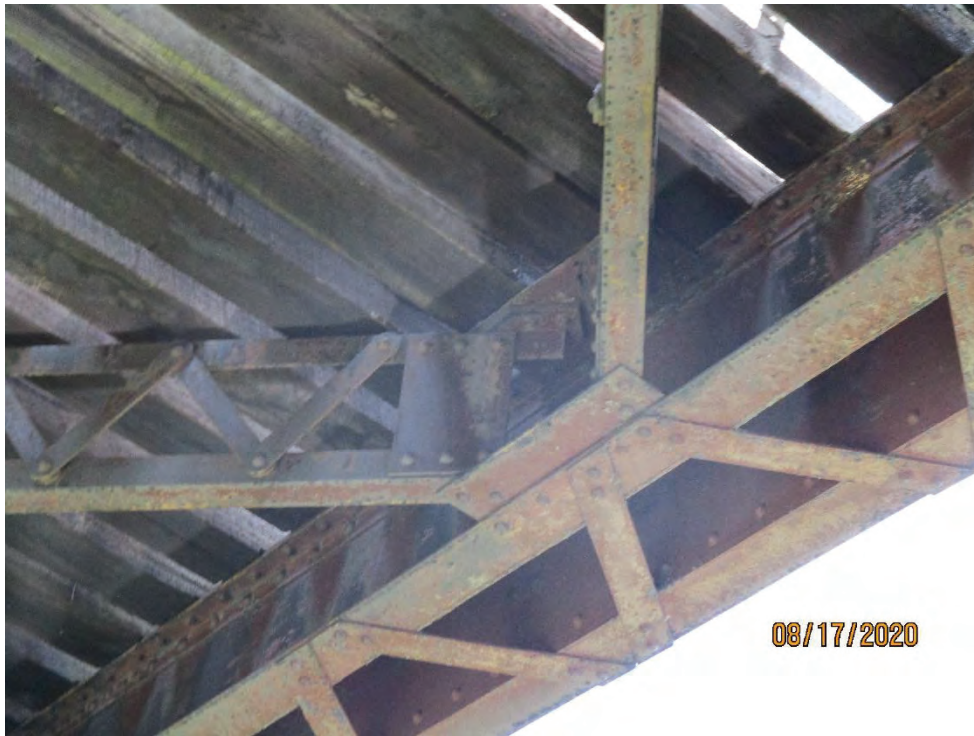
Typical top lateral bracing gusset plate corrosion

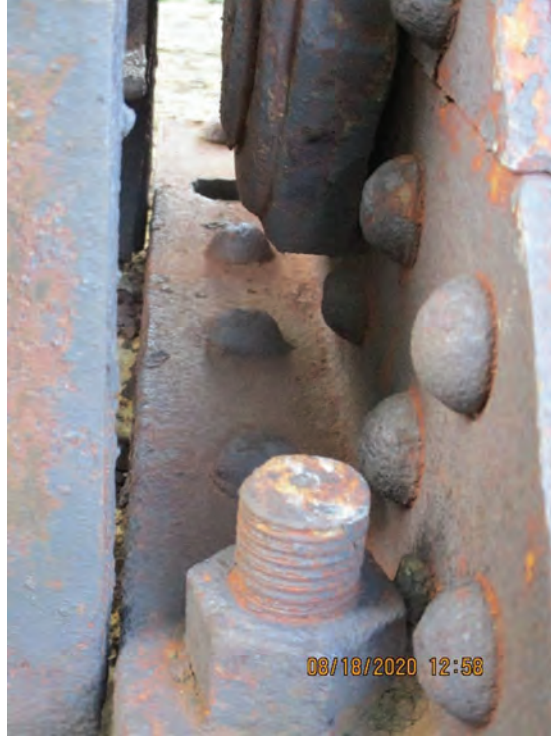
Pier 2, North Column – Missing SW Anchor Bolt

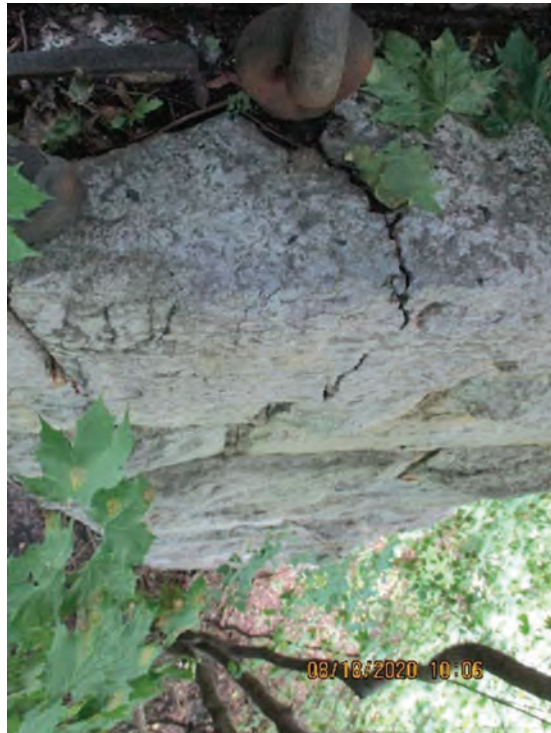
Pier 1, South side – crack in masonry through top 2 courses

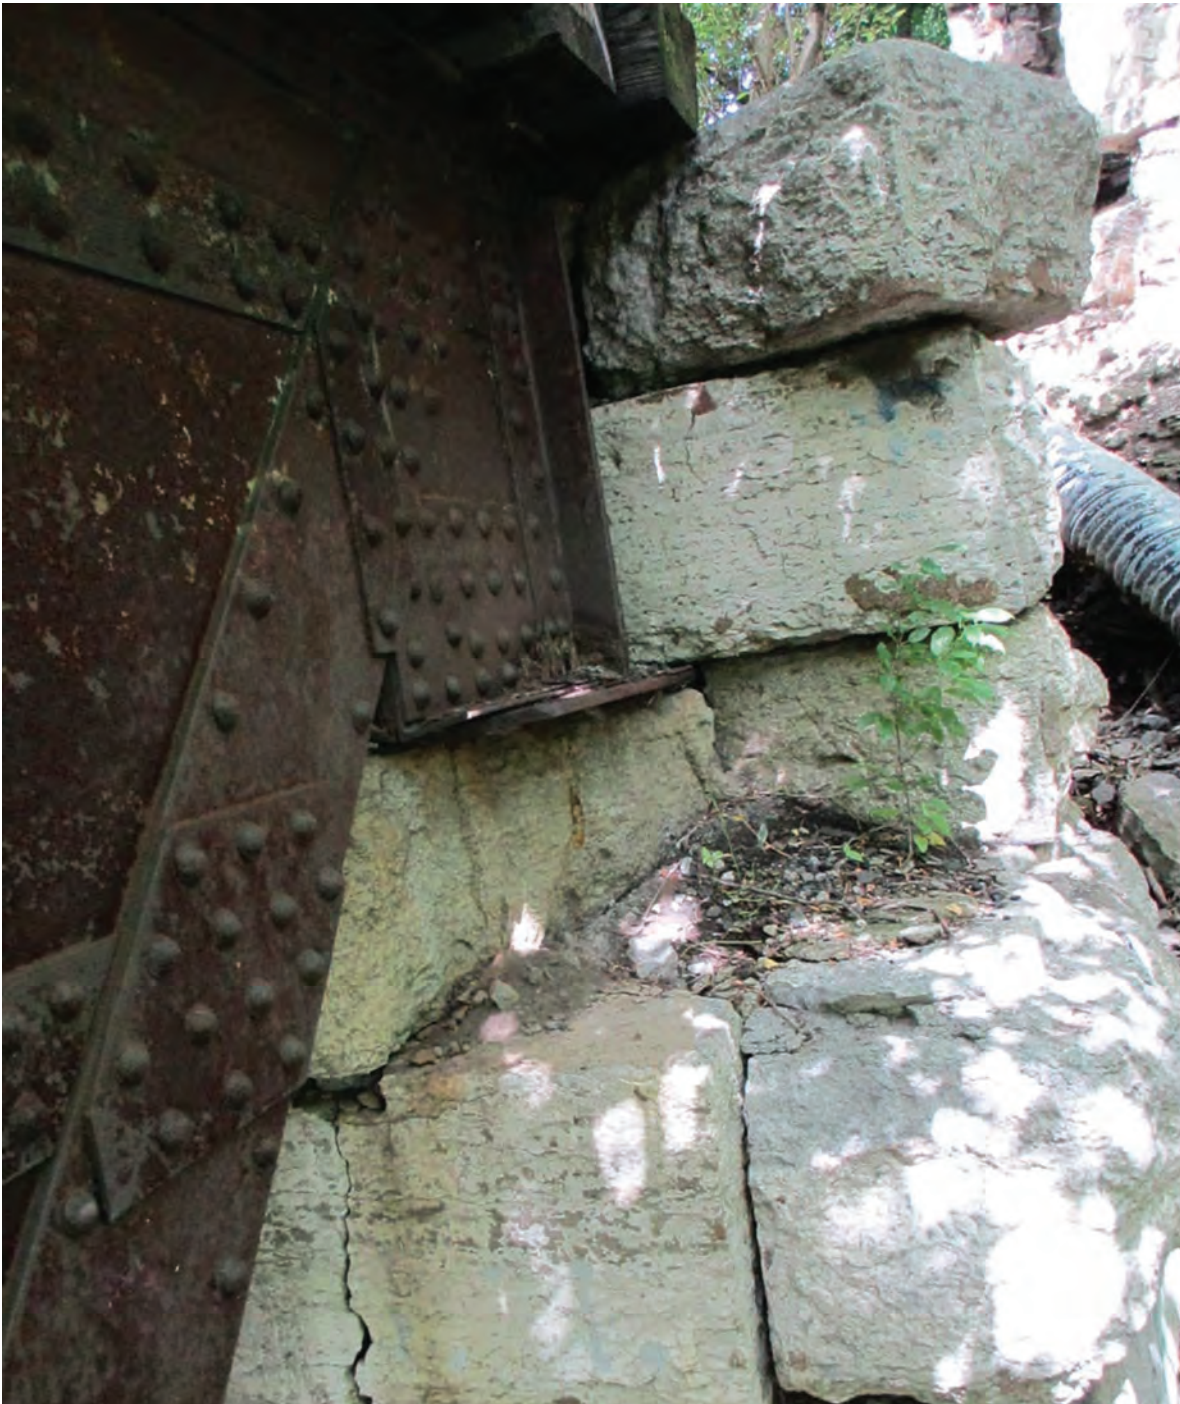
East Abutment, South Bearing – undermined bearing

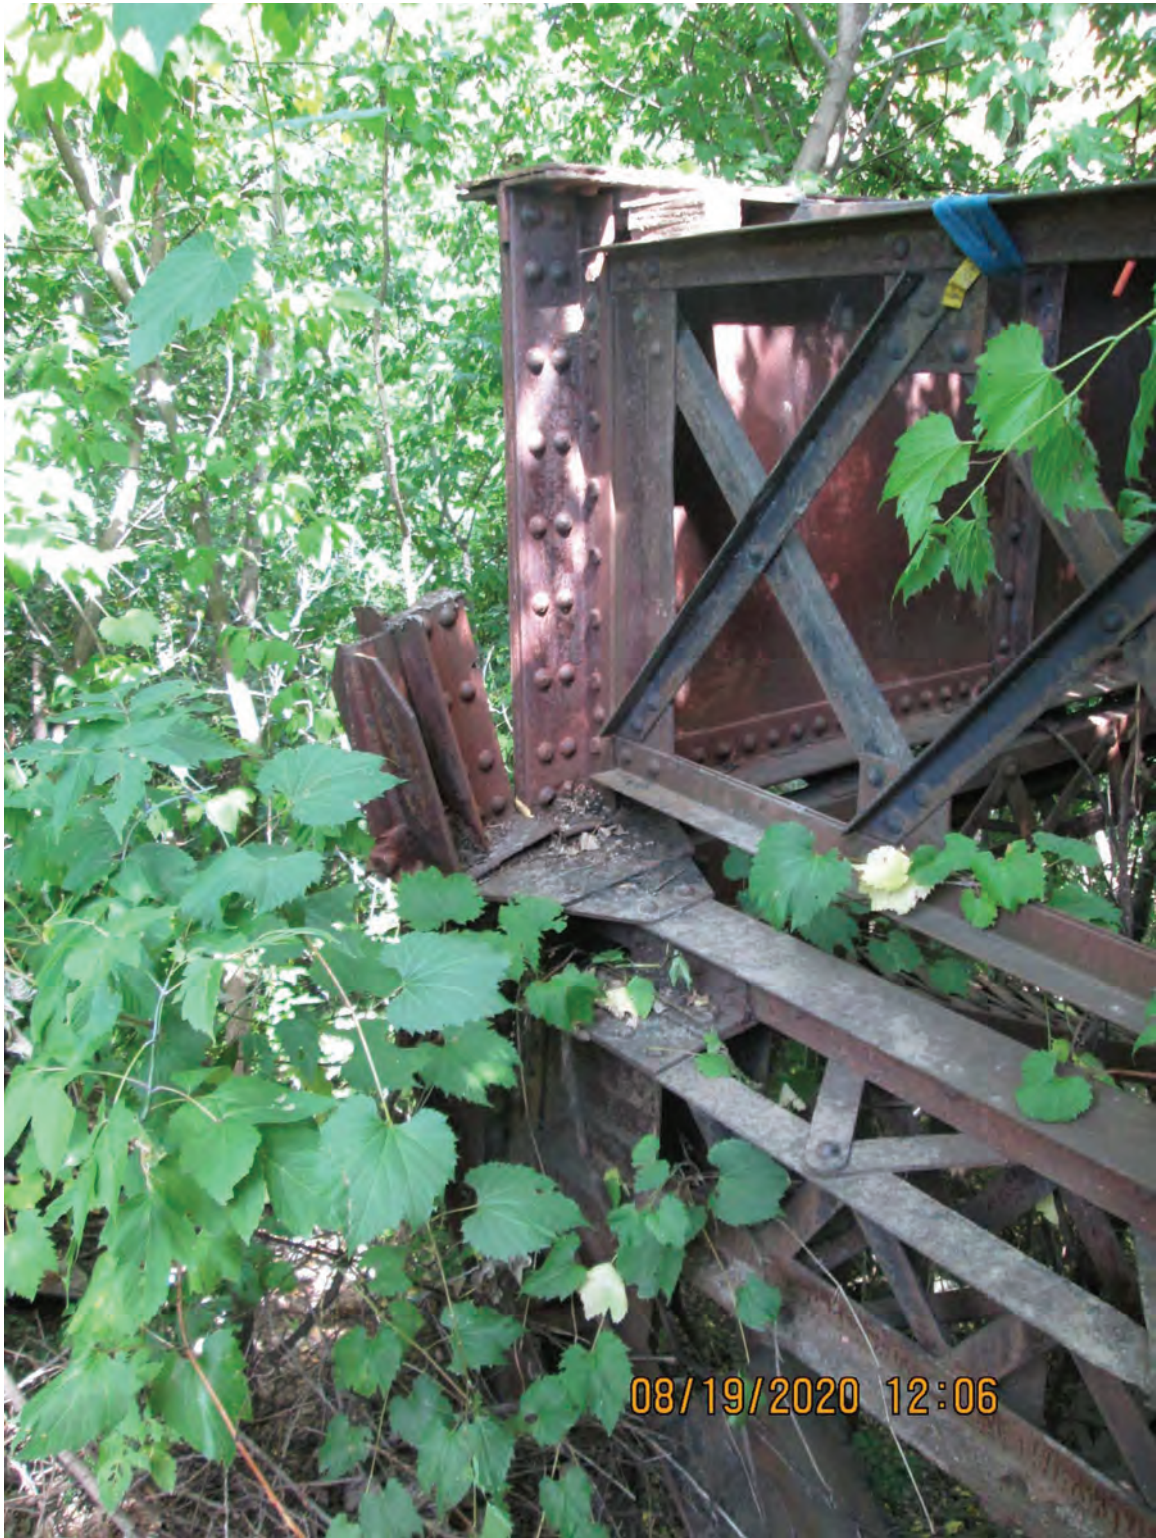
West end of bridge at Bent H – end 40' girder span has been removed
(looking northeast)

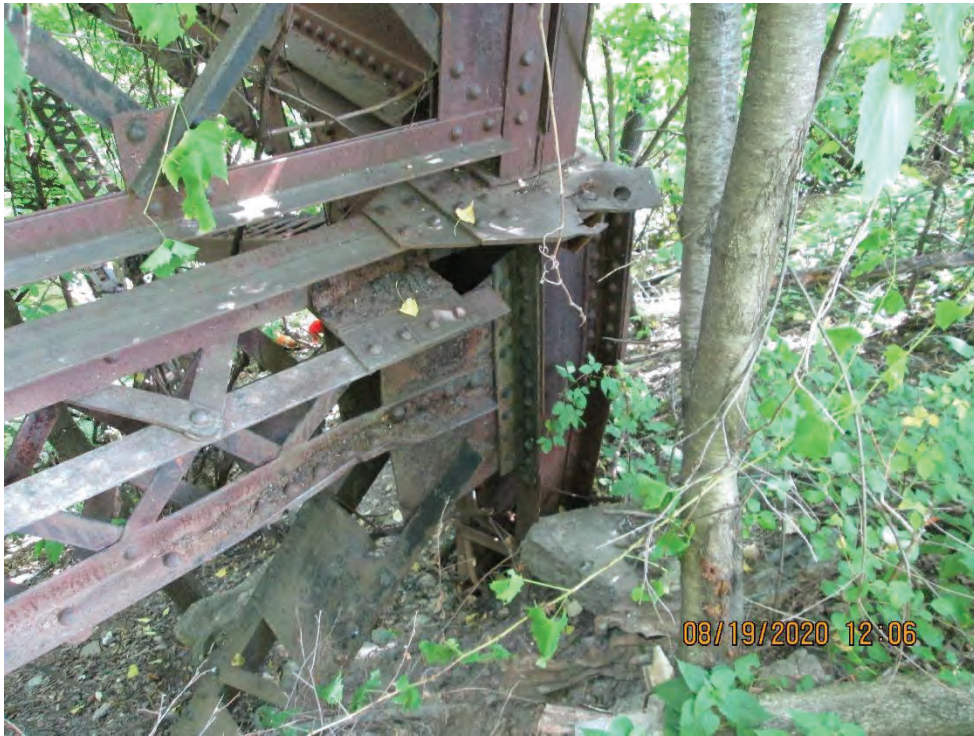
West end of bridge at Bent H – south tower almost completely buried
