Vacuum Oil - Brownfield Opportunity Area

Building Assessment Report

5 Flint Street

December 2014

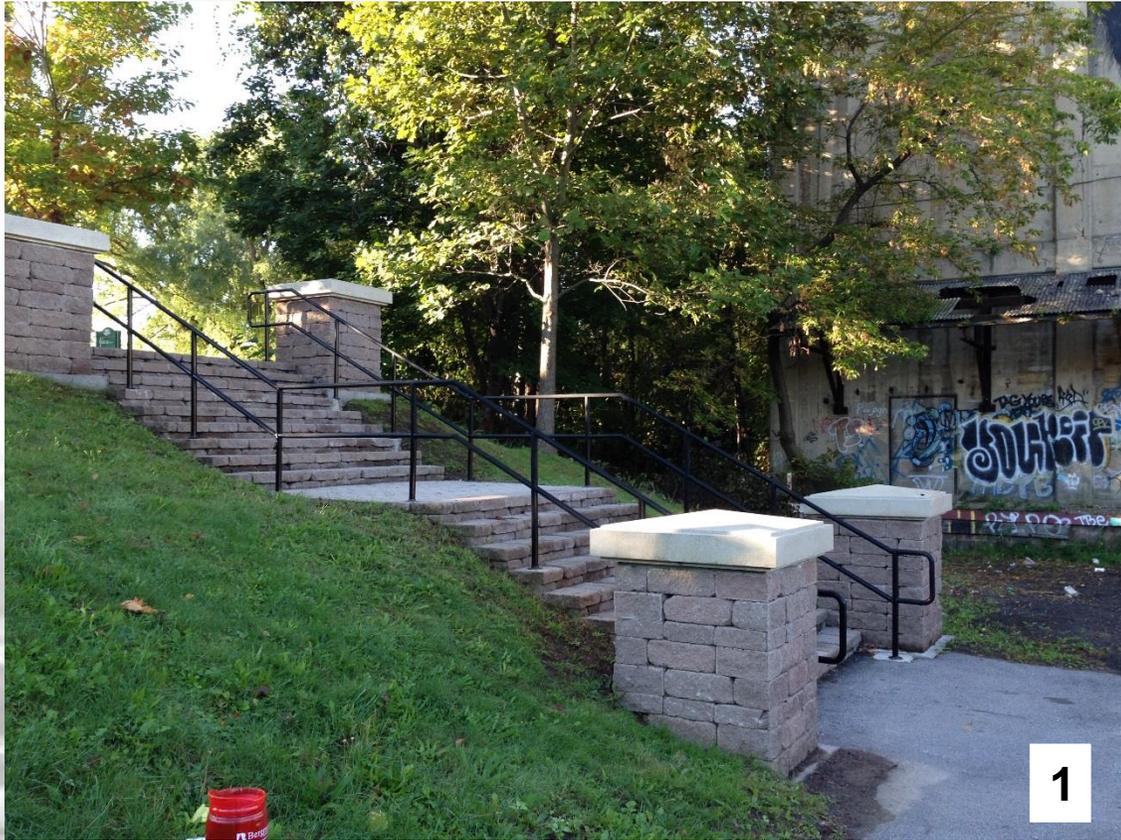
North Façade

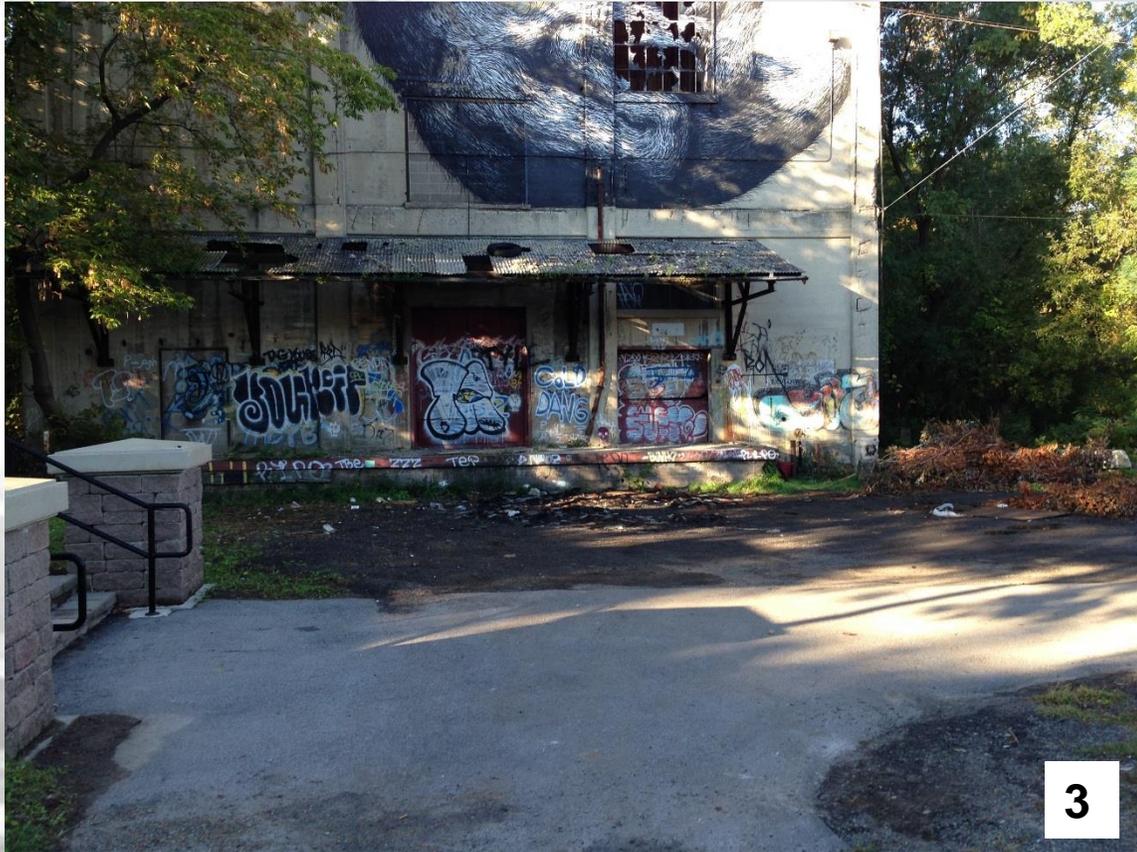
North Façade
• Loading Dock

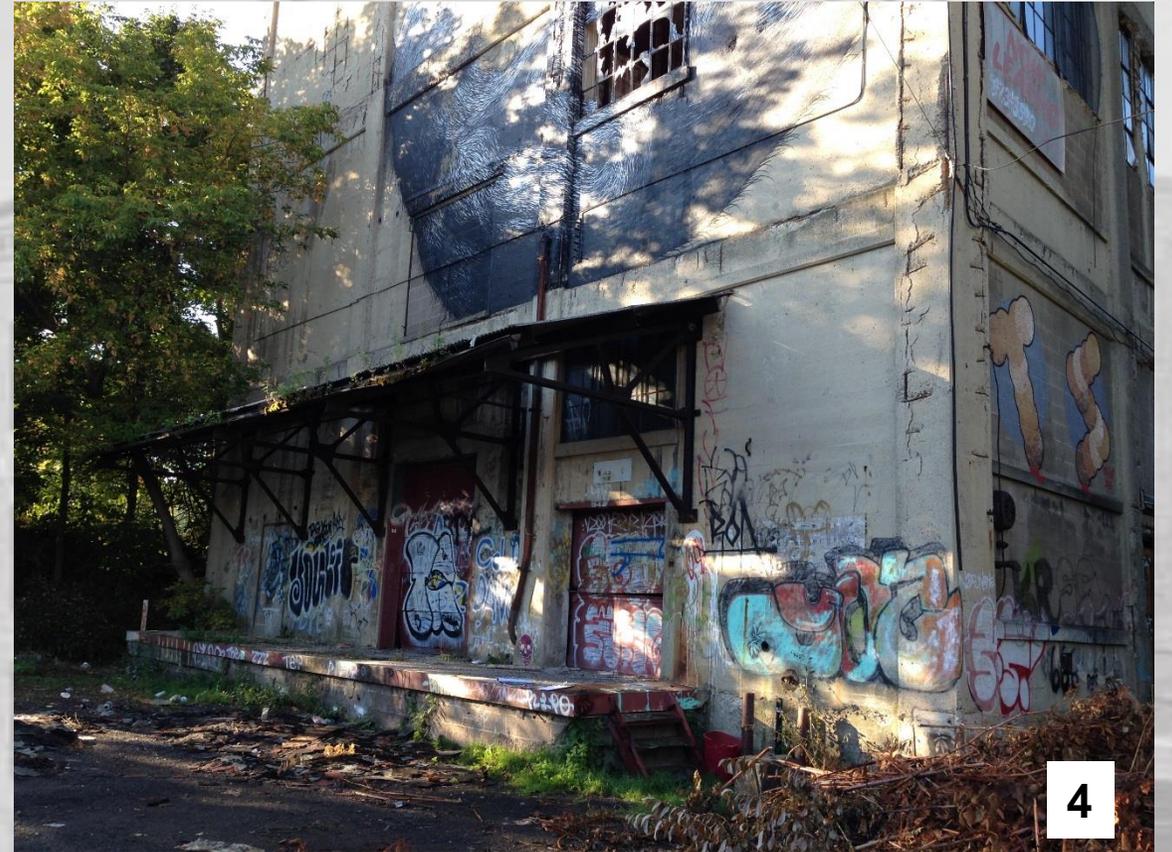
North West Corner

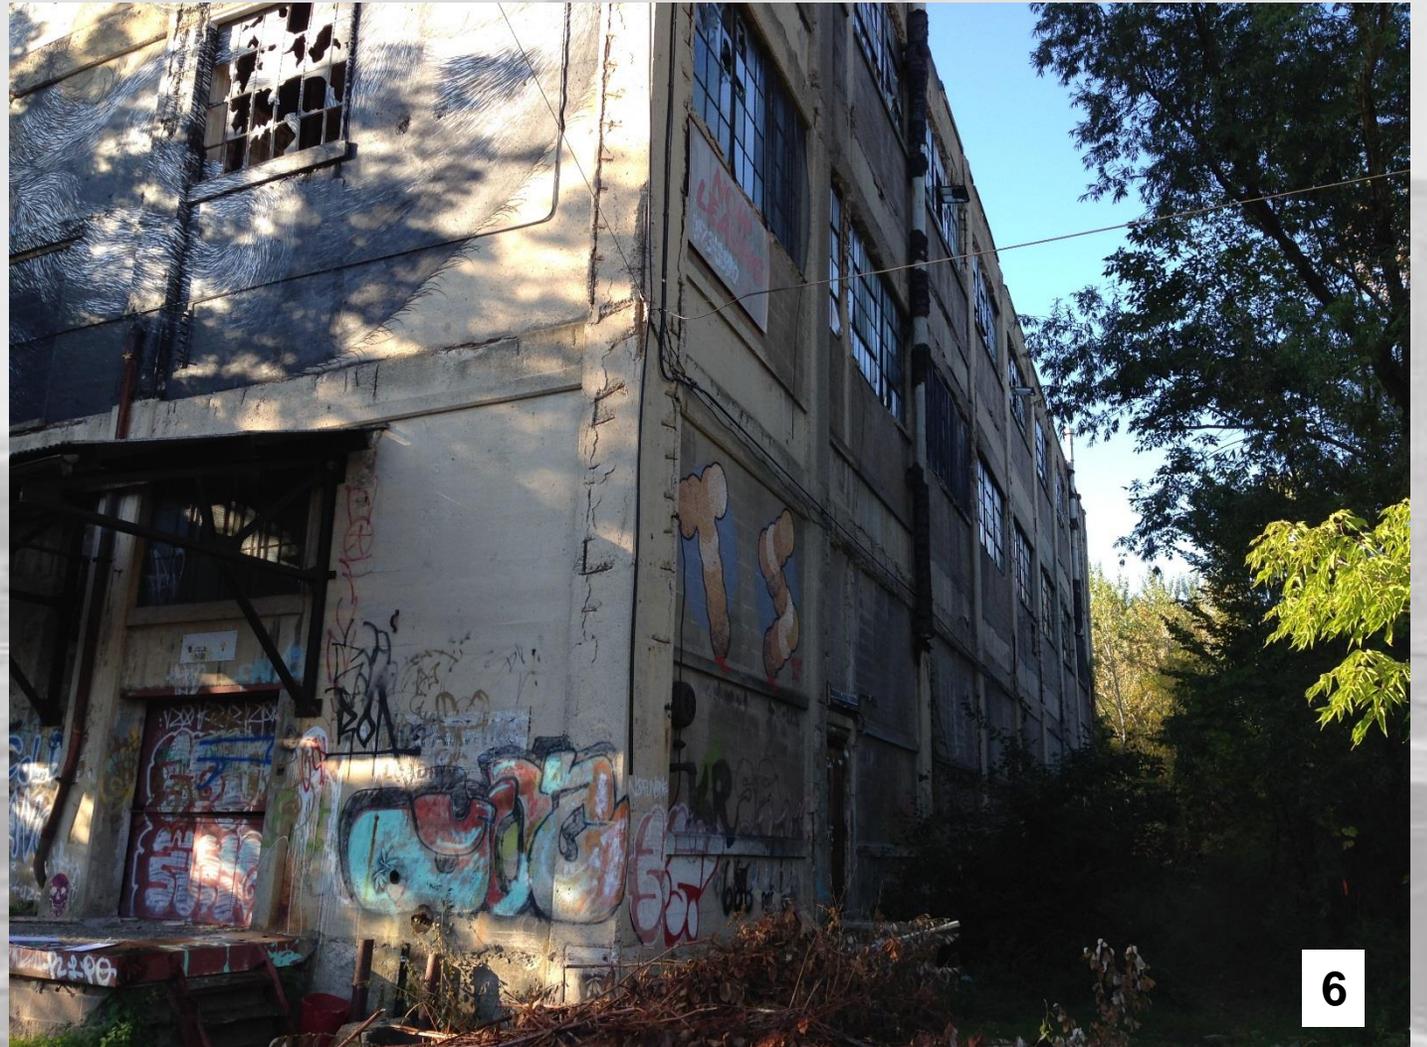
North West Corner

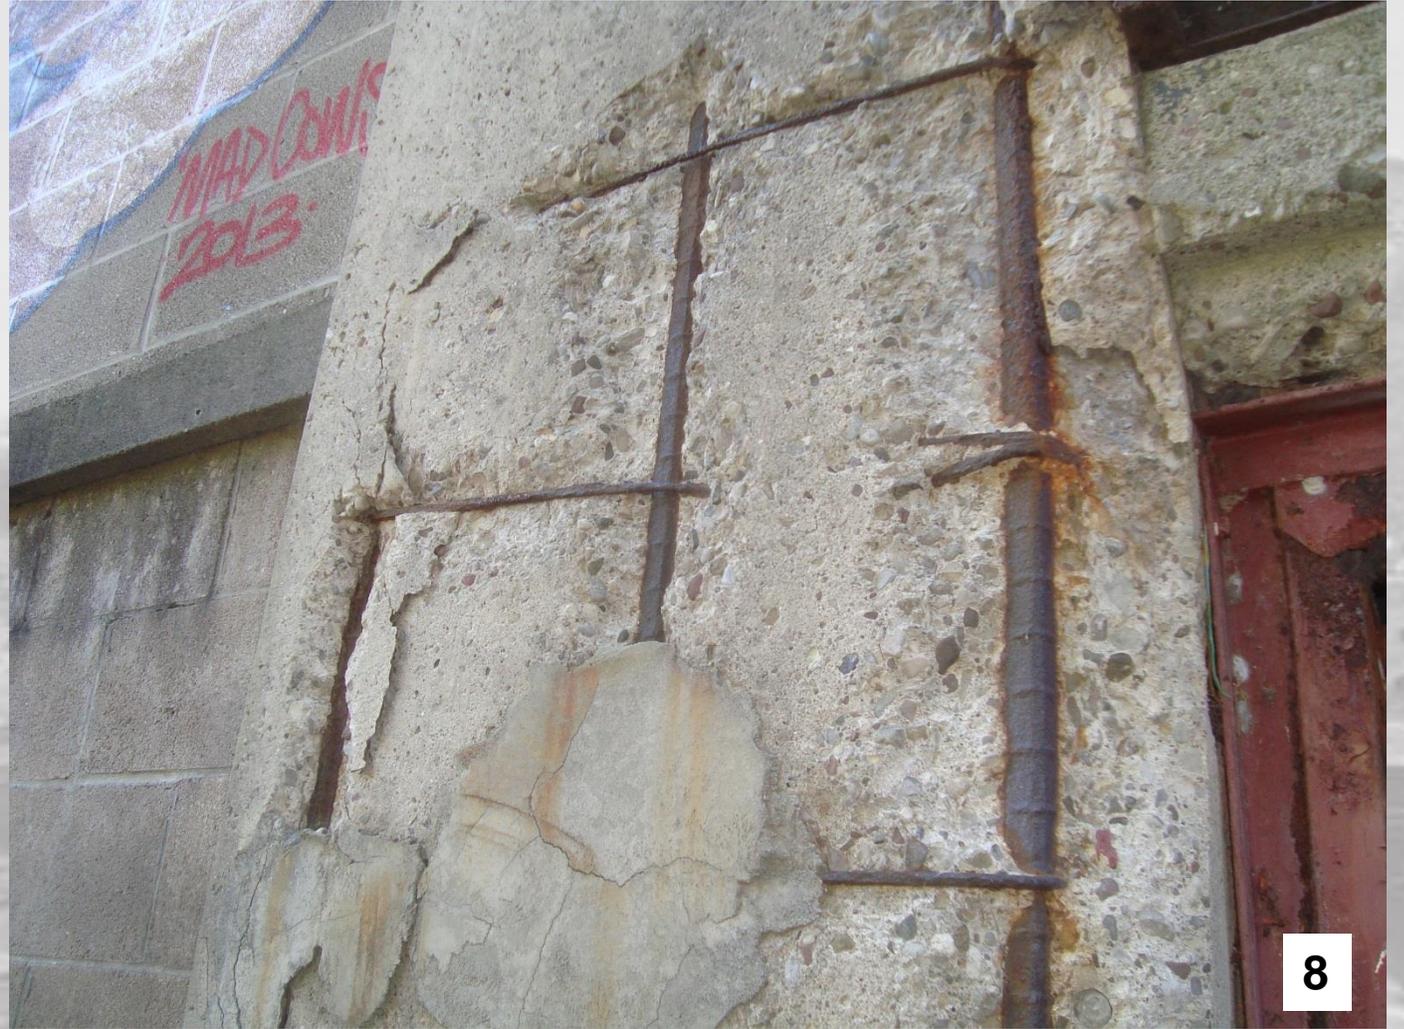
West Façade Column at Door

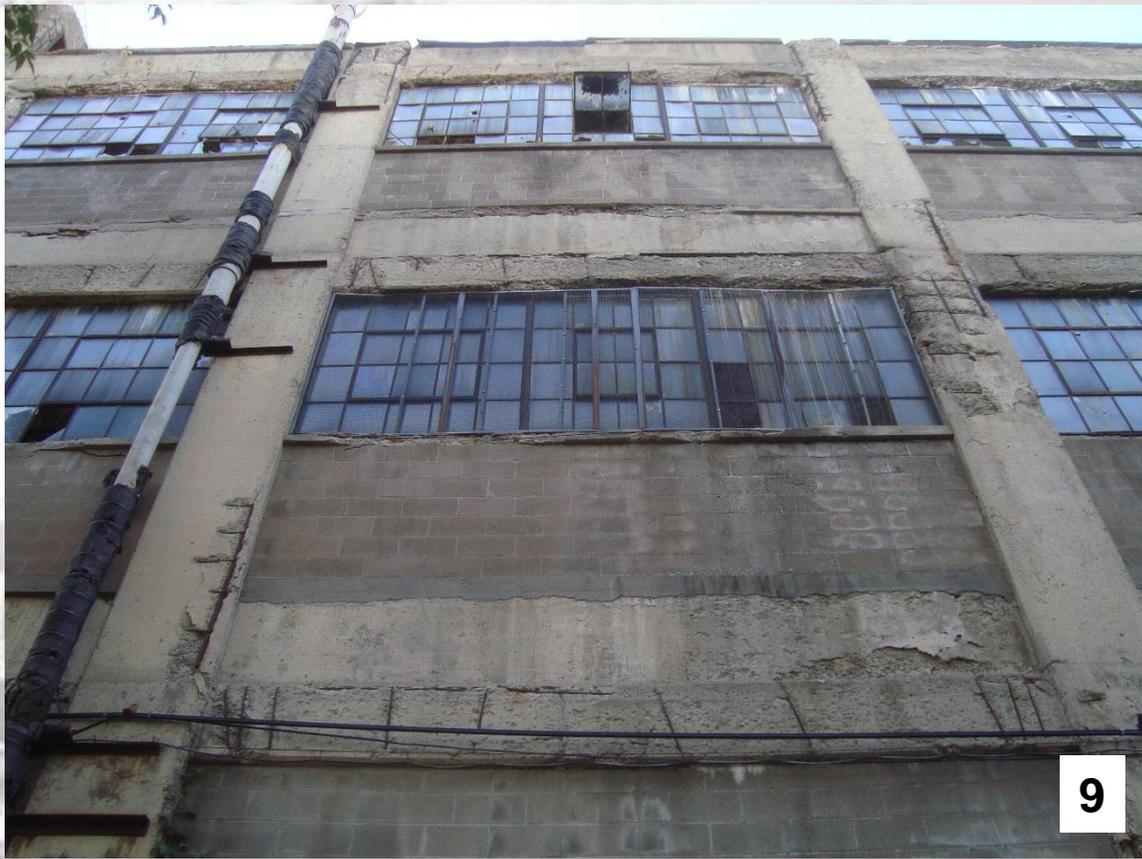
West Façade

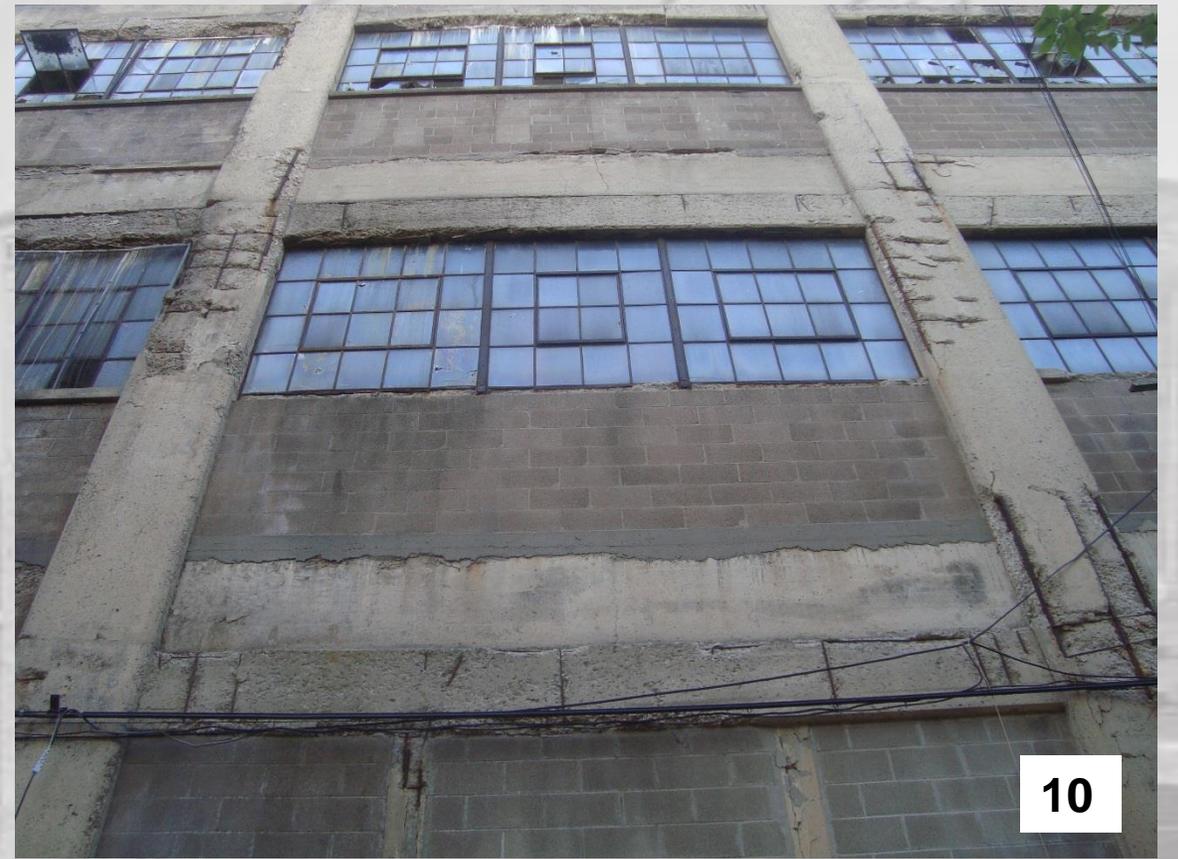
West Façade

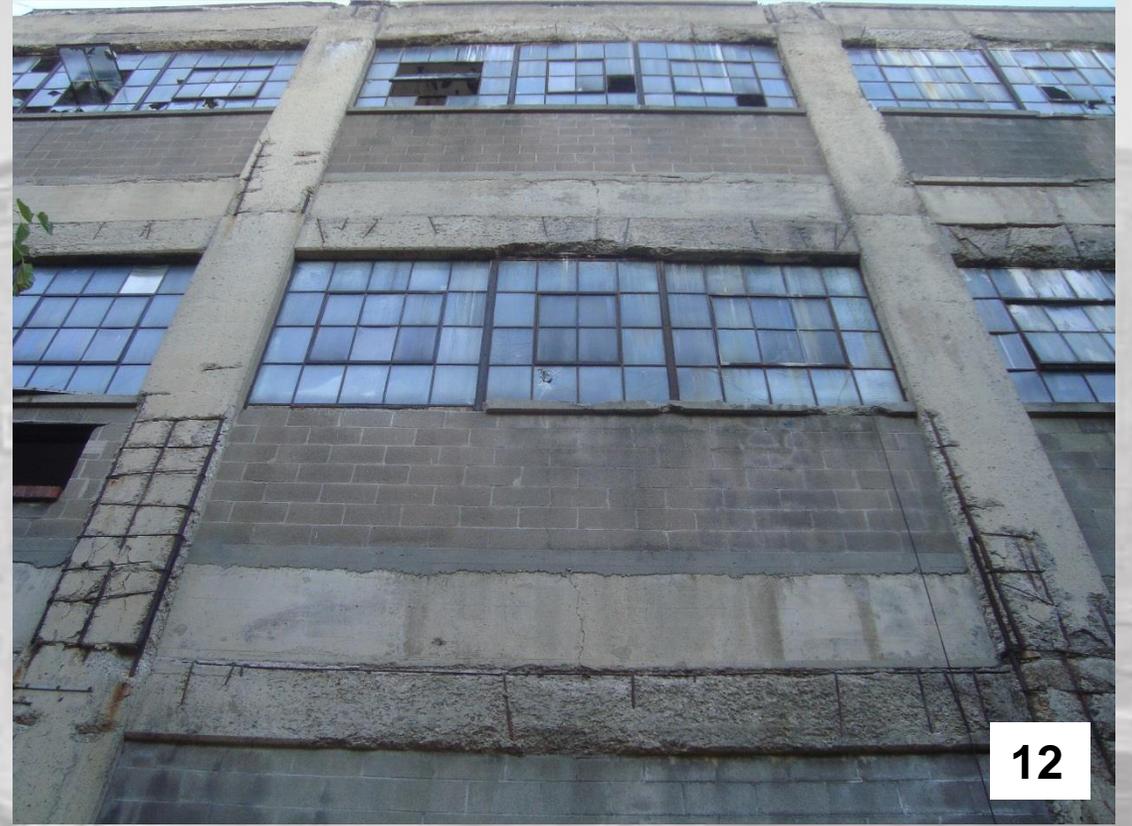
West Façade

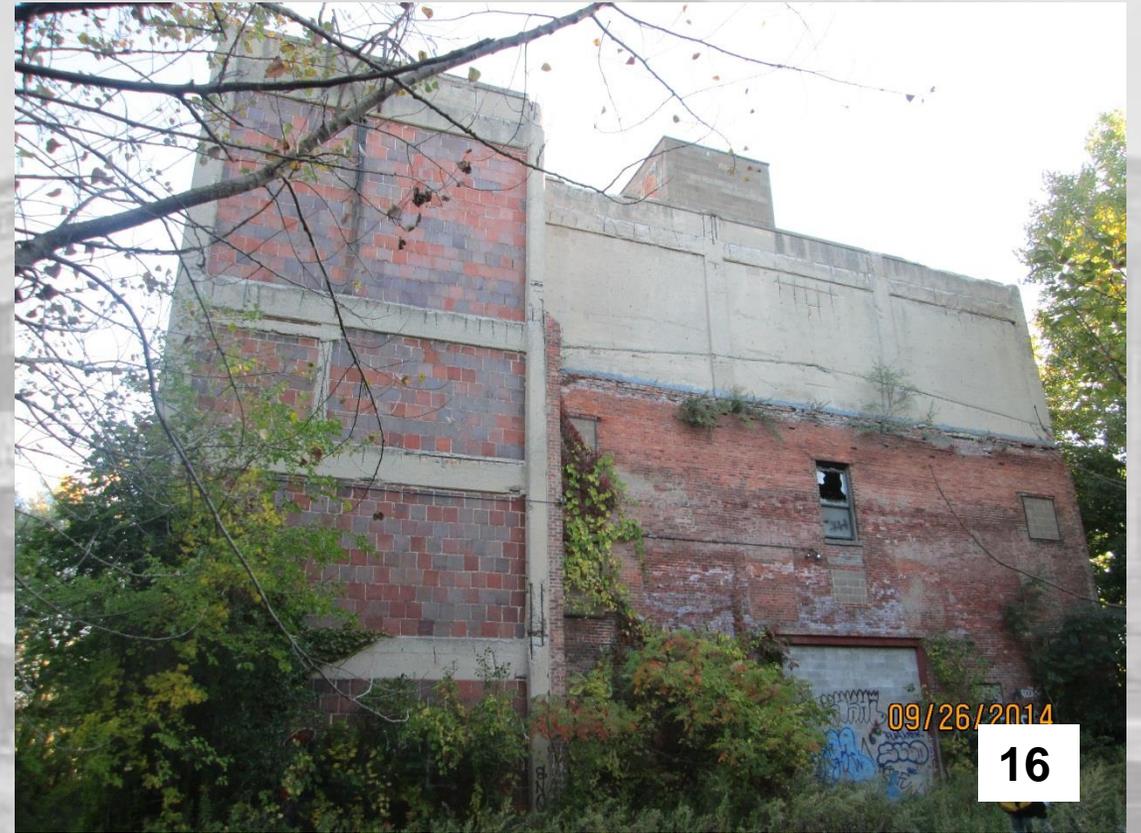
South Façade

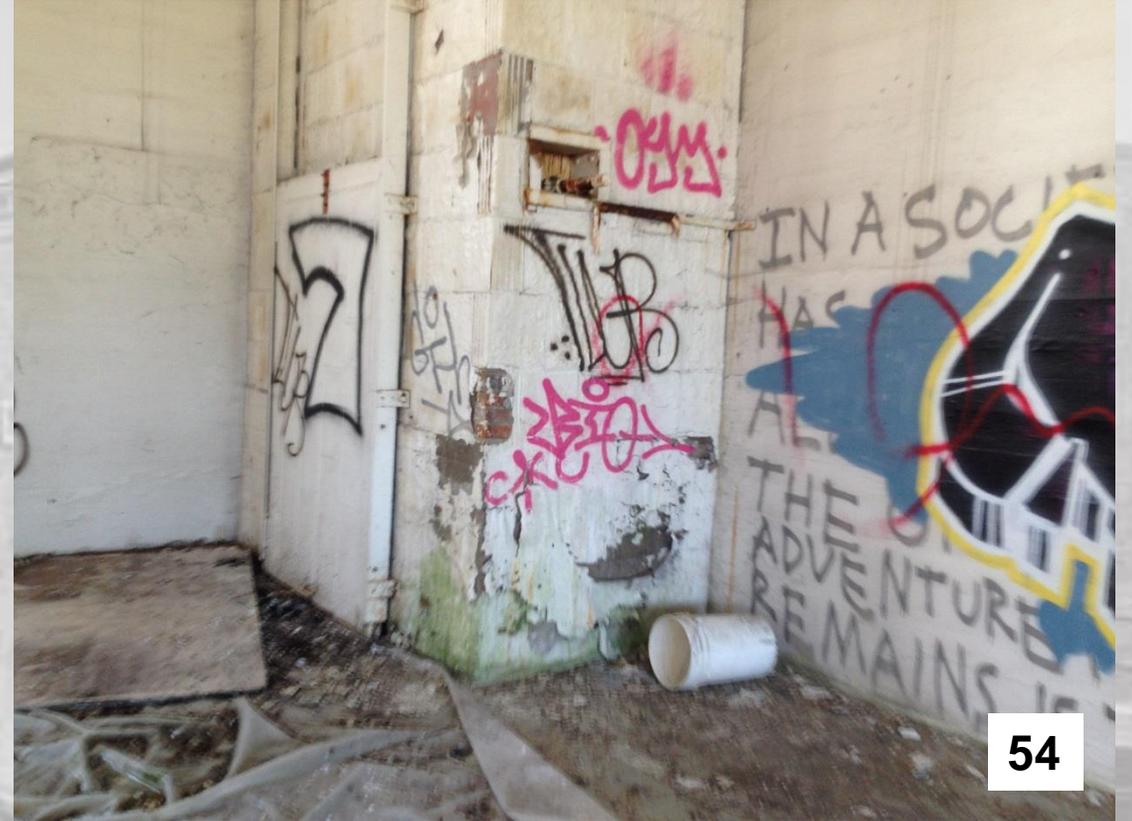
Third Floor dumbwaiter

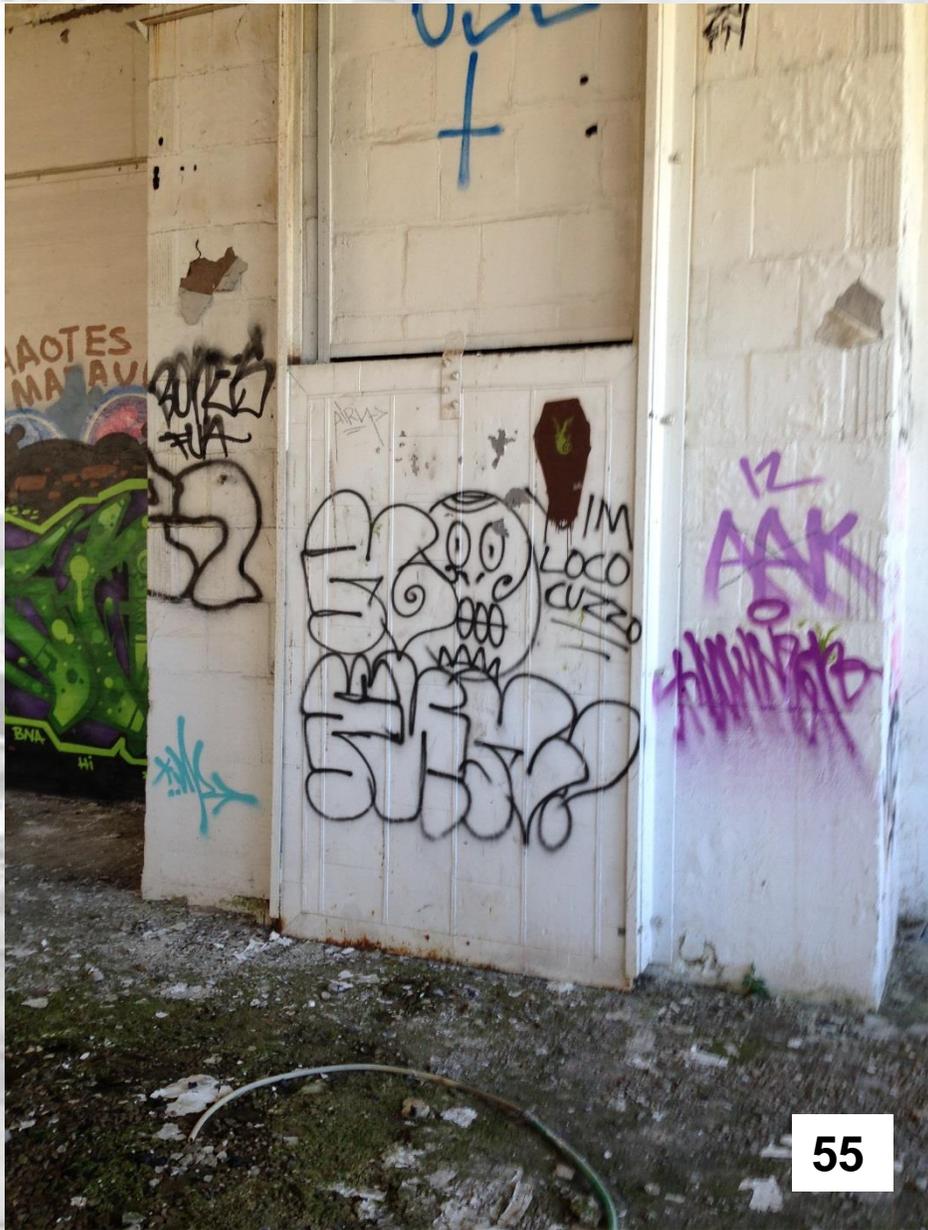
55

Third Floor dumbwaiter

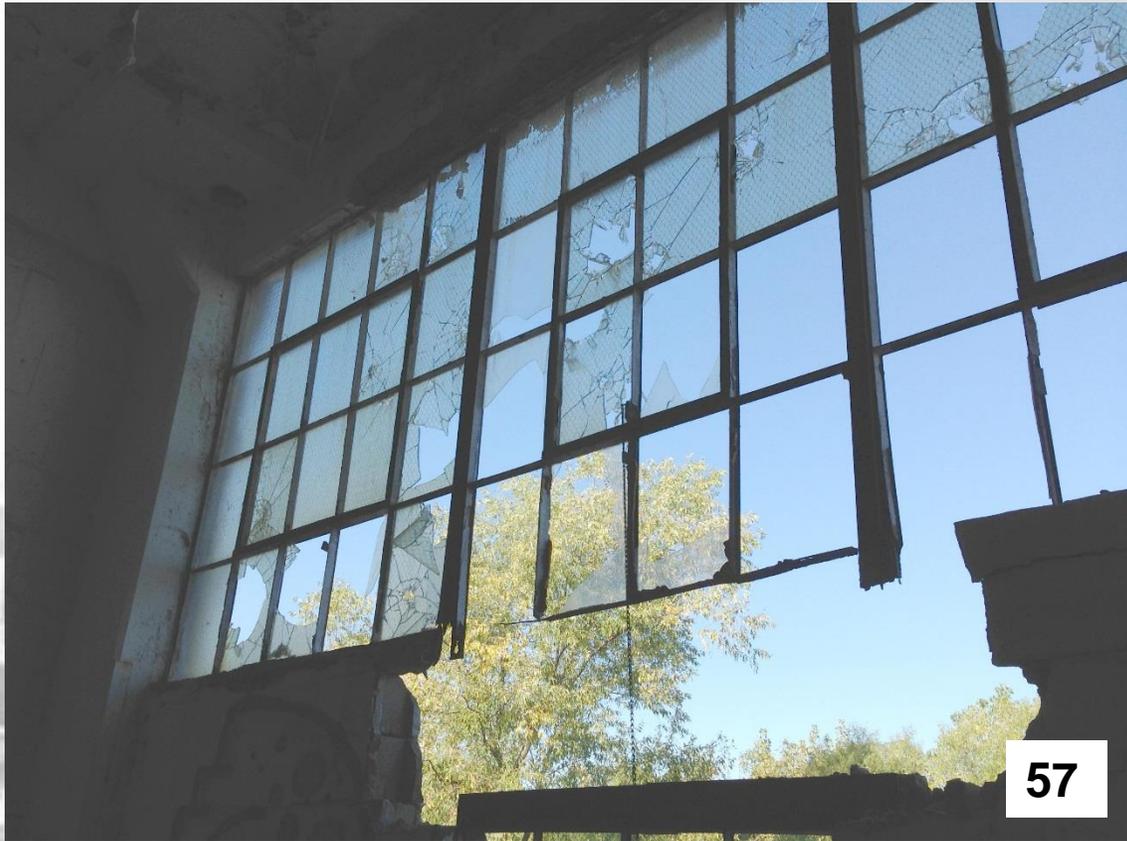
Third Floor last window bay on
South West wall

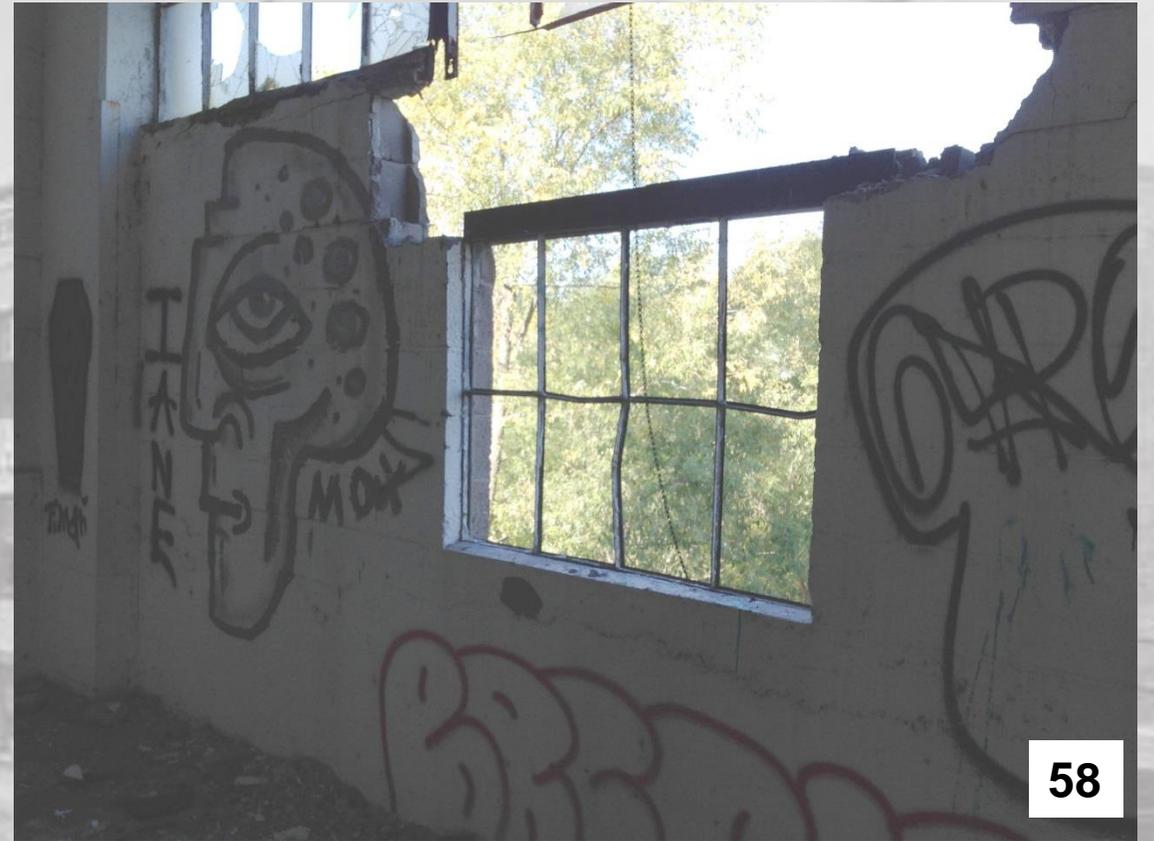
Third Floor last window bay on
South West wall

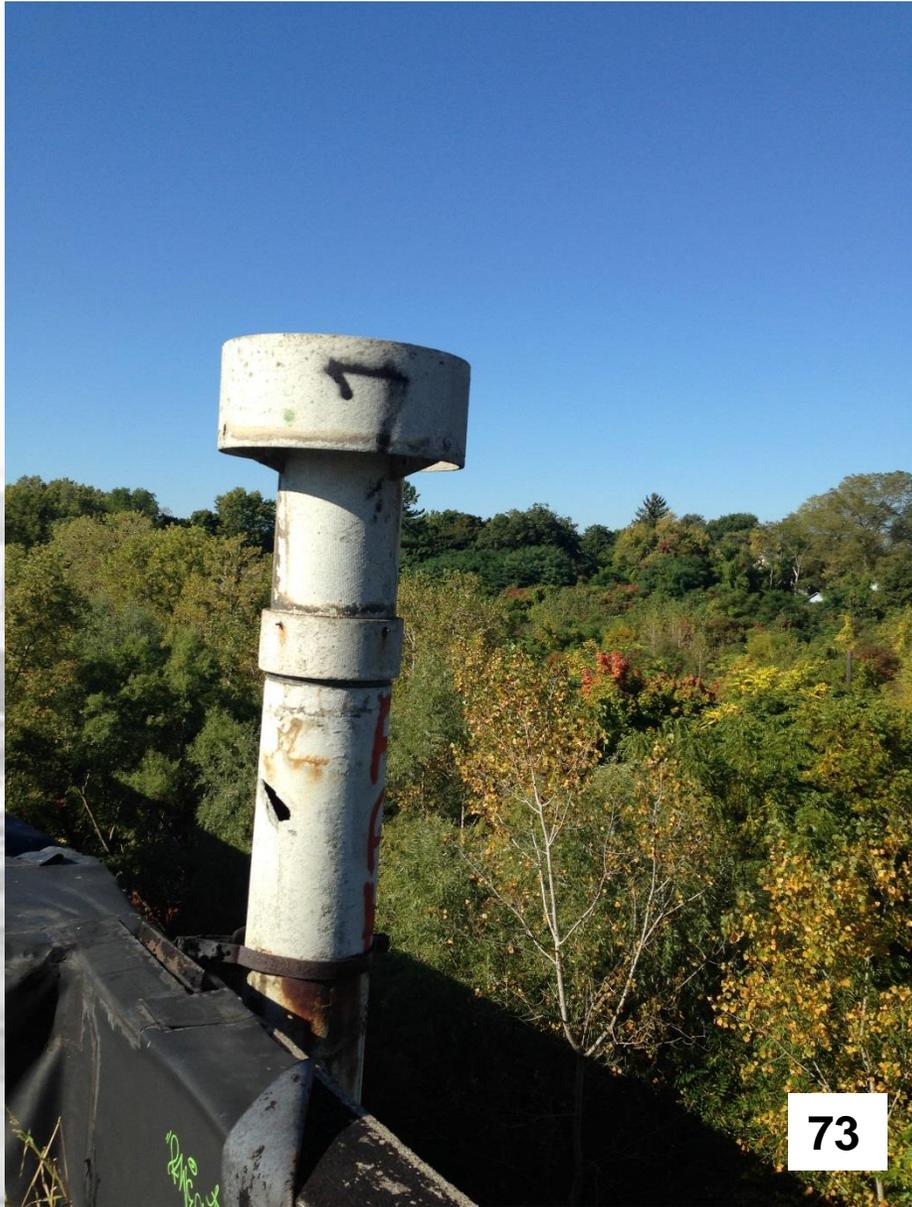
Heat Exhaust Stack

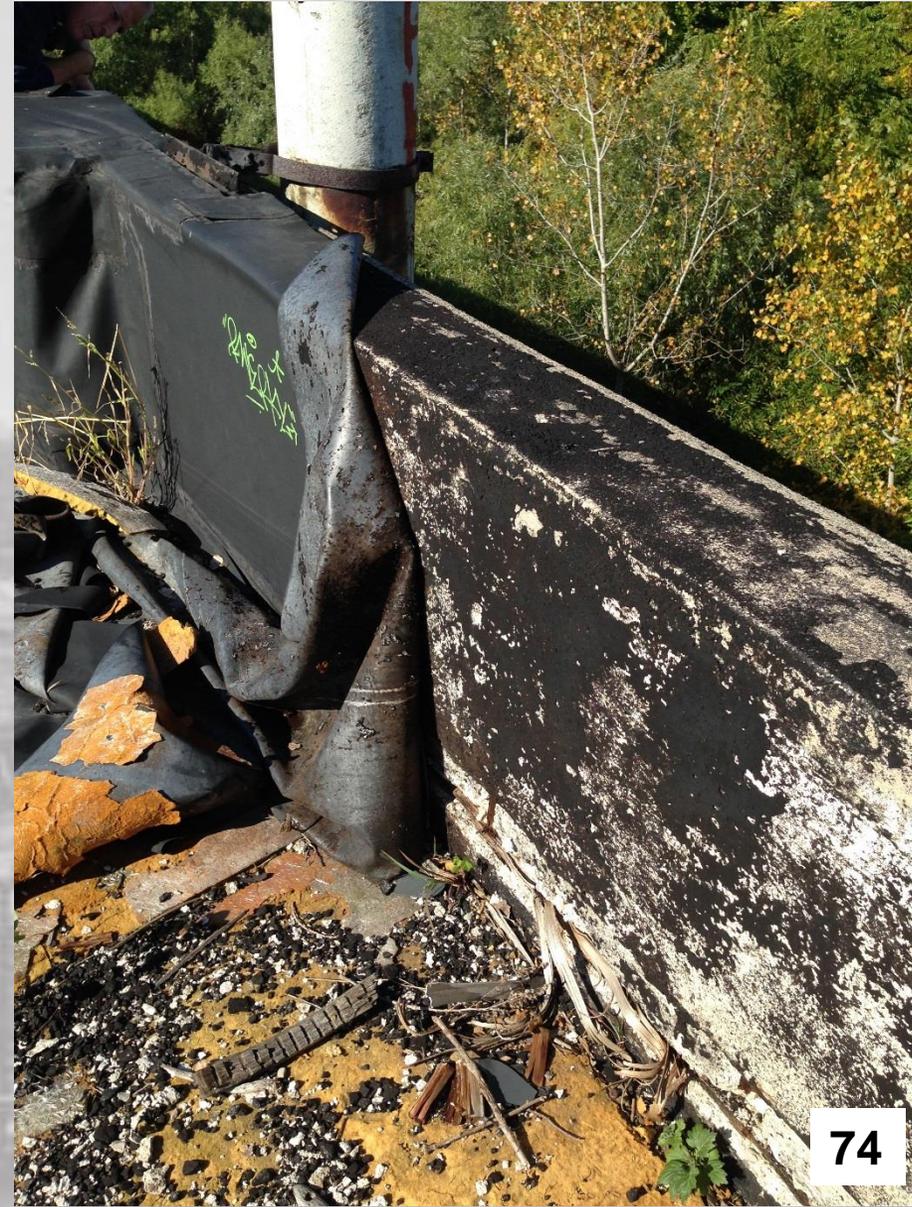
It is not known how long the roofing system has been in a state of failure. Present condition statements are based on visual observations. There currently is no roof insulation or membrane integral to the building covering the concrete roof deck. This also includes the roof on top of the storage building and on the roof and the stairwell and elevator enclosure. The tapered insulation fasteners remain protruding from the concrete roof deck. This is a safety concern. Most of the parapet is severely deteriorated and

Roof membrane not secured

Recommendation: Provide a temporary roof membrane until a permanent system can be constructed. The cost estimate provided in Appendix C includes a temporary Carlisle CCW Vapor Barrier. After façade repairs are made a new roofing system and parapet coping should be provided.

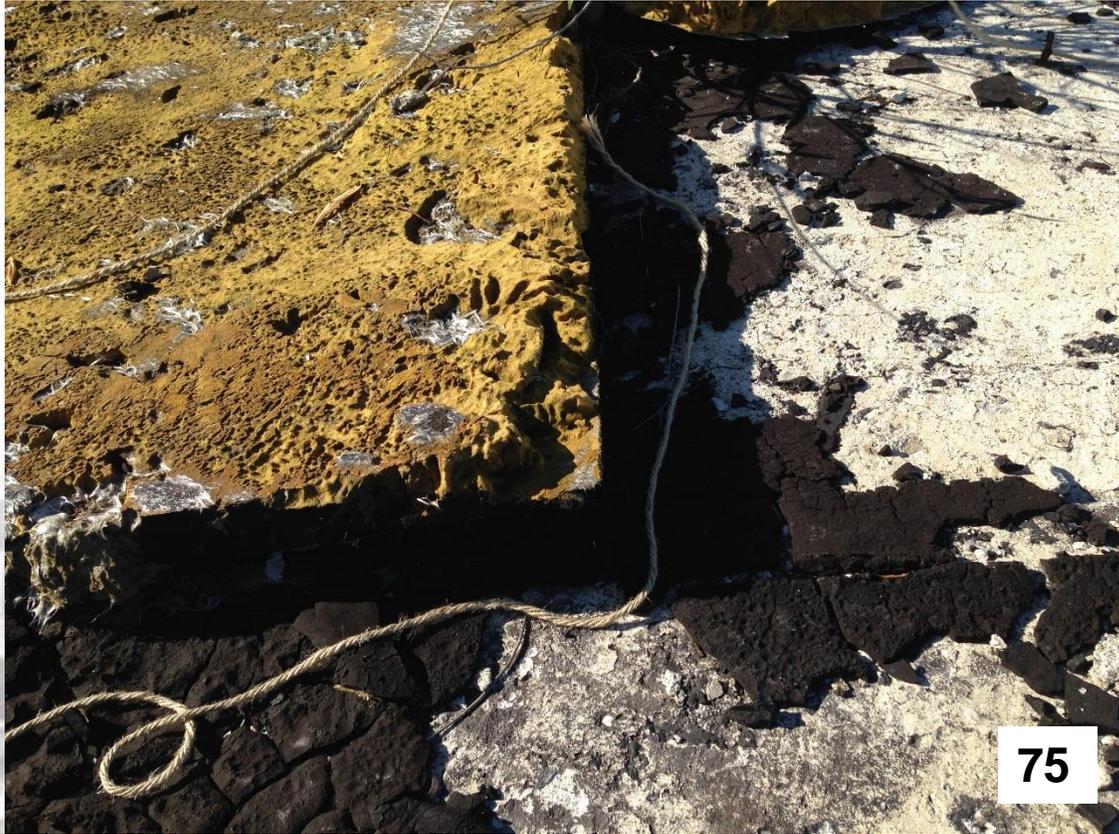
75

This slab surface is in very poor condition. The top surface is almost completely exposed due to the absence of roofing materials, with spalled concrete. The underside of the slab has spalled and the bottom reinforcing steel is rusted and exposed.

Roof Deterioration

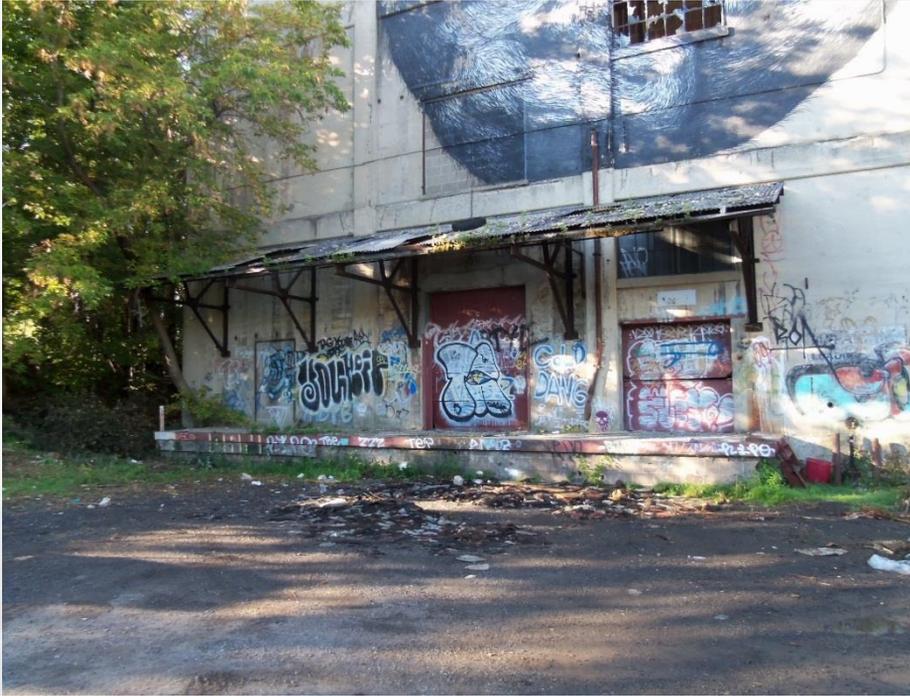
Loading Dock and damaged roof

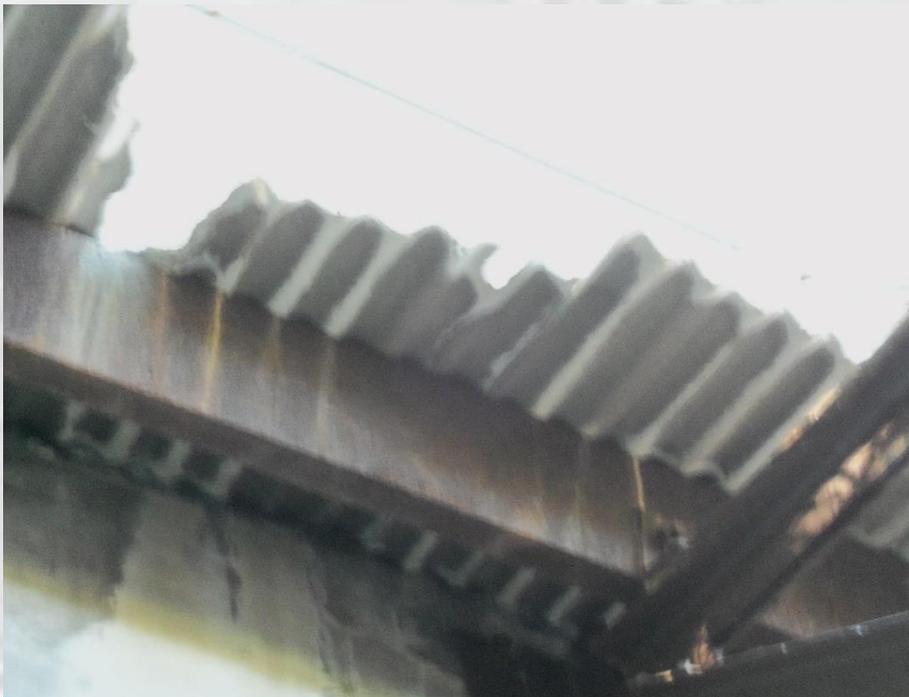
Loading Dock roof is suspect ACM

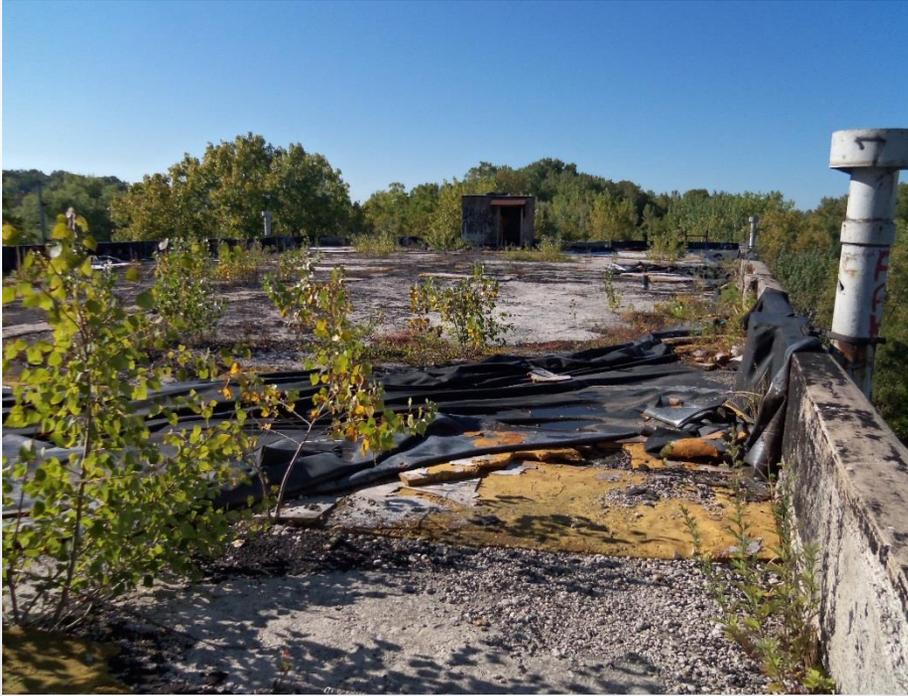
Roof condition – vents and materials

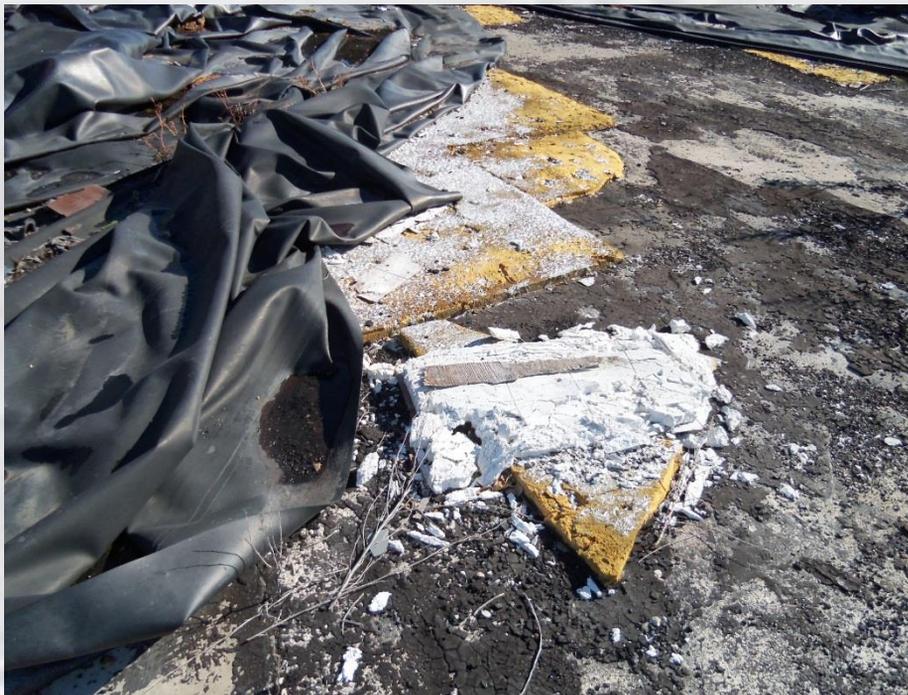
Suspect asbestos containing roofing board

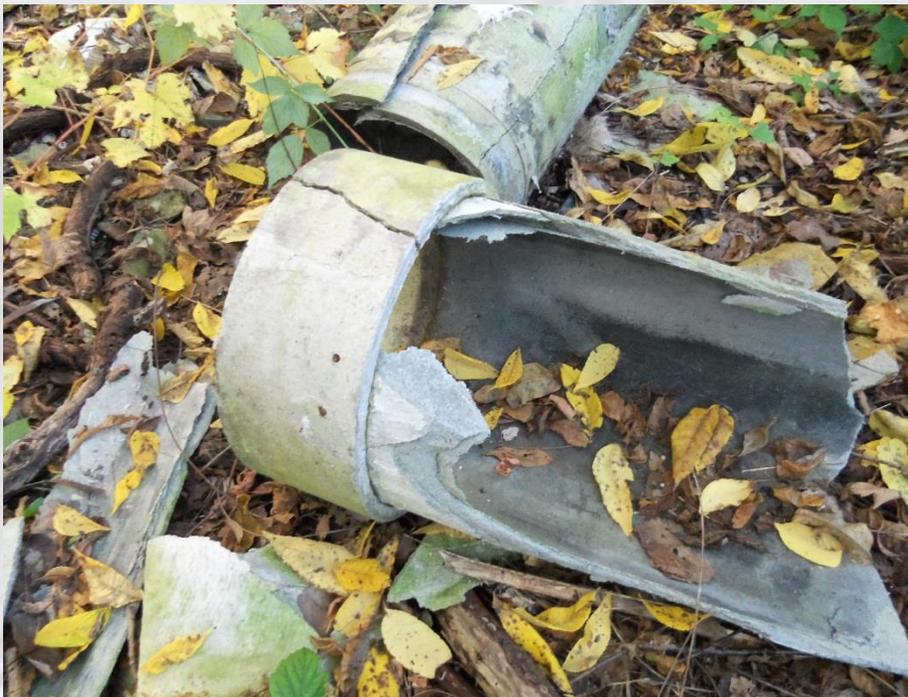
Broken Vent Cap suspect ACM

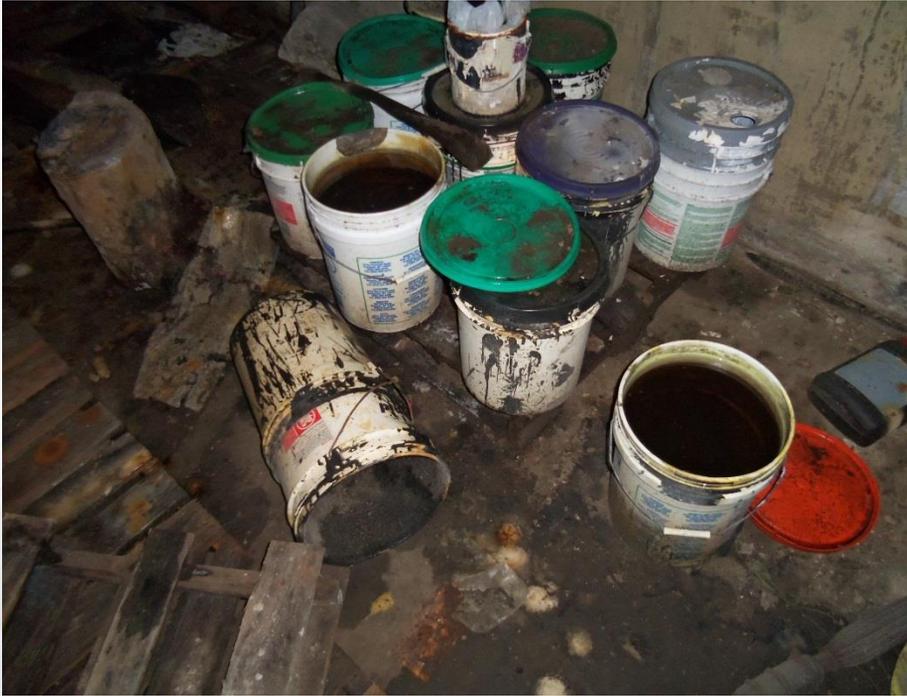
5-gallon containers

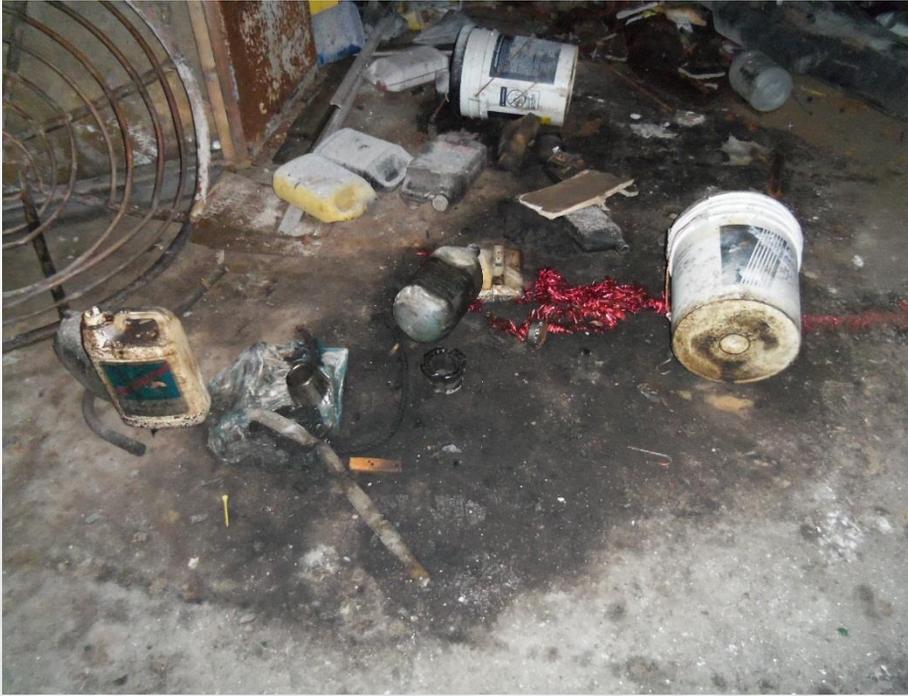
Miscellaneous containers and staining

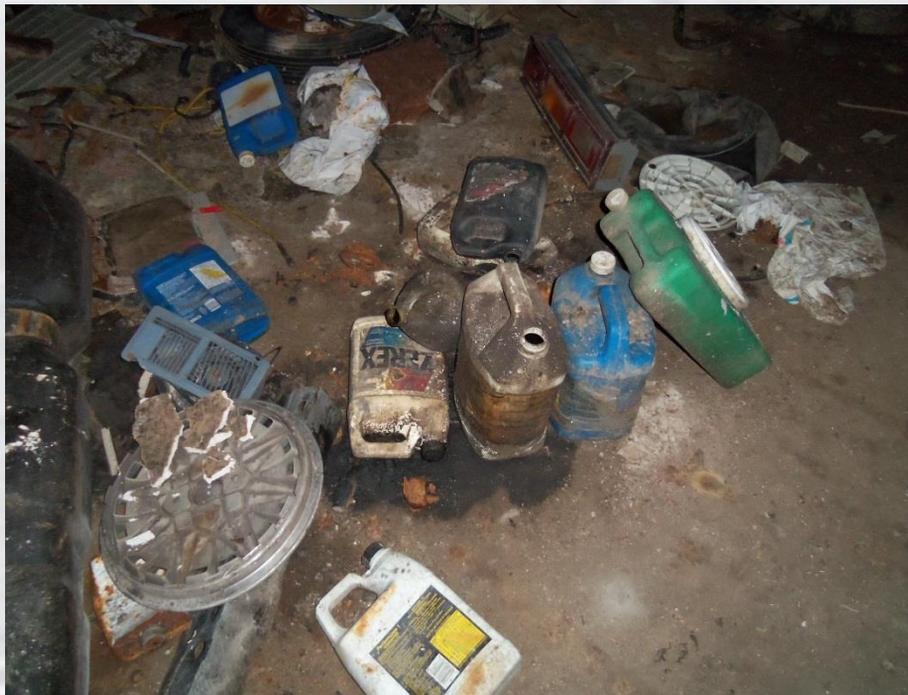
Miscellaneous containers and staining

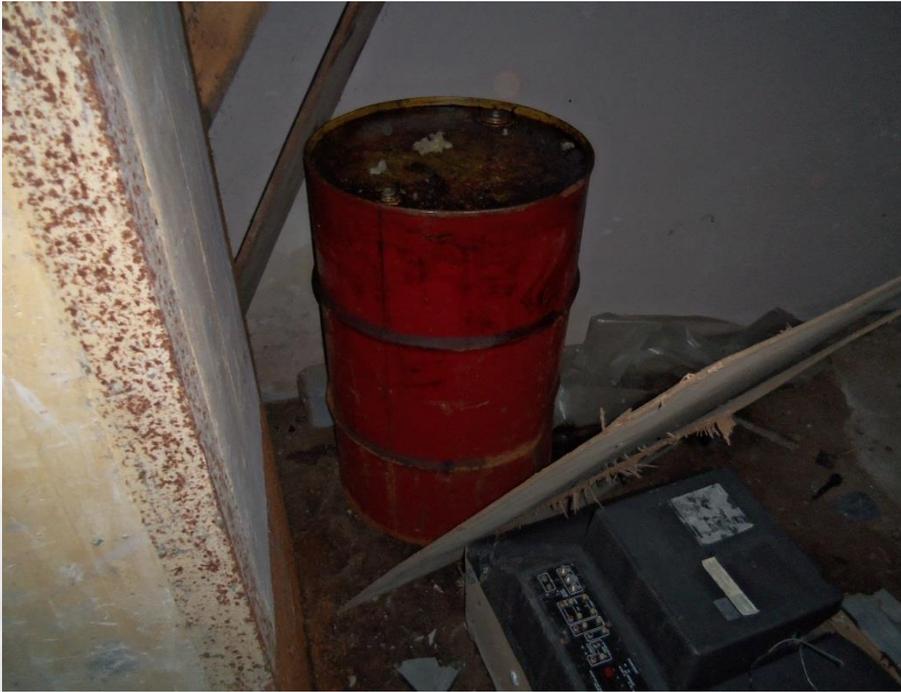
- One (1) 55-gallon steel drum labeled Pennzoil on the top. The drum appeared to be full. Due to the staining on the top of the drum, suspect waste motor oil.
- Fluorescent light bulbs within lighting fixtures, on floor and within boxes.
- Five-gallon buckets labeled joint compound, driveway seal, stain and paint. The buckets are a mix of empty and partially full containers. Some buckets appeared to contain water with residual material in the bottom. Additional buckets were labeled generically with a home improvement store name. The contents of these buckets is unknown.
- An empty automotive fuel tank.
- Miscellaneous containers in quart, gallon and two-gallon sizes labeled to contain: Gear oil, kerosene, antifreeze, motor oil, and windshield washer fluids.
- Empty and partially empty spray paint cans.
- Miscellaneous empty plastic containers.

Drum located on 1st Floor

Hazardous materials and containers should be properly removed and disposed according to federal, state, and local regulations prior to building demolition.
