# Midtown Parking Garage

Condition Survey

December 2010

**LABELLA**  
Associates, P.C.

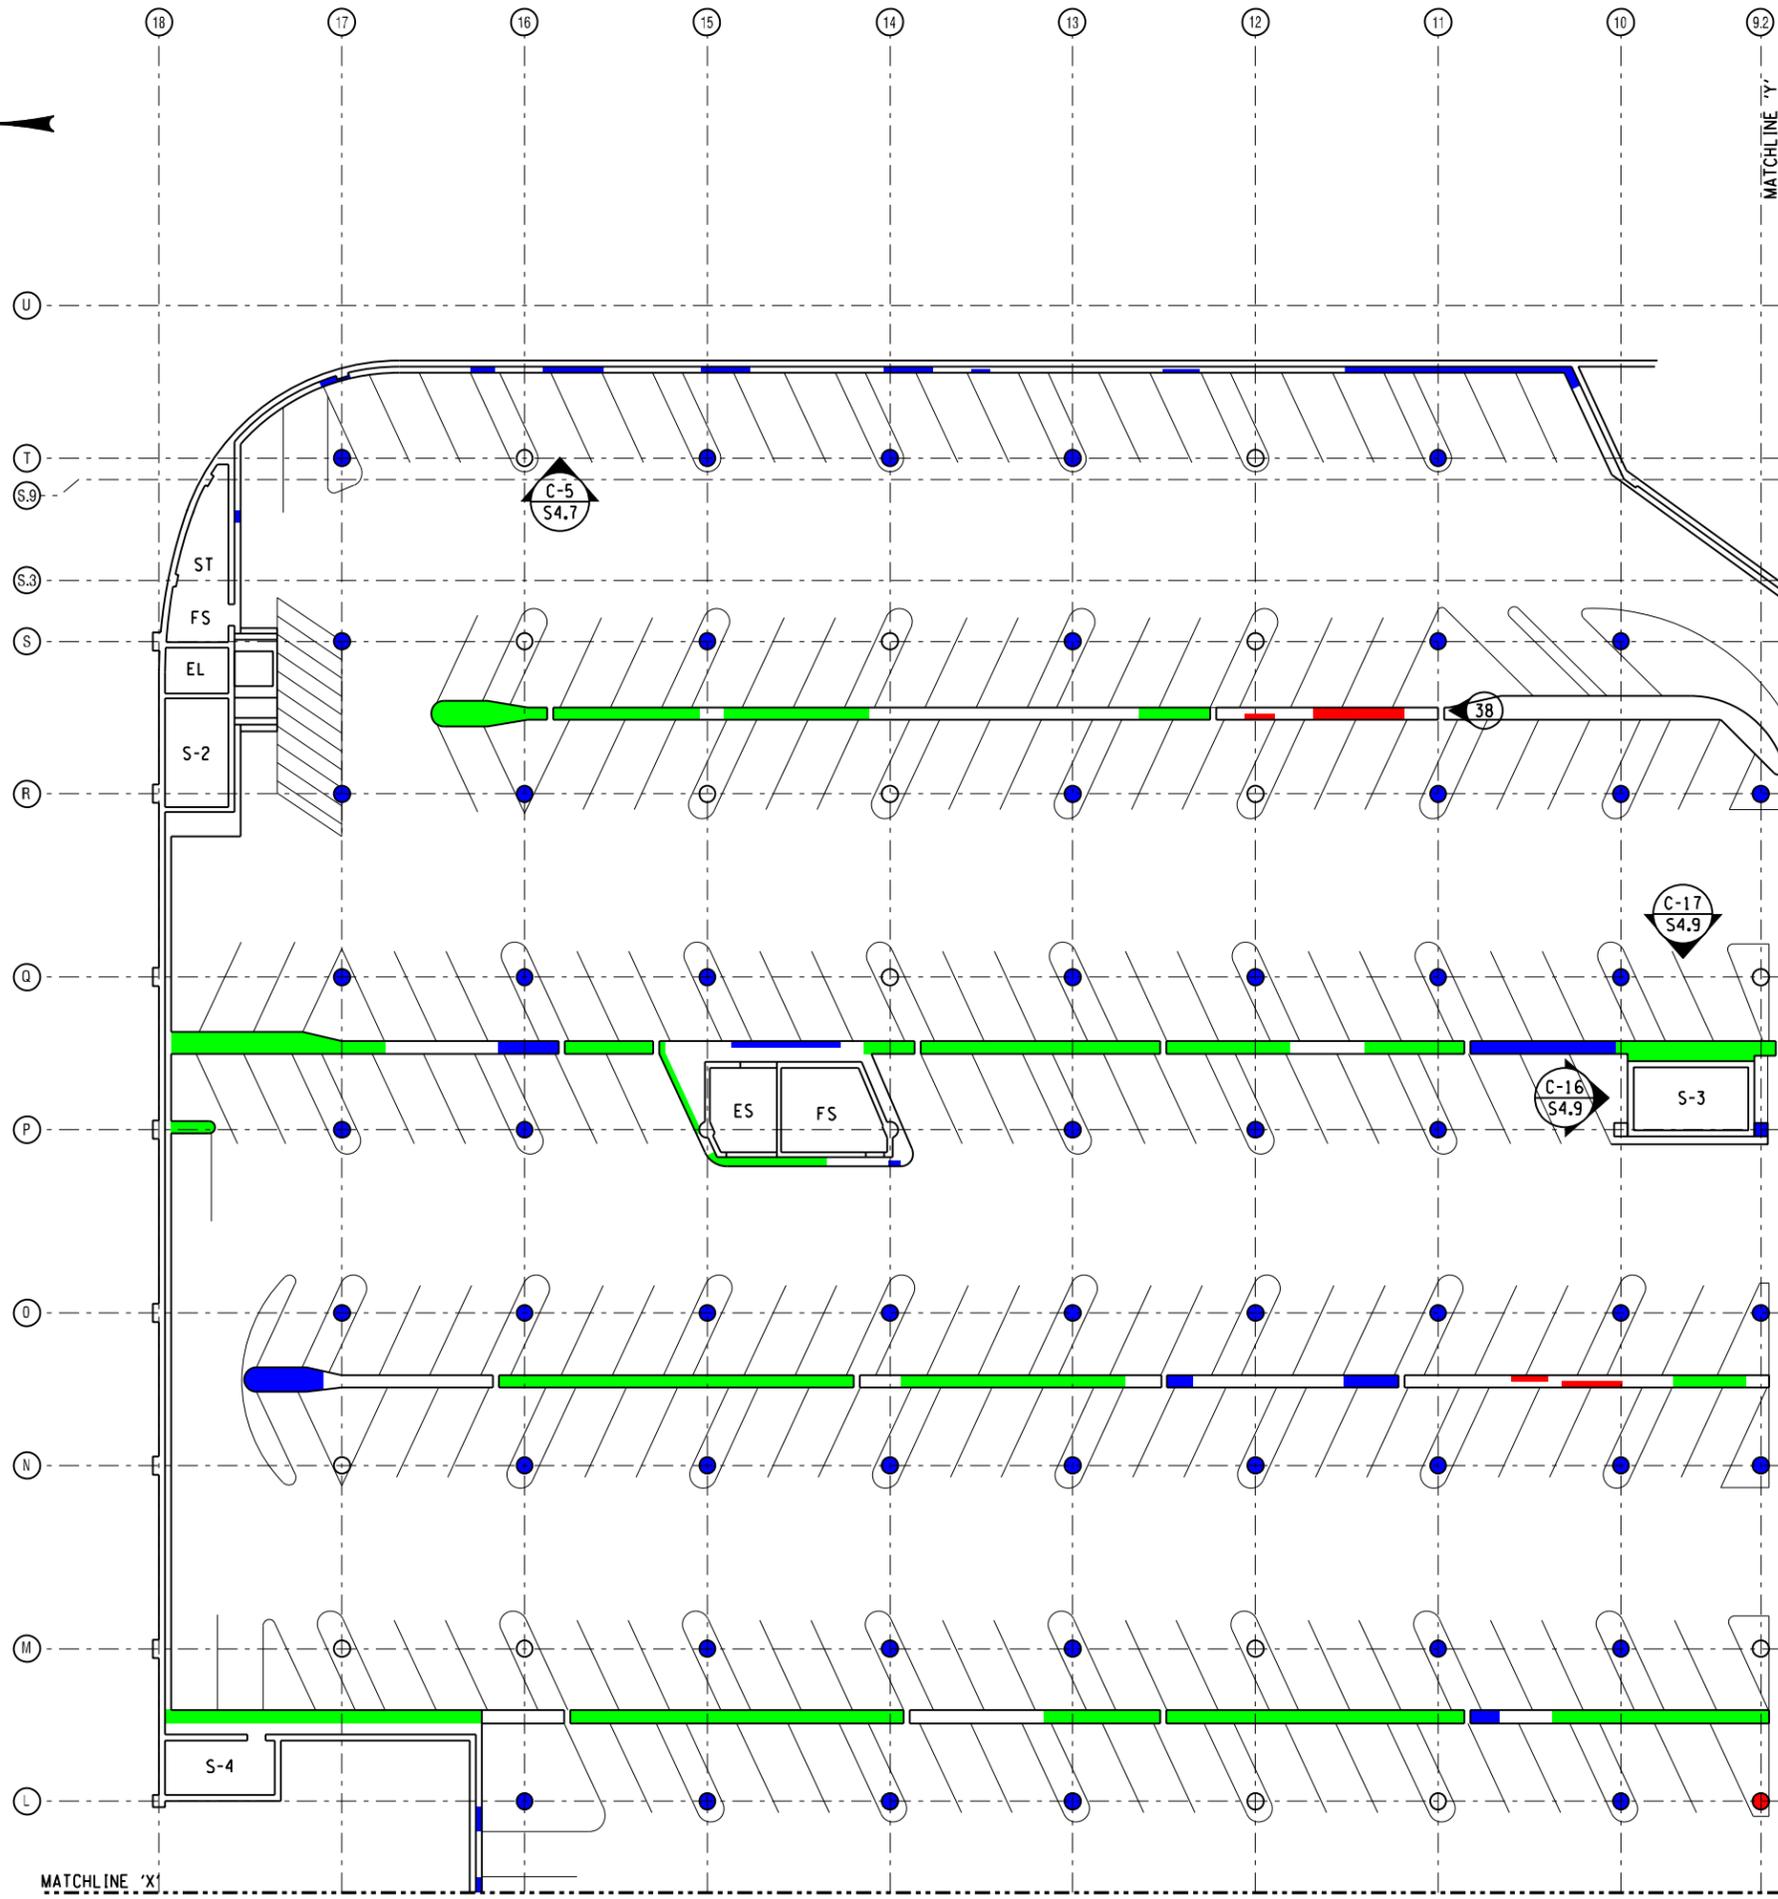
**S1.1**  
SHEET OF

Level C. The Level C asphalt overlay wearing surface is generally in good condition. Cracks, predominantly running between columns in the north/south and east/west directions, and small potholes were observed (see Photo 9).

the Clinton Avenue wall (in Ramp R-3). During a 9/29/10 site visit by LaBella Associates, Rochester District Heating personnel were available to open the three manhole covers. Being the utility tunnel is a confined space with hazardous materials, the inspection inside the tunnel only amounted to sticking a camera down the manholes to take photos. The photos revealed concrete spalls with severely corroded reinforcing bars at the manhole near Column 6-I (see Photo 47) and the manhole in the Ramp R-3 floor along the Clinton Avenue perimeter wall (see Photo 48).

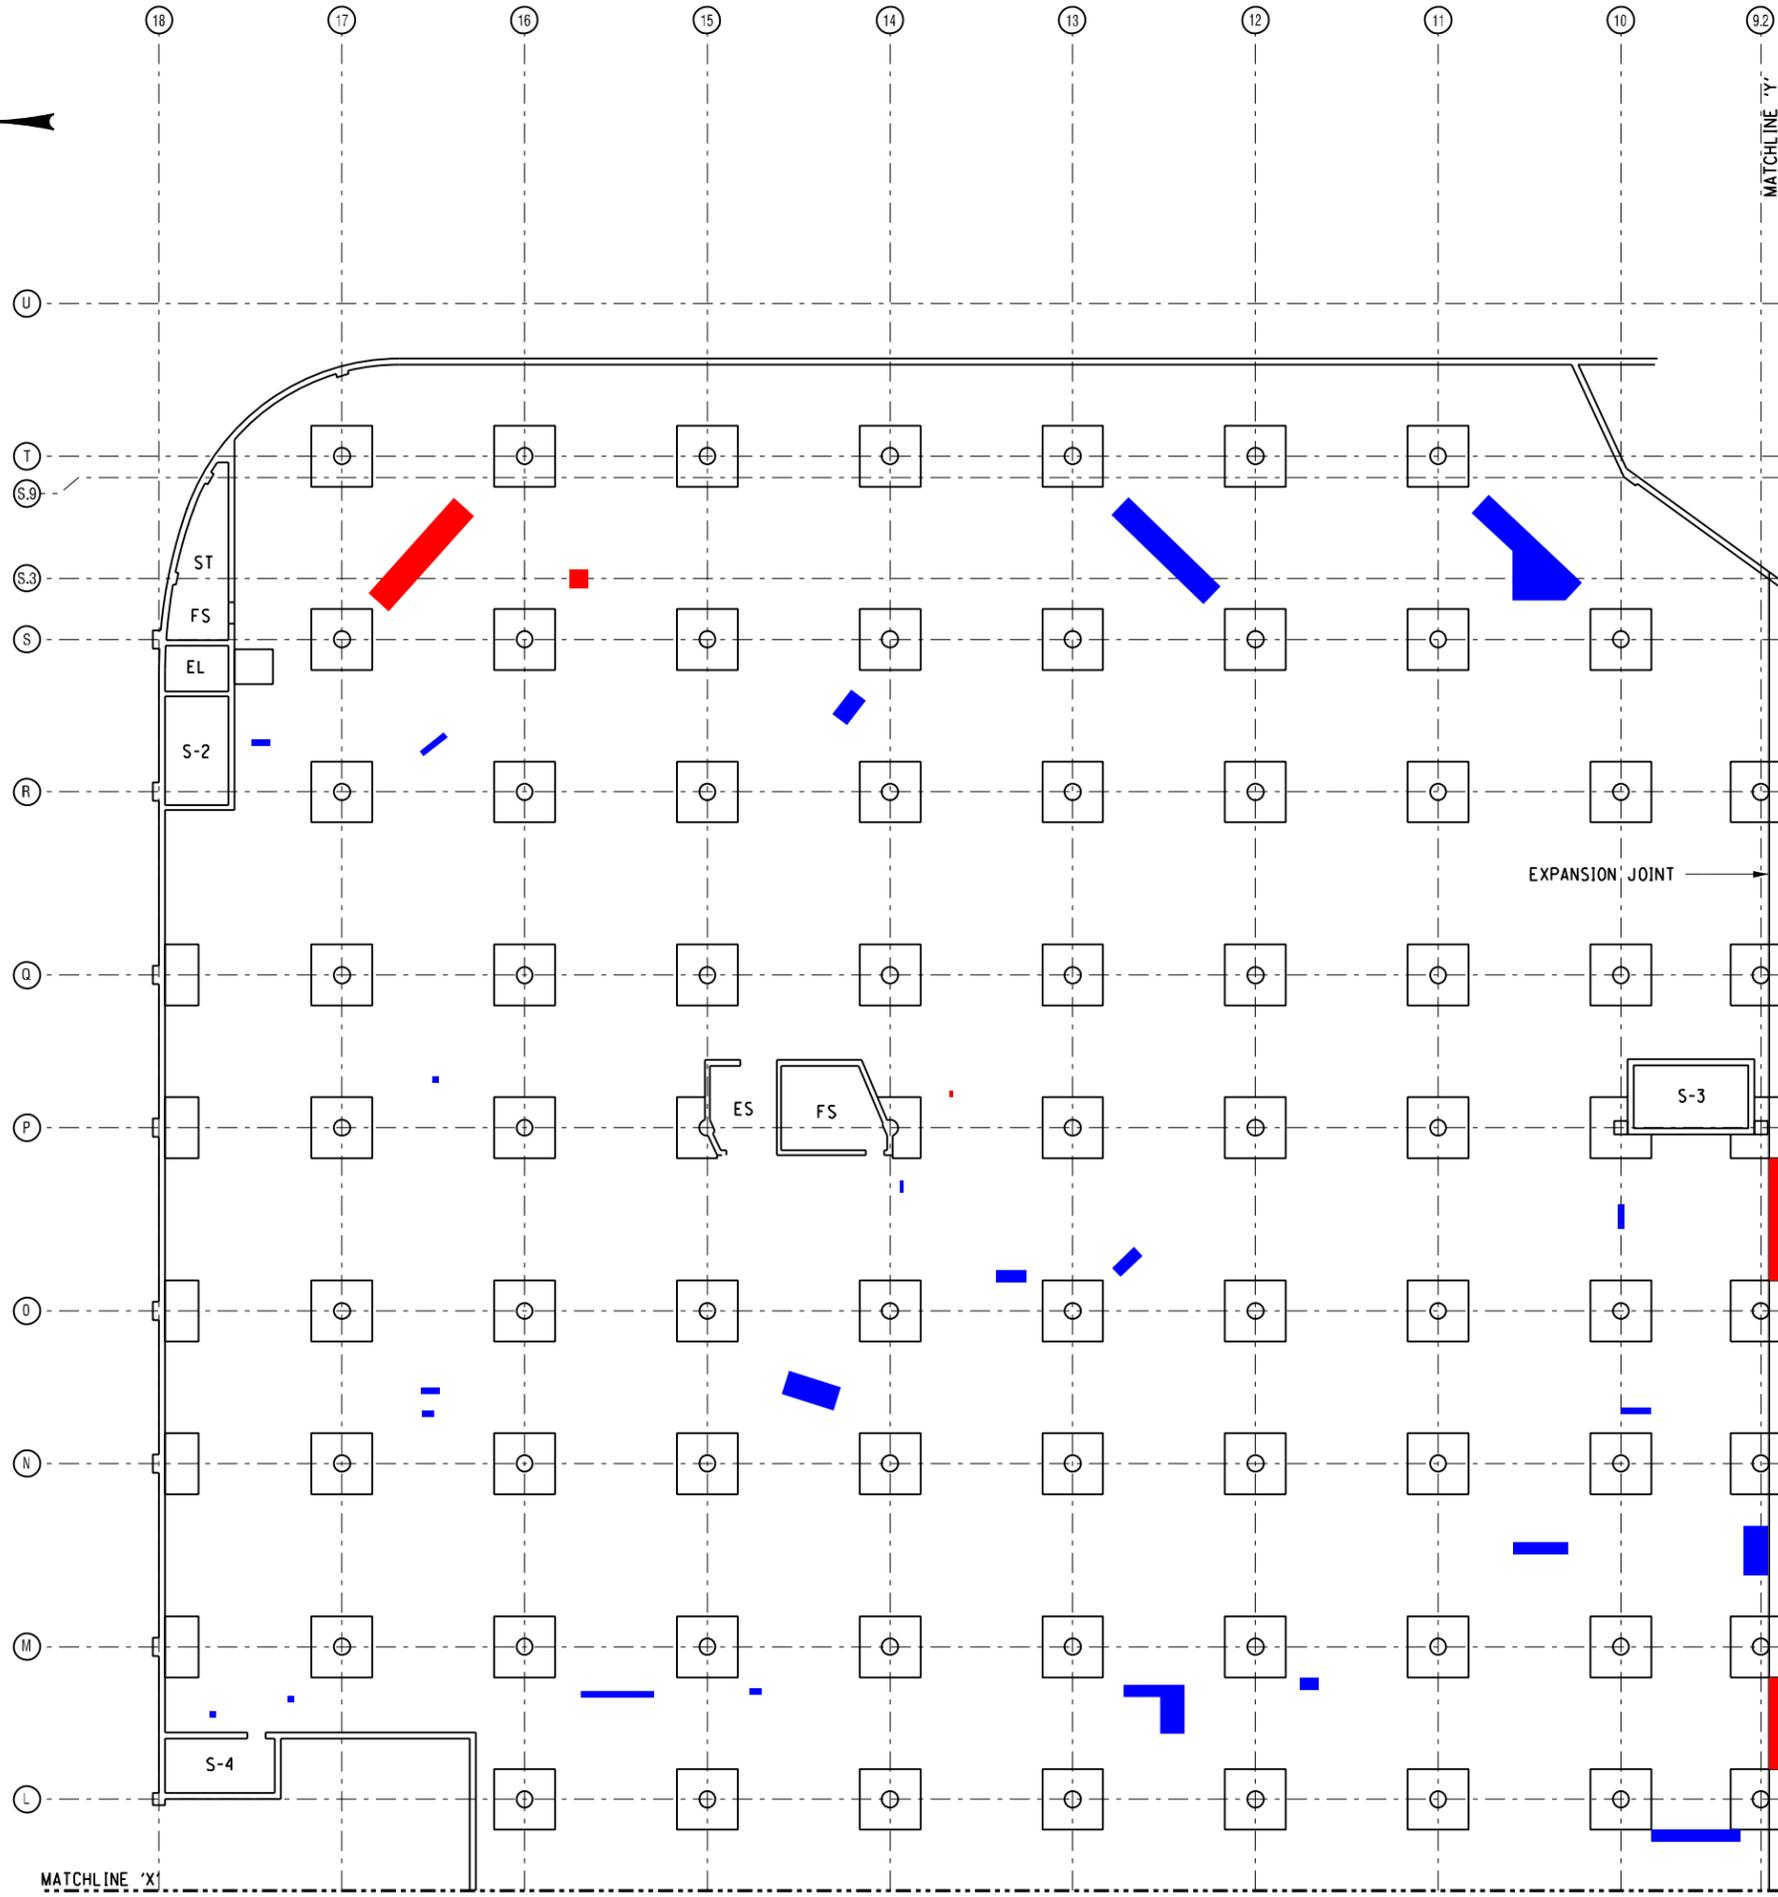
PROJECT/DRAWING NUMBER  
210301  
**S1.5**  
SHEET OF

The underside of the Level A and B slabs, especially under the drive aisles, exhibit numerous efflorescence stained and delaminated areas, scaled concrete, and spalled concrete exposing corroded slab reinforcement (see Photos 15, 16 & 19). The majority of the slab deterioration is in the southern half of the garage, with the southwest quadrant the worst. Most scaled and spalled concrete areas have deposited an outline of the deterioration on the floor below (see Photos 6 & 17).

Previous patching, partial and full depth, were observed and noted to be generally in good condition. There are some exceptions where these previous repairs have deteriorated. New delaminations and spalled concrete have also developed around previous patches (see Photos 14 & 21). This condition is called “ring corrosion” where the PH of the new concrete patch is different from the existing surrounding concrete accelerating corrosion of the reinforcement at the patch interface.

On Level C at Column 8-H, an efflorescence stained and spalled concrete area with exposed corroded reinforcement in the slab underside is adjacent to a crack and spall in the column drop panel (see Photo 18).

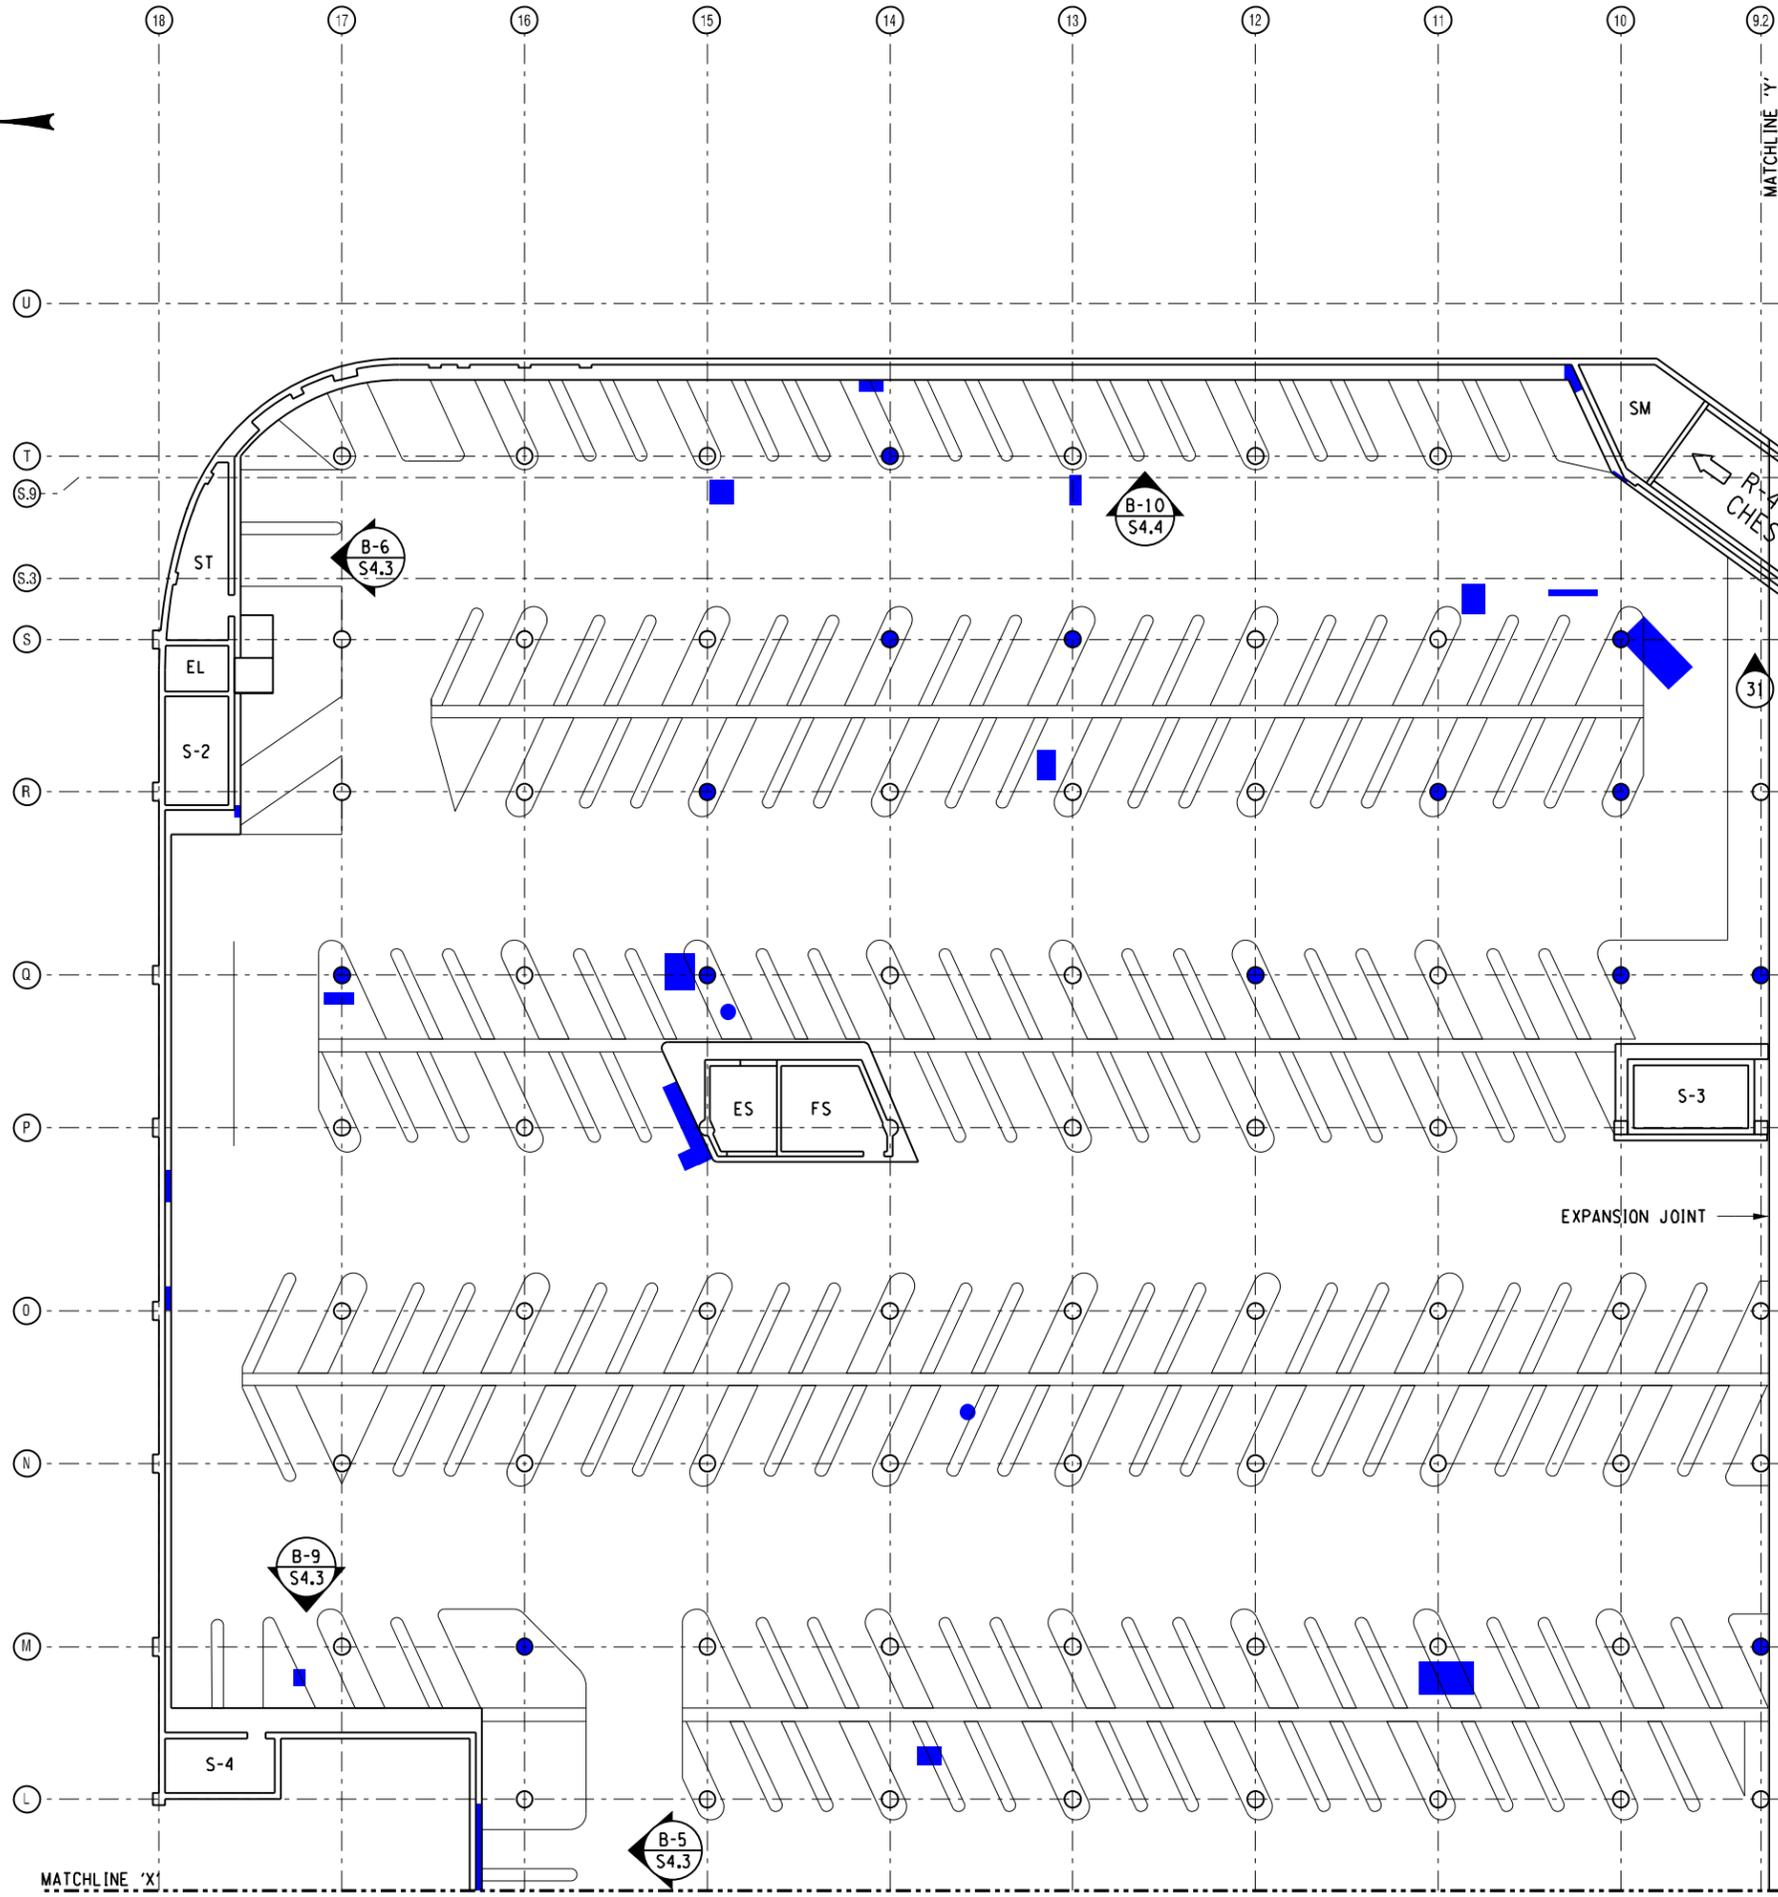
**S2.1**

Level A & B. As part of the rehabilitation work in the mid-1980's, the Level A and B structural concrete floor slabs were topped with a concrete overlay and traffic grade membrane system (see Photo 1). The traffic topping is in various degrees of deterioration. In the main drive and recirculation aisles, widespread areas of the membrane system is worn and disintegrated, exposing the concrete overlay (see Photos 5, 7 & 8). The remainder of the membrane system in these aisles exhibits random cracks and isolated debonded or worn areas. Isolated cracks were observed in the exposed concrete overlay (see Photo 6).

The membrane in the parking stall areas and drive aisles between the parking stalls is generally in good condition. On both garage levels, random cracks and isolated debonded and worn areas were noted (see Photo 3). The majority of the debonded areas are located along column lines. The largest quantity of debonded areas is located in the west half of Level B. The worn areas are predominantly in the drive aisles, especially where vehicles negotiate a turn.

Removal of the debonded membrane was performed at a few locations and generally revealed deterioration to the top of the concrete overlay (see Photo 4). At one location, concrete was removed to the top of the structural slab steel reinforcing bars.

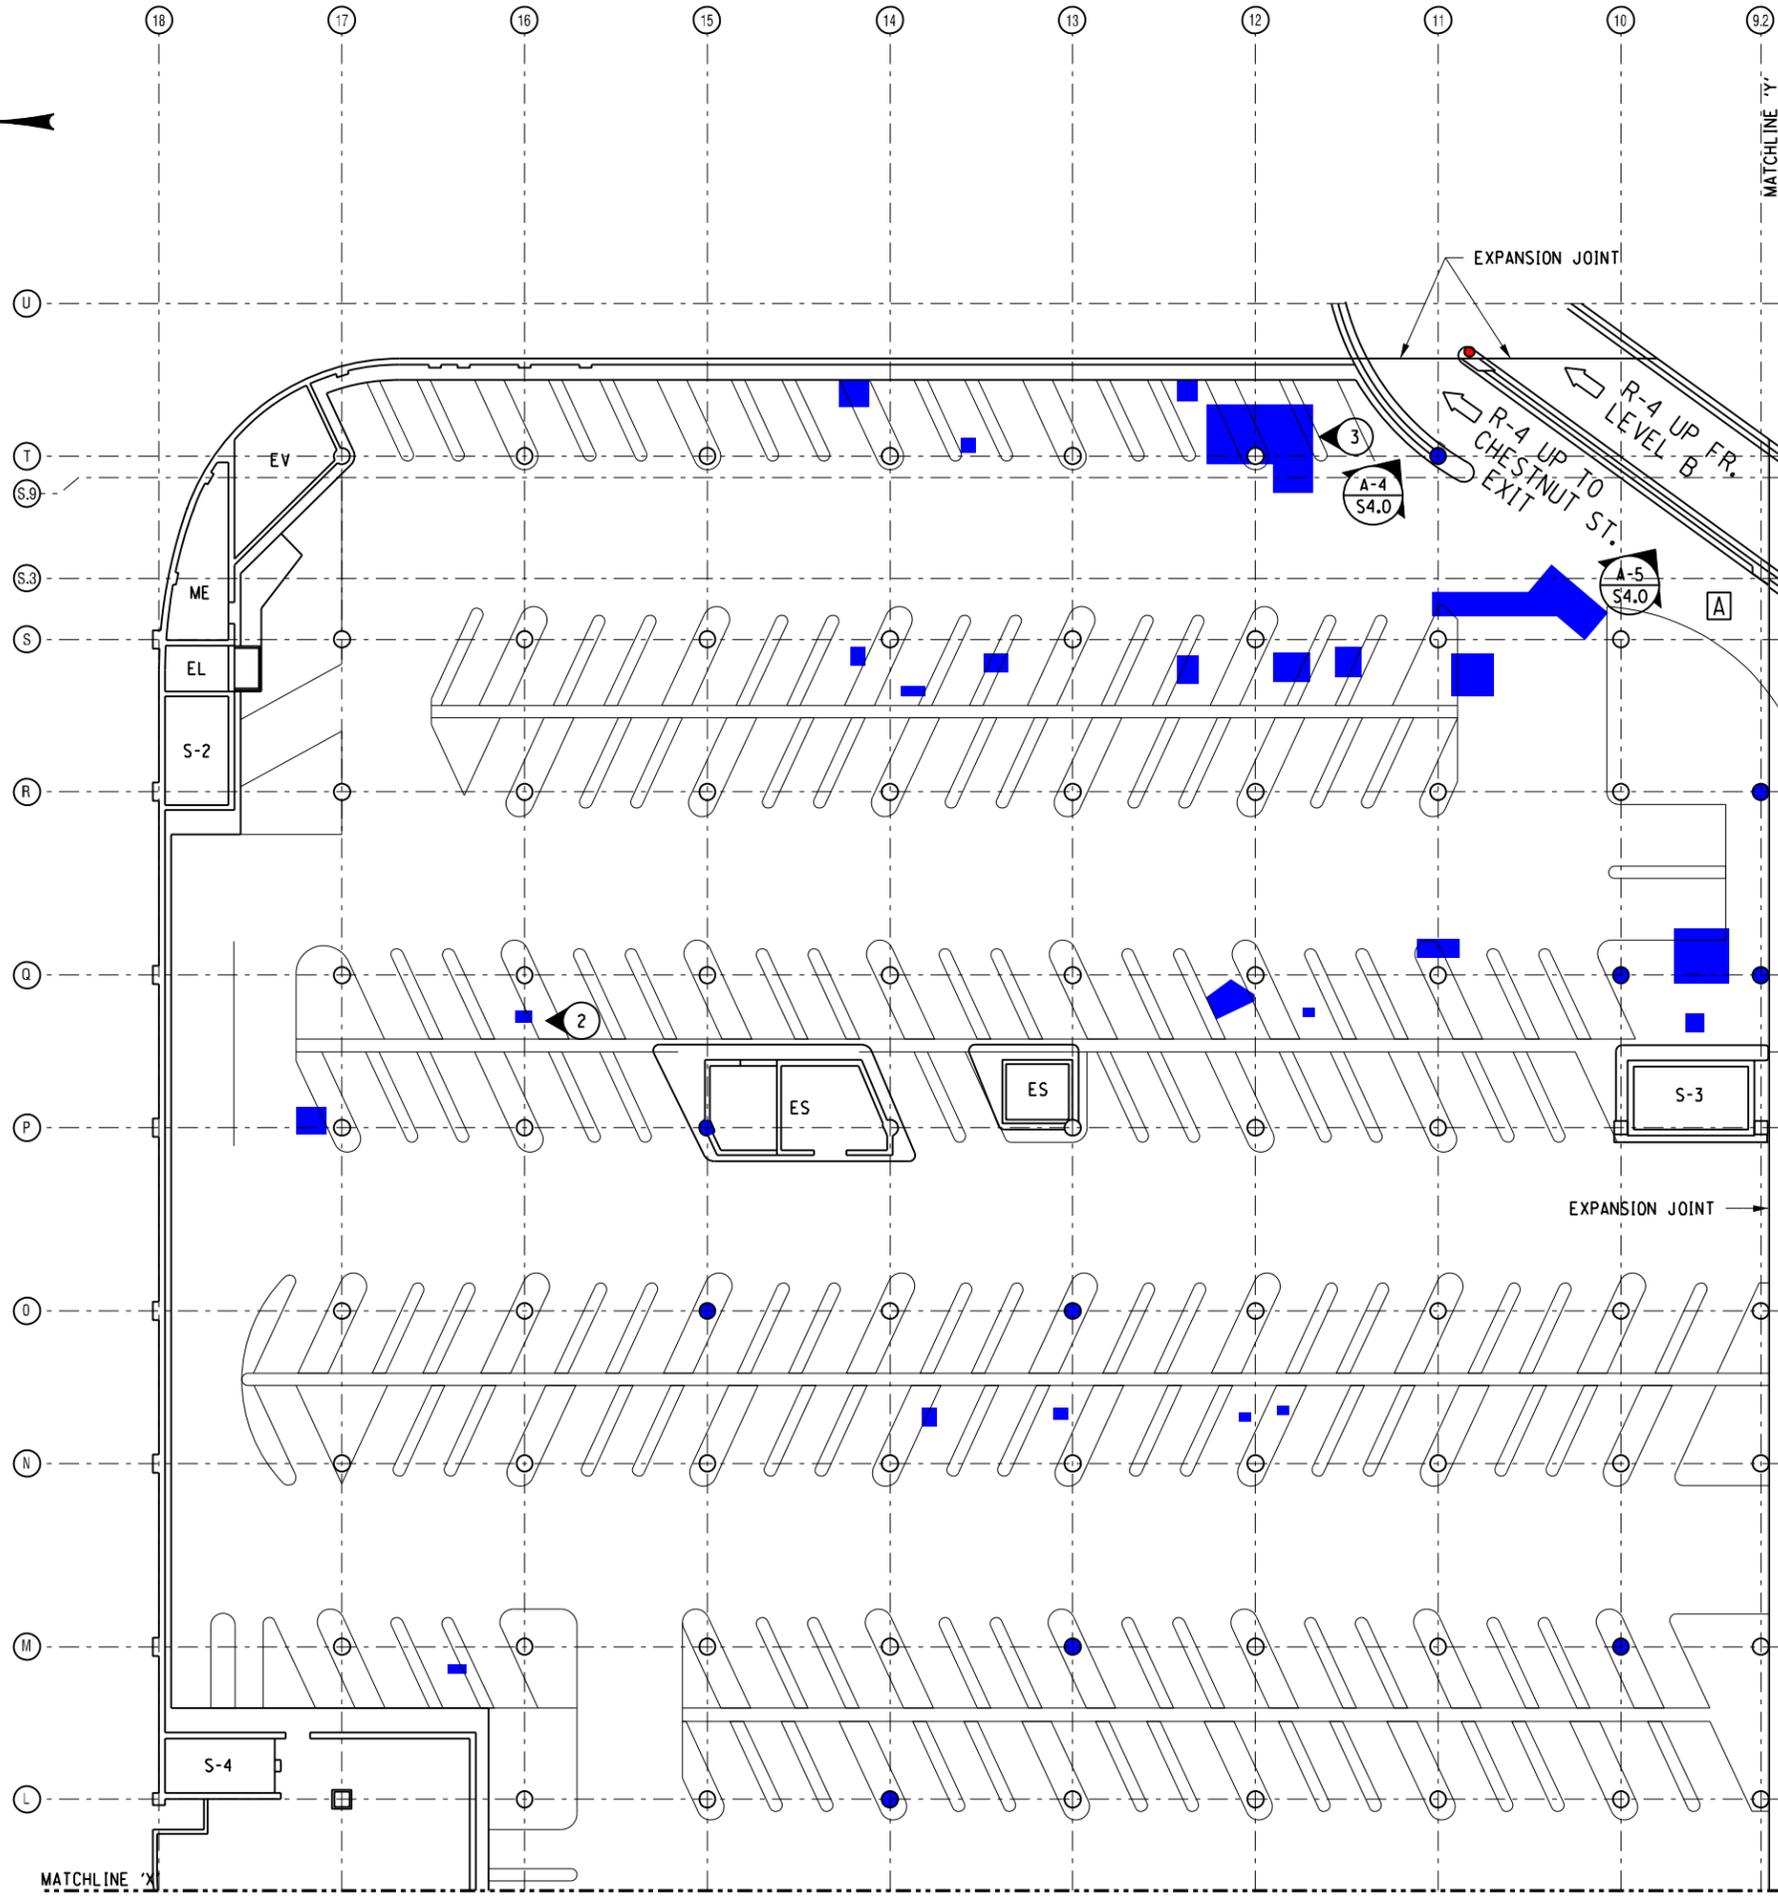
**S3.1**

Isolated areas of ponding water were observed on Level A (see Photo 2). The majority of the ponding was observed in the west half of the garage.

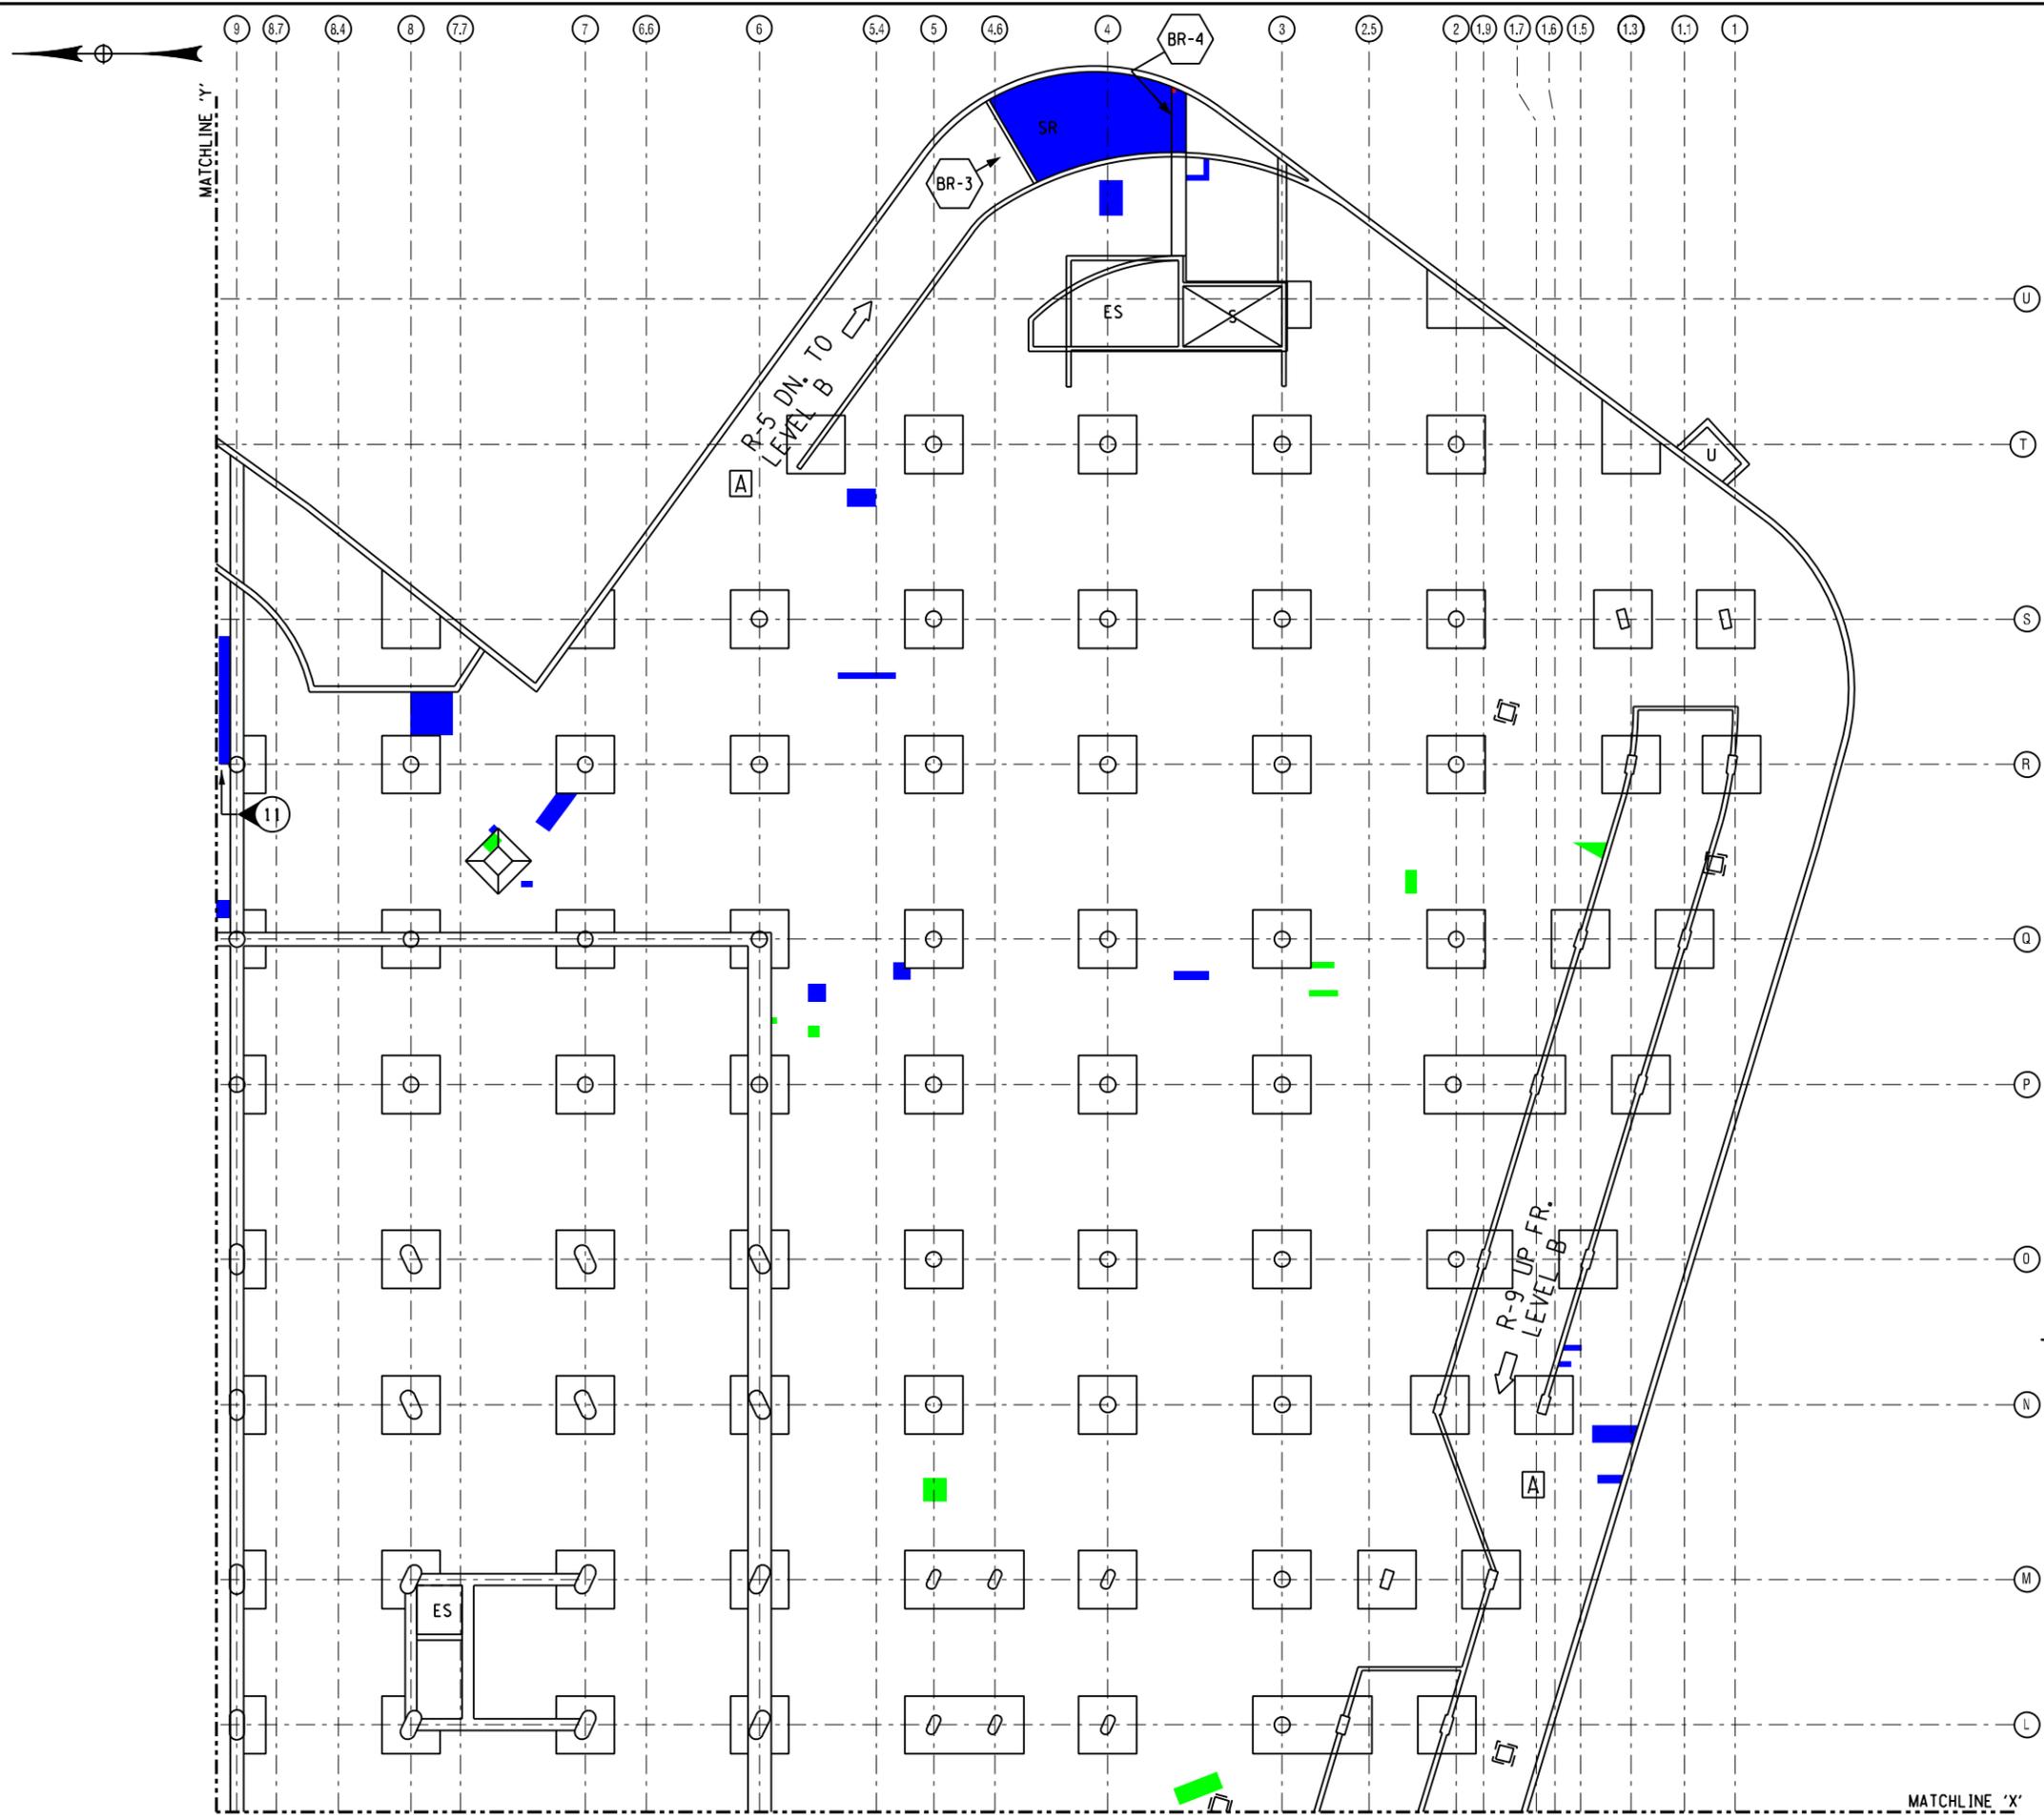
PROJECT/DRAWING NUMBER  
210301  
**S3.6**  
SHEET OF

The underside of the Mall Level slab is generally in good condition. The slab underside exhibits isolated efflorescence stained and delaminated areas, some with spalled concrete exposing slab reinforcement, and random cracks with some efflorescence and some dripping water (see Photo 10). The majority of the slab deterioration is in the southwest quadrant (under Broad Street). For observed deterioration, see Level A Reflected Ceiling Plan Drawings S3.5 to S3.8.
