PHASE I ENVIRONMENTAL SITE ASSESSMENT

UNDEVELOPED LAND 350 & 370 ORCHARD STREET AND 399 SAXTON STREET ROCHESTER, NEW YORK

Prepared for: Westside Health Services

April 25, 2003

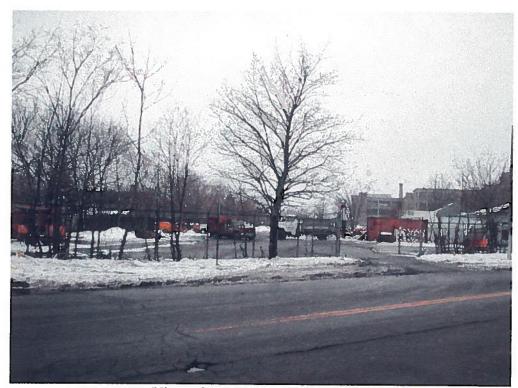
View of assessed property to west

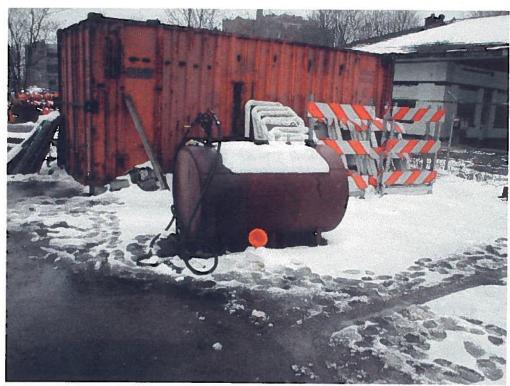
- (3.4.3) The assessed property is currently undeveloped and, as such, is not currently serviced by public water or sewer systems.
- (3.6.1) An approximate 250-gallon skid-mounted aboveground storage tank (AST) was observed on the 399 Saxton Street parcel. This tank reportedly contains diesel fuel and will be removed from the assessed property by Sealand when Sealand vacates the assessed property (refer to Section 4.2). No stains, spills, or odors were observed in the area of the AST, and it is not being identified as a recognized environmental condition in relation to the assessed property at this time.

AST located on 399 Saxton Street parcel

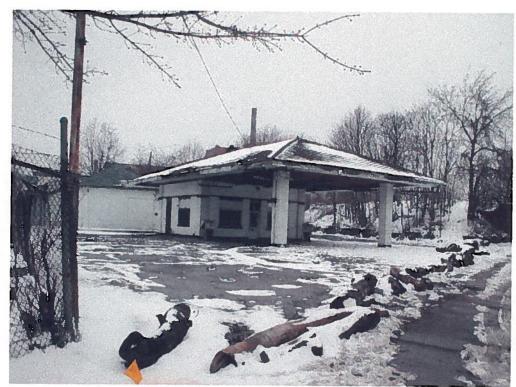
- (3.8) A vacant gas station with an active NYSDEC spill is located on an adjoining property to the east and north of the assessed property. Also, review of historical information indicates that a gas station has been present at this location since at least 1935, and that the area to the north and west of the assessed property has been used for industrial purposes since at least 1910 (refer to Sections 1.3 and 1.4). The historical uses of these adjoining and nearby properties are being identified as a recognized environmental condition in relation to the assessed property.

Vacant gas station located adjoining to the east/north of assessed property

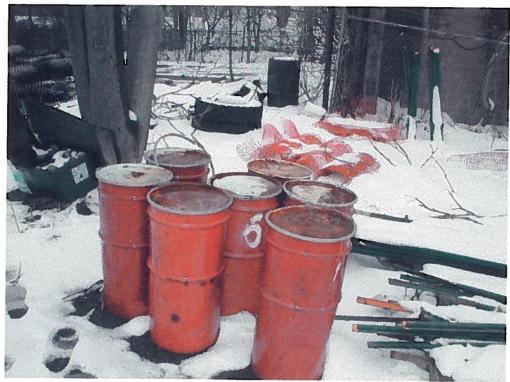
- (3.6.2) Seven approximate 25-gallon drums and one 55-gallon drum were observed on the 399 Saxton Street parcel. No stains, spills, or odors were observed in the area of the drums. The approximate 25-gallon drums reportedly contain bolts for the bridge reconstruction project and do not contain liquid. The 55-gallon drum was empty at the time of the site visit. The drums will reportedly be removed from the assessed property by Sealand when Sealand vacates the assessed property (refer to Section 4.2). Based on the information presented above, the presence of the drums on the assessed property is not being identified as a recognized environmental condition in relation to the assessed property at this time.

Drums located on 399 Saxton Street parcel

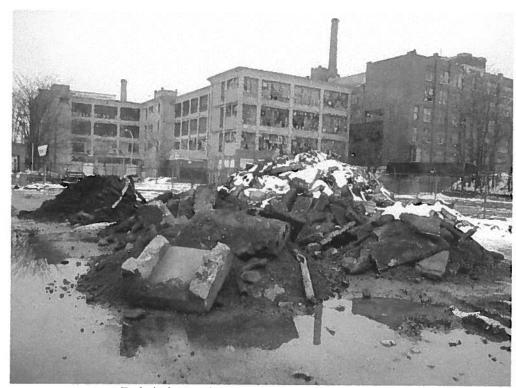
- (3.2) A pile of concrete rubble, and a pile of run-of-bank gravel were observed on the ground surface on the 350 Orchard Street parcel. The concrete is reportedly being staged temporarily by Sealand and will be removed from the assessed property. The rubble is from the bridge reconstruction project being performed by Sealand. The gravel is being used on construction projects on an as needed basis (refer to Section 4.2). Based on this information, the presence of the concrete rubble and the gravel on the assessed property is not being identified as a recognized environmental condition in relation to the assessed property at this time.

Debris located on 350 Orchard Street parcel

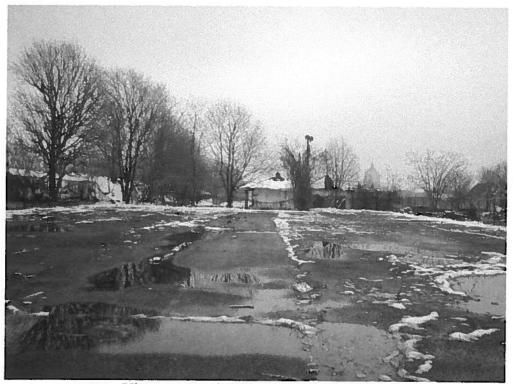
View to east of 370 Orchard Street parcel
