**UPDATE  
PRE-RENOVATION ASBESTOS SURVEY AND  
LIMITED HAZARDOUS MATERIALS ASSESSMENT REPORT**

**Pulaski Library**

**1151 Hudson Avenue  
Rochester, New York 14621**

Update June 2012

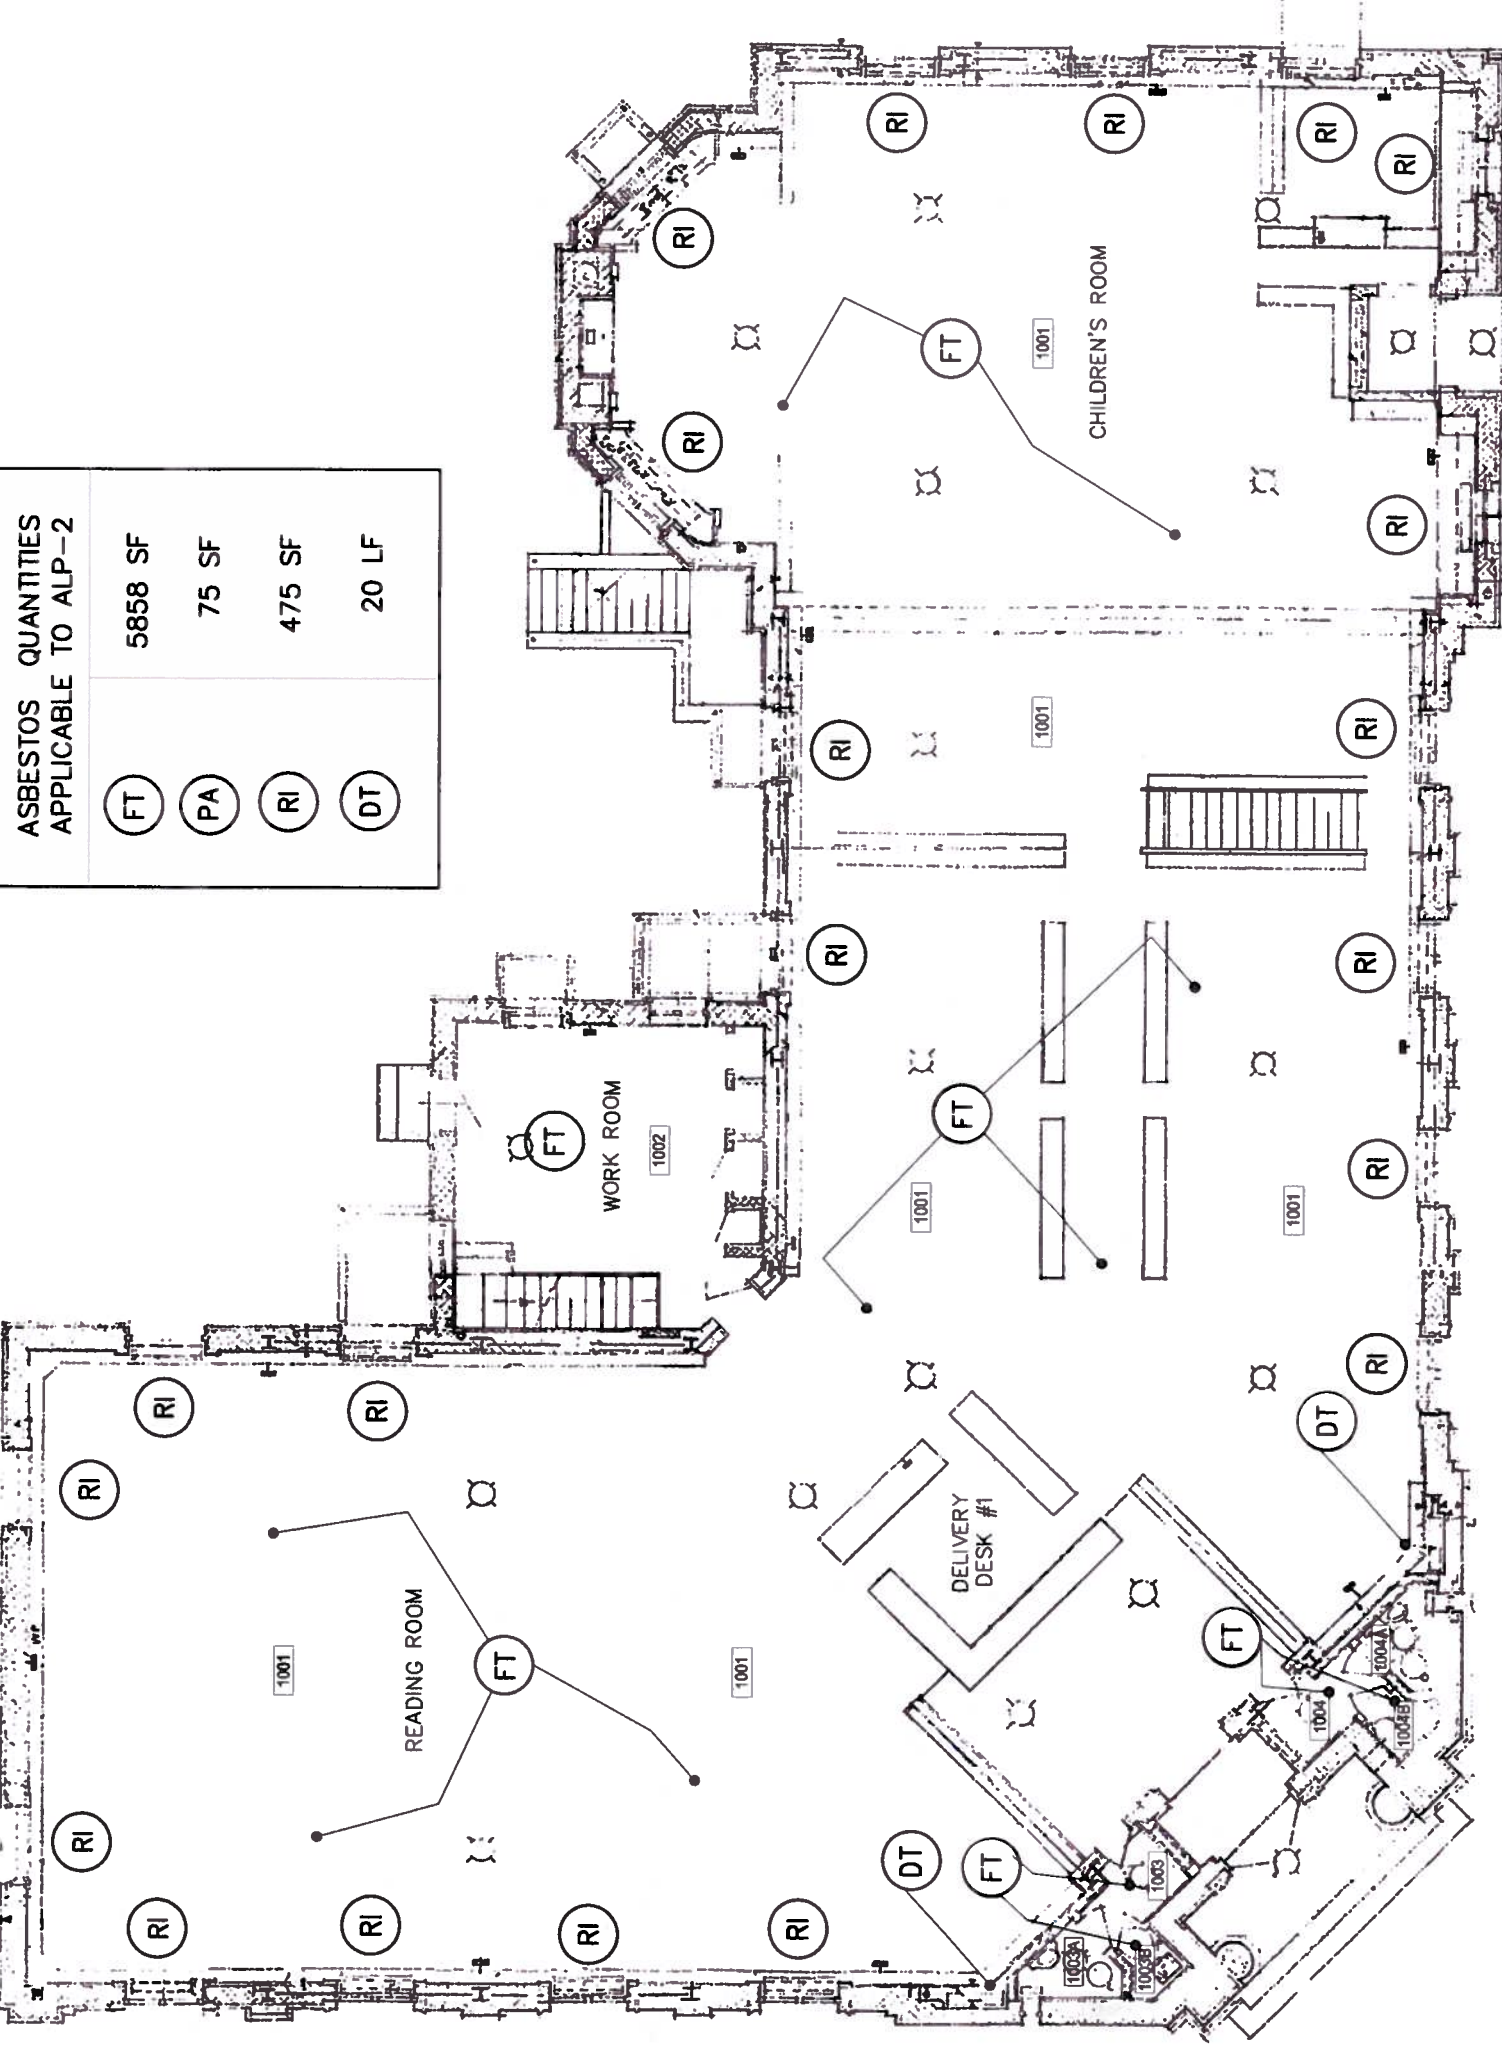
ASBESTOS AND MOLD LOCATIONS  
FIRST FLOOR PLAN

| RI | 475 SF |
| DT | 20 LF |

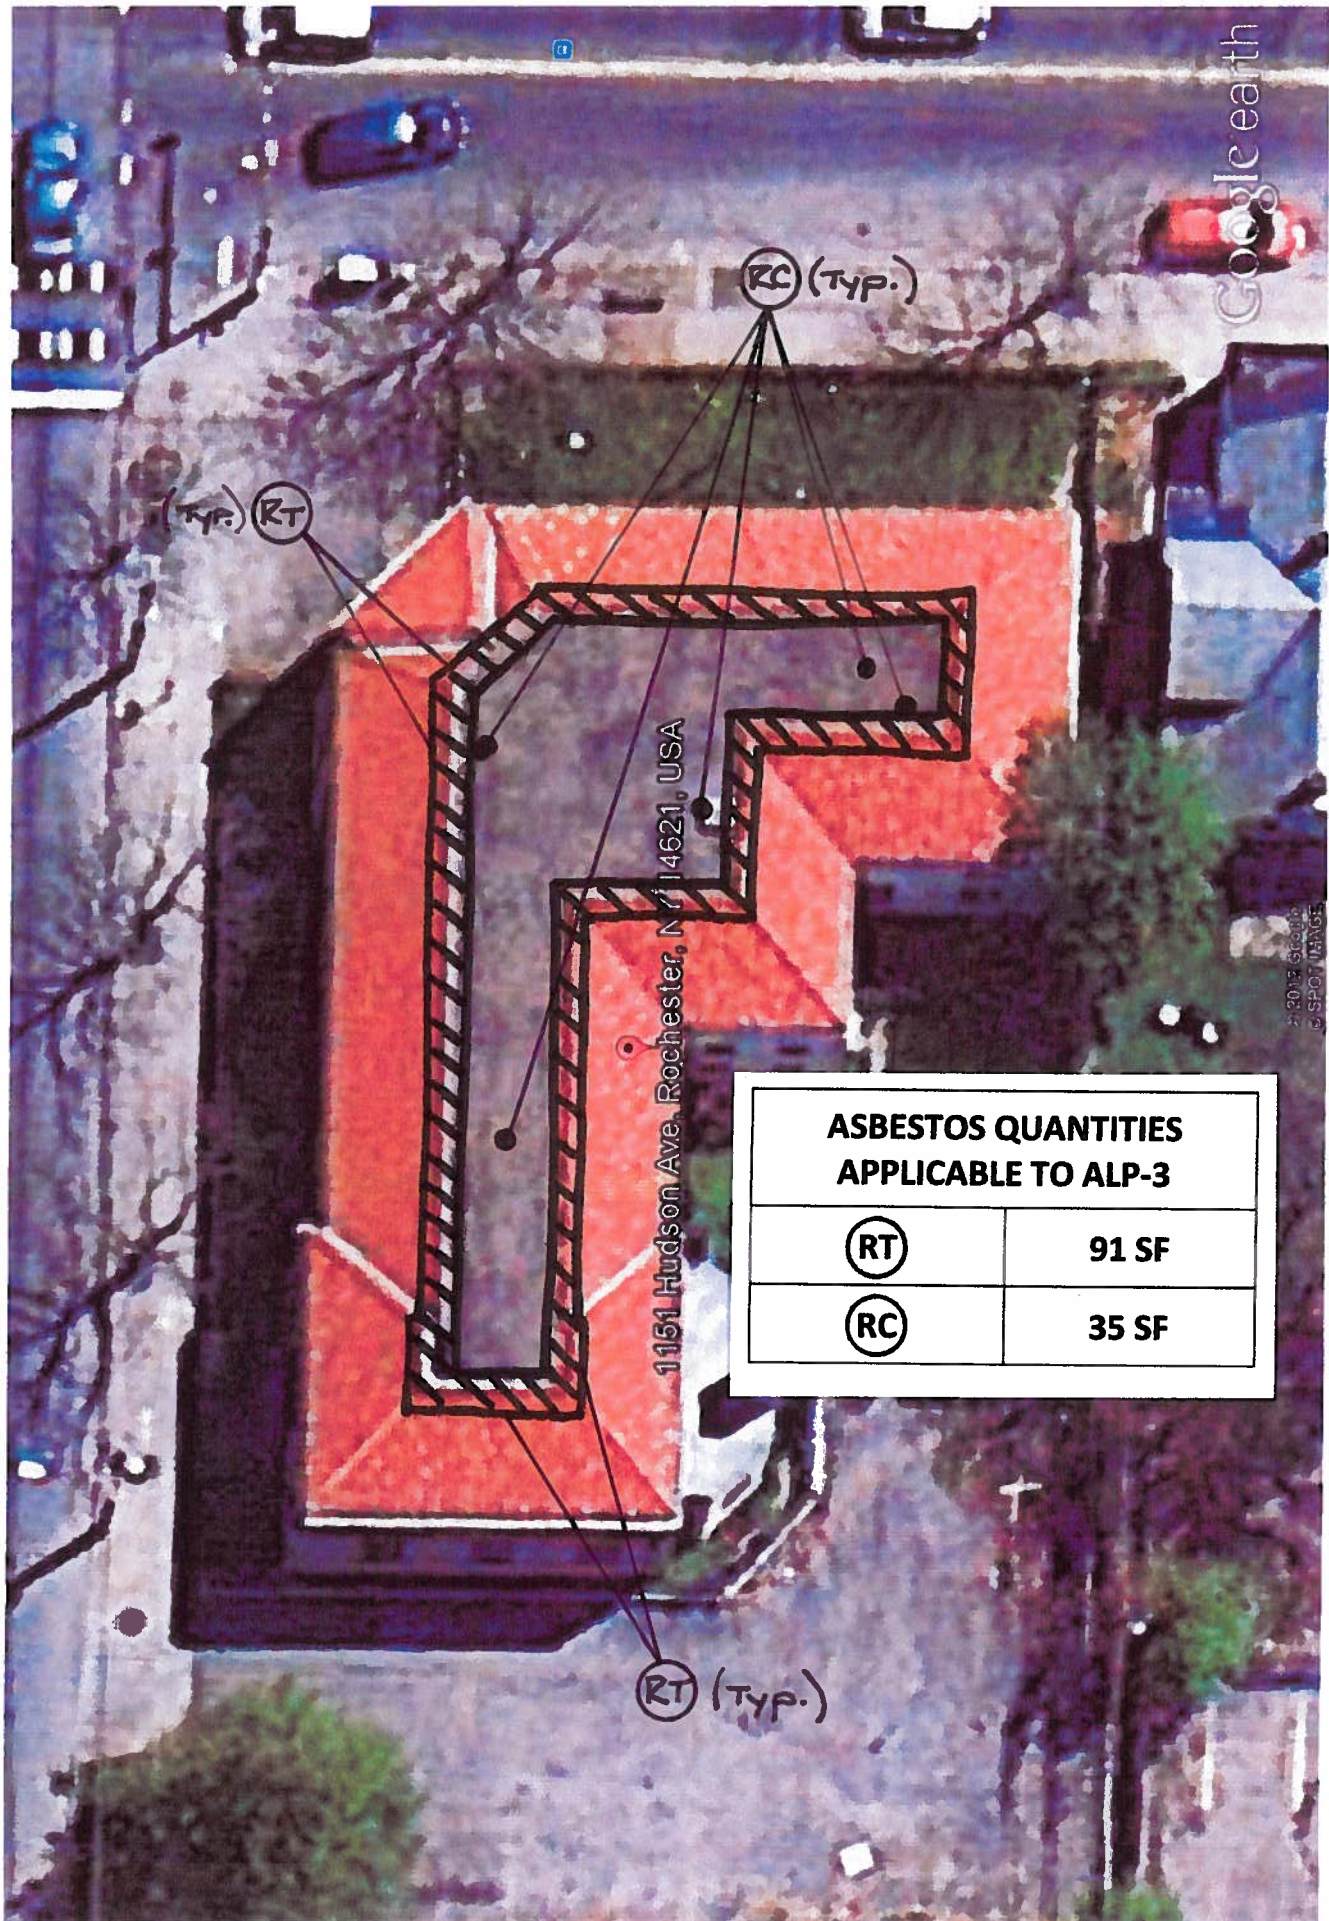
**ASBESTOS QUANTITIES  
APPLICABLE TO ALP-3**

| (RT) | 91 SF |
