RUNDEL LIBRARY Parapet Monitoring

JULY 2019

LBA PROJECT NO. 217916.08

**RE: Rundel Library High Parapet Monitoring
115 South Avenue, Rochester NY
LaBella Project No. 2171916.08**

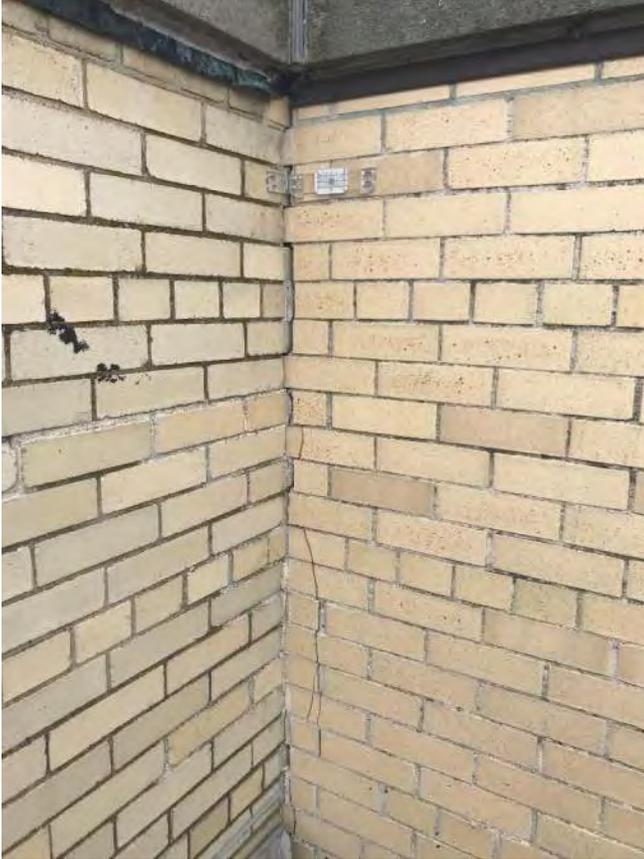
PHOTO 1
N.W. Riverside Corner
3/8" Wall Separation

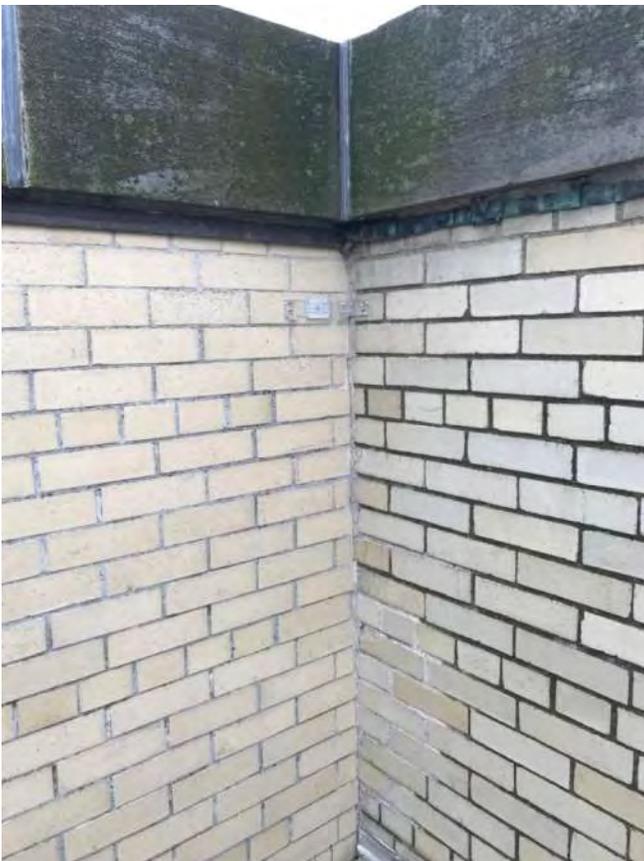
PHOTO 2
S.W. Riverside Corner
Mortar Crack

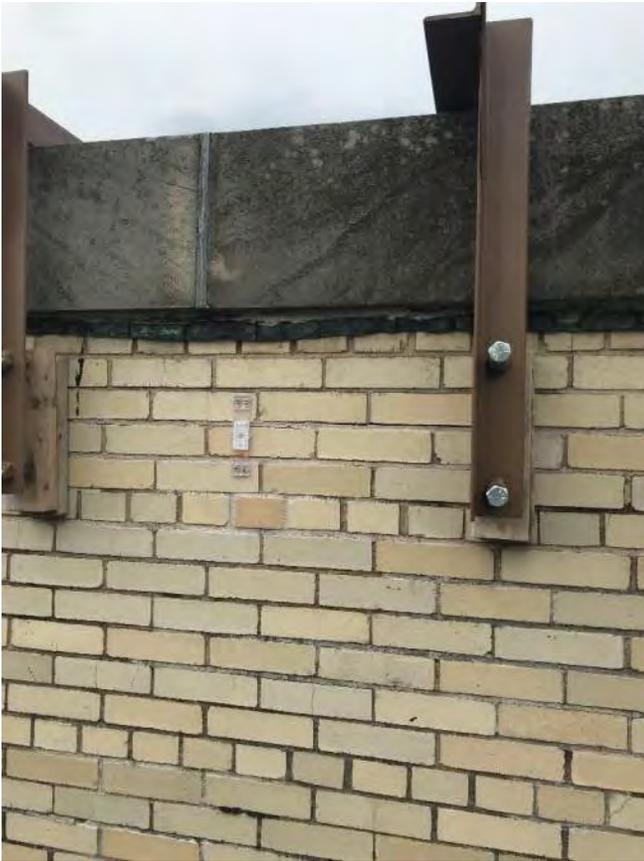
PHOTO 3

Horizontal Mortar Joint Crack

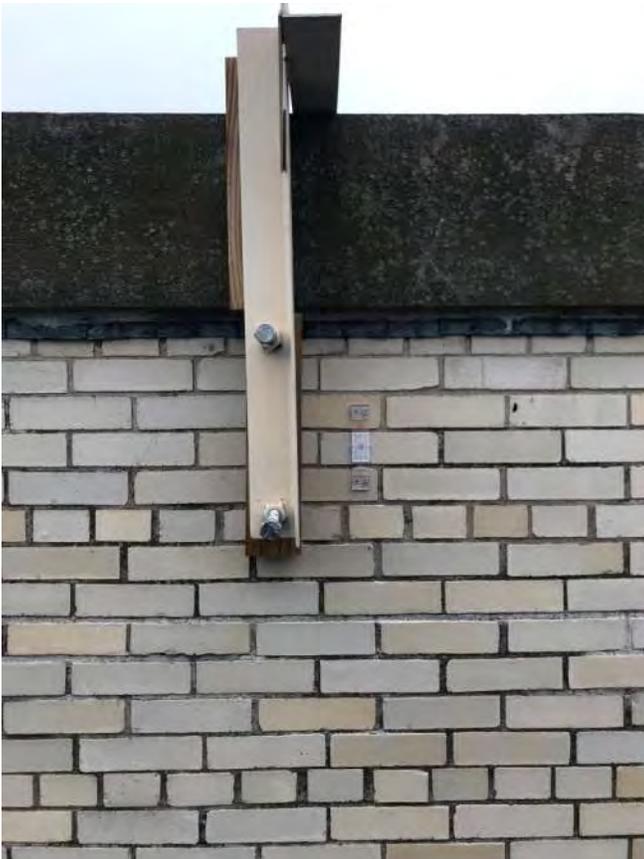
PHOTO 4

Horizontal Mortar Joint Crack

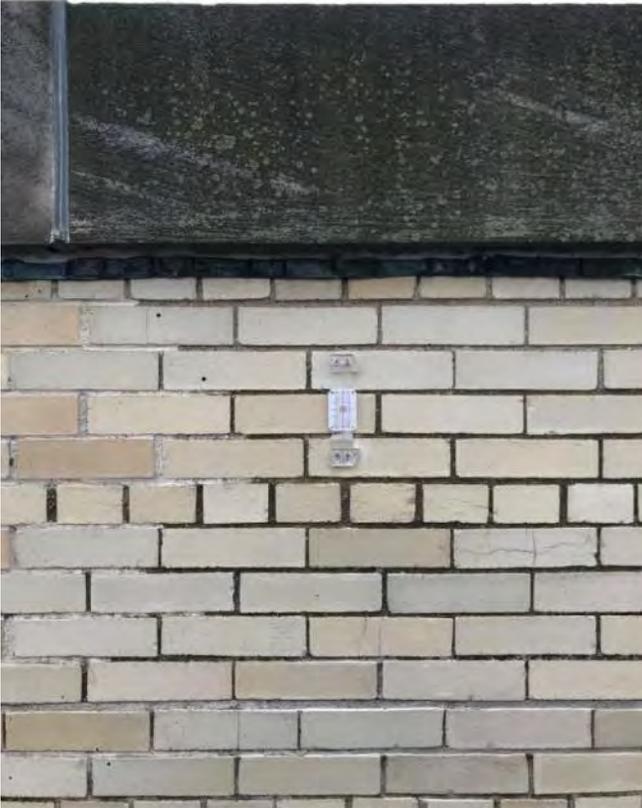
PHOTO 6

3/8" Vertical Joint Separation

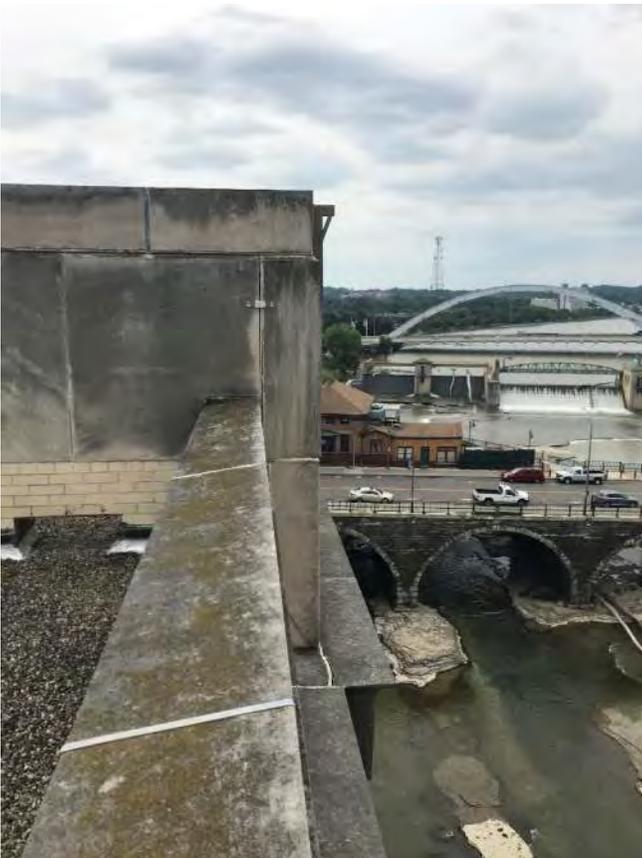
PHOTO 7
S.W. Riverside Exterior
Vertical Joint Separation

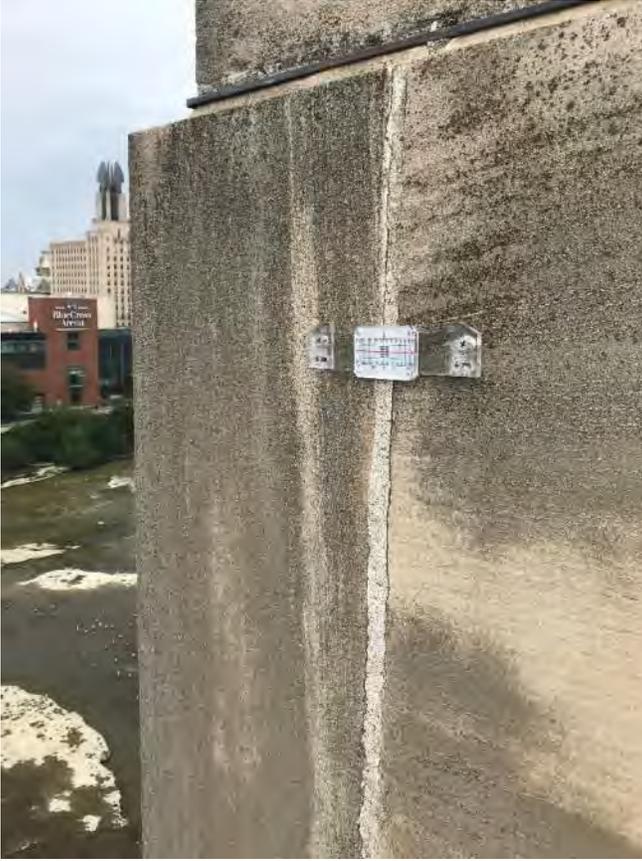
PHOTO 8
S.E.S. Entrance Corner
Vertical Joint Separation

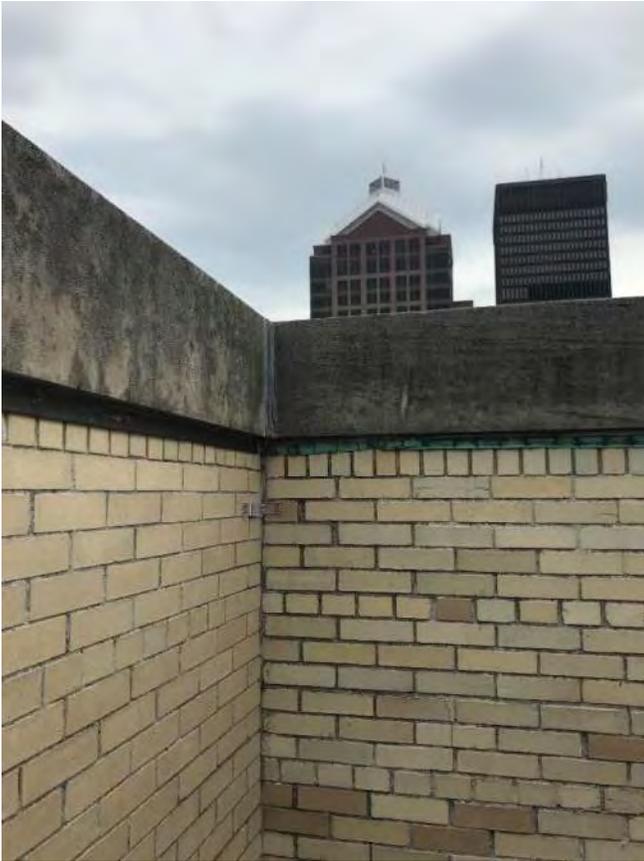
PHOTO 9
S.E.N. Entrance Corner
Vertical Joint Separation

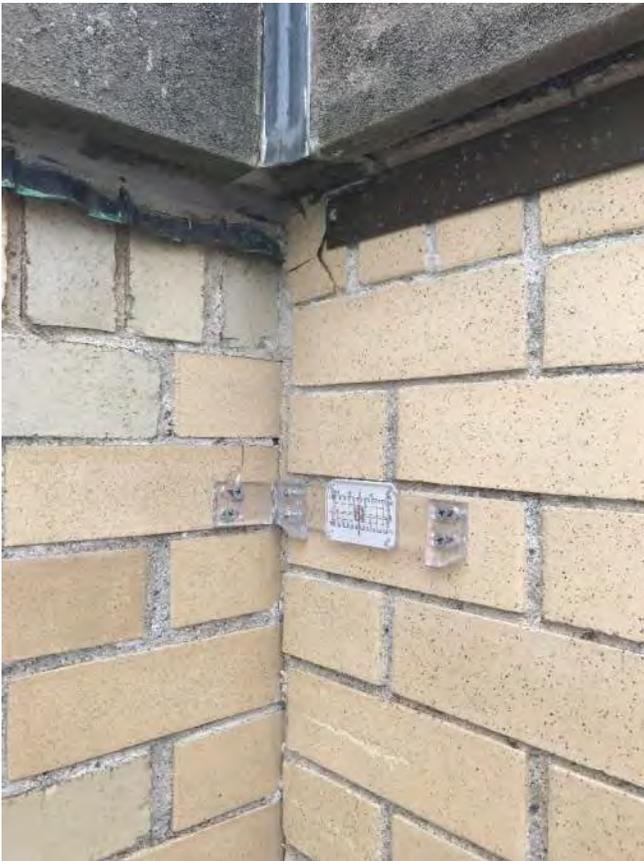
PHOTO 10
N.E.S. Entrance Corner
Vertical Joint Separation

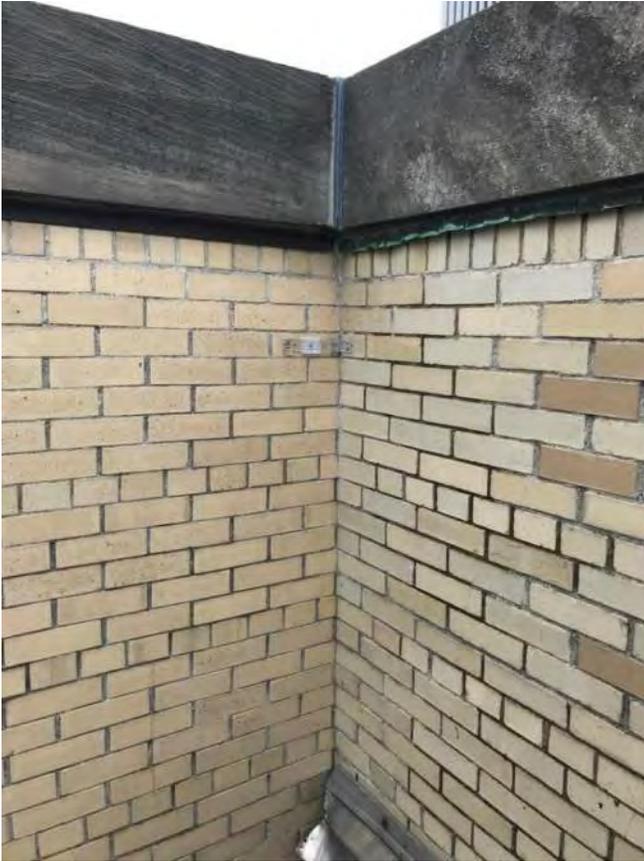
PHOTO 11
N.E.N. Entrance Corner
Vertical Joint Separation

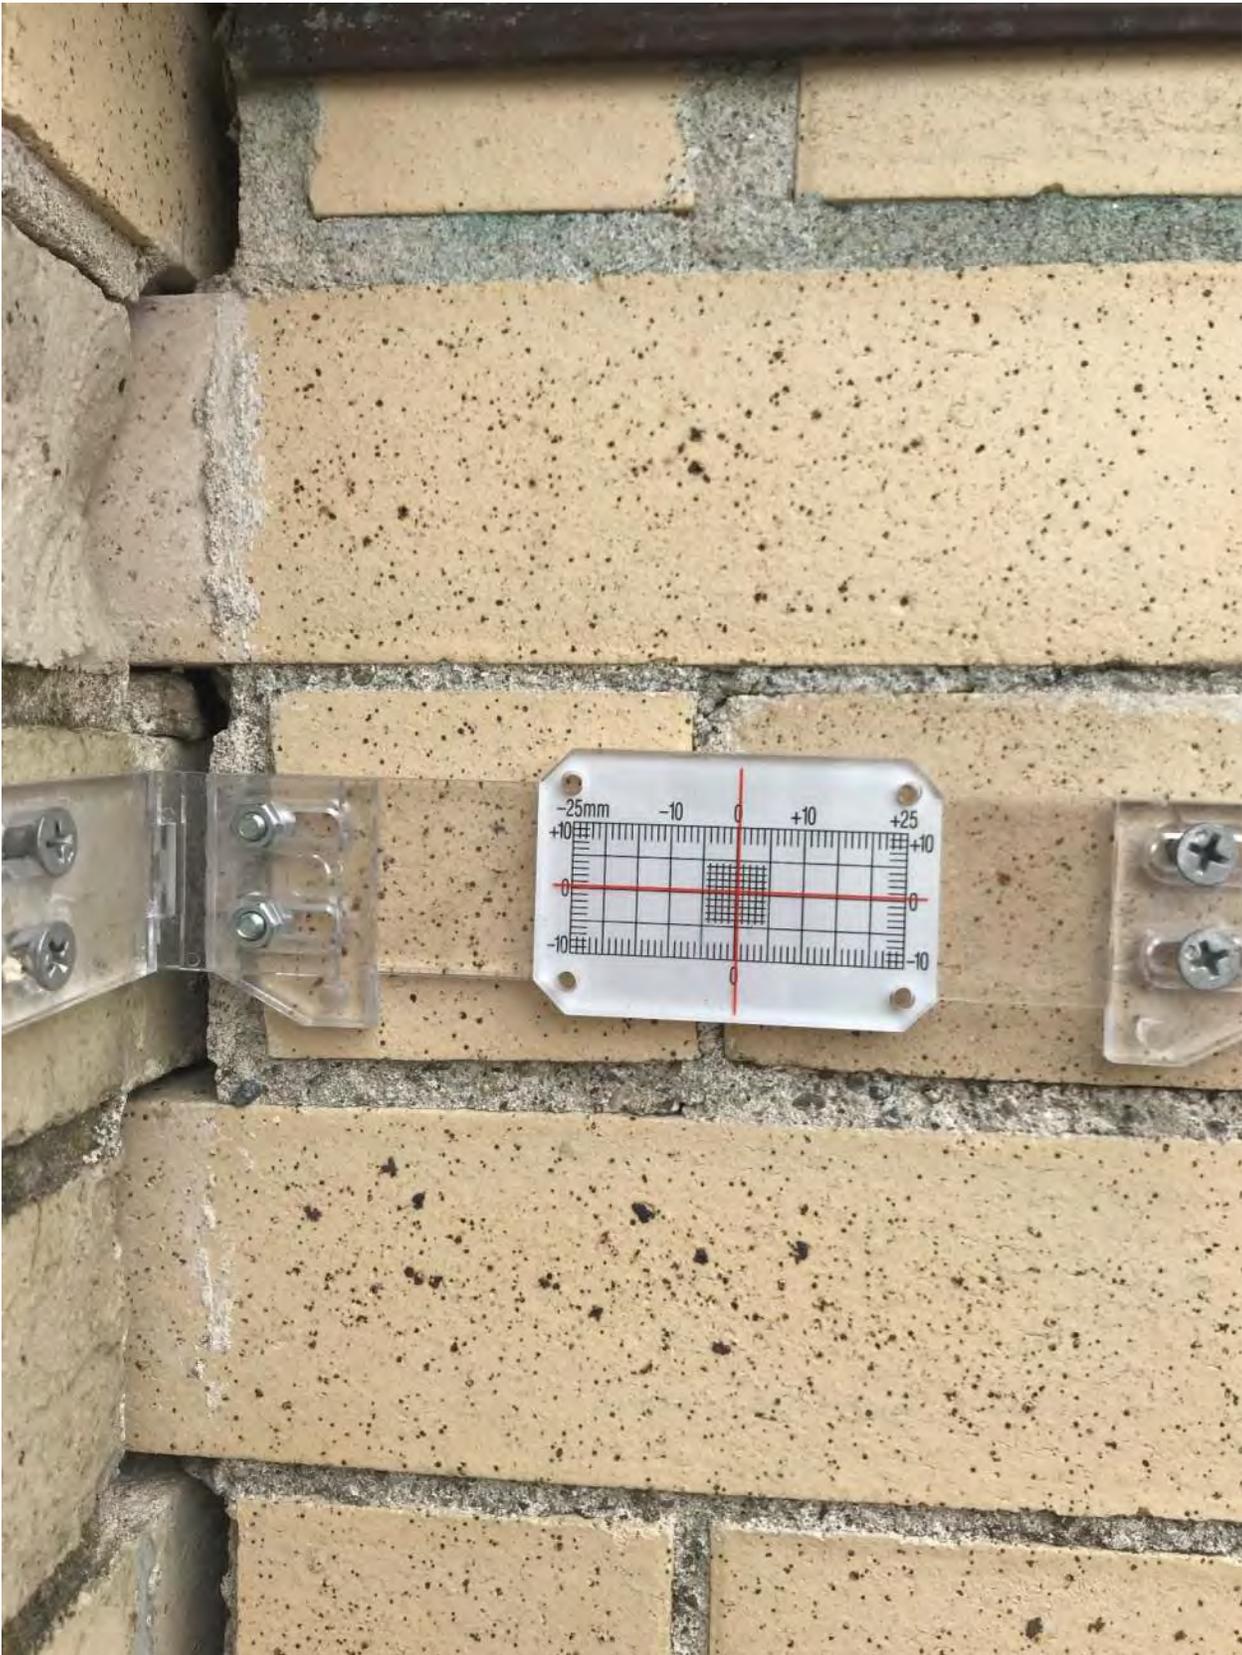
PHOTO 1A - DETAILED

0_{mm} Movement

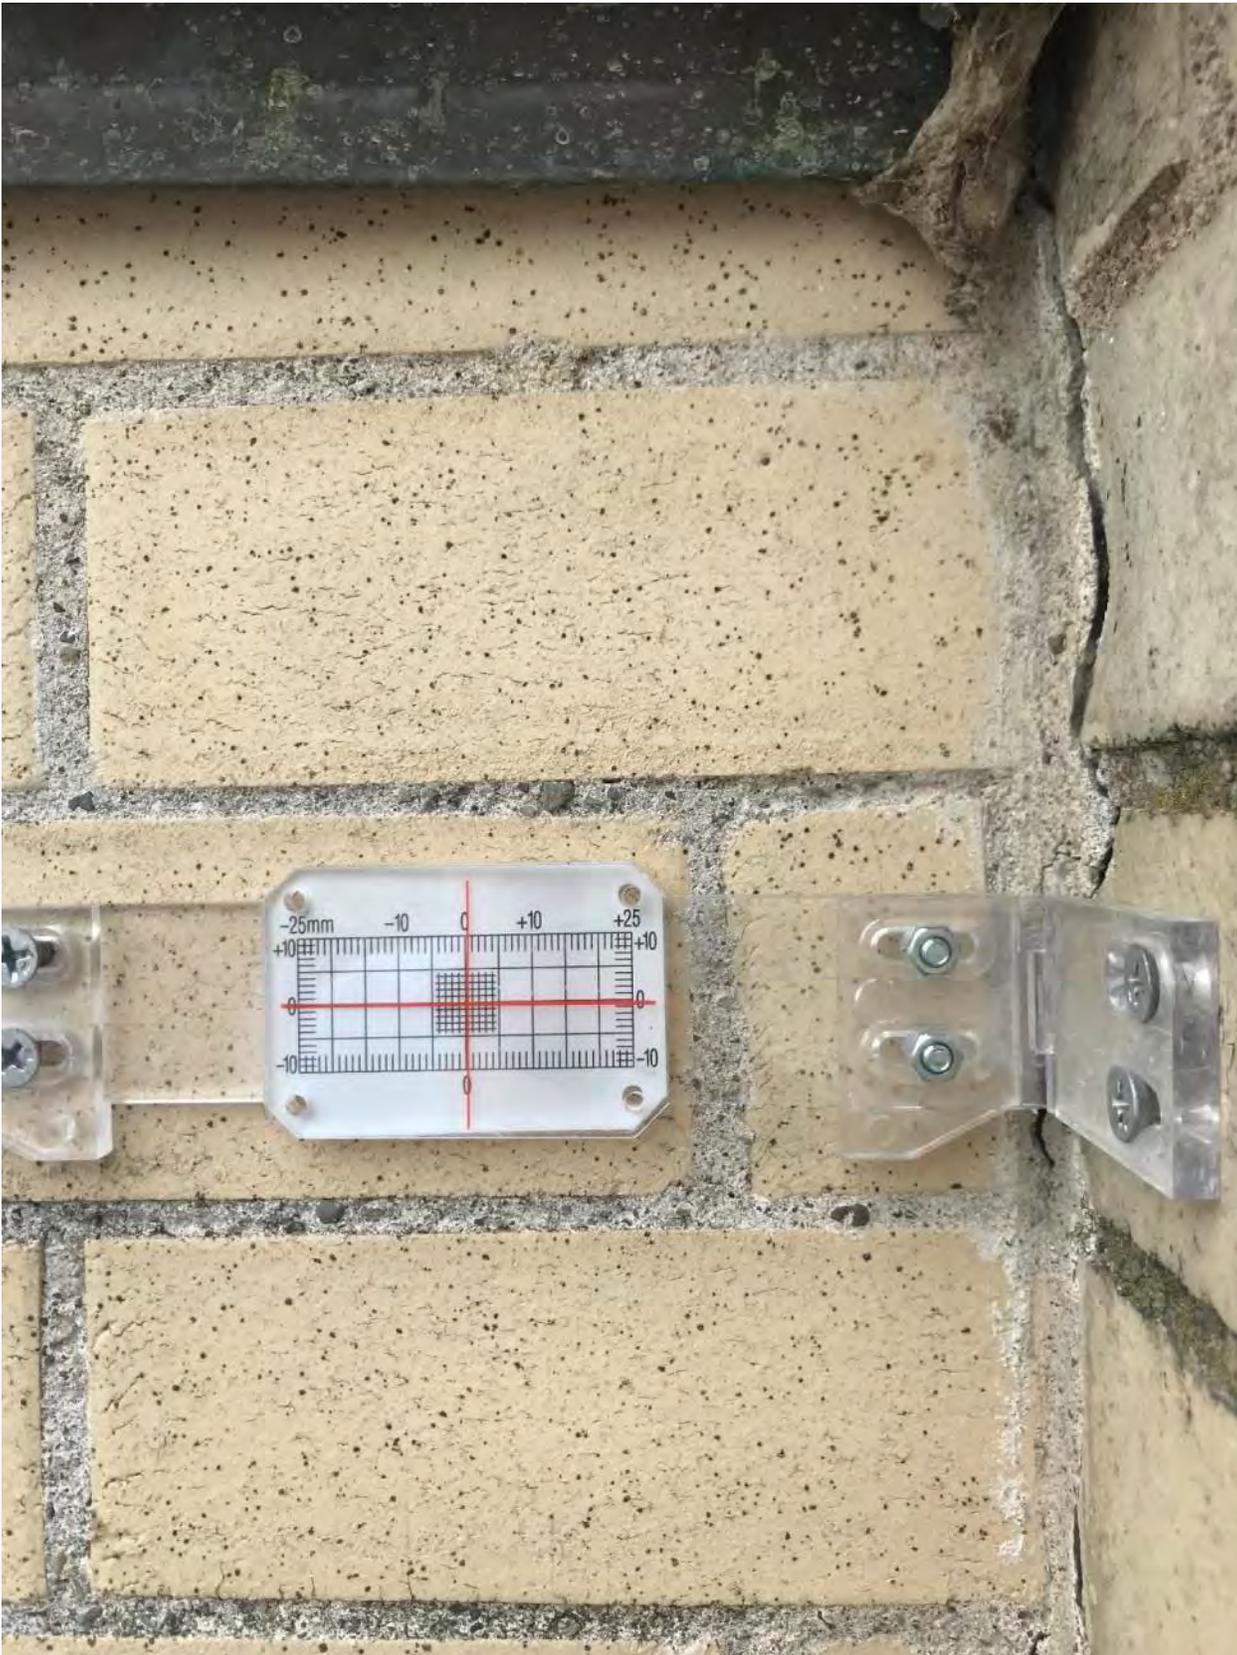
PHOTO 2A - DETAILED

0_{mm} Movement

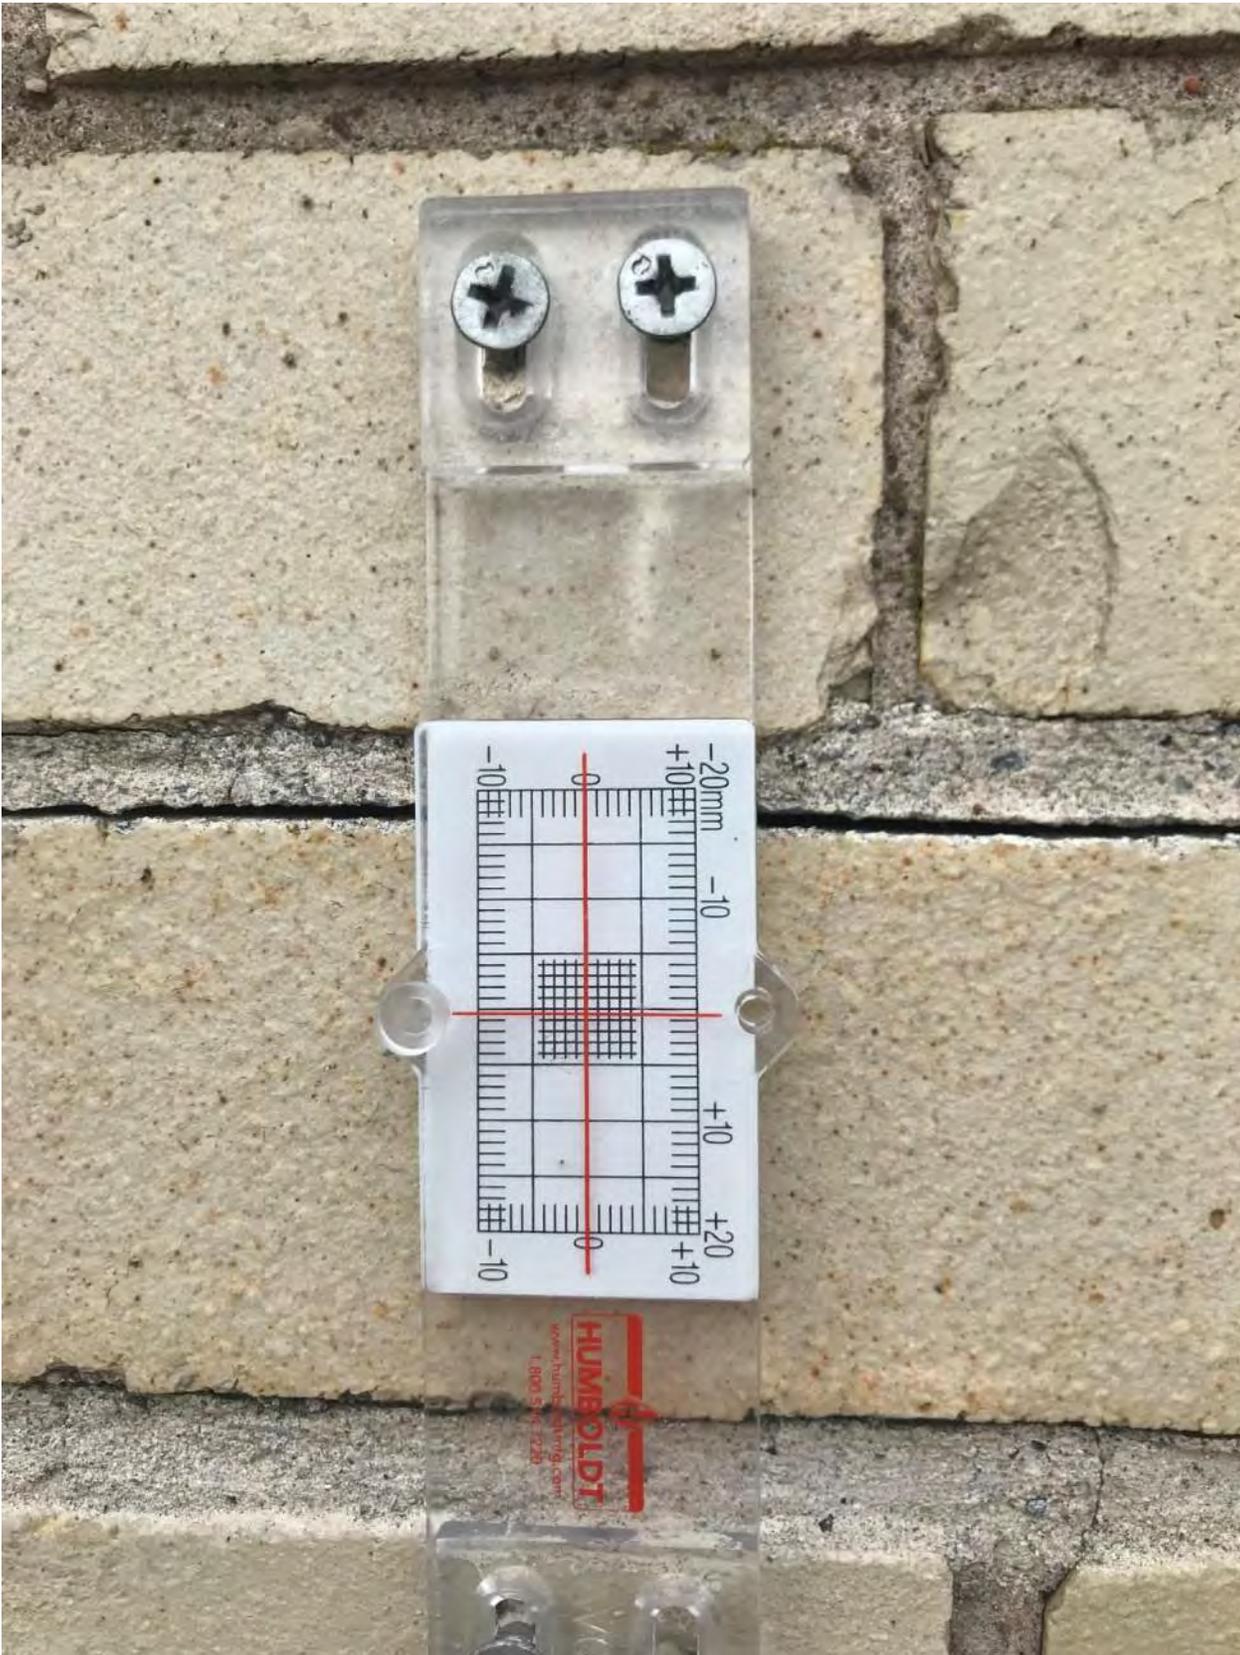
PHOTO 3A - DETAILED

0.55_{mm} Movement

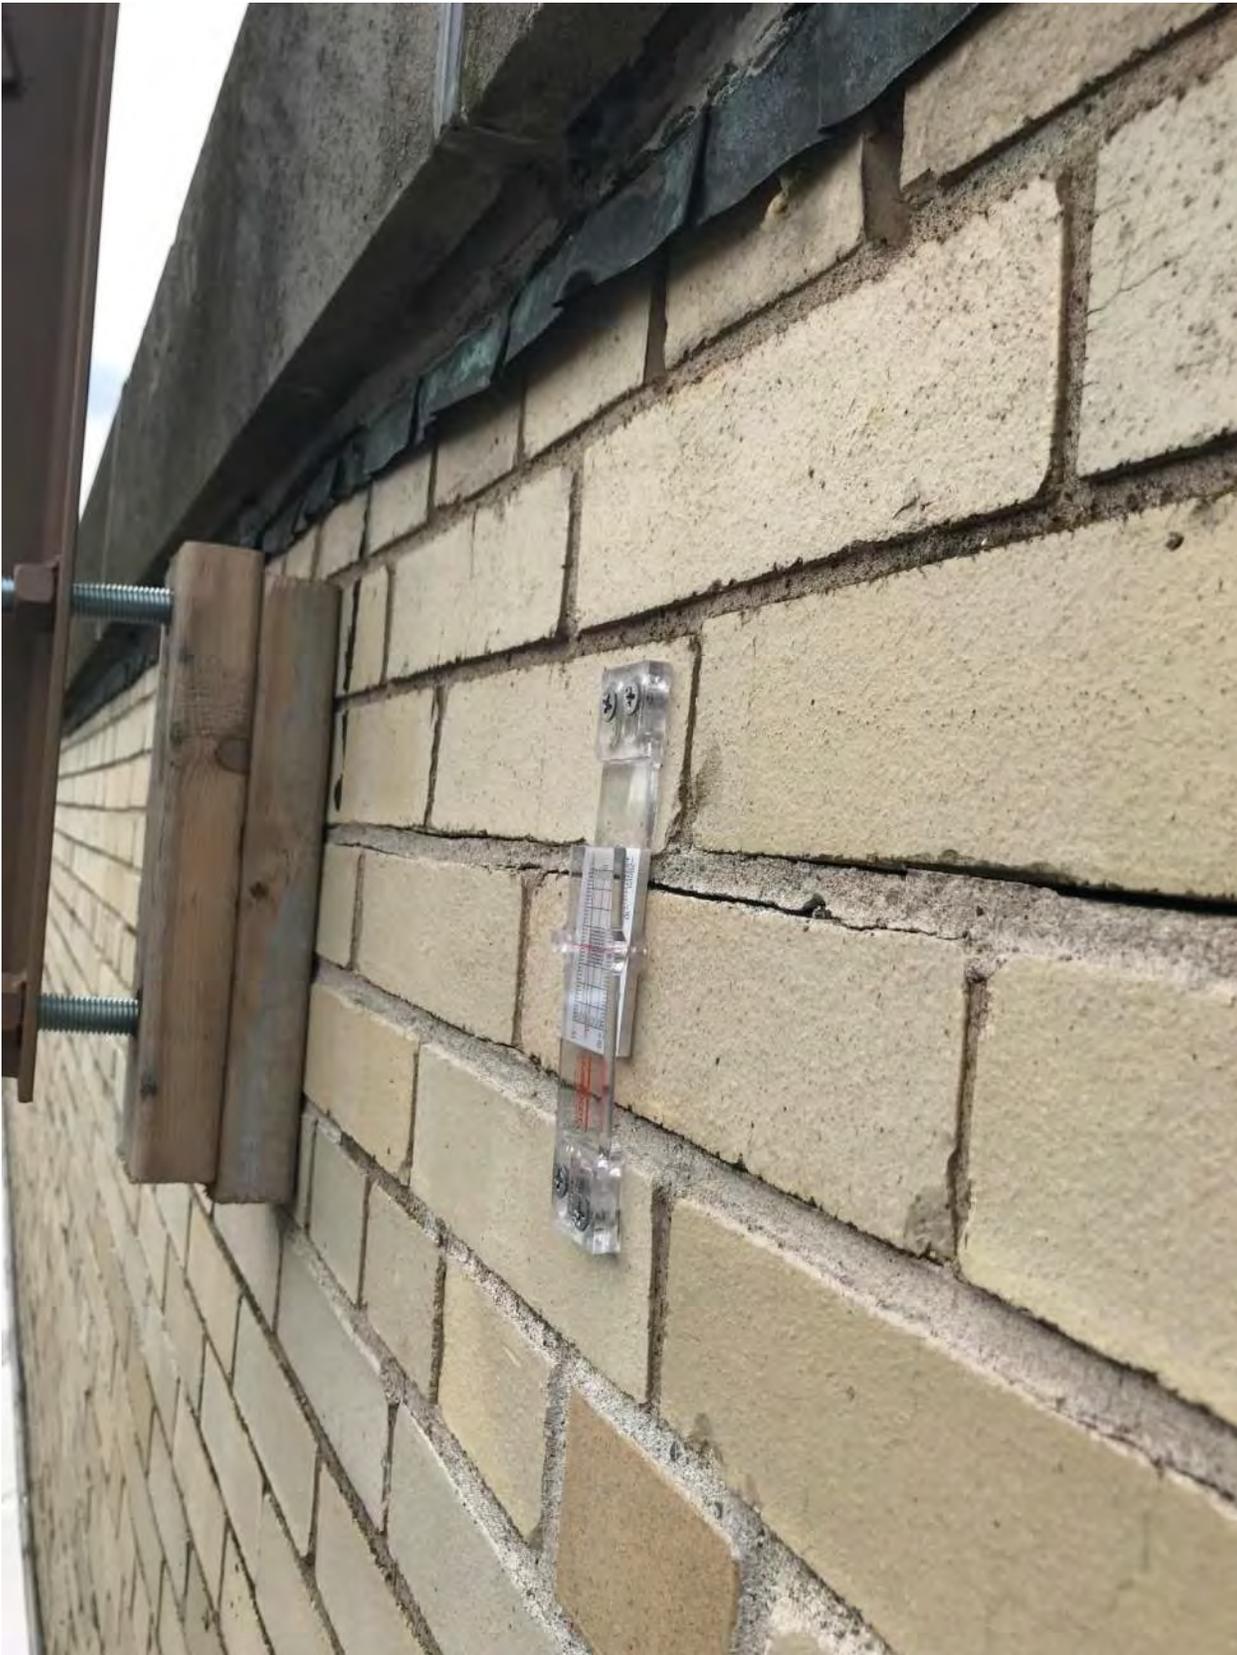
PHOTO 3B - DETAILED

Gauge out of plane

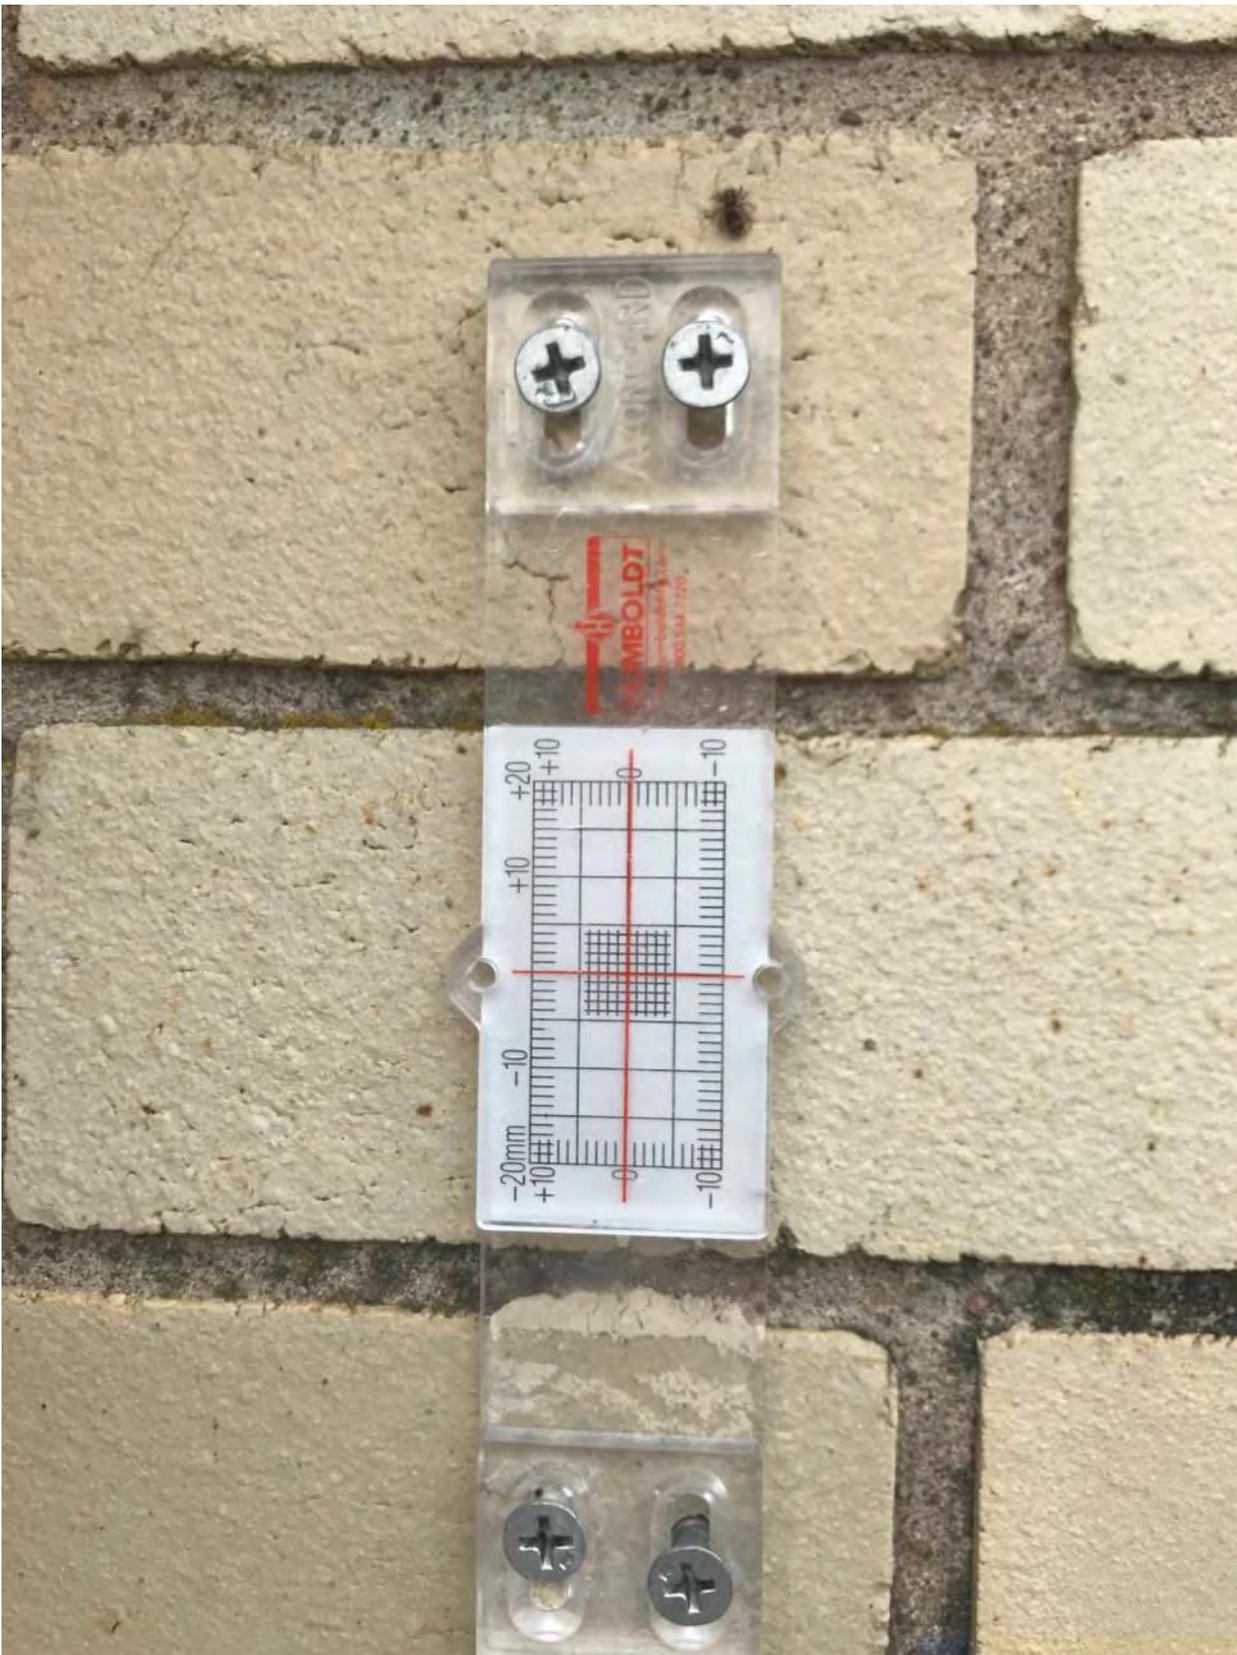
PHOTO 4A - DETAILED

0_{mm} Movement

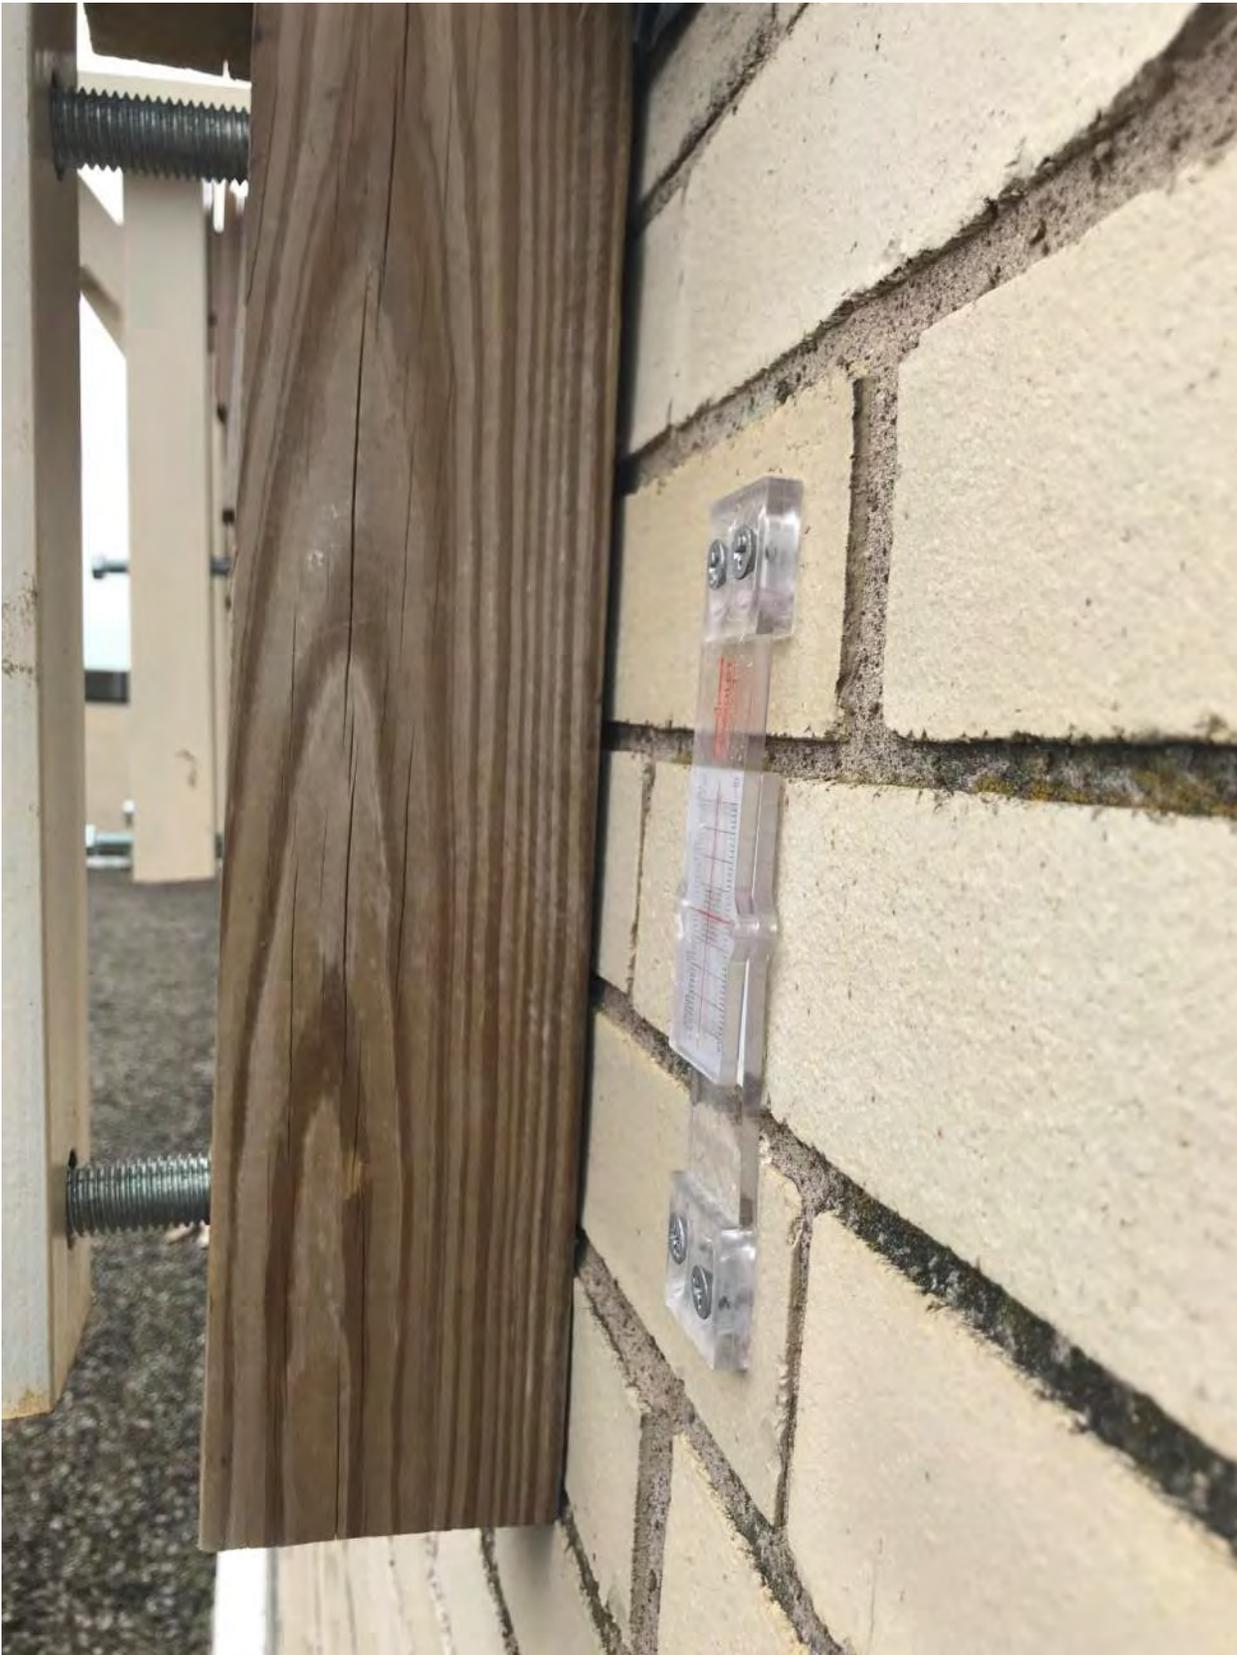
PHOTO 4B - DETAILED

Gauge slightly out of plan

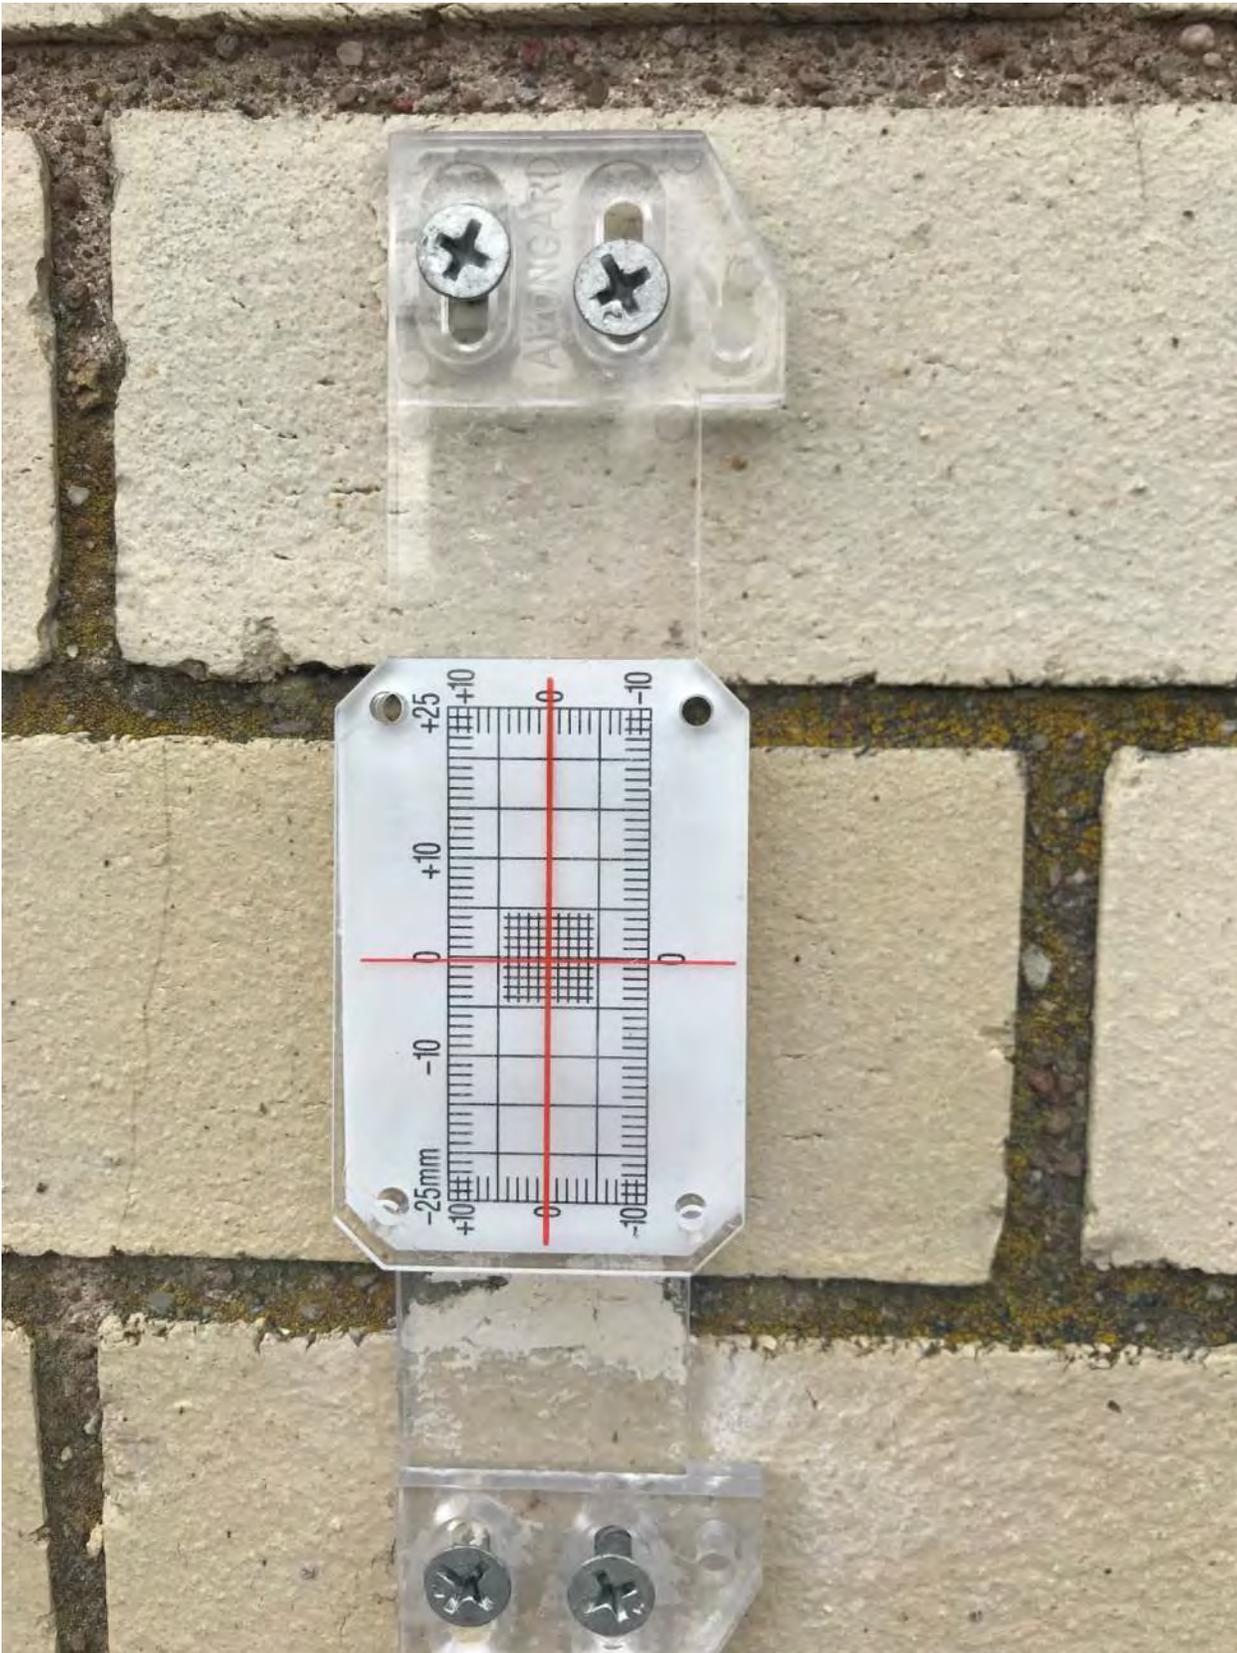
PHOTO 5A - DETAILED

0_{mm} Movement

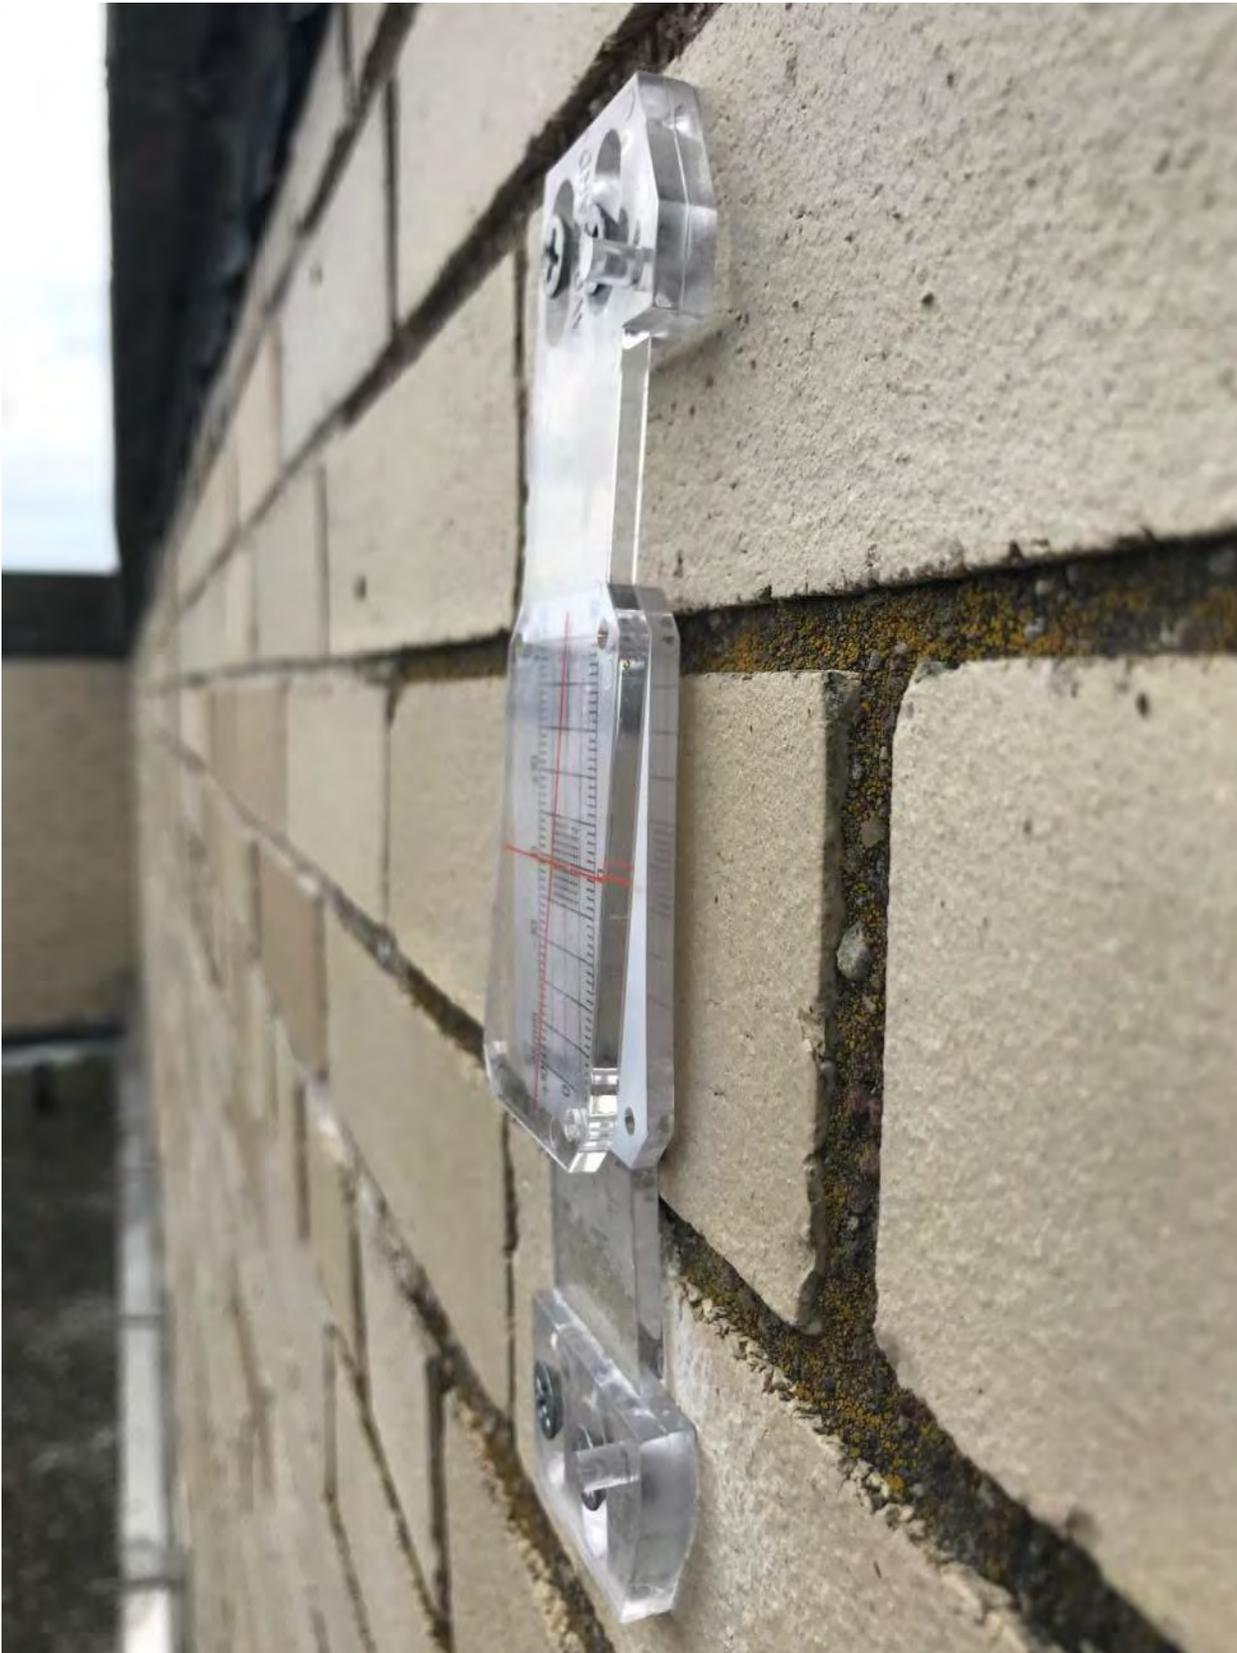
PHOTO 5B - DETAILED

Gauge out of plane
