RUNDEL LIBRARY Parapet Monitoring

JULY 2019

LBA PROJECT NO. 217916.08

**RE: Rundel Library High Parapet Monitoring
115 South Avenue, Rochester NY
LaBella Project No. 2171916.08**

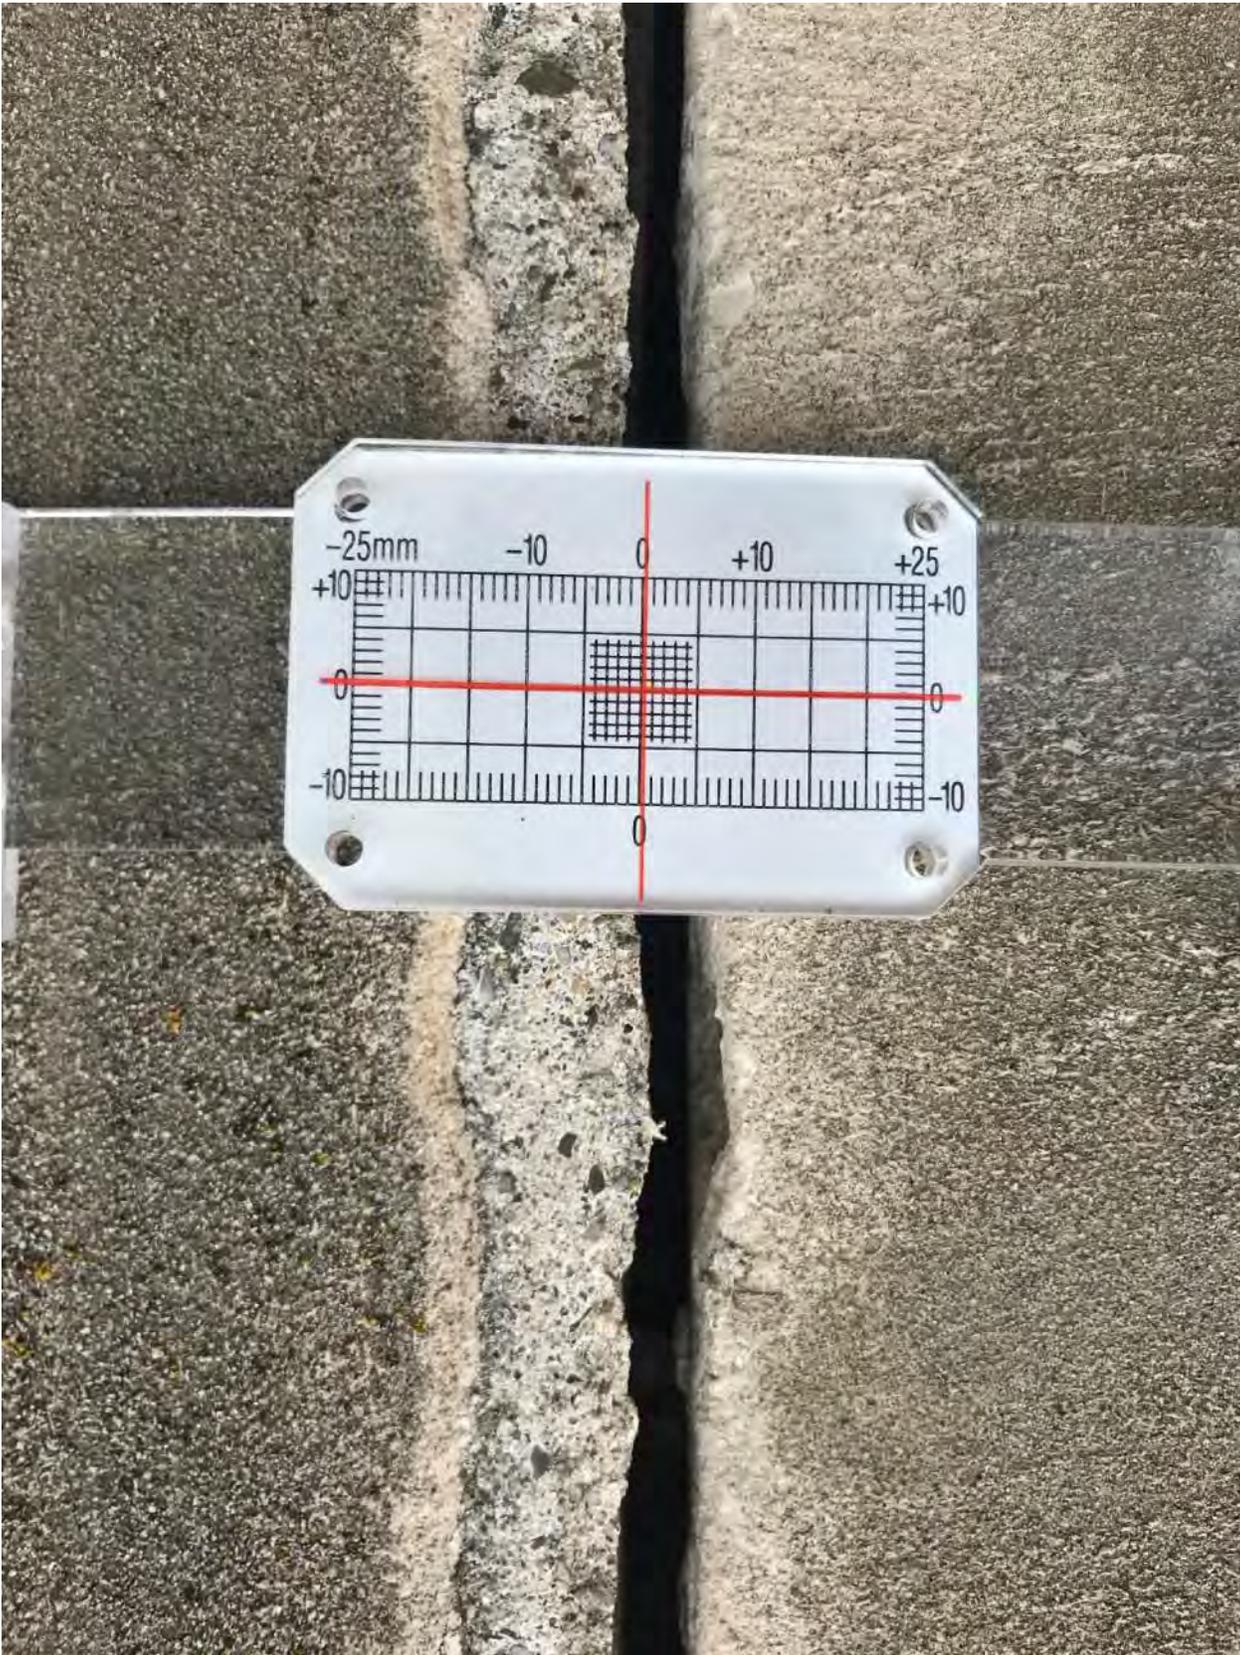
PHOTO 6A - DETAILED

0_{mm} Movement

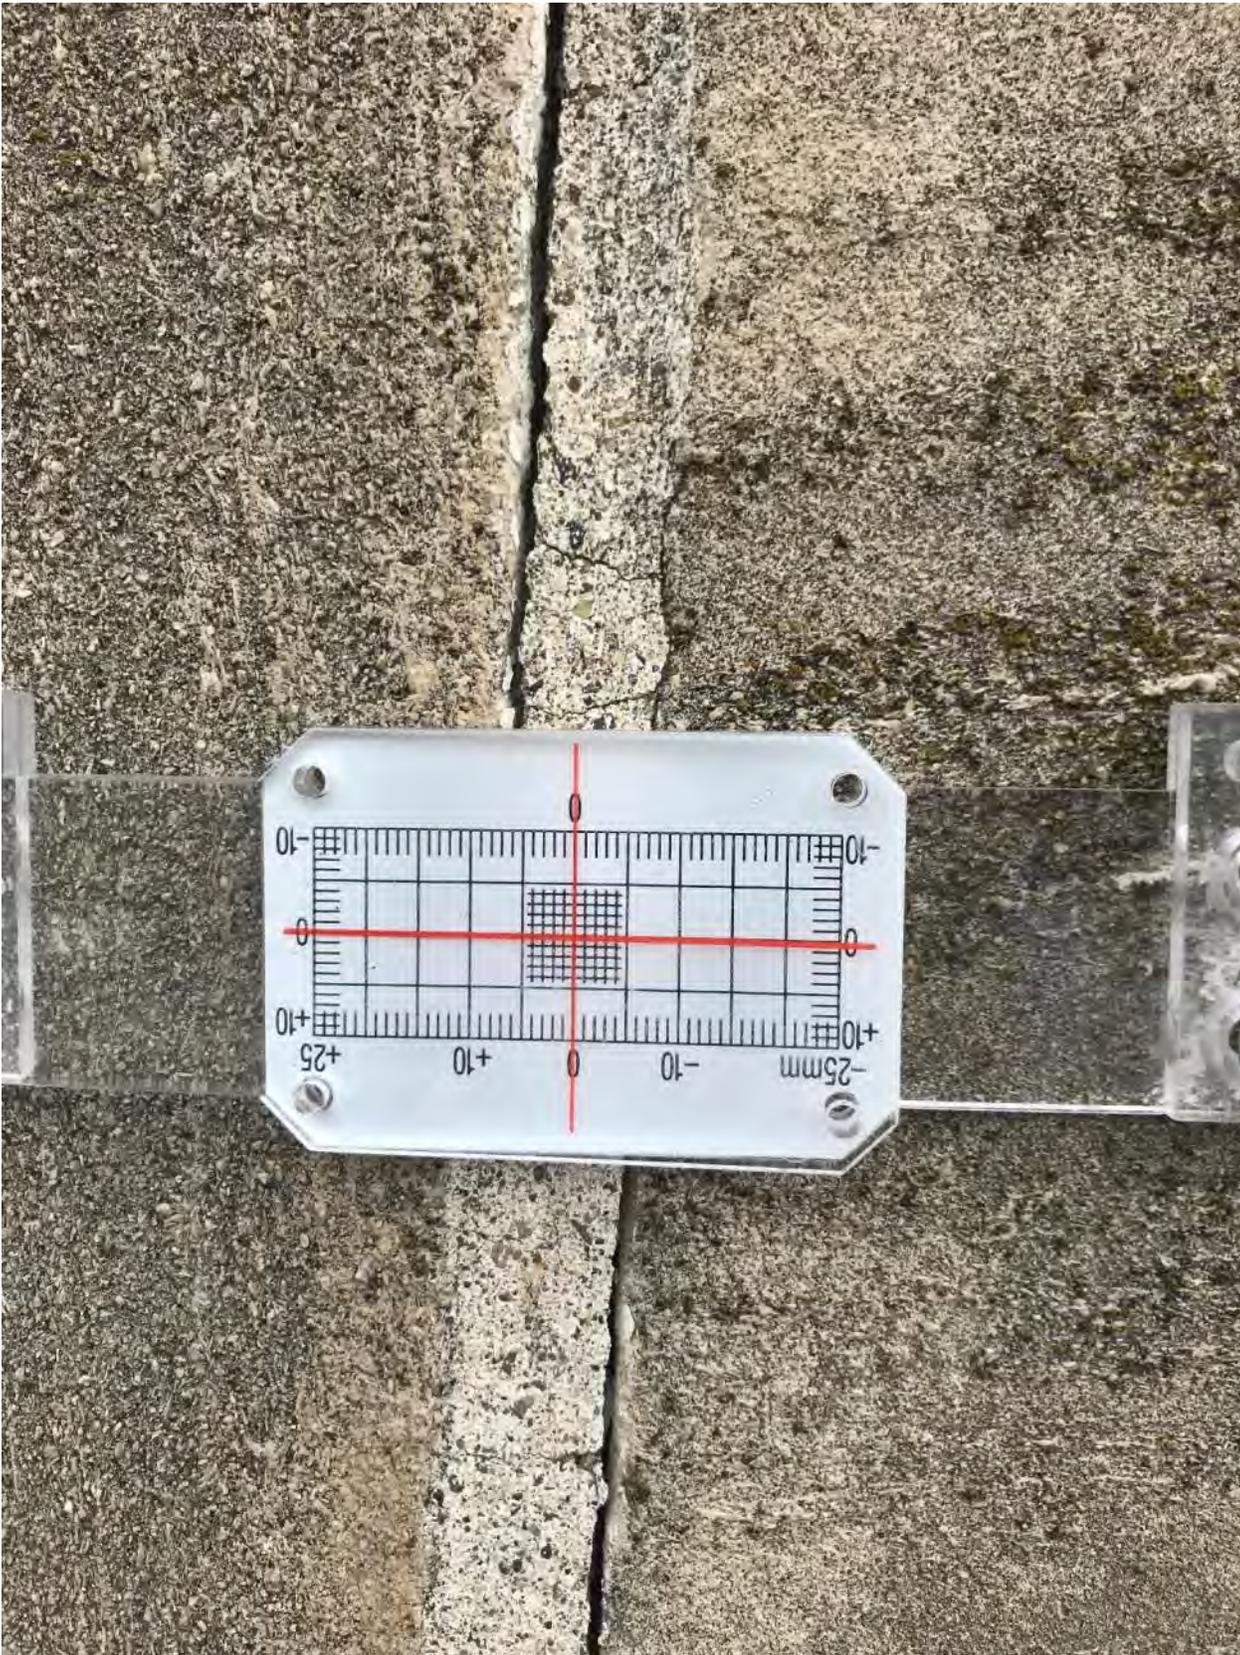
PHOTO 7A - DETAILED

0_{mm} Movement

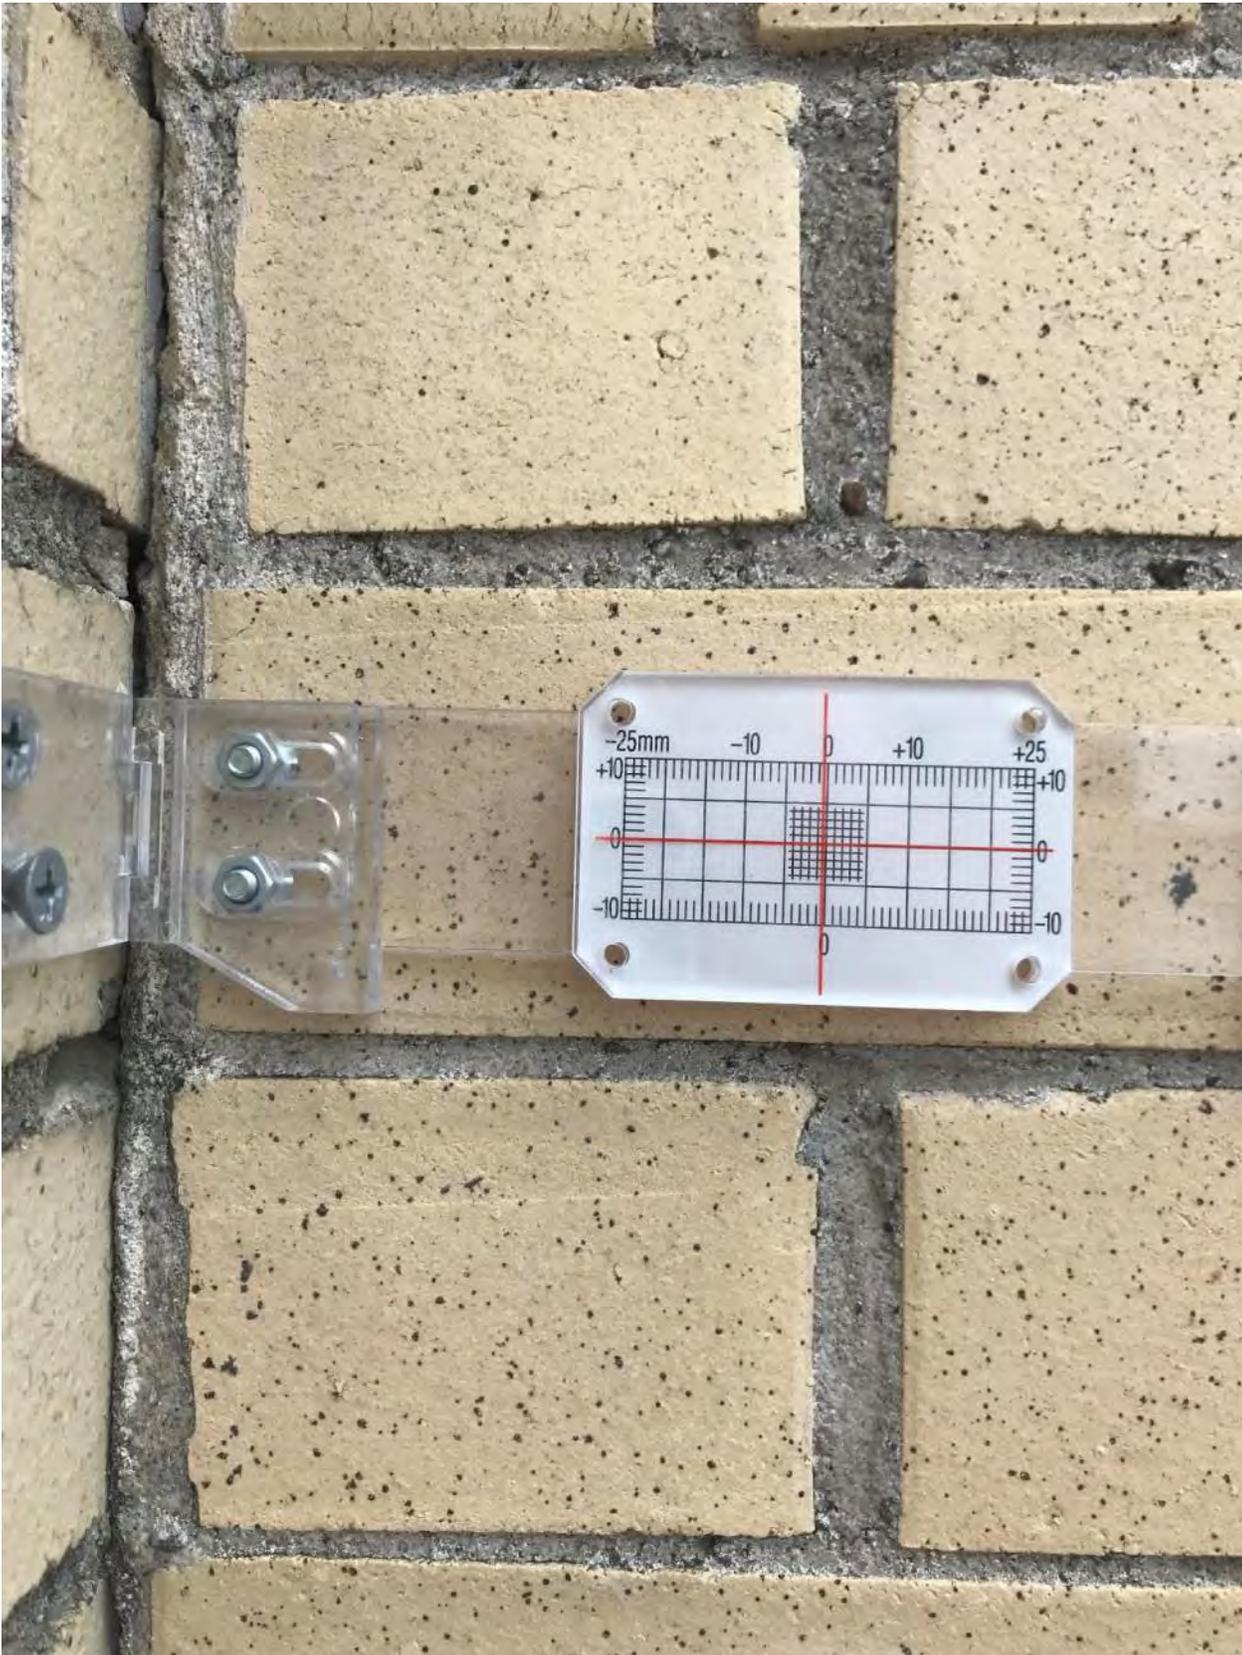
PHOTO 8A - DETAILED

0.5_{mm} Horizontal Movement

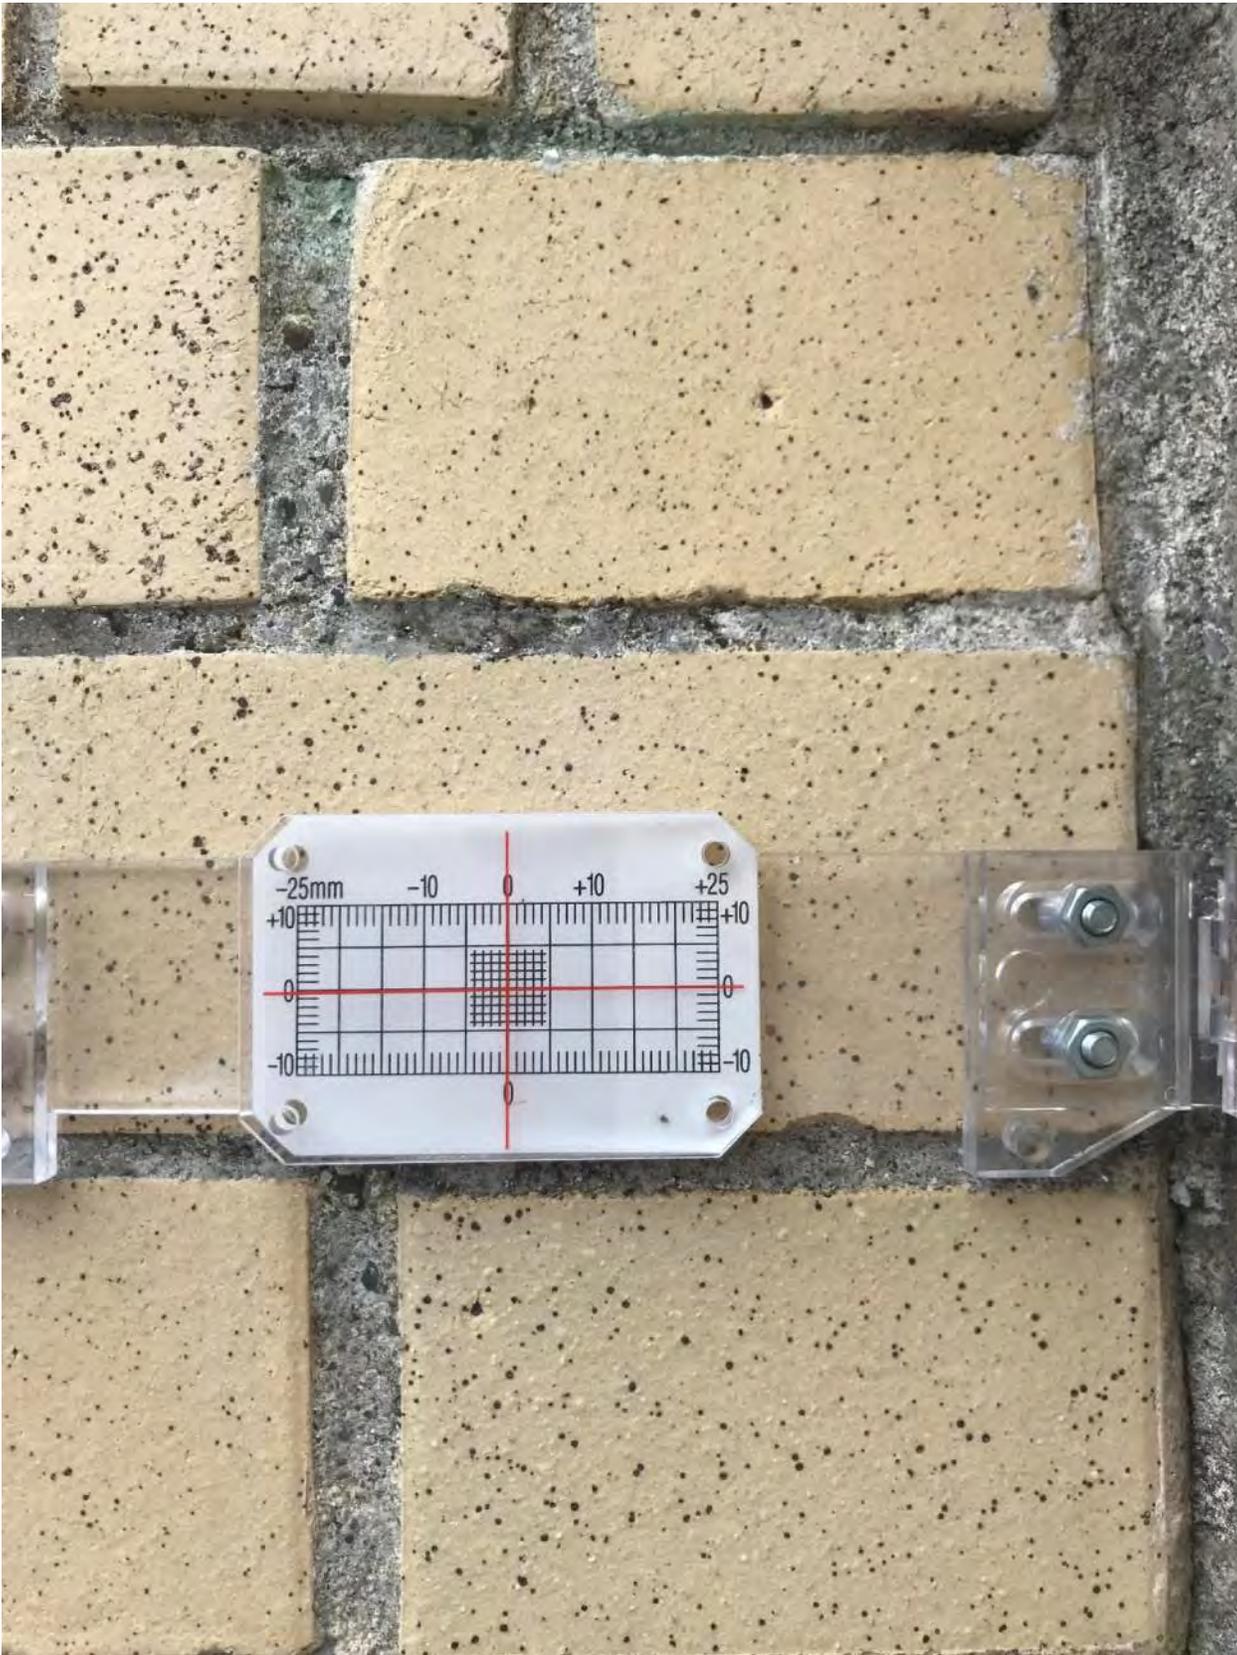
PHOTO 9A - DETAILED

0_{mm} Movement

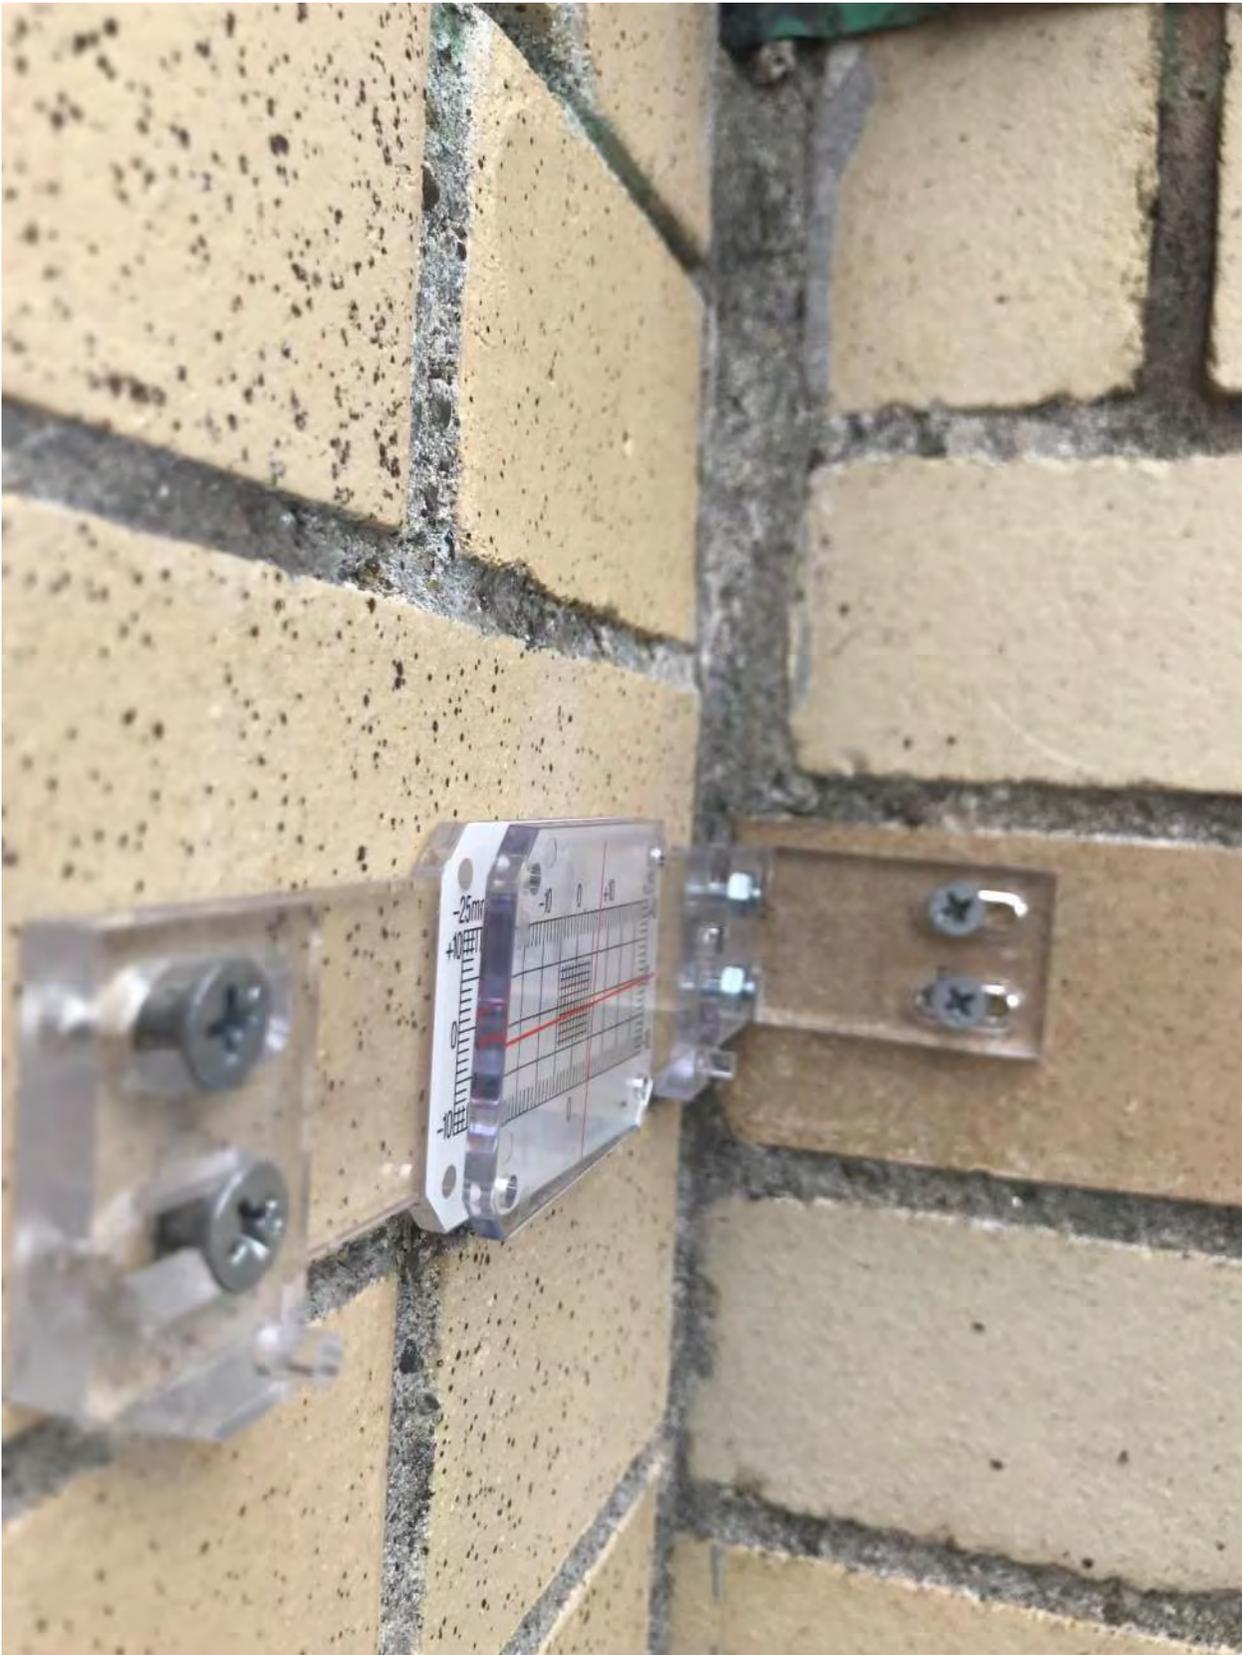
PHOTO 9B - DETAILED

Gauge out of plane

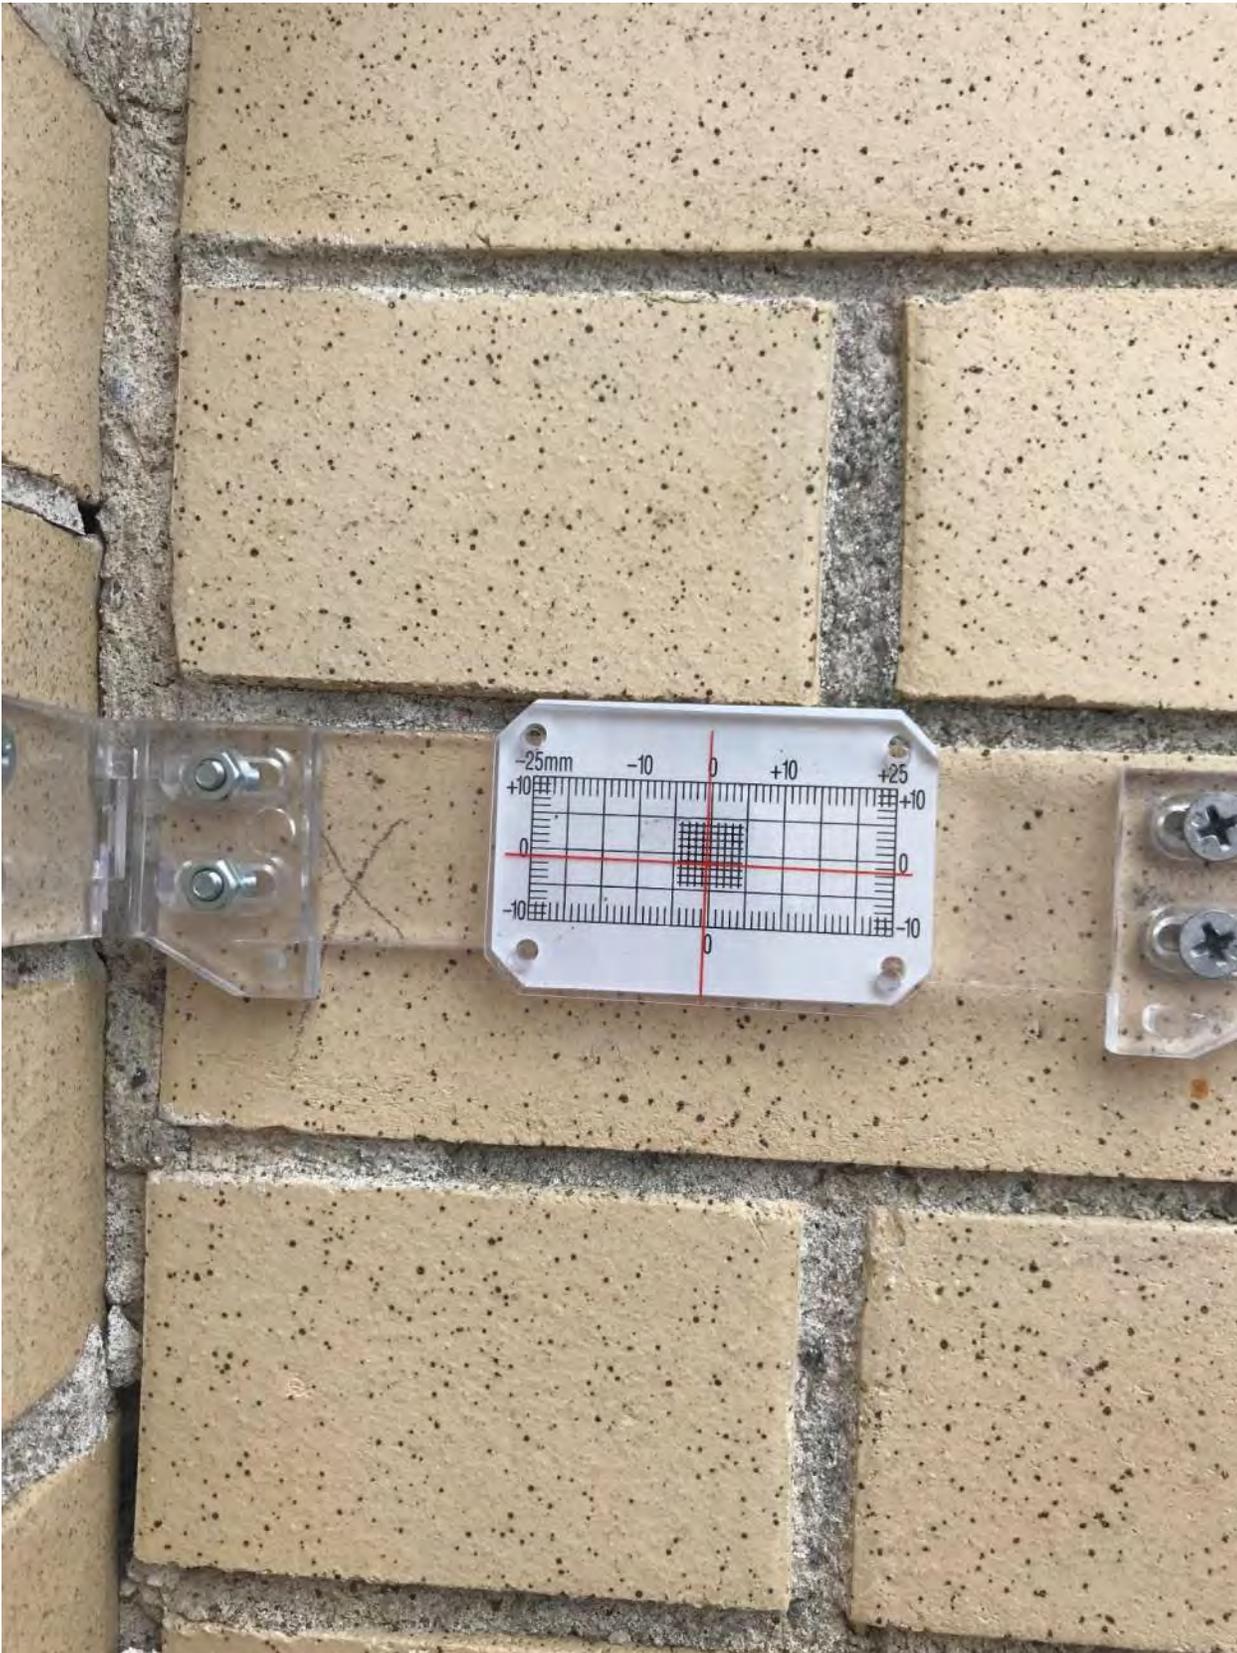
PHOTO 10A - DETAILED

0.5_{mm} Horizontal Movement | 1.5_{mm} Vertical Movement

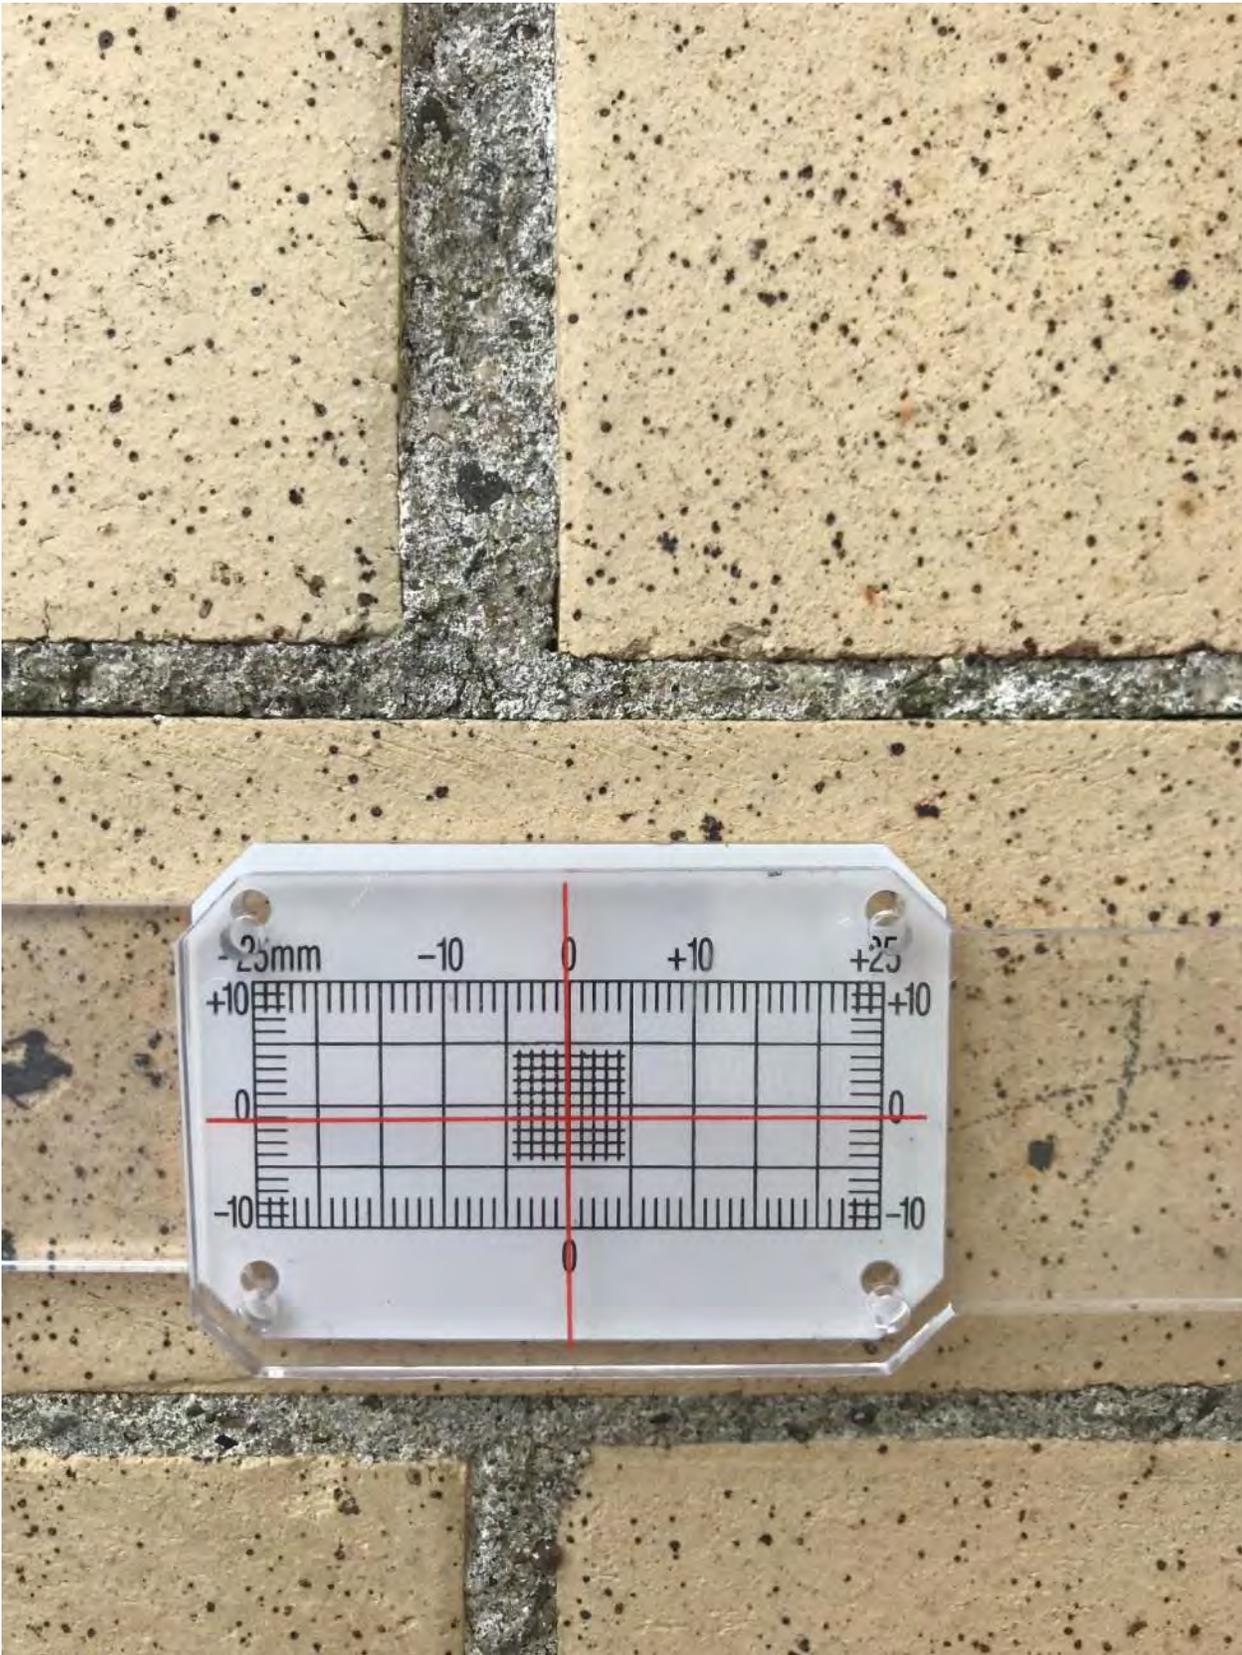
PHOTO 11A - DETAILED

0_{mm} Vertical Movement
