CITY OF ROCHESTER
DEPARTMENT OF ENVIRONMENTAL SERVICES
30 CHURCH STREET
ROCHESTER, NEW YORK

**ASBESTOS MANAGEMENT PLAN
BUILDING INSPECTION INFORMATION**

**MUNICIPAL PARKING GARAGES, PARKING
VIOLATIONS BUREAU**

Genesee Crossroads Garage

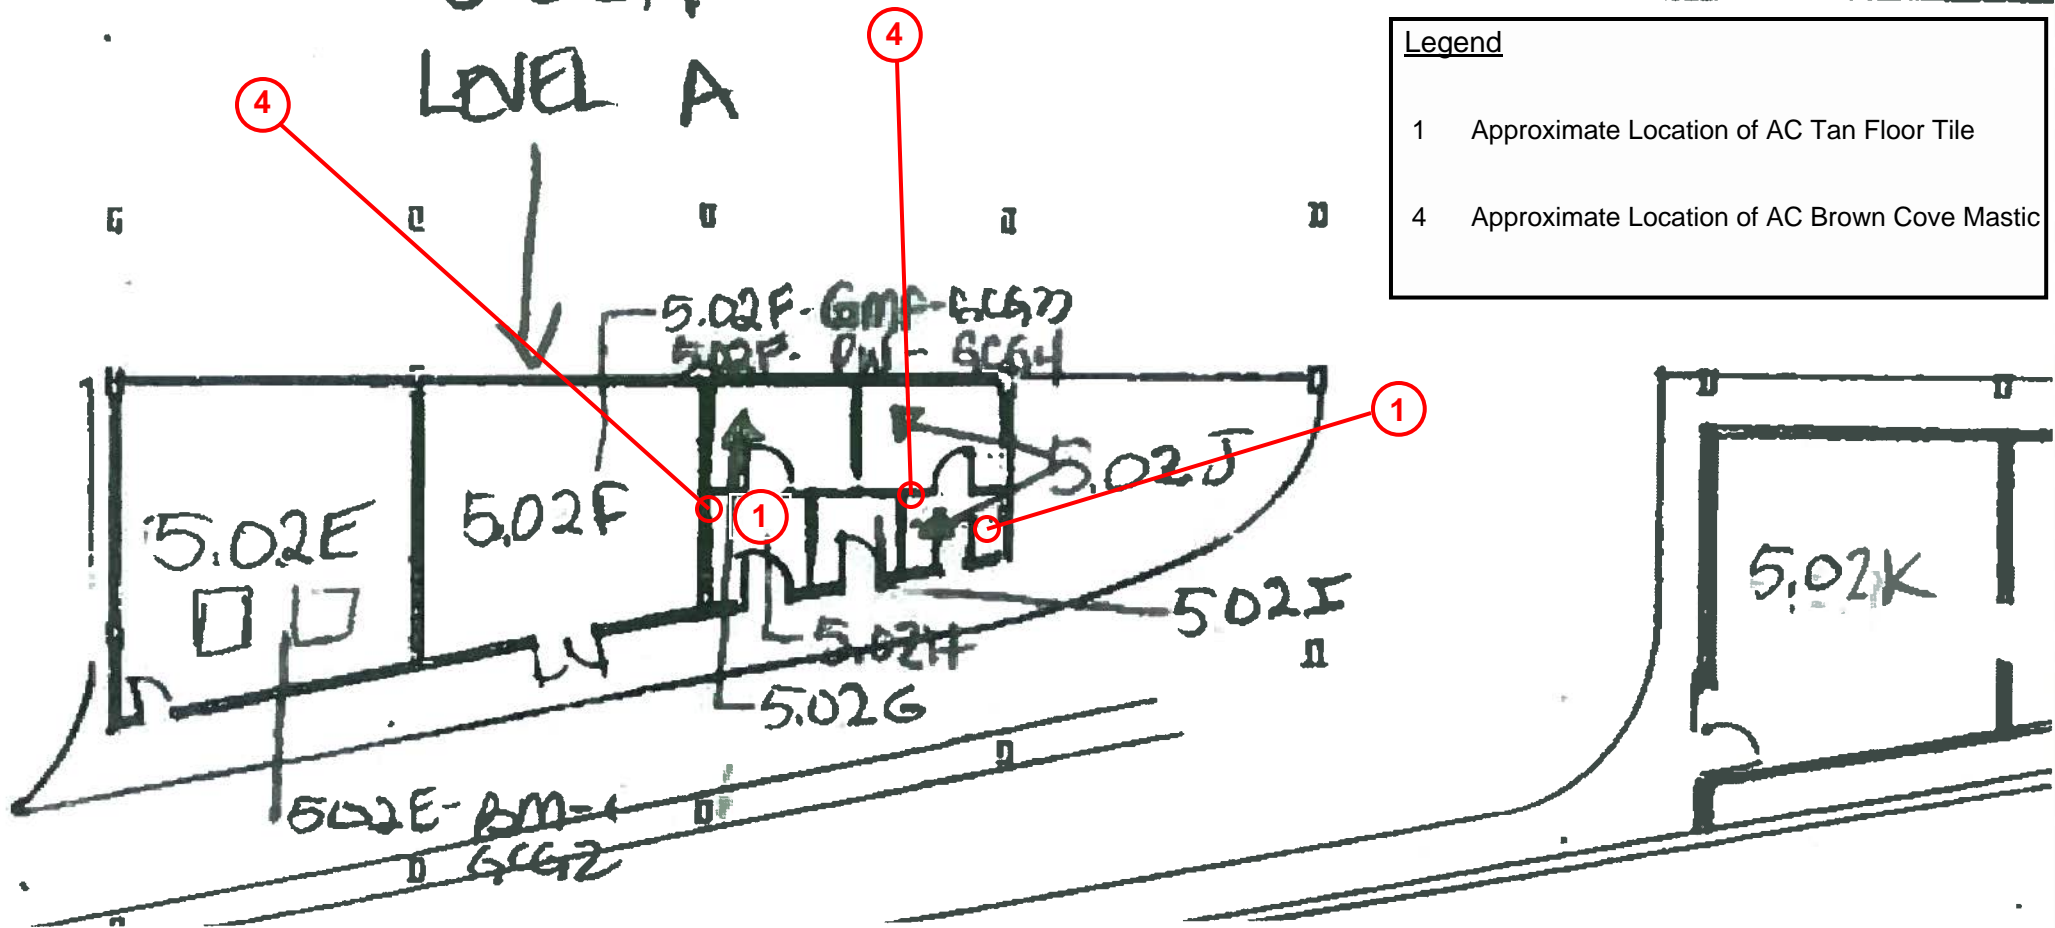
5.02N
LEVEL A

- 1 Approximate Location of AC Tan Floor Tile
- 4 Approximate Location of AC Brown Cove Mastic
