Building Condition Report

**Mechanical Condition Assessment
88 Elm Street
Rochester, New York 14604**

**City of Rochester
Department of Neighborhood and
Business Development
City Hall, Room 005A
30 Church Street
Rochester, New York 14614**

LaBella Project No. 210261.03

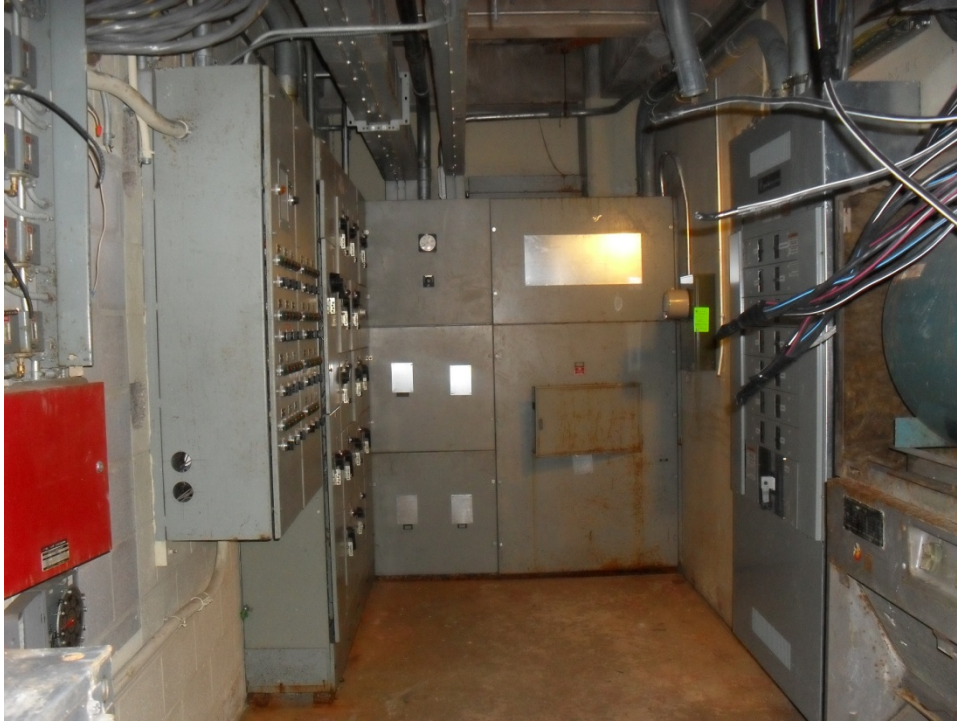
The original electrical service entrance equipment for this facility was installed in the late 1960s when the building was first constructed. The equipment is a 120/208-volt, 3-phase, 4 wire switchboard located in the basement, with service entrance raceway entering the facility below grade near the intersection of Atlas and Elm Streets. The switchboard was manufactured by Continental Electric. Refer to photos E-1 and E-2, Appendix A.

E-1: ELECTRICAL SERVICE AND DISTRIBUTION EQUIPMENT

Replace the electrical service entrance with new conductors and equipment sized to support the building's expected occupancy. Consider utilizing a 120/208-volt, 3-phase, 4-wire arrangement to eliminate the need for a service transformer.

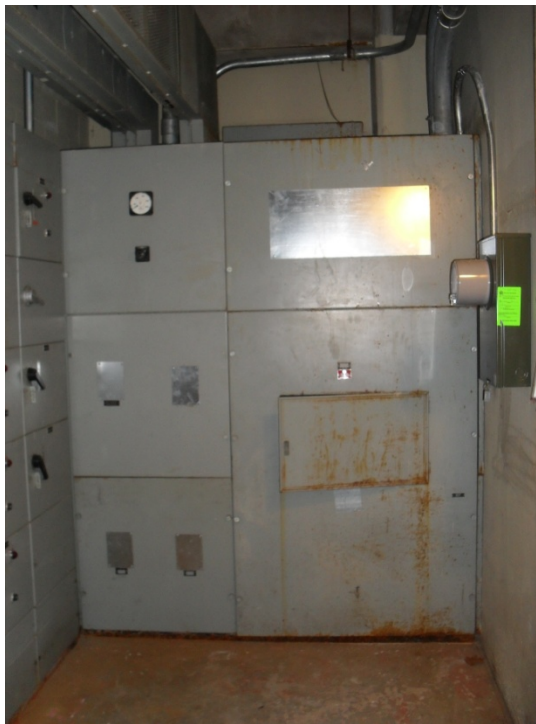
The original service entrance equipment, as noted above, has been emptied, and is not salvageable for reuse. The temporary service entrance, while in excellent condition, is not sized to support this type of building. The temporary electrical service could be beneficial for construction, and could also be used as part of the permanent electrical distribution system.

E-2: ABANDONED SERVICE ENTRANCE SWITCHBOARD

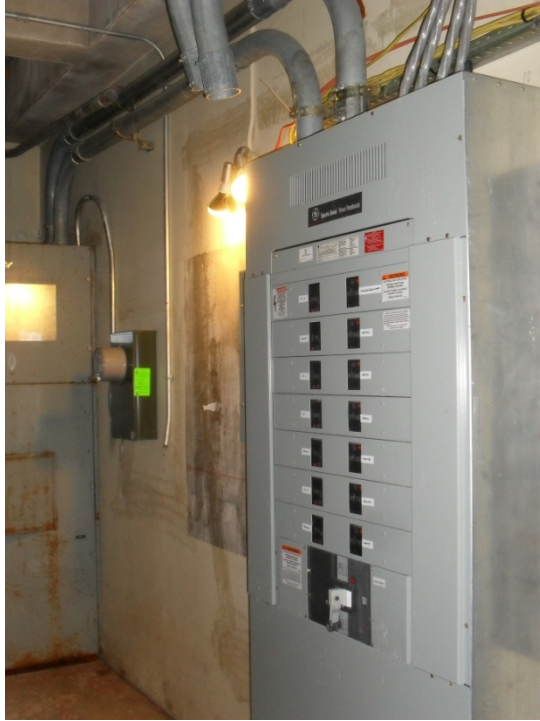
While the original service entrance switchboard for this building is still technically in the basement, the internal parts have been removed, and the shell is currently being used as a pull box and current transformer enclosure for a temporary electrical service. The temporary electrical service was installed to support a previous abatement project. Installed in 2010, the temporary electrical service is an 800-amp, 120/208-volt, 3-phase, 4-wire arrangement with current transformer type utility metering. Refer to photo E-3, Appendix A.

E-3: TEMPORARY SERVICE ENTRANCE SWITCHBOARD

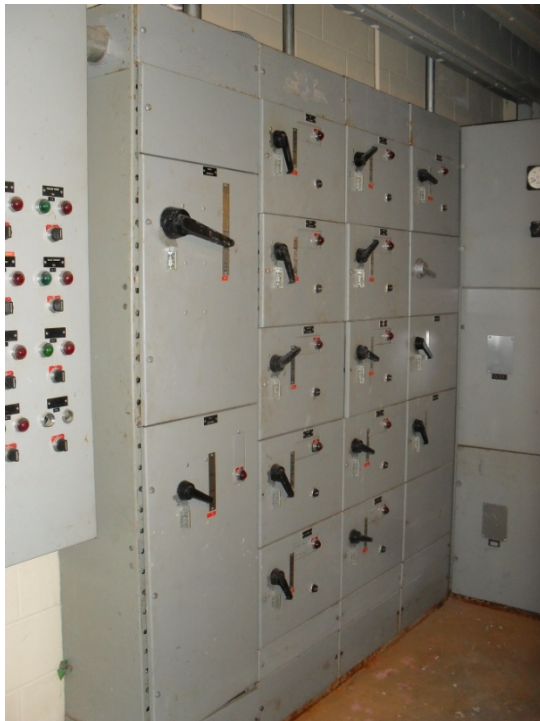
The motor control center, which provided power and motor starters for the mechanical equipment in the basement, has been mostly stripped of internal components and the associated feeders. The motor control center is also a product of Continental Electric. Refer to photo E-4, Appendix A.

Buss ducts appeared to be in poor condition, and obtaining the quantity of missing hardware required to put them back into service would likely be difficult and expensive, as Continental Electric is no longer in business. Replacement motor starters are likely available for the motor control center through other manufacturers, but the cost to retrofit an entire motor control center would likely be more expensive than new equipment, and the end result would be a non-UL listed system that is well past its expected service life. The temporary distribution, while convenient for construction purposes, is neither of adequate capacity, nor code compliant for a permanent installation.

E-4: ABANDONED MOTOR CONTROL CENTER

Provide a new electrical distribution system, either through buss duct or home-run cabling in metallic raceway, to feed power distribution panelboards on each floor of the structure and the mechanical penthouse. Provide new motor control centers and associated feeders as appropriate to support mechanical equipment in the basement and in the rooftop mechanical penthouse.

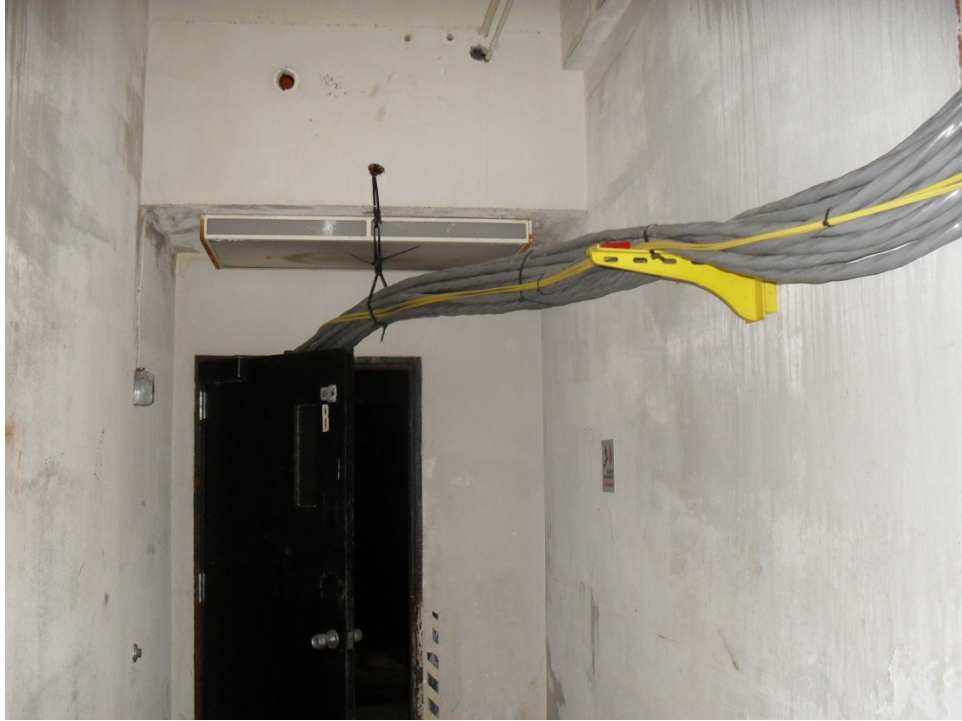
Temporary electrical panels are located on each floor of the building, connected back to the temporary electrical service panelboard with aluminum type SE jacketed cabling. The cabling is routed on cable racks through the basement, and then travels vertically on cable racks through one of the stair towers, feeding panels located on plywood backboards on the landings for each floor. The panels are 24-space, 120/208V, 3-phase, 4-wire 100A main lug load centers manufactured by GE. Circuit breakers are provided in the temporary electrical service panelboard, protecting the panels at 100-amps. Refer to photos E-5 and E-6, Appendix A.

E-5: TEMPORARY POWER DISTRIBUTION CABLING IN STAIR TOWER

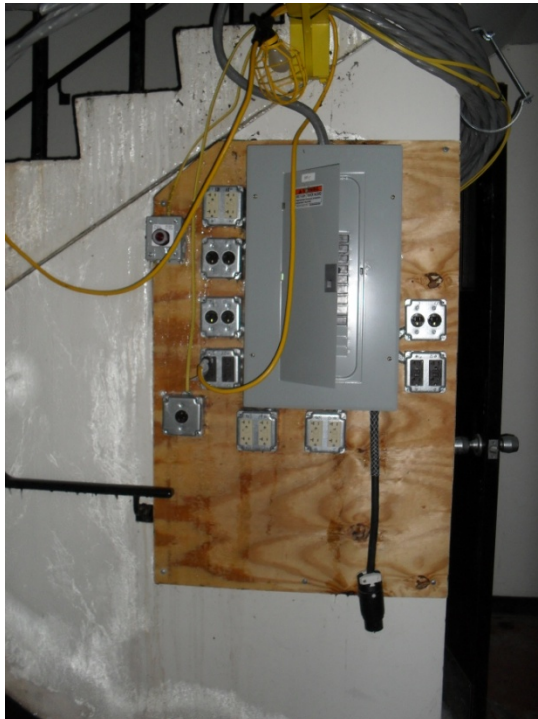
E-6: TEMPORARY POWER DISTRIBUTION PANEL IN STAIR TOWER

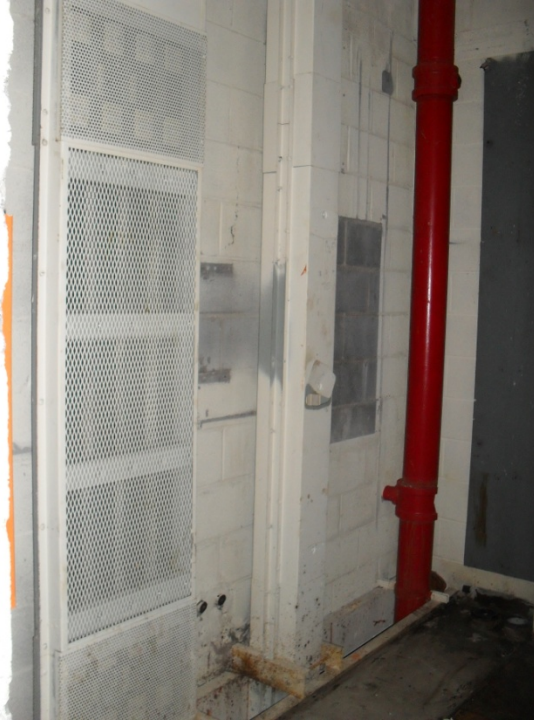
The original power distribution for the facility consisted of (2) 1000-amp Continental Electric buss ducts running vertically through the building, and a motor control center buss-tied to the original service entrance equipment. The buss ducts were previously directly connected the main switchboard, traveled horizontally through the basement, and then connected to the vertical shaft. At some point in the past, several sections of the horizontal bus ducts have been removed, along with the majority of the buss plugs. Panelboards that were originally connected to the buss plugs to provide power on each floor have also been removed. Refer to photo E-7, Appendix A.

E-7: VERTICAL SECTIONS OF BUSS DUCT IN STACKED CLOSETS

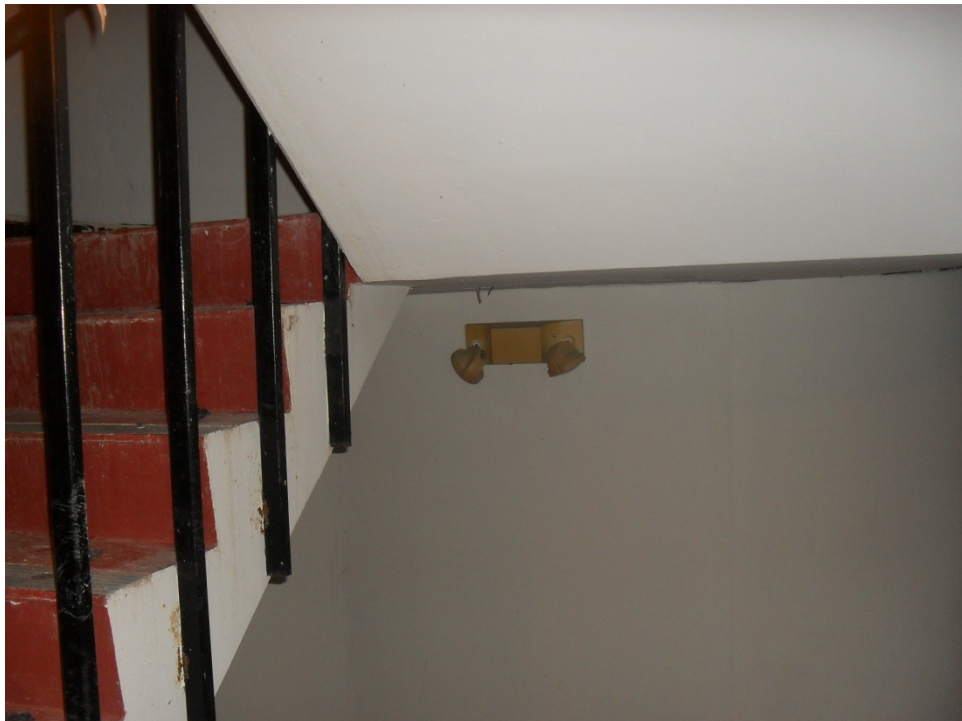
Interior lighting for the facility has been removed, with only a few luminaires remaining that have been abandoned in place, mainly in the stair towers and some recessed cans in the entrance soffit. No exterior luminaires, beyond the aforementioned recessed cans are present at this site. Some very limited temporary string lighting is present in the basement and one of the upper floors. Refer to photos E-8, E-9, and E-10, Appendix A.

E-8: TYPICAL ABANDONED IN PLACE LUMINAIRE

Provide new lighting throughout the facility, including required emergency egress lighting, to support the proposed occupancy.

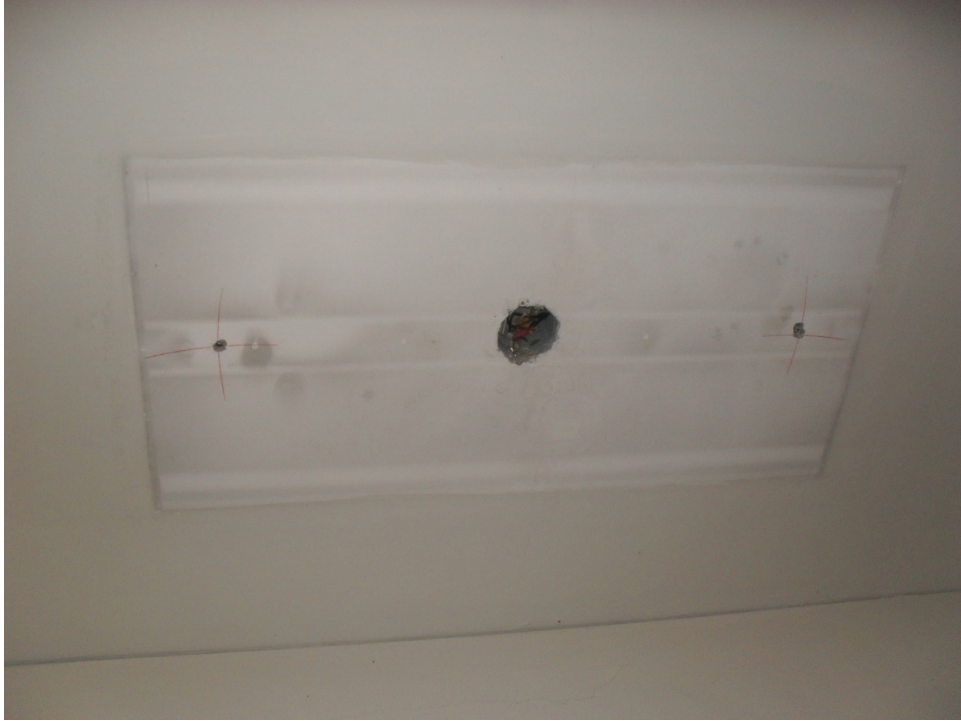
As mentioned earlier, some existing raceway poured into the concrete stair towers for lighting could likely be reused in a renovation.

E-9: LUMINAIRE RACEWAY RECESSED IN CONCRETE STAIR TOWER

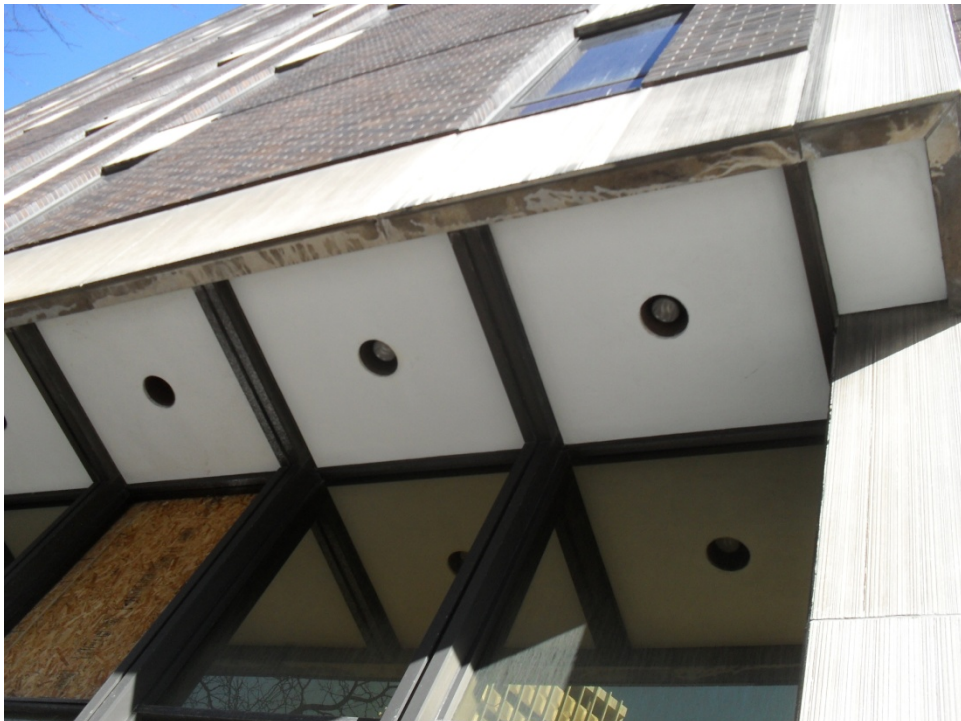
E-10: SOFFIT MOUNTED LIGHTING AT BUILDING ENTRANCE

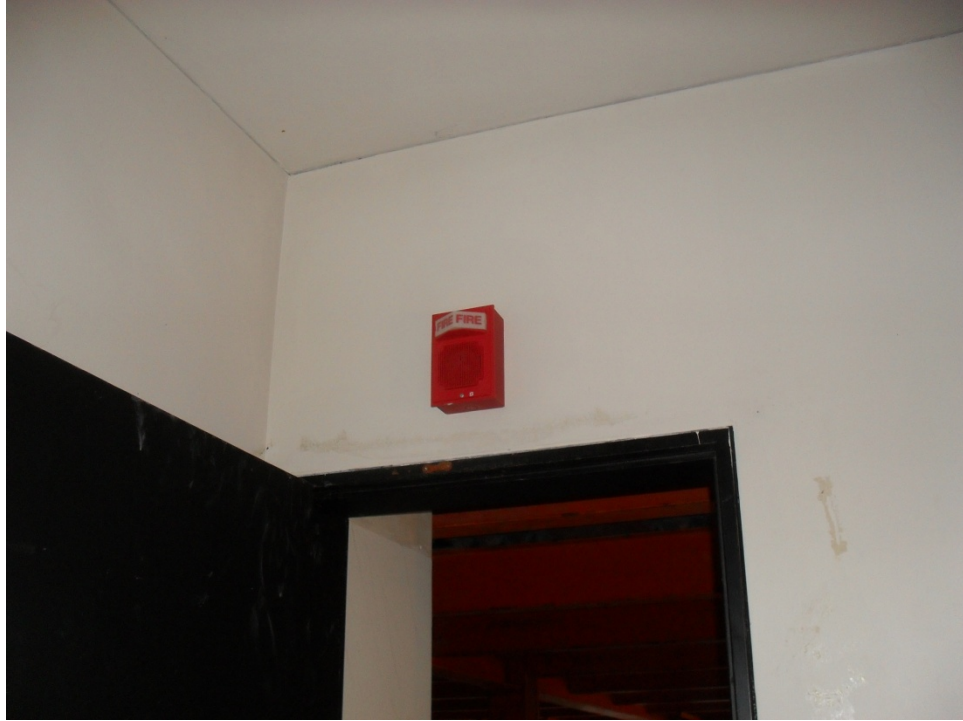
Existing fire alarm systems throughout the facility have been removed, with the exception of a handful of devices abandoned in place. Refer to photo E-11, Appendix A.

As mentioned earlier, some existing raceway poured into the concrete stair towers for fire alarm devices could likely be reused in a renovation.

E-11: TYPICAL ABANDONED IN PLACE FIRE ALARM DEVICE

Provide a new fire alarm and detection system throughout the building as required for the proposed occupancy.

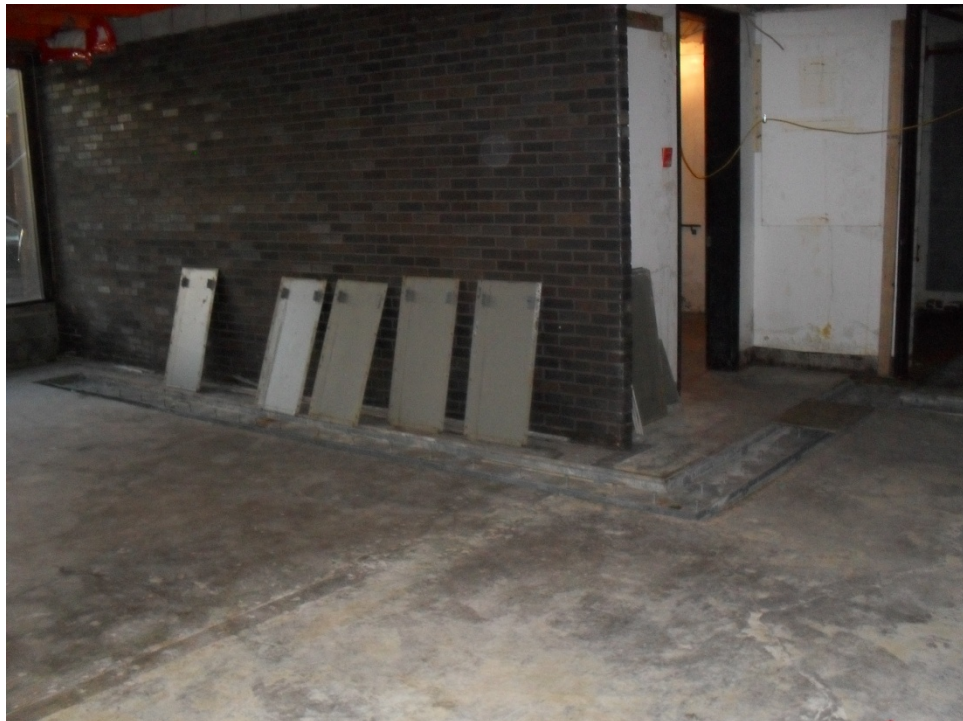
Telecommunications cabling was previously distributed throughout each floor utilizing an in-floor raceway system that still exists, with removable access plates leading back to the stacked vertical closets which also contain the existing buss duct for power distribution. Presumably vertical backbone cabling interconnected telecommunications backboards in these stacked closets. Refer to photos E-12 through E-15, Appendix A.

The existing in-floor raceway system appears to be in good condition, and could conceivably be reused, provided the layout is compatible with the proposed occupancy.

E-12: IN-FLOOR RACEWAY SYSTEM AND COVERS

Provide new telecommunications service entrance(s) and distribution as required to support the intended occupancy of the facility.

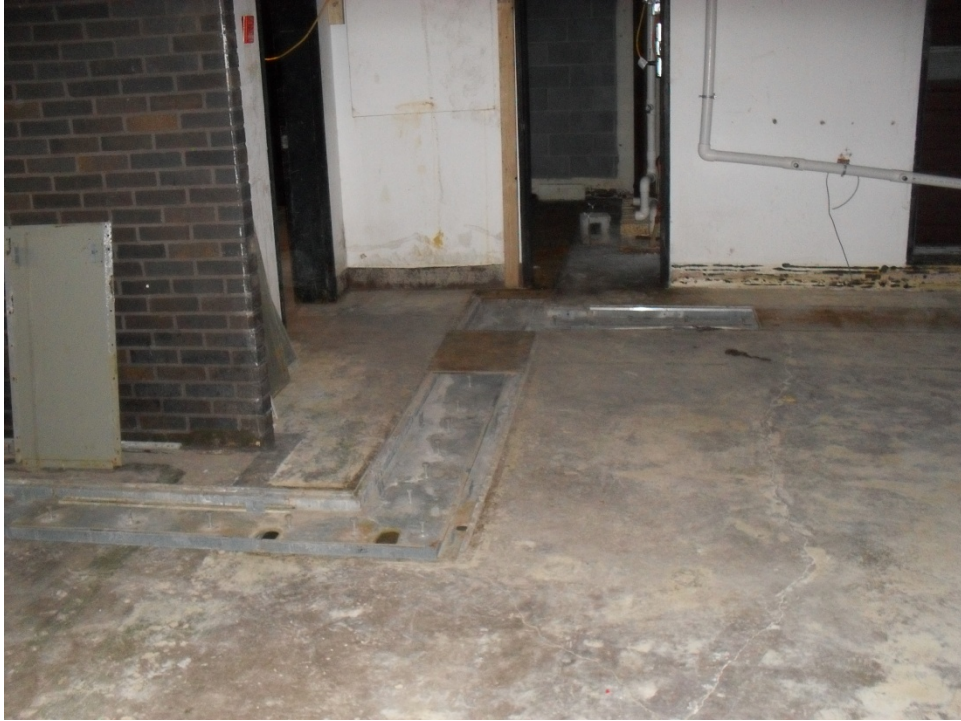
E-13: IN-FLOOR RACEWAY SYSTEM ENTERING STACKED CLOSET

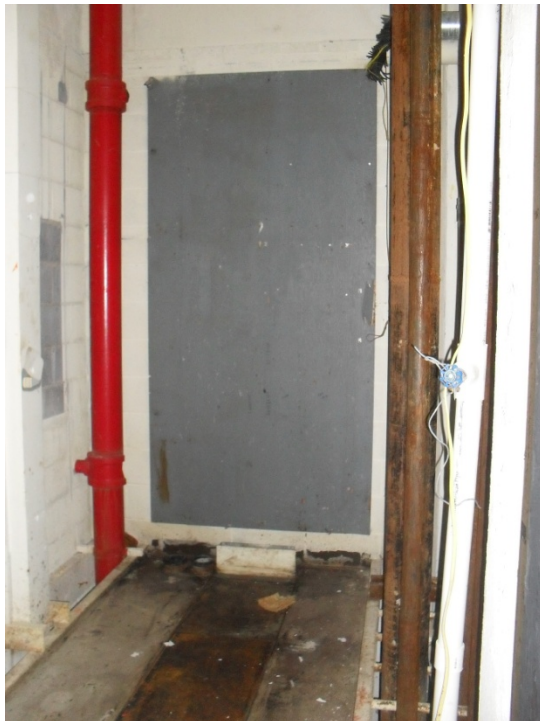
E-14: IN-FLOOR RACEWAY IN STACKED CLOSET AND TELECOMMUNICATIONS BACKBOARD

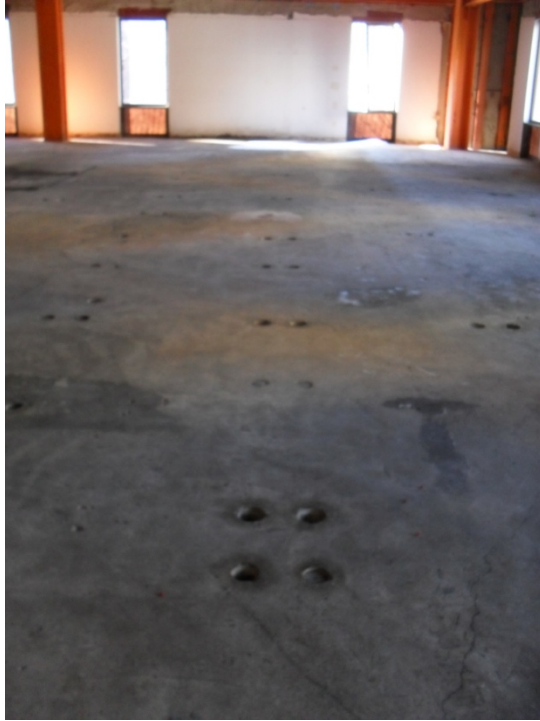
E-15: IN-FLOOR RACEWAY PENETRATIONS AND THROUGH-FLOOR PENETRATIONS

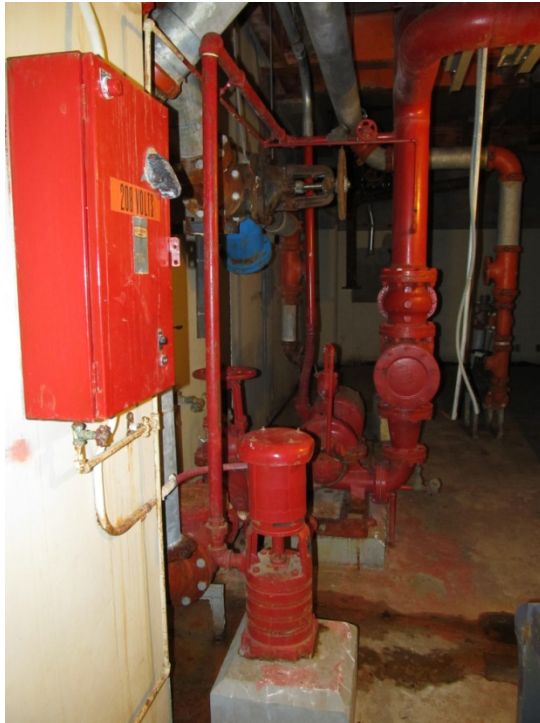
The existing fire pump and stair tower standpipes remain. All other existing fire protection equipment and devices including double check detector assembly and sprinkler distribution piping have been removed.

Fire Pump Station in Basement

Remove any existing fire protection system equipment, devices and controls except existing stairwell standpipes and provide new hydraulically calculated automatic fire protection system meeting current NFPA 13 requirements based on proposed occupancy and hazard.

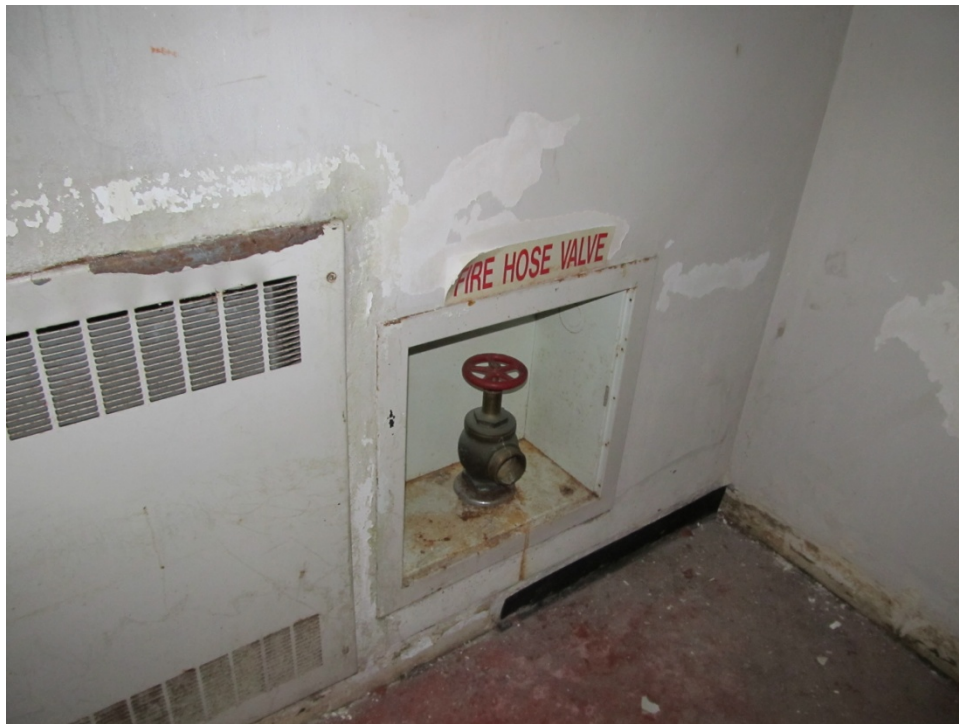
Typical Stairwell Fire Hose Connection

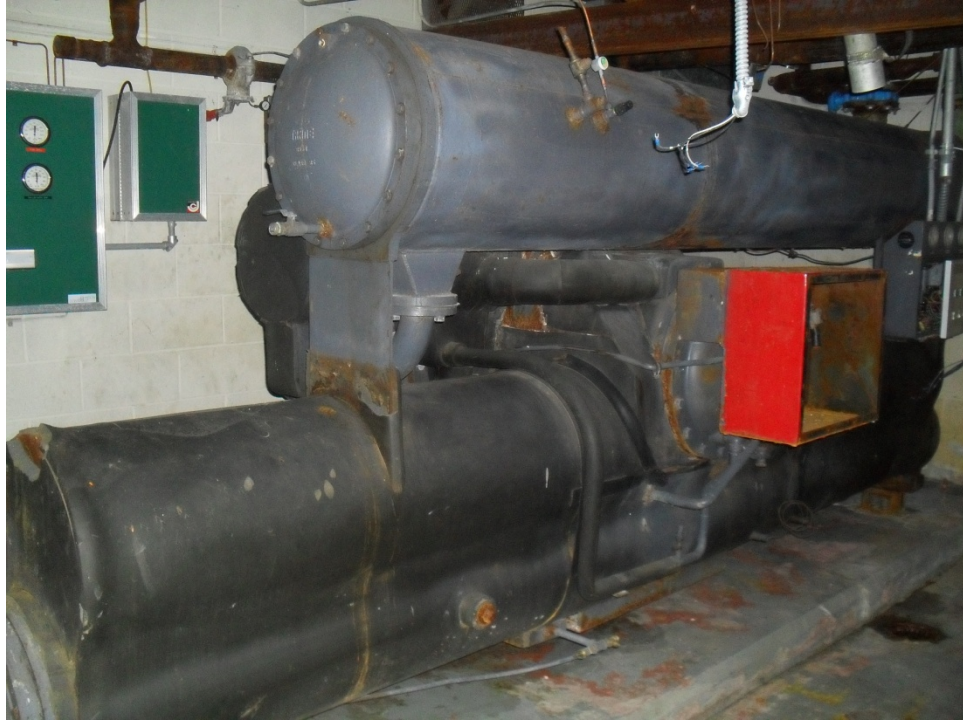
A Trane CentraVac centrifugal chiller model PCV2FC1D2 is located in the basement. The equipment has been disconnected and abandoned in place. The chilled water and condenser water pumps are abandoned in the basement.

Abandoned Centrifugal Chiller located in basement

All HVAC equipment and components remaining in the building should be removed. The chiller located in the basement would require removal by a technician certified according to regulations of the United States Environmental Protection Agency. New systems, designed for the proposed building configuration, should be installed. An opinion of probable construction costs for HVAC systems to service the entire building is \$2,912,000.

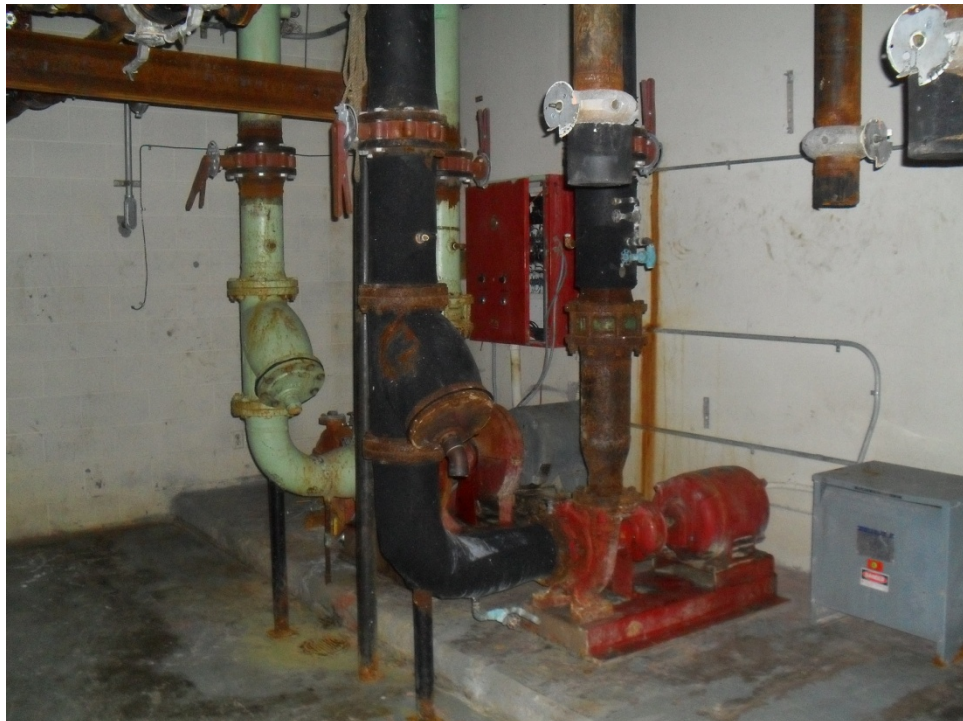
Abandoned chilled water and condenser water pumps

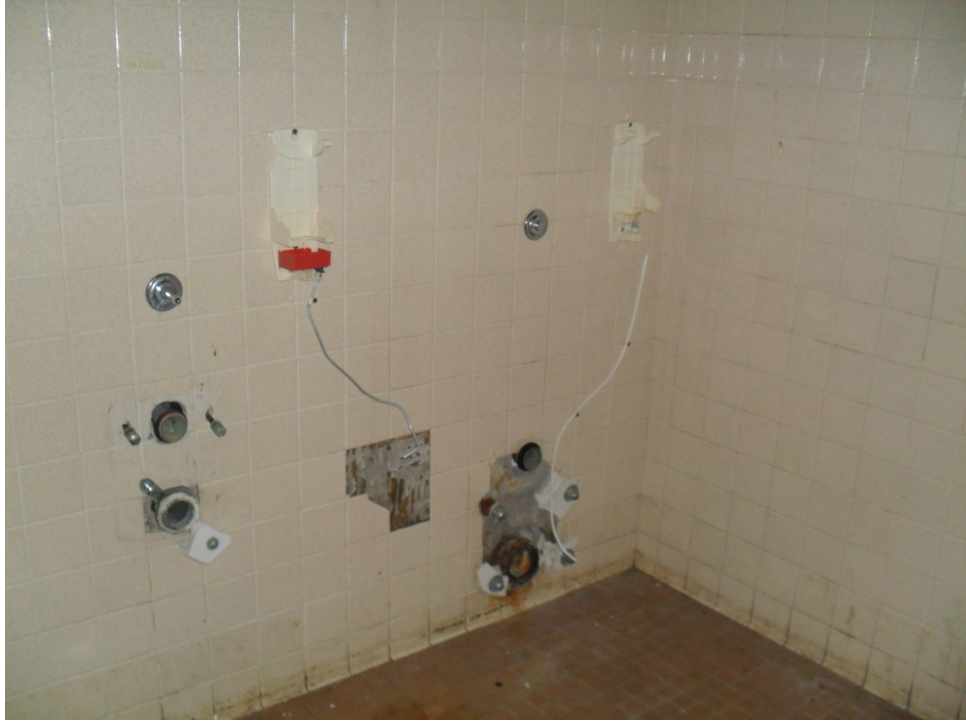
All existing wall hung plumbing fixtures have been removed in their entirety. Existing fixture carriers remain. Existing floor set service sinks remain.

Typical abandoned toilet room

Verify fixture count with proposed occupant load per floor and if existing toilet room layout is code compliant, install new plumbing fixtures utilizing existing fixture carriers and sanitary piping. If fixture count does not meet current code, then total renovation of existing toilet rooms will need to occur; including modification to fixture quantity, layout and sanitary/domestic water piping.

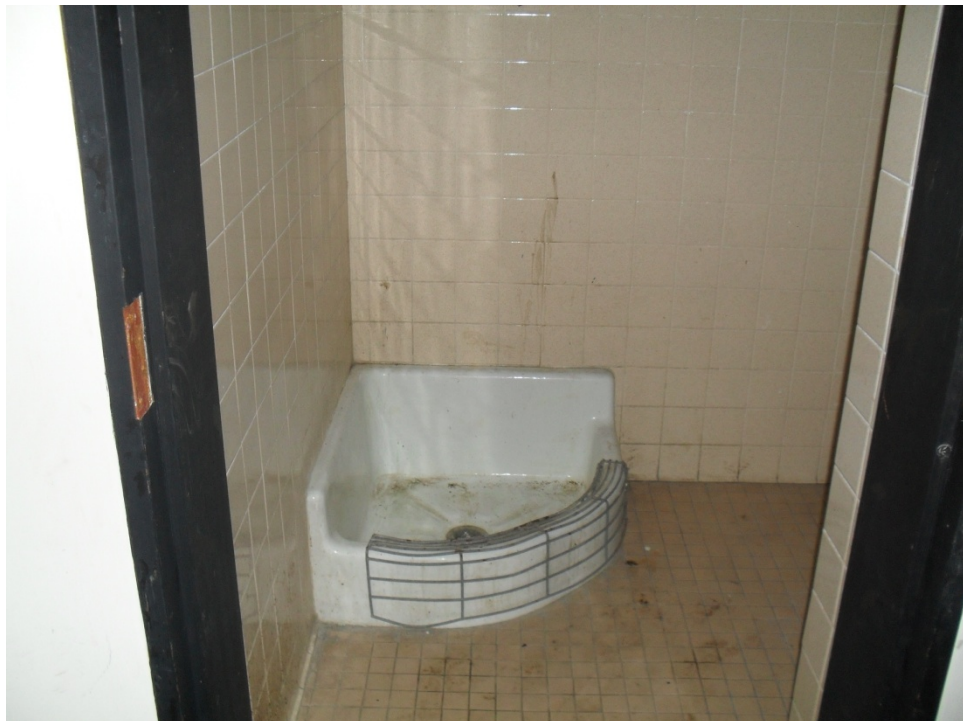
Abandoned janitor's closet

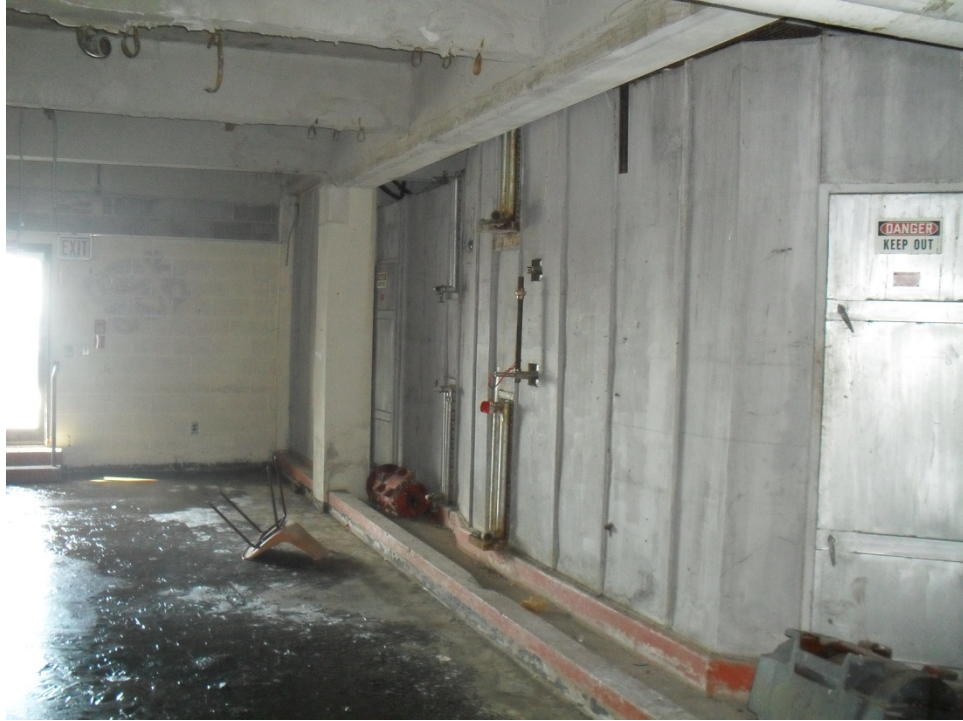
The cooling and ventilation for the building was provided primarily from a central air handling unit located in the penthouse mechanical space. Air was distributed to the individual floors via supply and return air duct risers located in

Abandoned AHU in penthouse mechanical space

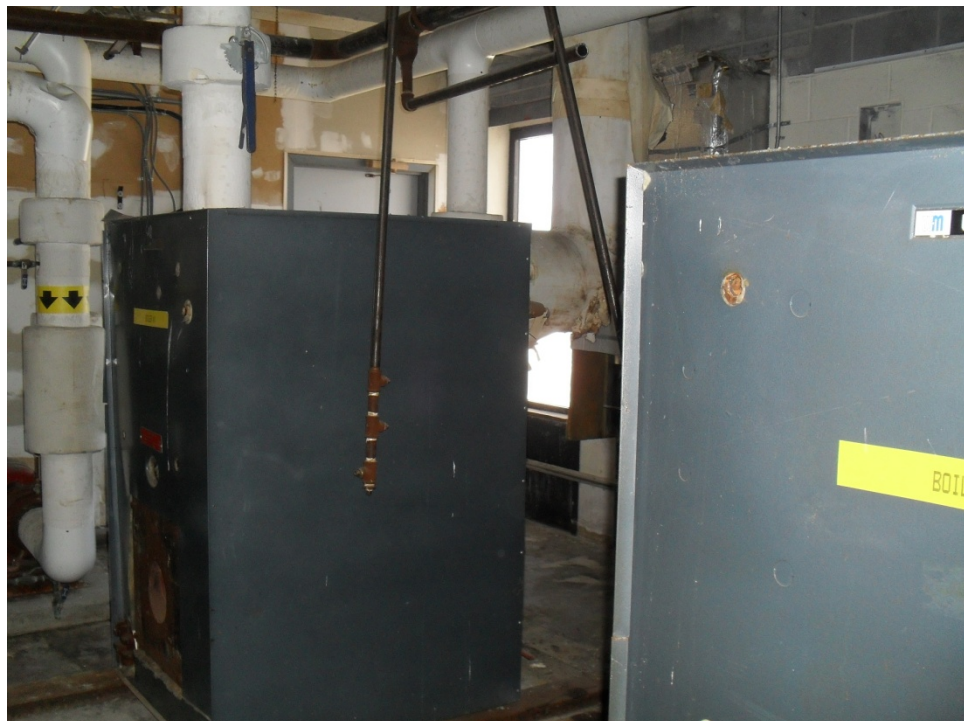
There are no existing operable heating systems. There are two Weil McClain cast iron sectional boilers located in the penthouse mechanical space. There are partial remnants of a hot water distribution system located in the penthouse as well as in the basement. Some pipe risers were located in a common piping shaft. All heating elements have been removed from the floor areas except for recessed hot water wall convectors located in toilet rooms and entrance areas.

Abandoned boilers in penthouse mechanical space

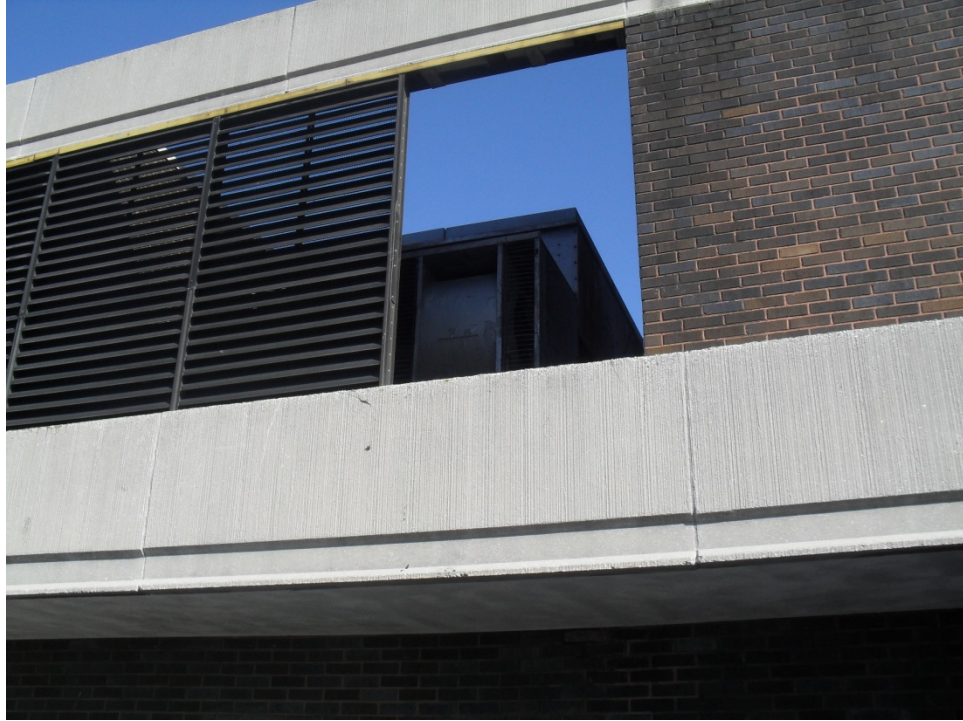
Abandoned cooling tower on roof
