**DRAFT SUBMITTAL - Structural**  
**SEPT 5, 2013**

**Existing Conditions Report**  
**68-92 Genesee Street, Rochester, NY**  
**Structural and Environmental Engineers Site Visit August 29, 2013**

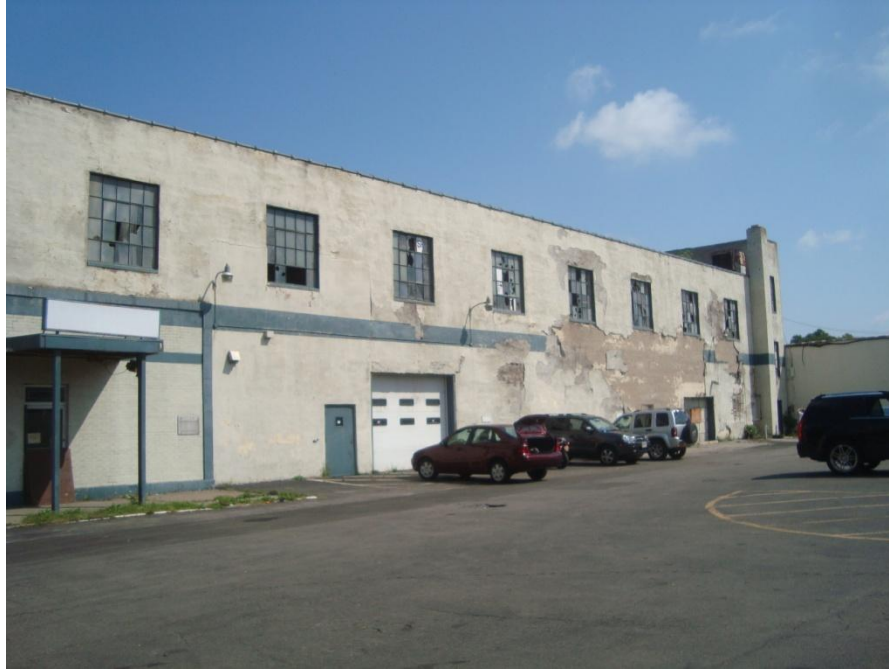
68-82 Genesee Street, Rochester, NY: South Elevation

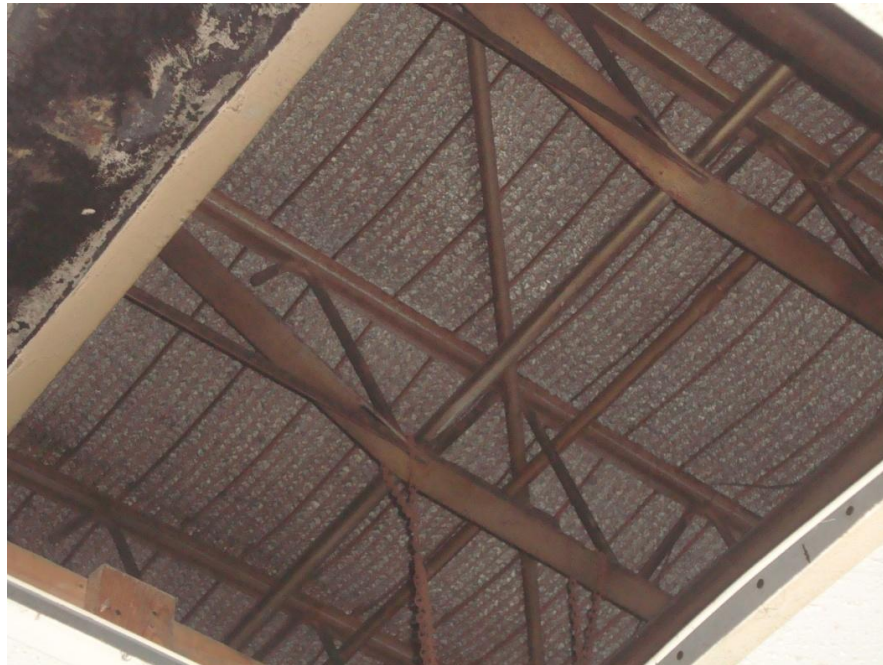
View – looking up at underside of second floor structural system. Concrete slab-on-steel-mesh spanning across tops of steel joist-trusses spaced at 18" o.c.

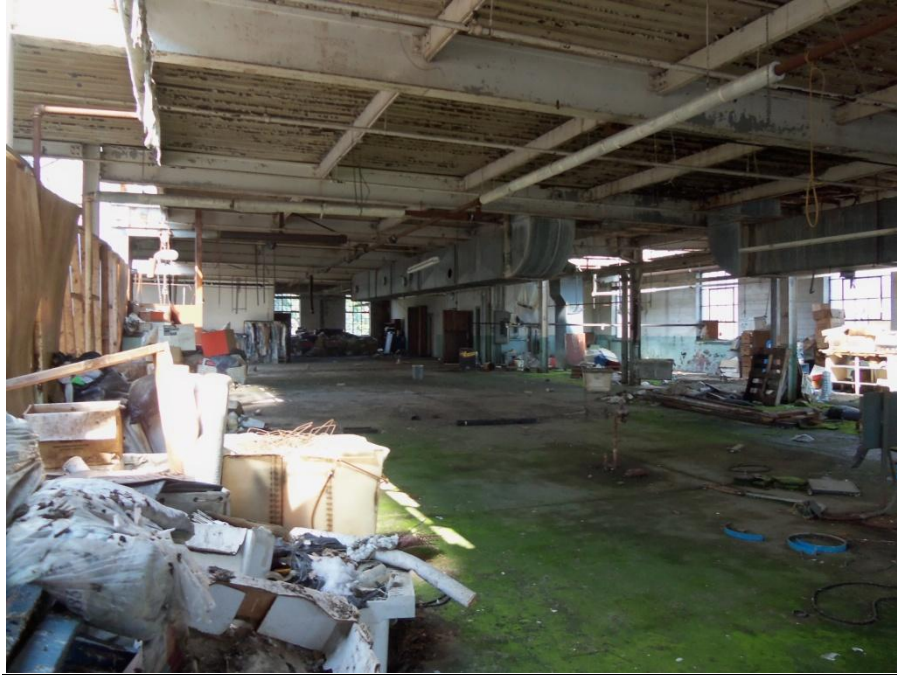
View of second floor, looking west. Roof deck spans left-to-right (north-south) over 8" deep roof channels spaced at 8" o.c.. Channels span east-west. Steel beam spans left-to-right (north-south)

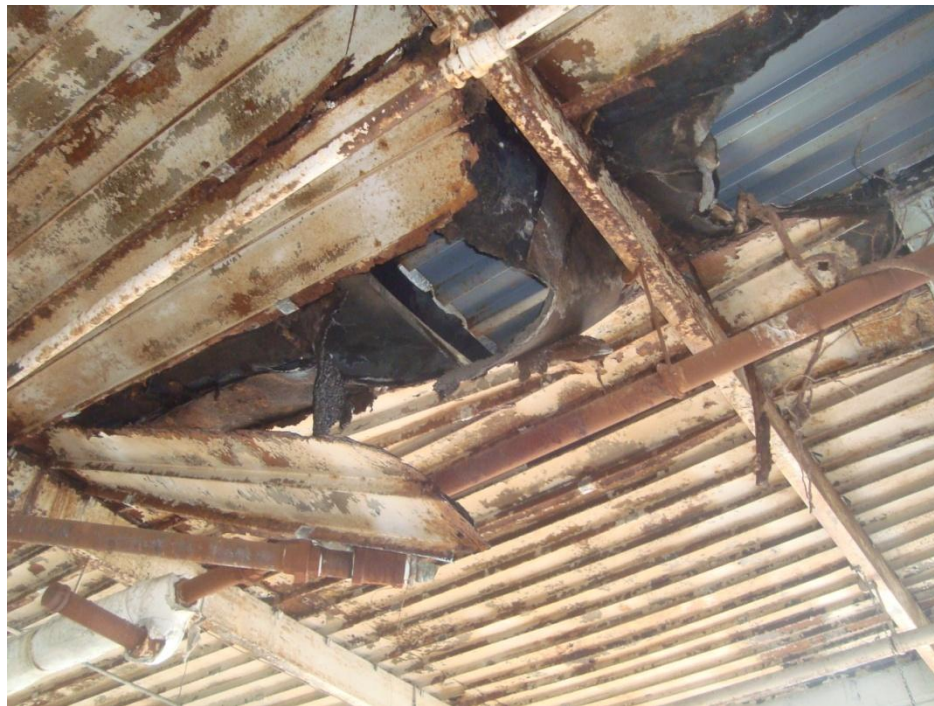
There are numerous localized penetrations through the roof where the roof deck is rusted and has caved in, and the skylights have many broken panes of glass. These conditions have allowed rain and snow into the second floor, resulting in many areas of heavy mold and moss growth on the floor and materials covering the floor surface.

There are large areas of rusted steel roof deck that appear structurally intact, however, the degree to which the deck's structural capacity has been compromised cannot be determined.

View of collapsed area of roof deck

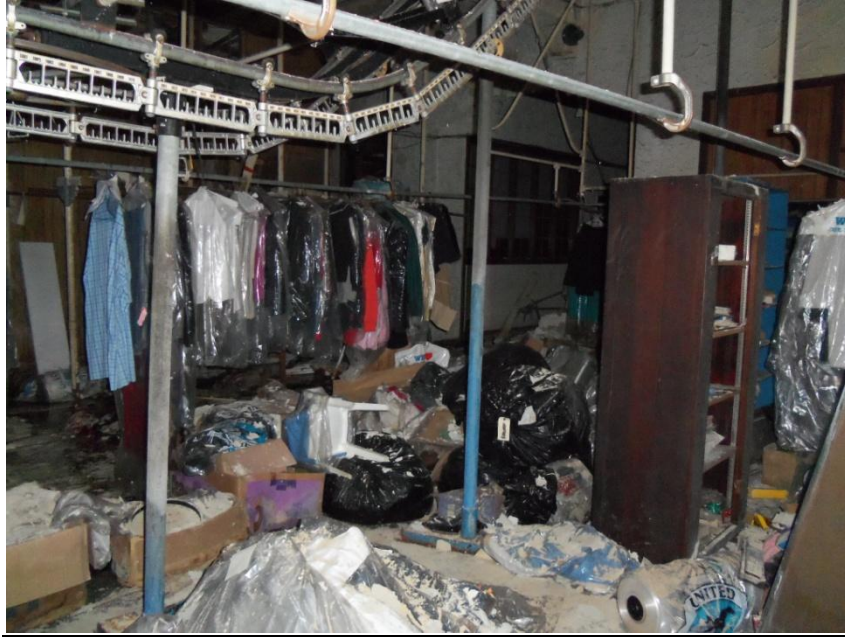
Typical area at first floor.
