Condition Appraisal – Midtown Parking Structure

WALKER
PARKING CONSULTANTS

PROJECT # 11-2343.00

MAY, 2008

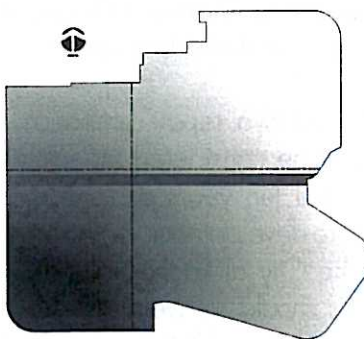
In order of extent and severity, the most significant deterioration in the facility occurs:

- East-west drive lanes on each supported floor
- South-west quadrant
- North-west quadrant
- South-east quadrant
- North-east quadrant

GRAPHICAL REPRESENTATION OF DETEIORATION. DARKER AREAS INDICATE GREATER DETEIORATION IN THE STRUCTURE

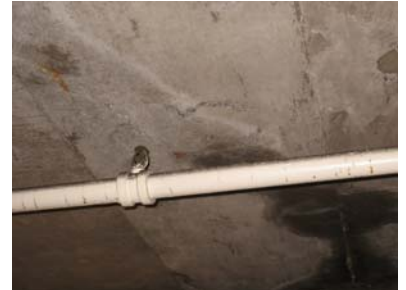
There is loose overhead concrete throughout the garage that could potentially fall on patrons or vehicles if not removed.

LOOSE OVERHEAD CONCRETE

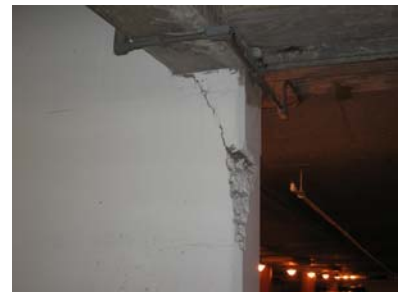
In two locations of wall/beam intersections on Level B adjacent to east/west expansion joint, wide cracks in the wall have compromised the beam shear capacity. The beams should be shored until permanent repairs are made.

CRACKED END OF WALL COMPROMISING THE BEAM SHEAR BEARING

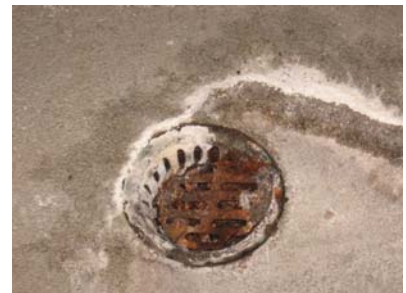
Broken or missing floor drain grates throughout the garage are a trip hazard to patrons. It is recommended that new grates be installed.

BROKEN FLOOR DRAIN GRATE

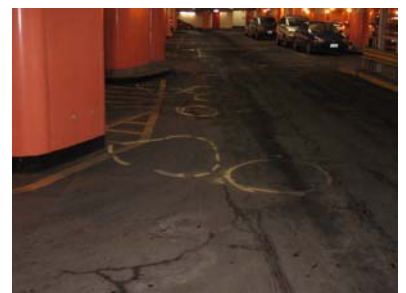
A chain drag survey of the supported floors on Levels A and B denoted floor delaminations. The majority are located along column lines where top steel is present and in the main drive lane between the north and south halves of the deck, where the original asphaltic coating remains. This coating is debonded from the concrete floor surface in many locations. The floor delaminations are much more prevalent on the west half of both floors where the parking is the heaviest. Salt laden snow is brought in by vehicles and deposited on the floor slabs

FLOOR DELAMINATIONS PRESENT IN MAIN DRIVE LANE

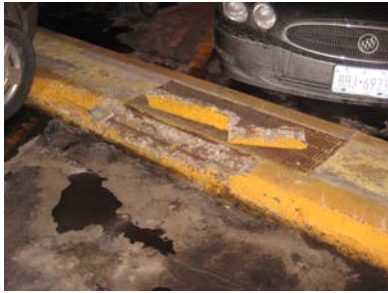
TYPICAL CURB DETERIORATION ON LEVEL C

Level C slab-on-grade has an asphalt topped concrete slab. This slab is generally in good condition. No potential trip hazards were observed. Concrete curbs are present between the rows of parked vehicles. These curbs separate parked vehicles and contain the garage exhaust systems. It appears that some sections of curbing have been replaced. Many delaminated sections of curb faces were observed throughout Level C. Delaminations of curb concrete were also noted around the perimeter of exhaust grates. Salt laded snow is brought in by vehicles and deposited onto and against the curbing resulting in concrete delaminations over time.

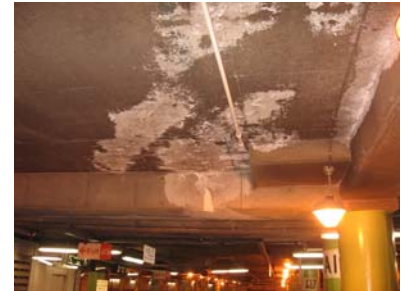
STAINED AND DELAMINATED CEILING

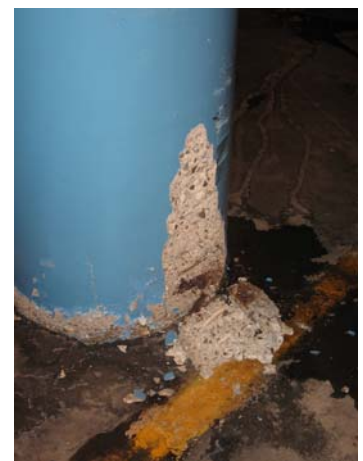
TYPICAL BOTTOM OF COLUMN
DETERIORATION ON LEVEL 'C'

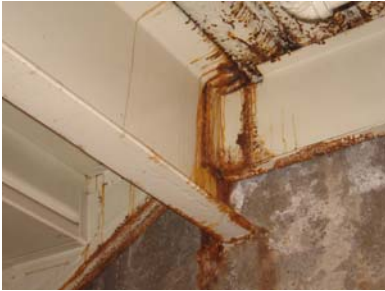
NOTE RUST ON STAIR FRAMING AND
UNDER SIDE OF METAL PAN

and pan system with concrete infill for the treads. There are florescent lights over the landings and emergency lighting and sprinklers are present in each stair. The handrails are aluminum. We observed broken wall tiles, cracks in the landing concrete, and burned out lights in the West and South stairs. Rust was present on welds and metal nosings in the South stairs.

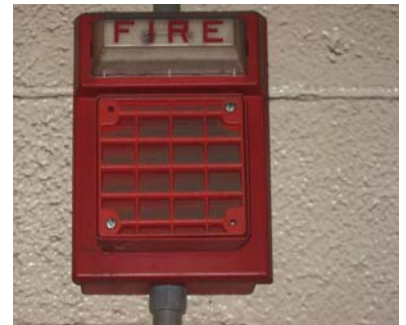
TYPICAL HORN STROBE – THIS DEVICE IS NOT IN COMPLIANCE WITH ADA REQUIREMENTS

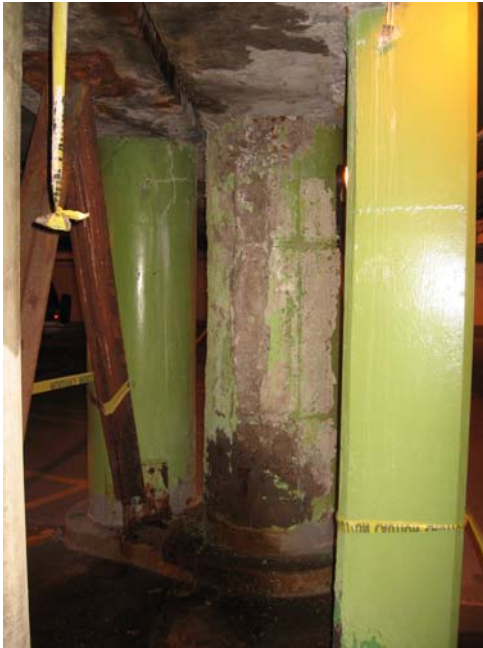
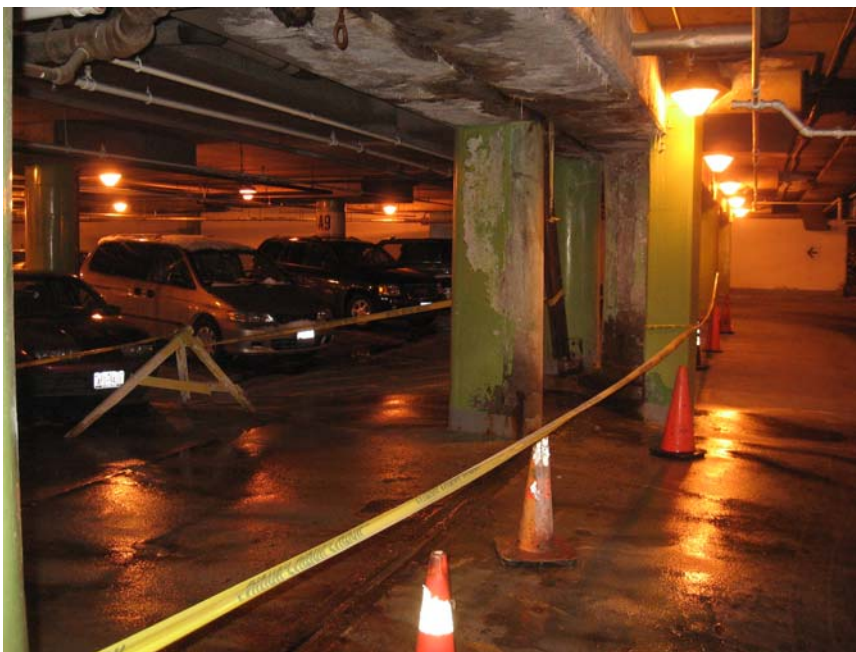
Expansion joint columns under the old Wegman's store and Broad Street are severely deteriorated. It is recommended that the expansion joint beams that the columns support be shored to grade until permanent repairs are made.

Photo 1 - Severely Deteriorated Beams And Columns Under Leaking Expansion Joint

Photo 2 - Severely Deteriorated Beams And Columns Under Leaking Expansion Joint

1. Shore the beams supported by the severely deteriorated columns along the expansion joint at Wegman's / Broad Street until permanent repairs are made.
2. Shore beams supported by deteriorated stub walls at two locations on Level B, adjacent to the east/west expansion joint until permanent repairs are made. These columns, beams and walls should be repaired in conjunction with the Broad Street expansion joint replacement.
3. Remove loose ceiling concrete throughout the structure that has the potential to fall on patrons and on vehicles.
4. Replace all broken or missing floor drain gates throughout the structure.

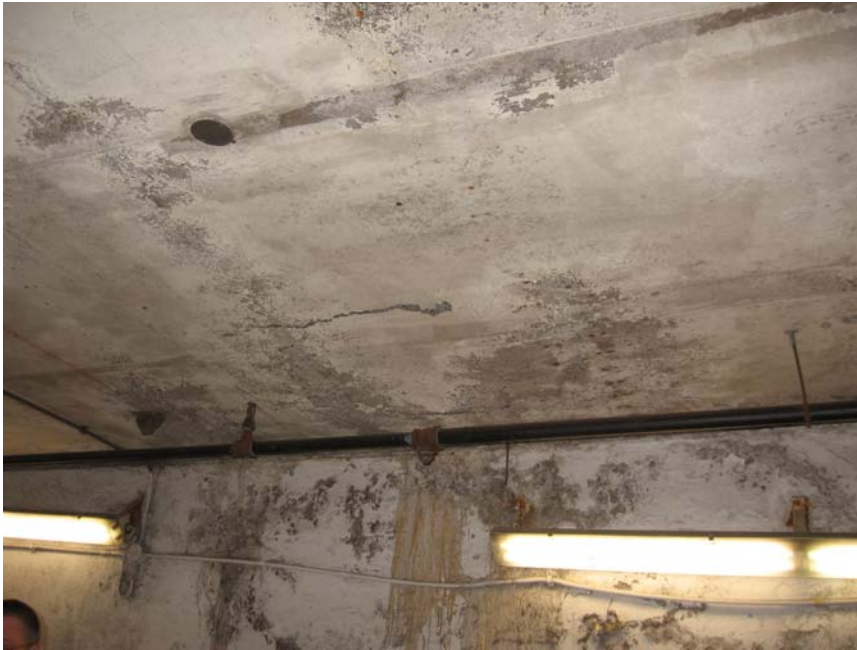
Photo 3 – Ceiling Delamination / Loose Concrete

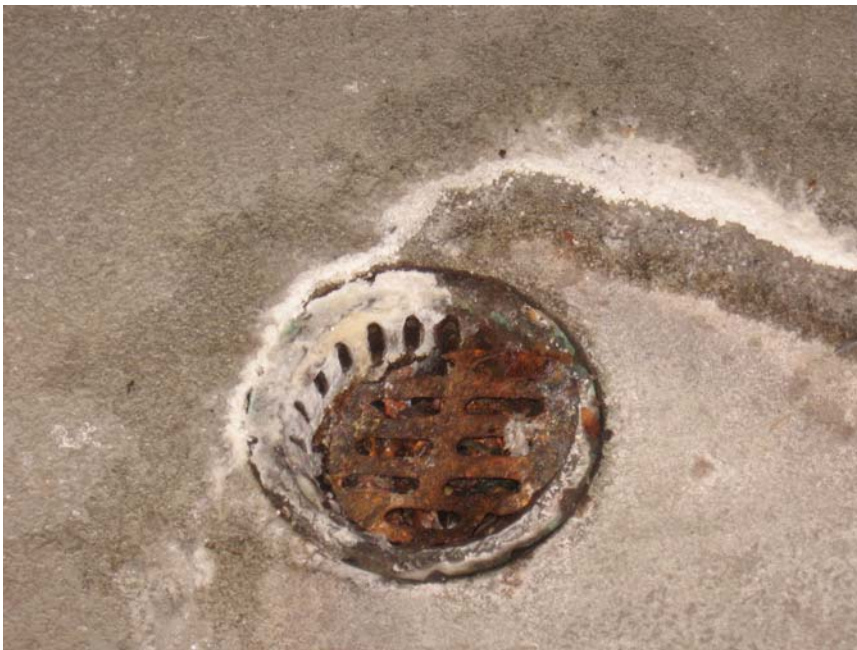
Photo 4 – Broken Drain Grate is Trip Hazard

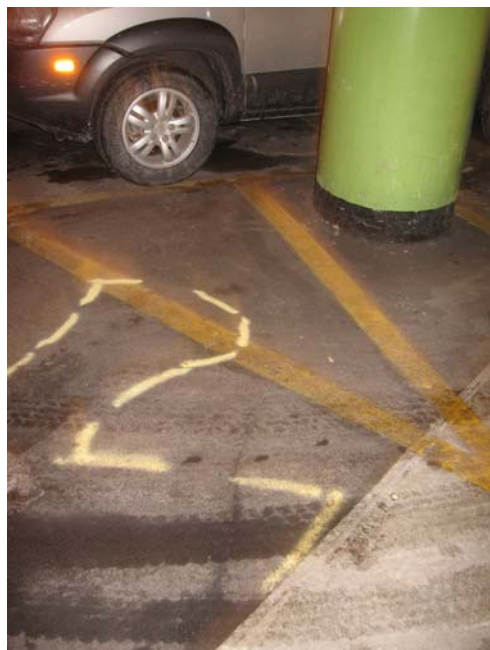
Photo 7 – Outline of Floor Delamination

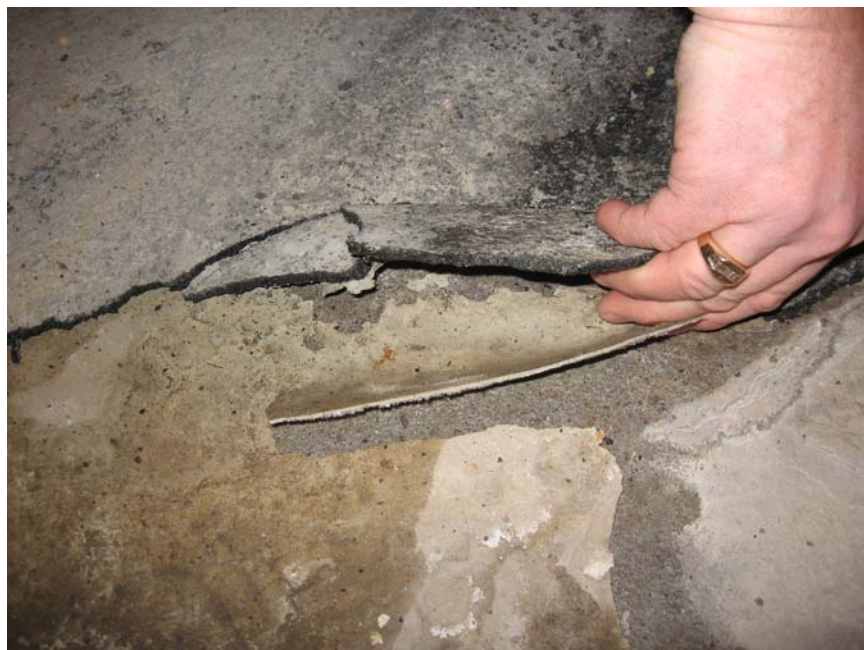
Photo 8 – Aged and Debonded Asphaltic Coating

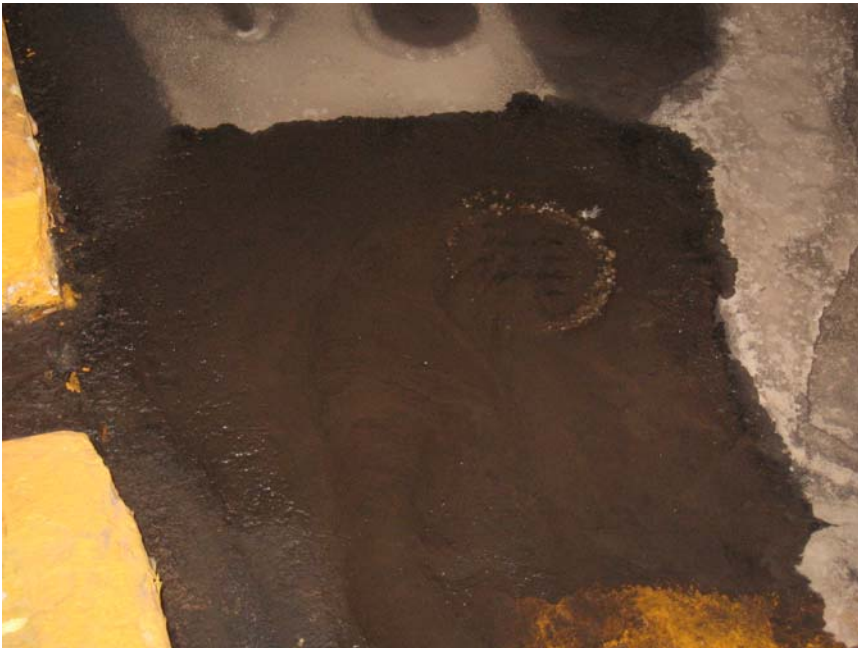
Photo 10 – Plugged Floor Drain Causing Ponded Water

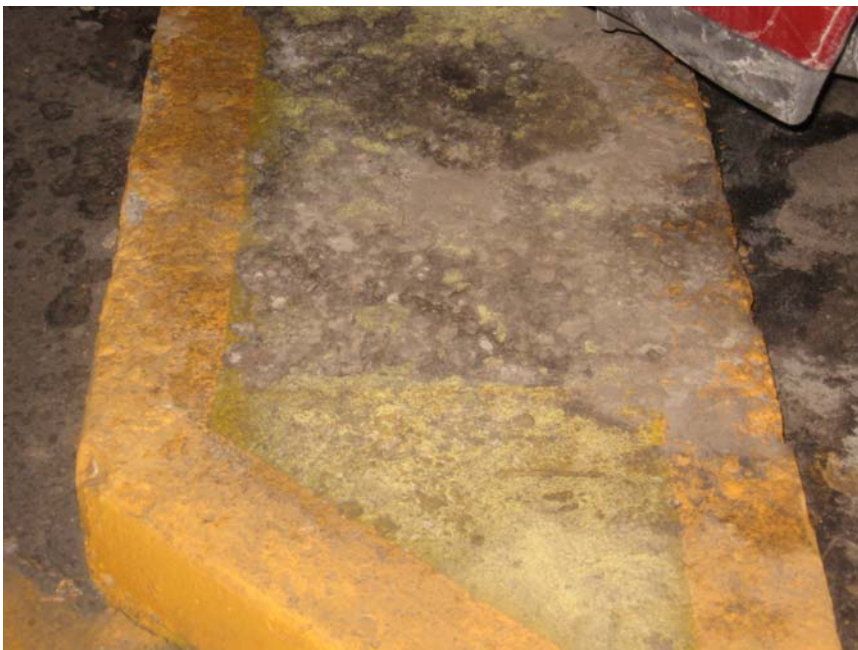
Photo 12 – Curb with Scaled Surface @ Level C

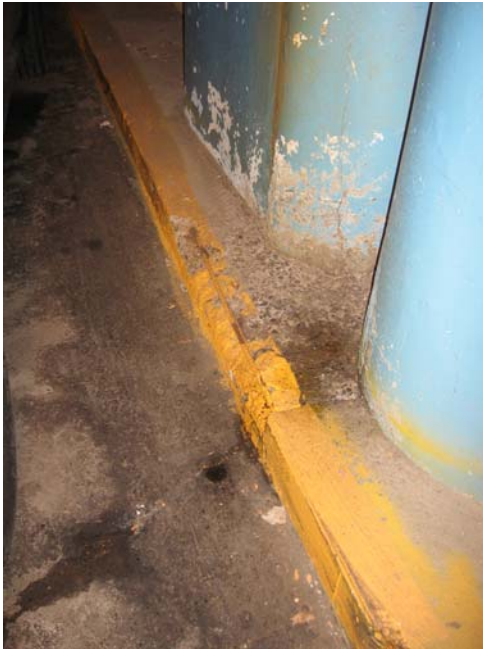
Photo 13 – Deteriorated Curb Face

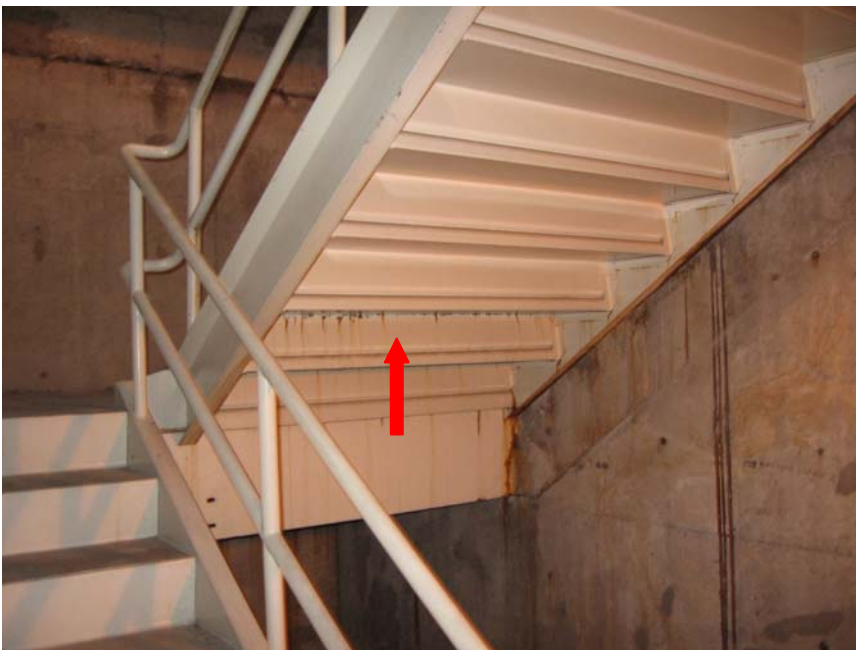
Photo 16 – Stairwell, Note Rust on Bottom of Pan.

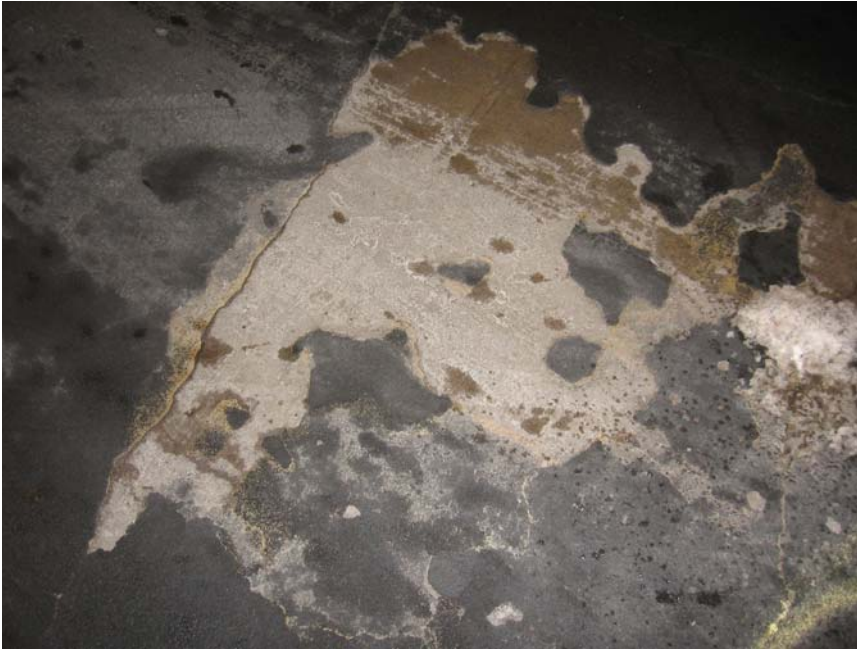
Photo 19 – Debonded / Missing Traffic Topping

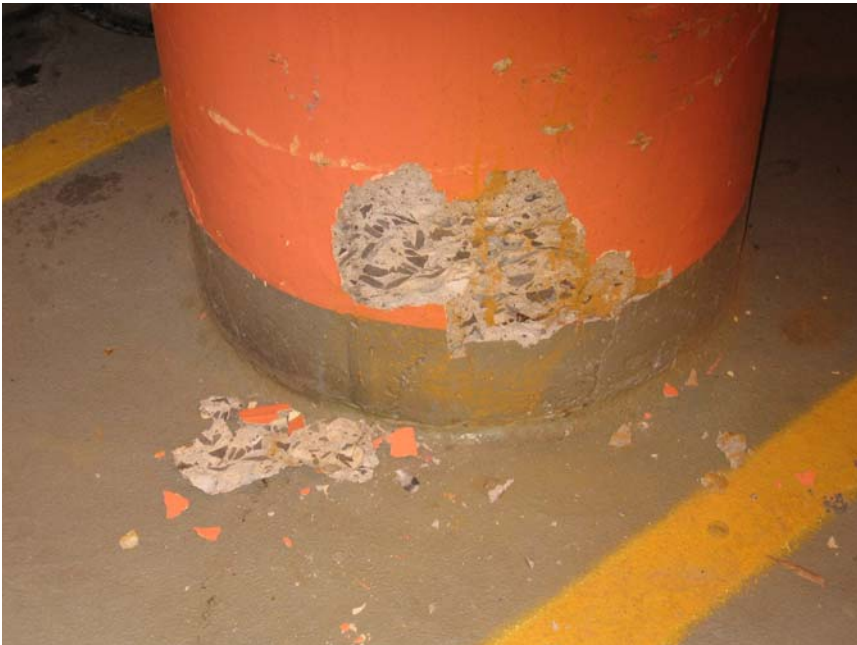
Photo 20 – Column Spall

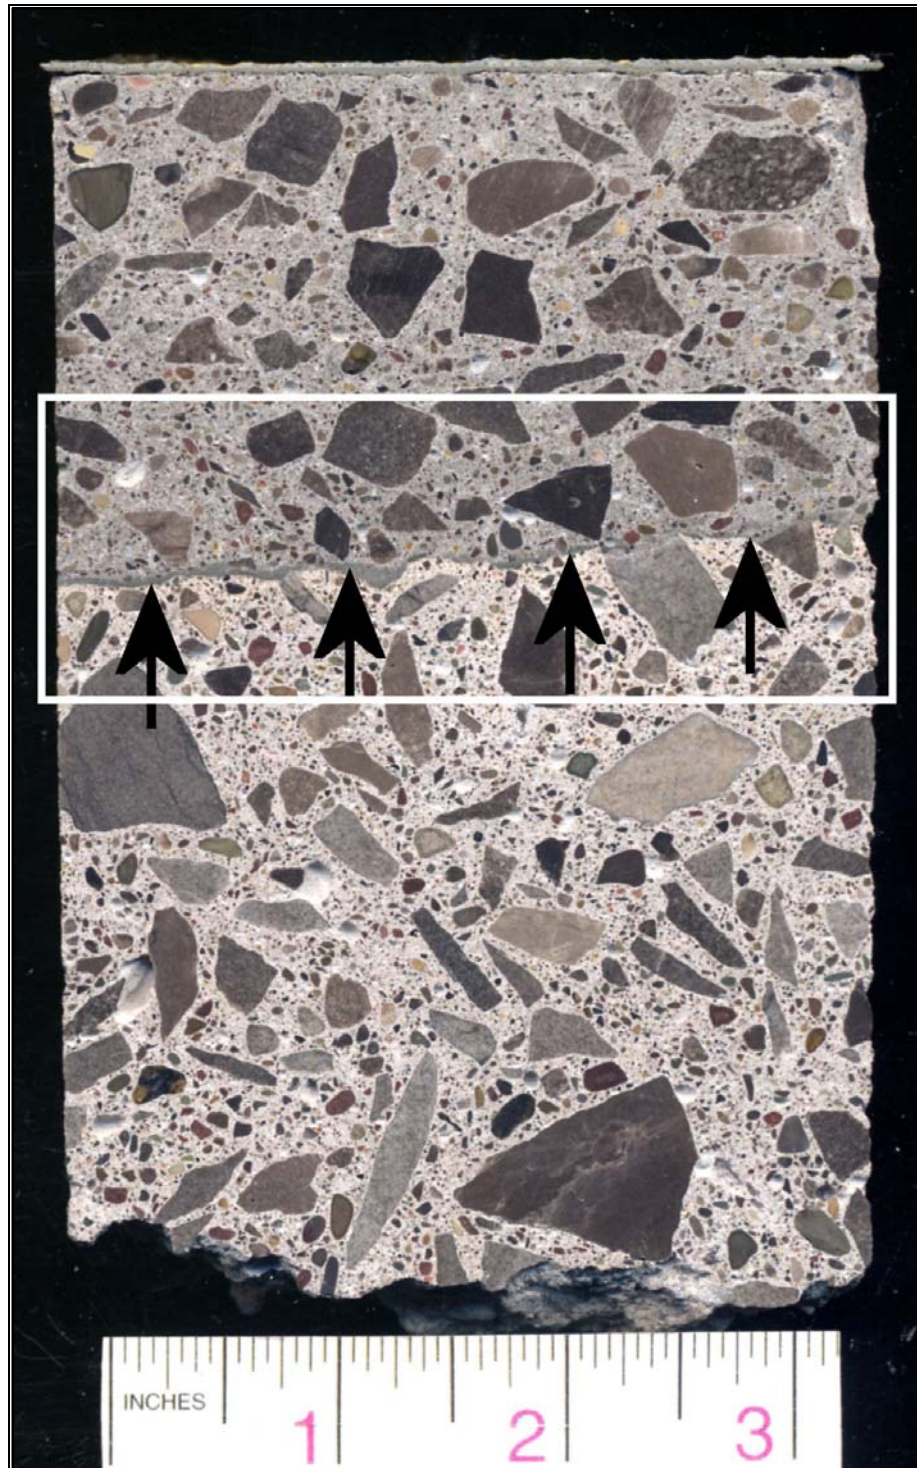
Figure 2: Lapped cross section of core showing the waterproofing membrane, topping concrete, and substrate concrete with a thin neat paste bond coat intimately bonding the topping and substrate concretes (boxed and enlarged in the next photo). Notice good grading and distribution of aggregates in both concretes.

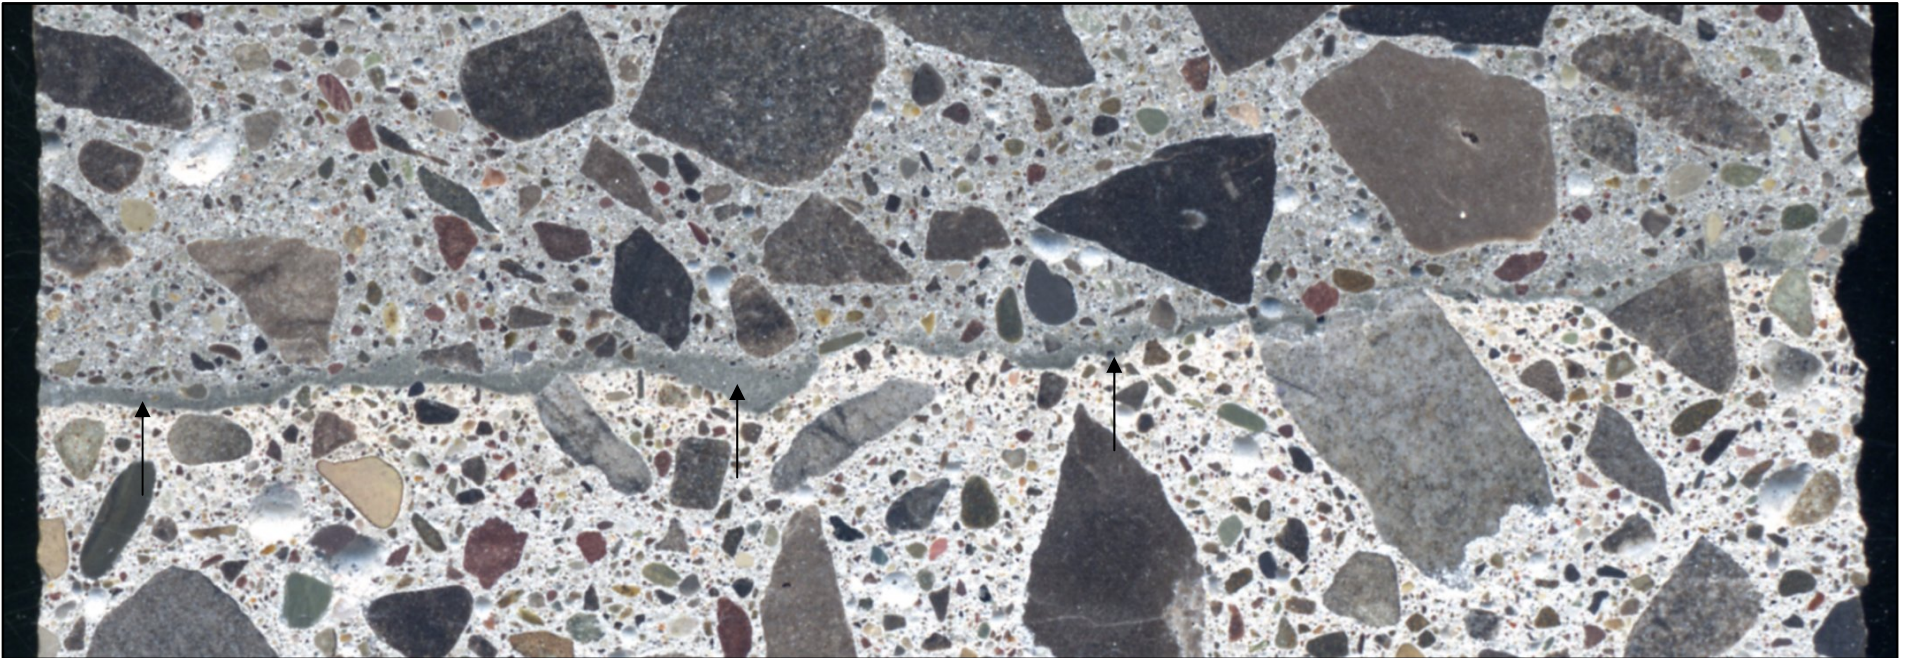
Figure 3: Enlarged view of the boxed area from Figure 2 showing the intimate bond between two concretes and the presence of a thin neat paste bond coat (arrows).
