WALKER
PARKING CONSULTANTS

CONDITION APPRAISAL

MIDTOWN PARKING STRUCTURE

ROCHESTER, NEW YORK

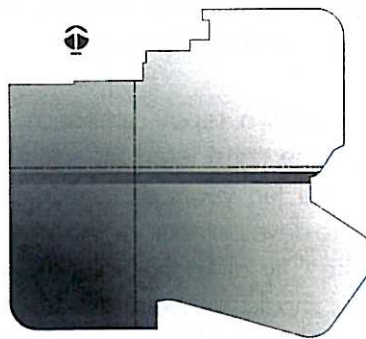
In order of extent and severity, the most significant deterioration in the facility occurs:

- East-west drive lanes on each supported floor
- South-west quadrant
- North-west quadrant
- South-east quadrant
- North-east quadrant

GRAPHICAL REPRESENTATION OF DETEIORATION. DARKER AREAS INDICATE GREATER DETEIORATION IN THE STRUCTURE

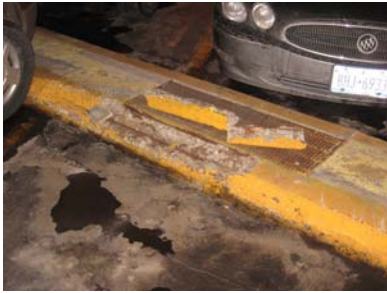
TYPICAL CURB DETERIORATION ON LEVEL C

Level C slab-on-grade has an asphalt topped concrete slab. This slab is generally in good condition. No potential trip hazards were observed. Concrete curbs are present between the rows of parked vehicles. These curbs separate parked vehicles and contain the garage exhaust systems. It appears that some sections of curbing have been replaced. Many delaminated sections of curb faces were observed throughout Level C. Delaminations of curb concrete were also noted around the perimeter of exhaust grates. Salt laded snow is brought in by vehicles and deposited onto and against the curbing resulting in concrete delaminations over time.

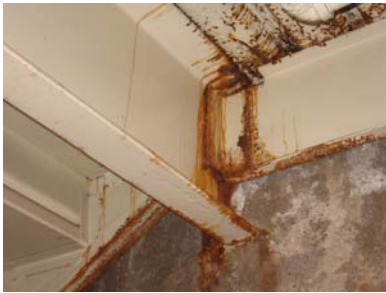
NOTE RUST ON STAIR FRAMING AND UNDER SIDE OF METAL PAN

and pan system with concrete infill for the treads. There are florescent lights over the landings and emergency lighting and sprinklers are present in each stair. The handrails are aluminum. We observed broken wall tiles, cracks in the landing concrete, and burned out lights in the West and South stairs. Rust was present on welds and metal nosings in the South stairs.

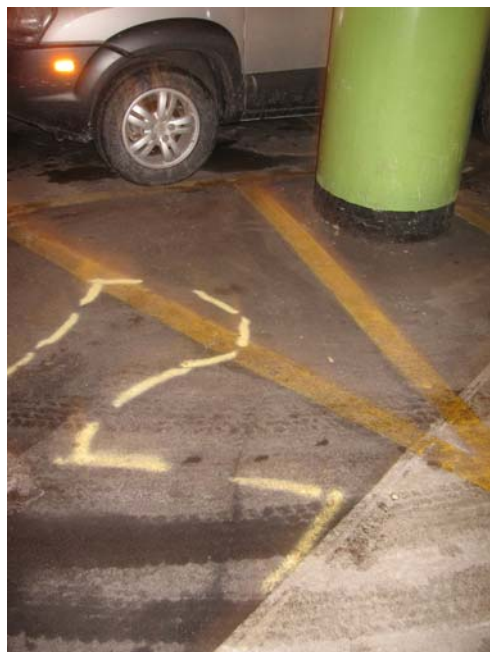
Photo 7 – Outline of Floor Delamination

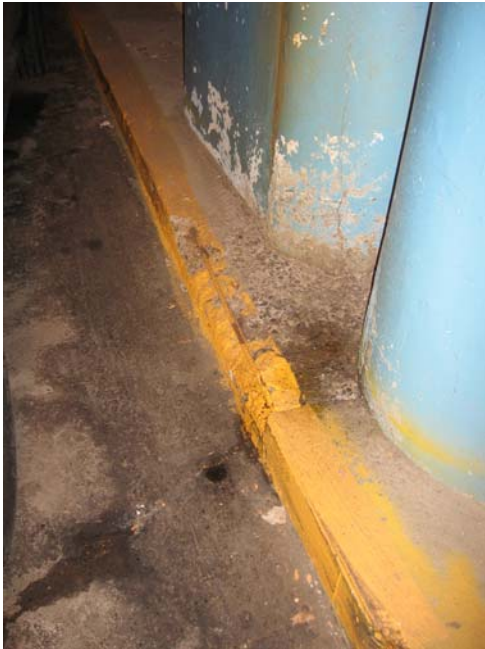
Photo 13 – Deteriorated Curb Face

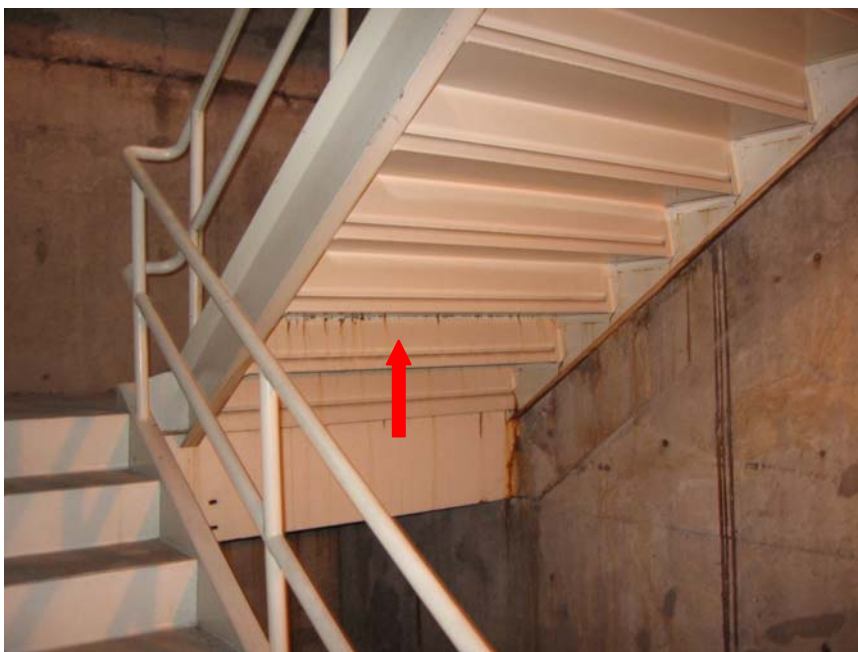
Photo 16 – Stairwell, Note Rust on Bottom of Pan.

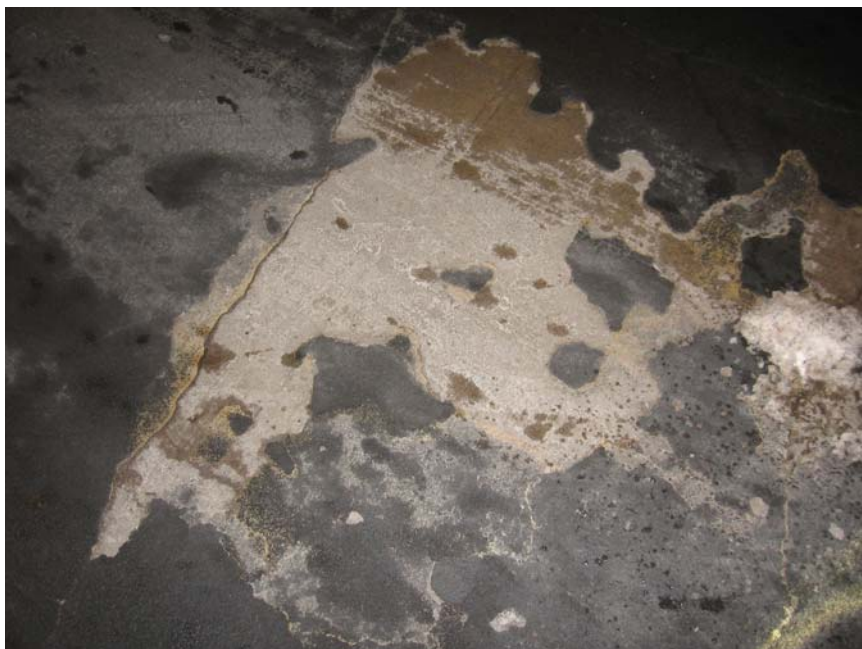
Photo 19 – Debonded / Missing Traffic Topping

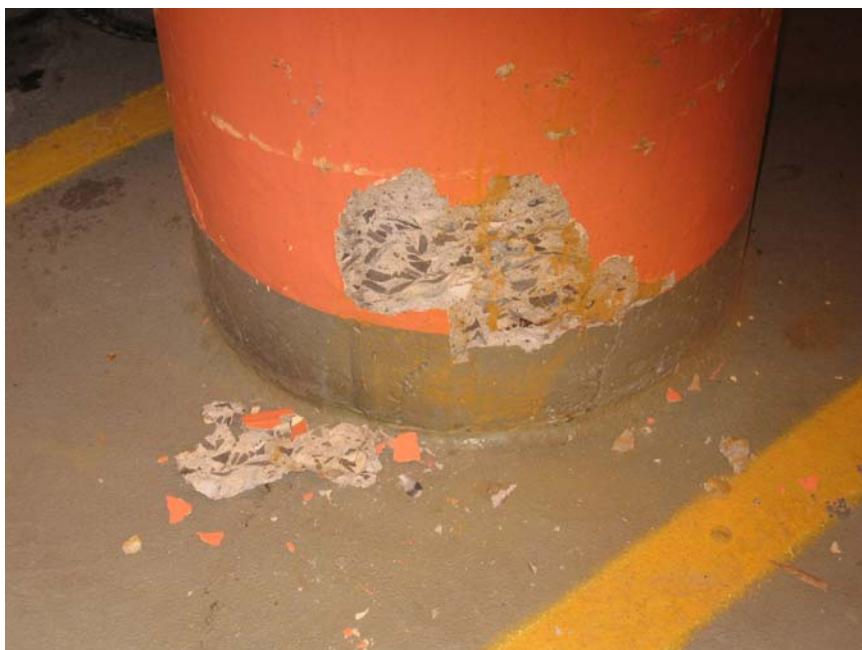
Photo 20 – Column Spall
