## Midtown Tower Asbestos Survey Report

Prepared by  
David Morse  
Industrial Hygienist

June 14, 2002

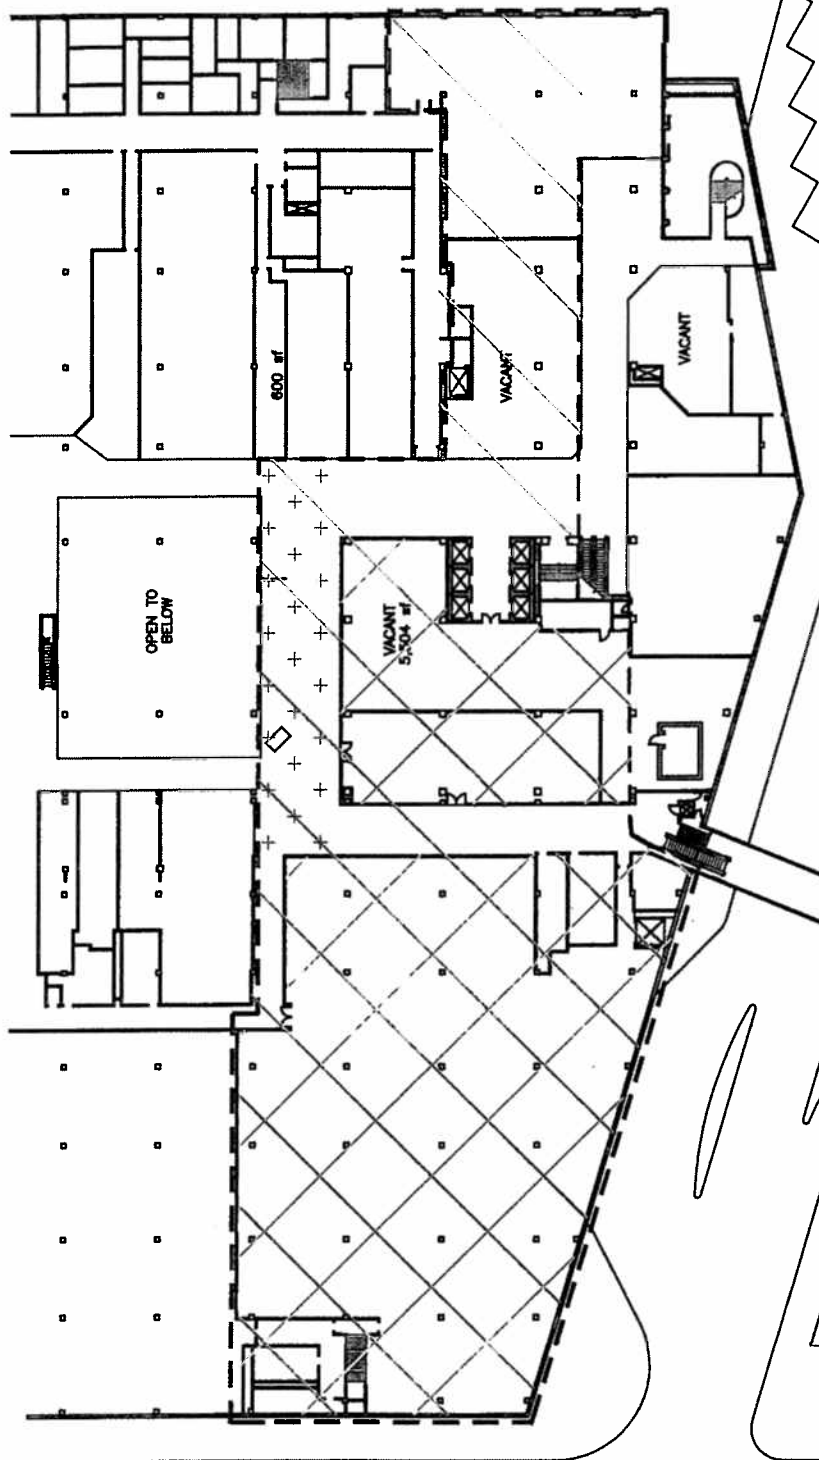
## First Floor Plan-Asbestos Survey

ASBESTOS STRUCTURAL FIREPROOFING IS APPLIED TO STEEL MEMBERS INCLUDING BEAMS AND COLUMNS WITH OVERSPRAY OF VARIOUS THICKNESSES ON THE DECK AND OTHER EXISTING SURFACES WITHIN THE CEILING.

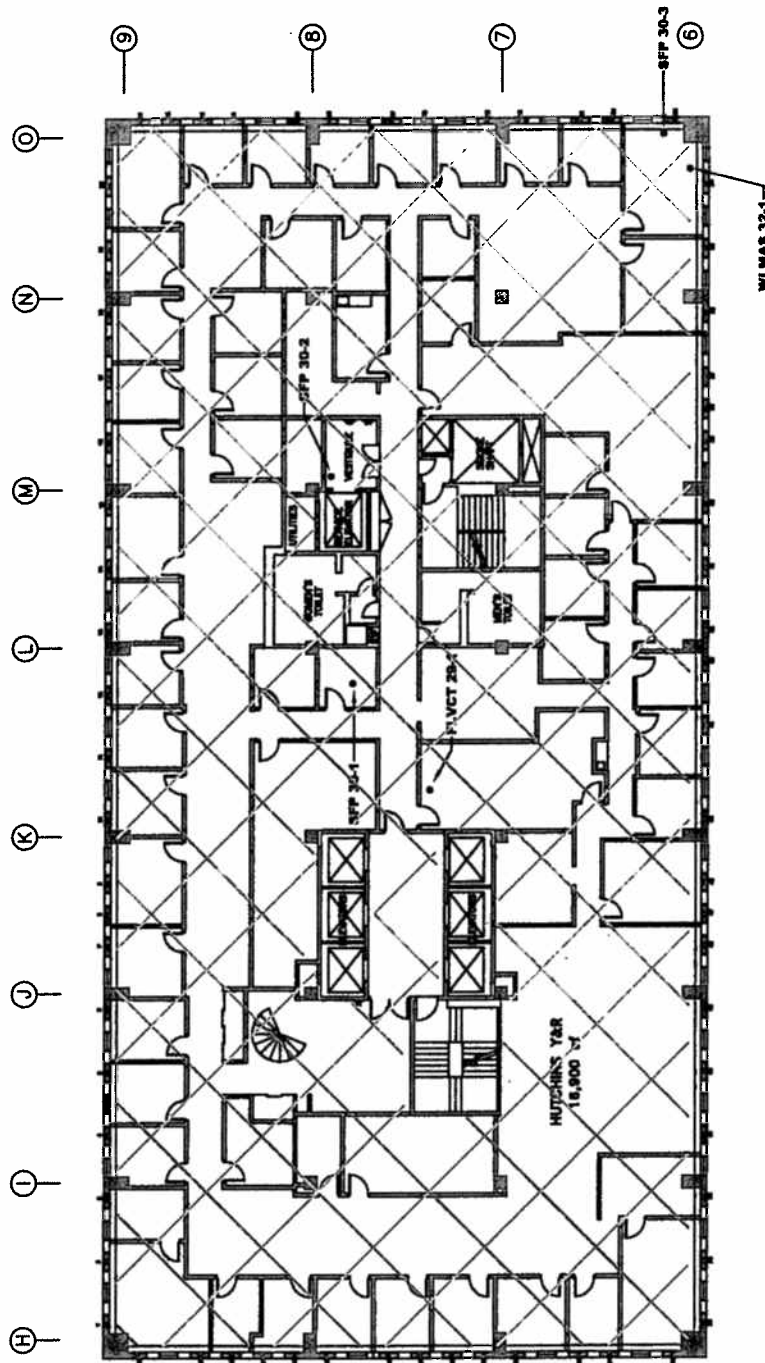
**MIDTOWN TOWER**  
Fourth Floor Plan--Asbestos Survey

NOTE:  
ASBESTOS STRUCTURAL FIREPROOFING IS APPLIED TO STEEL MEMBERS INCLUDING BEAMS AND COLUMNS WITH CONCRETE OR Gypsum PACKAGES ON THE DECK AND OTHER EXISTING SURFACES WITHIN THE CEILING.

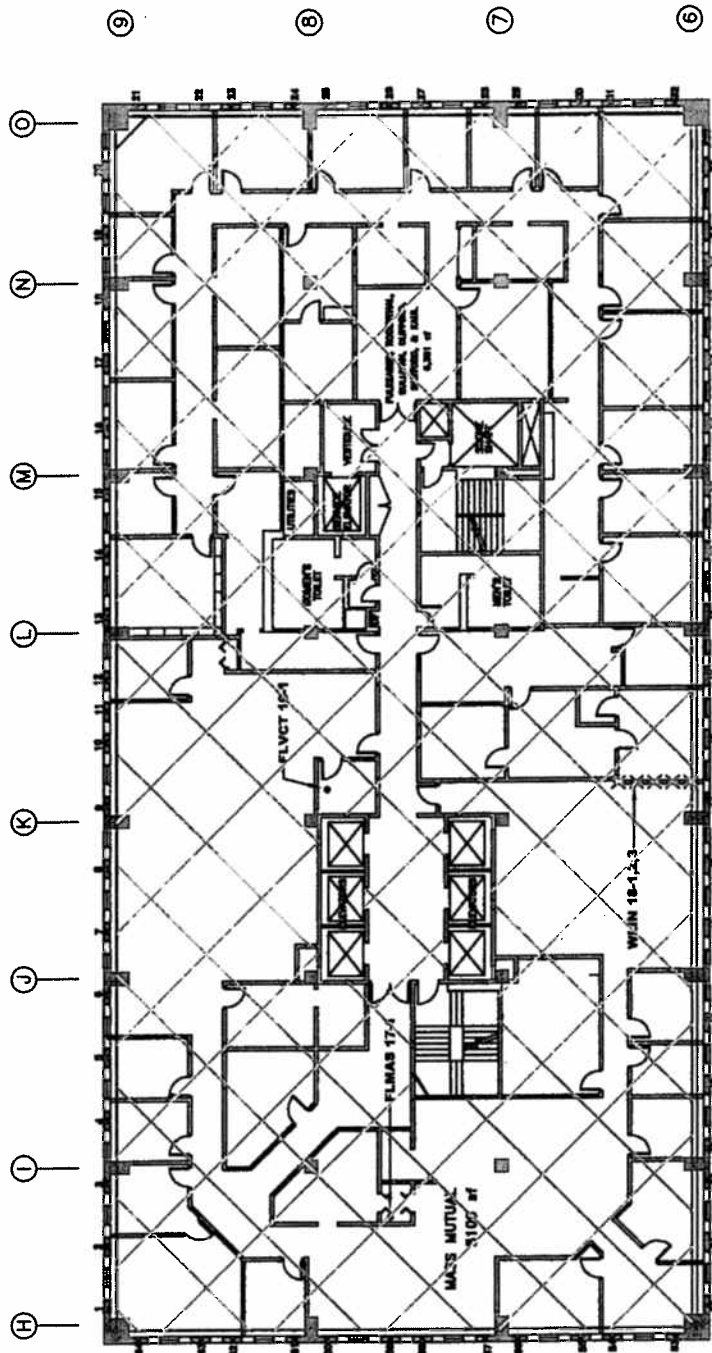
**MIDTOWN TOWER**  
 Thirteenth Floor Plan - Asbestos Survey

NOTE:  
 ASBESTOS STRUCTURAL FIREPROOFING IS APPLIED TO STEEL MEMBERS INCLUDING BEAMS AND COLUMNS WITH OVERSPRAY OF VARIOUS THICKNESSES ON THE DECK AND OTHER EXISTING SURFACES WITHIN THE CEILING.

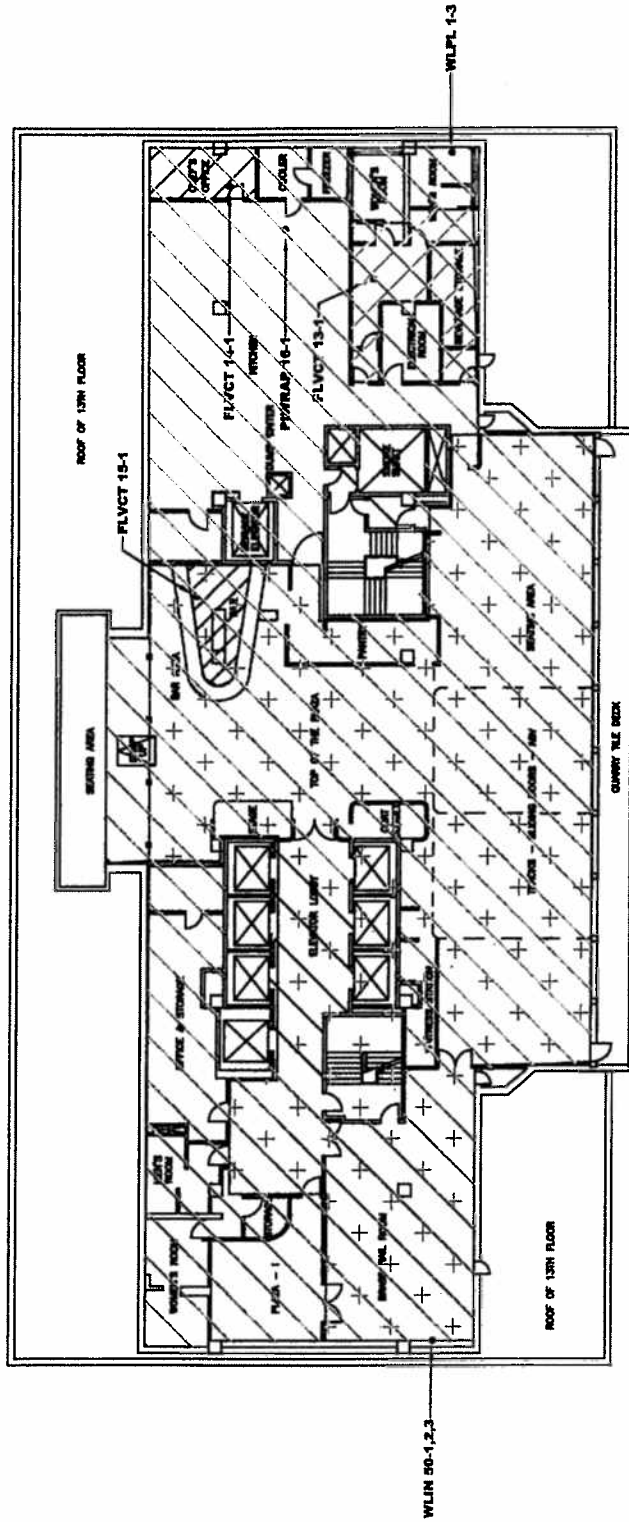
NOTE: ALL ROOF LEVELS ARE PRESUMED TO CONTAIN ASBESTOS. SAMPLING OF ROOFING MATERIALS WAS NOT PERFORMED PER CONTRACT.

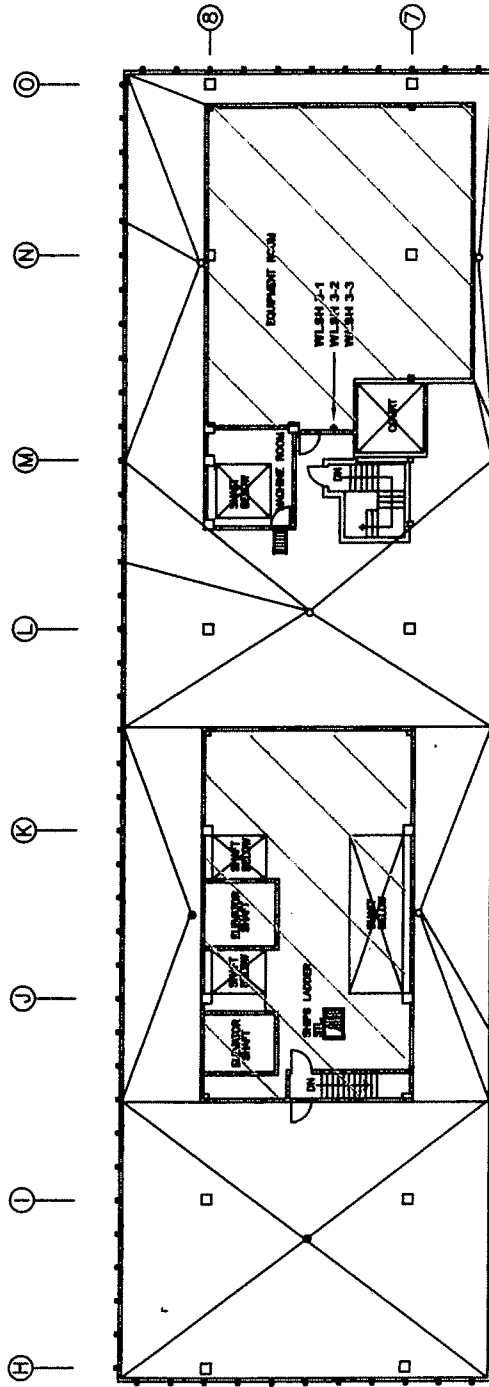
NOTE: ALL ROOF LEVELS ARE PRESUMED TO CONTAIN ASBESTOS. SAMPLING OF ROOFING MATERIALS WAS NOT PERFORMED PER CONTRACT.

ASBESTOS STRUCTURAL FIREPROOFING IS APPLIED TO STEEL MEMBERS INCLUDING BEAMS AND COLUMNS WITH OVERSPRAY OF VARIOUS THICKNESSES ON THE DECK AND OTHER EXISTING SURFACES.
