275 ST. PAUL STREET **PRELIMINARY STRUCTURAL ASSESSMENT**

GARDEN AERIAL
MONROE COUNTY, NEW YORK

JUNE 2014

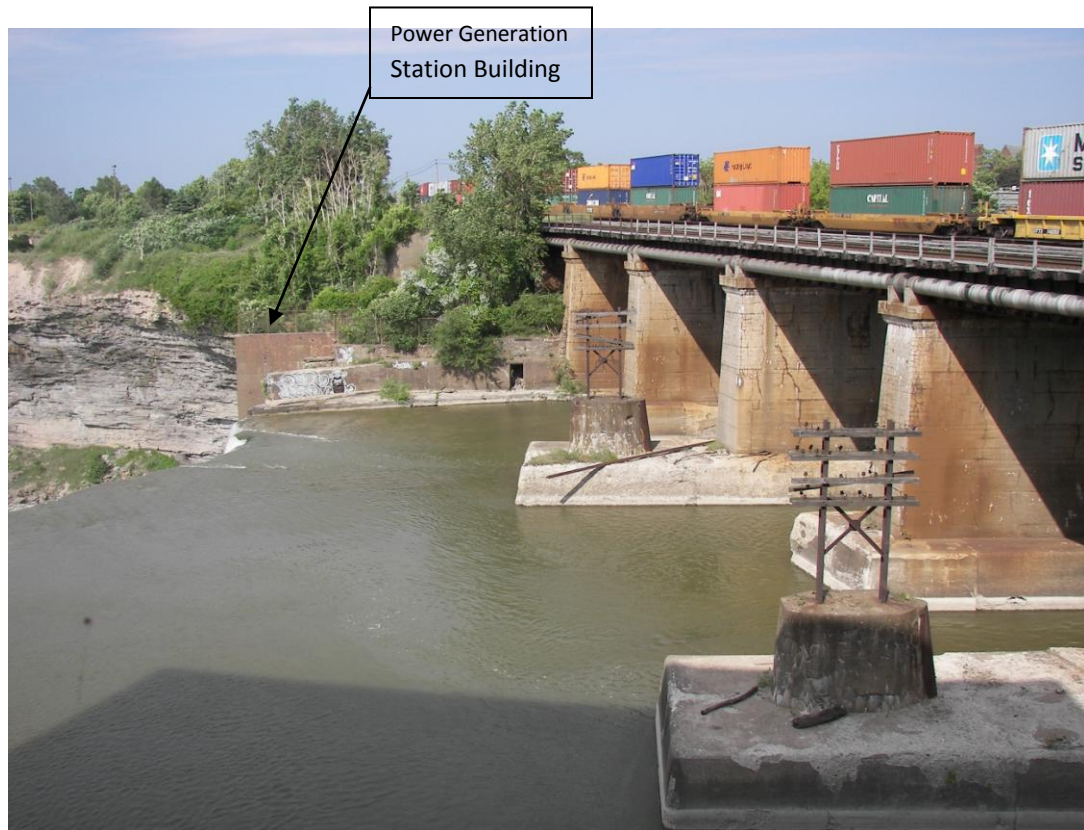
Larsen engineers structures team visited the site and determined that the existing structure is in poor to very poor condition. A multitude of cracks were observed in the brick masonry, steel beams were corroded, wood beams and floor joists are deteriorated or absent, and various anchors in the bedrock appear to have been compromised. Also, the roof slab has collapsed in many areas. The structural team and local geotechnical experts inspected the building conditions and determined that it is not structurally sound. Building material samples would be expensive to collect for structural assessment. It is essential to focus on restoring the existing structure and constructing a structural support system to prevent further deterioration and allow proper investigations to continue. This will provide a base level of structural integrity that will allow the required or future investigations and modifications. The photograph below shows the pylons and the power generation structure at the western end of the bridge.

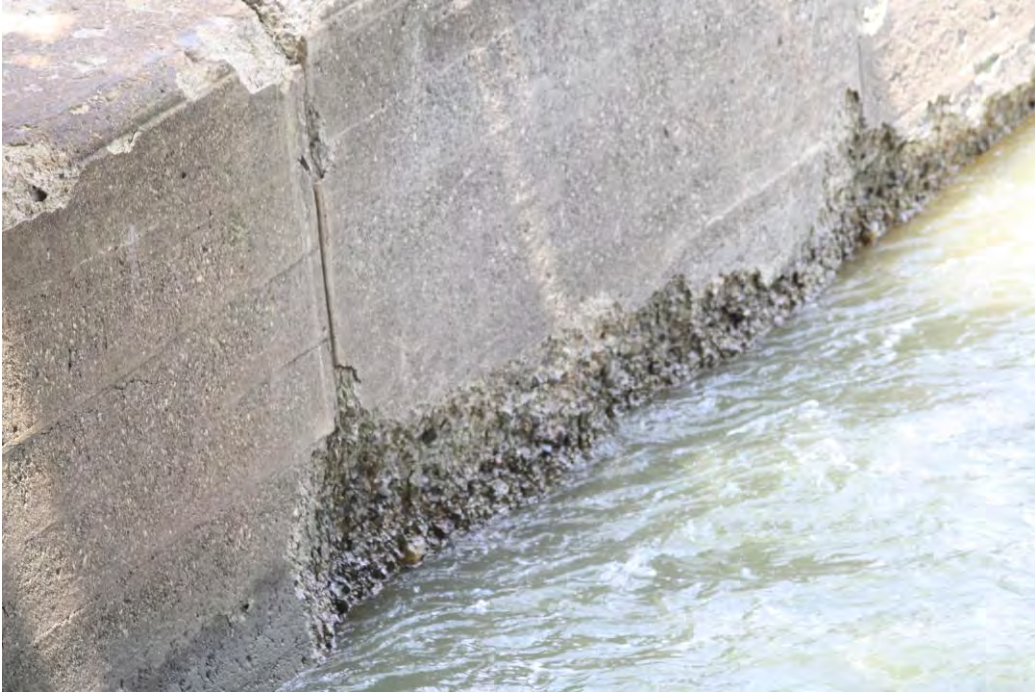
PYLON BASE CONDITIONS AT WATER LEVEL

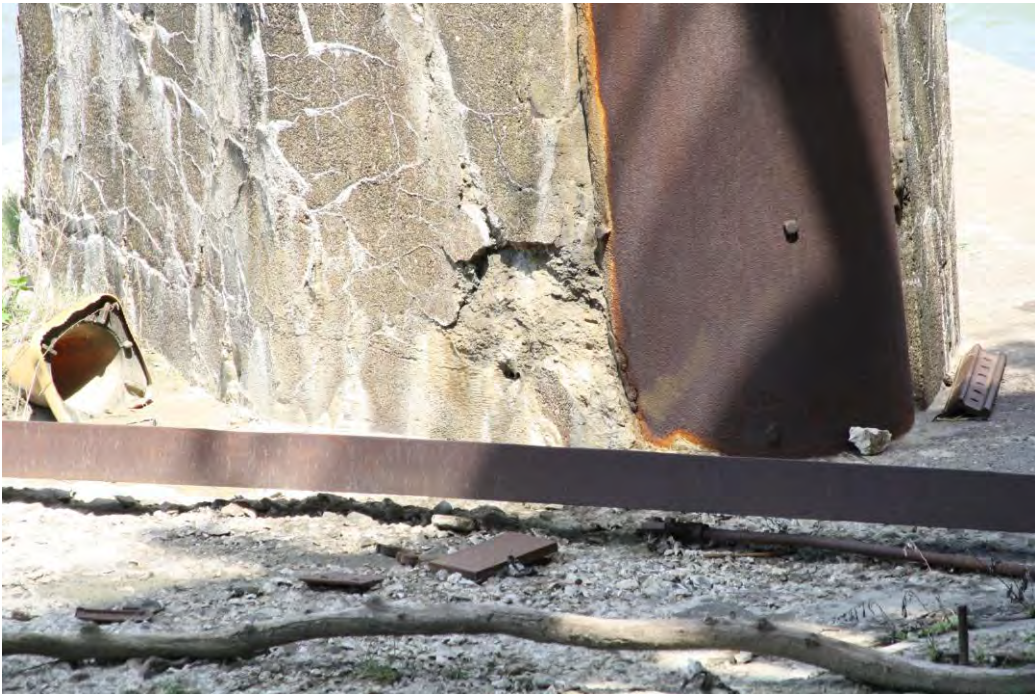
PYLON BASE LEVEL CONDITIONS

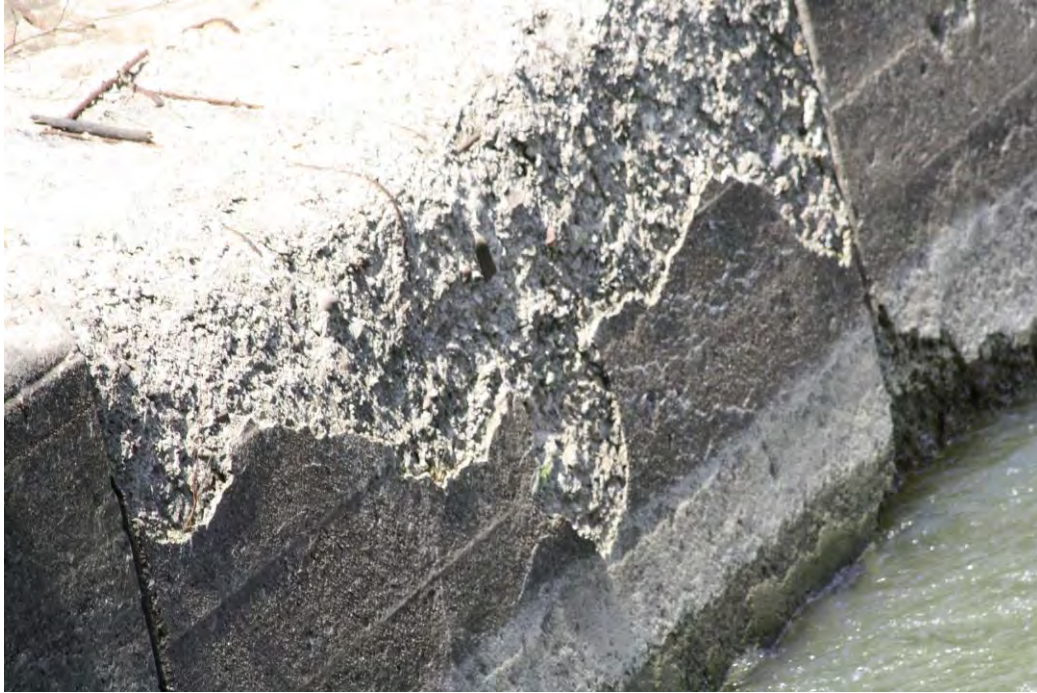
PYLON FOUNDATION CONDITIONS AT WATER LEVEL

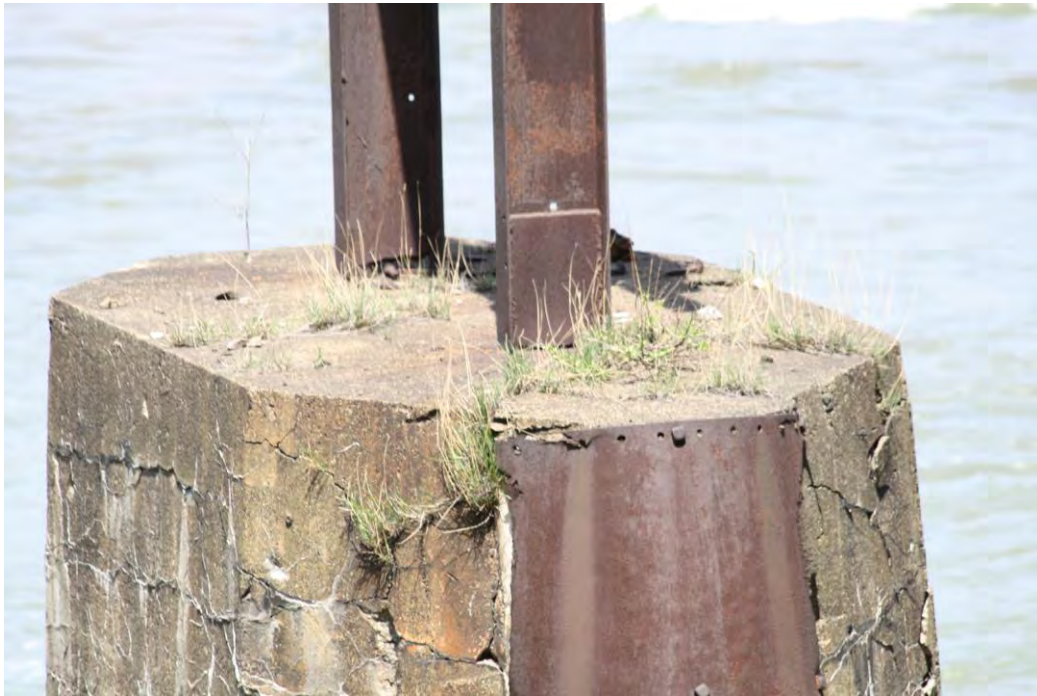
UPPER SECTION OF PYLON 2 SHOWN ABOVE

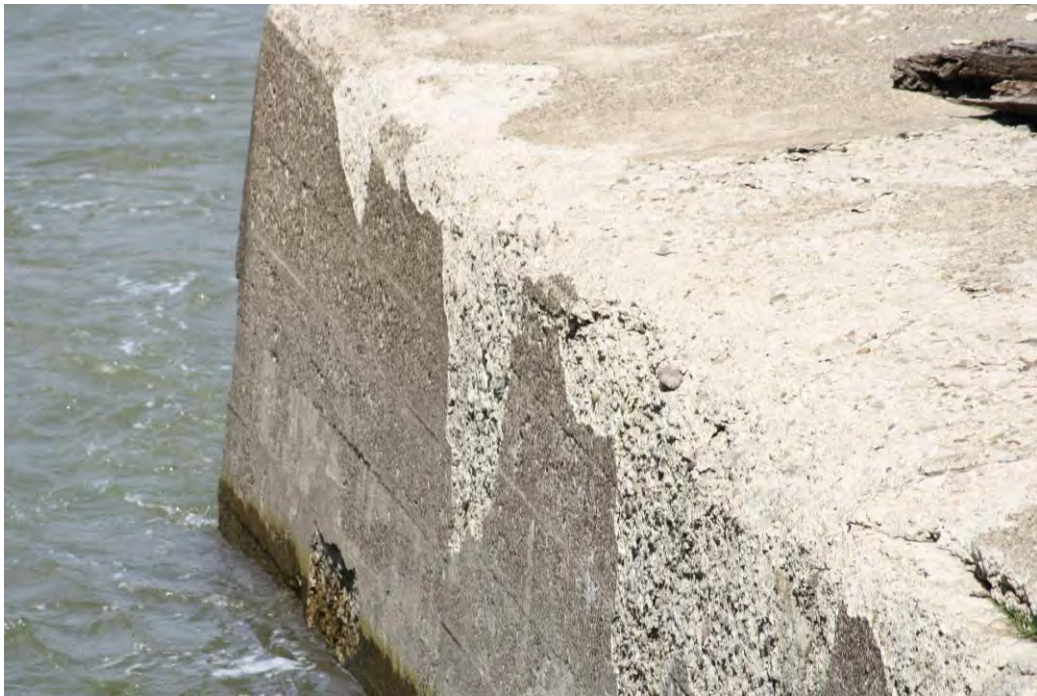
PYLON FOUNDATION AT WATER LEVEL

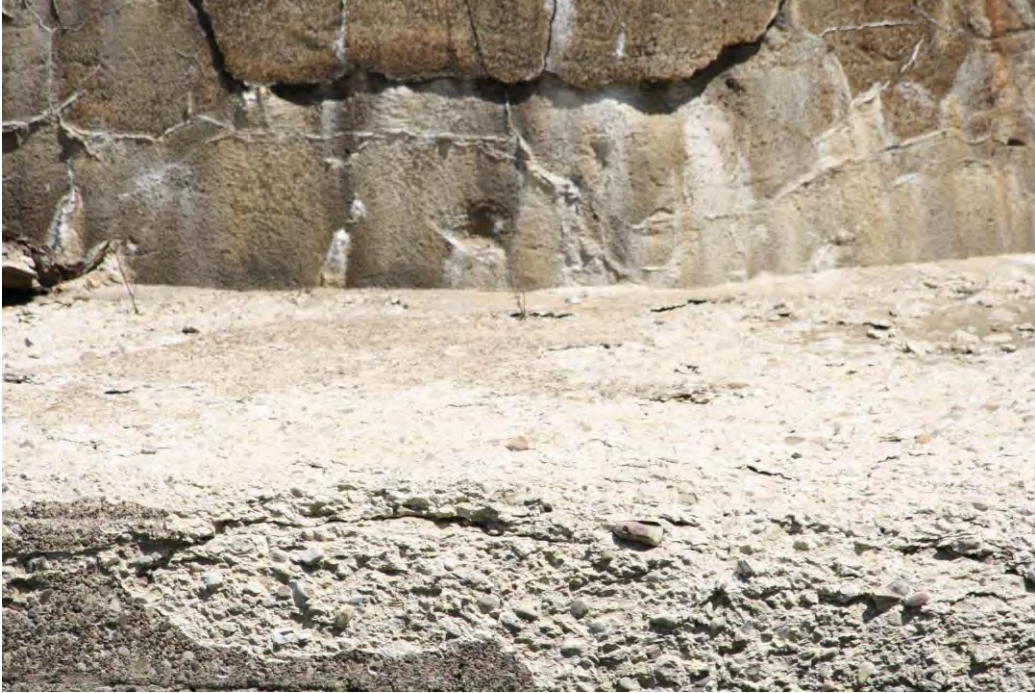
PYLON FOUNDATION STRUCTURAL CONDITIONS

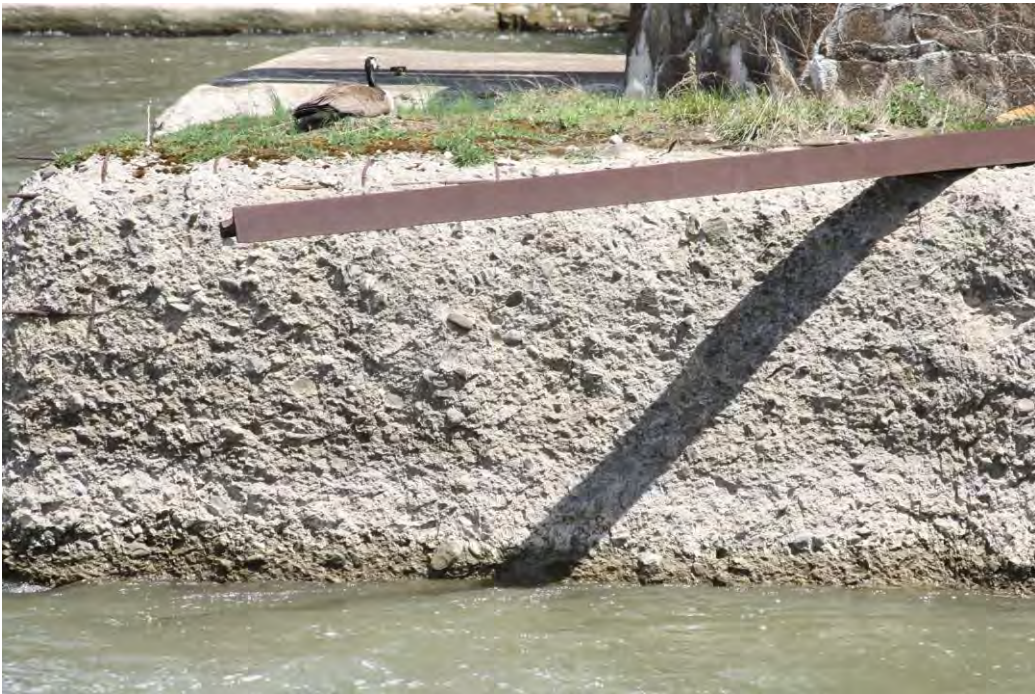
PYLON FOUNDATION STRUCTURAL CONDITIONS

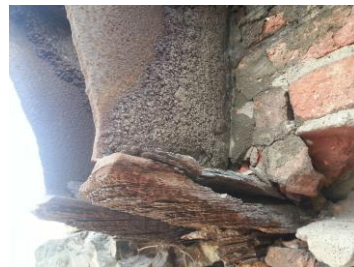
- Steel beams/columns are corroded
