Rundel Library Exterior Façade Observation

APRIL 2019

LBA PROJECT NO. 2191056

RE: Rundel Library Exterior Façade Observation
115 South Avenue, Rochester NY
LaBella Project No. 2191025

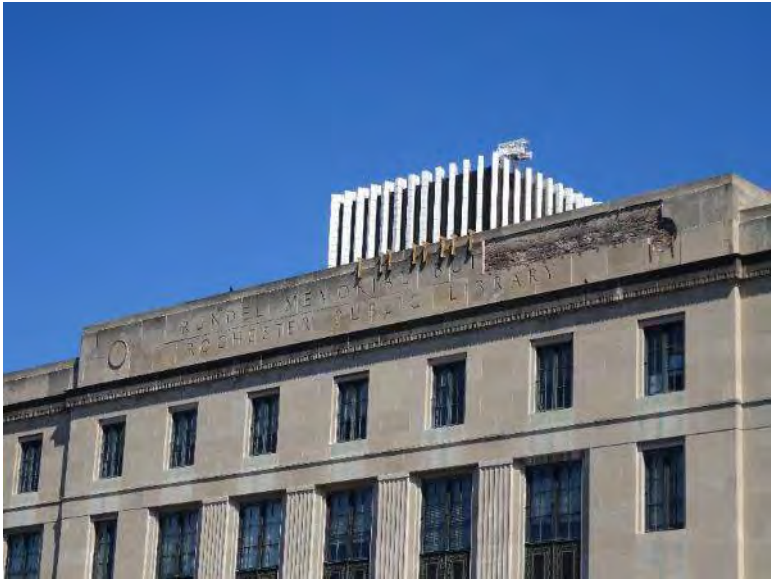
- Six individual panels over a length of approximately 25 feet detached. [Photo 1]
- Steel hook anchors are exposed at the top of the area the façade has detached. [Photo 2]
- After immediate investigation by LaBella, 4 adjacent stone façade panels were determined to be separating from the building and subsequently braced with steel brackets installed over the parapet. [Photos 3, 4]
- Thru-bolt anchors were installed to restrain the lower stone panels from separating. [Photo 5]

Photo	Description	Photos
1	<p>West parapet where 6 stone panels have detached and fallen</p> <p>Emergency repair brackets on adjacent separating panels</p>

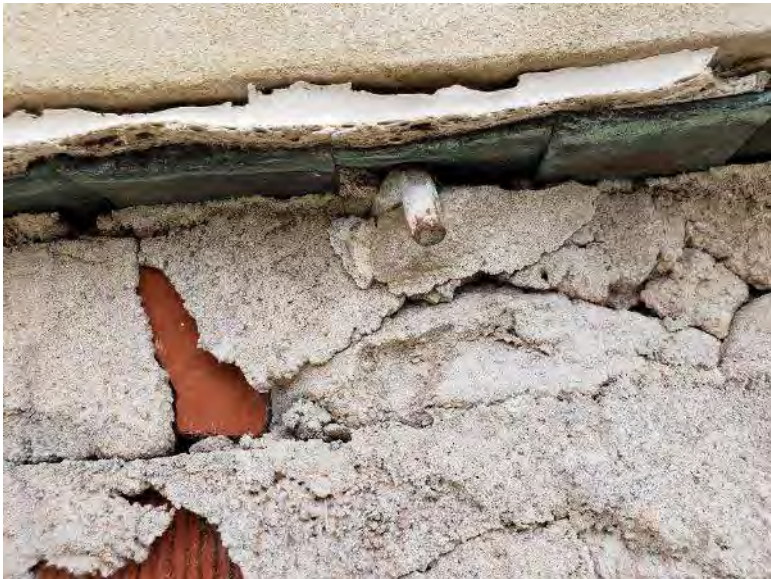
2	<p>Steel hook anchor visible where stone façade has fallen from</p> <p>Copper flashing visible below parapet cap</p>

While a steel anchor was visible at the location where stone panels detached and fell, no details are available on the existing drawings provided to LaBella [Figure A] and no other anchorage was visible during inspection. Permanent anchorage for the loose panels, as well as for the replacement of panels that have fallen, should be designed by a structural engineer. These panels, as well as the full perimeter of the parapet should be regularly monitored for additional movement by a structural engineer until fully repaired.

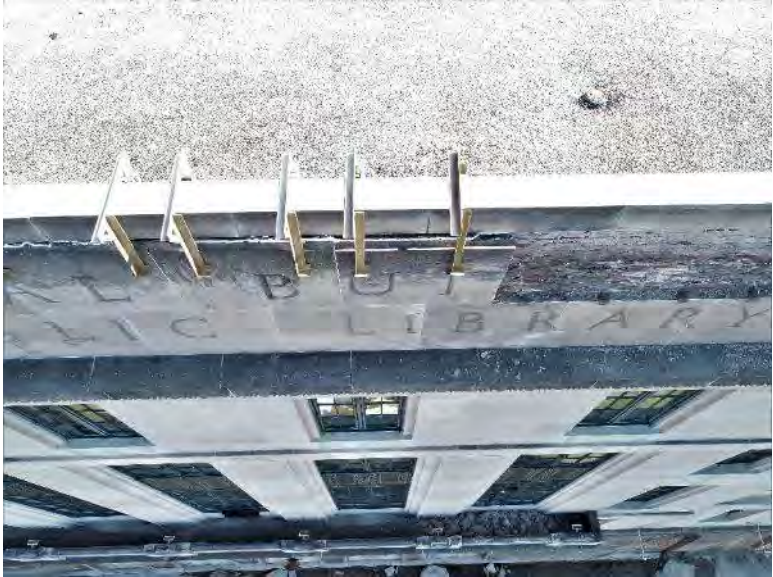
<p>3</p>	<p>Steel brackets installed over parapet to restrain separating panels</p> <p>Remains of fallen stone panels visible on balcony below</p>

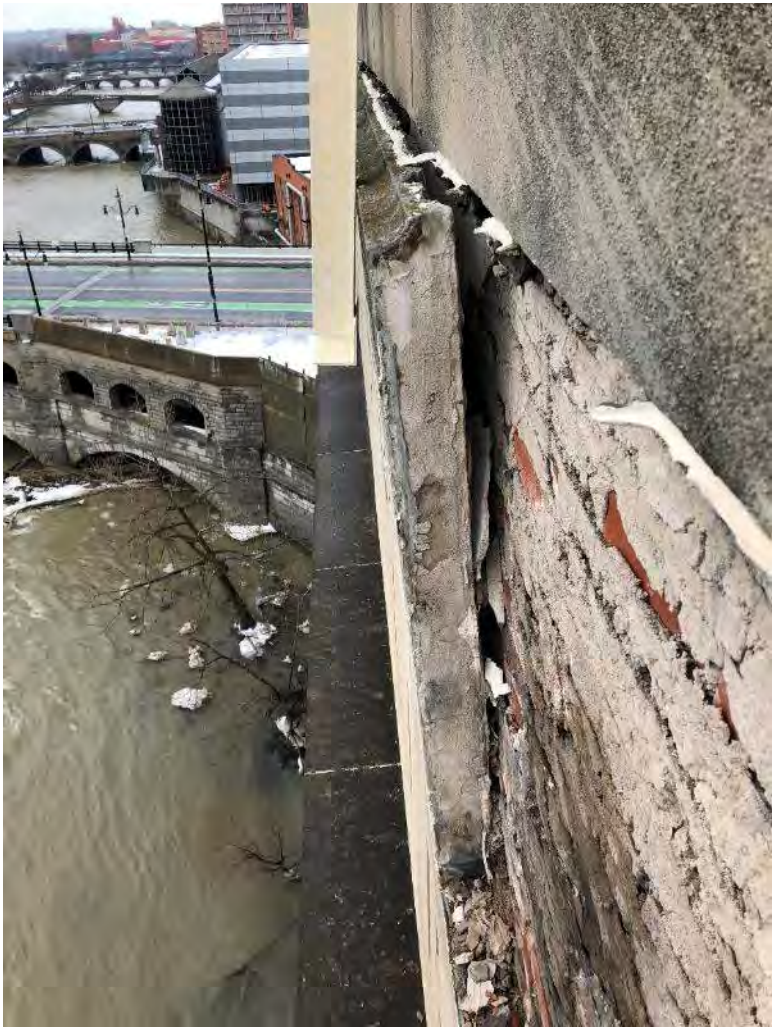
<p>4</p>	<p>Stone panel separation from side (photo taken with camera over top of parapet)</p>

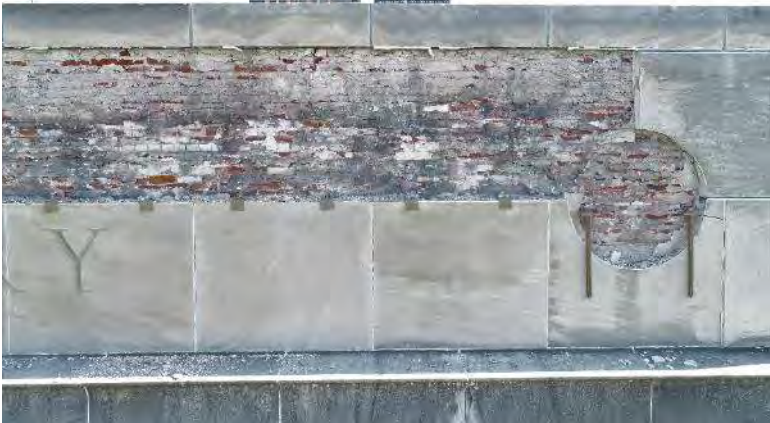
5	Thru-bolted anchors restraining lower stone panels

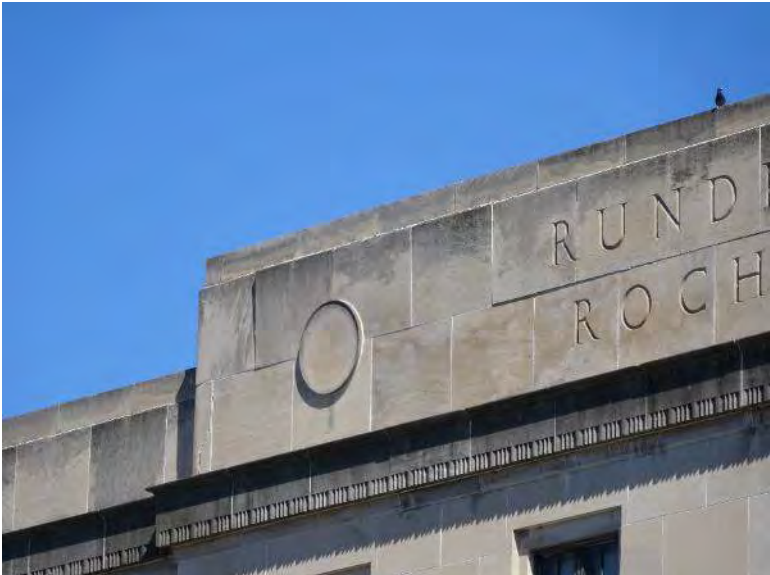
The west face of the building has a high parapet at its center and two lower parapets at its north and south ends. While some cracking and separation of the parapets' stone façade panels is visible from the ground level, drone imagery was able to provide closer and more useful perspectives. Select stone façade panels on the west (rear) face and the east (front) face are out-of-plane at the parapet level. Cracks and deteriorated caulk appear throughout the full perimeter. [Photos 6, 7]

6	Out-of-plane stone panel on west face of parapet (photo taken from ground)

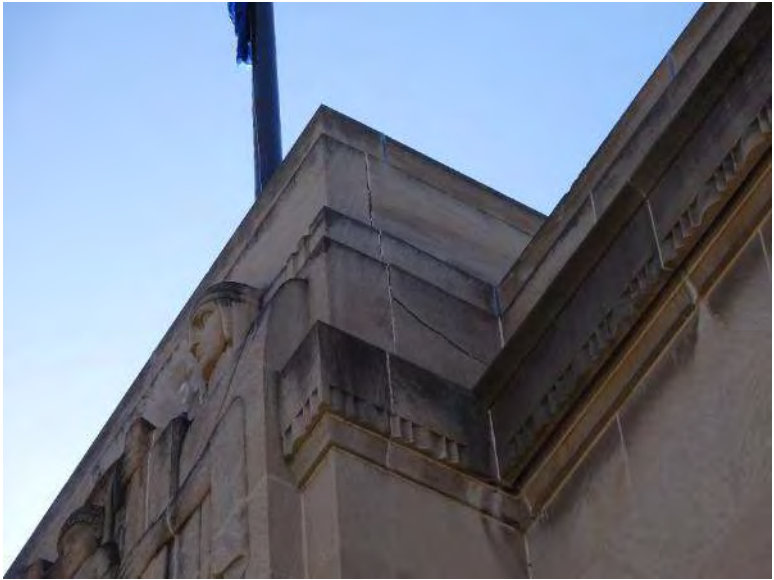
7	<p>Cracking and deteriorating caulk visible on the north side of the right bump-out at the front of the building</p> <p>(photo taken from ground)</p>

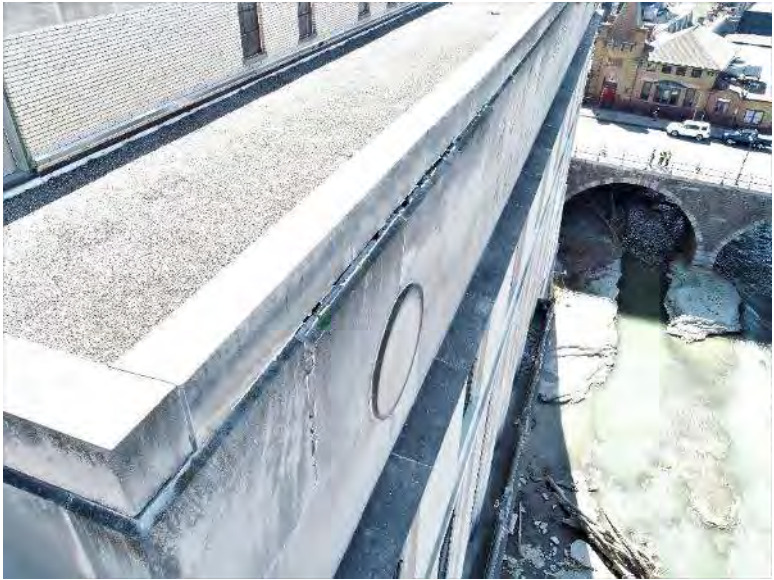
- Three un-braced stone panels on the left (north) side of the west raised parapet have separated from the brick along their top edge. [Photos 8, 9]
 - These panels were immediately brought to the attention of the city and have been braced. [Photo 10]
- Cracks through the stone panels and stone eave at the northern corner of the west raised parapet have previously been sealed with caulk. The crack through the stone façade panel has widened since the caulk was installed. [Photos 11, 12, 13, 14]
- The lower stone façade panel at the south corner of the west raised parapet is cracked [Photos 15, 16]
- Caulking in joints between stone façade panels has gaps and signs of deterioration along the entire length of the parapet. [Photos 15, 17, 18, 19, 20, 21]

A close-up photograph of a stone building corner. The image shows a light-colored stone facade with a prominent vertical crack running down the corner. The caulk at the top of the crack is dark and appears to be deteriorating or missing. The sky is visible in the background.
8	<p>3 stone façade panels separating from west parapet</p>

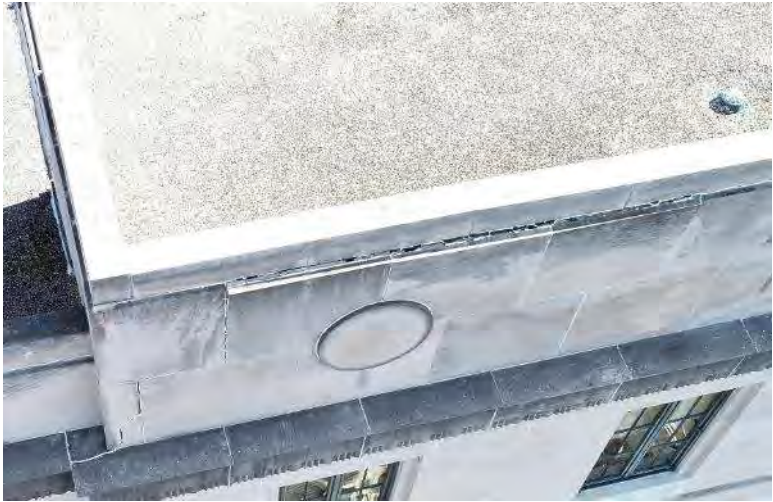
9	3 stone façade panels separating from west parapet

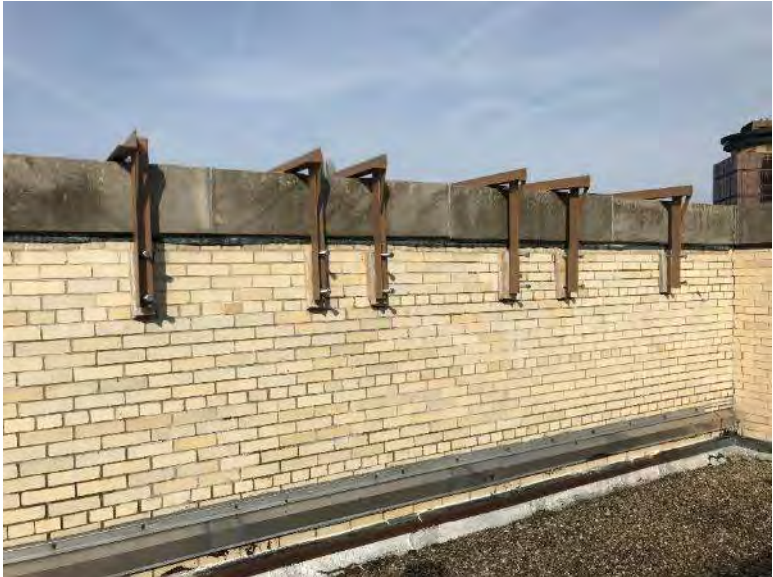
10	Braces installed at 3 stone panels after LaBella's inspection

Three stone façade panels on the west parapet and two on the east parapet were areas of immediate concern, and were brought to the attention of the City directly after completing the visual inspection. These panels have all since been braced with the addition of steel brackets, similar to those previously installed on the panels adjacent to those that fell in February.

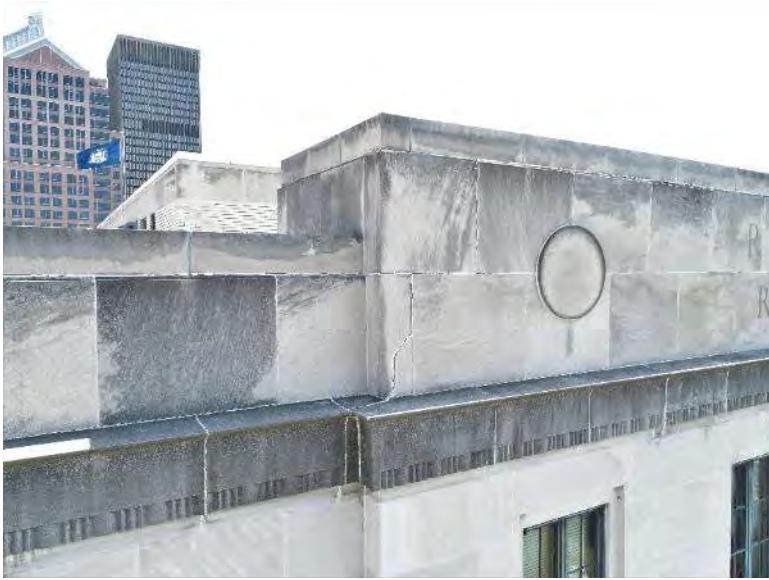
- Separation is visible on exterior side of parapet corner. A gap exists between stone façade panels at the return. [Photo 33]
 - This gap is at the same location as the cracked stone façade panels and eave at the northern corner. [Photos 11, 12, 13, 14]

11	<p>Cracking in stone façade panel and stone eave at northern corner of west raised parapet</p>

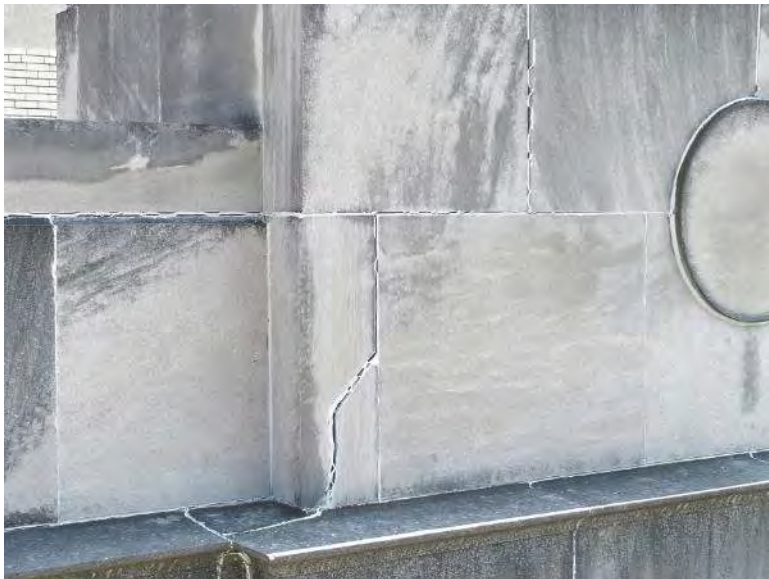
<p>A photograph showing the northern corner of a west raised parapet. The stone facade panel and the stone eave below it exhibit visible cracking. A circular vent is visible on the right side of the parapet. In the background, other city buildings are visible under a clear sky.</p>
12	<p>Cracking in stone façade panel and stone eave at northern corner of west raised parapet</p> <p>Caulk separation and large gap show the crack through the stone façade panel has gotten wider since being sealed</p>

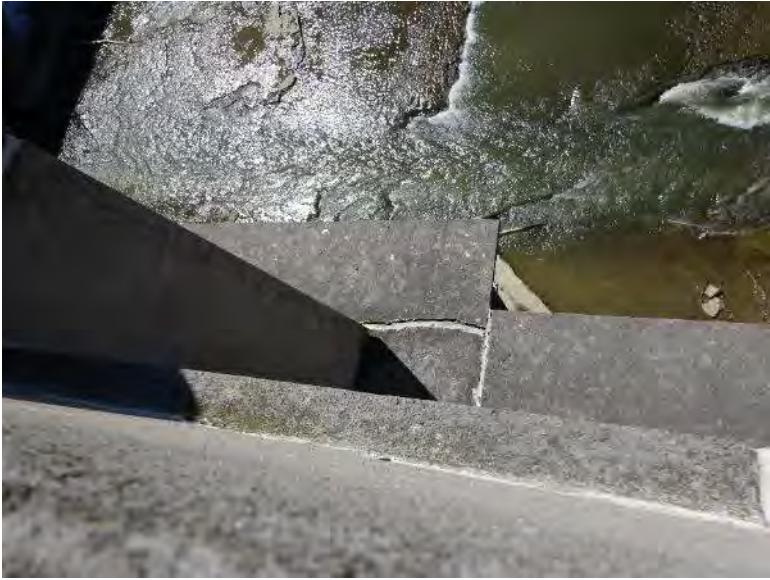
13	<p>Previously caulked stone eave crack at northern corner of raised west parapet</p> <p>Separation between caulk and stone shows crack has gotten wider, or caulk has deteriorated</p> <p>(Photo taken from roof)</p>

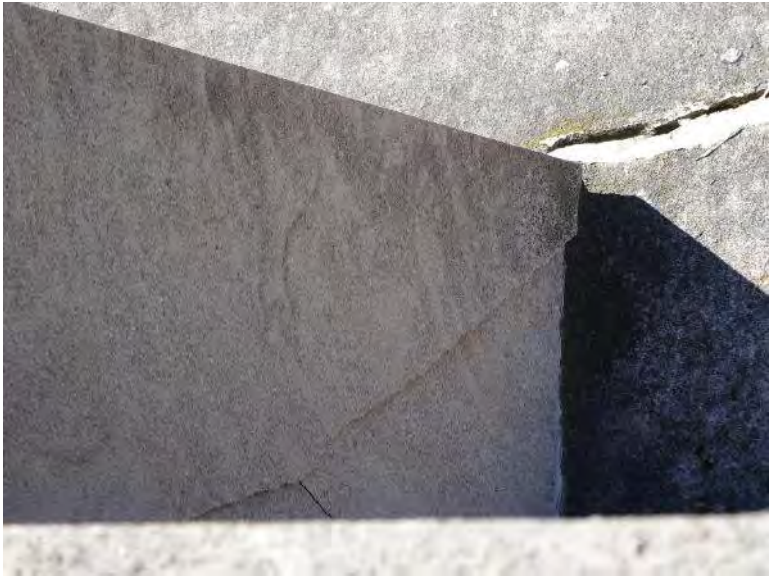
14	<p>Stone façade corner panel at northern corner of raised west parapet is cracked and shifted out-of-plane</p> <p>(Photo taken from roof)</p>

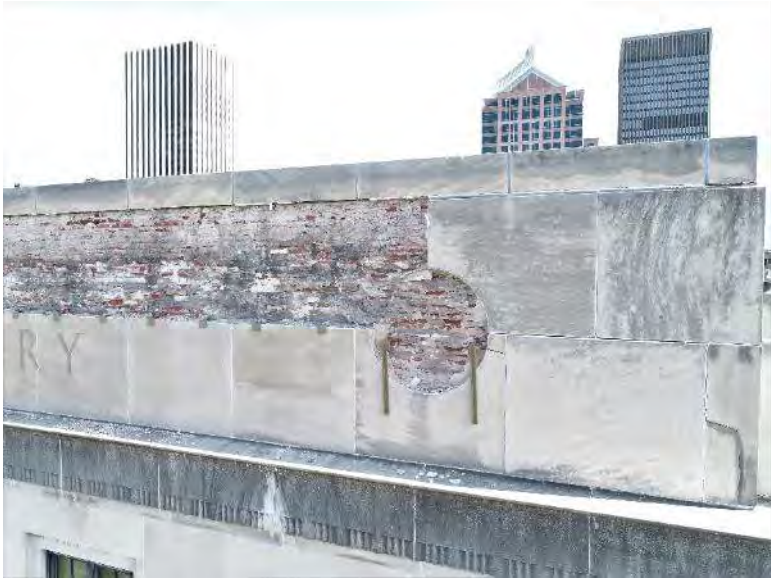
<p>15</p>	<p>Lower stone façade panel at south corner of west parapet is cracked</p> <p>Caulk gaps and deterioration are visible throughout joints in stone panels</p>

Water intrusion is the likely cause of the stone façade panel movement observed. Freezing water forces the panels away from the building and water can corrode the anchors holding those panels in place. Existing caulk should be removed from all joints around the perimeter of the parapet and replaced with new sealant. All cracked stone panels, both with existing sealant and without, should be injected with an epoxy sealant through the full length of the crack.

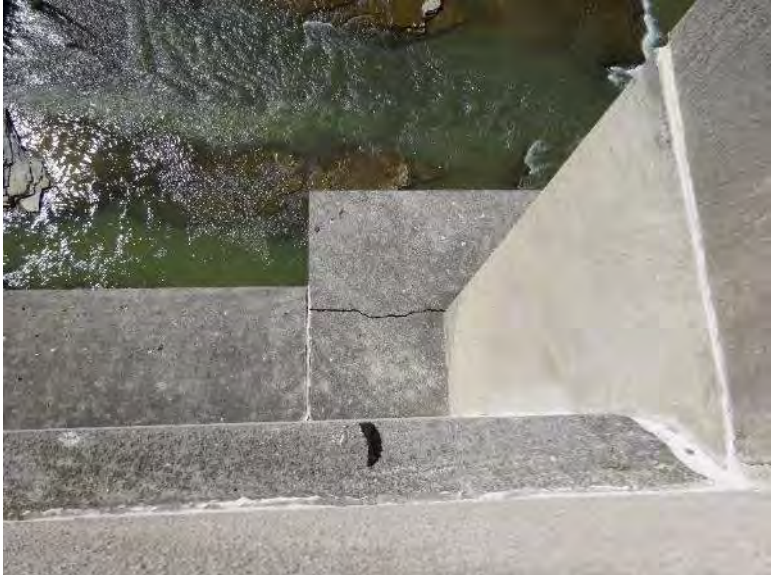
<p>16</p>	<p>Stone eave at southern corner of raised west parapet is cracked</p> <p>(Photo taken from Roof)</p>

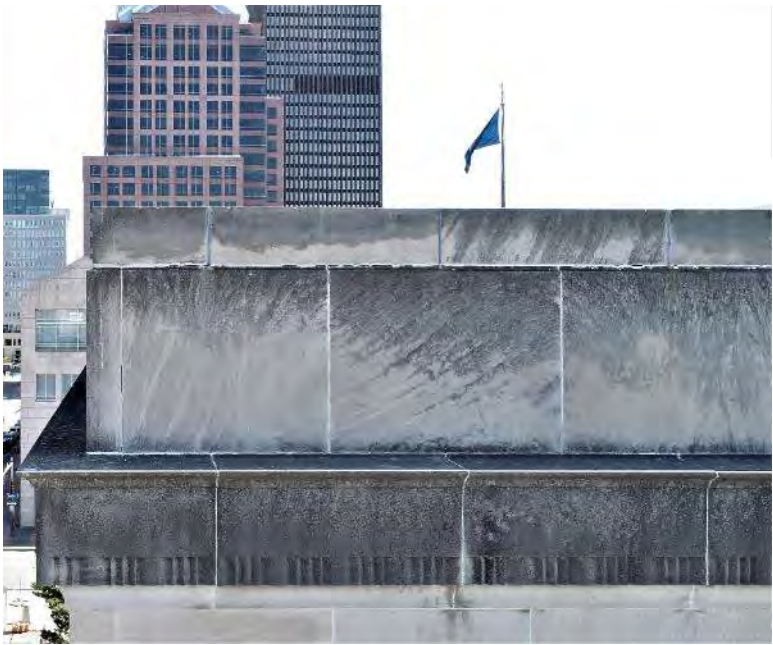
17	Caulk gaps and deterioration are visible throughout joints in stone panels

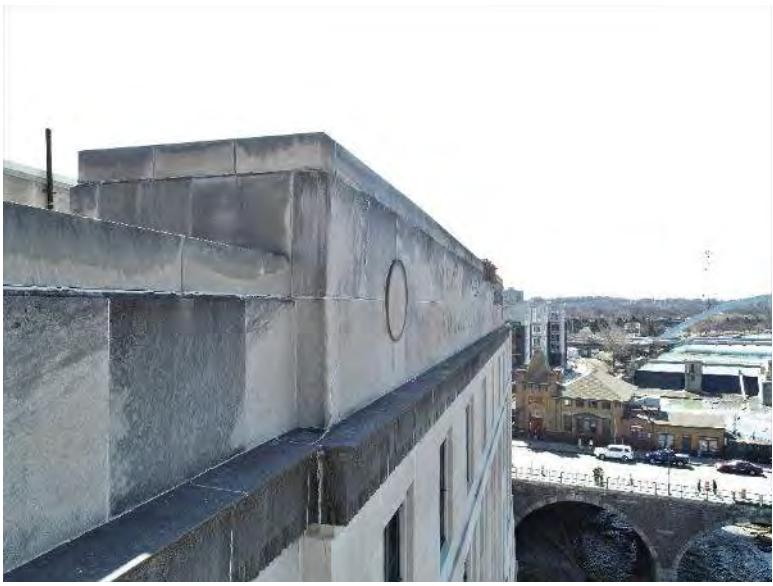
18	Caulk gaps and deterioration are visible throughout joints in stone panels

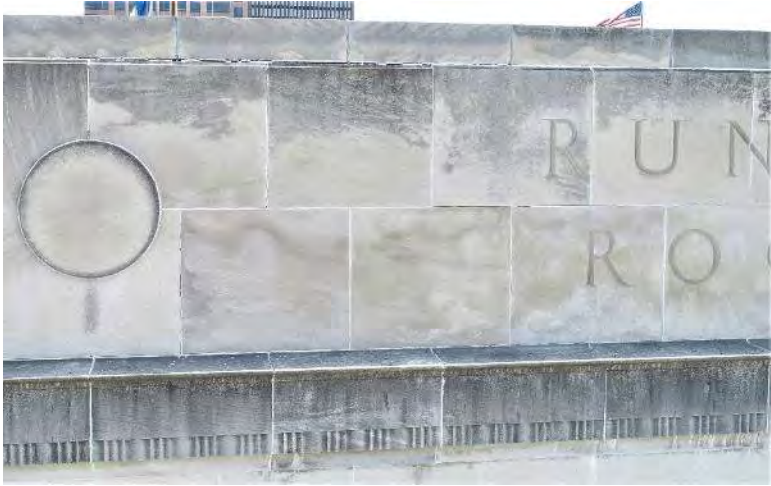
19	Caulk gaps and deterioration are visible throughout joints in stone panels

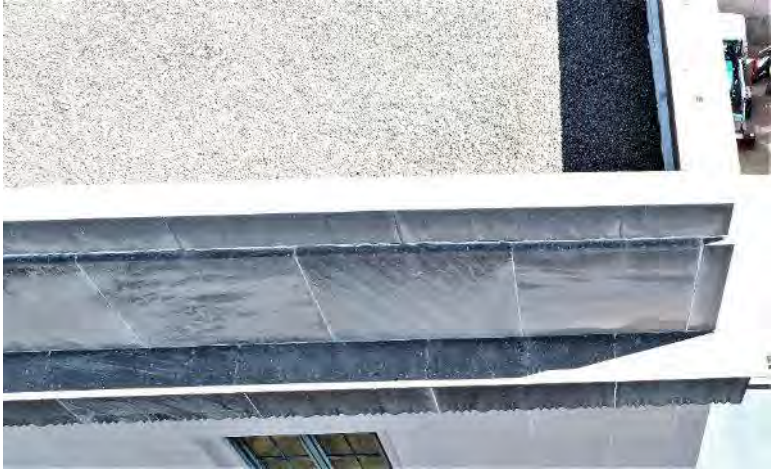
20	Caulk gaps and deterioration are visible throughout joints in stone panels

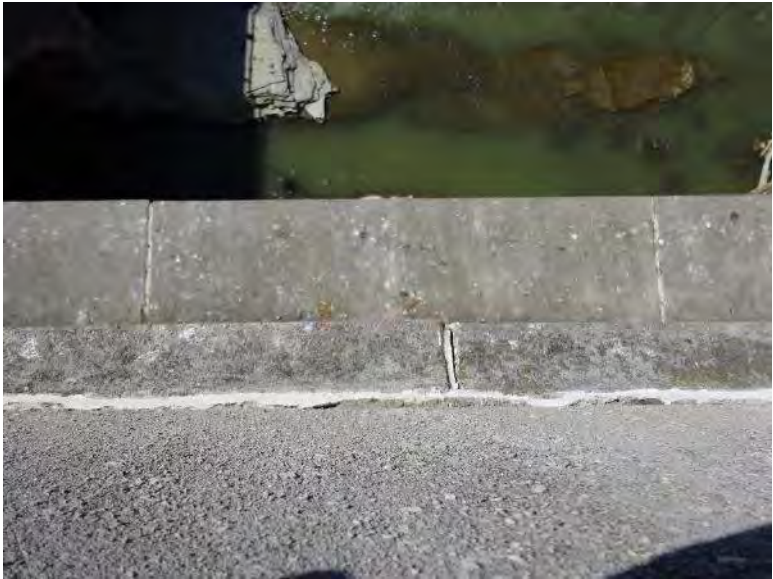
21	<p>Caulk gaps and deterioration are visible throughout joints in stone panels</p> <p>(Photo taken from roof)</p>

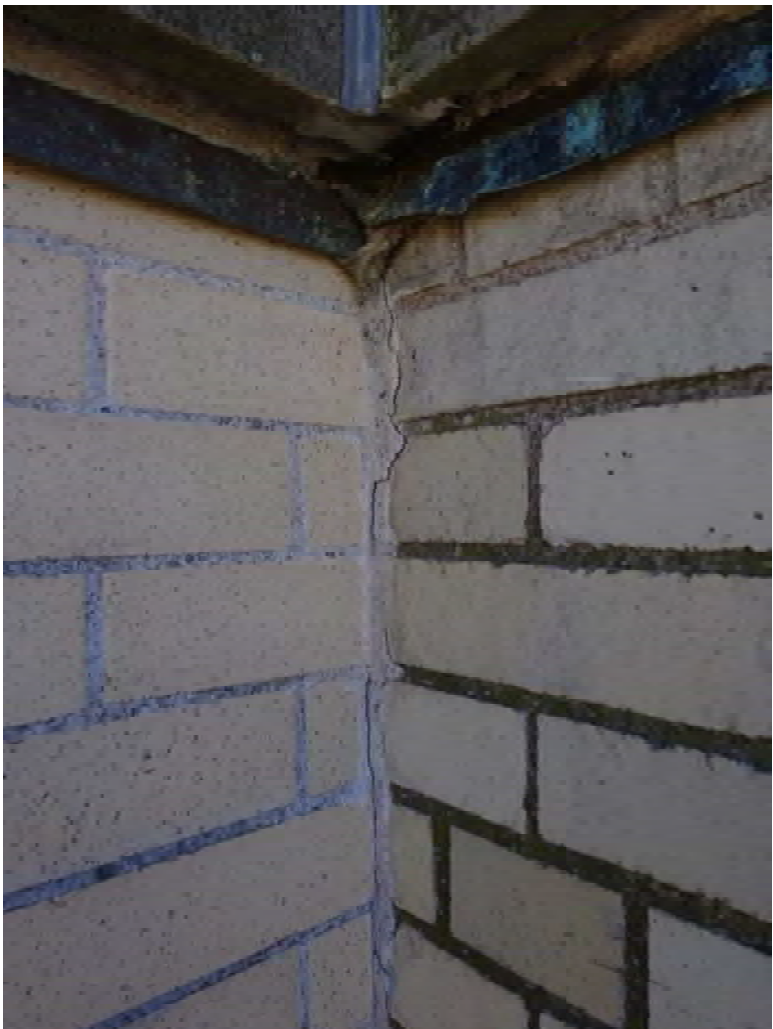
- A small crack exists through the mortar at the south corner of the parapet at its return, for its full height. [Photos 22, 23]
- Horizontal cracks exist through mortar joints along the length of the raised west parapet. [Photos 24, 25]

22	<p>Crack through mortar down height of south corner of west raised parapet</p> <p>(Photo taken from roof)</p>

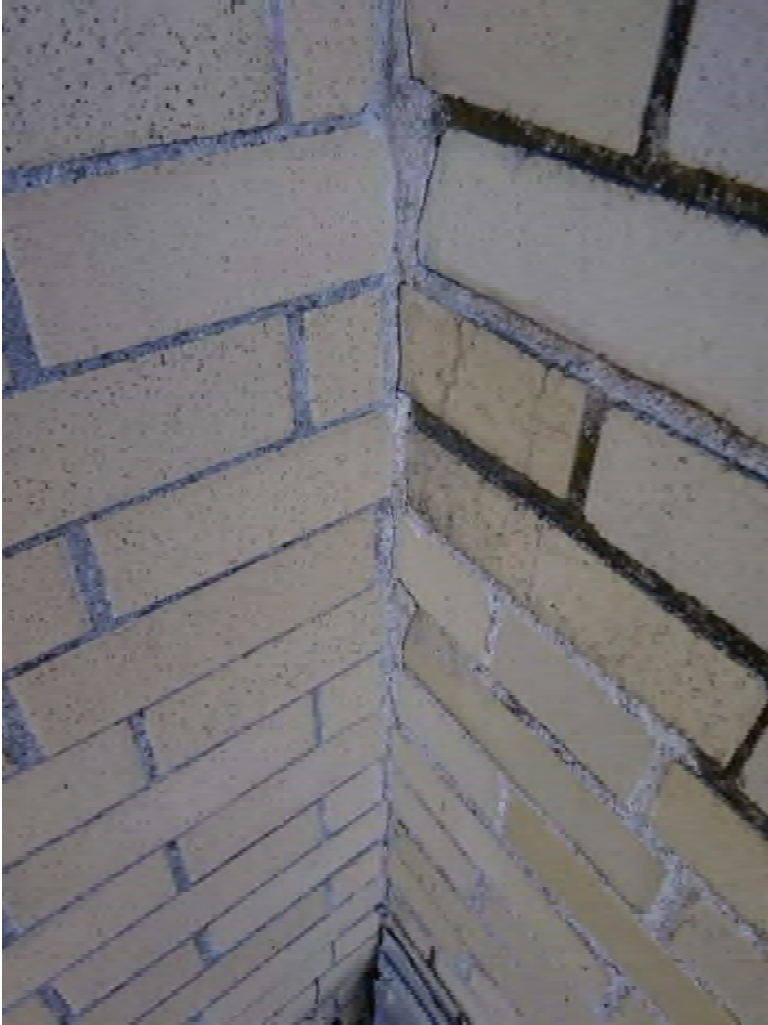
23	<p>Crack through mortar down height of south corner of west raised parapet</p> <p>(Photo taken from roof)</p>

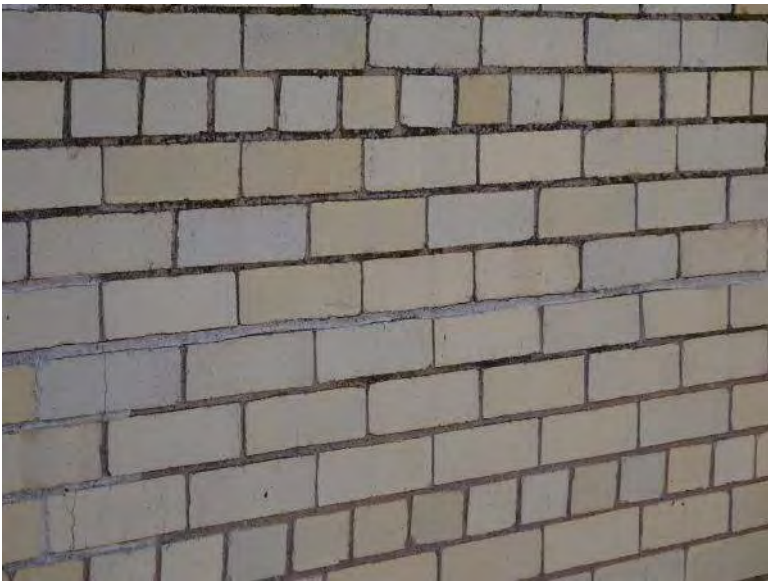
24	<p>Horizontal cracks in mortar joints on back side of raised west parapet</p> <p>(Photo taken from roof)</p>

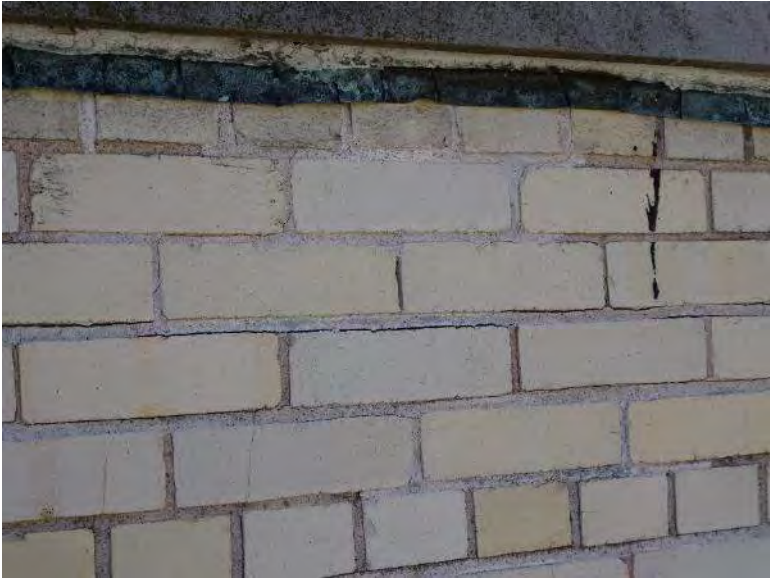
<p>25</p>	<p>Horizontal cracks in mortar joints on back side of raised west parapet</p> <p>(Photo taken from roof)</p>

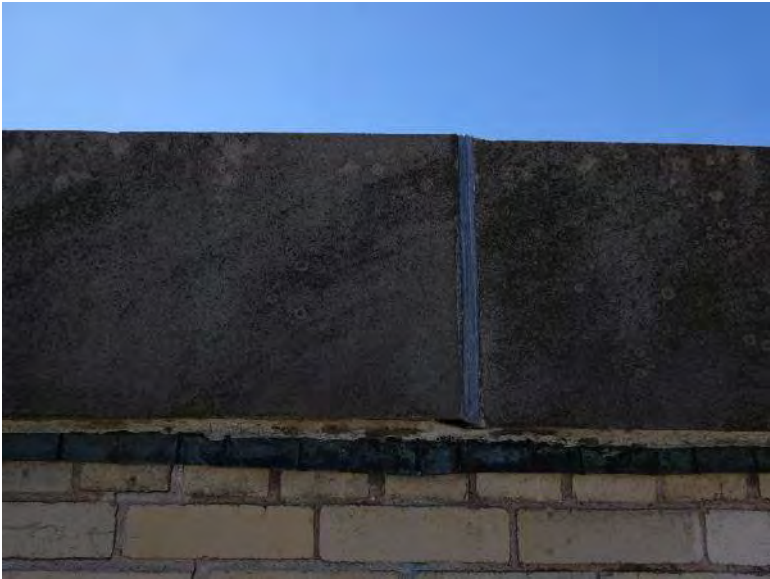
- One stone parapet cap, with masonry structure behind, is raised out-of-plane from the rest with a gap in the caulk sealant between it and the original copper flashing below [Photos 26, 27]

<p>26</p>	<p>Stone parapet cap on raised west parapet out-of-plane from others</p> <p>(Photo taken from roof)</p>

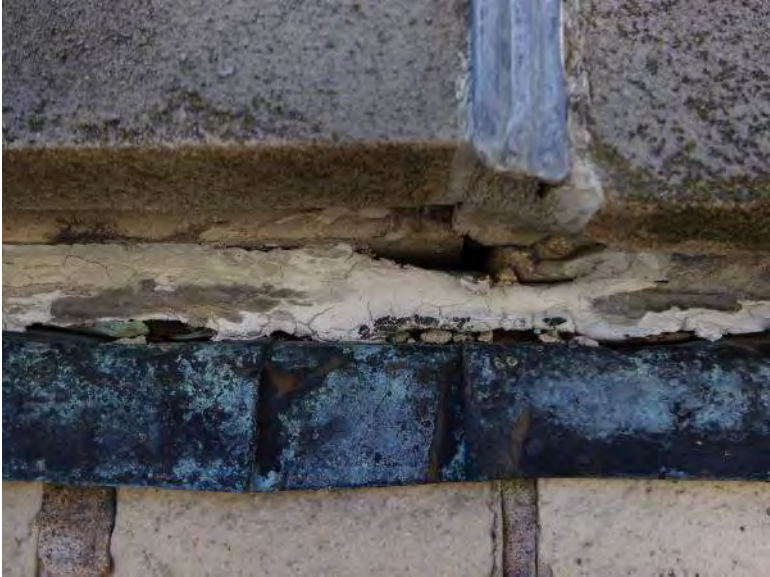
27	<p>Raised stone cap on west parapet with masonry structure behind. Gap is shown between cap and original copper flashing below. Caulk is deteriorating</p> <p>(Photo taken from roof)</p>

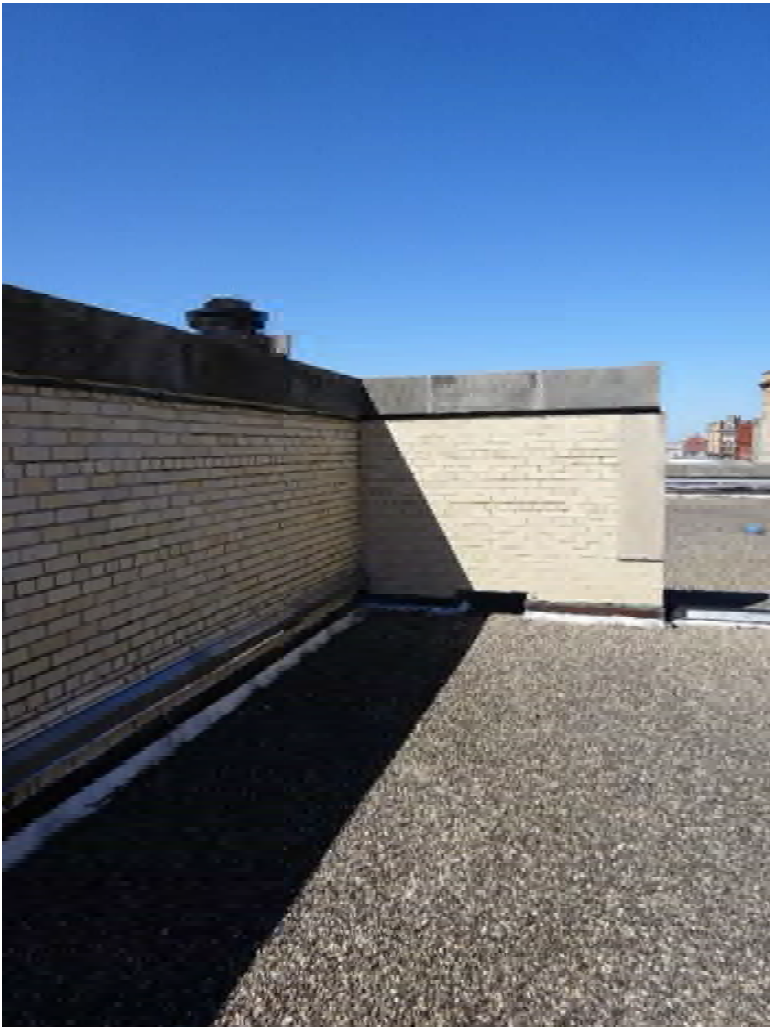
- A large crack exists in the north corner of the raised west parapet at its return. The crack extend the full height of the parapet. [Photo 28]
 - The gap between the west face of the parapet and its return shows there has been movement of the parapet. The gap was measured as 5/16" wide on 3/27/2019. [Photo 29]

28	<p>Northern corner of raised west parapet at return. Location of large crack</p>

The brick separation at the norther corner of the raised west parapet should be monitored by a structural engineer to determine if the crack is active or inactive. The engineer can then determine whether the parapet needs to be reinforced or braced. All gaps in mortar and caulking should be filled and sealed to prevent water and moisture intrusion.

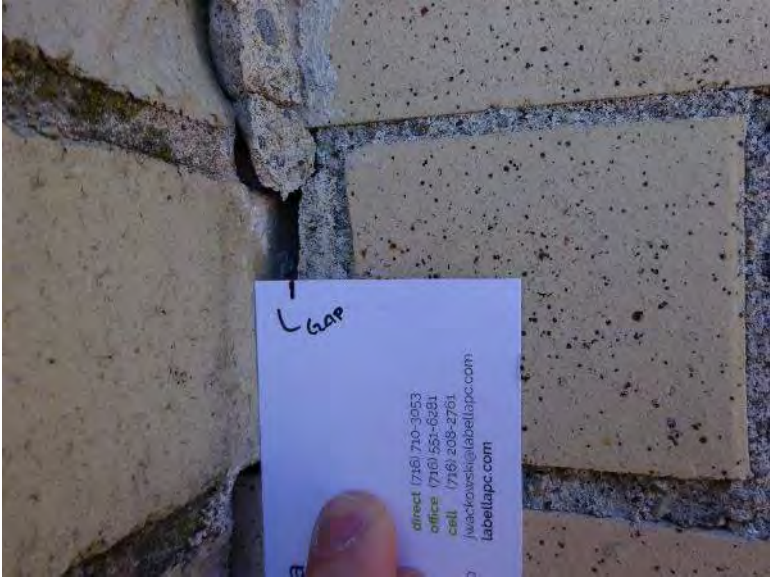
29	<p>Gap between raised west parapet and its return at its norther corner</p>

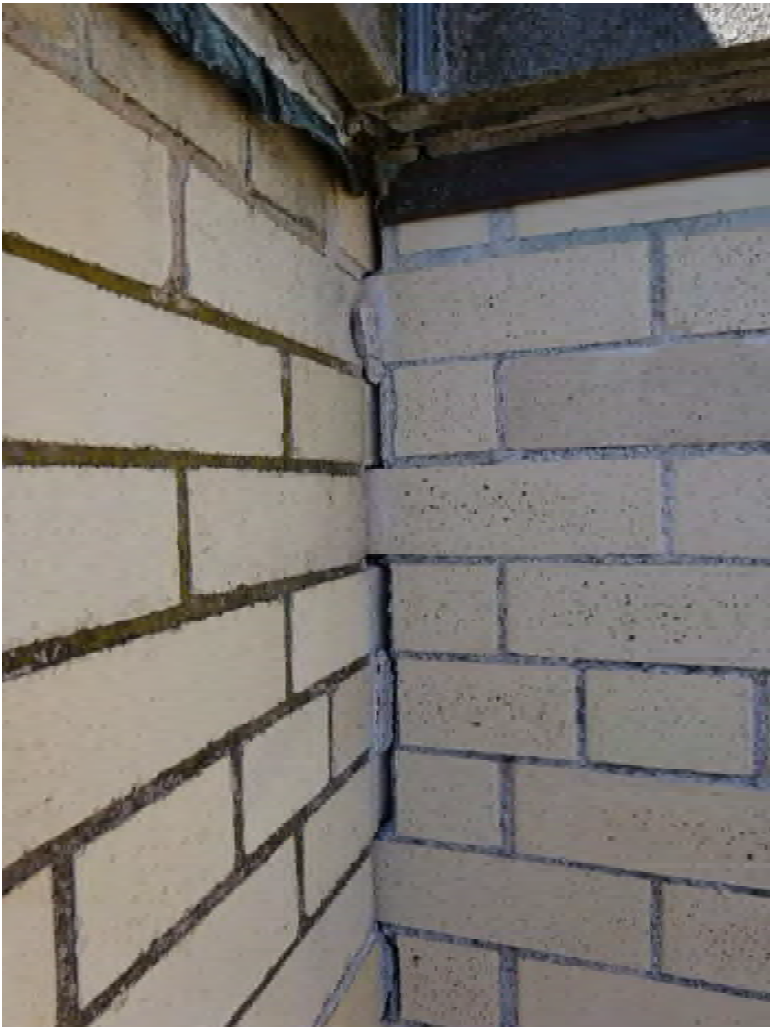
- Remaining mortar shows 5/16" gap is separation, not mortar loss. [Photo 30]
 - Crack spreads through bricks in the parapet return wall [Photo 31]
 - Corner separation is visible in both directions of parapet and return. [Photo 32]

30	<p>Gap between raised west parapet and its return at its norther corner</p> <p>Separation occurs where loose mortar has been lost and where mortar remains, indicating movement.</p>

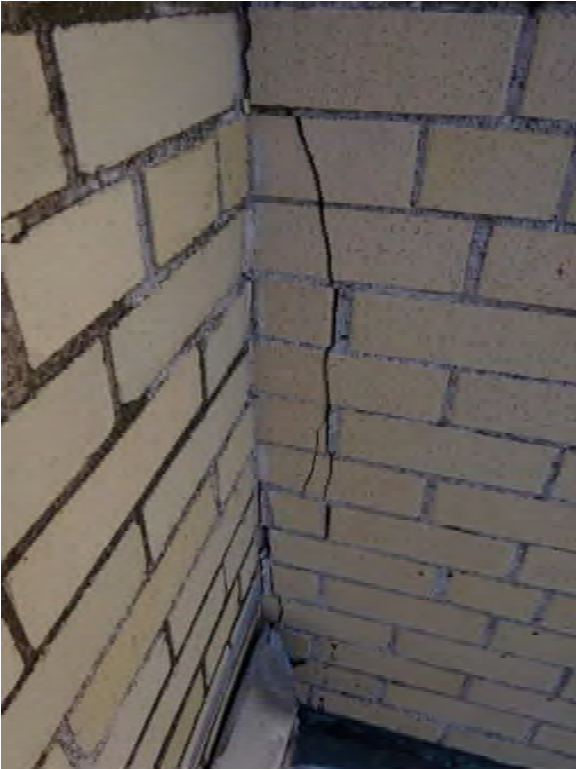
<p>31</p>	<p>Gap between raised west parapet and its return at its norther corner</p> <p>Crack spreads down through bricks in parapet return</p>

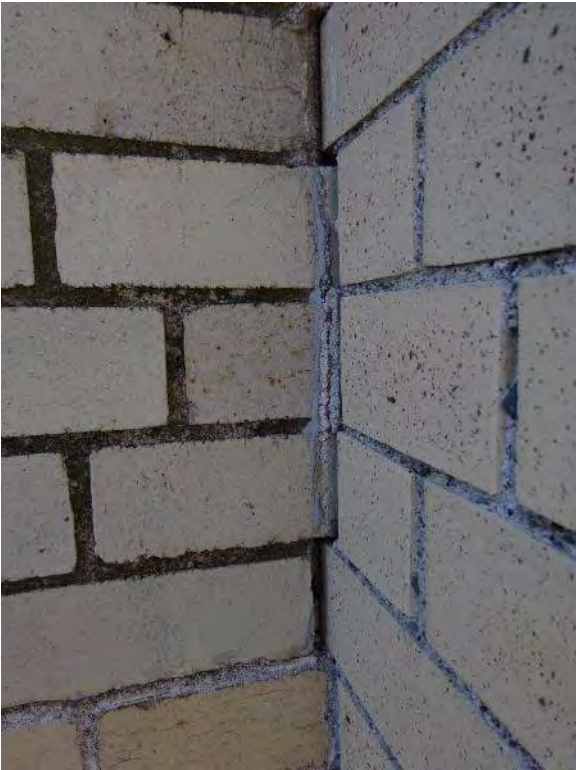
<p>32</p>	<p>Gap between raised west parapet and its return at its norther corner</p> <p>Separation is visible in both directions or parapet and return. The bricks forming the return are shifted from the existing mortar line</p>

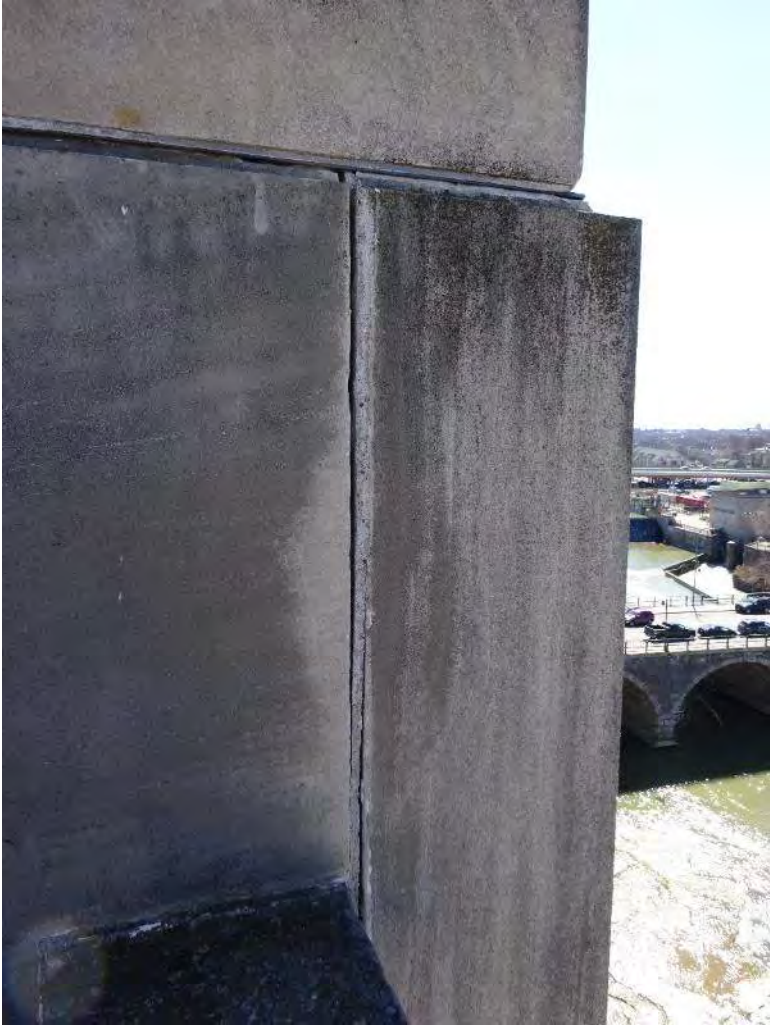
<p>33</p>	<p>Gap between raised west parapet and its return at its norther corner</p> <p>Gap visible at brick-face interior corner of parapet is coupled by gaps between stone façade panels on the exterior side</p>

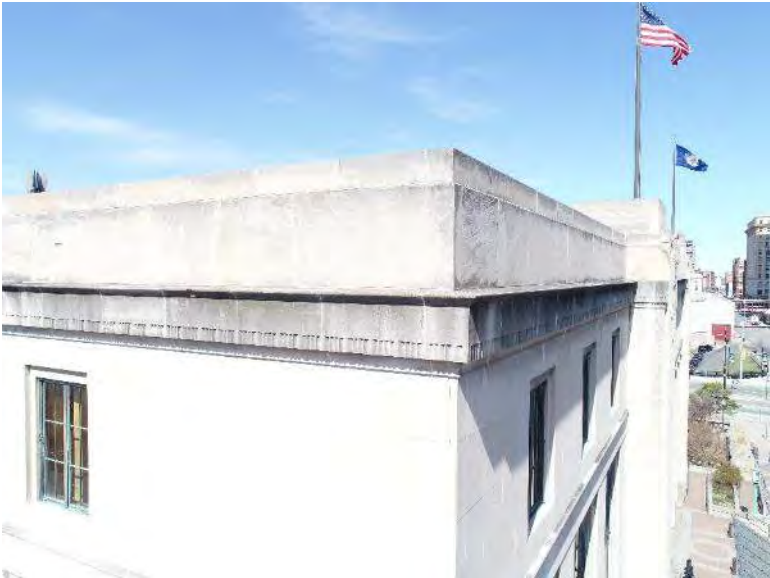
<p>34</p>	<p>South Parapet Corner</p>

The north and south faces of the building have only short parapets without raised portions. There parapets are constructed of multi-wythe brick with a stone panel façade. Along the length of both parapets, and the full perimeter of the building, the caulking between the joints of stone façade panels is deteriorating, with visible cracking and gaps. Most caulk gaps are visible in the horizontal joint between the stone façade panels and the parapet cap. [Photos 34, 35, 36, 37, 38, 39]

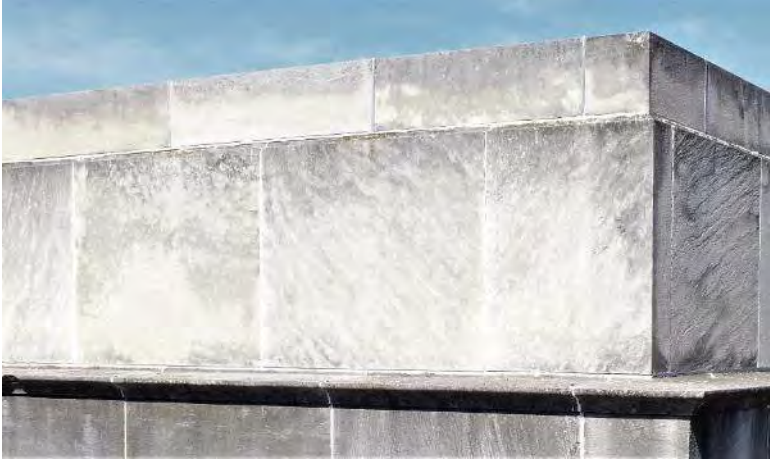
35	<p>Caulk gaps between stone façade panels and cap of parapet along south face of building</p>

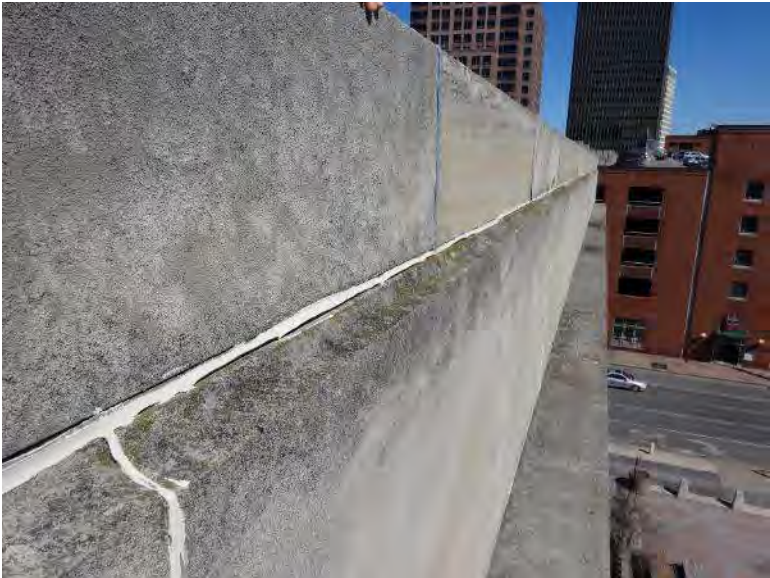
36	<p>Caulk gaps between stone façade panels and cap of parapet along south face of building</p> <p>(Photo taken from roof)</p>

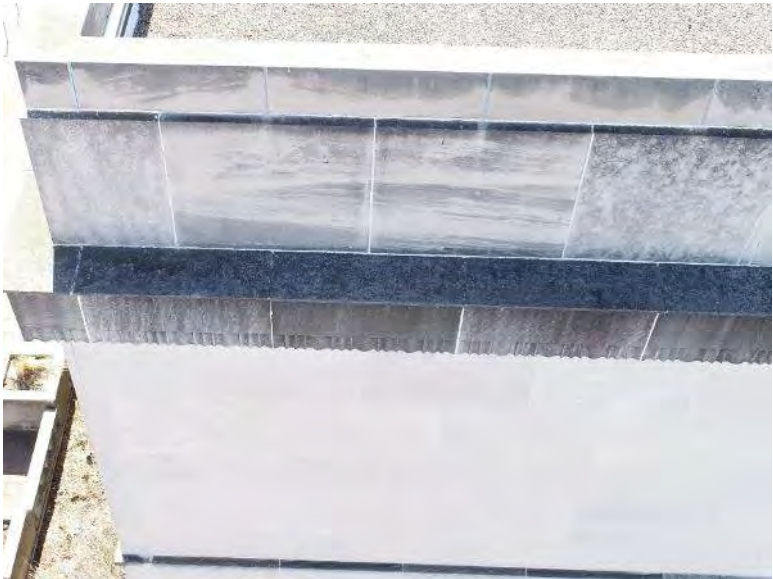
37	Caulk gaps between stone façade panels and cap of parapet along north face of building

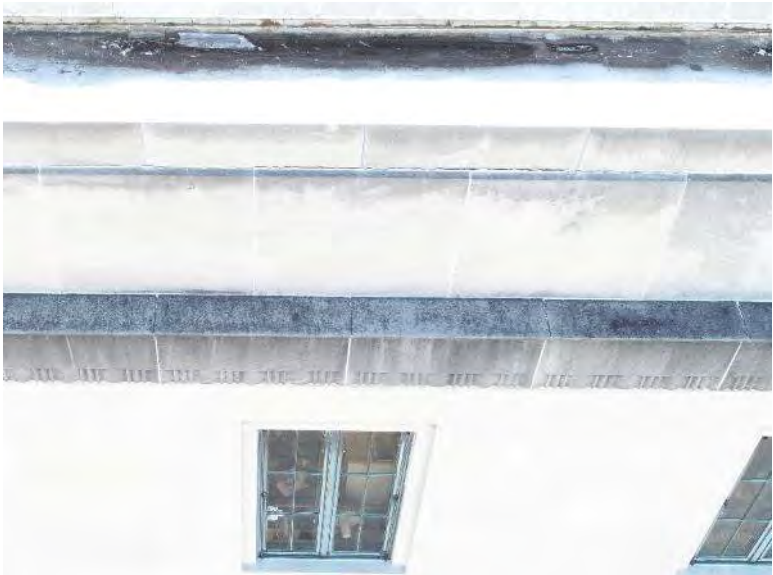
38	Caulk gaps between stone façade panels and cap of parapet along north face of building

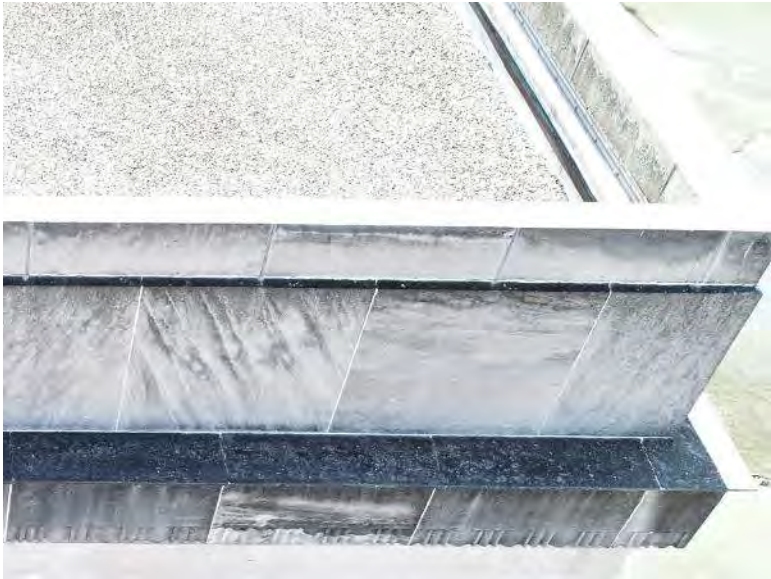
39	<p>Caulk gaps between stone façade panels and cap of parapet along north face of building</p>

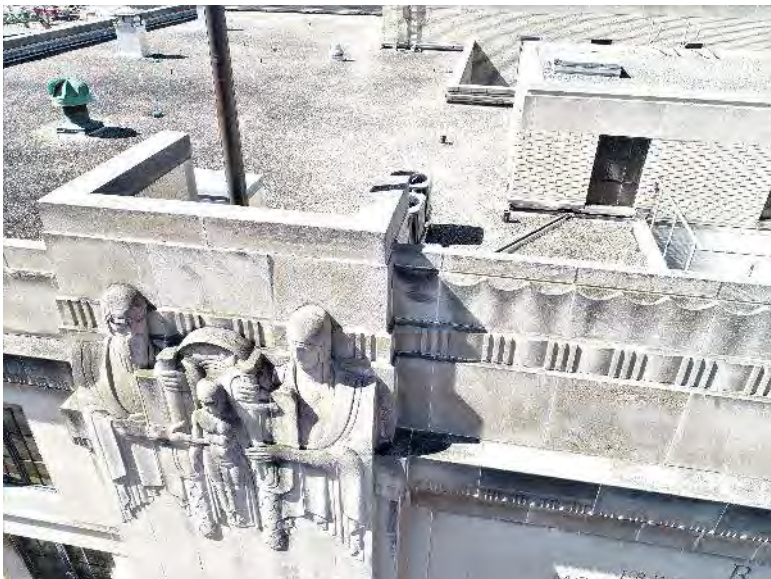
- The center stone façade panel above the artistic stonework on the southern high east parapet appears to be out-of-plane from the other panels on this face. [Photos 40, 41]

40	<p>Southern East High Parapet</p> <p>Middle stone façade panel appears out-of-plane from others</p>

- This panel has since been braced with temporary steel supports in response to LaBella's immediate recommendations. [Photo 50]
- Caulk gaps and deterioration are visible in the joints between the stone façade panels of the southern high east parapet, on all 3 faces. [Photos 41, 42]
