Rundel Library Exterior Façade Observation

APRIL 2019

LBA PROJECT NO. 2191056

RE: Rundel Library Exterior Façade Observation
115 South Avenue, Rochester NY
LaBella Project No. 2191025

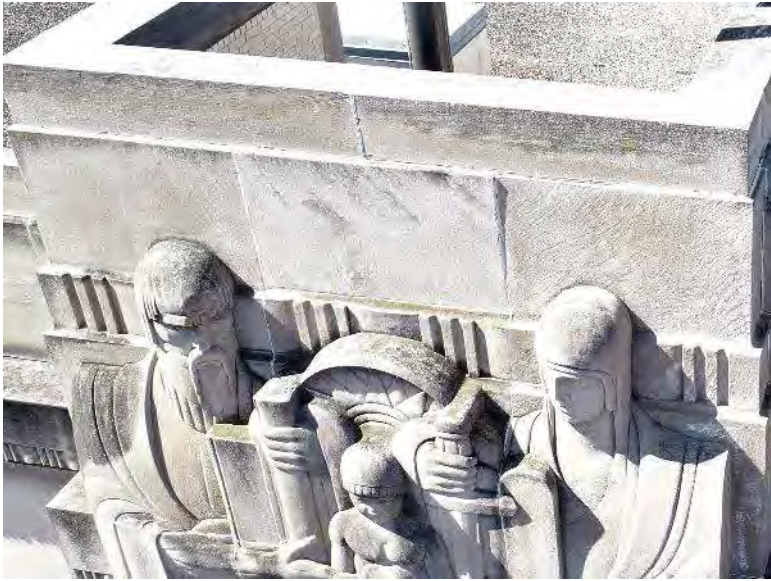
<p>41</p>	<p>Southern East High Parapet</p> <p>Middle stone façade panel appears out-of-plane from others</p> <p>Caulk gaps are visible in joints between stone façade panels</p>

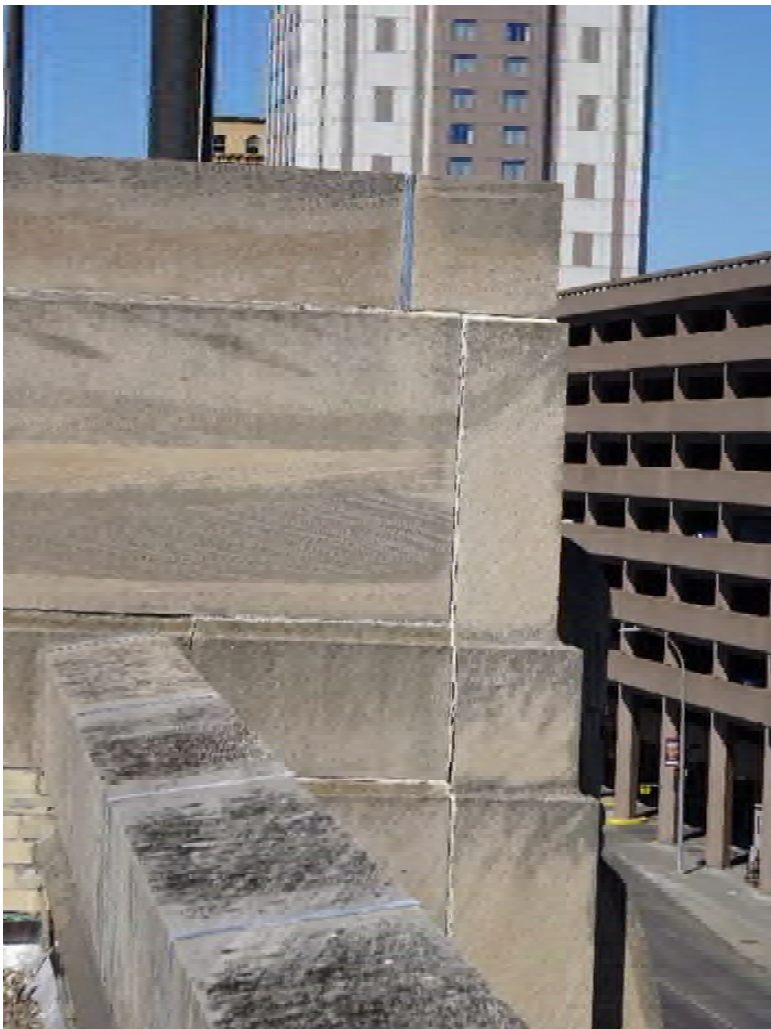
- A stone façade panel on the southern face of the southern high east parapet is cracked near its intersection with the southern low parapet. [Photo 42]

<p>42</p>	<p>Southern East High Parapet</p> <p>Caulk gaps are visible in joints between stone façade panels</p> <p>Stone Façade panel adjacent to the lower parapet is cracked</p>

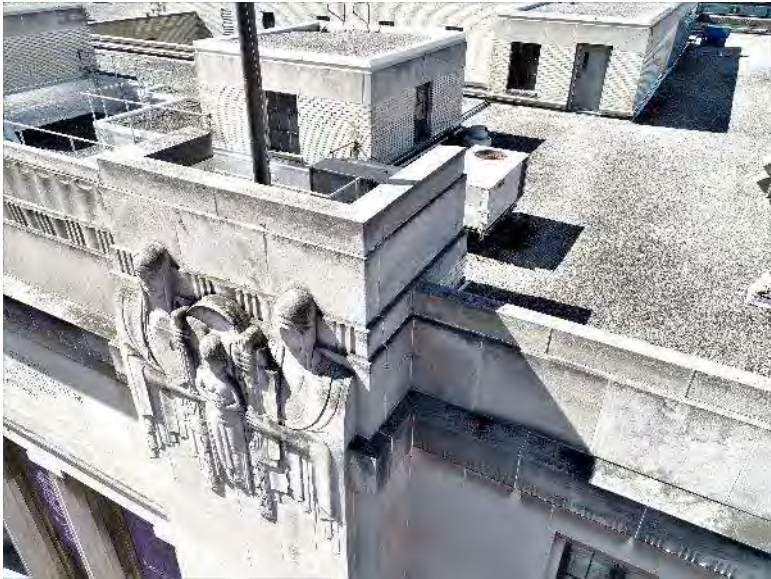
- The center stone façade panel above the artistic stonework on the northern high east parapet appears to be out-of-plane from the other panels on this face. [Photos 43, 44]

<p>43</p>	<p>Northern East High Parapet</p> <p>Middle stone façade panel appears out-of-plane from others</p>

- This panel has since been braced with temporary steel supports in response to LaBella's immediate recommendations. [Photo 50]

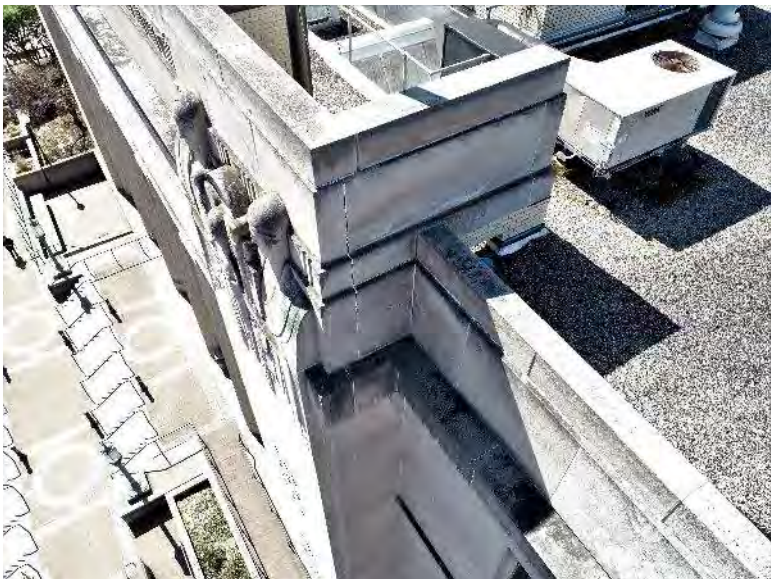
<p>44</p>	<p>Northern East High Parapet</p> <p>Middle stone façade panel appears out-of-plane from others</p> <p>Caulk gaps are visible in joints between stone façade panels on east face and northern return side</p>

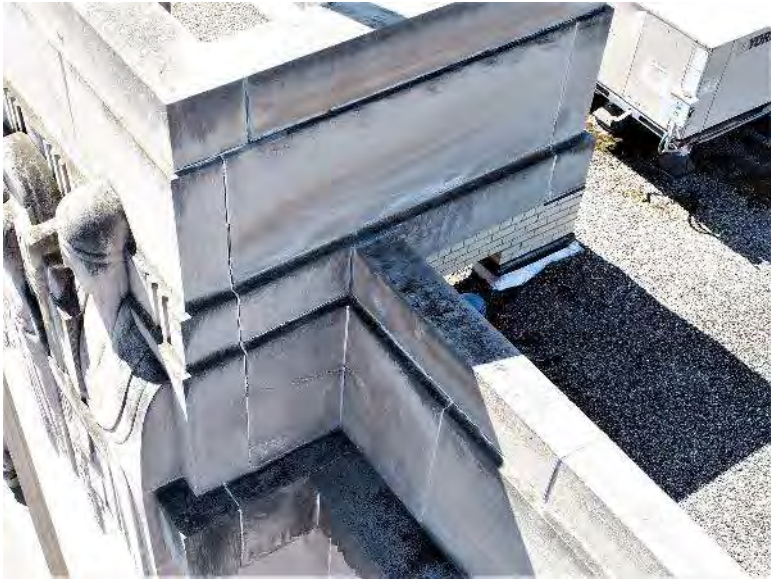
<p>45</p>	<p>Northern East High Parapet</p> <p>Caulk gaps and missing caulk is visible in joints between stone façade panels on east face and northern return side</p> <p>Two stone façade panels in this corner are cracked</p>

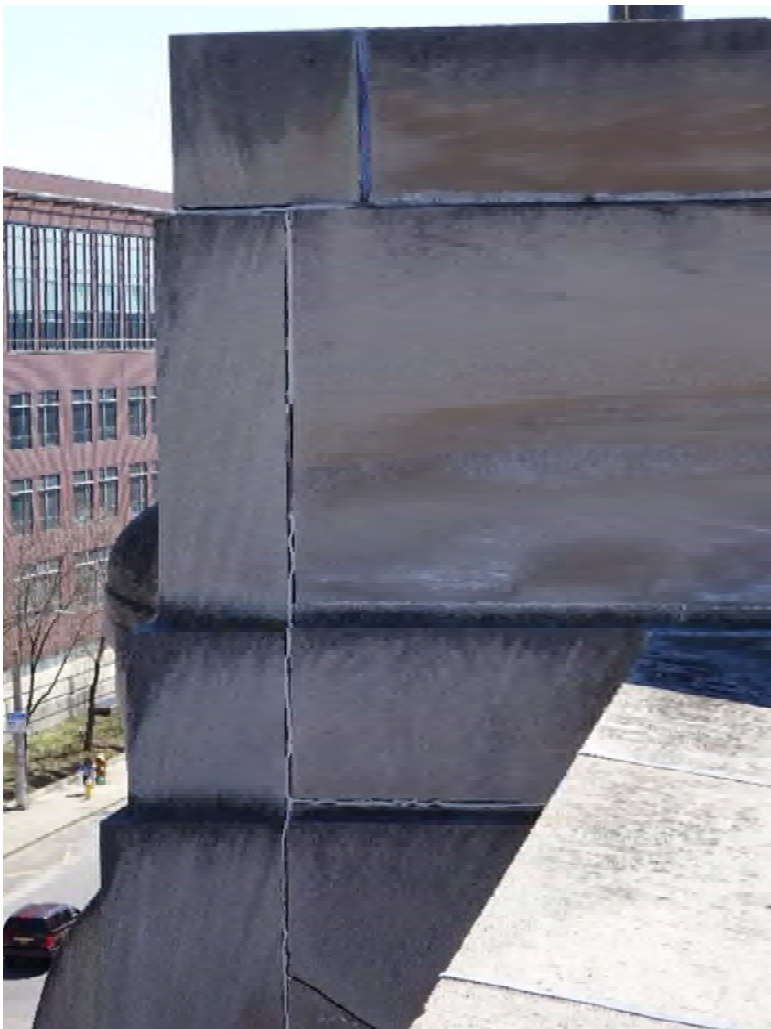
<p>46</p>	<p>Northern East High Parapet</p> <p>Caulk gaps and missing caulk is visible in joints between stone façade panels on northern return side</p> <p>Lower stone façade panel is cracked</p>

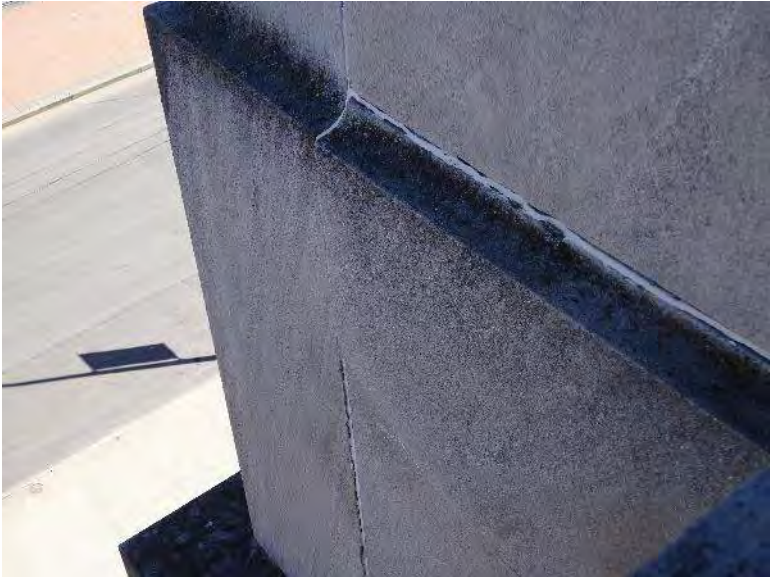
47	<p>Northern East High Parapet</p> <p>Top portion of cracked lower stone façade panel is out-of-plane from the bottom half and other panels on this face</p>

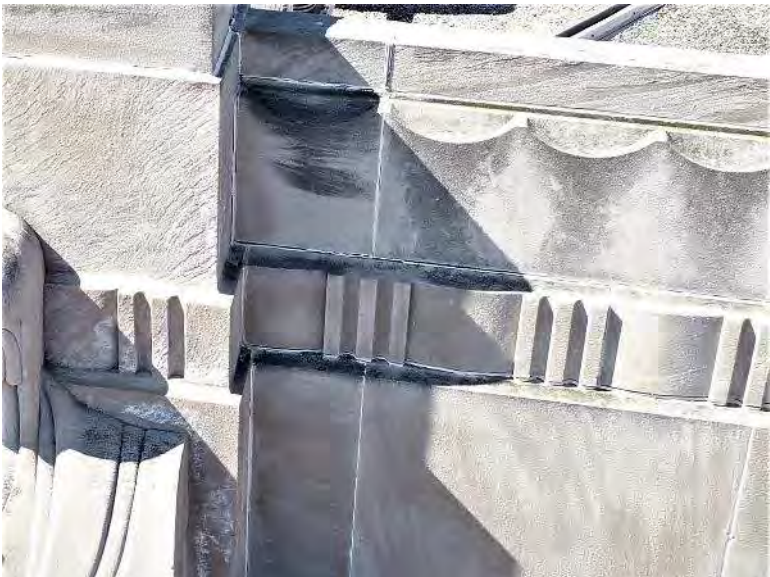
48	<p>Caulk gaps in joints between stone façade panels along east parapet</p>

Water intrusion is the likely cause of the stone façade panel movement observed. Freezing water forces the panels away from the building and water can corrode the anchors holding those panels in place. Existing caulk should be removed from all joints around the perimeter of the parapet and replaced with new sealant. All cracked stone panels, both with existing sealant and without, should be injected with an epoxy sealant through the full length of the crack.

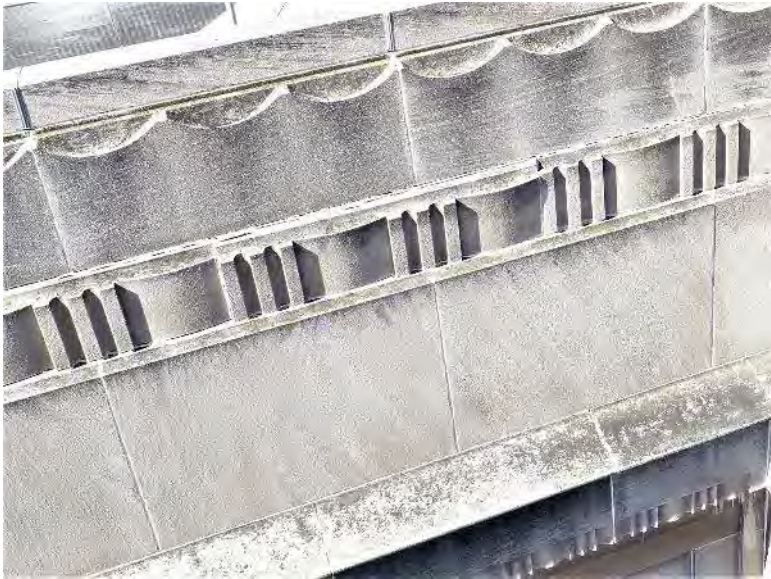
49	Caulk gaps in joints between stone façade panels along east parapet

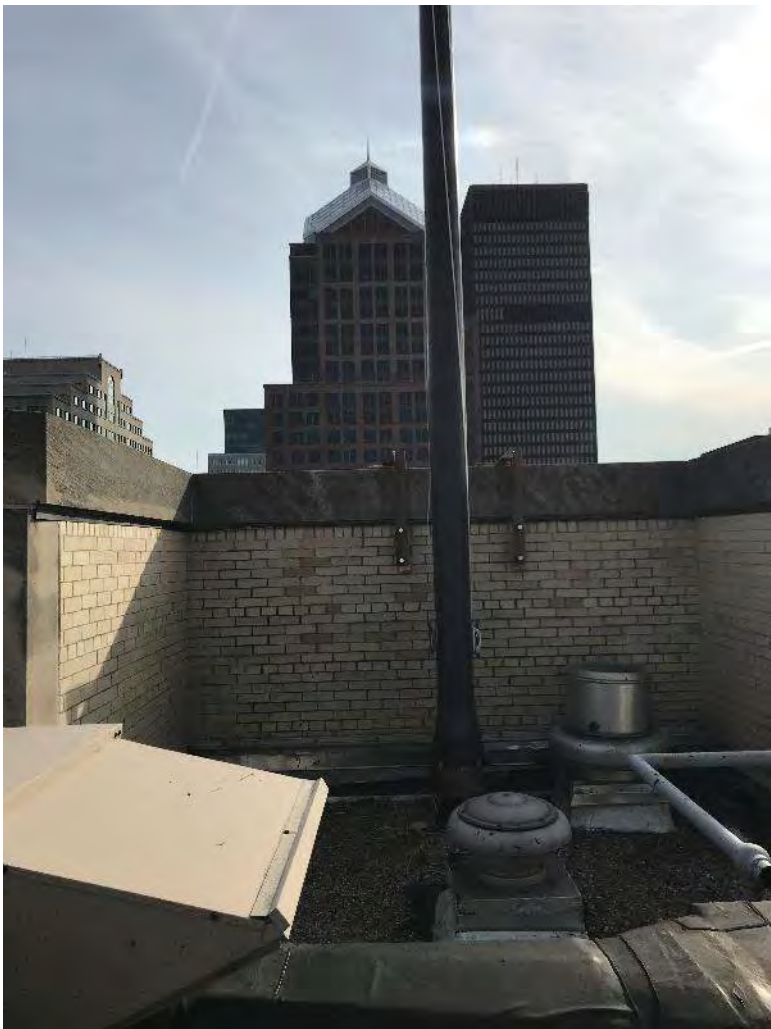
50	Temporary steel brackets installed at raised east parapets to restrain out-of-plane stone façade panels

Three stone façade panels on the west parapet and two on the east parapet were areas of immediate concern, and were brought to the attention of the City directly after completing the visual inspection. These panels have all since been braced with the addition of steel brackets, similar to those previously installed on the panels adjacent to those that fell in February.

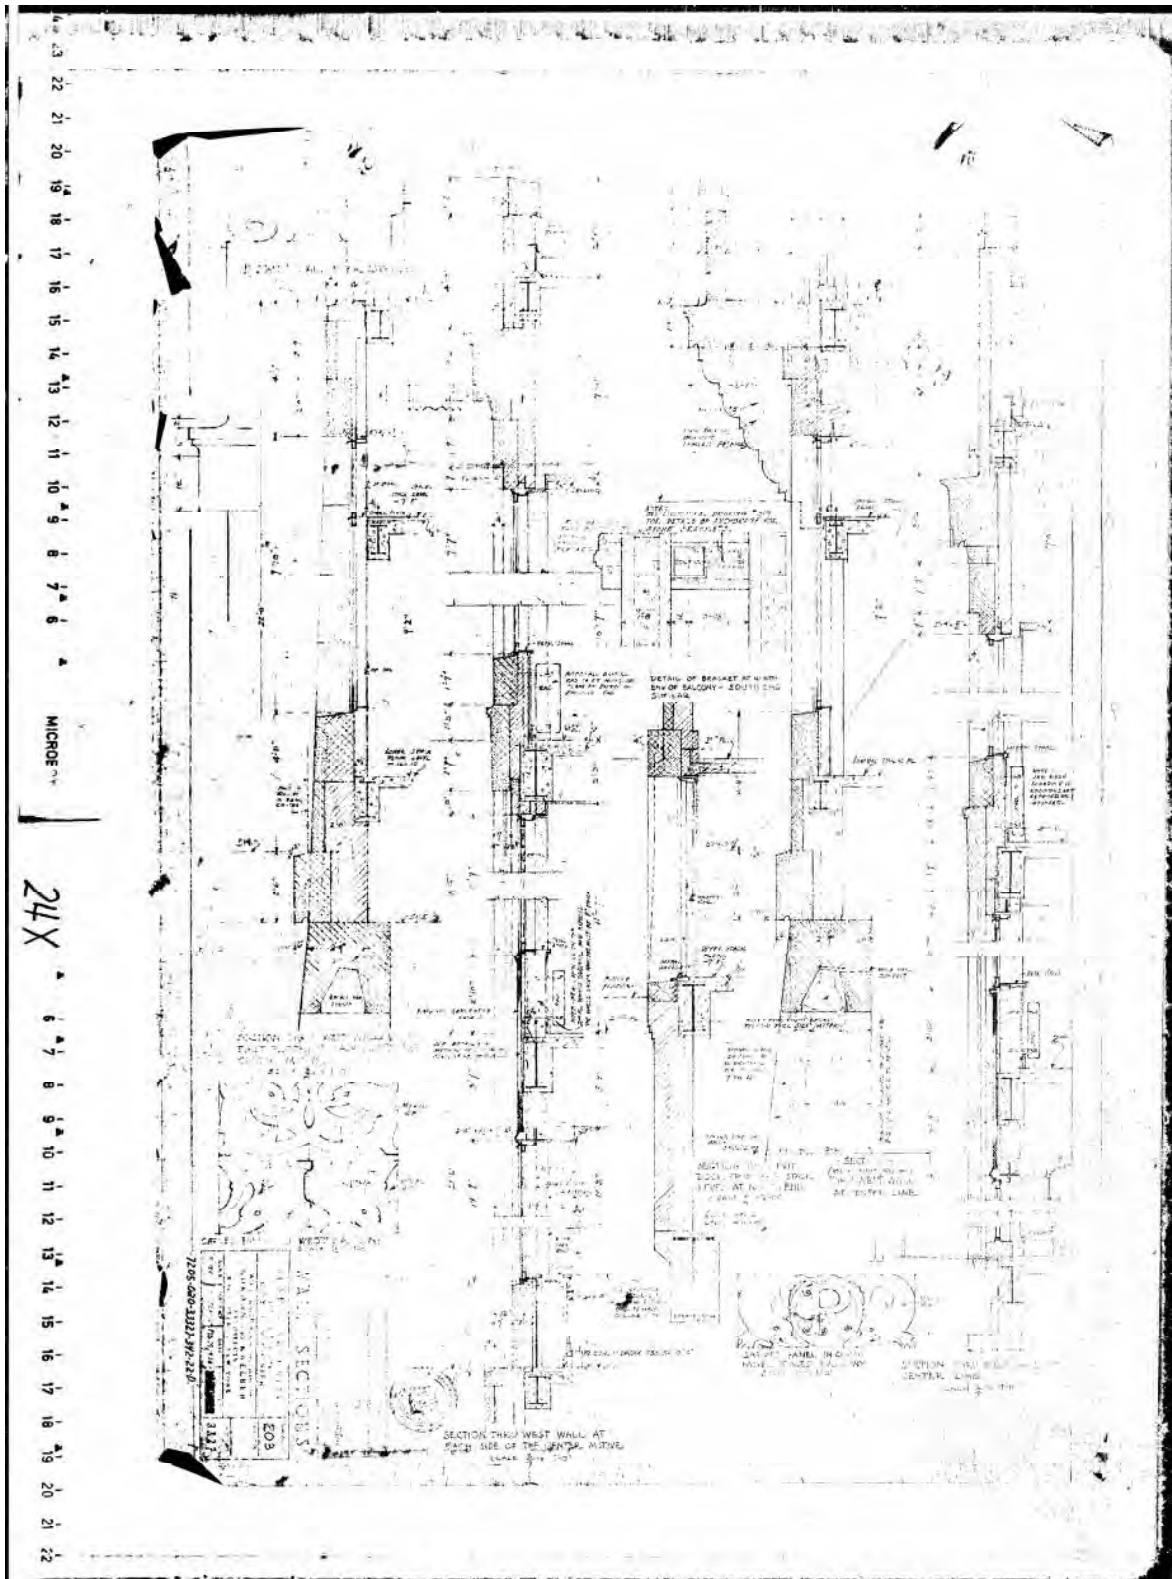
Figure A - Existing 1934 Drawing detailing wall sections at parapets

While a steel anchor was visible at the location where stone panels detached and fell, no details are available on the existing drawings provided to LaBella [Figure A] and no other anchorage was visible during inspection. Permanent anchorage for the loose panels, as well as for the replacement of panels that have fallen, should be designed by a structural engineer. These panels, as well as the full perimeter of the parapet should be regularly monitored for additional movement by a structural engineer until fully repaired.
