RUNDEL LIBRARY Parapet Monitoring

AUGUST 2019

LBA PROJECT NO. 217916.08

RE: Rundel Library High Parapet Monitoring
115 South Avenue, Rochester NY
LaBella Project No. 2171916.08

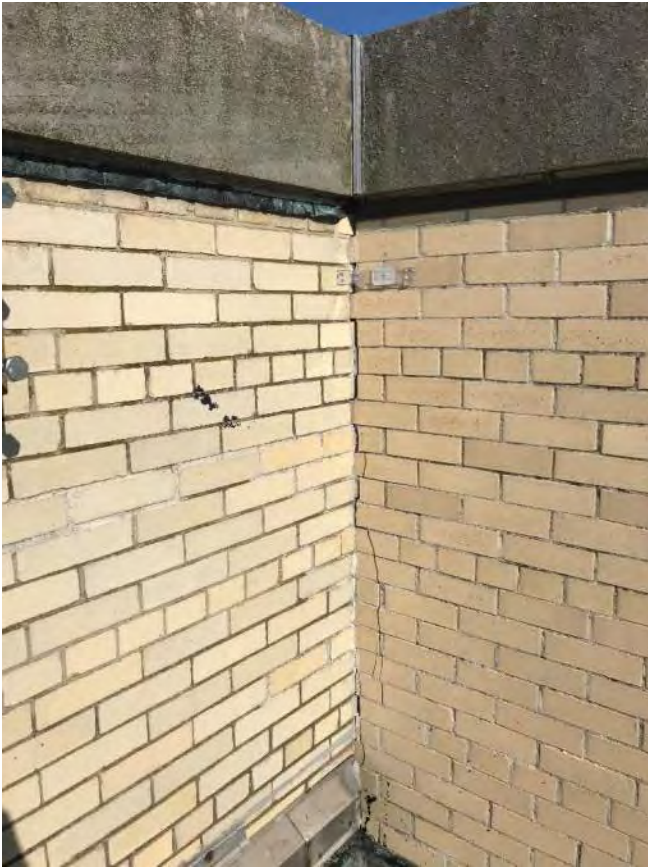
PHOTO 1
N.W. Riverside Corner
3/8" Wall Separation

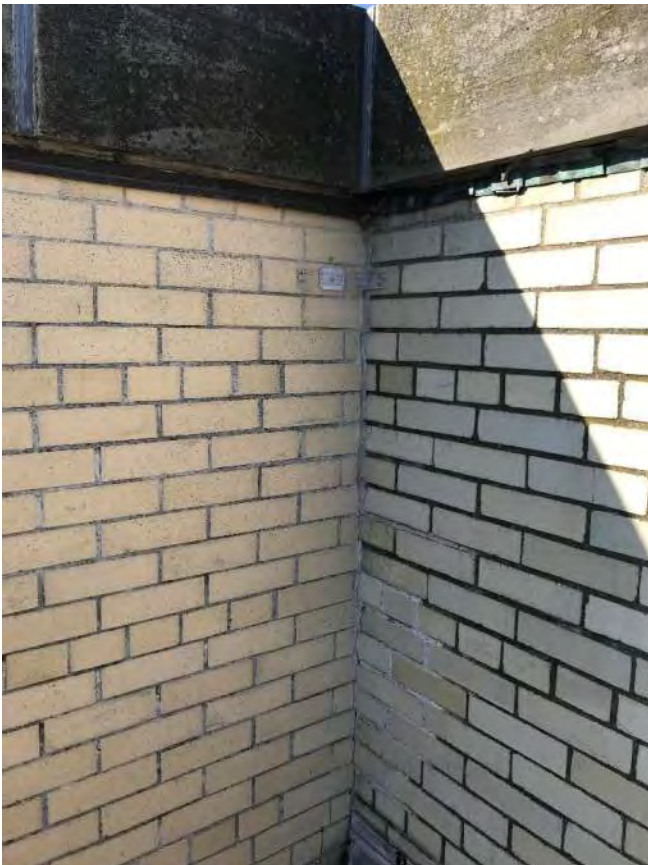
PHOTO 2
S.W. Riverside Corner
Mortar Crack

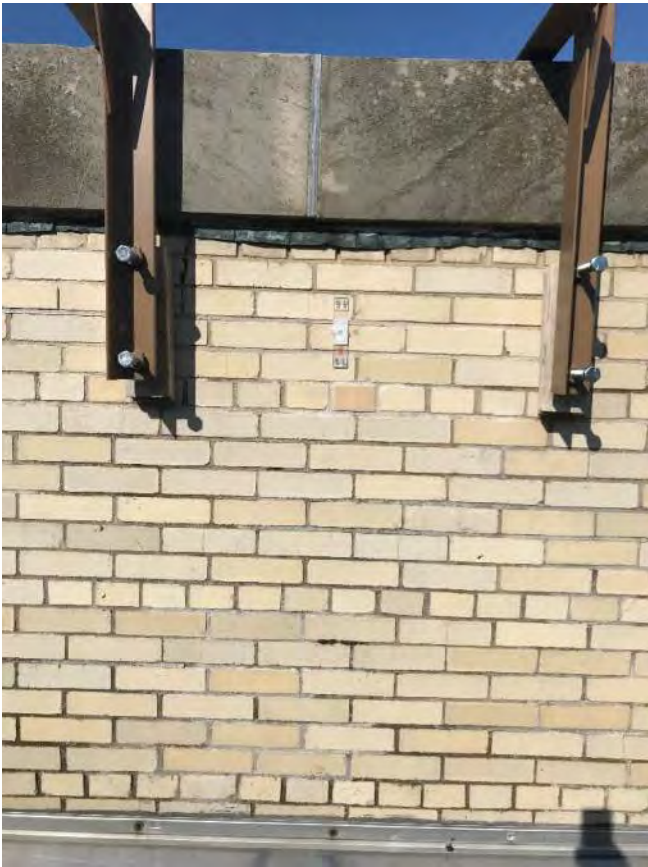
PHOTO 3

N.W. Riverside Straight

Horizontal Mortar Joint Crack

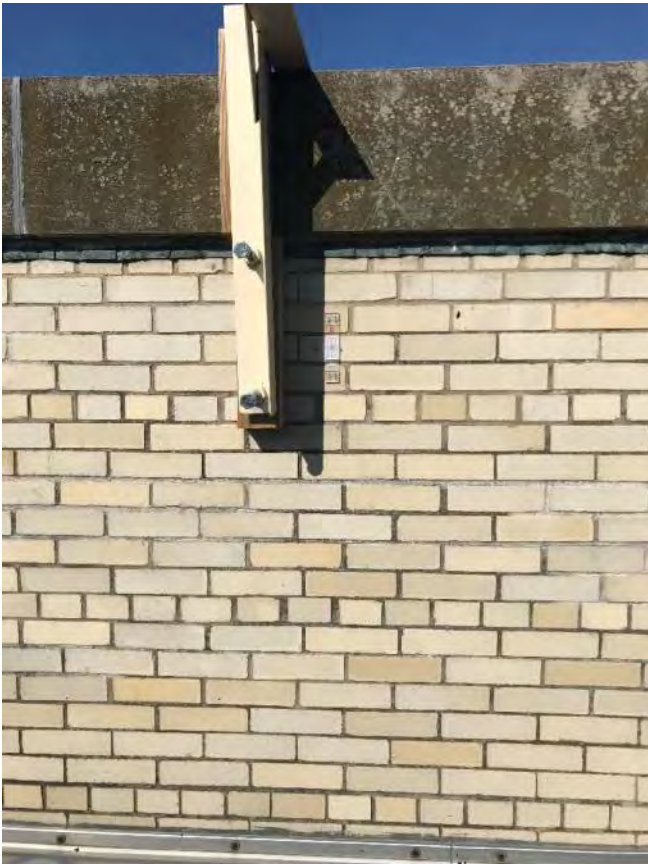
PHOTO 4

W. Riverside Straight

Horizontal Mortar Joint Crack

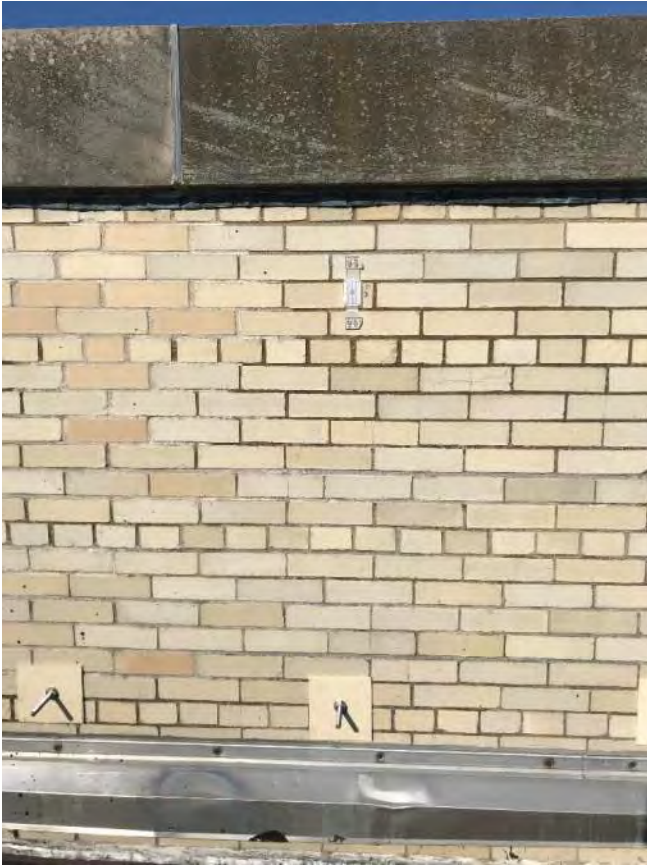
PHOTO 5

S.W. Riverside Straight

Horizontal Mortar Joint Crack

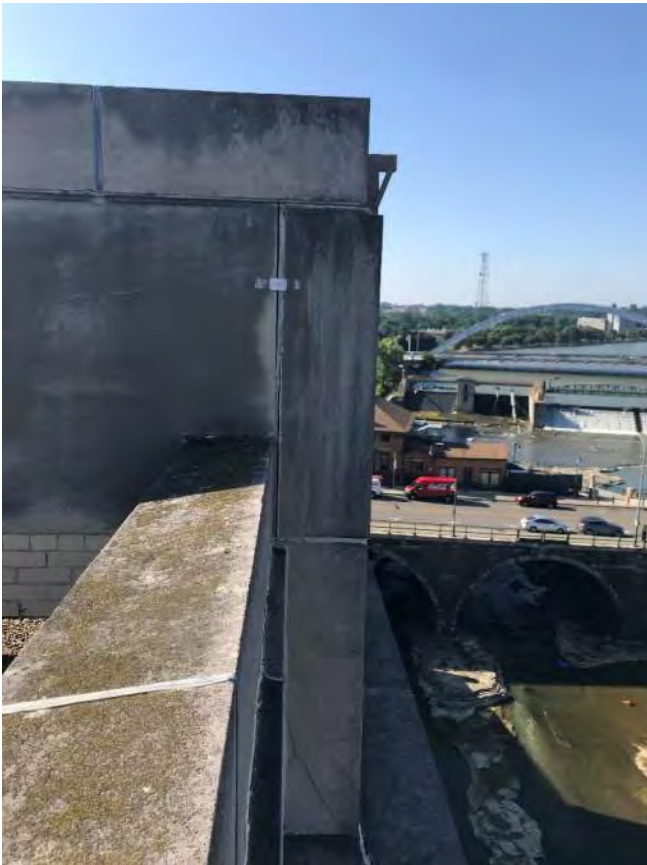
PHOTO 6

N.W. Riverside Exterior

3/8" Vertical Joint Separation

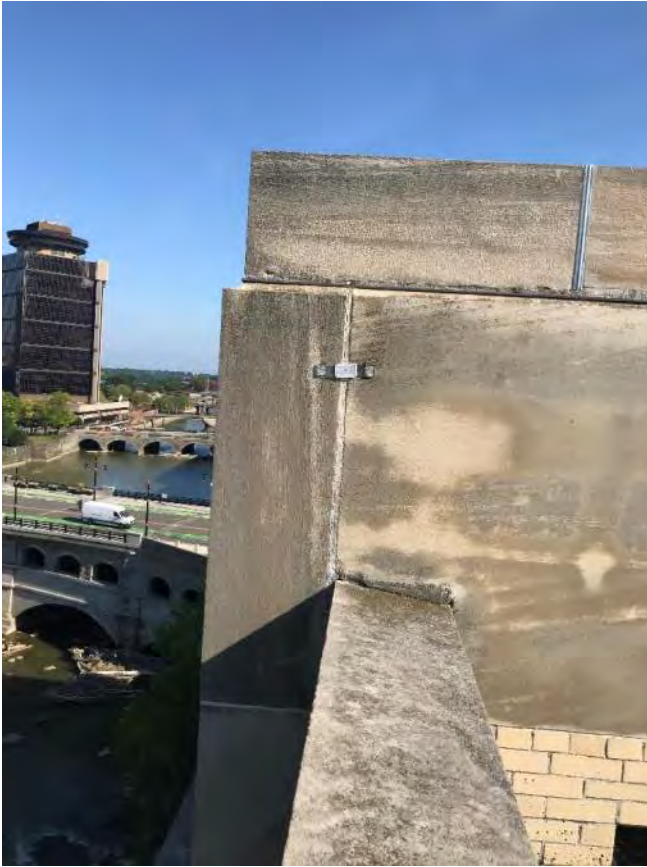
PHOTO 7
S.W. Riverside Exterior
Vertical Joint Separation

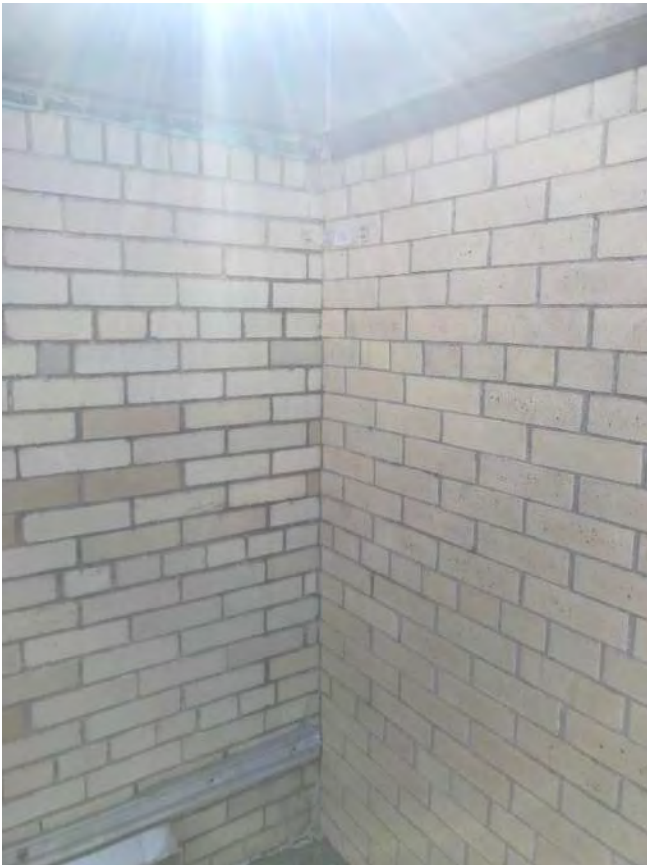
PHOTO 8
S.E.S. Entrance Corner
Vertical Joint Separation

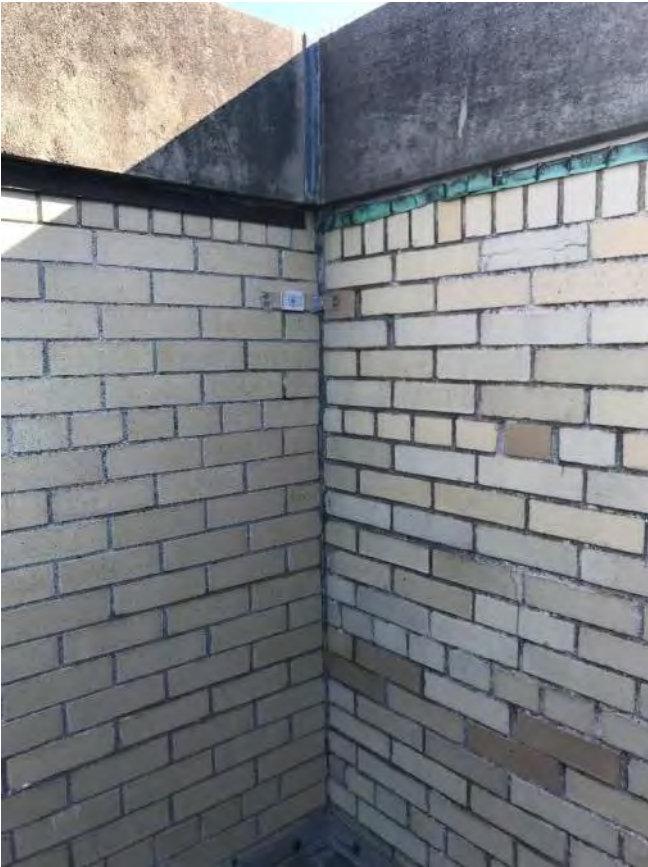
PHOTO 9
S.E.N. Entrance Corner
Vertical Joint Separation

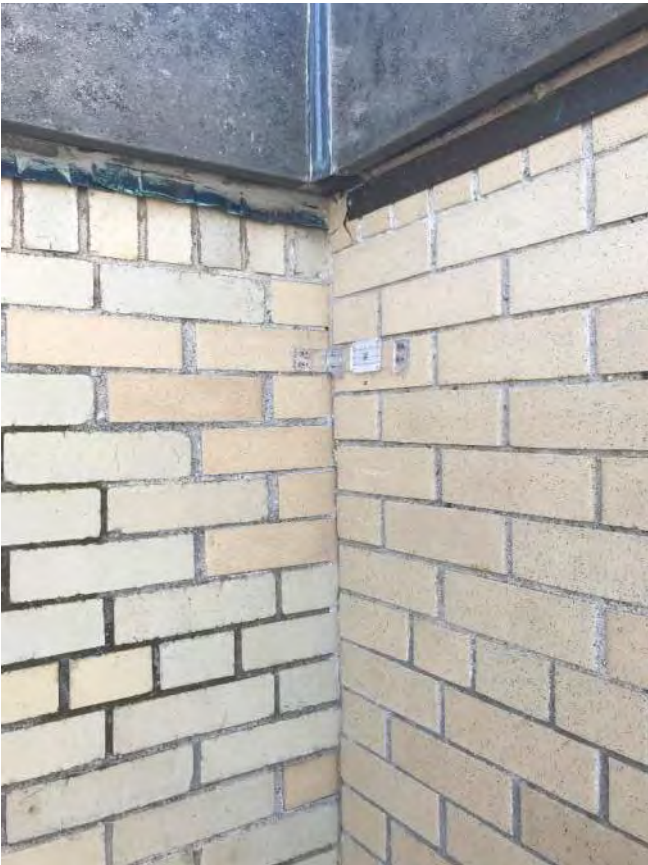
PHOTO 10
N.E.S. Entrance Corner
Vertical Joint Separation

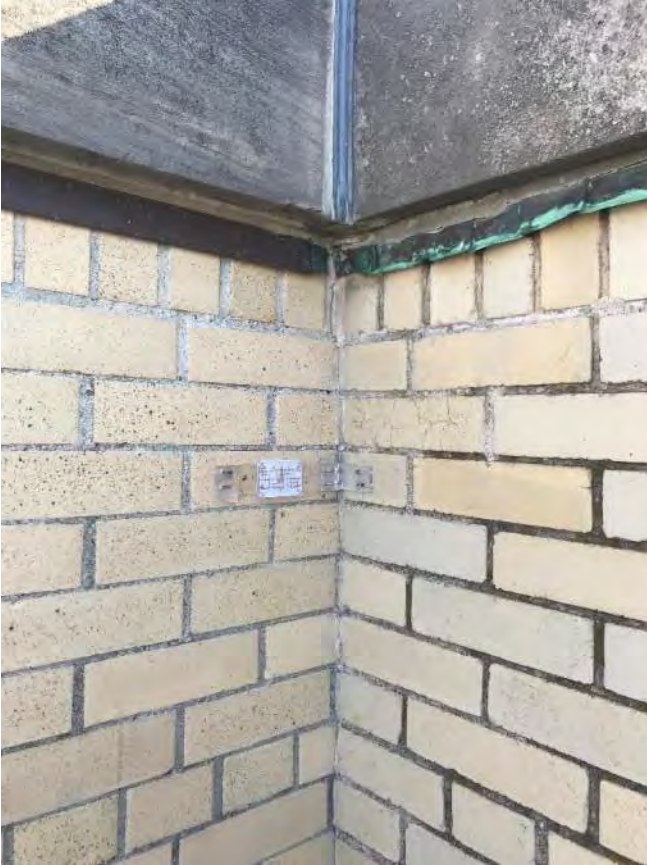
PHOTO 11

N.E.N. Entrance Corner

Vertical Joint Separation

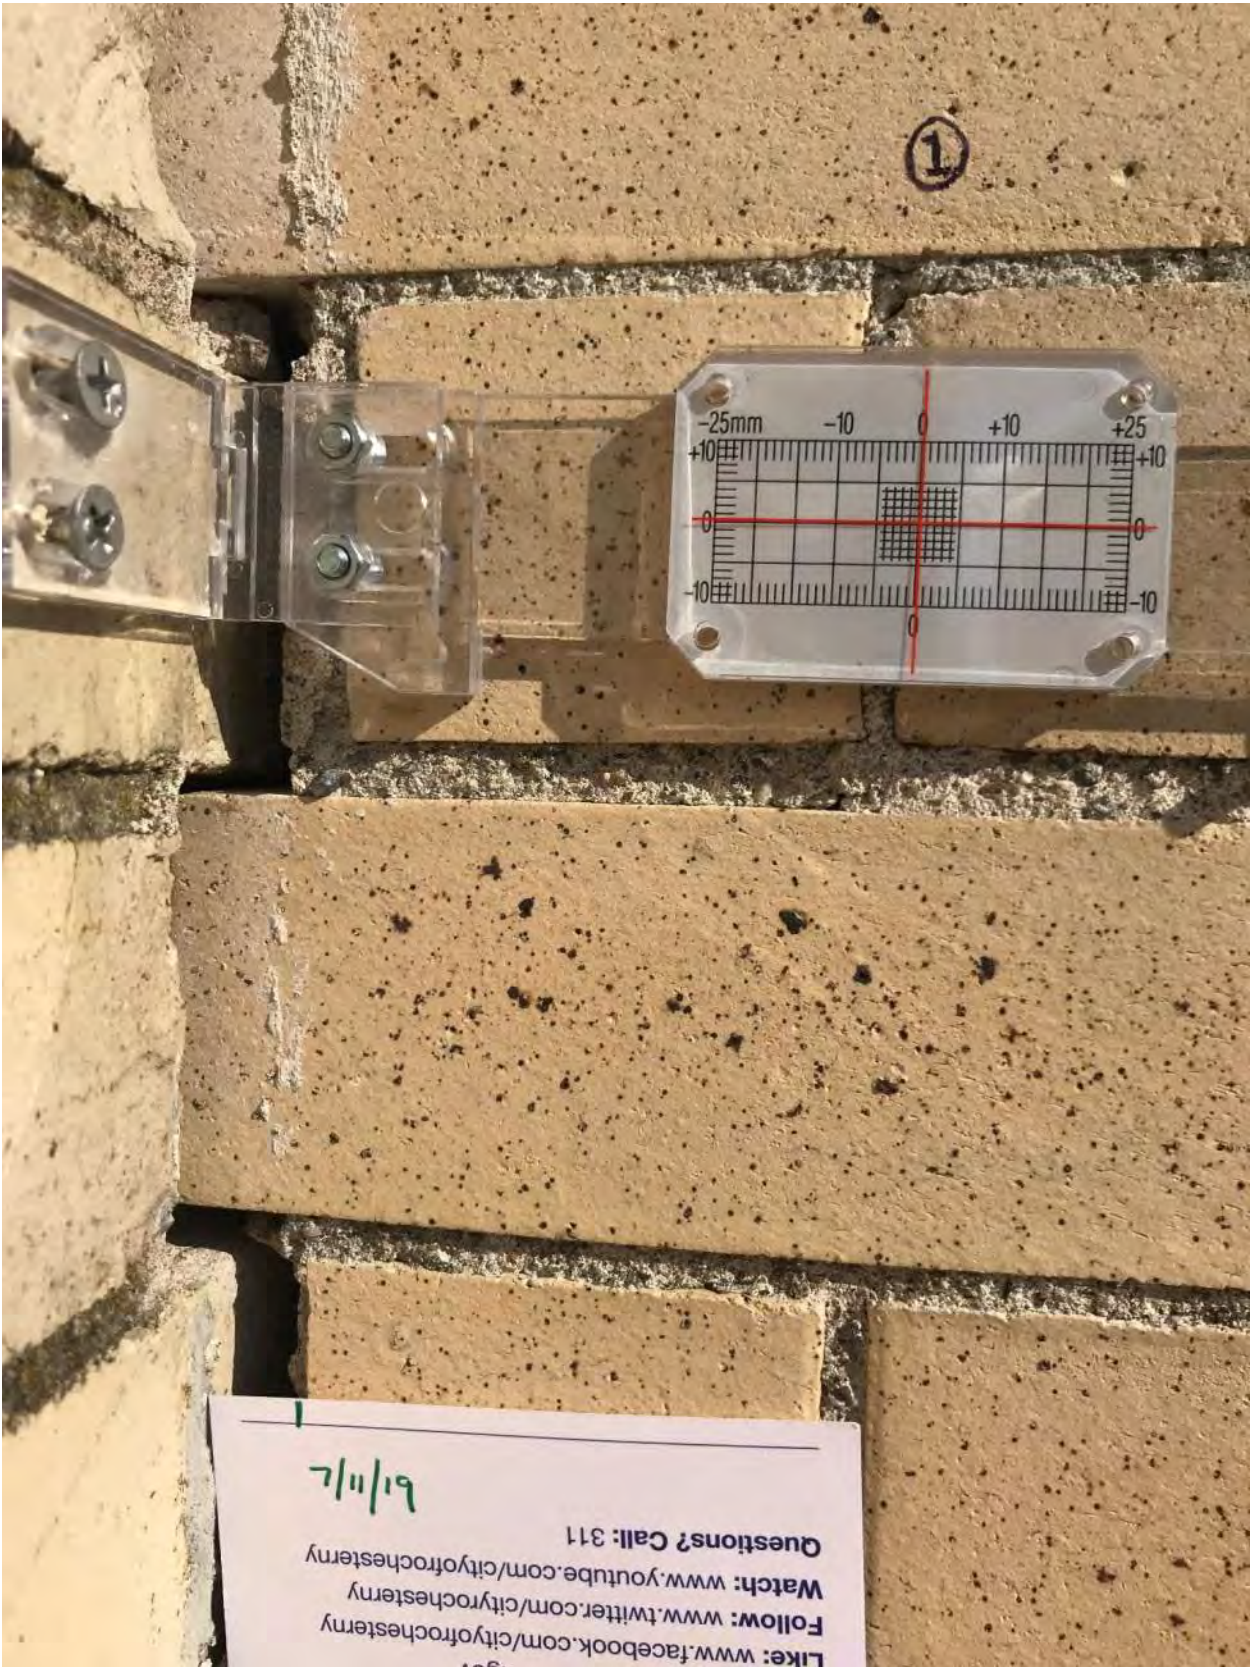
PHOTO 1A - DETAILED

0_{mm} Movement

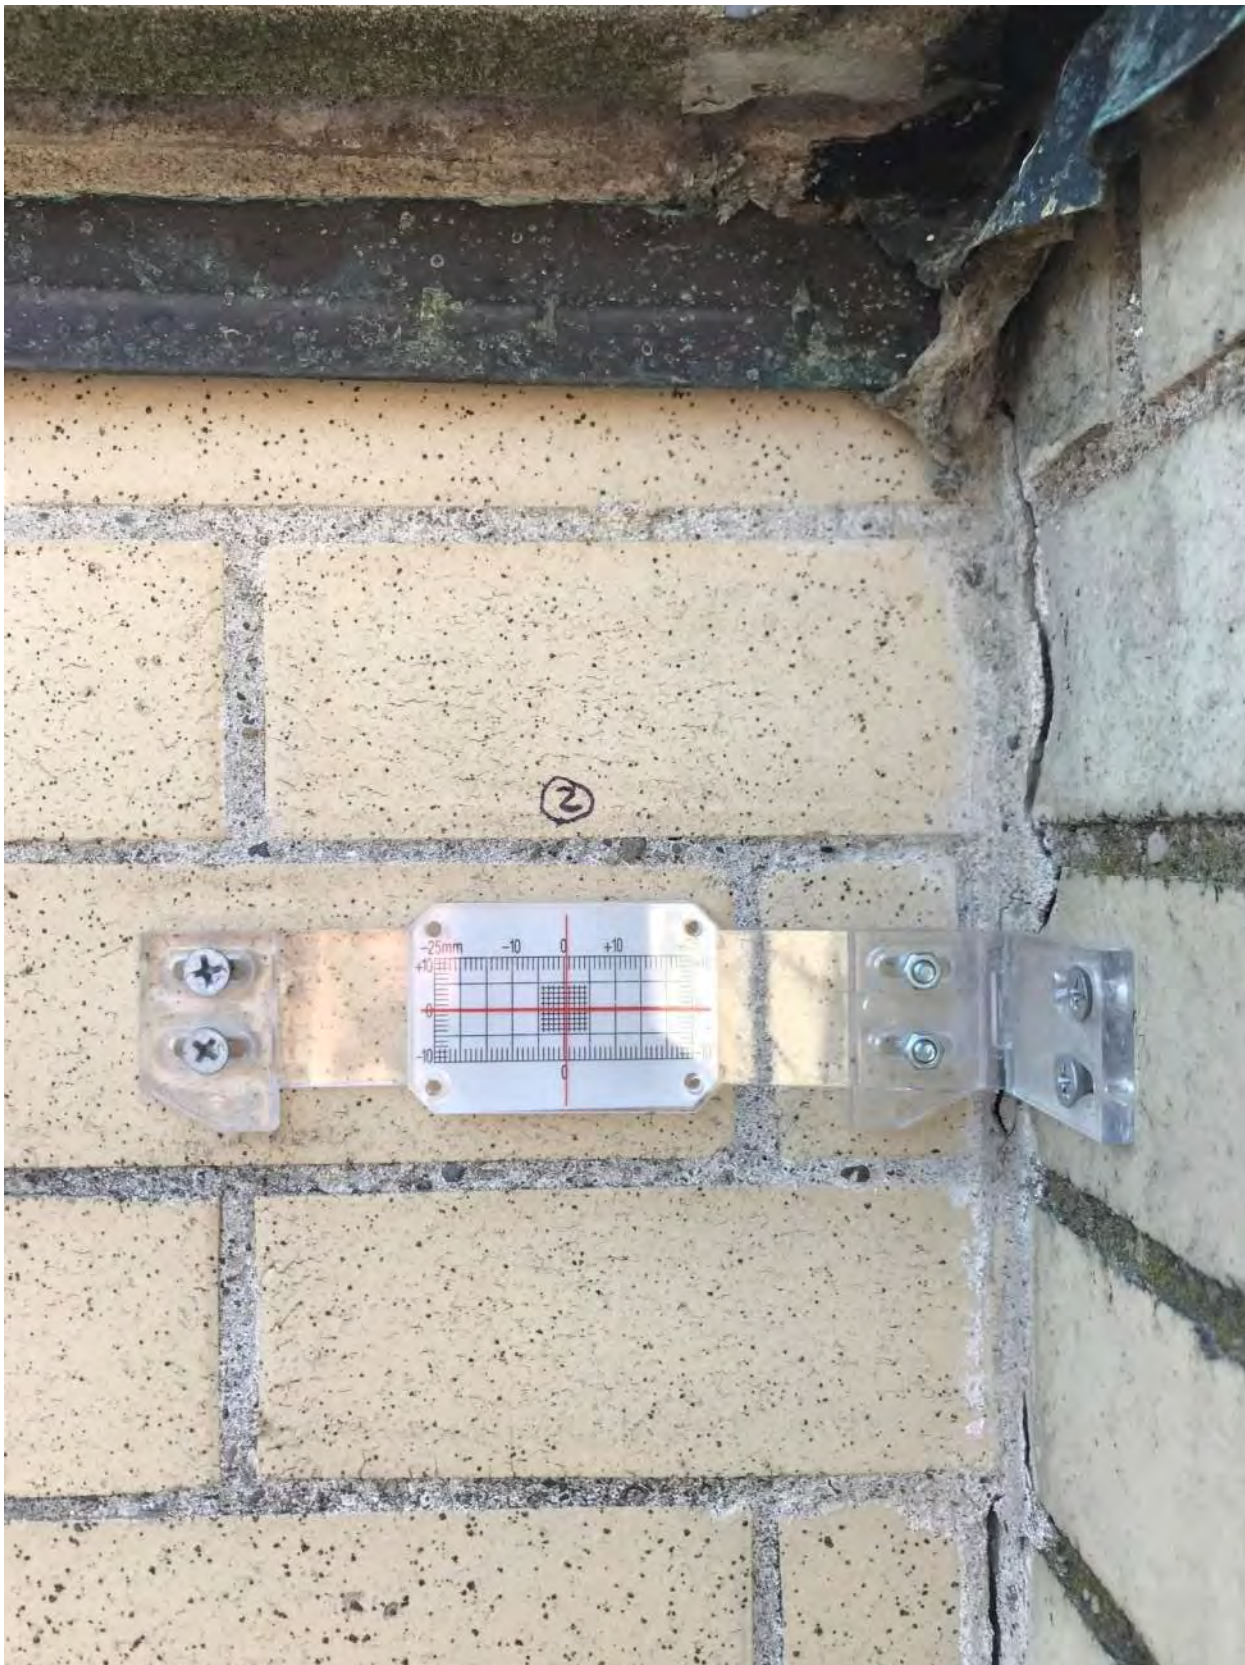
PHOTO 2A - DETAILED

+0.5_{mm} Horizontal Movement

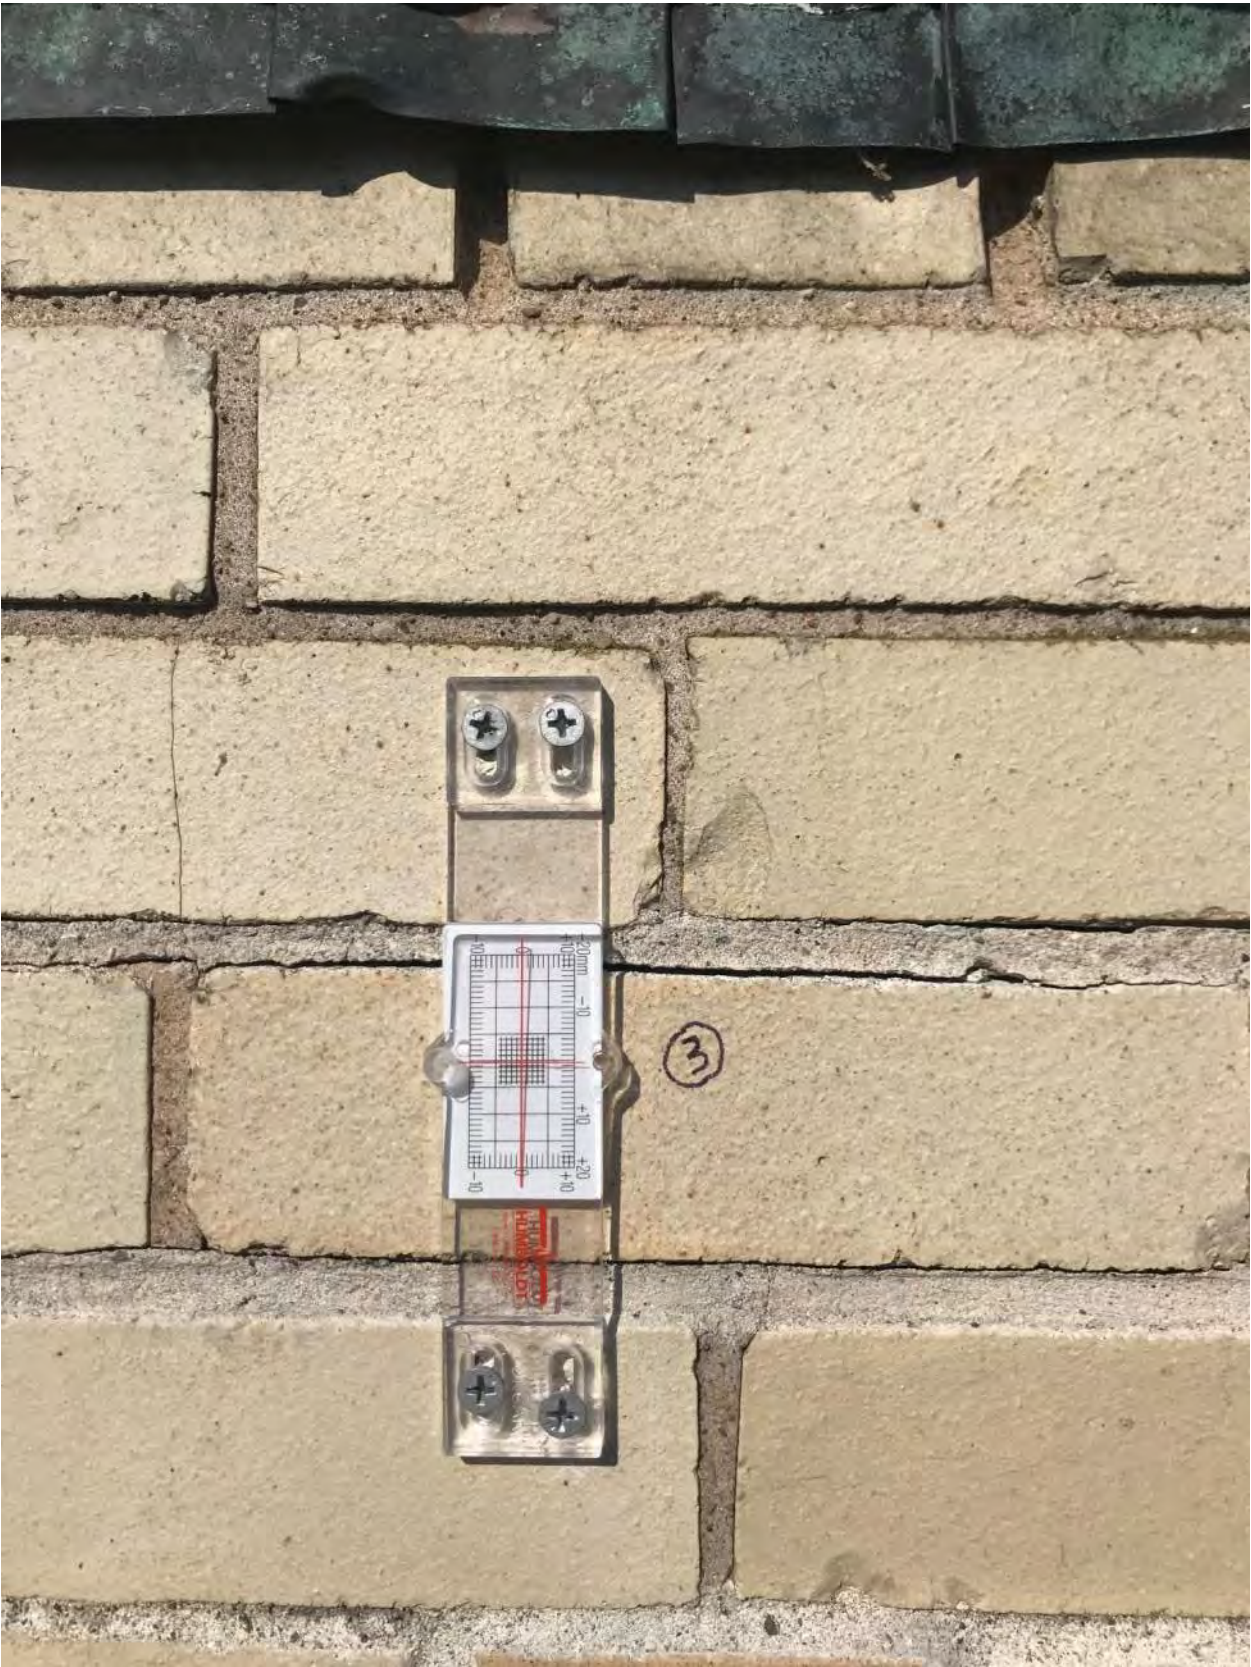
PHOTO 3A - DETAILED

+0.5_{mm} Vertical Movement

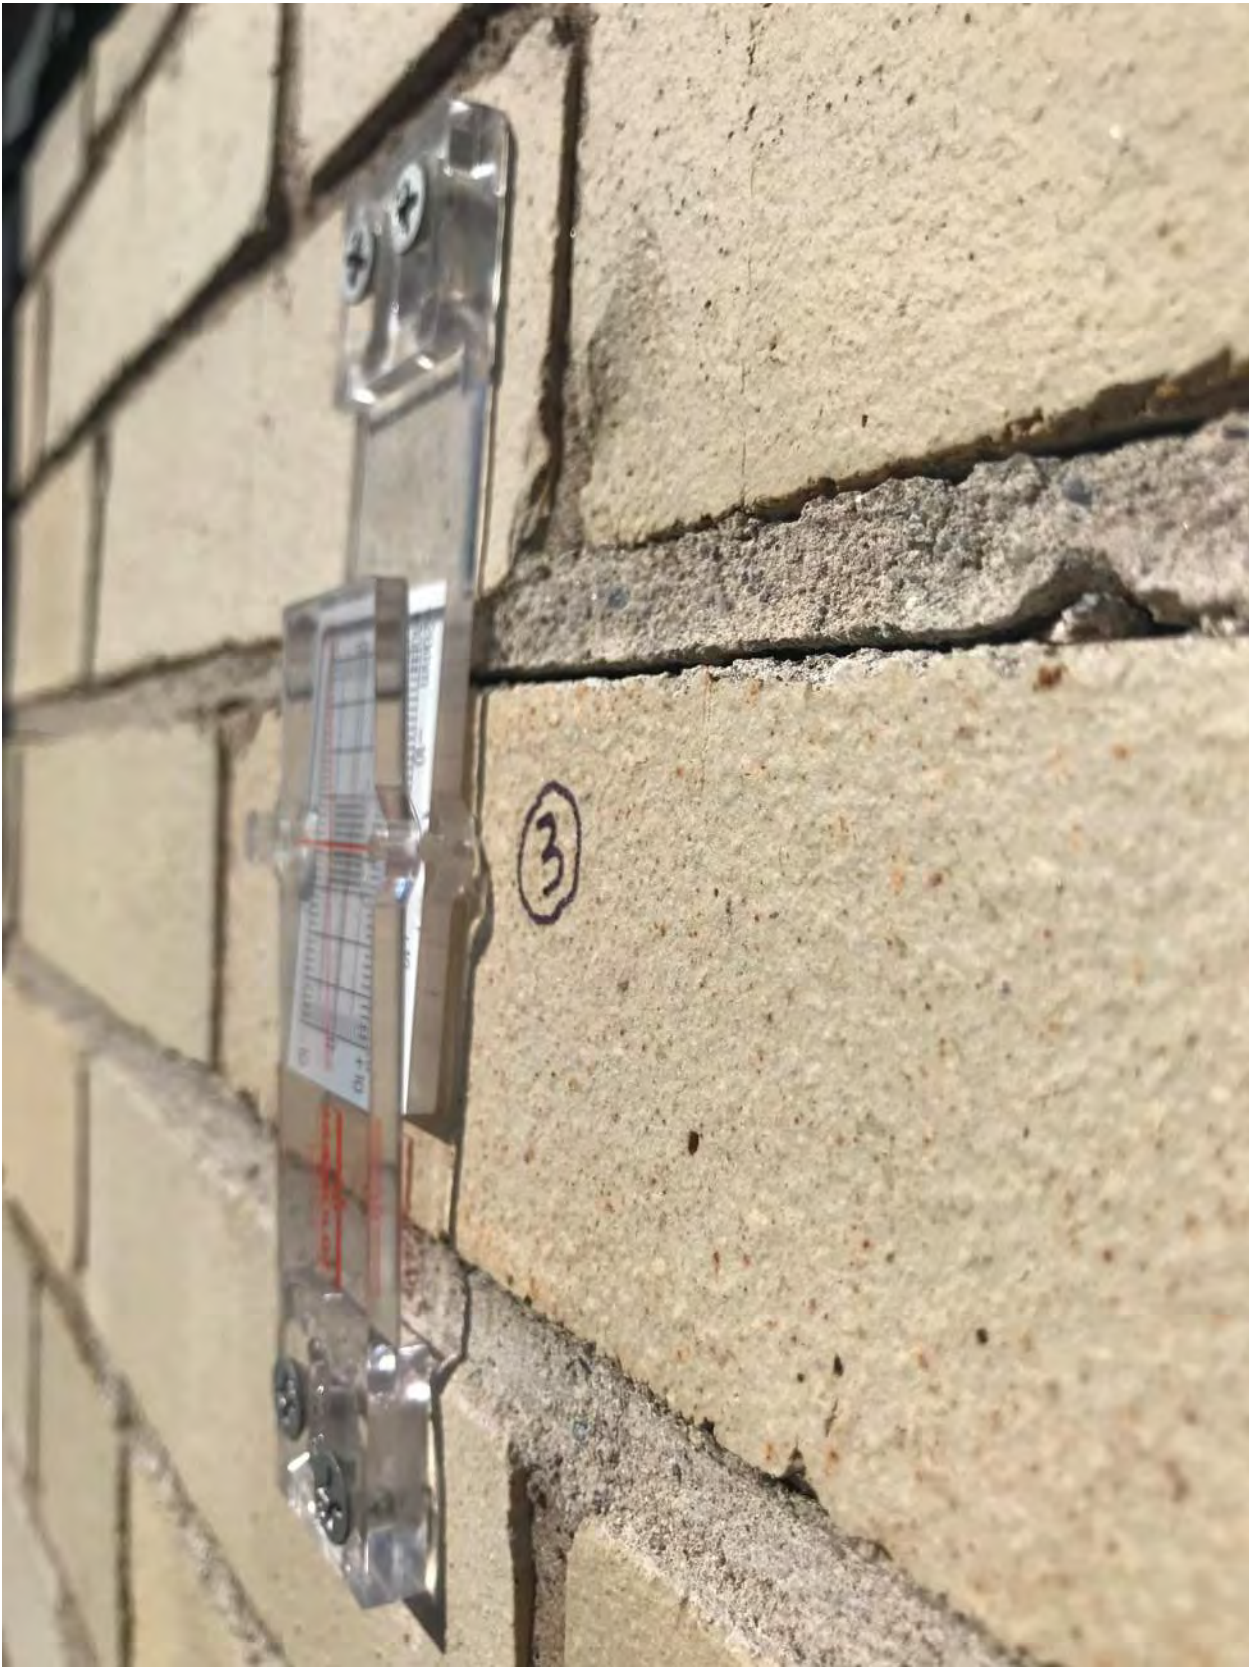
PHOTO 3B - DETAILED

Gauge out of plane

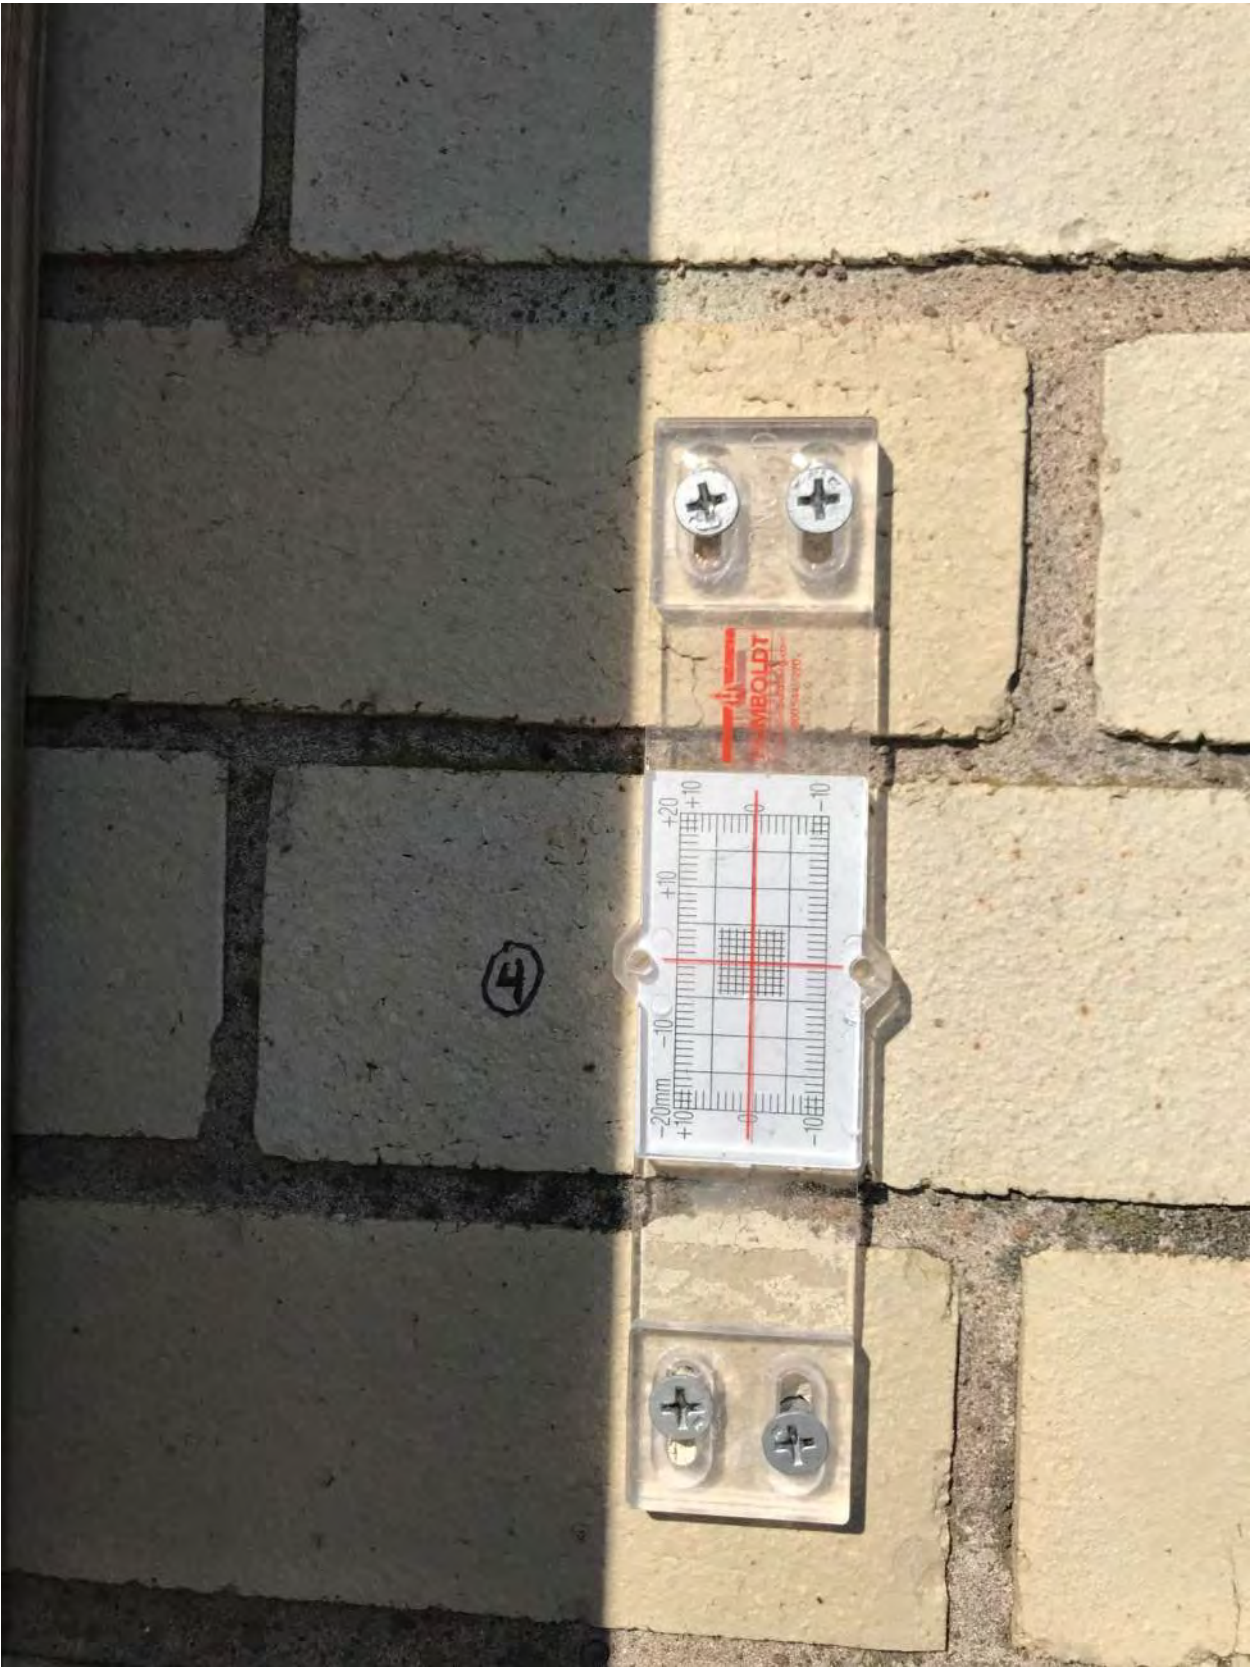
PHOTO 4A - DETAILED

0_{mm} Movement

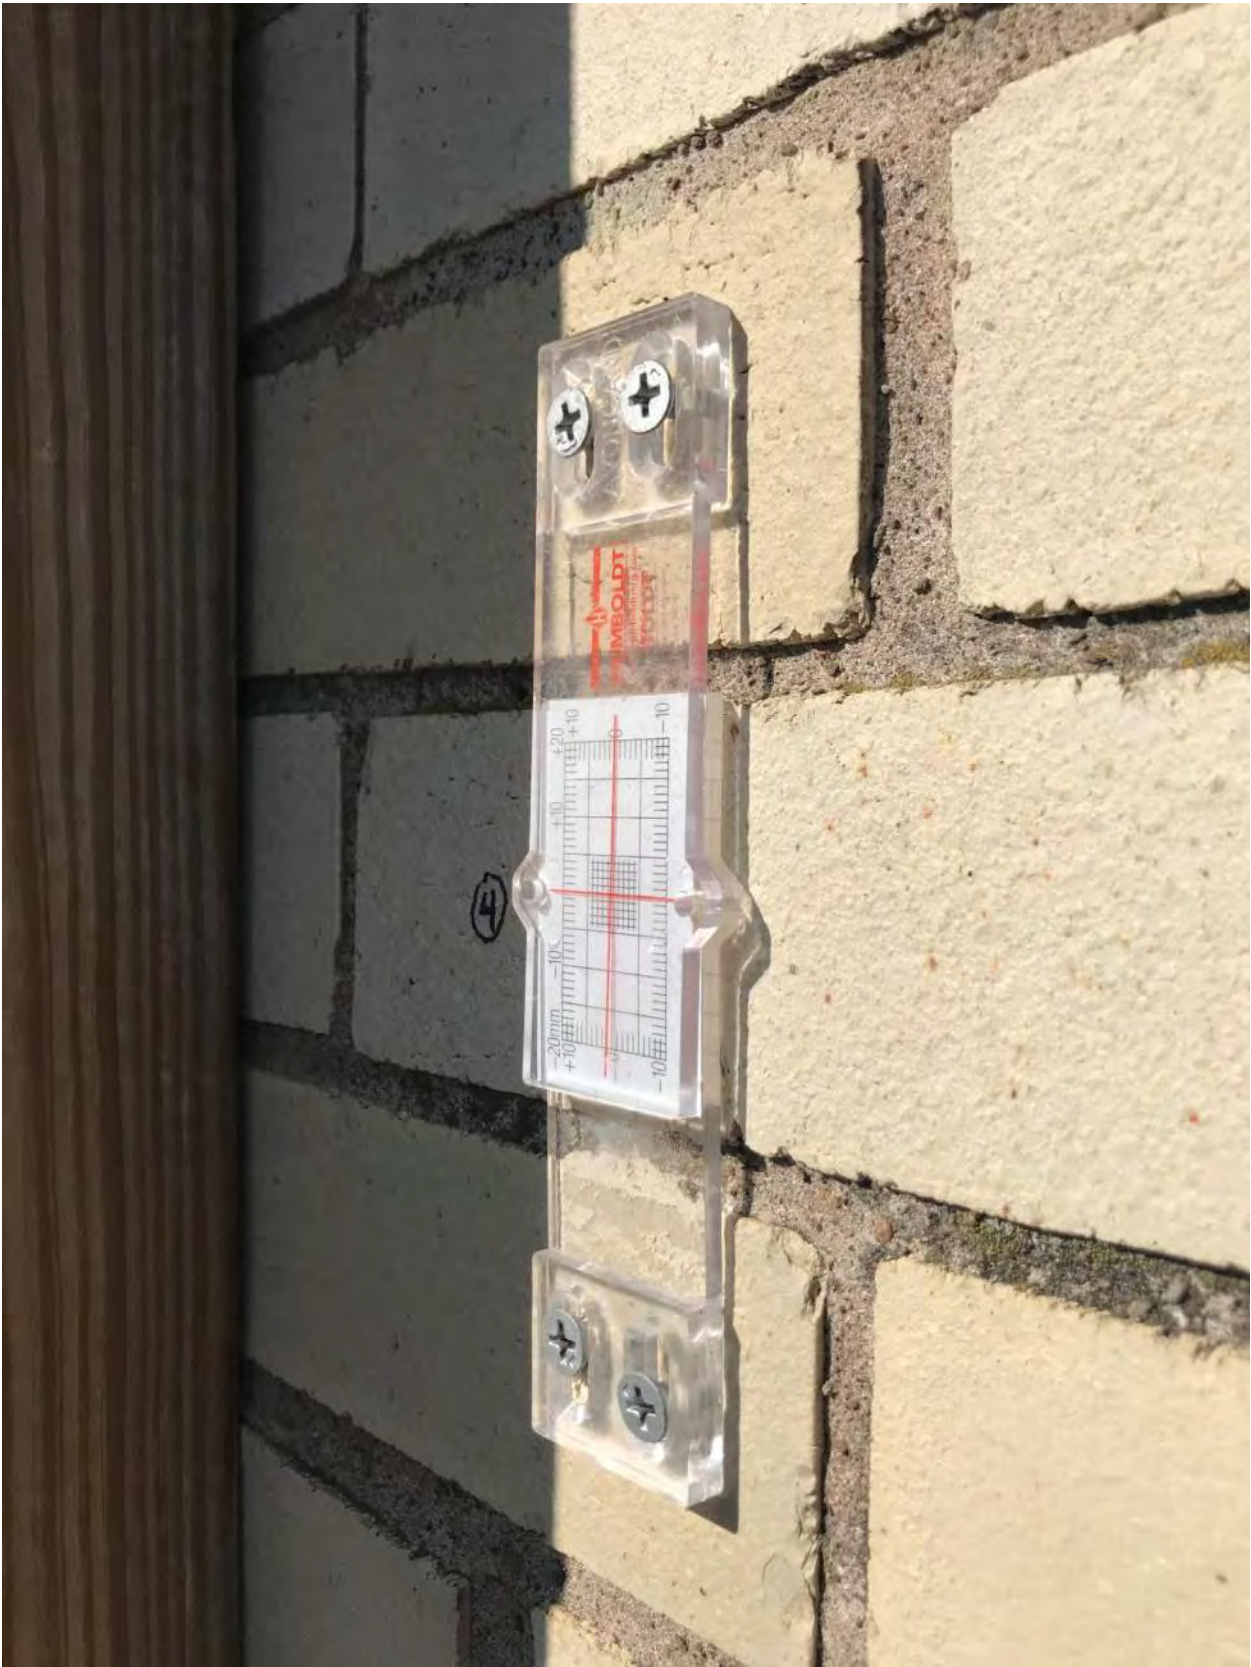
PHOTO 4B - DETAILED

Gauge slightly out of plan

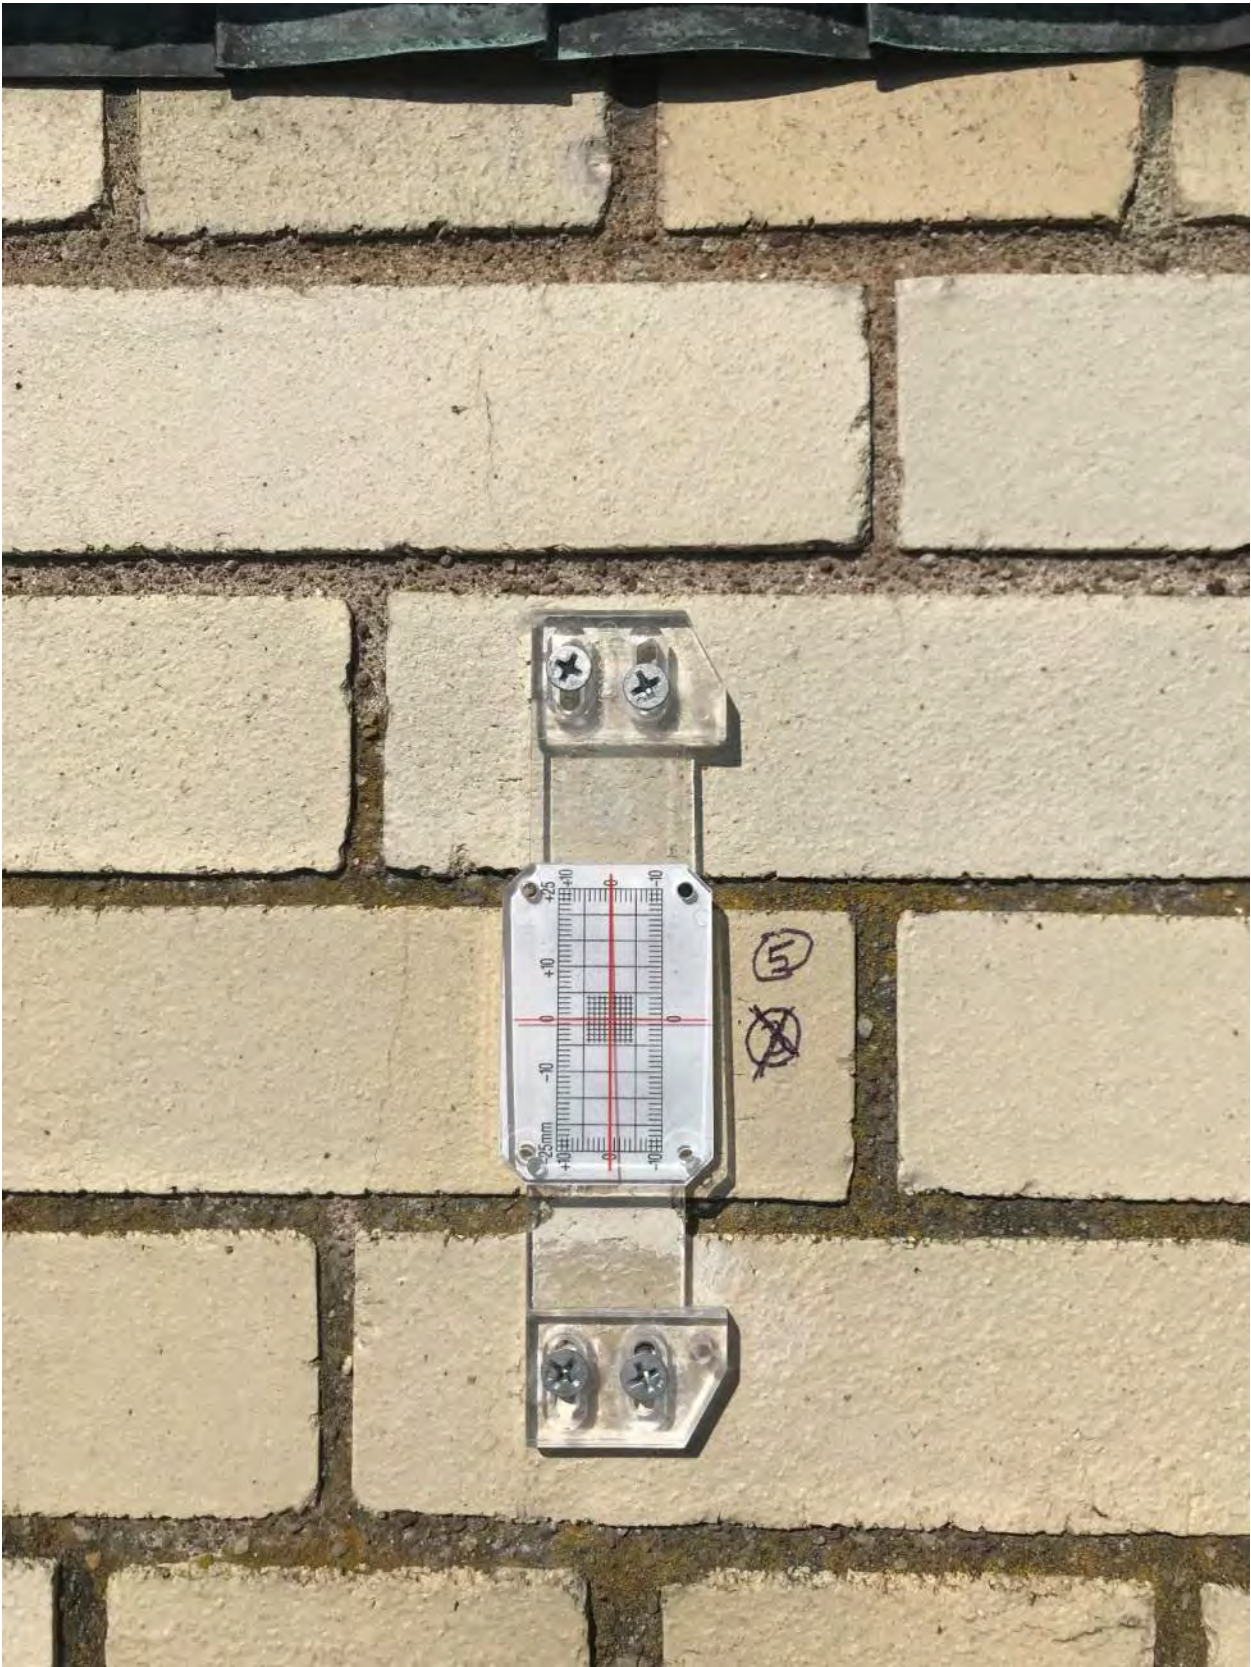
PHOTO 5A - DETAILED

0_{mm} Movement

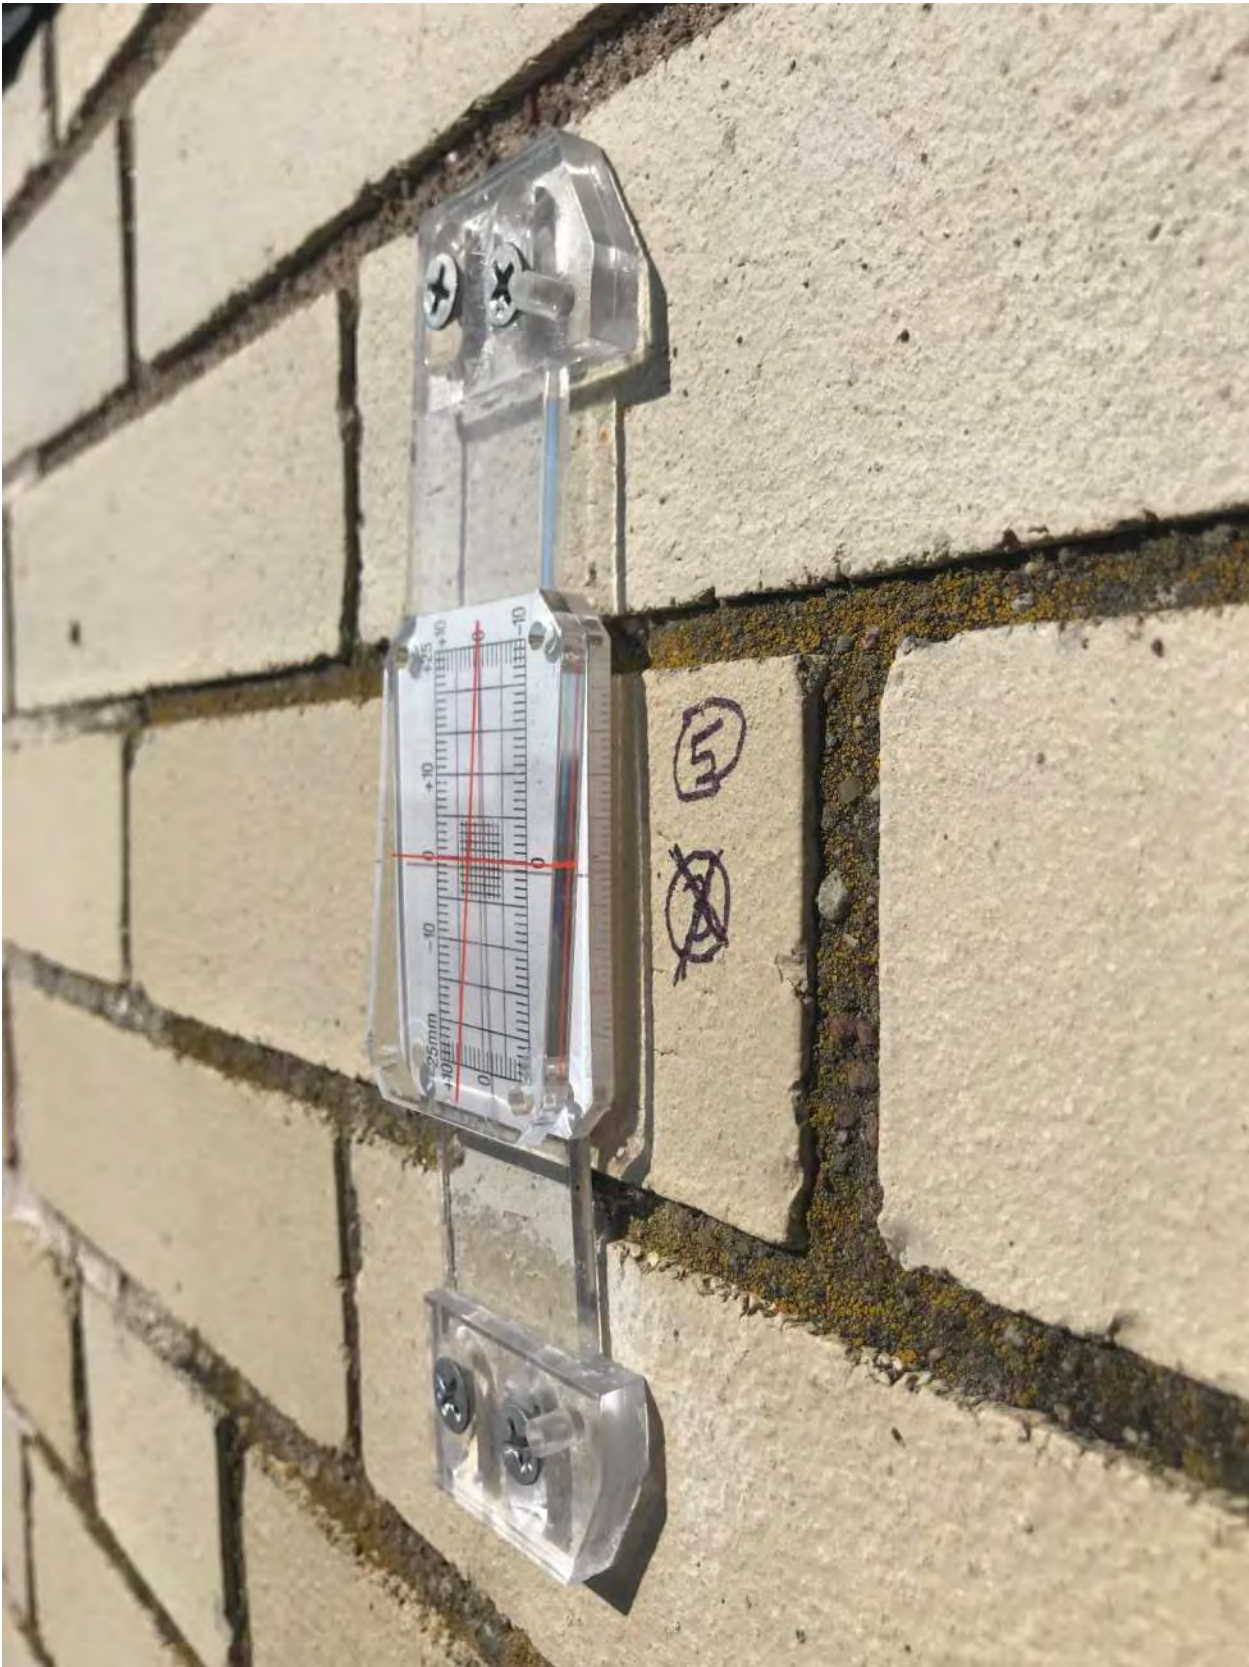
PHOTO 5B - DETAILED

Gauge out of plane
