RUNDEL LIBRARY Parapet Monitoring

AUGUST 2019

LBA PROJECT NO. 217916.08

RE: Rundel Library High Parapet Monitoring
115 South Avenue, Rochester NY
LaBella Project No. 2171916.08

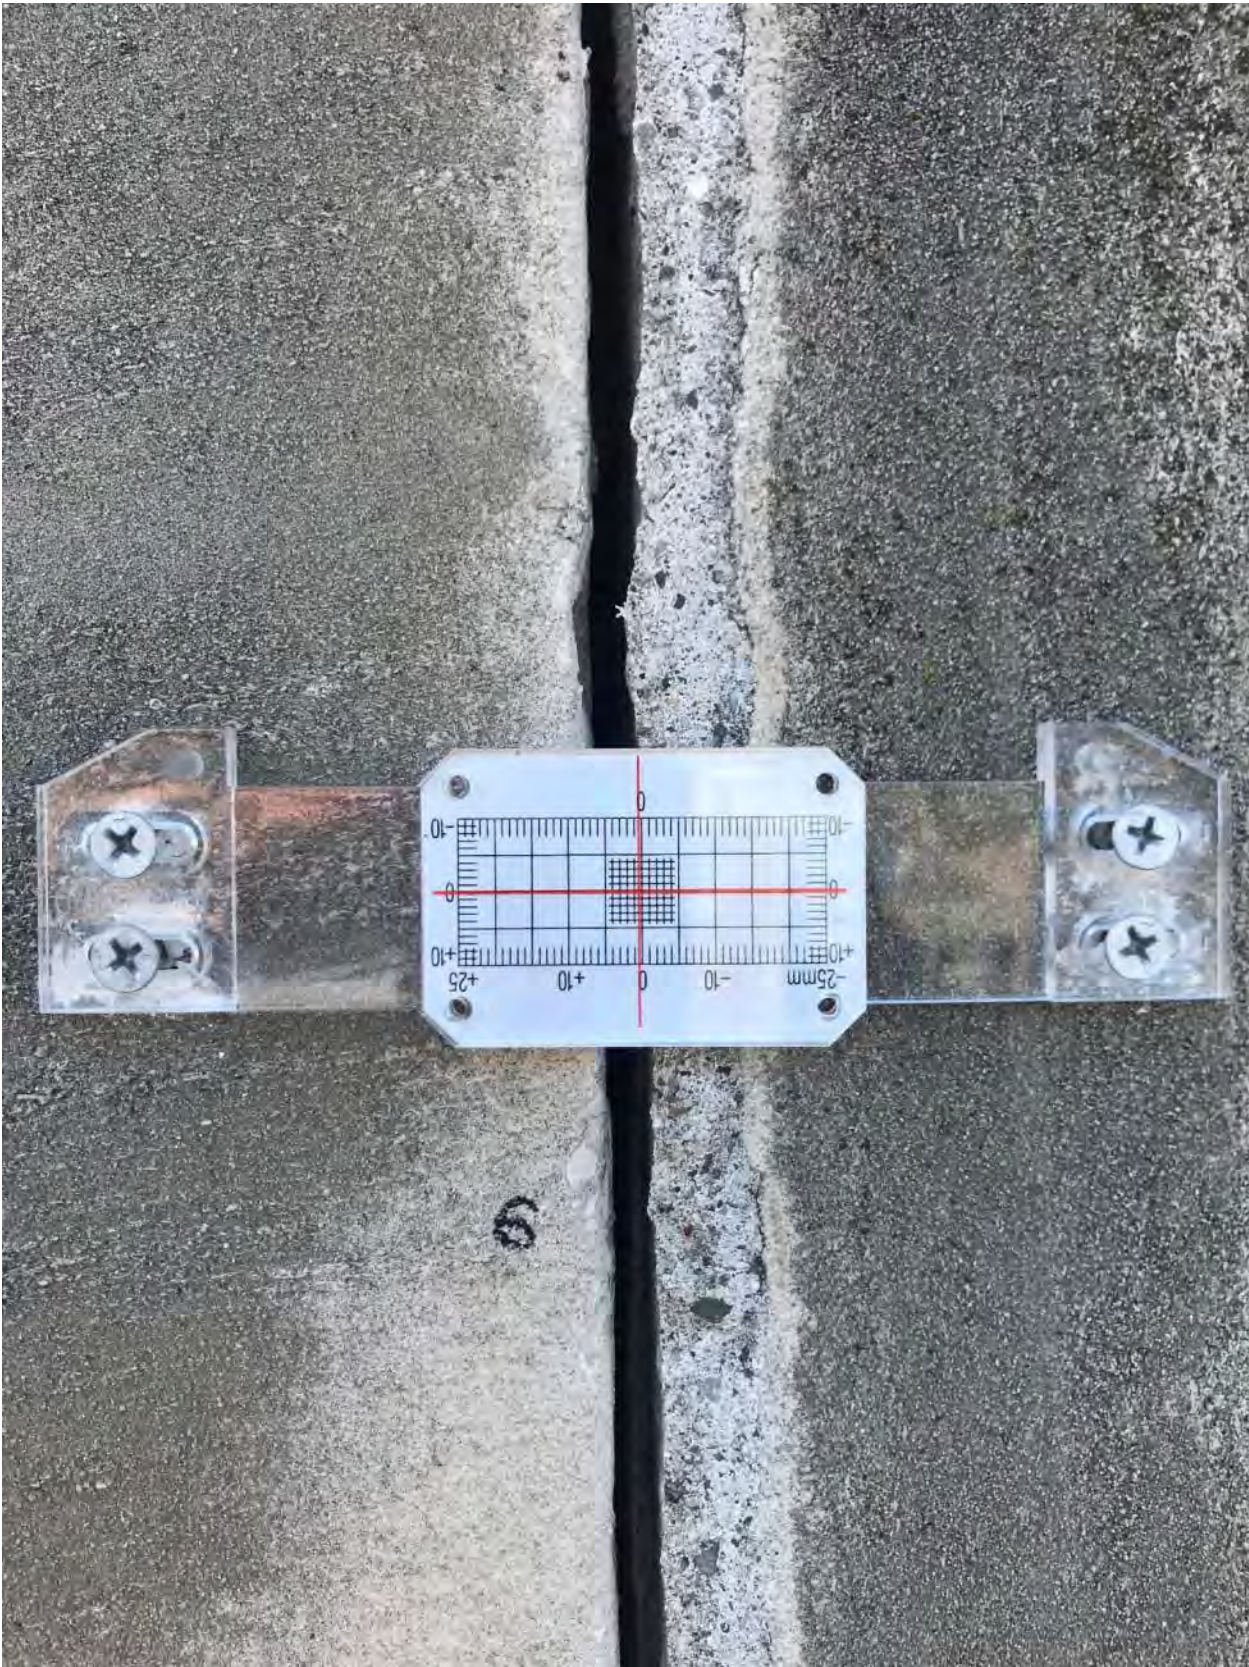
PHOTO 6A - DETAILED

-0.5_{mm} Horizontal Movement

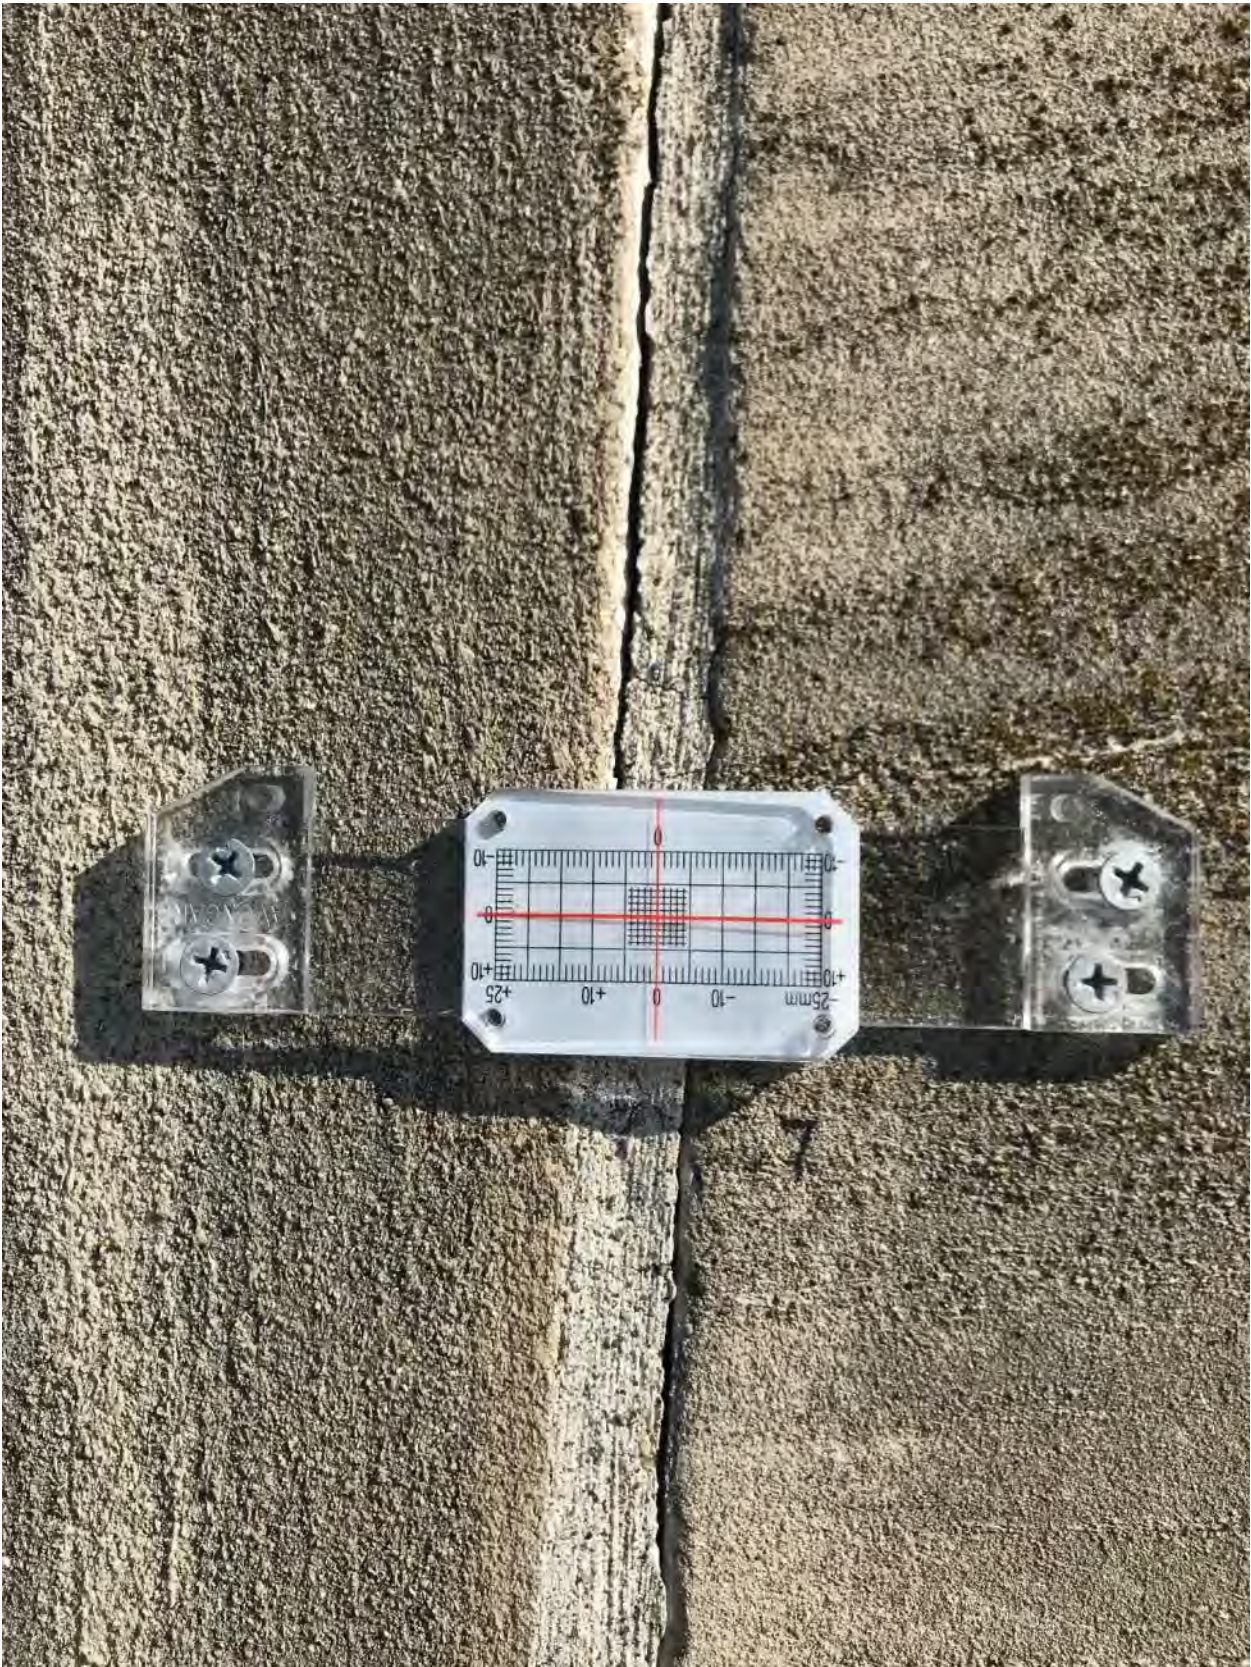
PHOTO 7A - DETAILED

0_{mm} Movement

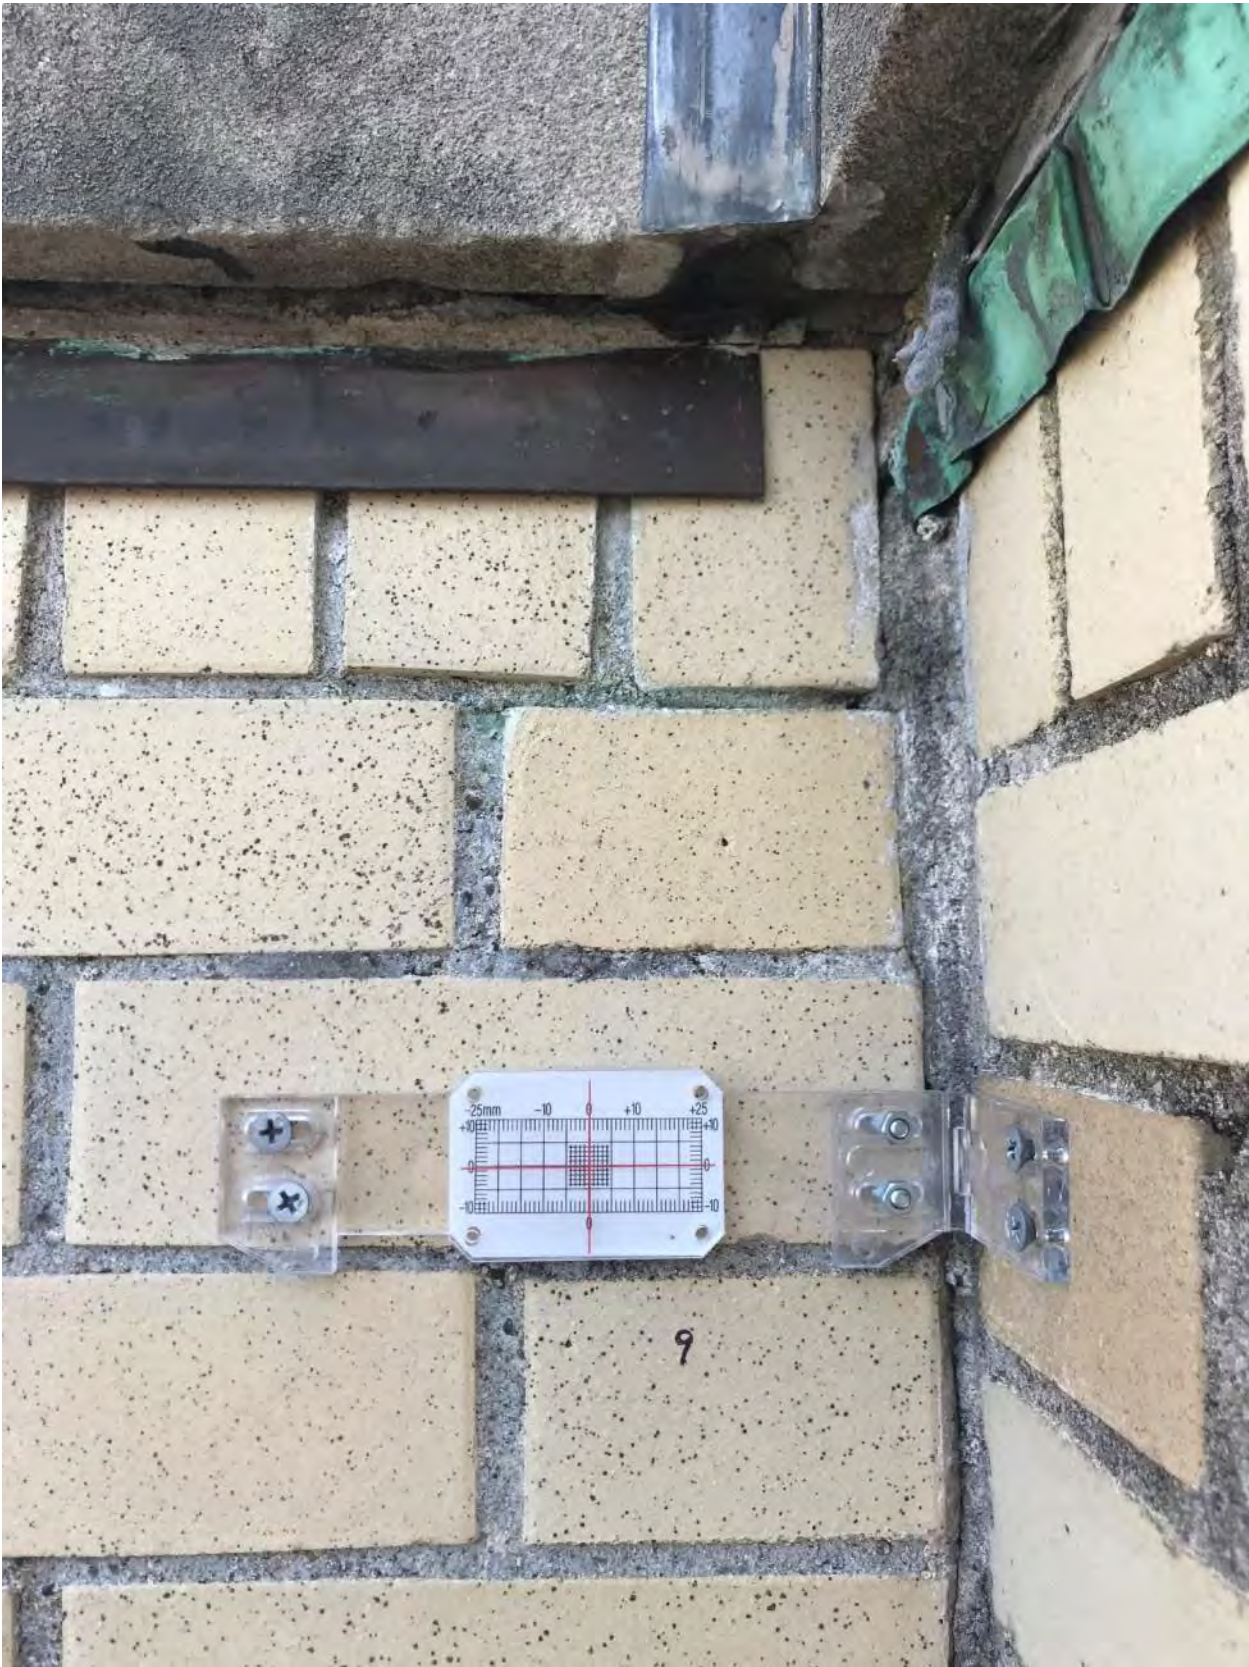
PHOTO 9A - DETAILED

0_{mm} Movement

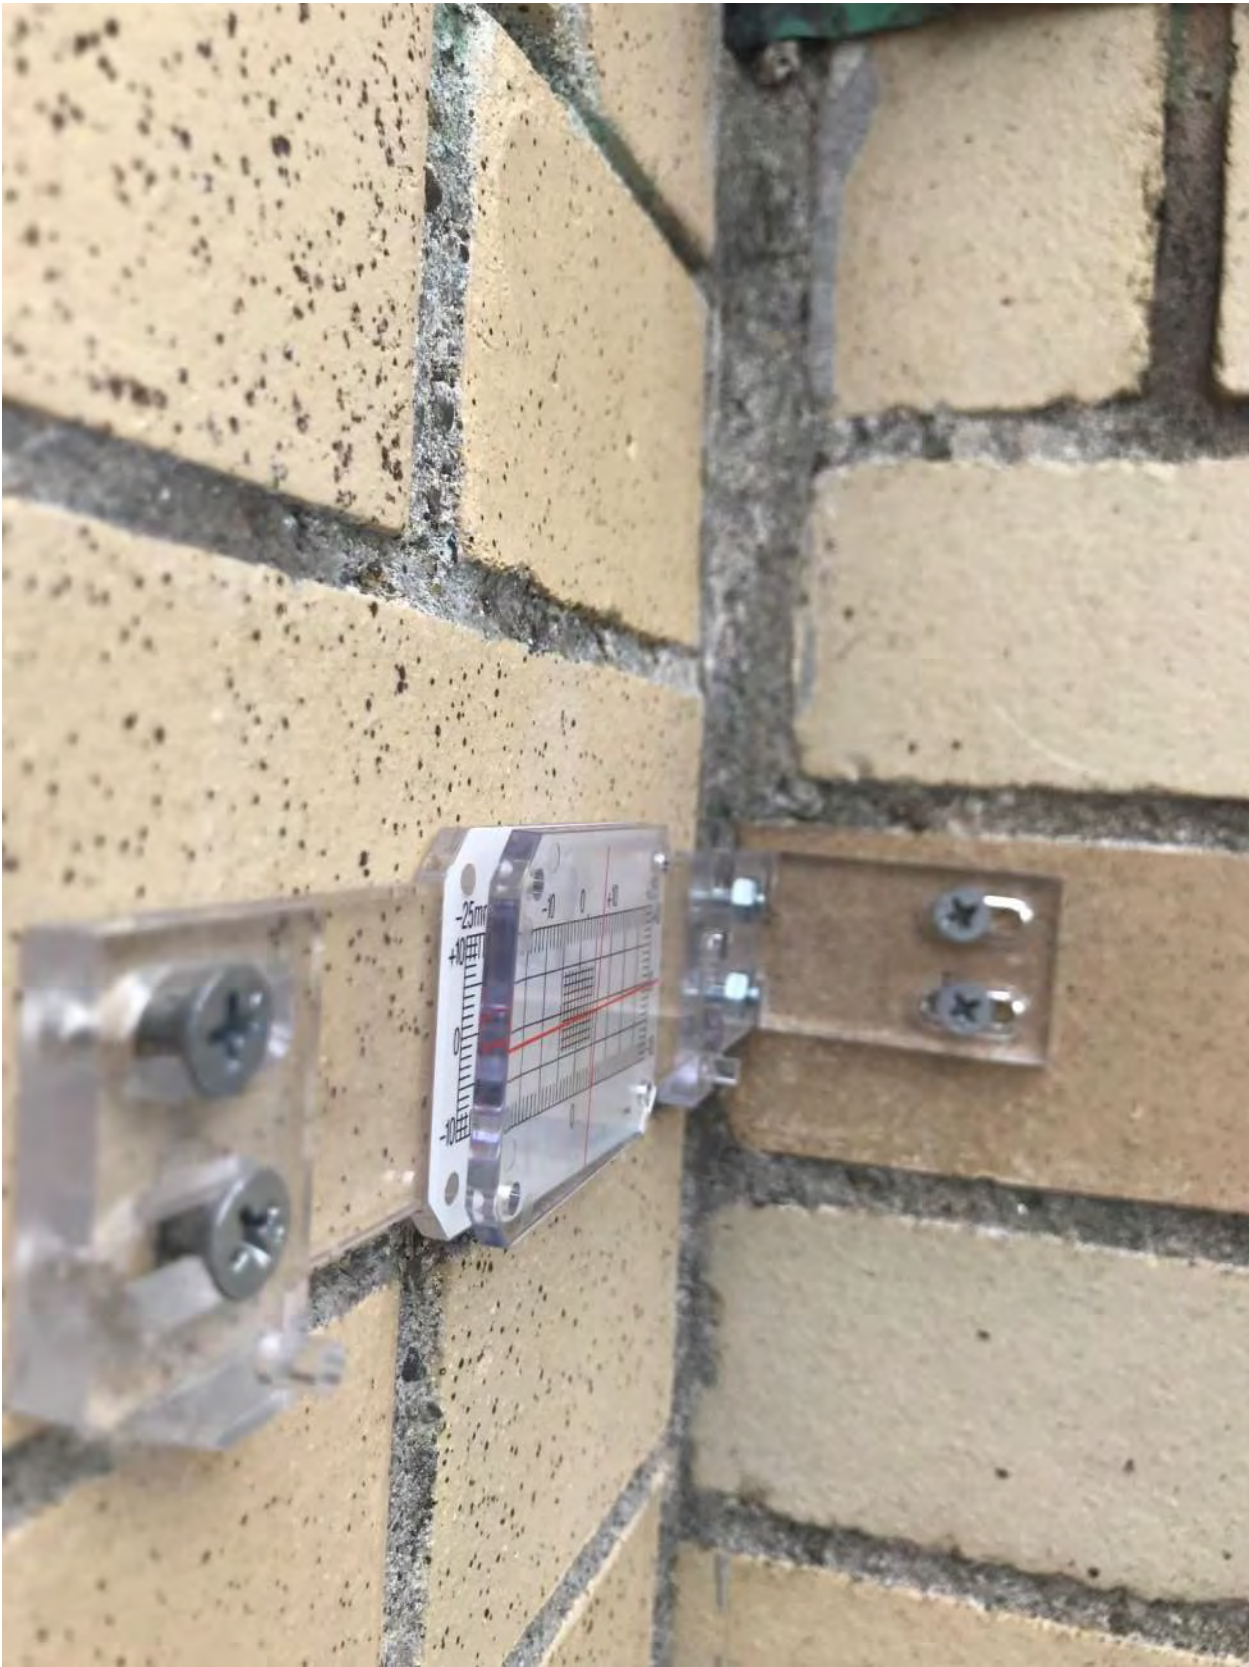
PHOTO 9B - DETAILED

Gauge out of plane

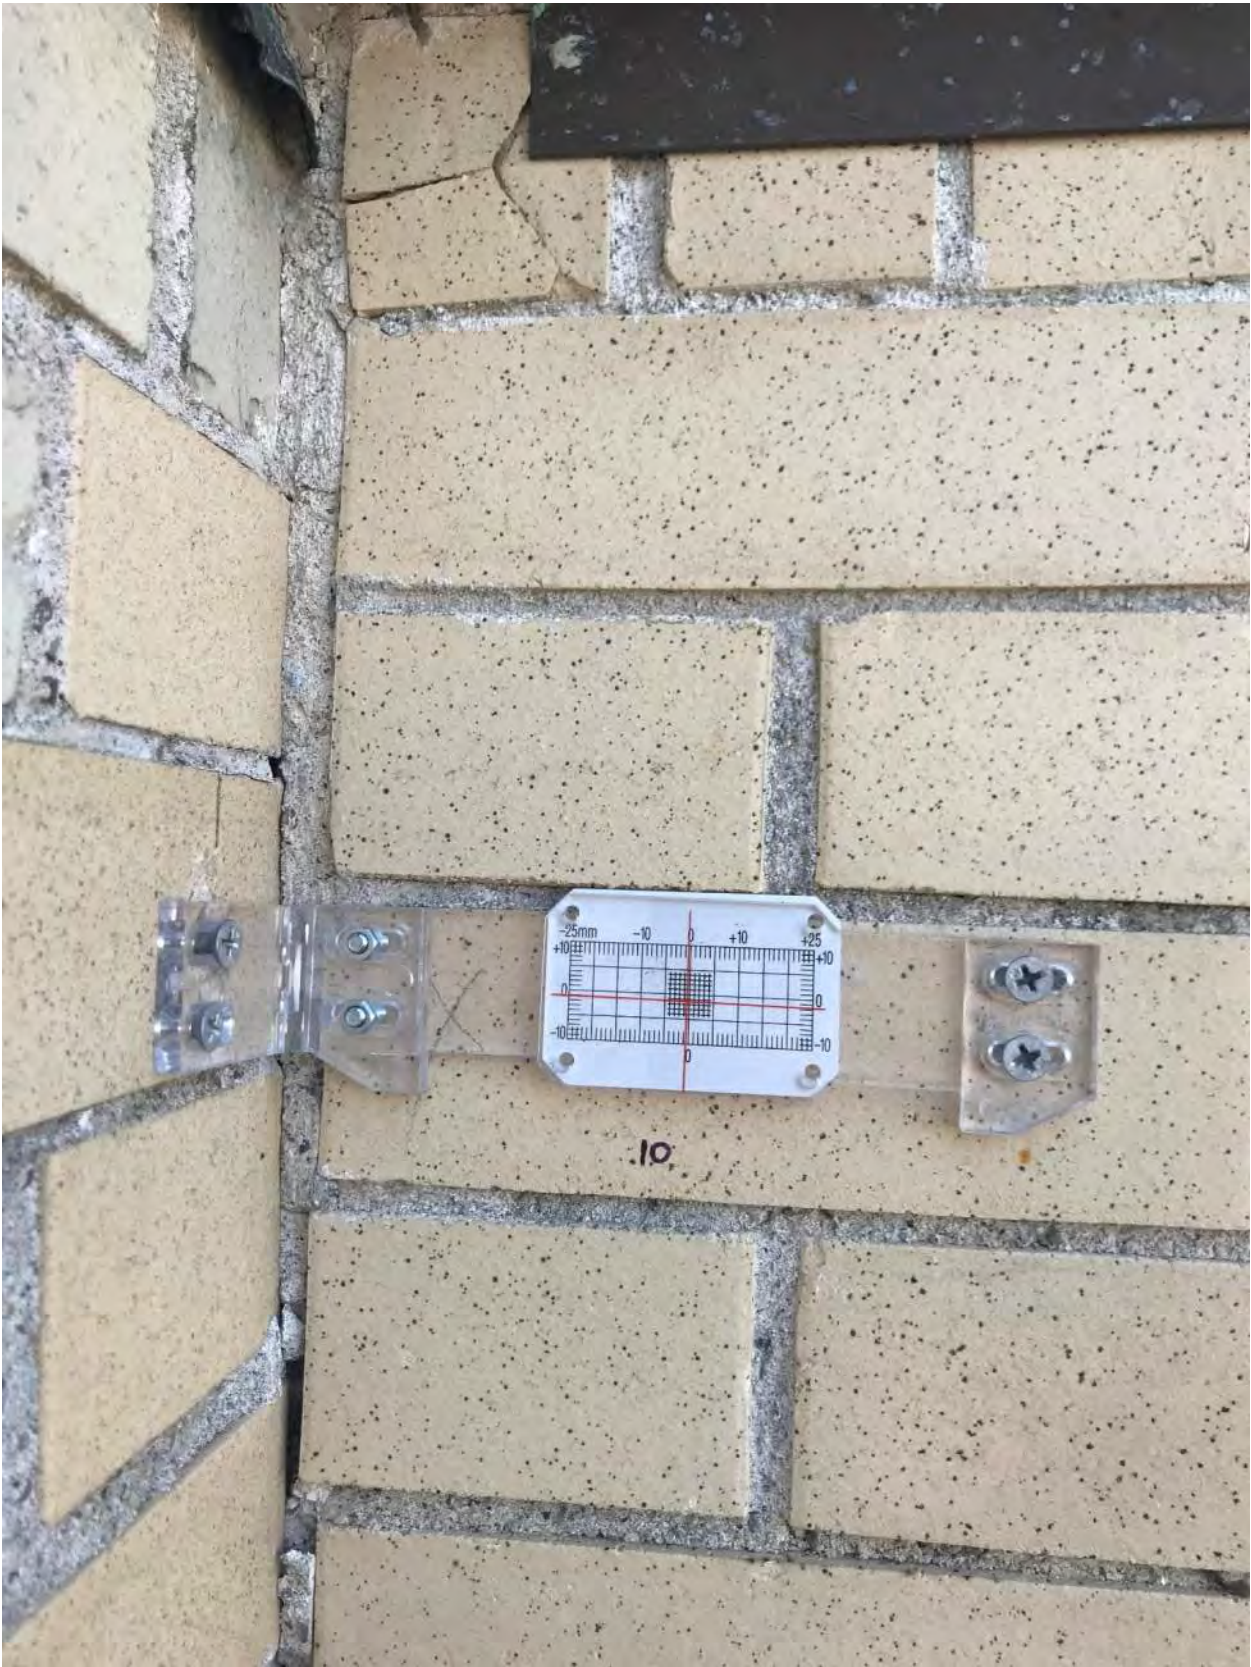
PHOTO 10A - DETAILED

-0.5_{mm} Horizontal Movement | 1.5_{mm} Vertical Movement

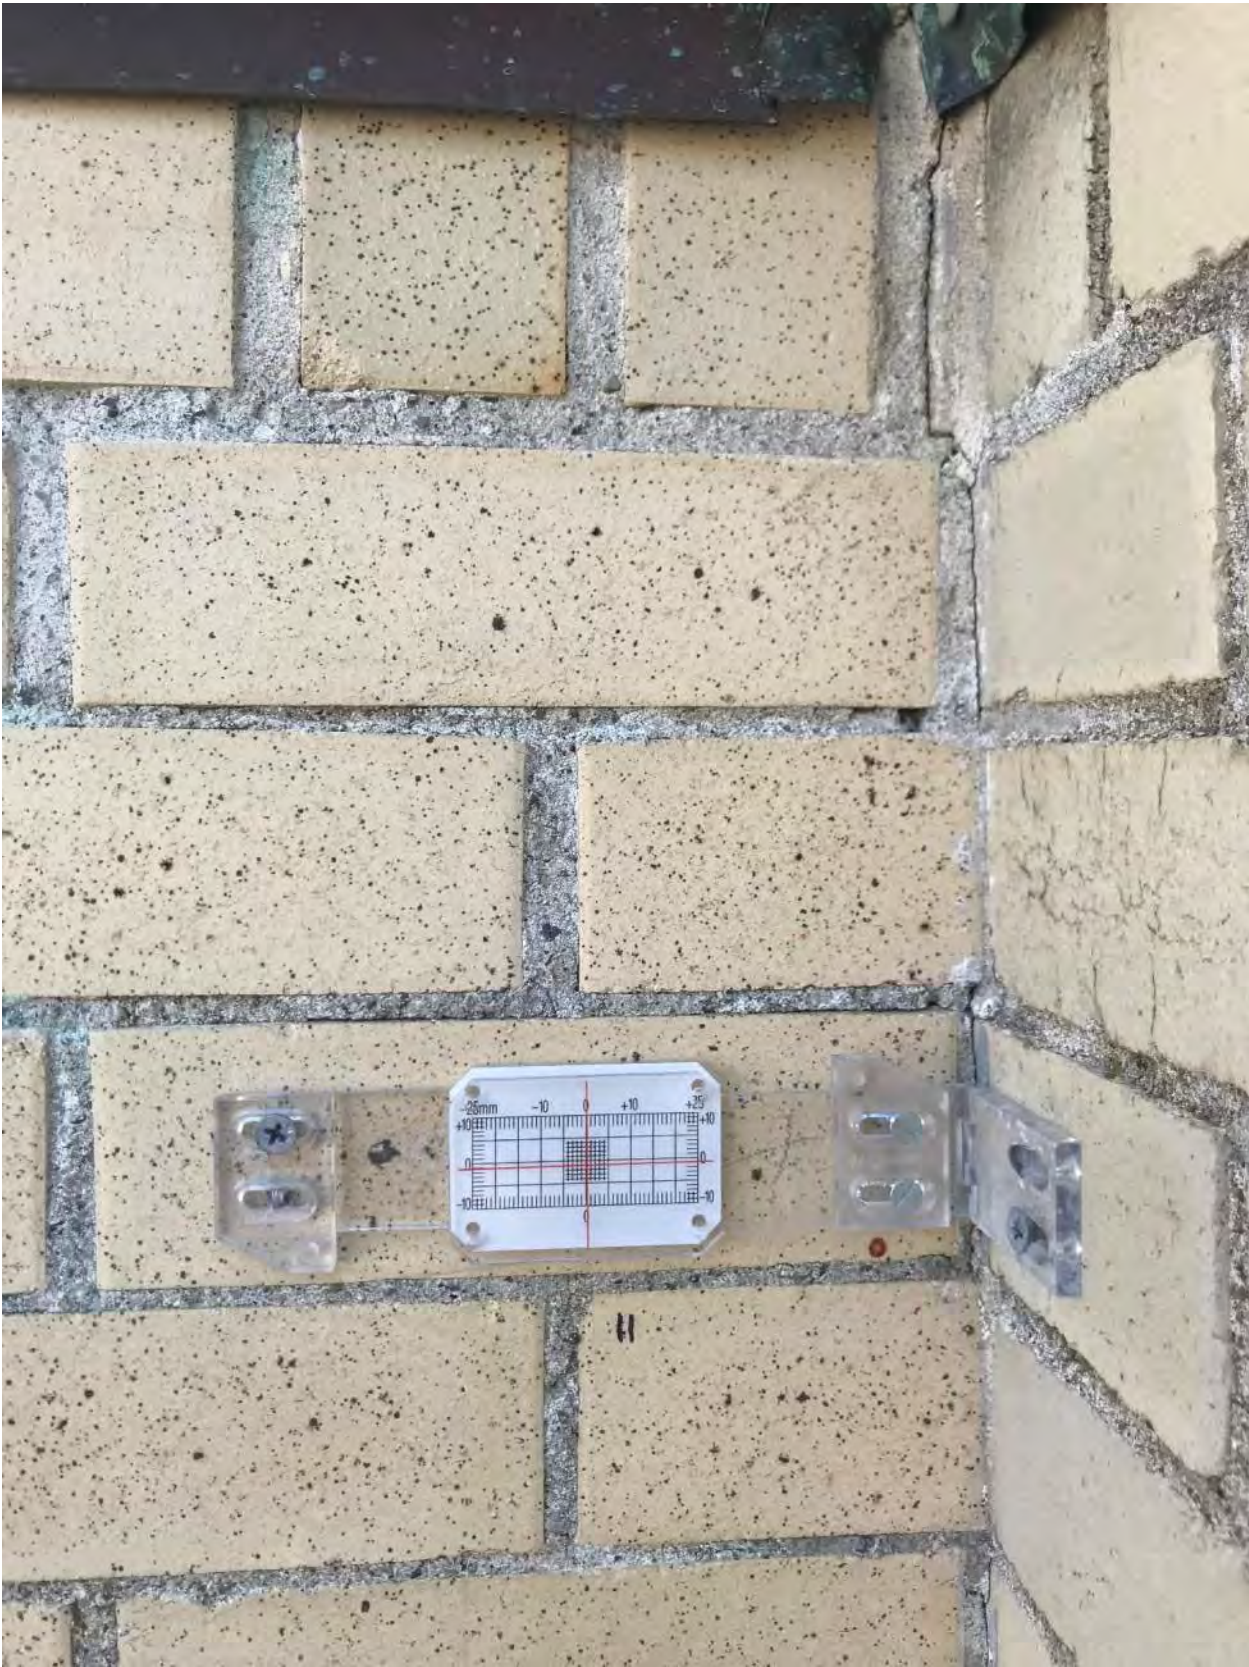
PHOTO 11A - DETAILED

1_{mm} Vertical Movement
