RUNDEL LIBRARY Parapet Monitoring – Drone Inspection

SEPTEMBER 2019

**RE: Rundel Library High Parapet Monitoring
115 South Avenue, Rochester NY
LaBella Project No. 2171916.08**

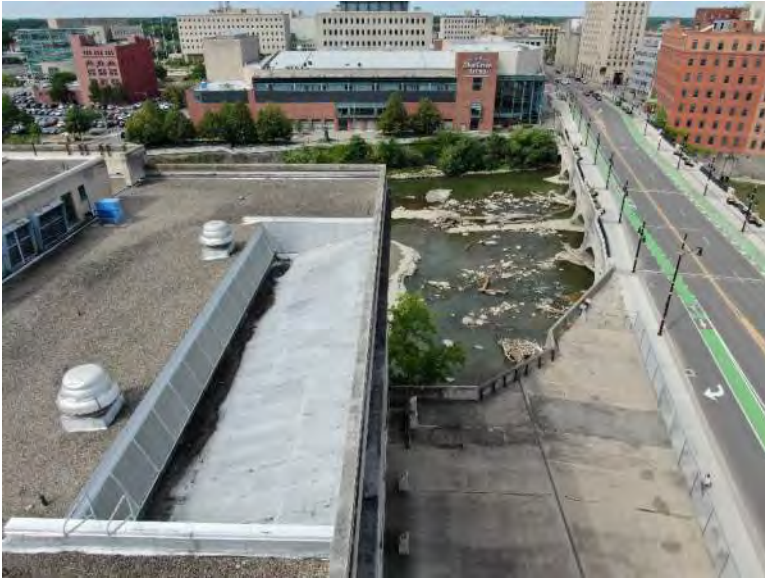
PHOTO 1
North Parapet

The north parapet extends approximately 3 feet above roof level. [Photo 1]

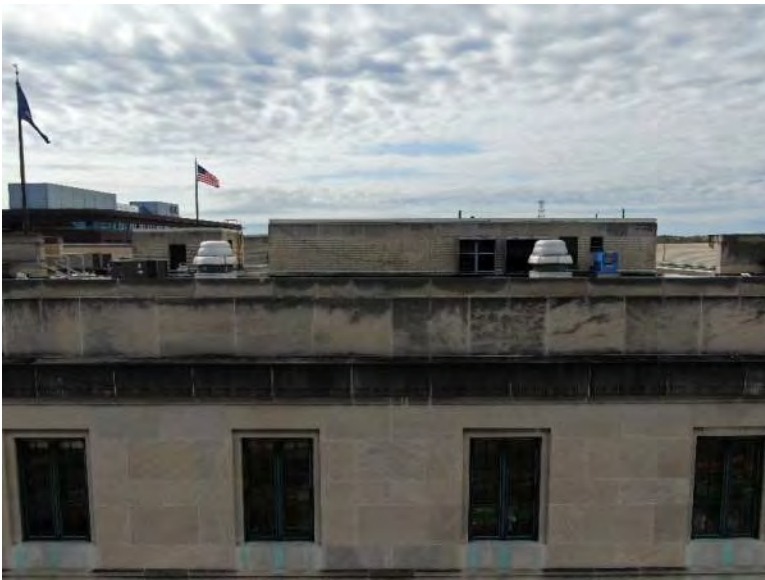
PHOTO 2
North Parapet

- Sealant deterioration and gaps are visible between stone façade panels along the parapet's length. [Photo 2]
- 3 adjacent stone façade panels near the center of the parapet appear to be leaning away from the building, with large sealant gaps between the tops of panels and the parapet cap stones above. [Photos 3 - 6]

Sealant gaps between panels

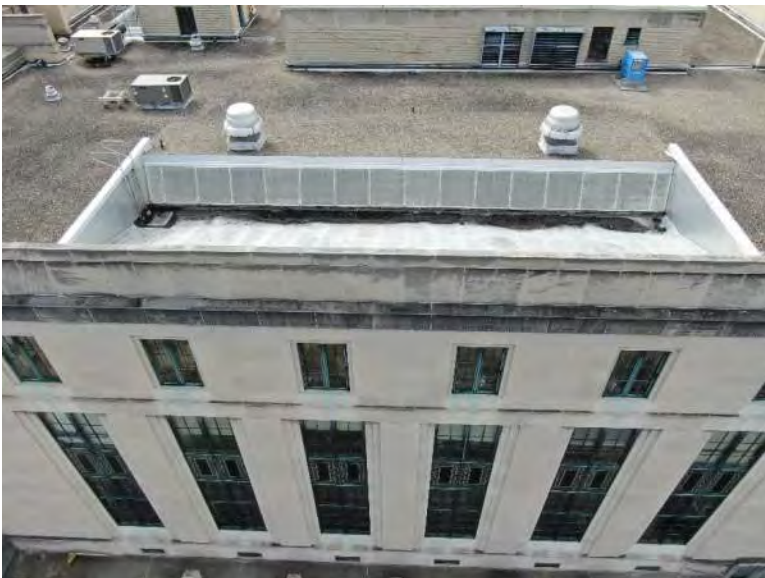
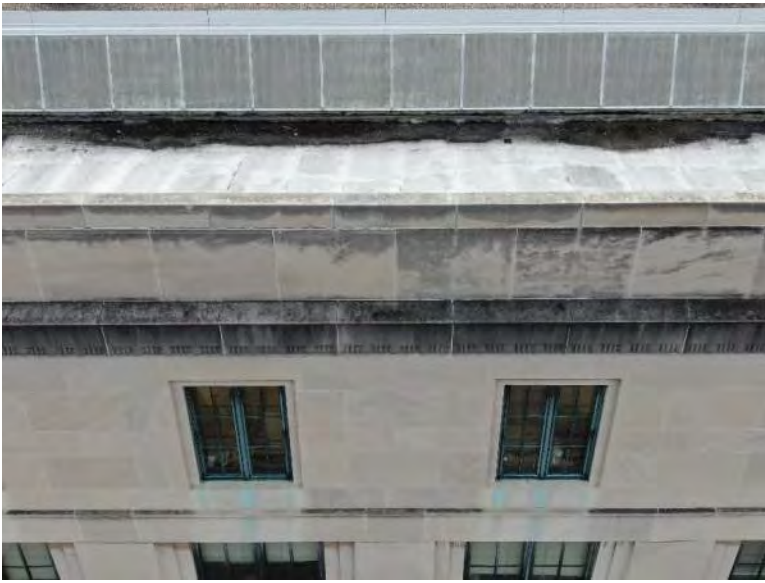
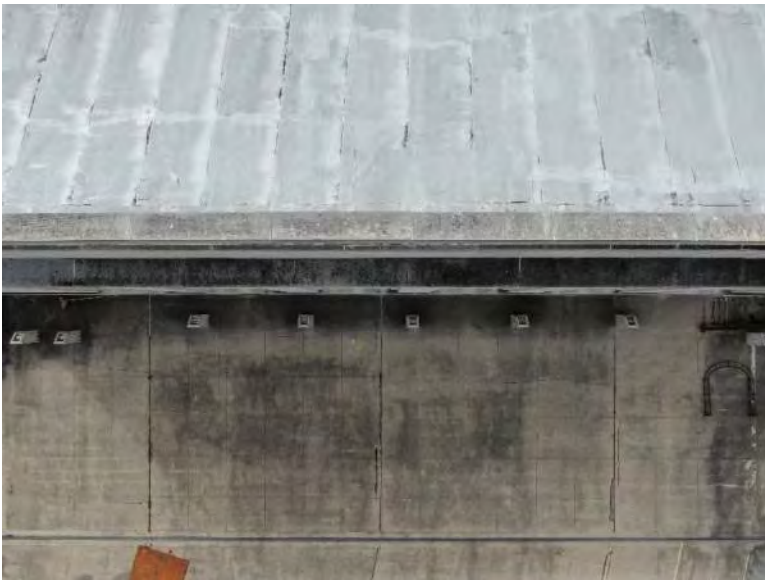
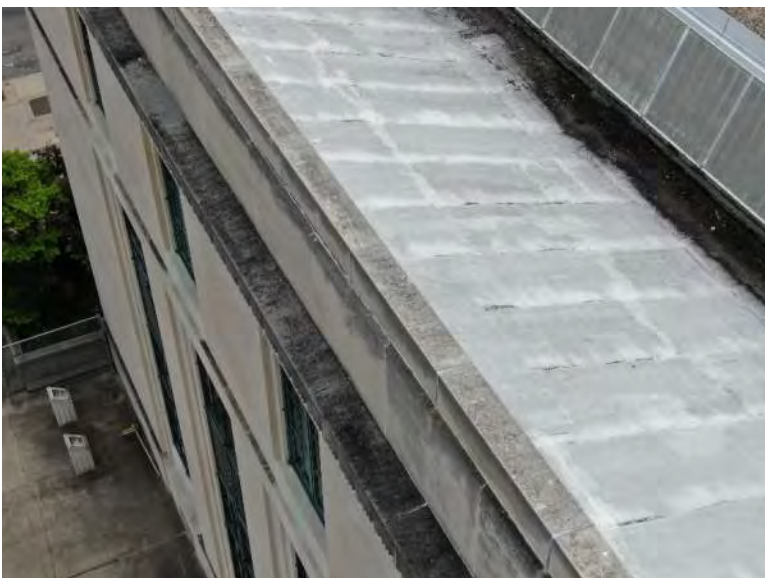
3 panels leaning away from parapet

It is our opinion that the 3 stone façade panels on the north parapet should be restrained from falling in a manner similar to the braces that have been previously installed.

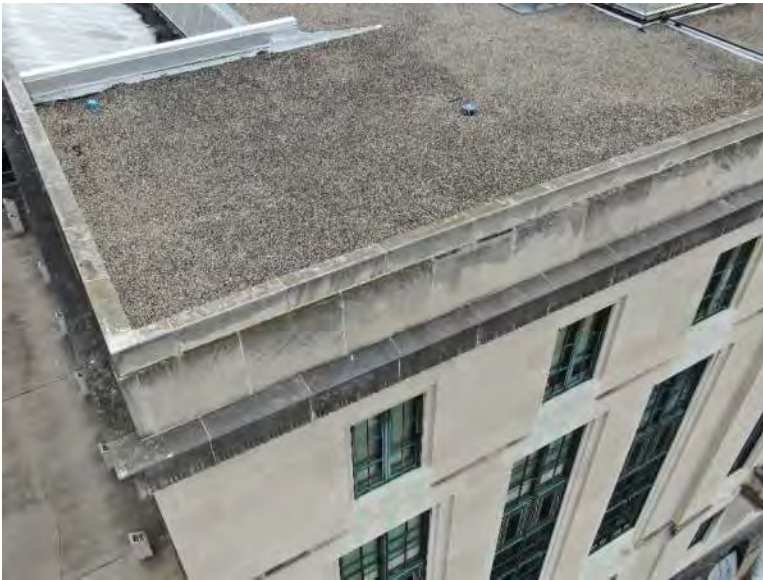
PHOTO 7
West Parapet

The northern portion of the west parapet extends approximately 3 feet above roof level. [Photo 7]

Northwest corner of west parapet

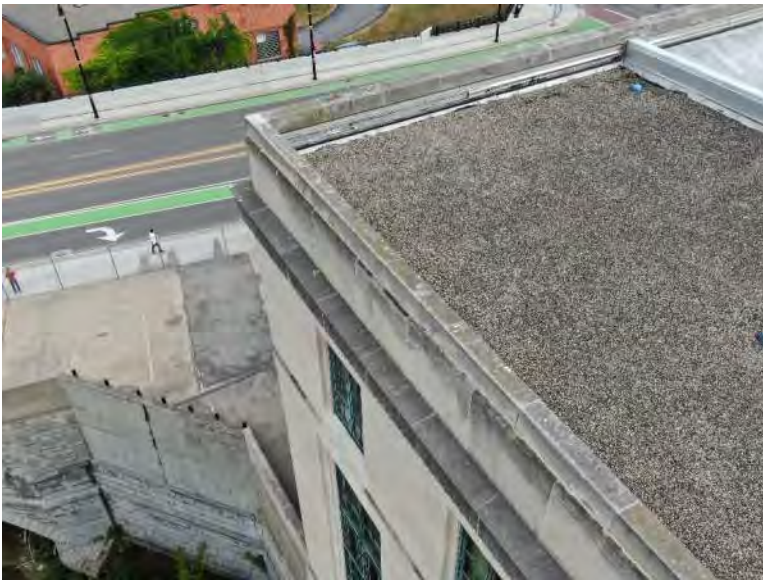
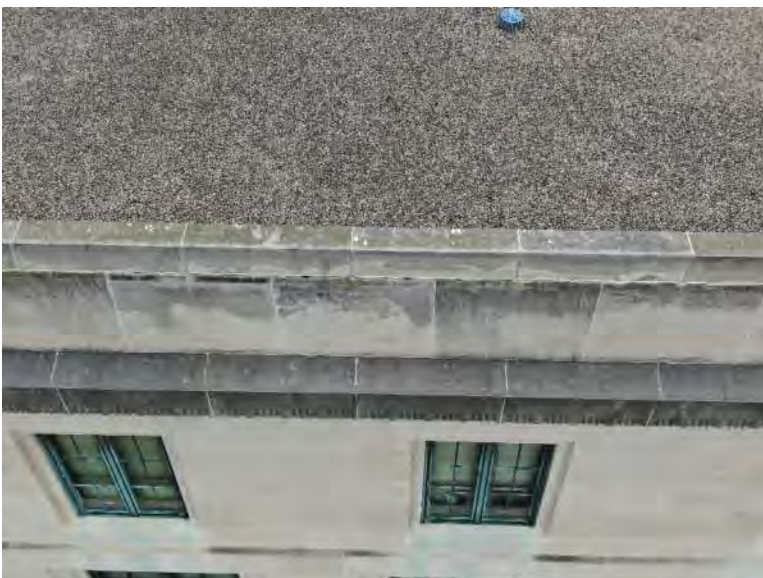
- Sealant deterioration and gaps are visible along the entire length of the northern portion of the west parapet in the horizontal joint between the stone façade panels and the parapet cap stones. [Photos 8 - 9]
 - These blocks do not appear to be out-of-plane or leaning away from the structure.

Sealant gaps along tops of panels

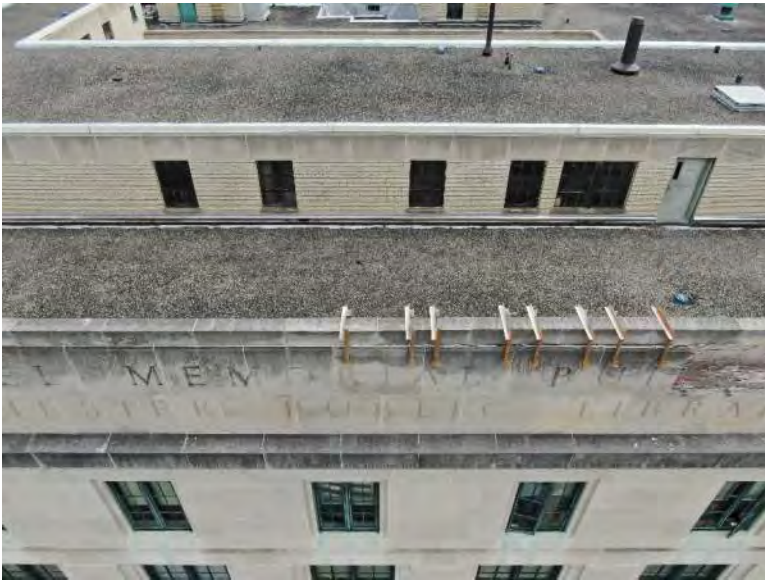
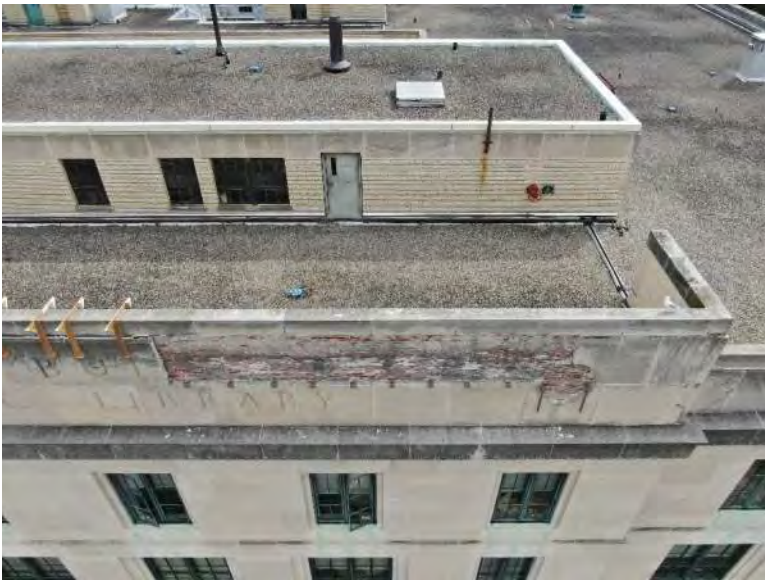
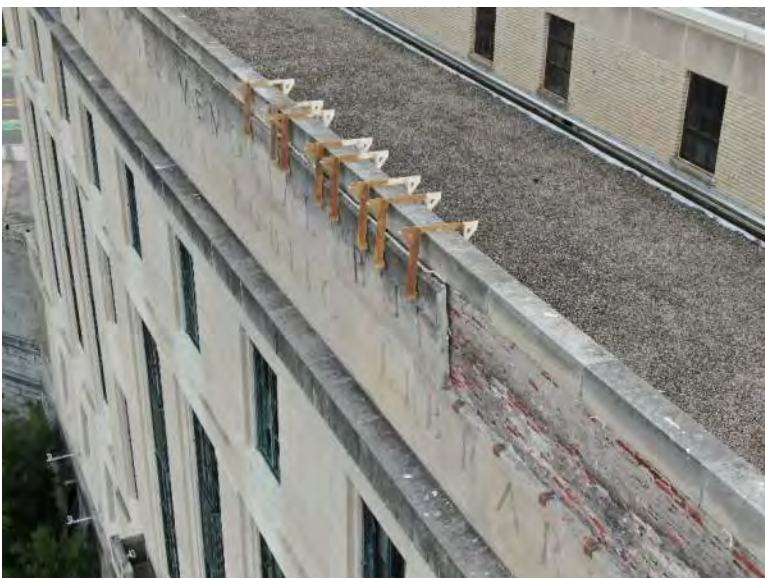
High Parapet - Bracing
