B.I.N. 2211290

Feature Carried PONT DE RENNES (RED BRIDGE)

# 2012 INSPECTION

PROJECT: PONT DE RENNES PEDESTRIAN  
BRIDGE OVER GENESEE RIVER  
DETAILED INSPECTION  
BIN 2211290  
CITY OF ROCHESTER DEPARTMENT  
OF ENVIRONMENTAL SERVICES

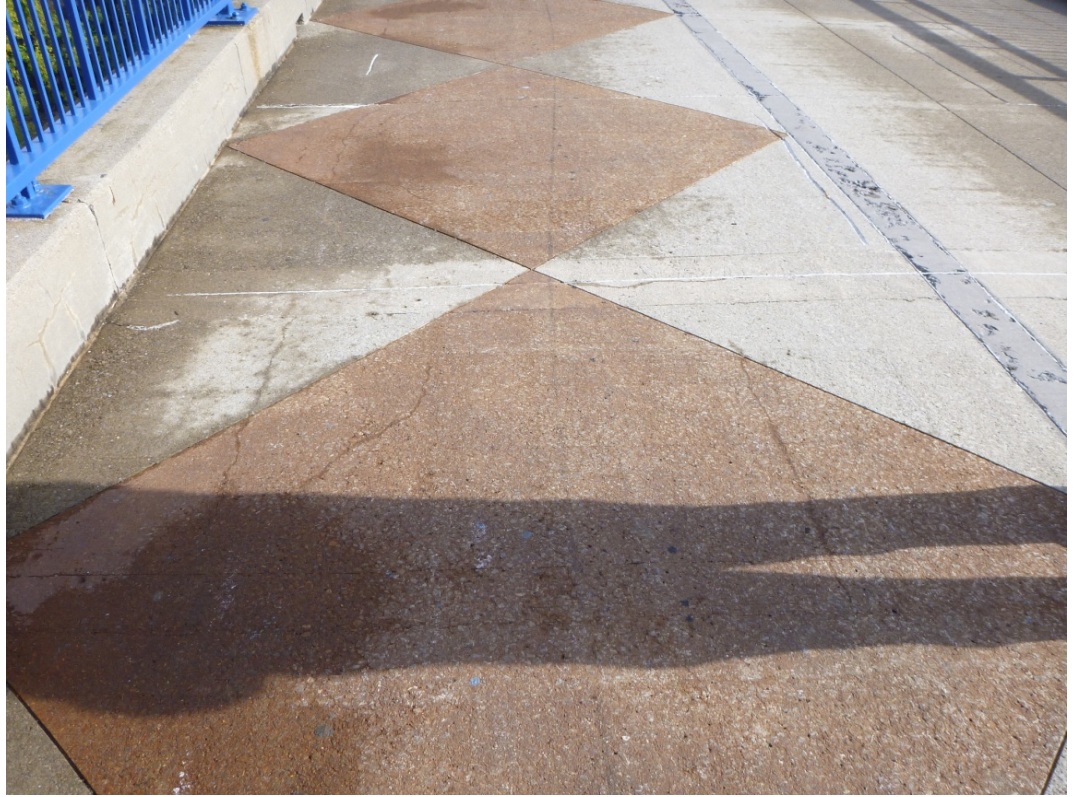
Typical longitudinal crack in concrete wearing surface.

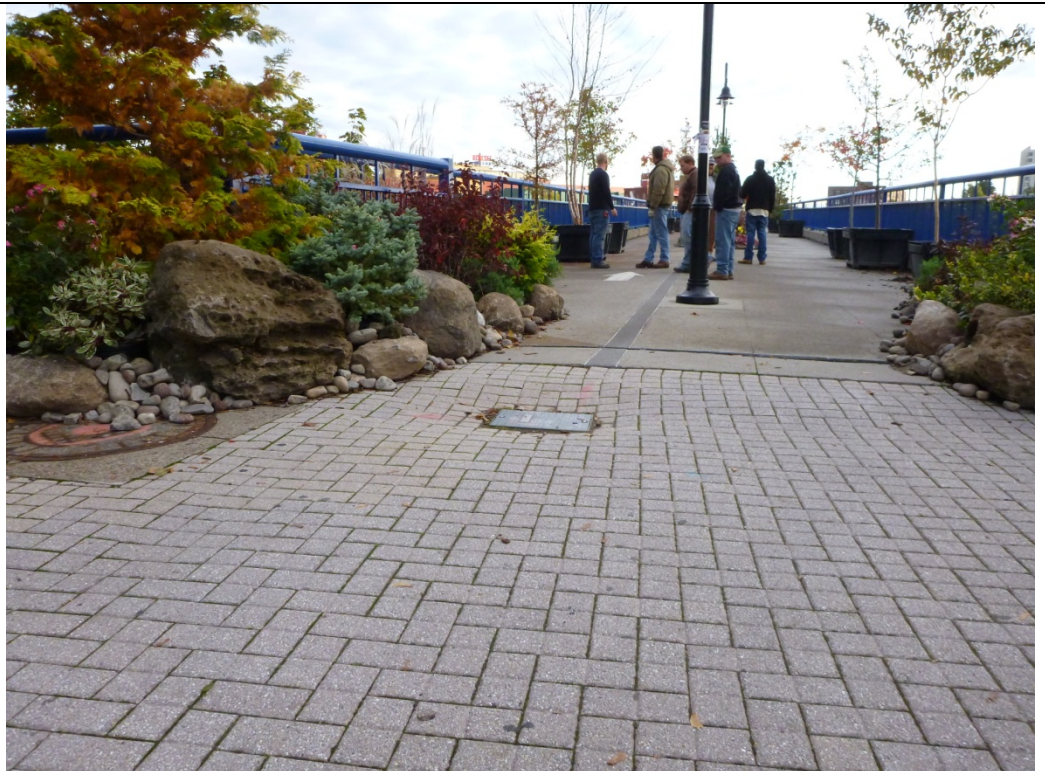
Begin (West) Approach

TP349-27 Bridge Seat and Pedestals
Debris build-up on end bridge seat contributing to the deterioration of the horizontal strut between bearings.
TP349-55 Settlement
The pavers at the begin approach have settled several inches around the electrical box. This creates a low spot at the box and a tripping hazard. (See Photo 8)
The asphalt walkway immediately to the south side of the end approach has settled and sloughed. This creates an uneven walking surface and a tripping hazard. (See Photo 9)
TP 350 - 28 Primary Members
Span 1: Primary members are rated a 4 due to pack rust, section loss and holes in members.

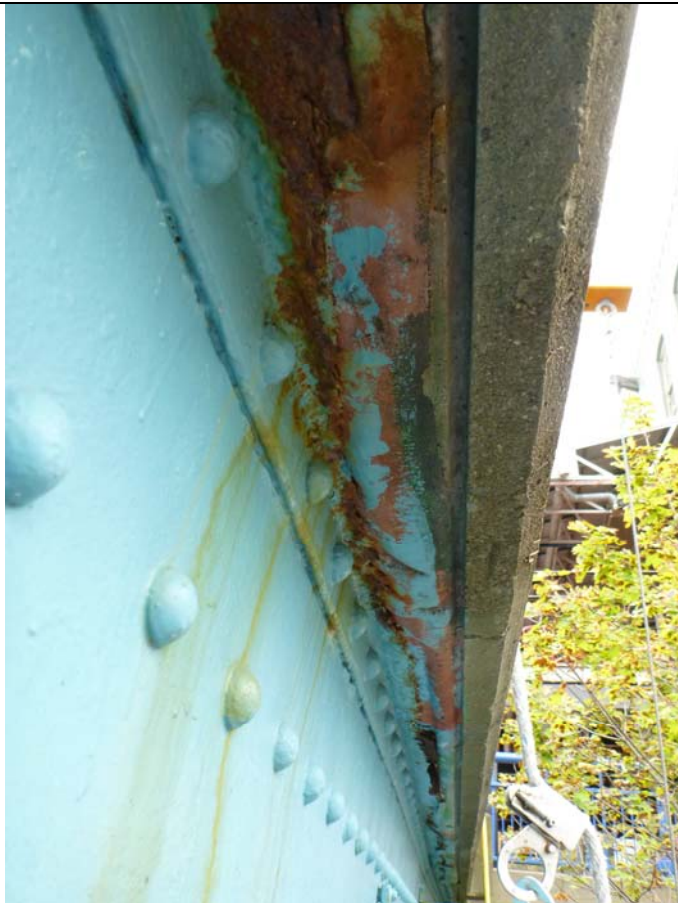
Span 1 Left Truss  
Between U2 and U1

• Left truss between U2 and U1 – Severe section loss in fascia beam top flange angles. This is worst condition but condition exists in most spans. (See Photo 10)

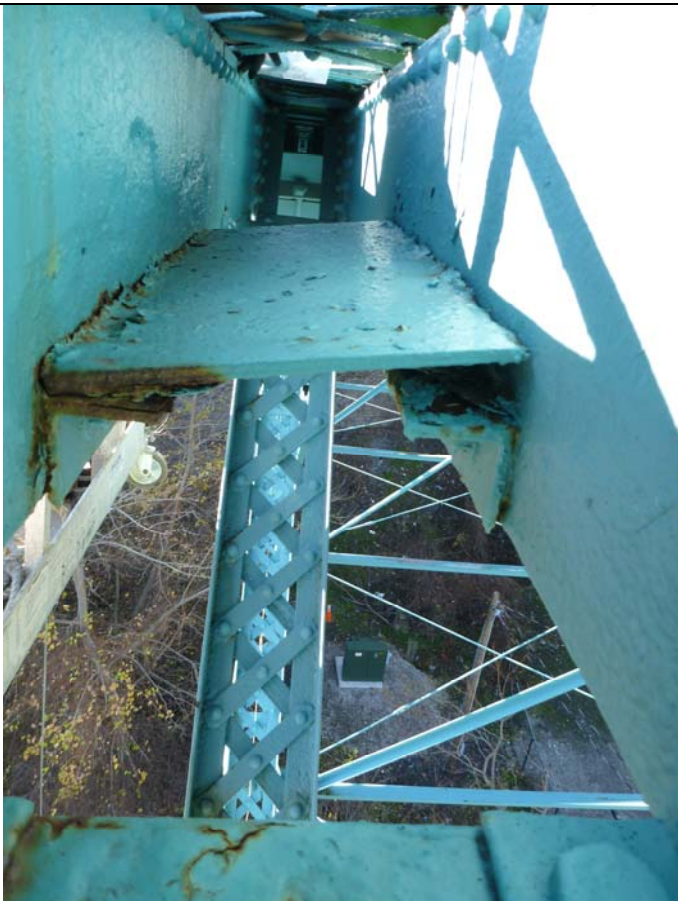
Span 1 Right Truss  
Between U8 and U9

• Right truss between U10 and U9 – Pack rust in top chord stay plate and stay plate has come loose due to failed welds. (See Photo 11)
• Right truss U6 to L8, at L8 – Pack rust in angles of truss diagonal. Typical at every diagonal location. (See Photo 12)

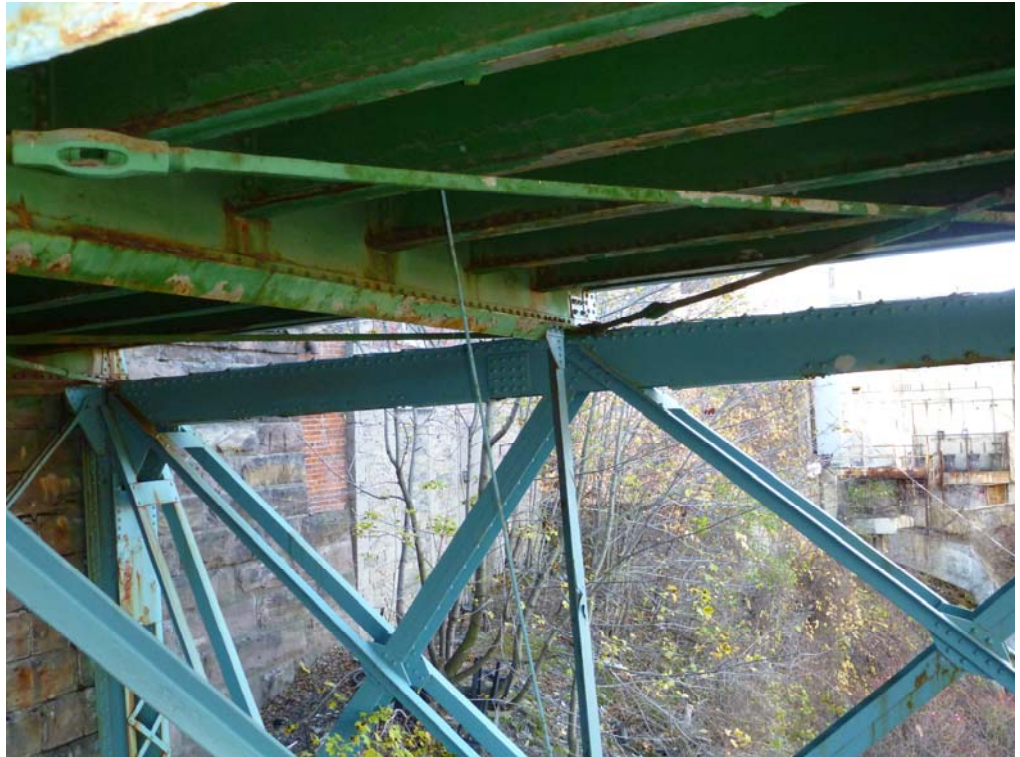
Span 1  
U1 Right to U1 Left

• Between U1 right truss and U1 left truss – Typical corrosion in stringers at floorbeam connection. (See Photo 14)
• Floorbeam at U0 – Severe section loss in backside flange angle of floorbeam. (See Photo 15)

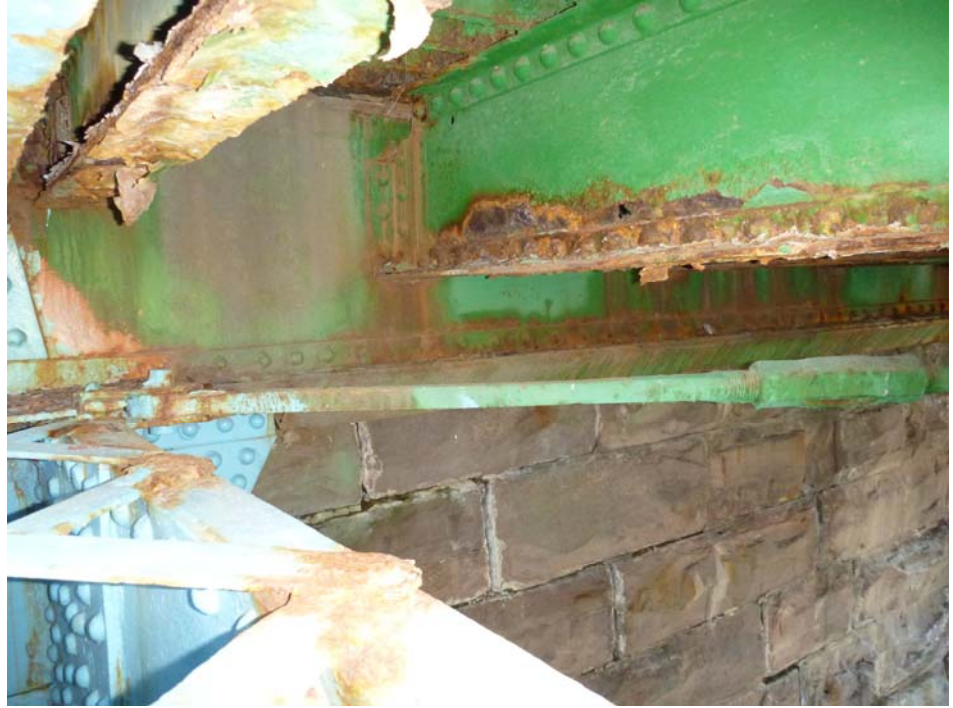
Span 1 Right Truss  
At U0

• Right truss between U2 and U1, at U1 – Hole in fascia beam web.
• Right truss between U1 and U0, at U1 – Hole in fascia beam web.
• Right truss at U0 – Section loss and hole in stringer web near right truss. Section loss and deterioration present in other stringers. (See Photo 16)

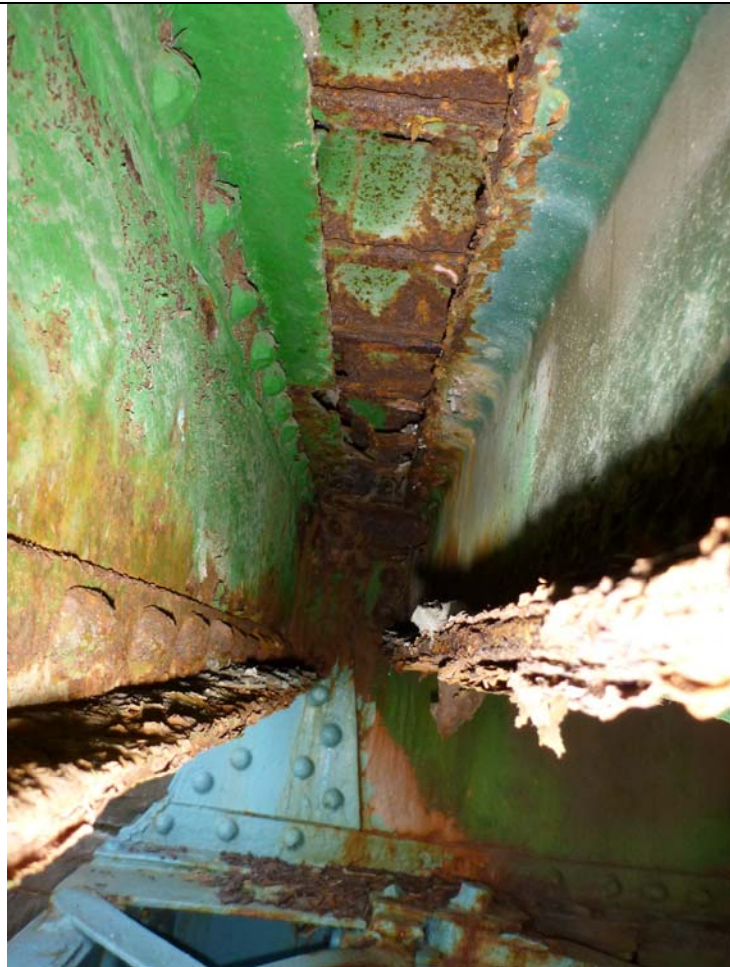
Span 1 Right Truss  
At U0

• Right truss at U0 – Section loss and corrosion in fascia stringer flange angles and corrosion on adjacent stringer. (See Photo 17)
Span 2: Primary members are rated a 4 due to section loss in stringer, bowed fascia beams and section loss in fascia beam to floorbeam connection.

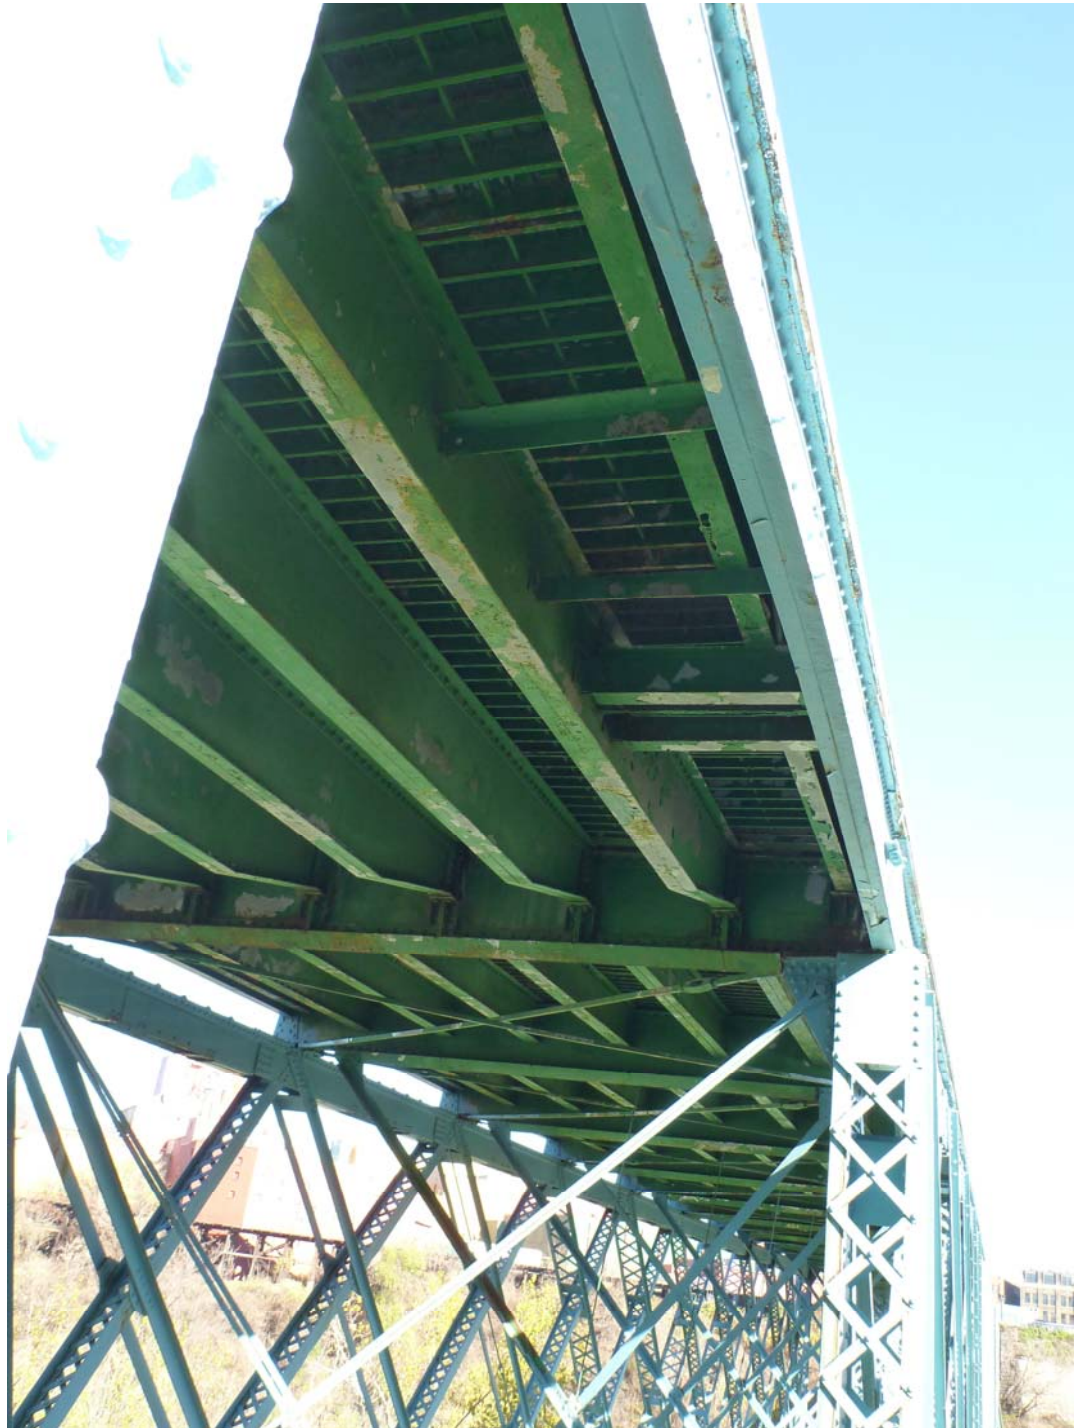
Span 2 Right Truss

• Right truss – Bowed fascia beam. Typical at both fascias. (See Photo 18)
• Right truss at U0 – Severe section loss and holes in fascia stringer bottom flange. (See Photo 19)
Span 3: Primary members are rated a 4 due to pack rust, section loss and holes in members.

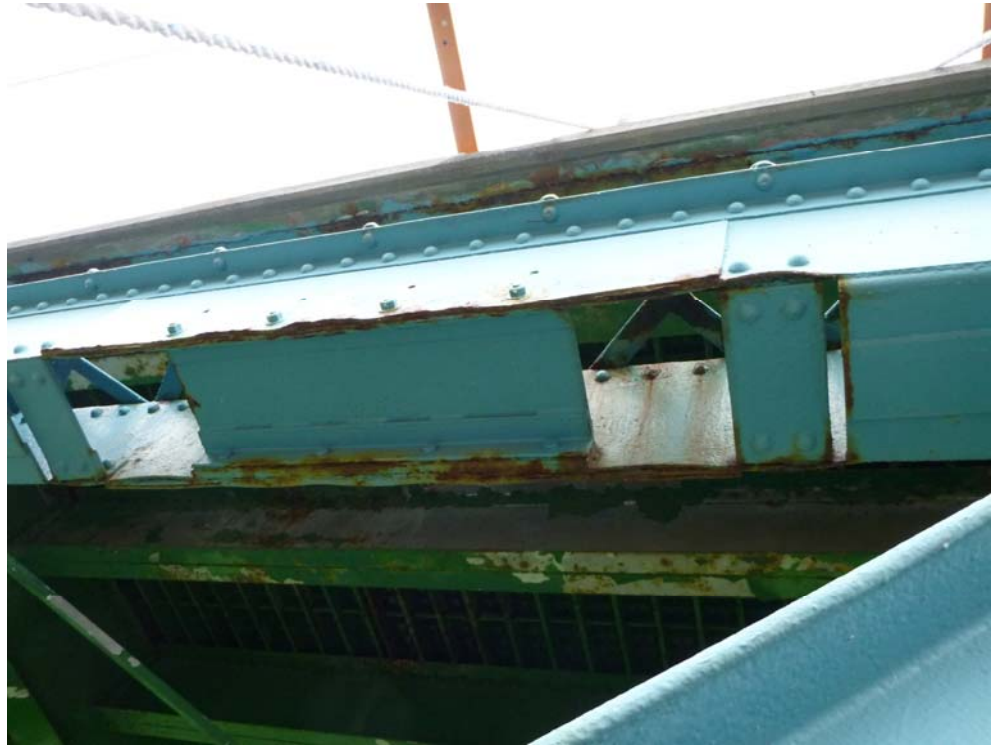
Span 3 Left Truss  
Between U1 and U0

• Left truss at U1 to L0, at U1 – Pack rust in diagonal angle members. Typical in most spans.
• Left truss between U1 and U0 – Pack rust in stay plate and previous top chord repair plate. (See Photo 20)

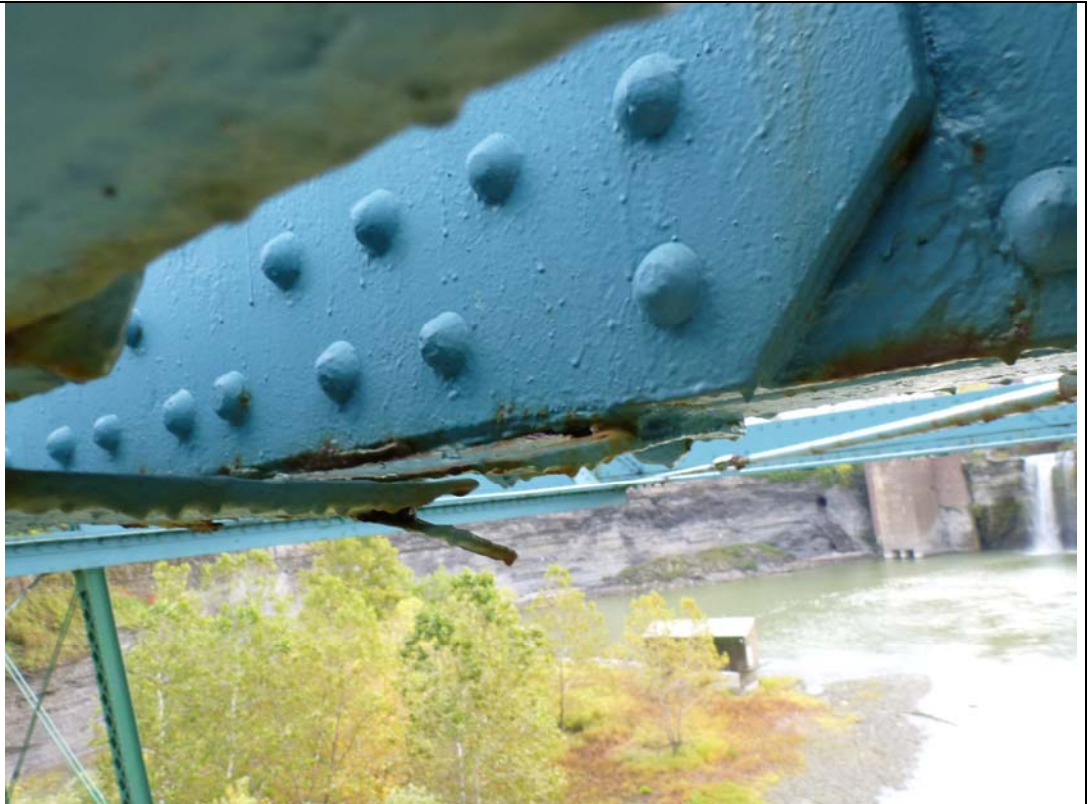
Span 5 Left Truss  
L7 to L8 @L7

• Left truss between U10 and U9 – Pack rust in top chord stay plate and section loss to top chord web plates.
• Left truss between L8 and L7, at L7 – Cracked and bent bottom chord splice/stay plate. (See Photo 23)

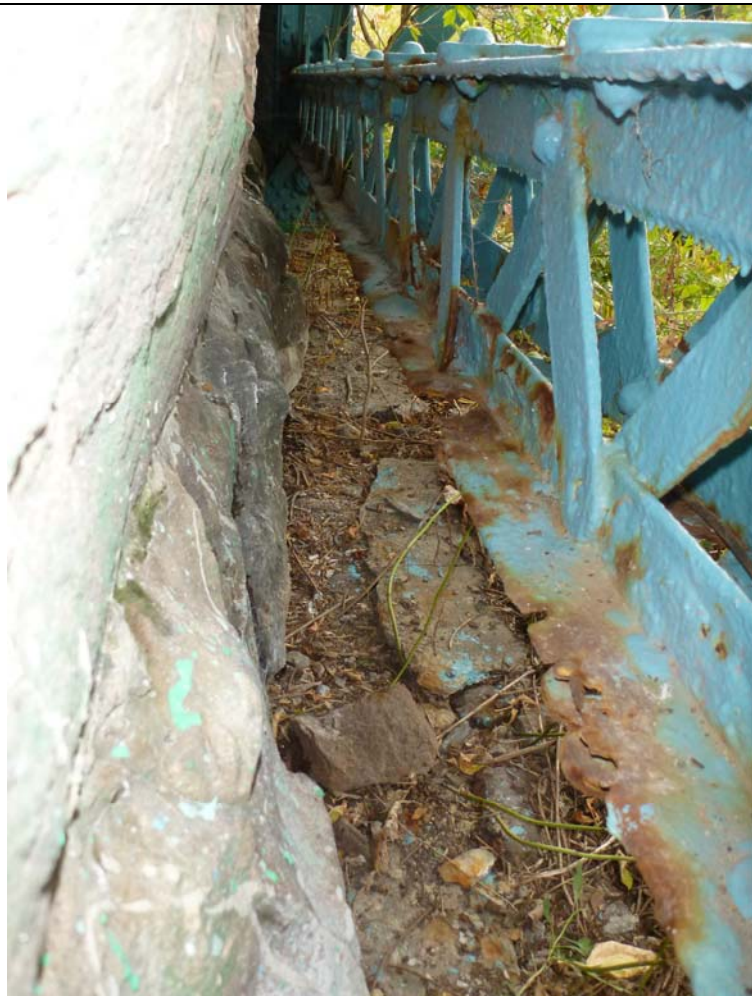
Span 9 @ End Abutment  
L9 Left to L9 Right

Span 9: Primary members are rated a 4 due to pack rust, section loss and holes in members.
• Member between L9 Right Truss and L9 Left Truss at bearings– Significant section loss in strut angles with holes and up 50% section loss. (See Photo 27)

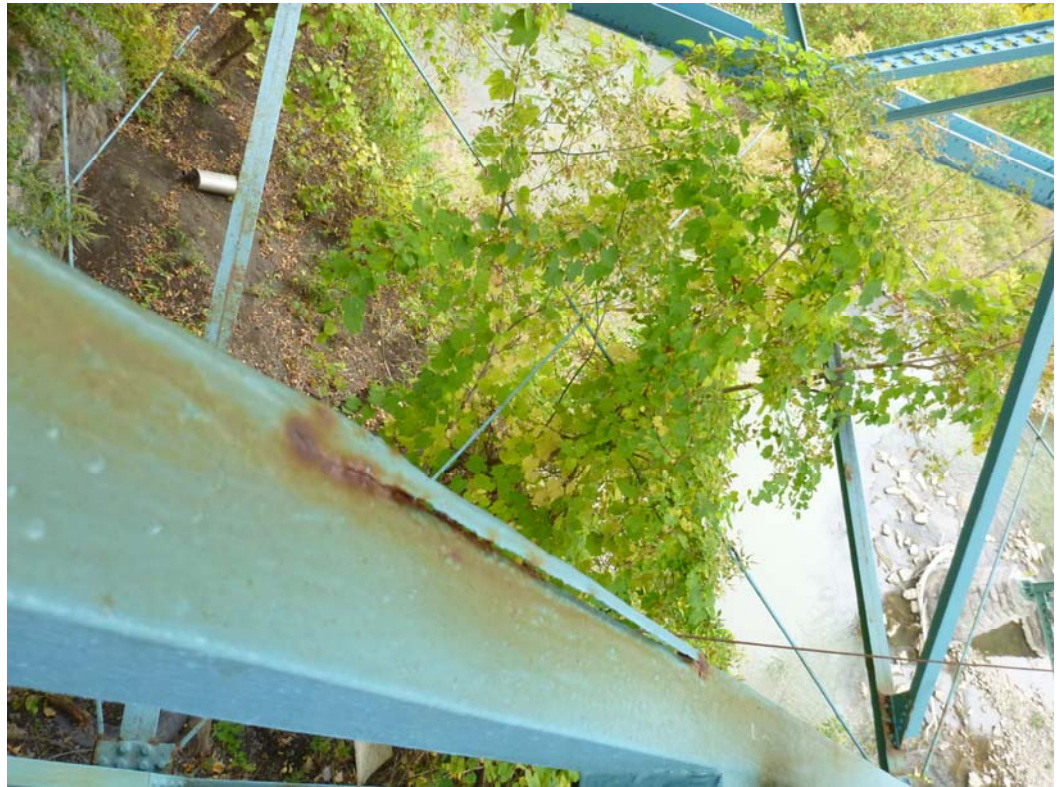
Span 9 LeftTruss  
U8 to L7

• Left truss diagonal between U8 and L7, near U8 –Section loss in interior angles. Small portion of angle leg separated from angle. ( See Photo 28)
• Left truss at U8 – Holes and corrosion in main members of deck grating system. (See Photo 29, 30)

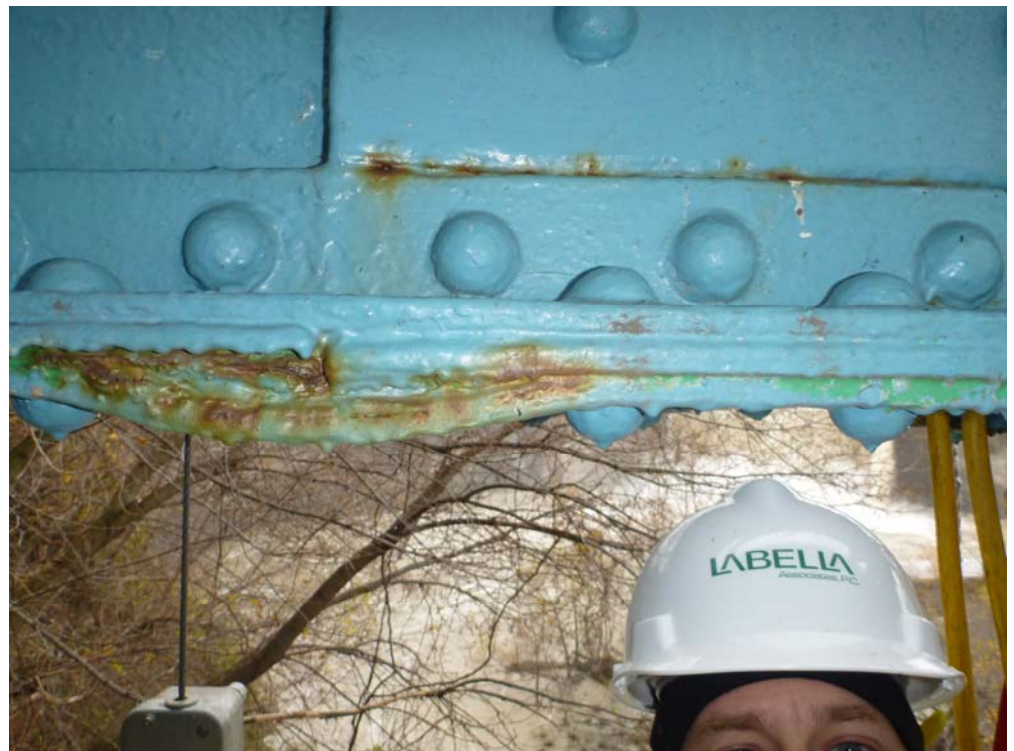
Span 9 Right Truss  
Between L8 and L7

• Right truss between L8 and L7 – Pack rust in bottom chord flange splice. (See Photo 32)
• Right truss at U6 – Small hole in floorbeam web near fascia stringer connections.

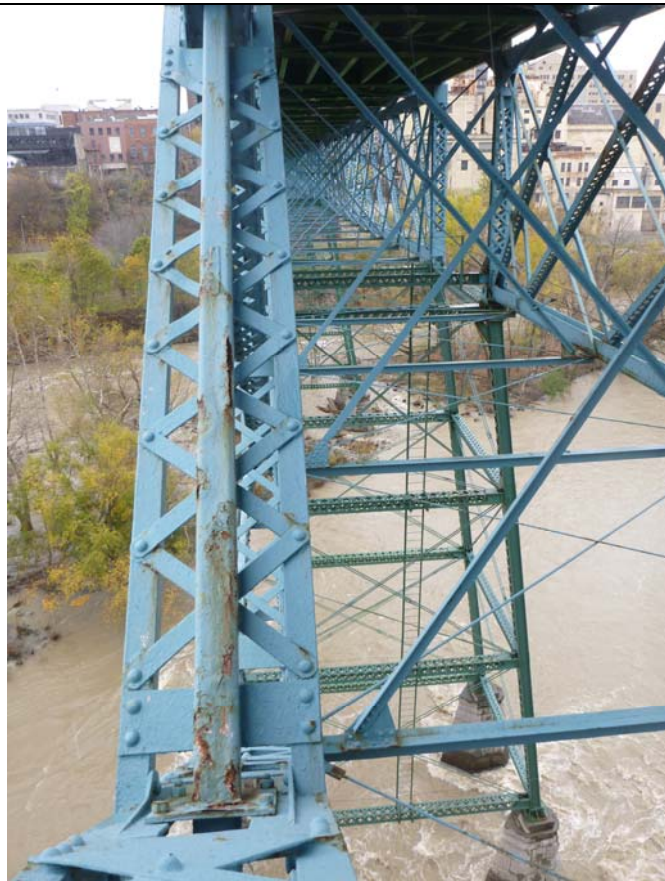
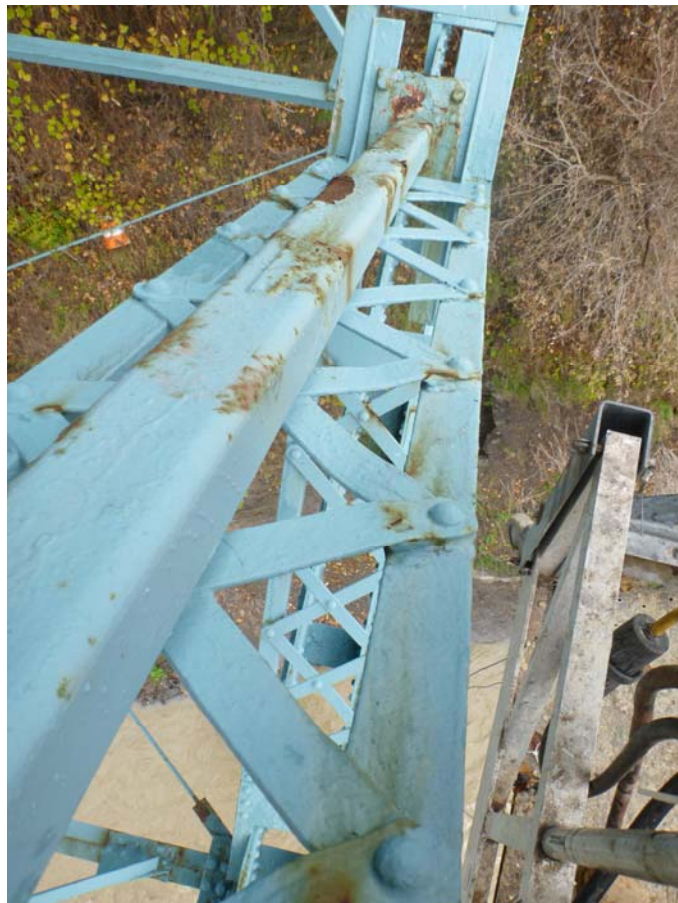
Span 9 Right Truss  
Diagonal L5 to U3

• Right truss diagonal between L5 and U3 – Previous diagonal was buckled and braced with HSS tube. The HSS tube has corrosion and section loss. (See Photos 33, 34)

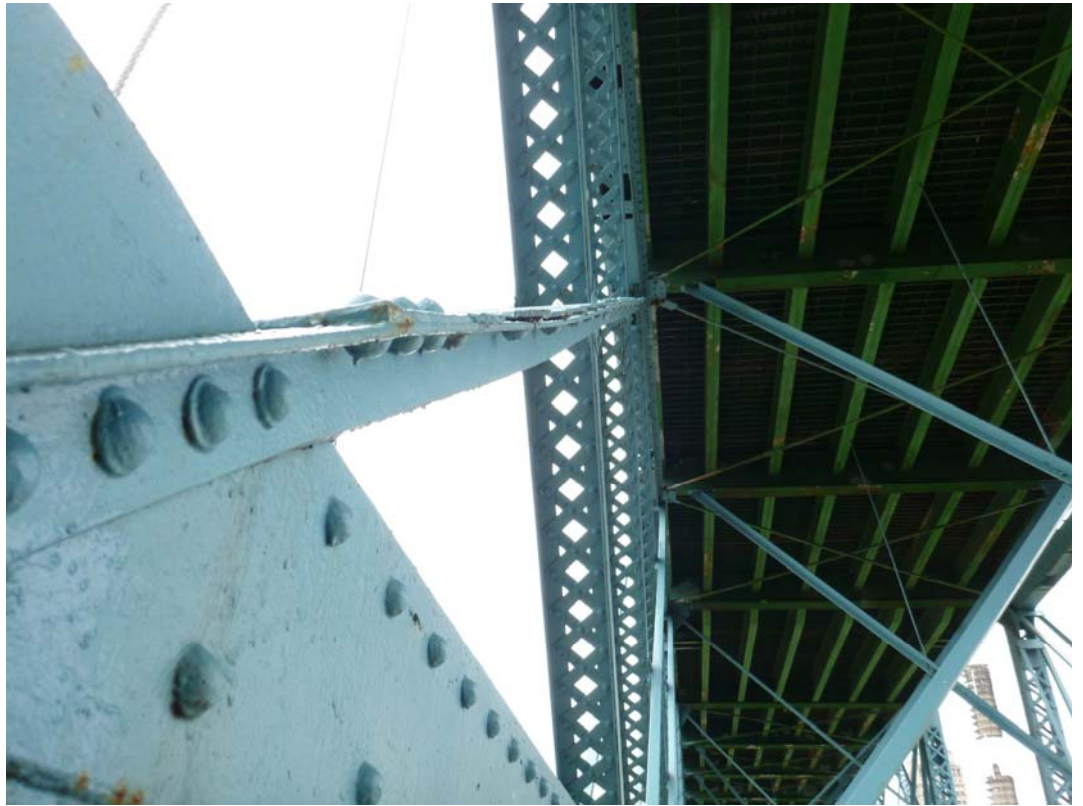
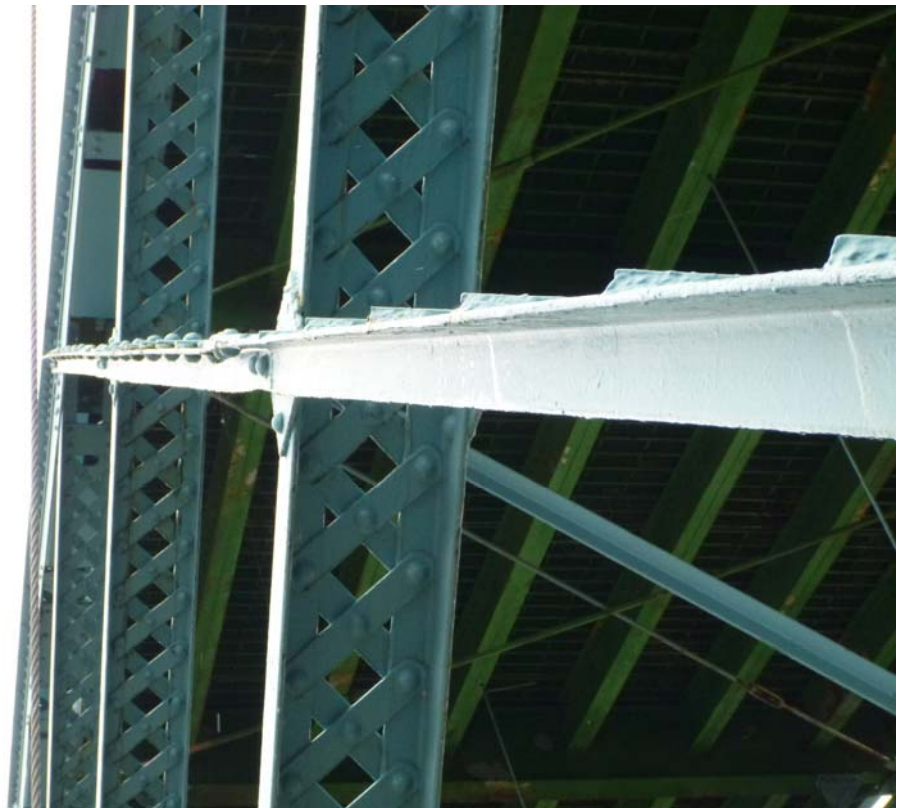
Span 9 Right Truss  
Diagonal L4 to U2

• Right truss diagonal between L4 and U2 –Angles are slightly buckled. (See Photos 35, 36)
• Right truss between L3 and L2 – Pack rust in bottom chord flange splice.

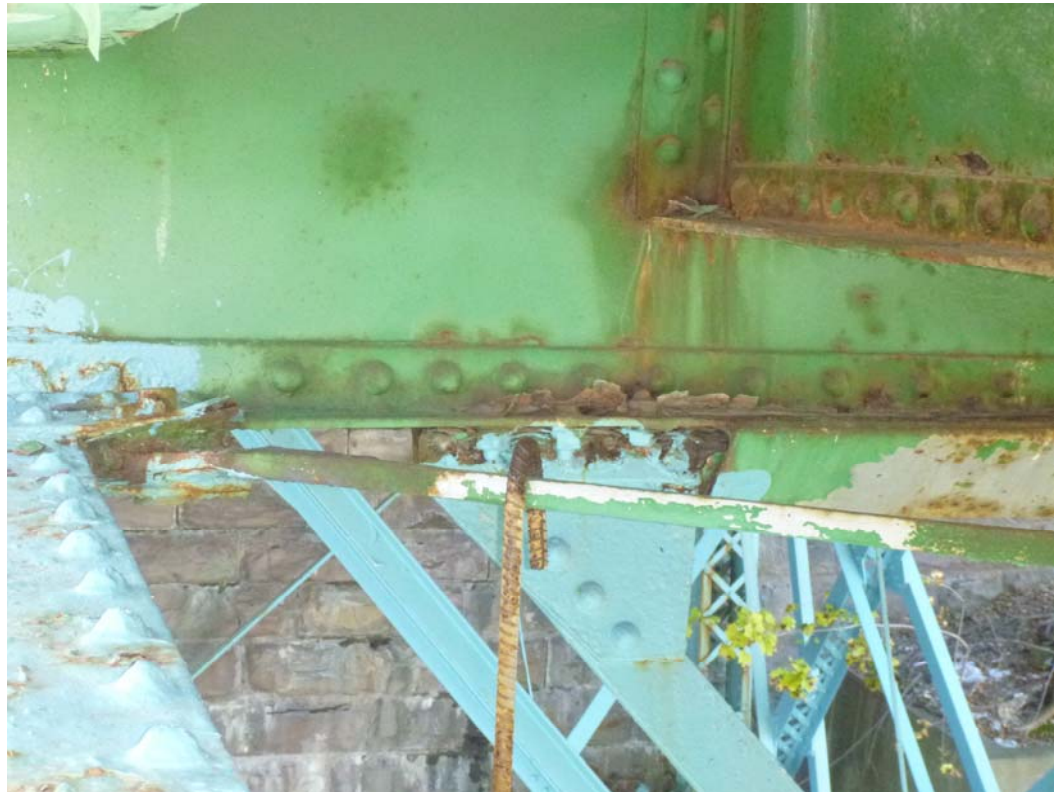
Span 1 Right Truss  
U3 Right to L4 Left @ U3  
Right

• Right truss top lateral bracing at U2 East - Pack rust at eyebar forging, corrosion and section loss in upper and lower plate of eyebar connection
• Right truss top sway bar connection at U3 - Heavy corrosion and section loss on sway bar to floorbeam connection plate (See Photo 37)
