Rochester Animal Services

Masterplan and Facility Assessment Report

May 25, 2023

Purpose and Method

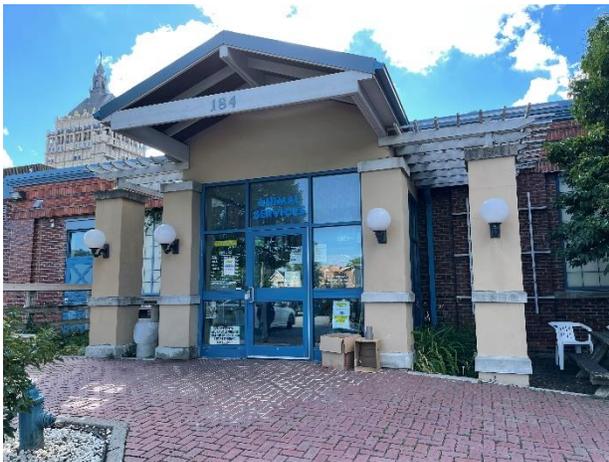
Wood entry trellis and parged masonry columns.

- North wall:
 - Flash-cap the two-part stone masonry caps atop CMU entry columns.
 - Restore the parging at concrete masonry entry columns.
 - Rehang the gutter and downspout on the west side of the standing seam roof.
 - Replace cracked or spalled clay brick masonry.
 - Repoint clay brick masonry.
 - Replace cracked and/or spalled clay tile masonry.
 - Repoint clay tile masonry.
 - Clean clay tile masonry.
 - Re-seal facings of clay tile masonry with a penetrating weather barrier.
 - Recoat the exposed wood entry trellis.
 - Recoat metal windows.
 - Reseal metal window perimeters.

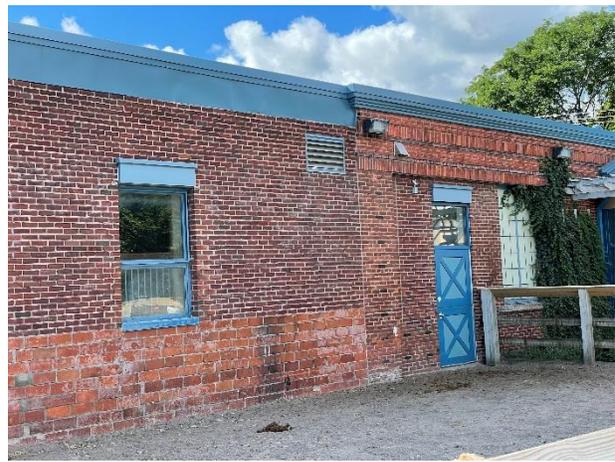
Cracked and spalled clay-tile masonry water-table.

- Spalled and cracked structural clay tiles make up a portion of the exterior, load-bearing masonry walls. Deteriorating clay tiles will eventually require removal and replacement. Structurally sound clay tile may remain in place. All structural clay tiles should be repointed to ensure that water does not penetrate the mortar bed and enter tile cavities. The structural clay tile is unfaced and not suitable for exposure to the elements. An applied weather barrier covering is recommended. Alternatively, the unfaced clay-tile masonry could be replaced with faced clay-tile masonry or preferably faced brick masonry.

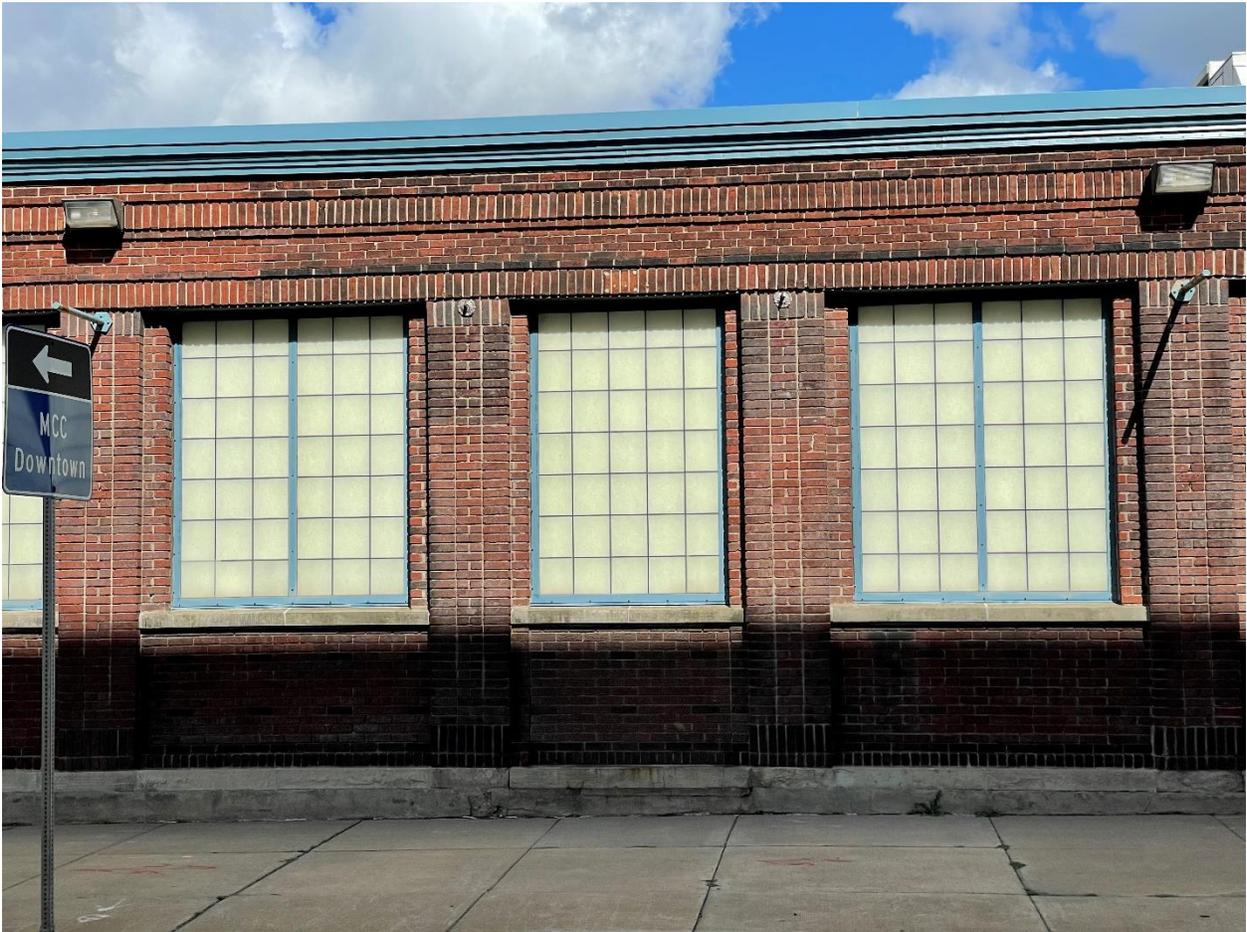
South wall, in need of foundation parging, brick masonry repointing, and re-sealing window perimeters.

- South wall:
 - Replace cracked and/or spalled clay brick masonry.
 - Repoint the brick masonry.
 - Clean the brick masonry.
 - Repoint/re-charge the stone foundations.
 - Recoat metal frames of translucent wall system.
 - Reseal joints between the translucent wall system and masonry rough openings.

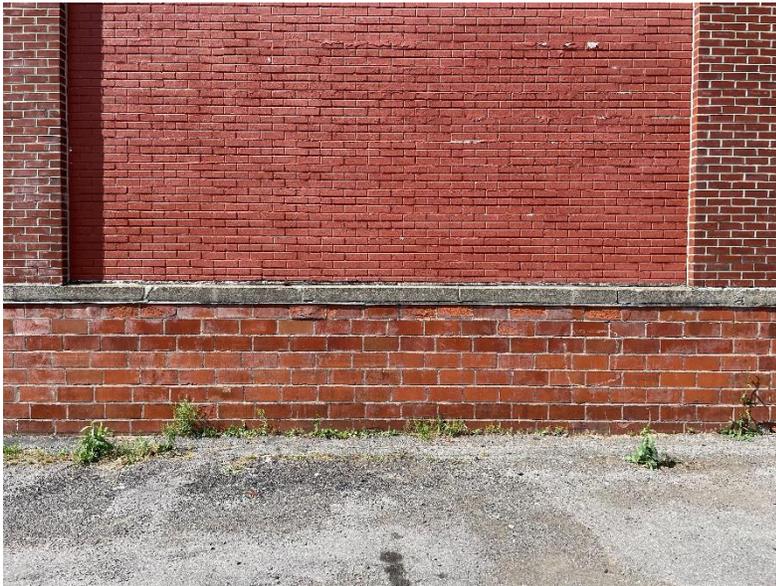
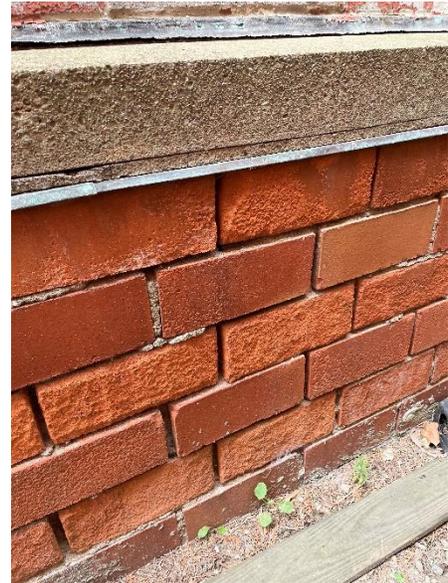
East wall with faux-brick panels over precast concrete, over structural clay-tile masonry.

- East wall:
 - Correct the backup framing behind faux brick panels that have moved out-of-plane.
 - Reseal perimeter joints around faux-brick panels.
 - Remove and replace cracked and/or spalled clay-brick masonry.
 - Repoint clay-brick masonry.
 - Clean clay-brick masonry.
 - Repoint precast concrete water-table. Reset where required.
 - Reseal vertical joints in the precast concrete water-table.
 - Replace spalled clay-tile masonry below water-table.
 - Repoint clay-tile masonry below water-table.
 - Clean clay-tile masonry below water-table.

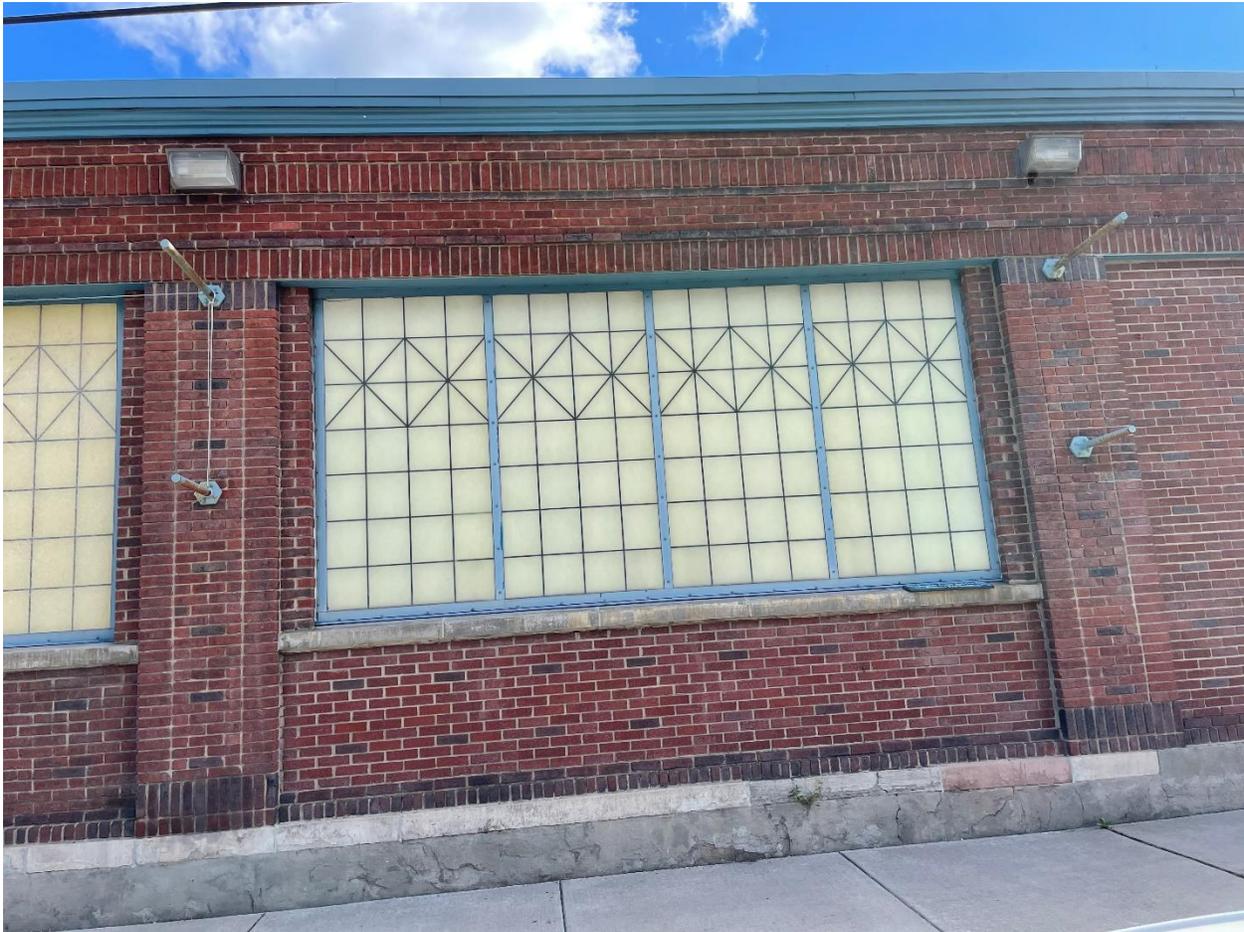
West wall, horizontal mortar joints in brick masonry have failed as brick drops with sagging steel lintels.

- Steel lintels above wide window openings are sagging. This is an indication that the steel was either undersized or has begun to corrode and fail. At a minimum, these lintels carry the weight of the brick masonry above. At worst, depending on how the roof was framed, these lintels may also be carrying some portion of the roof load. Either way, the failing lintels will eventually require corrective measures.

- West wall:
 - Replace sagging metal lintels over windows.
 - Remove and reset/replace brick over new lintels.
 - Repoint clay-brick masonry.
 - Clean clay-brick masonry.
 - Re-parge stone foundation.
 - Recoat metal frames of translucent wall system.
 - Reseal joints between the translucent wall system and masonry rough openings.

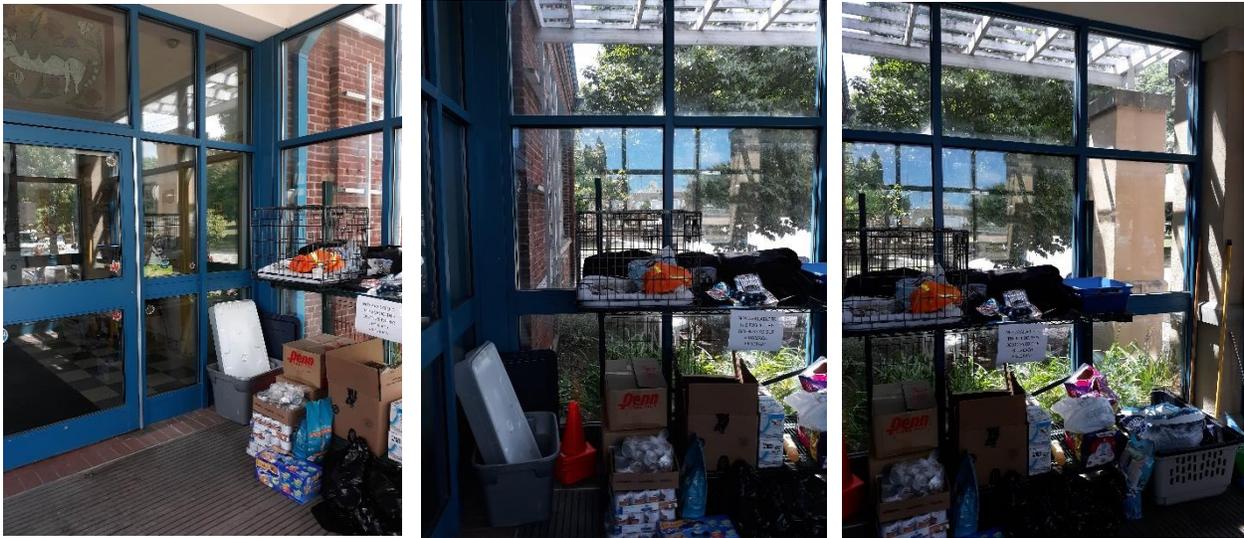
Outreach Program supplies in the entry vestibule indicate a lack of alternative storage space.

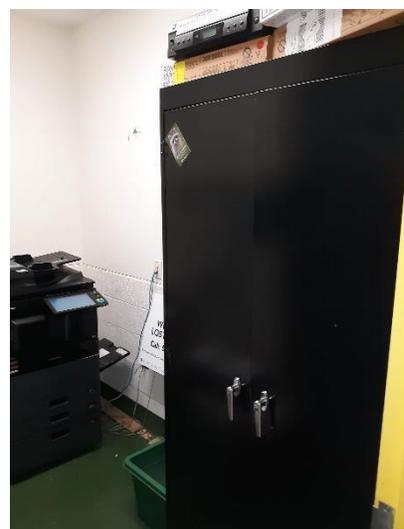
The entrance to this room is not behind the reception desk, and its contents are visible to the public.

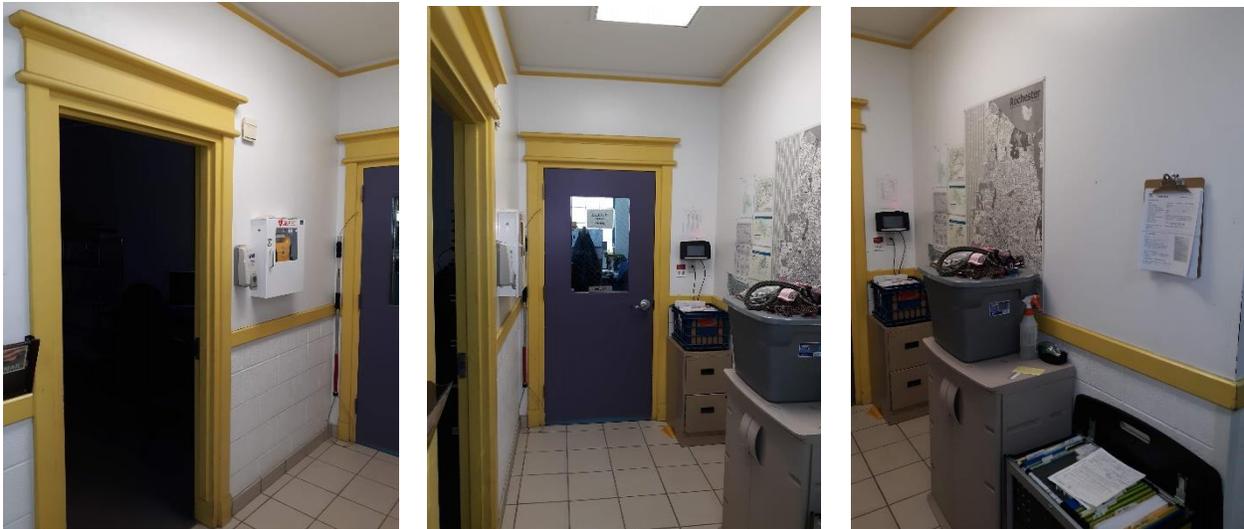
This passage unfortunately permits unrestricted public access to the ACO Office, and the Open Office.

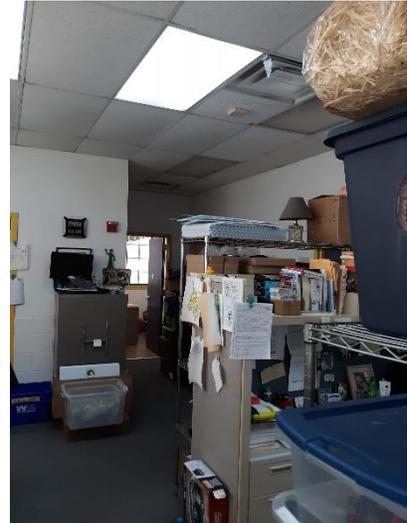
Open Office: There is insufficient space for the many storage cabinets, bins, shelving, and filing cabinets.

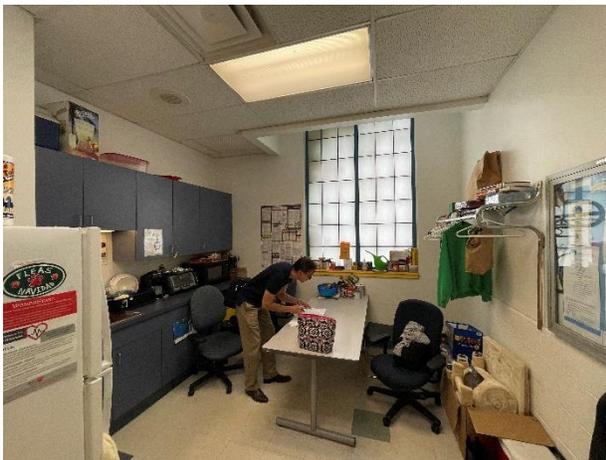
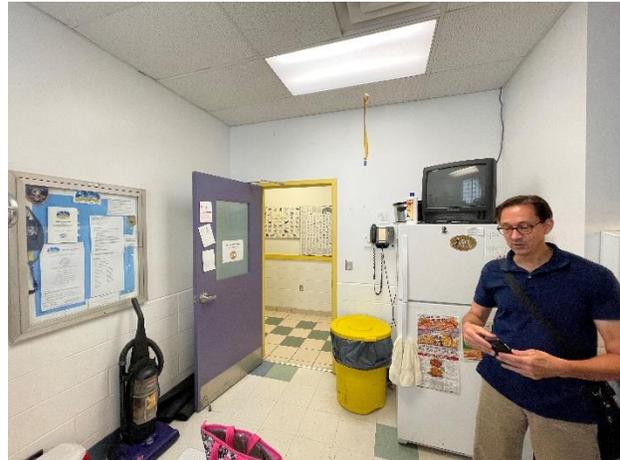
Animal supplies and equipment are in boxes on the floor, indicating a lack of storage space elsewhere.

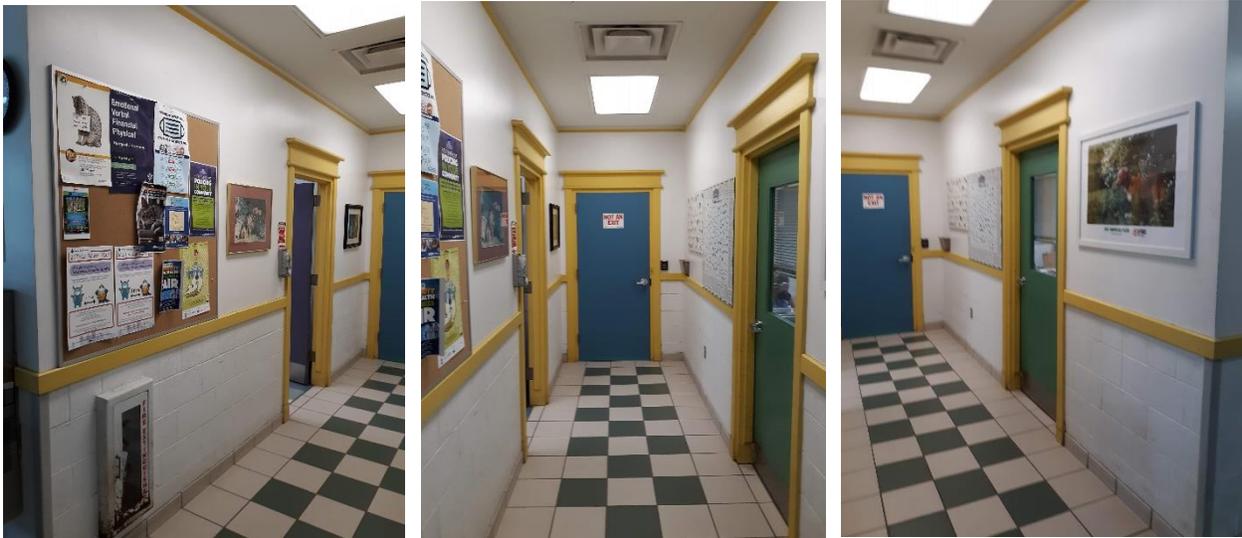
This passage unfortunately permits public access into what should be restricted back-of-house areas.

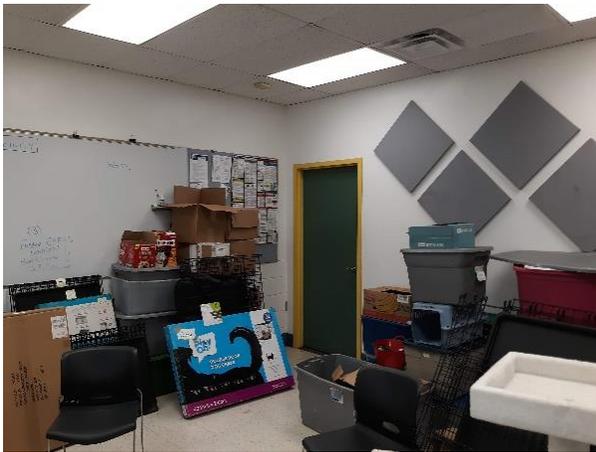
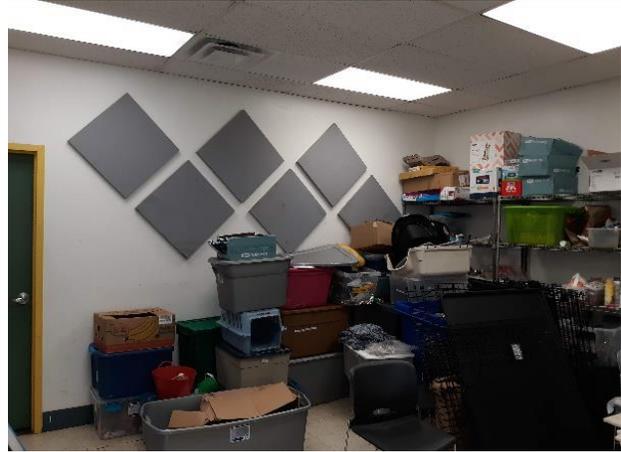
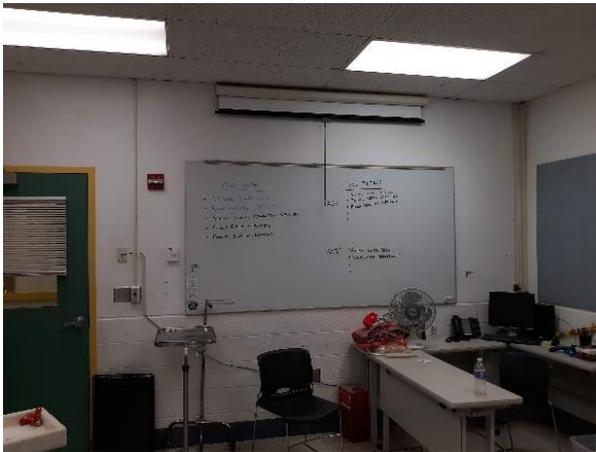
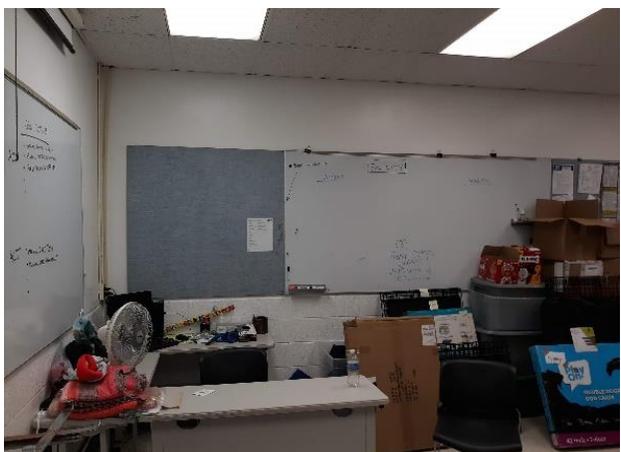
The Conference Room is inundated with overflow storage that should be located elsewhere.

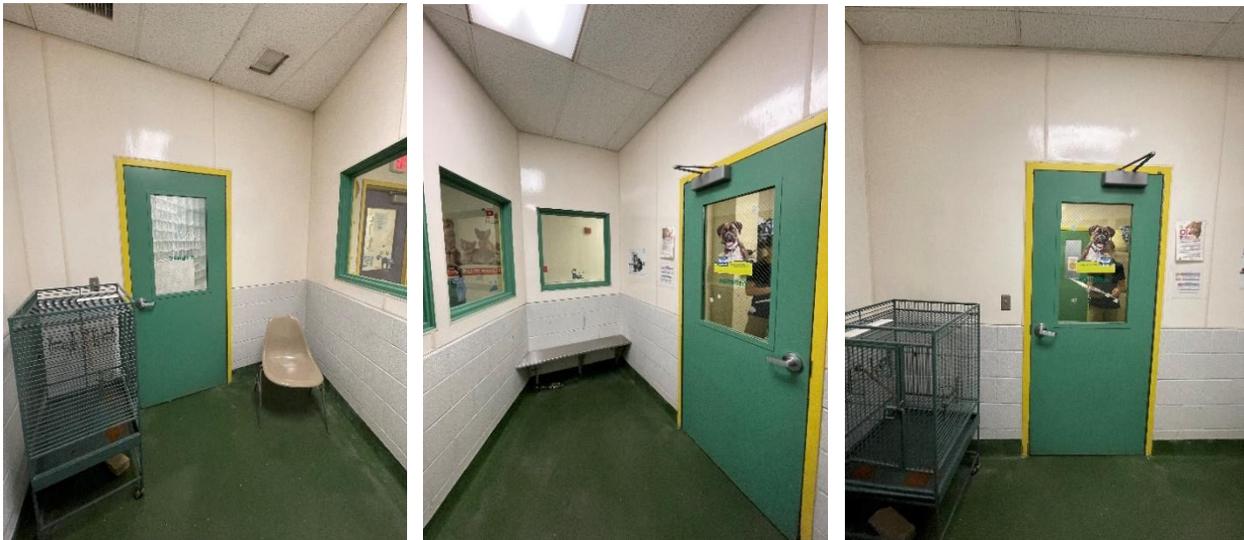
The location of this space requires that clients traverse the main back-of-house corridor.

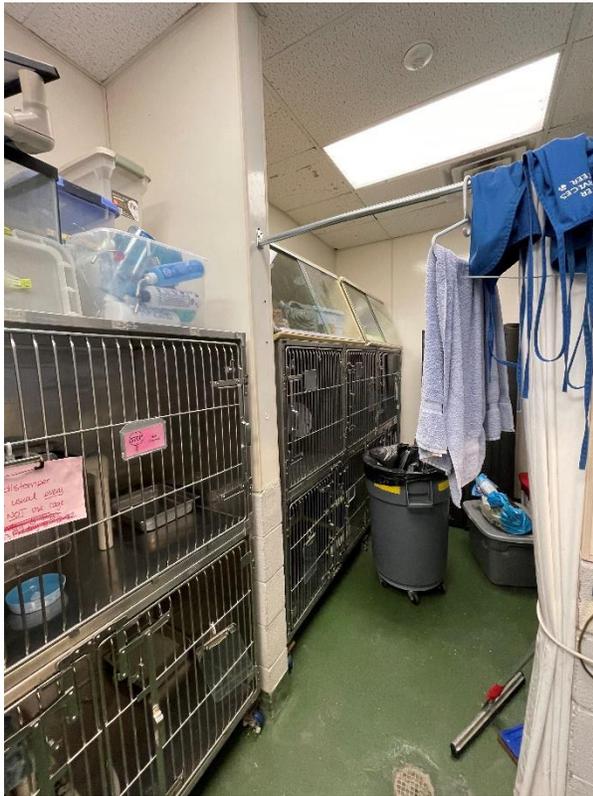
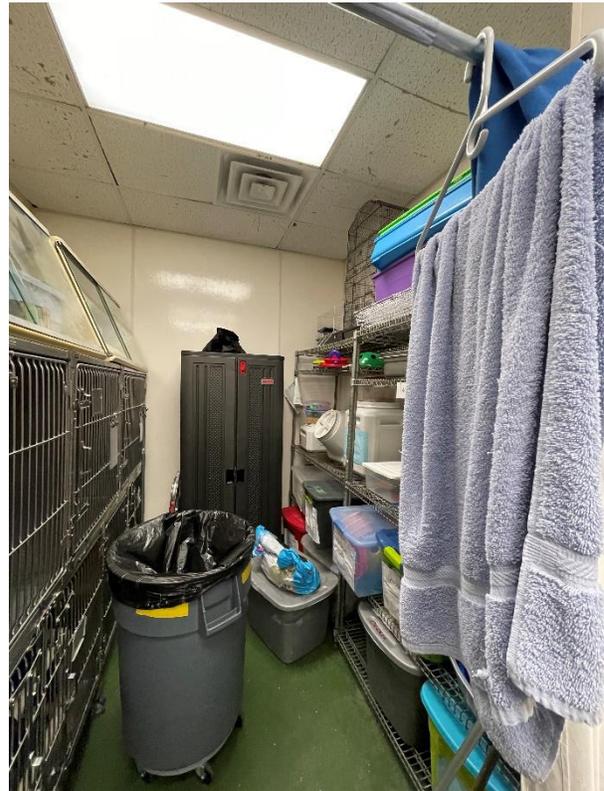
Views westward, Cat Isolation is atmospherically contiguous to the Cat Kitchen, which is not desirable.

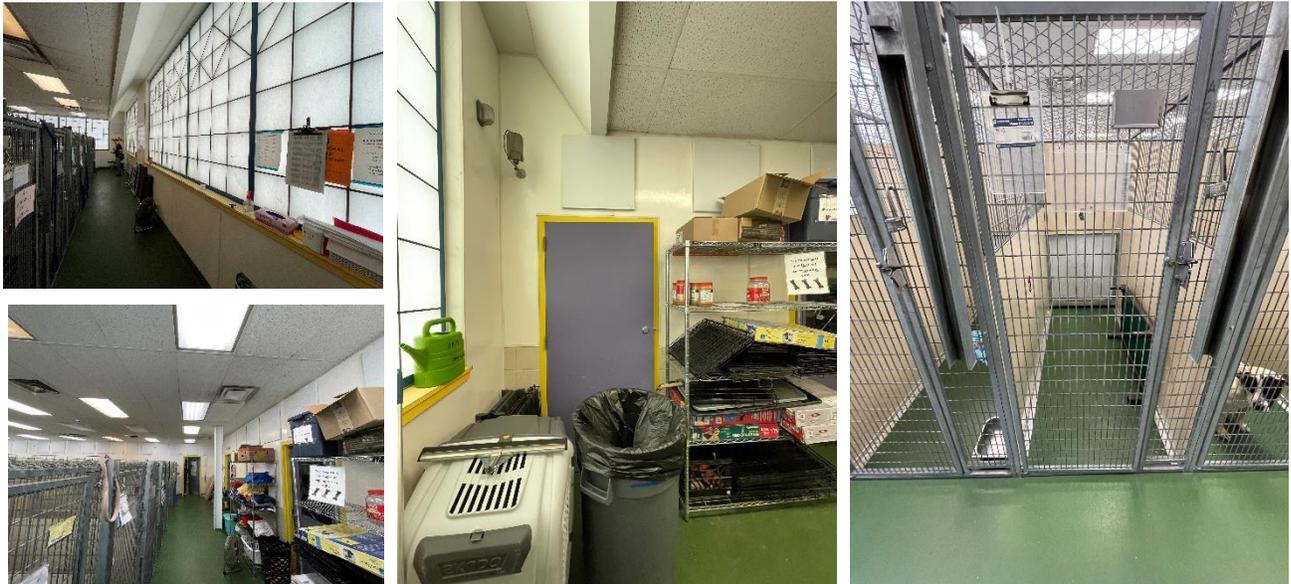
Natural daylight via translucent wall panels. Storage space is lacking. Eighteen two-compartment runs.

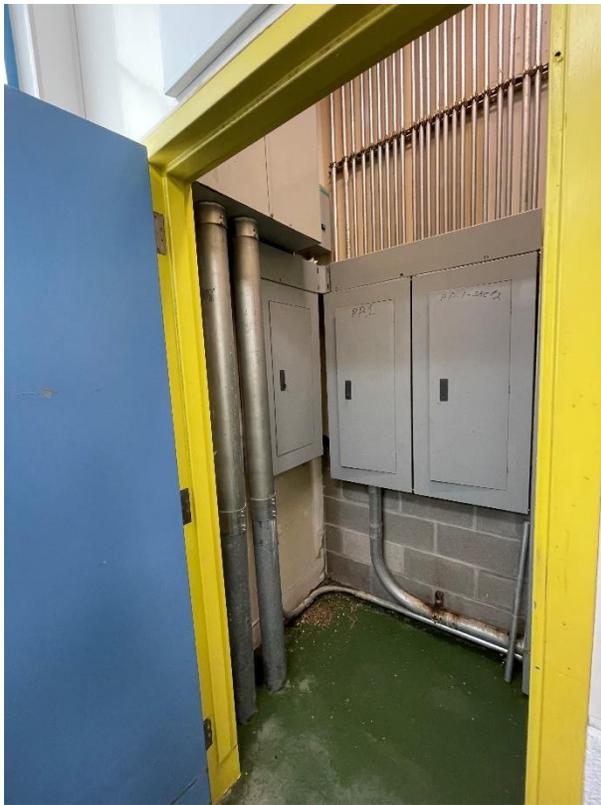
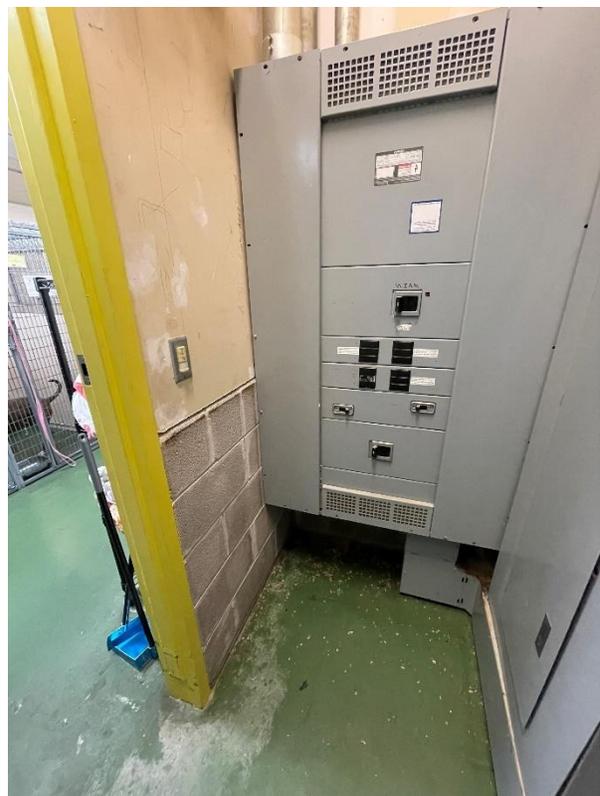
Mice droppings indicate that a pathway into the building exterior needs to be identified and eliminated.

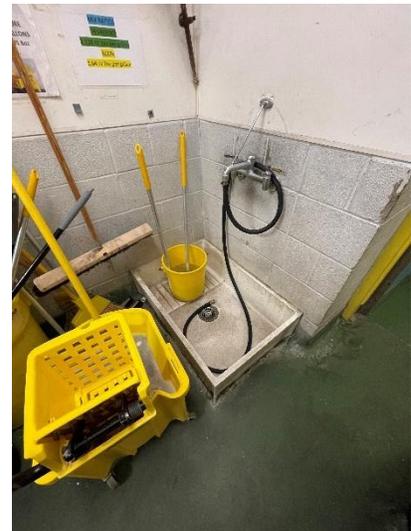
Piping on the wall remains from an abandoned plumbing system that has been partially removed.

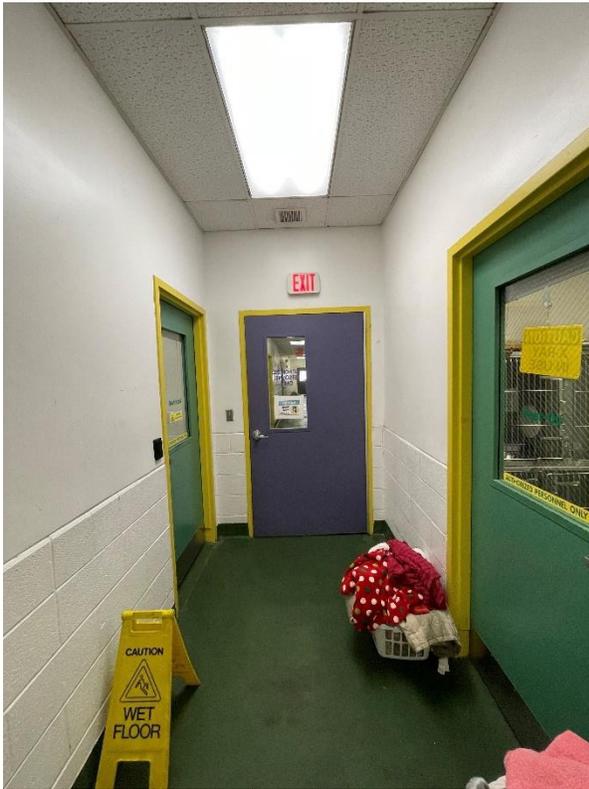
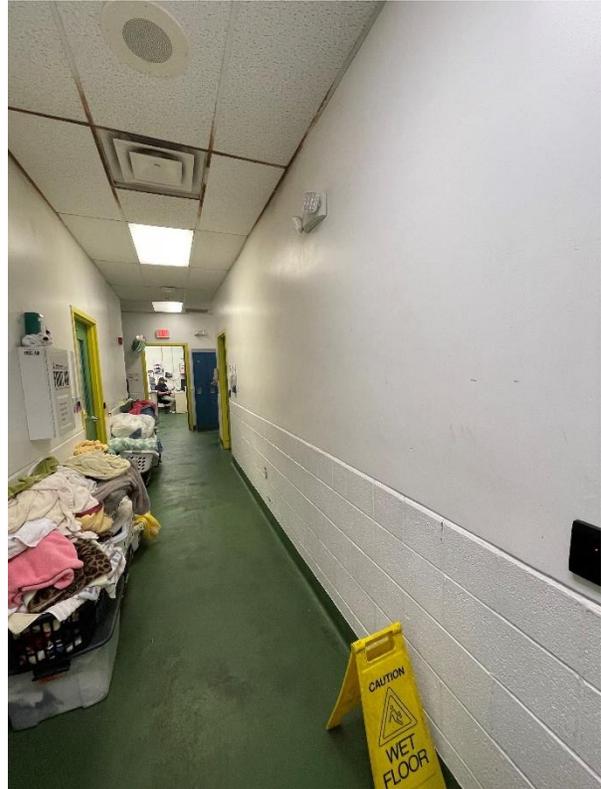
This corridor connects treatment spaces to recovery spaces. It's located in the eastern half of the building and is demised from the main back-of-house corridor by a cross-corridor partition and door. While signed for entry only by authorized personnel, the cross-corridor door is not secured. Within this corridor, dozens of dirty laundry baskets lay directly on the floor, just outside of the treatment suite, indicating that the facility lacks a proper soiled laundry hold. We observed the following code deficiency: Laundry baskets on the corridor floor impede safe exit access (FC 1031.2).

Laundry baskets on the corridor floor indicate that the facility lacks a proper soiled laundry hold.

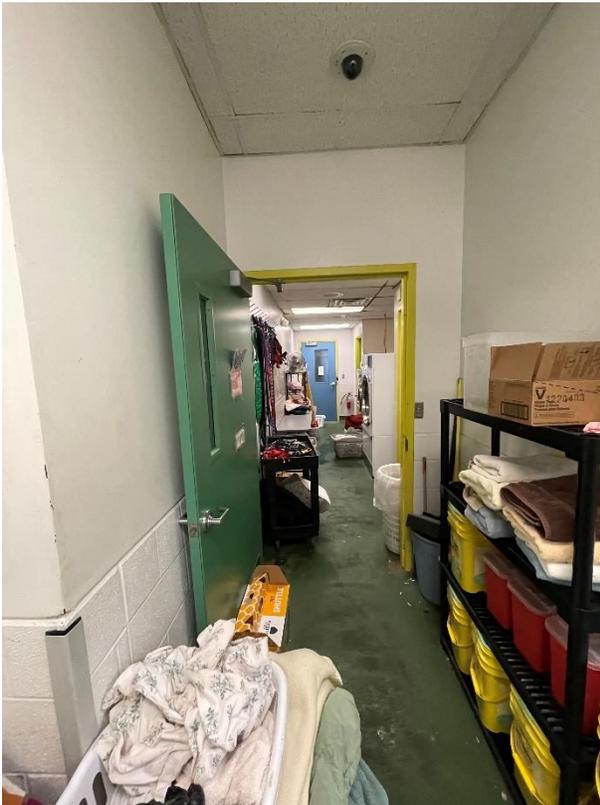
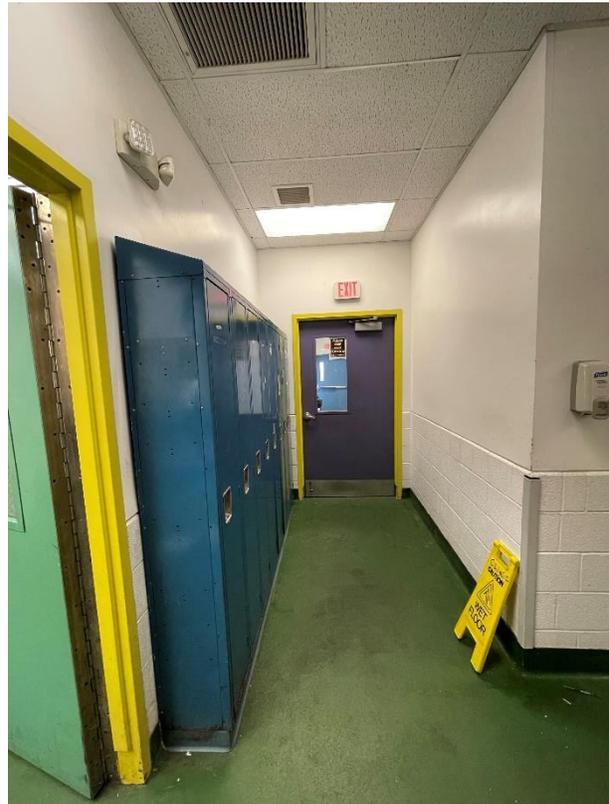
This corridor serves Laundry to the north, Technicians to the east, Intake Garage to the south, and is atmospherically contiguous to Corridor 2 to the west. We observed the following code deficiency: Exit access is hindered by laundry baskets on the floor, an open shelving unit on the east wall, and metal lockers that encroach on the minimum clearance at the latch side of the cross-corridor door to the south (FC 1031.2).

Exit access is hindered by laundry baskets, an open shelving unit on the east wall, and metal lockers.

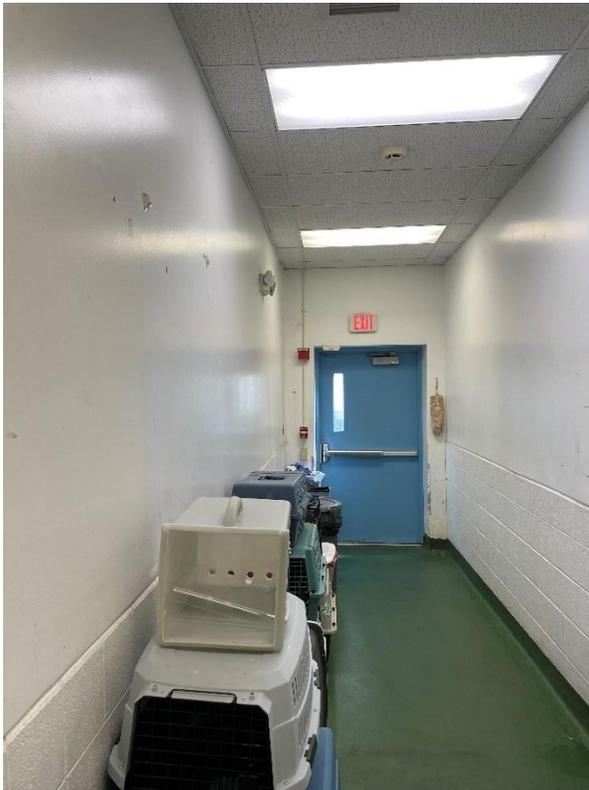
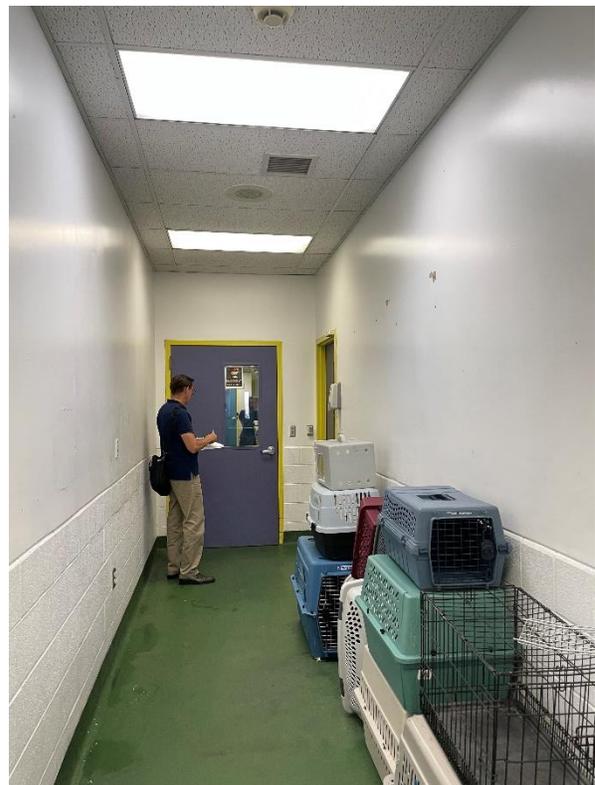
This corridor connects to Corridor 3 at the north, the Intake Garage at the east, and an exterior exit door at the south. Exit access is impacted by pet carriers, training crates, and plastic bins stored on the floor flanking the east wall. We observed the following code deficiency: Exit access impeded (FC 1031.2).

Pet carriers, training crates, and plastic bins indicate a lack of proper storage areas elsewhere.

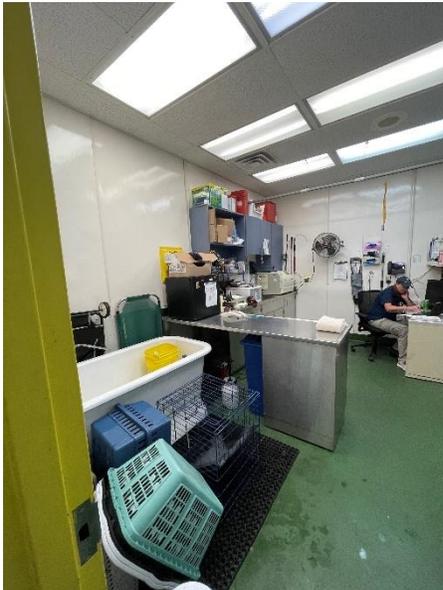
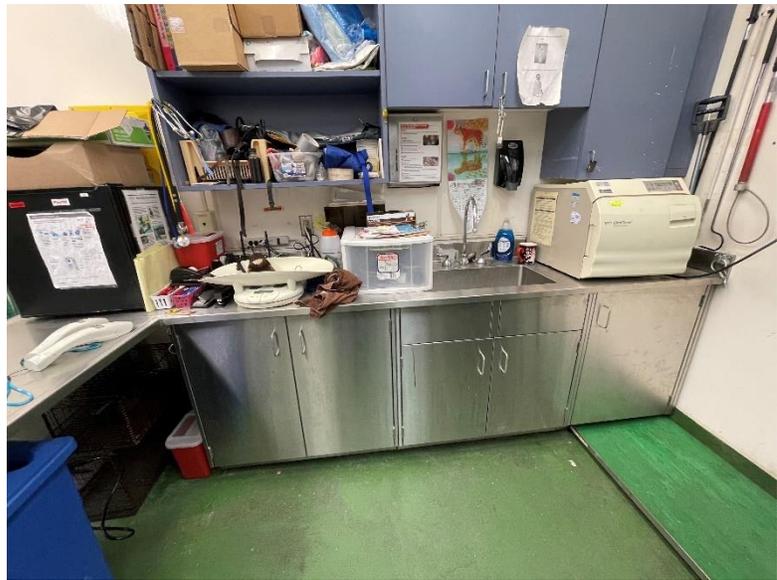
A shelter manager's workstation indicates lack of proper office space elsewhere in the facility. A lack of contained storage results in items sitting directly on the floor and sections of fully covered countertops.

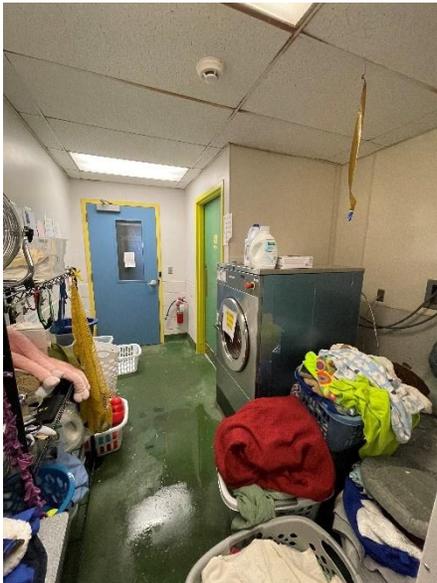
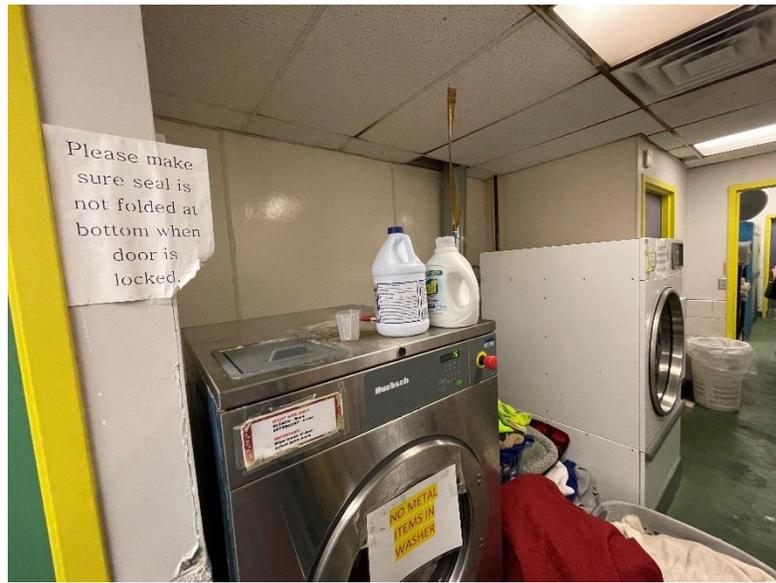
The lack of a proper soiled hold has resulted in laundry baskets on the floor impeding the exit access.

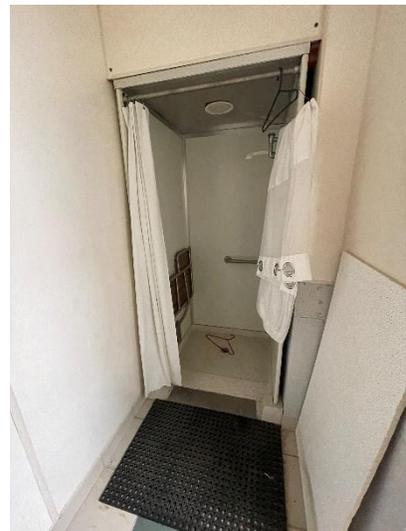
These are single-occupant toilet rooms. Showers with gaps at the sides present an unsanitary condition.

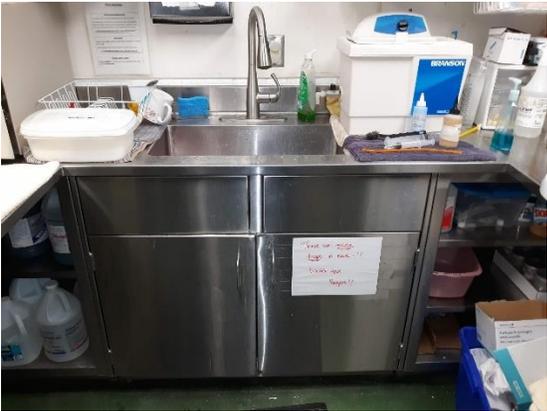
The Exam Room appears to be part lab and part pack-prep. This space is undersized for the quantity of supplies and equipment present.

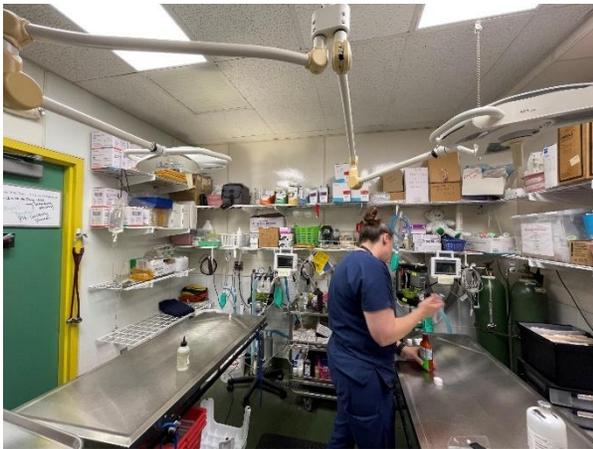
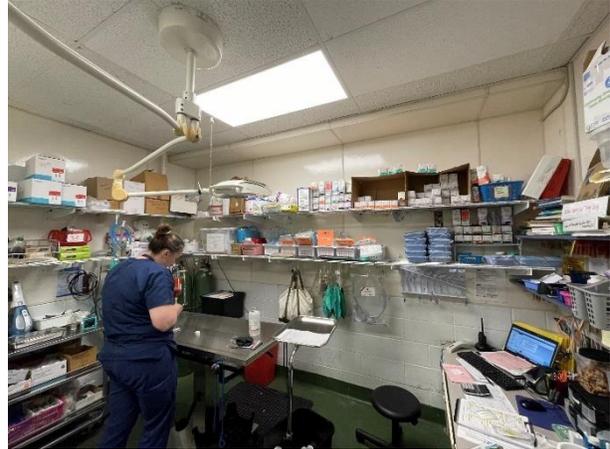
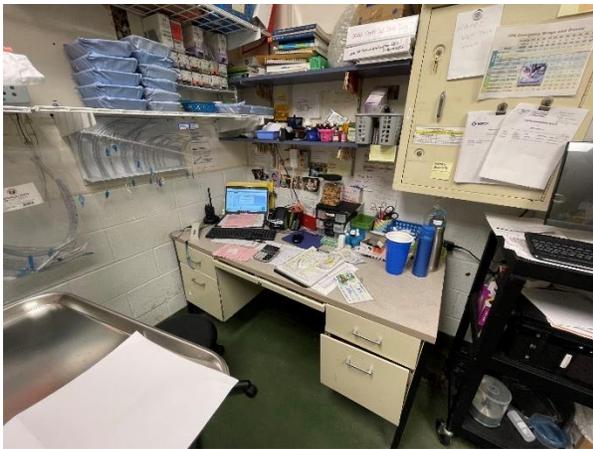
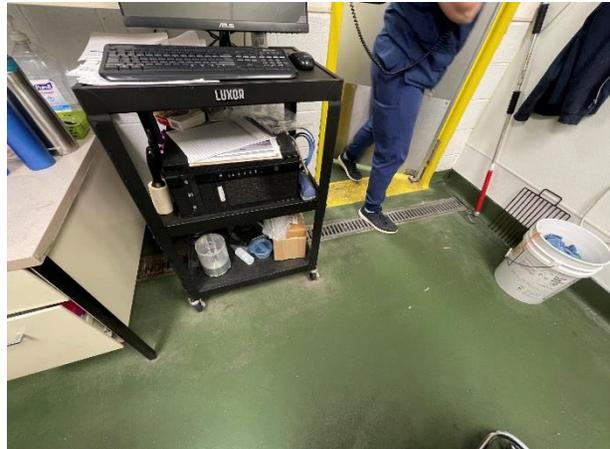
Surgery: Open shelving, trench drains, porous and friable ceilings, and HVAC air flow are not conducive to infection control.

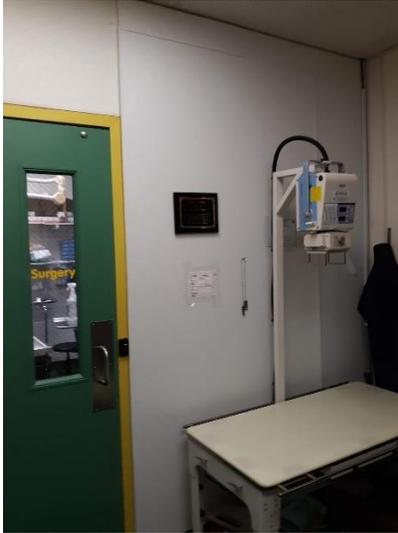
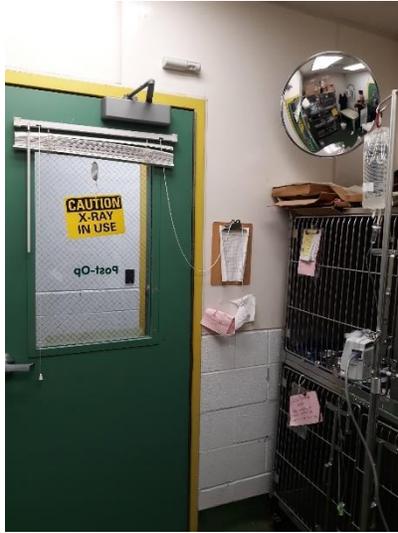
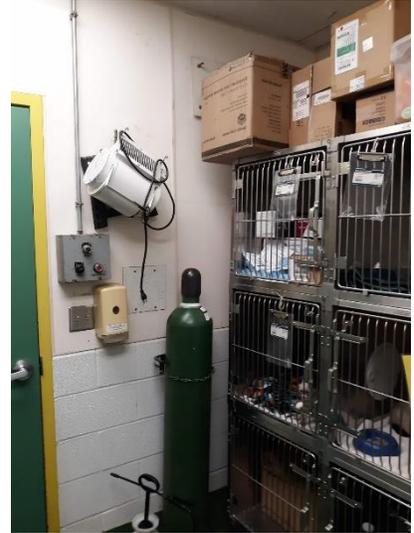
Post-Op lacks proper storage space as evidenced by boxes of sponges and other supplies sitting directly atop the cages. The X-ray table is not ideal to this setting and indicates a lack of space in the facility for a dedicated X-ray room to serve the treatment suite.

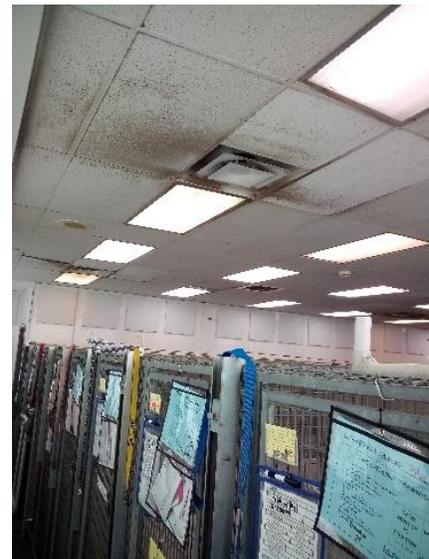
Discoloration at diffusers/grilles.
