**PHASE I ENVIRONMENTAL SITE ASSESSMENT
REPORT**

The City of Rochester
City Hall
30 Church Street
Rochester, New York 14614

200 East Avenue / 62-64 Scio Street

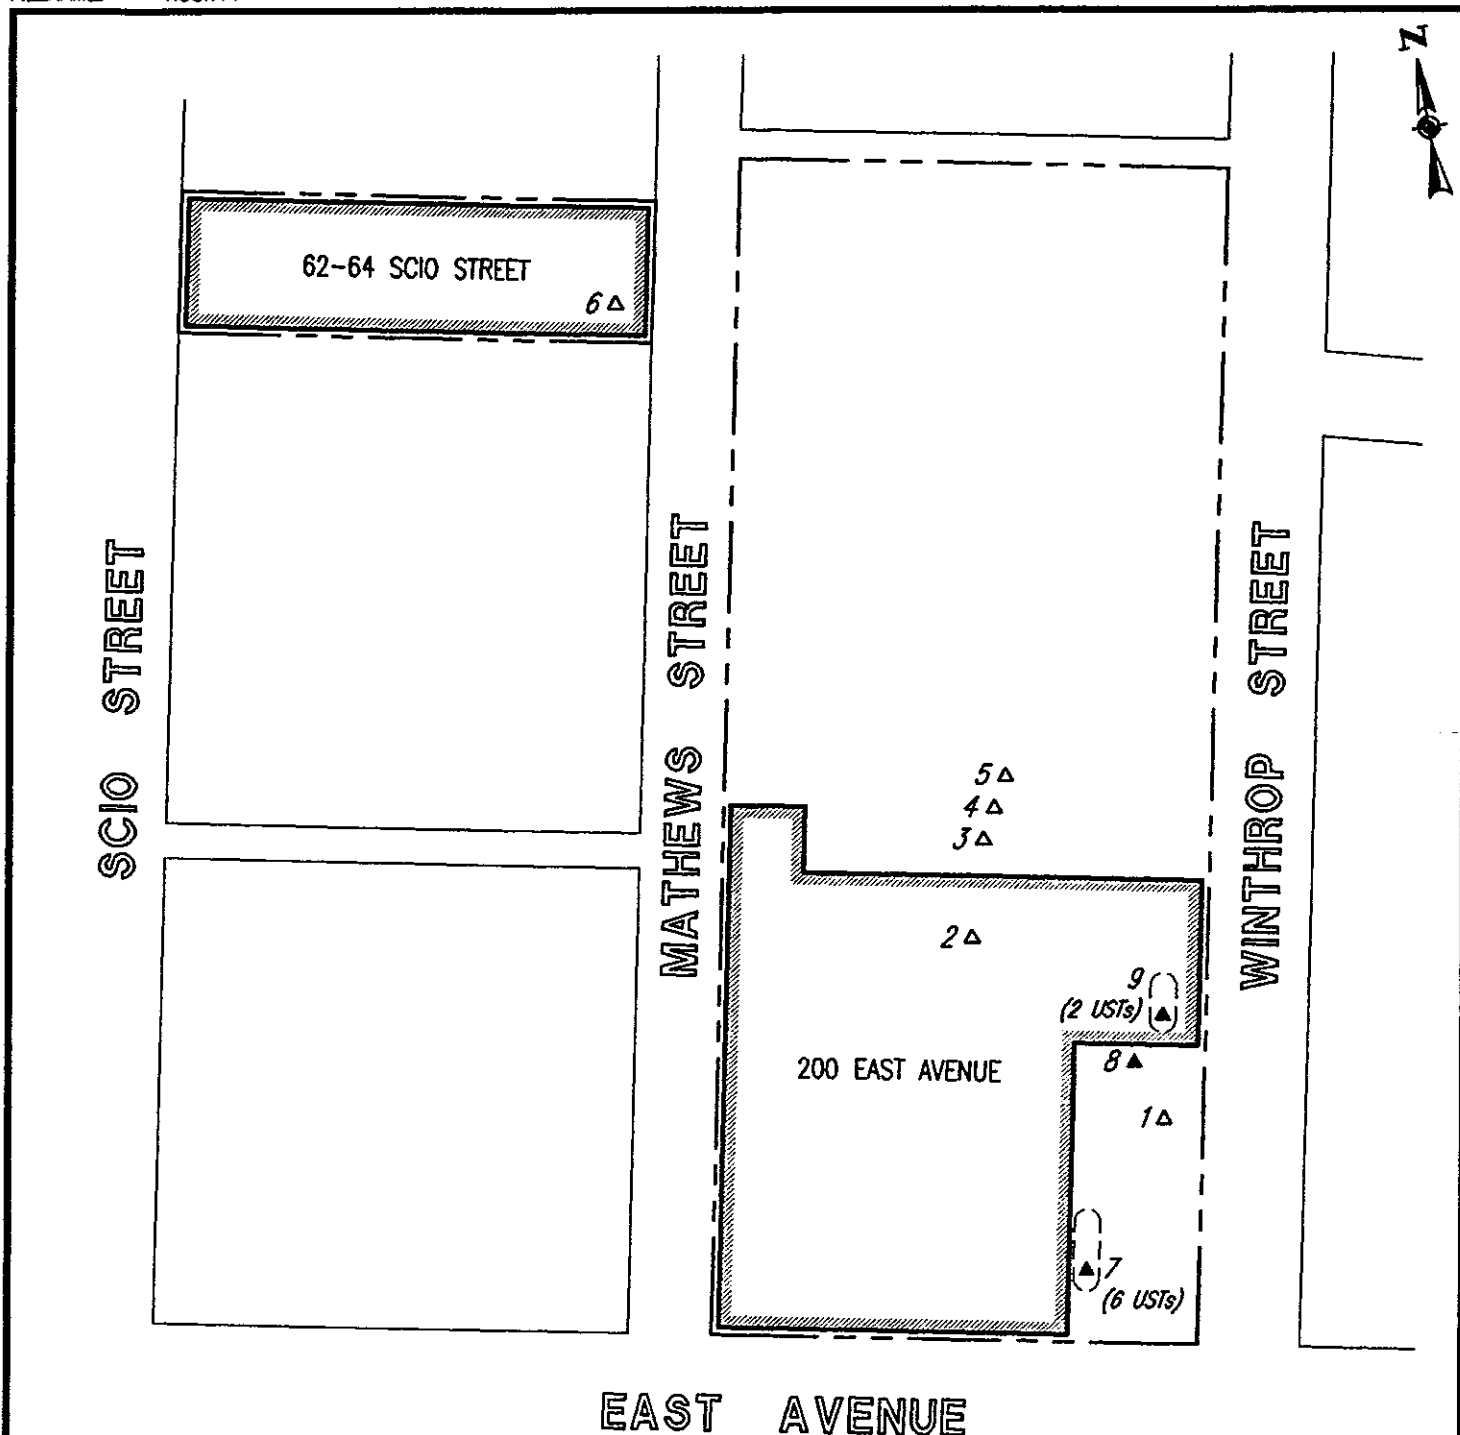
APPENDIX B

- A fillport and monitoring well were observed in the southeastern parking lot located next to the former parts store (see tank location 1 on the map in Appendix B). In addition, a vent pipe was observed on the exterior of the service area approximately 20' north of the fillport.
- Three fillports and two monitoring wells were observed in the central portion of the parking lot located north of the service area (see tank locations 3, 4, and 5 on the map in Appendix B). The fillports were located approximately 10' to 15' north of the service entrance.

- A concrete patch was observed to the southeast of the cashiers cage located inside the service area (see tank location 2 on the map in Appendix B). This concrete patch may indicate the location of an UST that was filled with concrete in the past (refer to Section 4.1).

- A metal plate was observed in the southeast portion of the service area. A one-inch diameter hole was observed in this area of the floor, and it appeared that there was a below grade area beneath the concrete floor (see suspect tank location 9 on the map in Appendix B). This area is also identified on Sanborn maps as having had tanks in the past (refer to Section 1.5).

- What appeared to be a fillport and a vent pipe were observed on the east side of the warehouse building (see tank location 6 on the map in Appendix B).

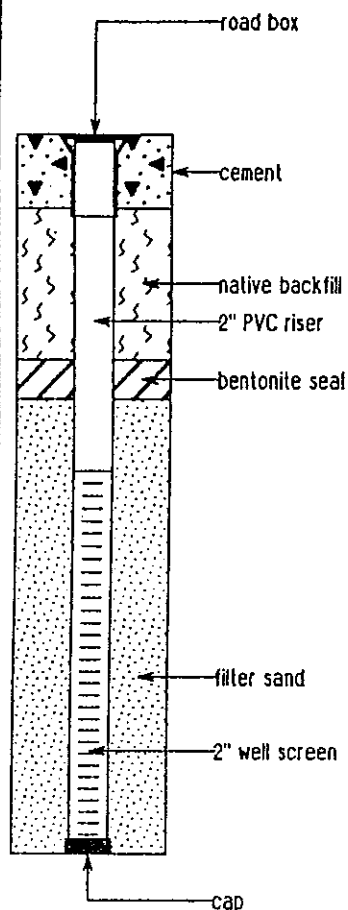
BORING LOG AND WELL CONSTRUCTION FOR WELL RIZ-1

Blow Counts	Recoy/Advance	PID (ppm)	Depth (ft)	Sample Interval	Graphic Log	Materials Description
grab		1.5				asphalt
						gray fill consisting of fine to coarse sand with angular gravel up to 2" in diameter and clumps of orange silty sand, trace coal and brick fragments
						drilling cuttings change to orange-gray silty fine sand with dolomite fragments
18			5			
17	14/24"	1.0				till grading downward into weathered bedrock, angular fragments of gray fine-grained dolomite in a matrix of fine medium orange/gray sand.
21						
25						
14						
13	11/24"	0.5				
20						
21						
50/3"	0/3"	0.5				
			10			depth to water 7.87'
						auger refusal on bedrock, Lockport Formation dolomite
			15

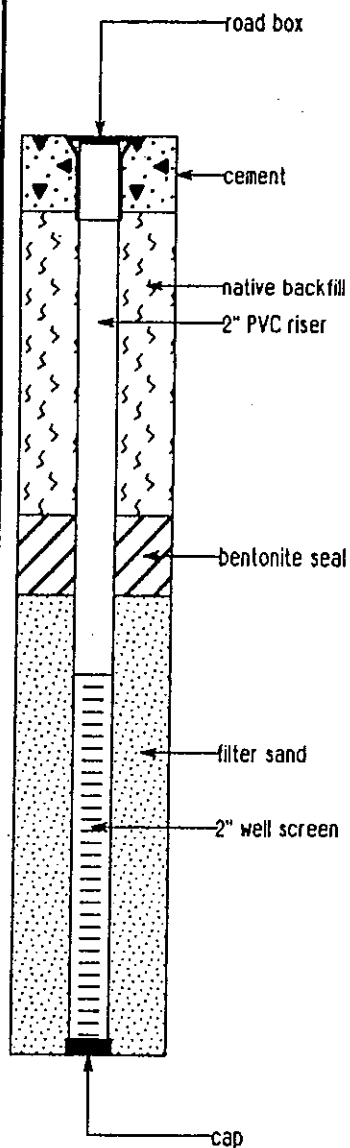
BORING LOG AND WELL CONSTRUCTION FOR WELL RIZ-3

Blow Counts	Recov/Advance	PID (ppm)	Depth (ft)	Sample Interval	Graphic Log	Materials Description
grab		0.0				asphalt
60/1"	1/2"	0.0	5			gray sand and gravel fill with layers of brick, ceramic tiles, and metal debris. augers grinding very hard from 5 to 9' no split spoon samples attempted. break through at 9 feet.
						depth to water 7.23'
23 23 25 15 5 28 25 50/5"	0/3" 14/24"	35 45	10 15			till grading downward into weathered bedrock. angular fragments of gray fine-grained dolomite in a matrix of fine medium orange/gray sand. weathered gasoline odor
						auger refusal on bedrock, Lockport Formation dolomite

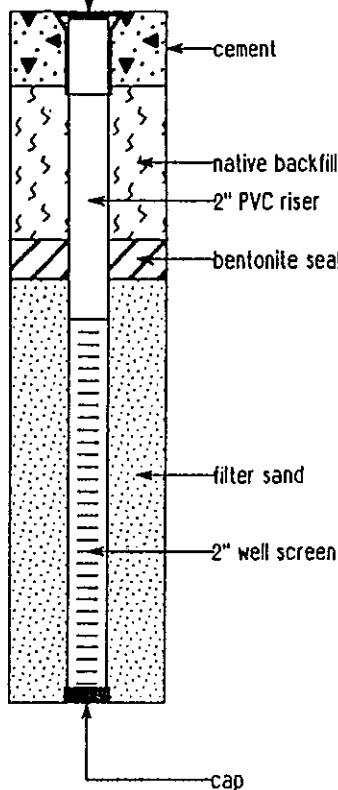
BORING LOG AND WELL CONSTRUCTION FOR WELL RIZ-4

grab		0.0			brown sand and gravel fill with fine to coarse sand and angular gravel up to 3/4"
		4			5		
		2	18/24"	0.0			
		8					
		10					
		11					
		21	11/19"	0.5			
		18					
		50/1"					
		37					
		34	10/16"	0.0	10		
		50/4"					
					15		
							reddish brown silty fine sand with few red and gray dolomite pebbles
							angular gray and red dolomite fragments in a matrix of reddish brown fine sand and silt
							same as above, higher percentage of rock fragments, sample saturated, no odor.
							auger refusal on bedrock, Lockport Formation dolomite
