Cornerstone Park Improvements

Preliminary Investigations Report

PREPARED BY MCCORD SNYDER LANDSCAPE ARCHITECTURE, PLLC
 NOVEMBER, 2013

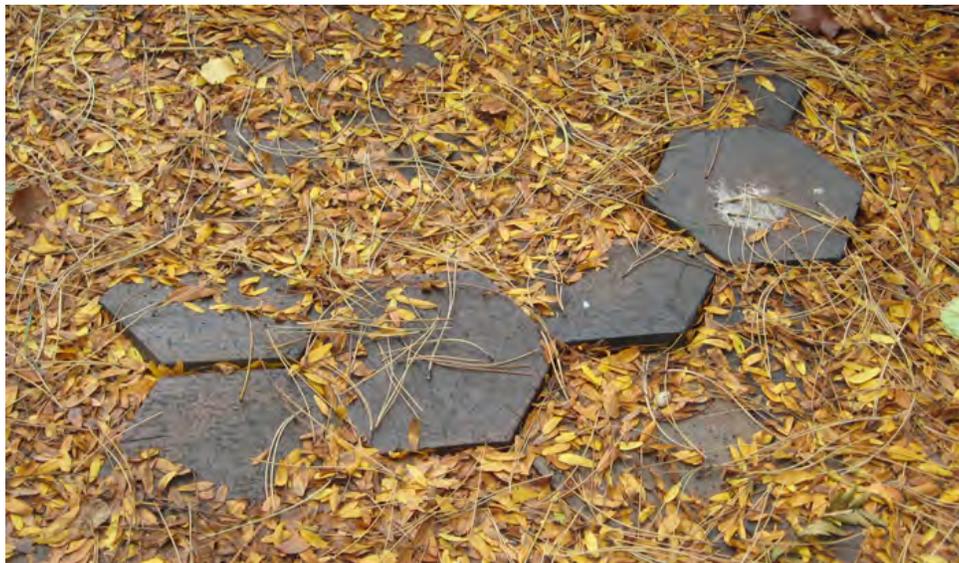
Figure 4 - Hexagonal brick pavers have heaved and become unsafe or are missing in many locations.

Pavement. Sidewalks surrounding the park on 3 sides and within the right-of way and along the entrance to the South Avenue Garage, are standard concrete in generally good condition and have been well-maintained. Sidewalks within the site are primarily paved with hexagonal, fired brick pavers (Figure 3) that have heaved in many locations to an unacceptable extent either individually or in larger groups of pavers, due to frost heave, roots, and other factors (Figure 4). These pavers are only 1.25" thick and, as such, are more like tiles and they cannot function to interlock as can more modern, thicker pavers and bricks. It is suggested these pavers be completely removed and disposed of. The broken areas of sidewalk are an impediment to access by the disabled.

1. Remove existing pavement and paving stones.
2. Cut the walkway areas to subgrade elevation. Note that the rubble was up to 2' in size and there were about five such pieces in one test pit. 'Mass' excavation will result in "large" pieces that will have to be handled and disposed of. Proof roll the subgrade with a roller or large plate tamper. Undercut soft areas or organic debris. This completed, we can expect that the rubble fill will reasonably support new walkways. Some long-term settlement is possible without deep excavation and filling of the entire site. It should be noted that no settlement has been observed at any location on site.
3. Backfill utility trenches with crusher run stone,

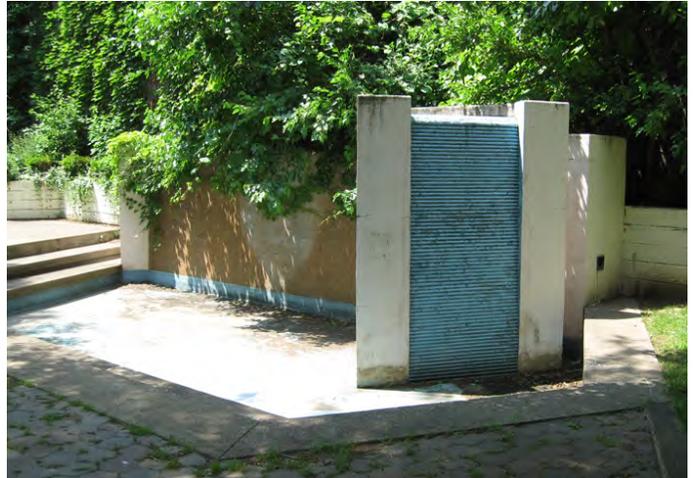
Water Feature: Two steps down to presumably the water level of the existing, non-functional waterfall feature, are in good condition (Figure 5). The bottom of the pool area was once painted blue but is now more grey concrete as it has not been re-painted in quite a while. The waterfall features including the wide falls, and the tower, both about 8 ft. ht. above the pool elevation, appear to be in good condition. The water has not been turned on for this feature for a number of years and was not functioning for this investigation. Various controls, wiring, outlets, piping, etc. appear to be in severely deteriorated condition.

Figure 5 - Existing concrete water feature no longer functions

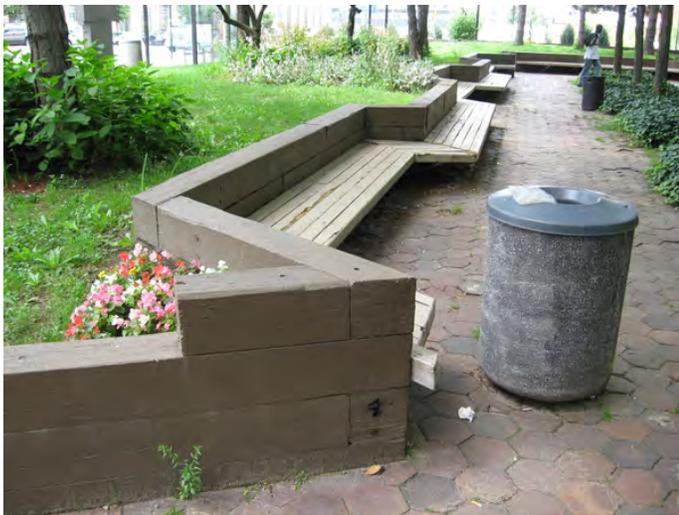
Figure 6 - Existing timber retaining walls and benches.

Timber Retaining Walls and Curbing: All timber retaining walls (8x8 timbers bolted and spiked) appear to be nearing the end of their useful life. Although there is no evidence of structural failure in any respect, there is evidence of rot at ends of various components of the wall (Figure 8) as well as evidence of damage due to being struck by vehicles and broken (Figure 7). The walls have been painted white along the building wall (north) side of the park and dark brown stained elsewhere in the park. The 1992 maintenance memos say that the timbers were nearing the end of their useful life 20+ years ago and no significant improvements appear to have been made in the interim. Any effort to save these walls would be costly and involve numerous timber replacements and applications of preservative, stain, and or paint and would extend the life of this feature for some length of time.

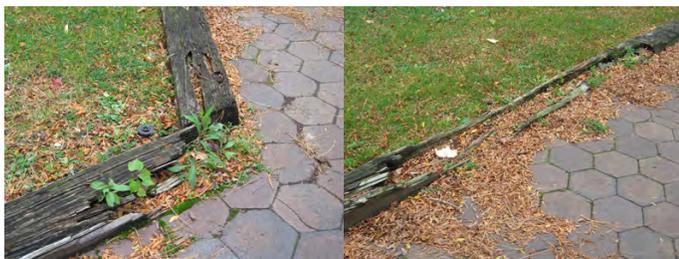
Figure 7 - Timber curbs are rotting and broken in numerous locations.

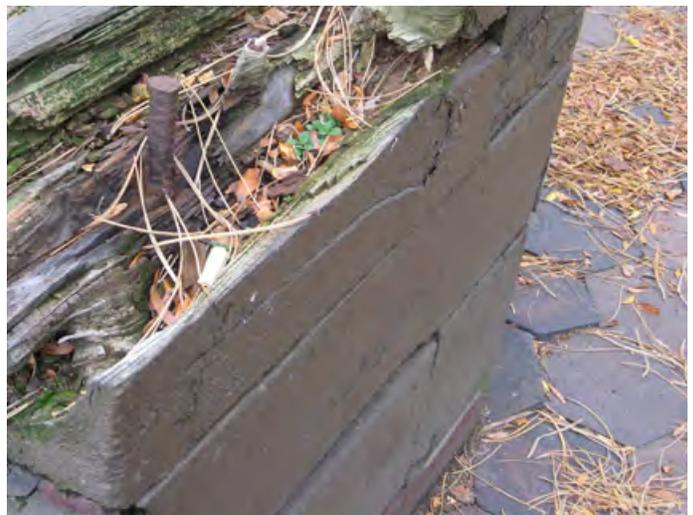
Figure 8 - Timber retaining walls are rotted and deteriorating in many areas.

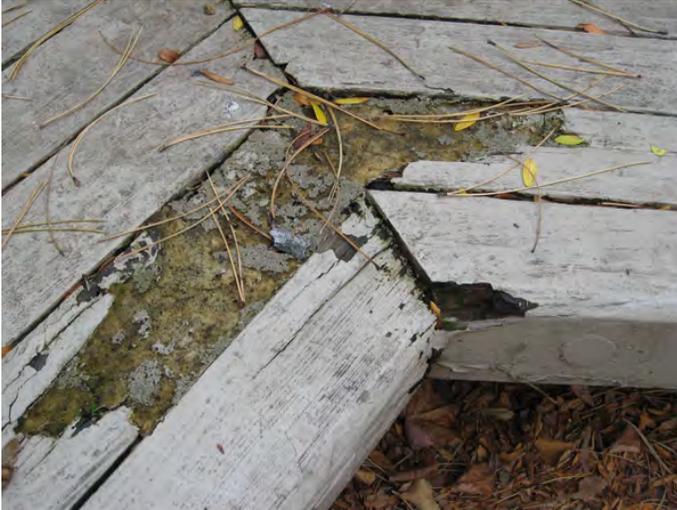
Figure 9 - Damaged and rotting timber benches are at the end of their useful life.

Long, continuous wood benches bolted to the timber retaining walls have been maintained reasonably well over the years and would continue to function adequately for a time to come given that same level of maintenance. They are, however, higher maintenance than other types of benches that are available in that they need to be painted or stained periodically to keep them from rotting and splintering. They are nonetheless nearing the end of their practical use life. The underlying galvanized steel or cast aluminum supports appear to be in good condition and could be salvaged for some other use.

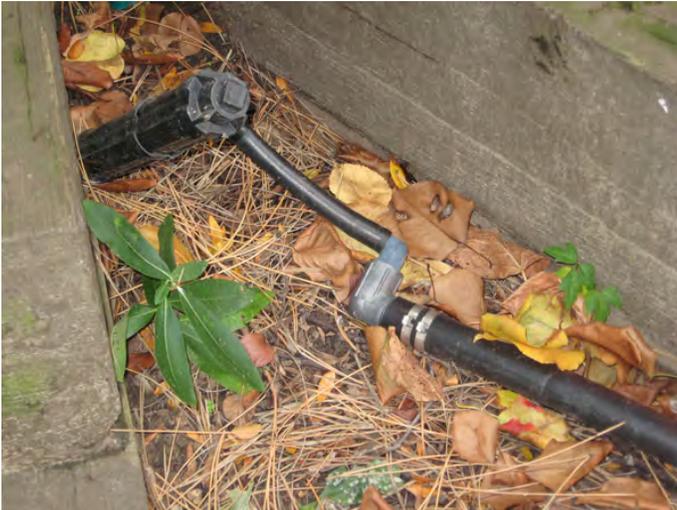
An irrigation system (Figure 11) was installed and presumably functional at some point but has since fallen into disrepair and is no longer used. There are numerous pieces of the system still visible in landscape areas including spray heads, drip pipes, black pipe, and connectors. The entire system should be removed and disposed of.

Figure 11 - An extensive irrigation system is in disrepair and no longer functions.

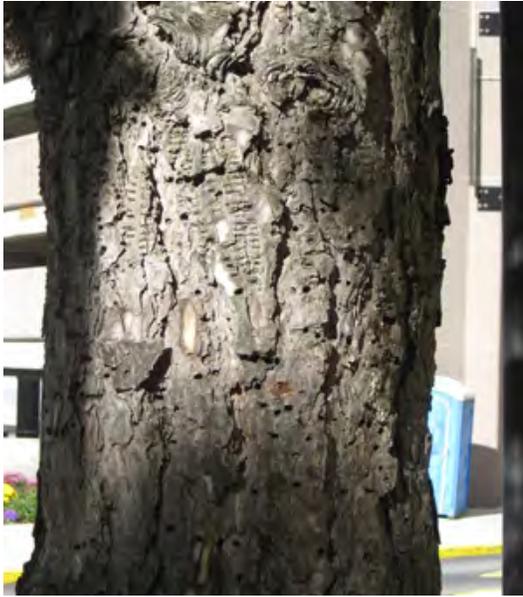
Several existing red pine (*Pinus resinosa*) remain of what was originally 14 trees surrounding the central seating area / water feature of the site. They are well overgrown and no longer satisfy their presumed original intent of visually screening the outside / street side from the interior of the park. With branches being trimmed to well above eye height, they no longer screen the park but do offer shade to seating areas to some degree. Almost all red pines have been infected with the pine bark beetles (Figure 14) and should be removed.

Figure 14 - Red Pines are infested with pine bark beetles.

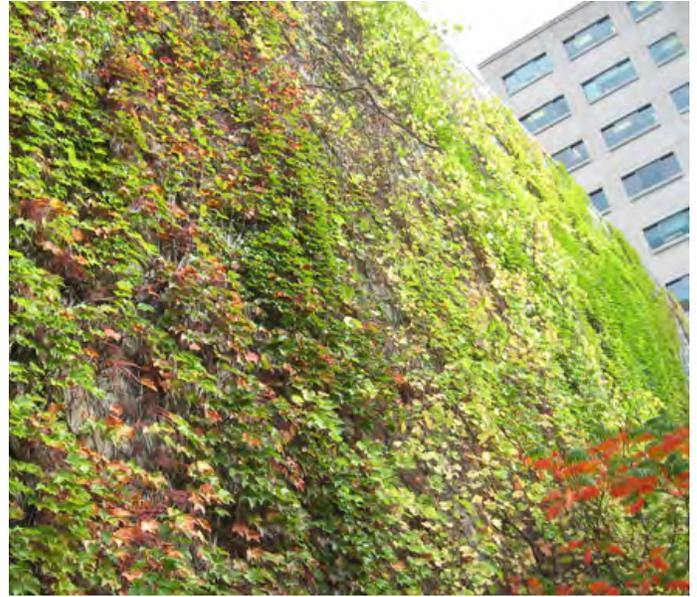
Figure 15 - The north wall (63 Stone Street) is nearly completely covered with vines.

Wall vines are primarily Boston (Japanese) Creeper (*Parthenocissus tricuspidata*), with some wild vines (Poison Ivy, Wild Grape), one invasive species (Oriental Bittersweet, *Celastrus orbiculatus*) and other landscape varieties intermixed all growing up onto the light grey stucco-style wall. cursory examination of the wall reveals that the wall and stucco material appear to be holding up very well (i.e. no cracking or missing pieces noted). Vines have spread, perhaps undesirably, to the east and west sides of the Frontier building, partially covering windows and doorways. The original agreement with Frontier places maintenance of wall vines as their responsibility.

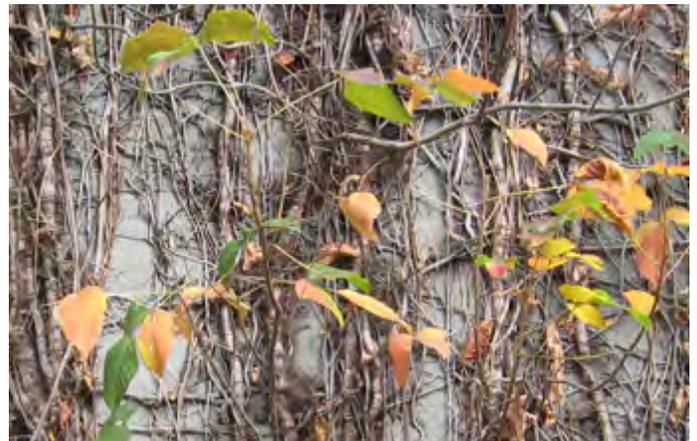
Figure 17 -Poison Ivy growing on the north wall.

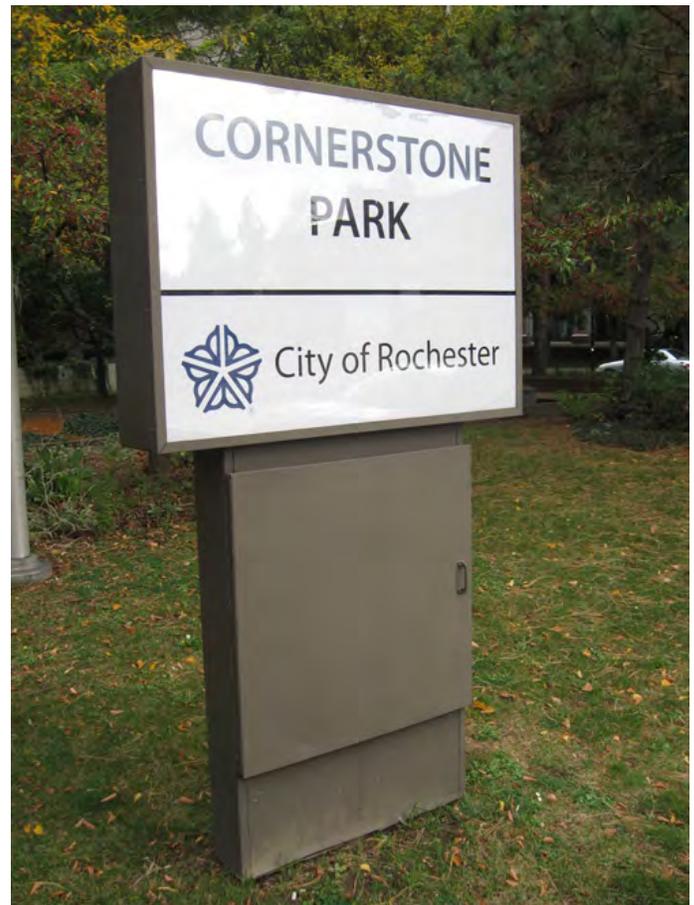
Signage: A site park designation sign is located centrally along the Broad Street frontage, facing Broad street. It is in good condition. It appears to have at one time been internally lit, however it is not know at this point whether any lighting is still functional.

Figure 19 -Park identification sign, facing Broad Street. Sign is in good condition. Appears to have been internally lit at one point. It is not known if lighting still is operational.

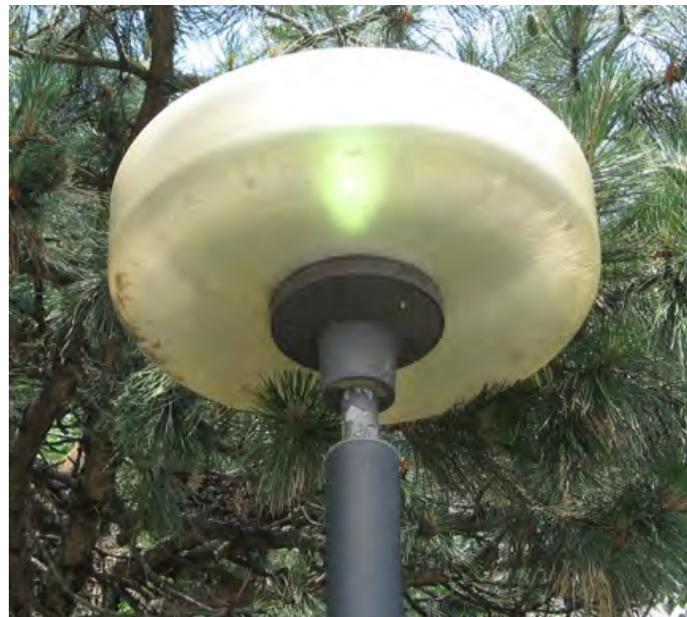
In the park area, landscape and pole lights are installed. For the most part, the landscape lighting fixtures have been removed. However, wiring, junction boxes and outlets remain. Originally, six (6) area lighting poles were installed. Today, the poles remain, with only four (4) operational and having light fixtures in place. The remaining two (2) poles, located along the South Avenue parking ramp garage driveway, have had the light fixtures previously removed. Lighting system components are operational, however, show age and weathering, and are energized continuously.

Figure 29 - Existing Light Pole

Existing outdoor electrical systems and equipment are approaching the end of normal, useful service life and should be completely removed. Considering the level of landscape changes, maintaining any part of the electrical systems will hamper and possibly limit landscaping options. Removal and replacement of the outdoor and underground electrical systems, wiring and equipment will allow the area electrical needs to keep pace, and expand with, the park upgrade and revitalized appearance.

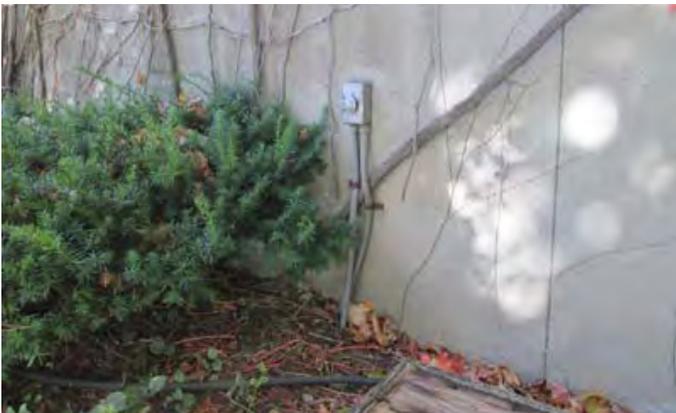
Spaced around the park are three (3) 120 volt convenience outlets. It does not appear any of the receptacles are currently ground-fault circuit (GFCI) protected. In addition, weatherproof covers are either missing or not functional.

Figure 33 - Receptacle Cover Not Closing Tight

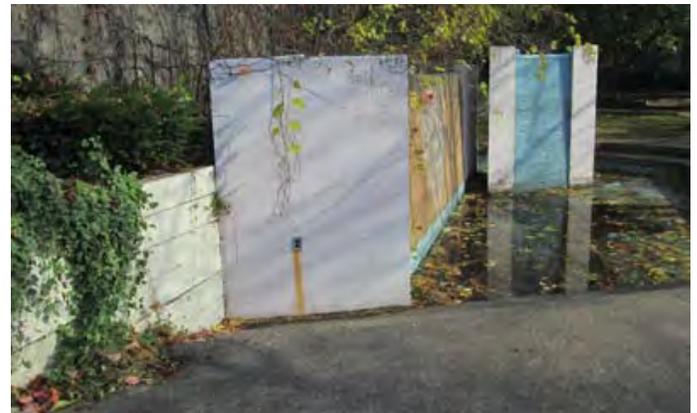
Figure 34 - Receptacle Without Weatherproof Cover

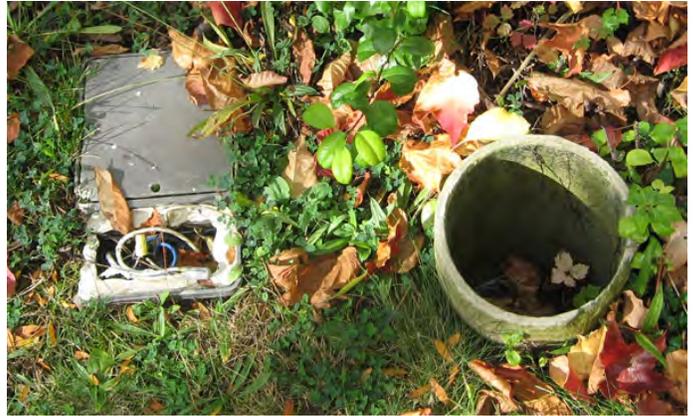
There are numerous 8"x12" boxes located throughout the site, some with covers removed and with wiring exposed. They are usually located next to a buried open cylinder with additional wiring inside. These may have been where uplighting lamps were located at one time. None contain fixtures or lamps at this time.

Figure 35 - Remains of existing up-lighting system components

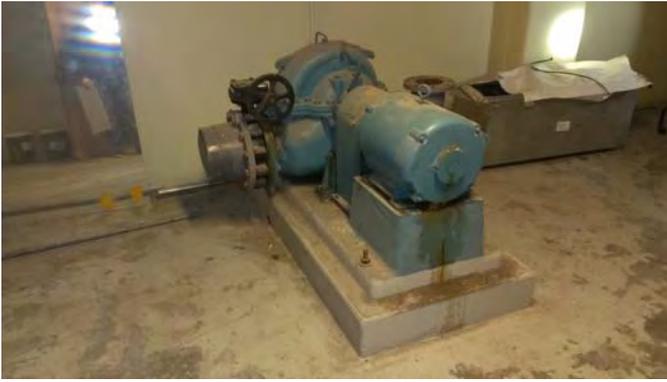
It appears, originally, a 15 HP pump, located in the Frontier building supplied water to the park fountain / water feature. This pump is now totally disconnected. Currently, two (2) submersible pumps for the fountain / water feature are located in a manhole to the east of the fountain / water feature. Actual pump sizes are unknown. Based on the circuit breaker size, the pumps are estimated to be no larger than 5 HP each. Water level in the manhole is maintained by a float switch connected to a solenoid valve in the Frontier building. Equipment appears to be operational.

Figure 38 - Abandoned 15 HP fountain pump

Existing plumbing systems and equipment are approaching the end of normal, useful service life and should be completely removed. Considering the level of landscape changes, maintaining any part of the plumbing systems will hamper and possibly limit landscaping options. Removal and replacement of the outdoor and underground plumbing systems and equipment will allow the area plumbing needs to keep pace, and expand with, the park upgrade and revitalized appearance.
