The Honorable Loretta C. Scott Center for Human Services Facility Inspection & Repair Design Services

City Bldg. ID No. 9.84 City Project No. 23035

FACILITY CONDITIONS AND NEEDS ASSESSMENT REPORT

Facility Conditions and Needs Assessment Chambers Building

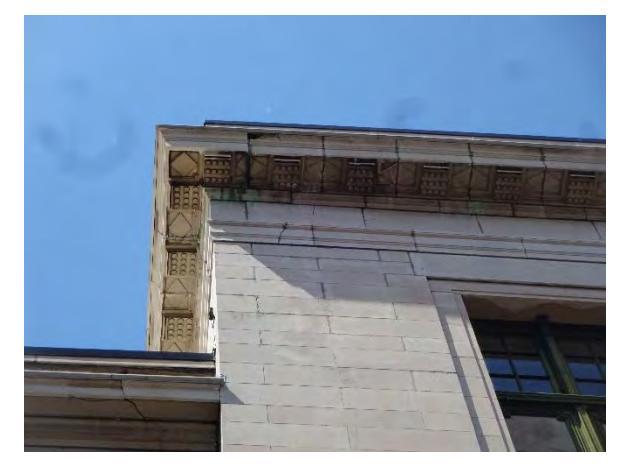
Figure – Cracked Cornice

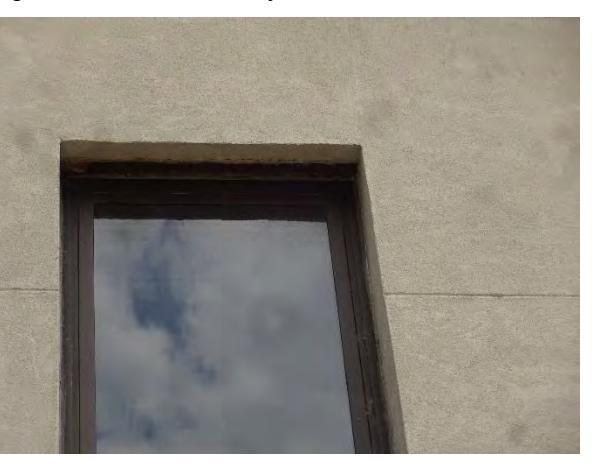
Figure – Rusted Lintel

We observed much of the window, door, and vent lintels (from grade through the roof level) are showing signs of rust and in some cases starting to rust jack. All lintels should be cleaned of rust, then primed and painted to preserve and protect them from future deterioration and failure.

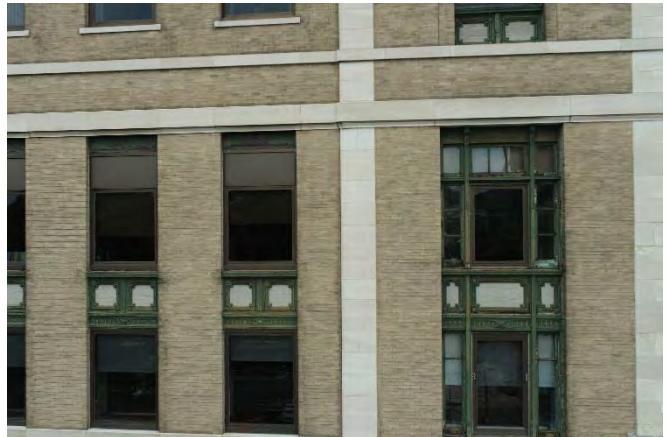
Figure – Rusting lintel Starting to Rust Jack

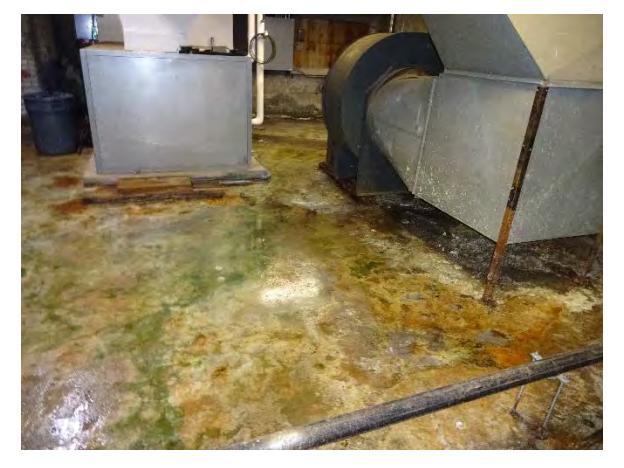
See structural report for sub-basement water mitigation. In addition to the remediation noted in the structural survey report, we feel a perk test should be done below the floor of the sub-basement to understand the needs for a possible underfloor perimeter drain.

Figure – Standing Water in Sub-Basement

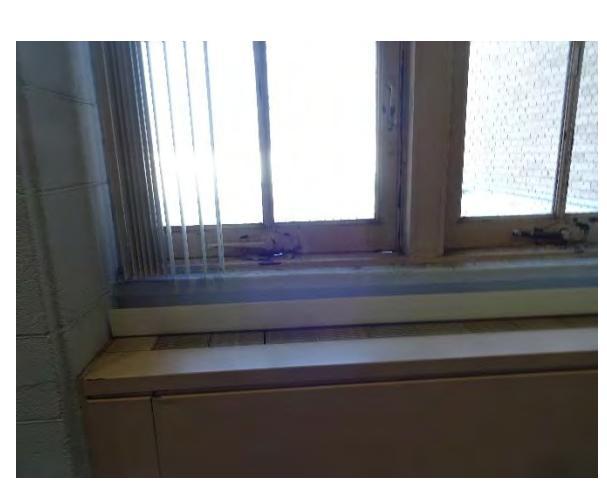
Figure – Daylight at Bottom of Window (1915 Building)

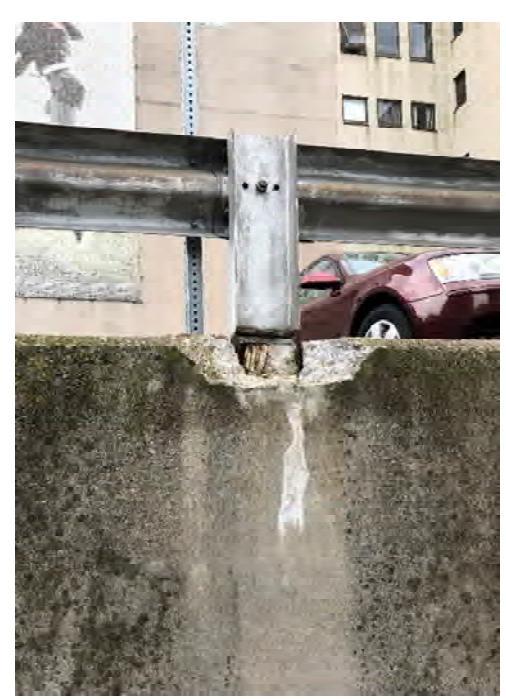
lead to corrosion of the steel. The corrosion of the steel causes swelling and expansion of the embedded anchors and often leads to concrete spalling. It is recommended that each of the locations where the concrete retaining wall has deteriorated shall be patched. At each location the concrete surface shall be cleaned of any loose fragments, debris or other contaminants and a concrete bonding agent (i.e. Sika Armatec 1C or similar) and patch mortar product (i.e. Sika Repair 223 or similar) shall be applied. Patching each of the locations is important to help reduce further corrosion of the steel and deterioration of the concrete. It is also recommended that a caulk or sealant (i.e. Sikasil 728 SL or similar) be used to fill the joints around each of the guardrail support posts.

Figure – Spalled Concrete at Guardrail Support (0171)

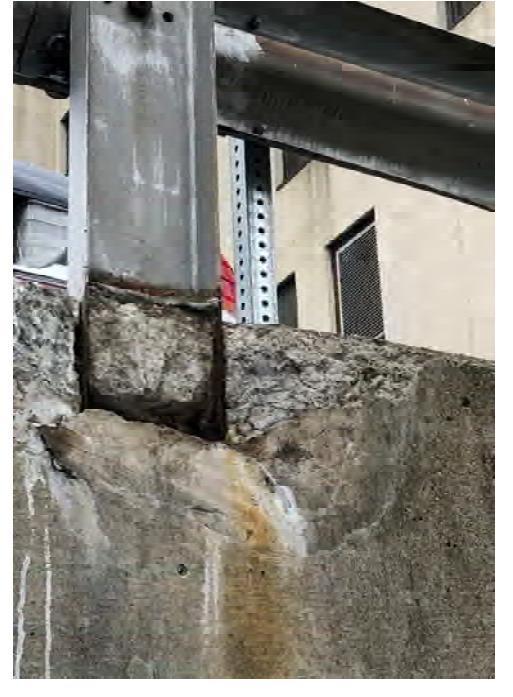
Figure – Spalled Concrete at Guardrail Support (0173)

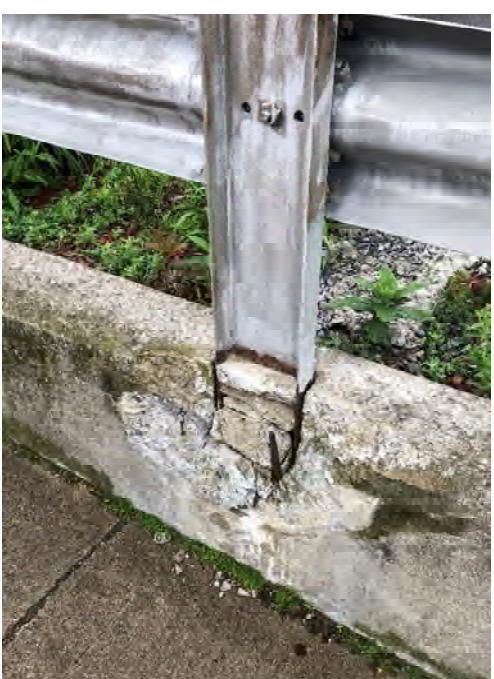
Figure – Spalled Concrete at Guardrail Support (0178) CHAMBERS BUILDING ASSESSMENT REPORT – OCTOBER 15, 2021

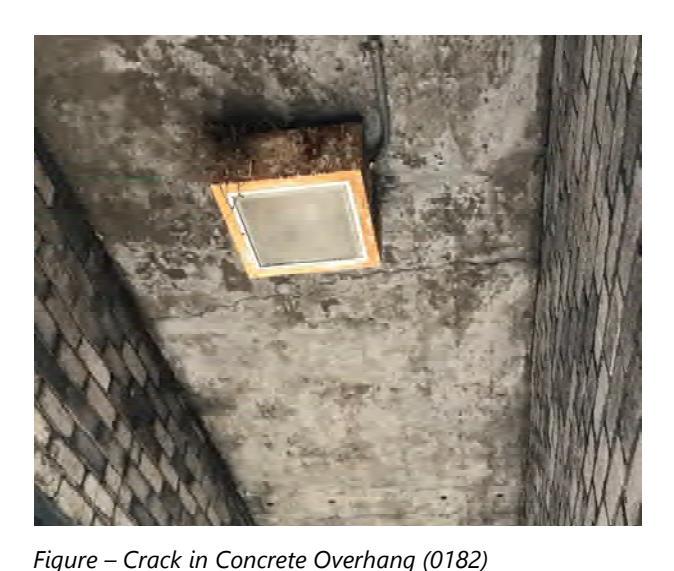
Along the underside of the exterior overhang located along the east side of the building, just west of the parking lot, there is visible concrete spalling and cracking visible. These areas of concrete should be repaired using an injectable mortar or epoxy (i.e. Hilti Cl 060 Crack Injection System or similar) to fill any visible cracking and a bonding agent (i.e. Sika Armatec 1C or similar) and concrete repair mortar (i.e. Sika Repair 223 or similar) to patch the areas of spalling concrete. It is important to repair any exterior deterioration to reduce the risk of moisture infiltration into the building, and in the case of spalled concrete to reduce the risk of the concrete reinforcement corroding when exposed to the exterior elements.

Figure – Spalled Concrete at Concrete Overhang (0183)

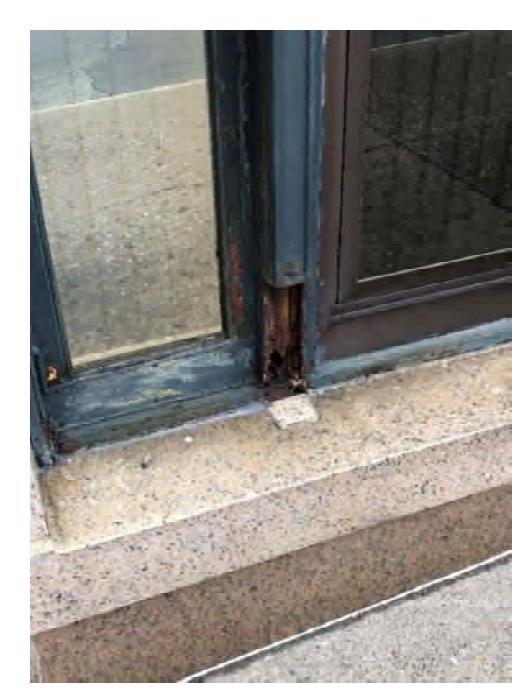
Figure – Corroded Window Jamb (0188)

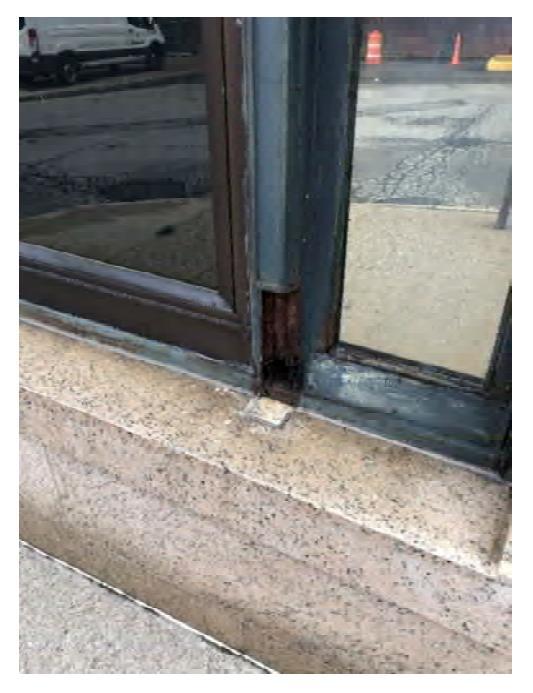
Figure – Corroded Window Jamb (0189)

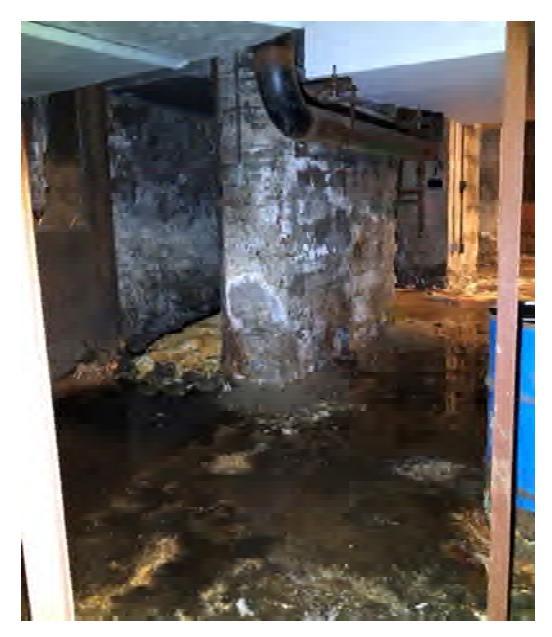
eastern basement wall be completed to allow for the application of new waterproofing along the exterior side of the basement walls. This approach would serve as the most effective method of addressing the water issue and reducing the water infiltration through the basement walls. Application of an interior wall treatment would be far less effective at preventing water infiltration over the remaining life of the building and even if this approach worked perfectly, it would mean that the moisture would be permanently trapped within the wall, which is not desirable structurally. In addition, it is recommended that the existing sump pump be removed and replaced to assist with moving any existing moisture out of the basement. Any coatings or sealants encountered during excavation along the exterior side of the eastern basement wall will require sampling and analysis for asbestos or be assumed as ACM.

Figure – Standing Water at Basement Floor (0005)

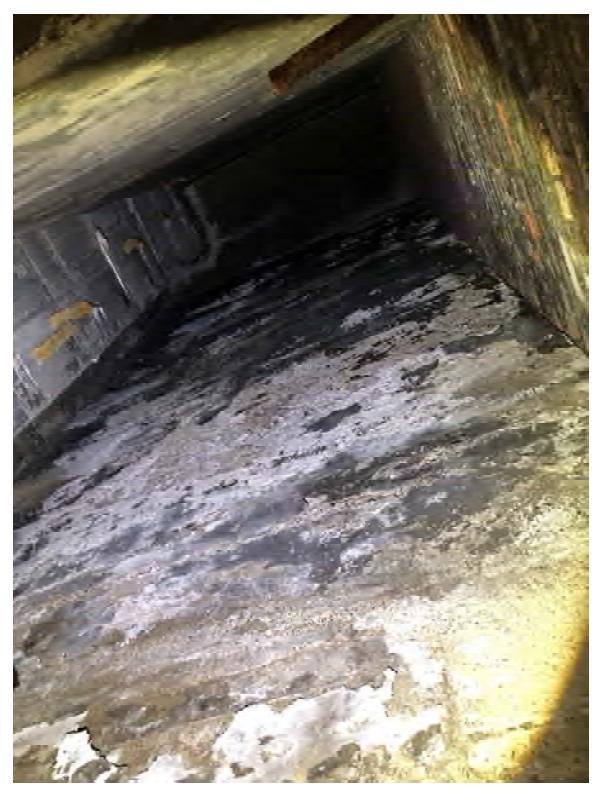
As a result of the high levels of moisture present within the basement, many of the masonry and concrete walls are showing signs of significant deterioration. The moisture should be addressed prior to performing any long-term repairs of these portions of the building, otherwise any patch performed will only continue to deteriorate at an accelerated rate. Once the water has been addressed as recommended above then these portions of masonry and concrete shall be repaired using a surface applied cementitious mortar repair product (i.e. Sika Repair 224 or similar). Caulks, mortars, concrete patches, and sealants that may be impacted by repair activities will require sampling and analysis for asbestos or be assumed as ACM.

Figure – Spalled Concrete Basement Walls (9976)

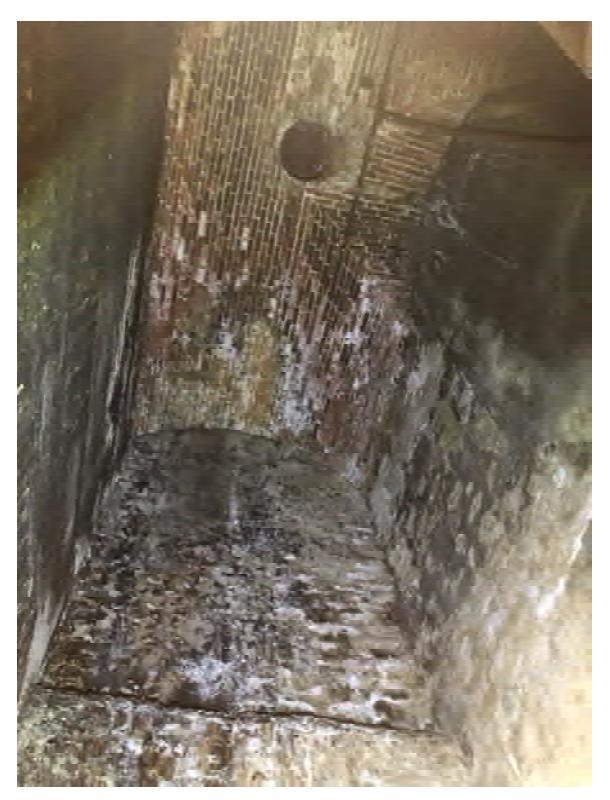
Figure – Crumbling Masonry Basement Walls (9985)

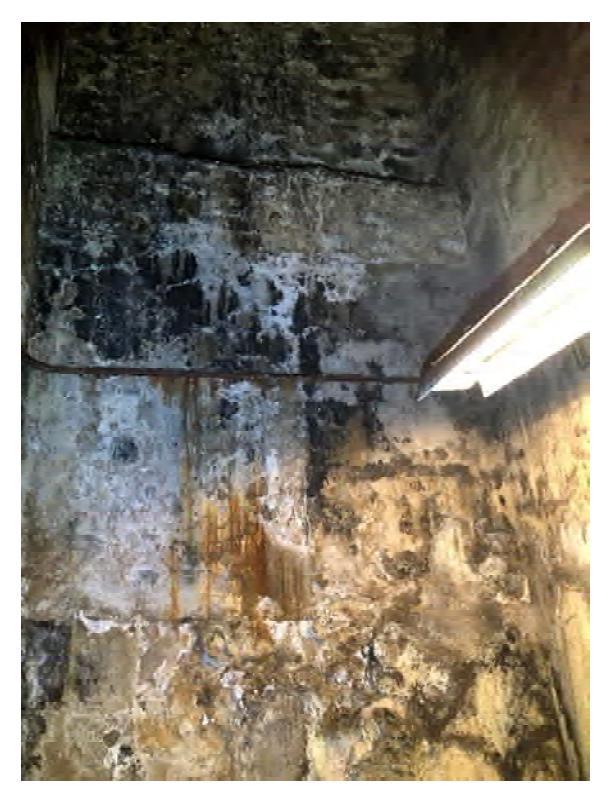
Figure – Deteriorated Basement Walls (9986) Corrosion and Deterioration of Equipment Supports:

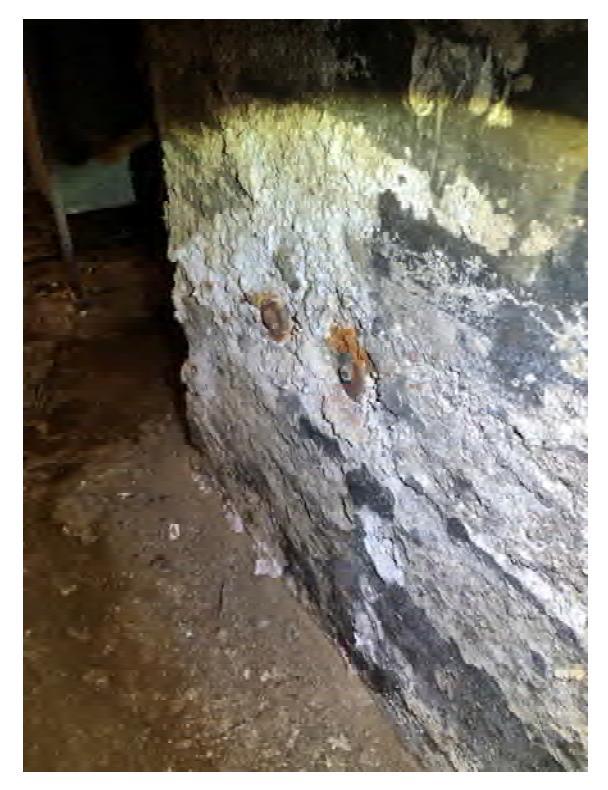
Figure – Deteriorated Concrete Basement Walls (9988)

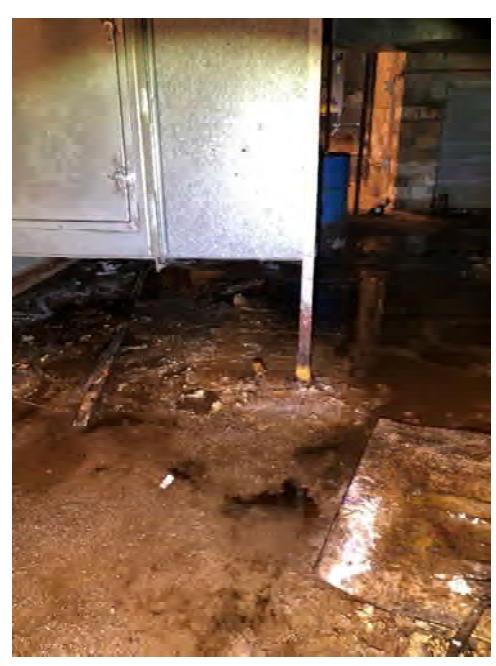
As a result of the large amounts of standing water within the basement, many of the existing steel equipment support frames are significantly corroded. These supports should be replaced with new support framing, but only after the water issue has been mitigated. Note that an alternate approach could be to install new concrete housekeeping pads to support the equipment in lieu of steel frames.

Figure – Corroded Equipment Support Post (9982)

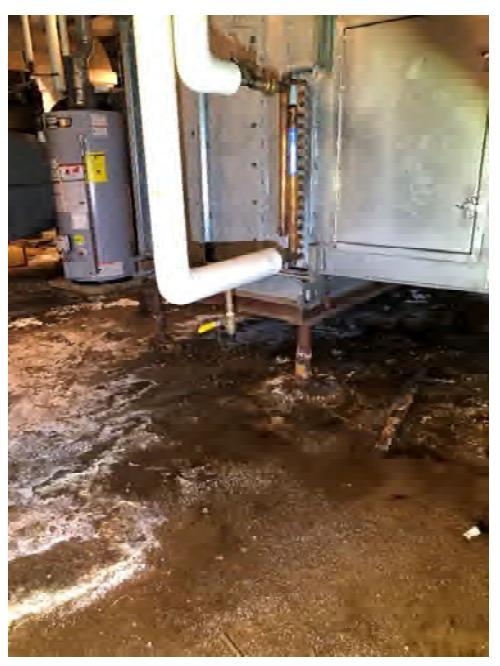
Figure –Corroded Equipment Support Frame (9983)

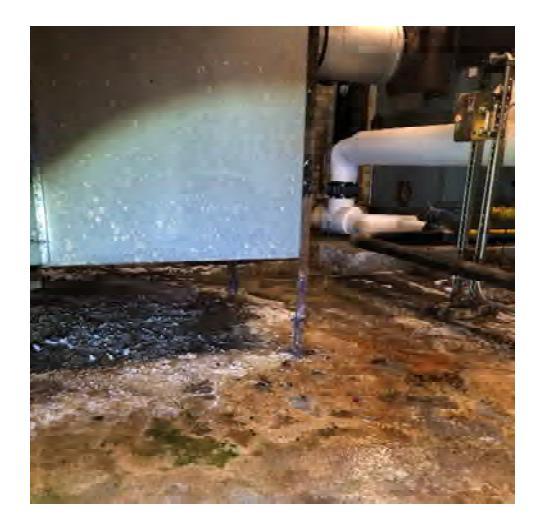
Figure – Corroded Equipment Support Post (9998)

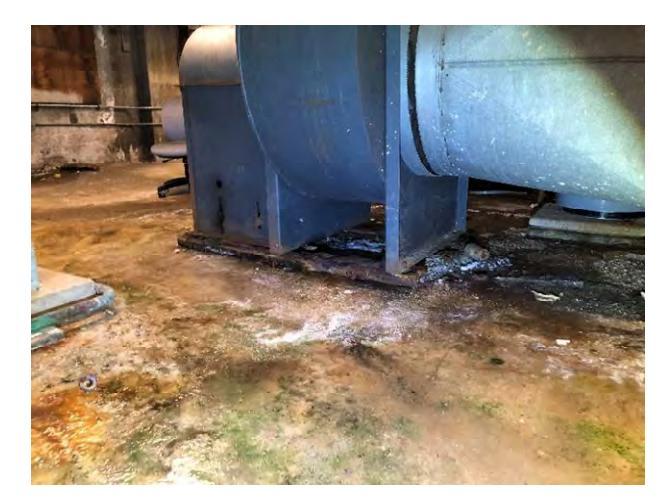
Figure – Deteriorated Equipment Support (9999)

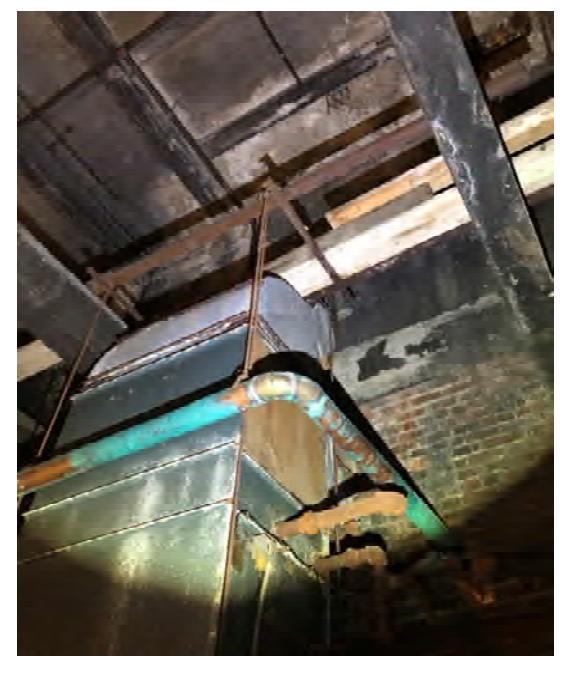
Several of the existing suspended equipment hanger support frames are significantly corroded. These supports should be replaced with new support framing and new hanger rods, but only after the water issue has been mitigated. All Thermal Systems Insulation (TSI) associated with plumbing and HVAC systems that may be impacted by support replacement is assumed to be ACM or will require sampling and analysis for asbestos.

Figure – Corroded Equipment Support Hangers (9974) Spalled Concrete at Underside of Concrete Slab:

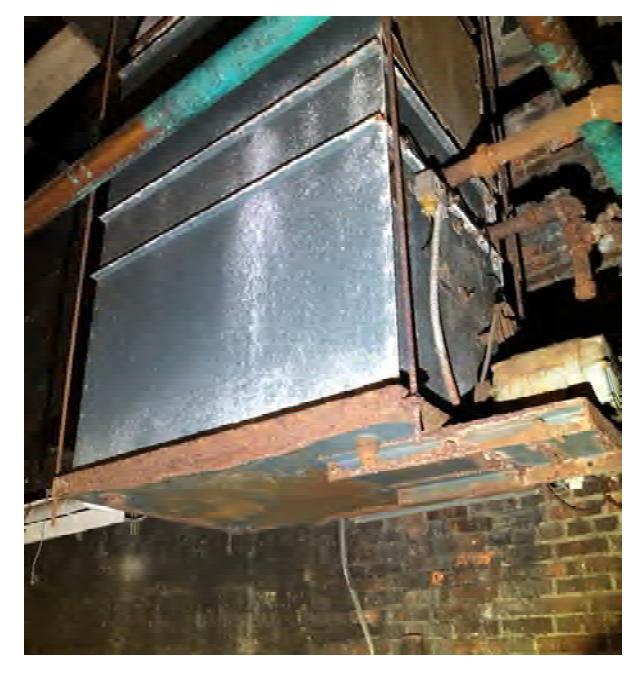
Figure –Corroded Equipment Support Frame (9975)

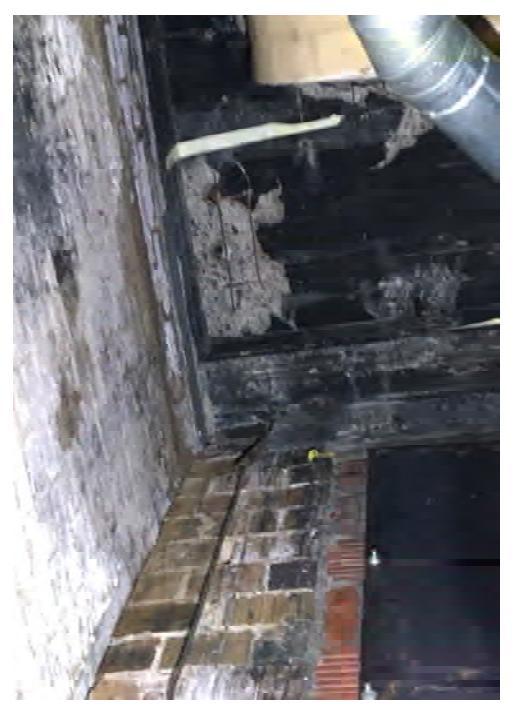
Figure – Spalled Concrete and Exposed Rebar (0003)

each of these spalled concrete locations that a bonding agent (i.e. Sika Armatec 1C or similar) be applied and that a concrete patch product (i.e. Sika Repair 223 or similar) be used to restore the concrete cover along the underside of the reinforcement.

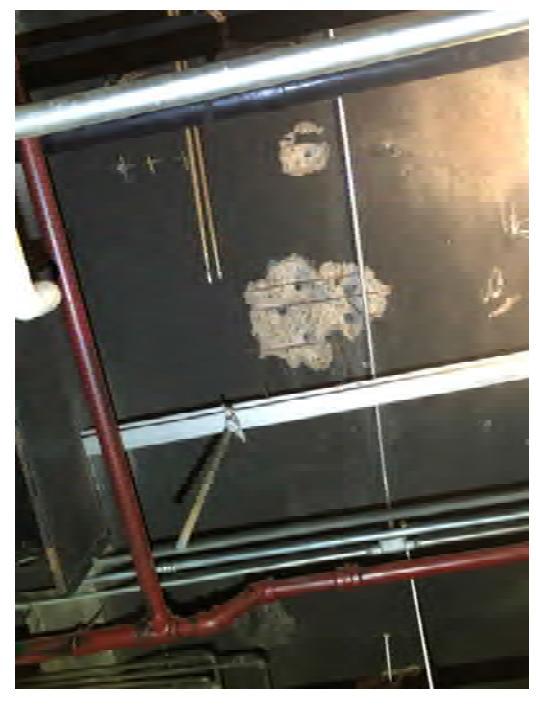
Figure – Spalled Concrete and Exposed Rebar (0015)

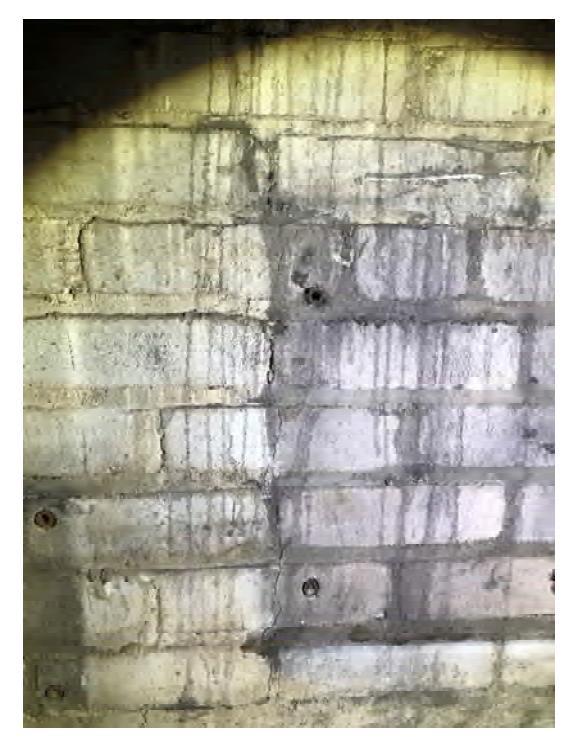
Figure – Cracked Masonry at Anchor Inserts (0008)

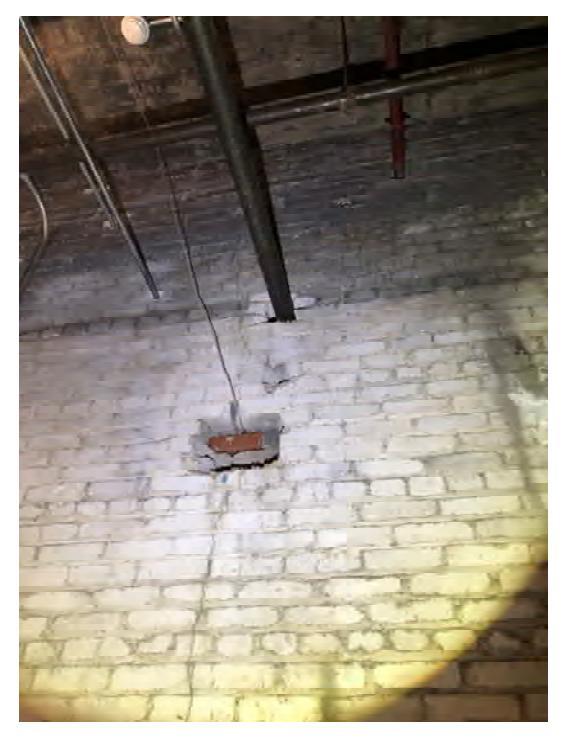
Figure – Cracked Masonry at Wall Penetration (0010)

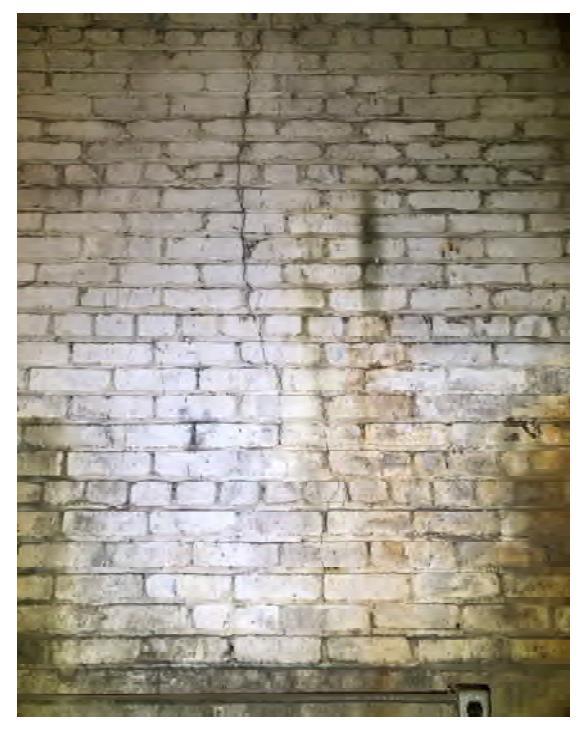
Figure – Cracked Masonry (0009)

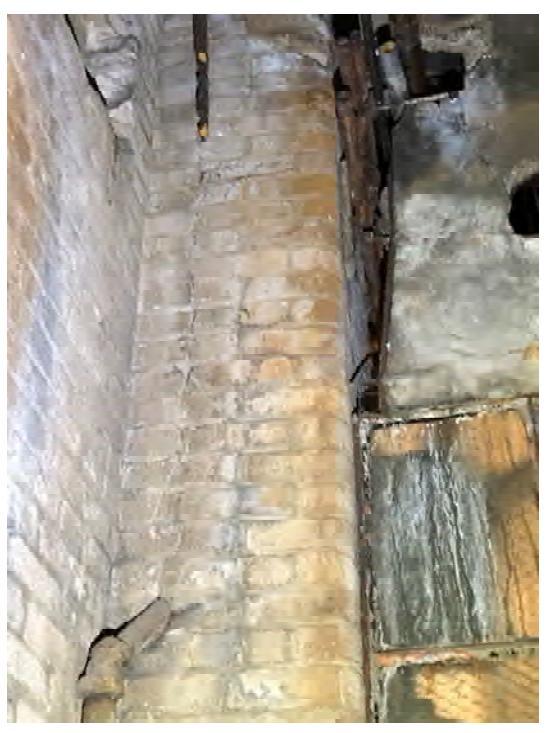
Figure – Cracked Masonry Column Enclosure (0012)

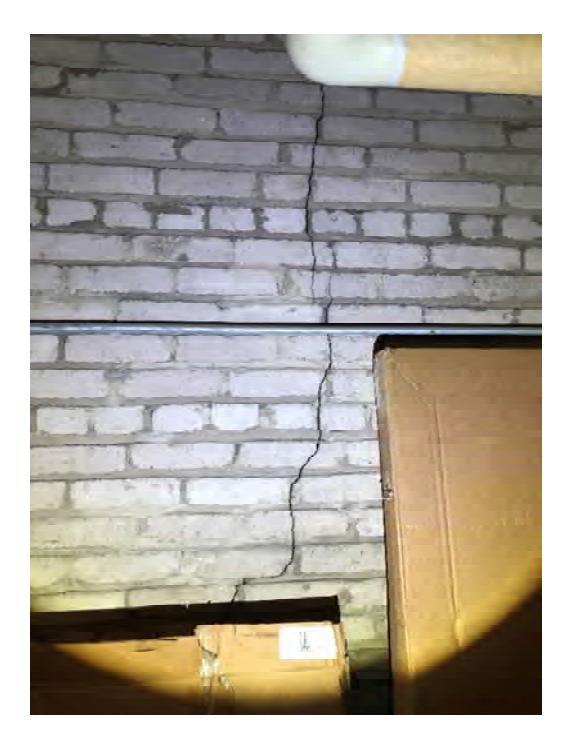
Figure – Cracked Masonry (0040)

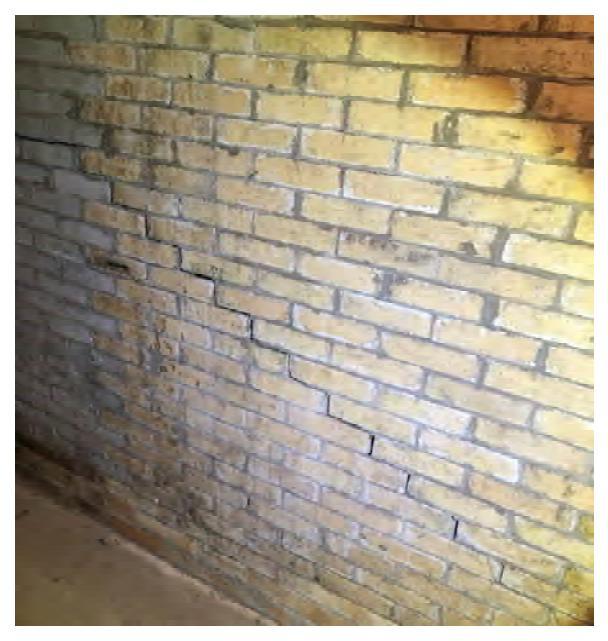
Figure – Diagonal Stairstep Crack in Masonry (0027)

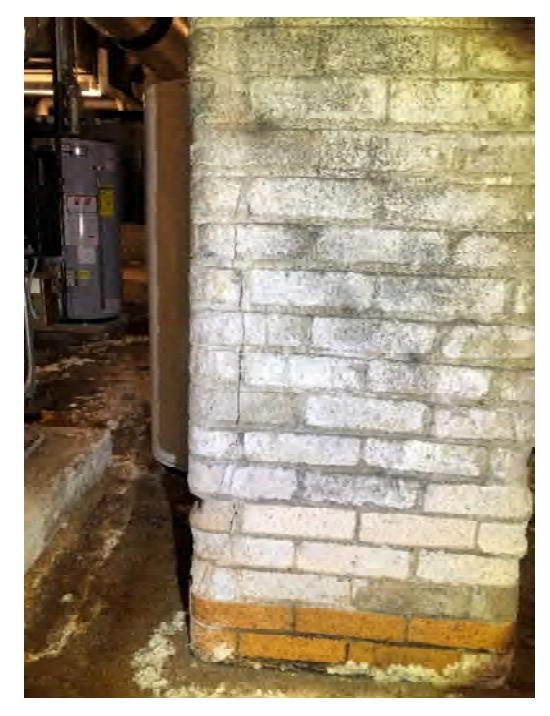
Figure – Cracked Masonry at Column Enclosure (9980)

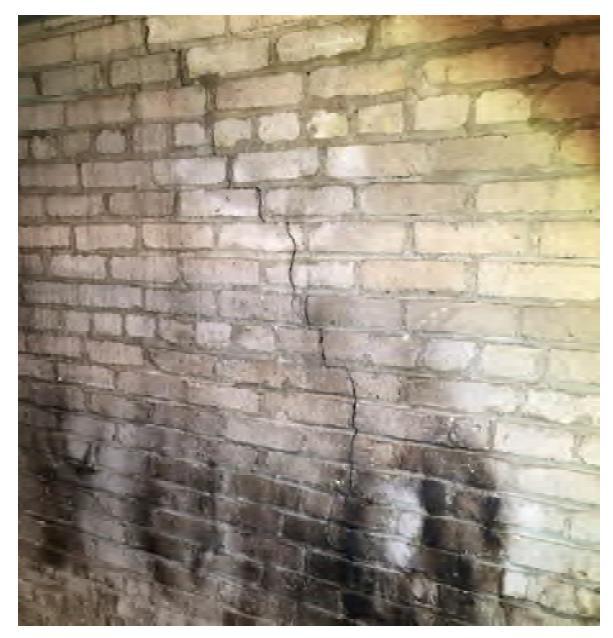
Figure – Diagonal Stairstep Crack in Masonry (0029)

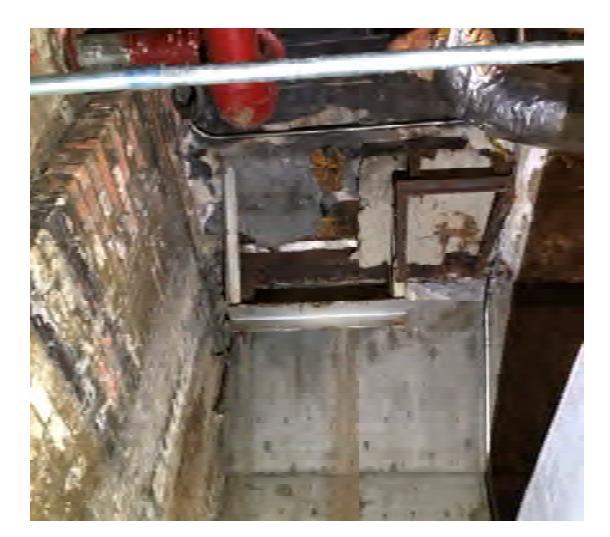
Figure – Deteriorated Steel Framing (0071) Spalling Concrete Walls and Efflorescence:

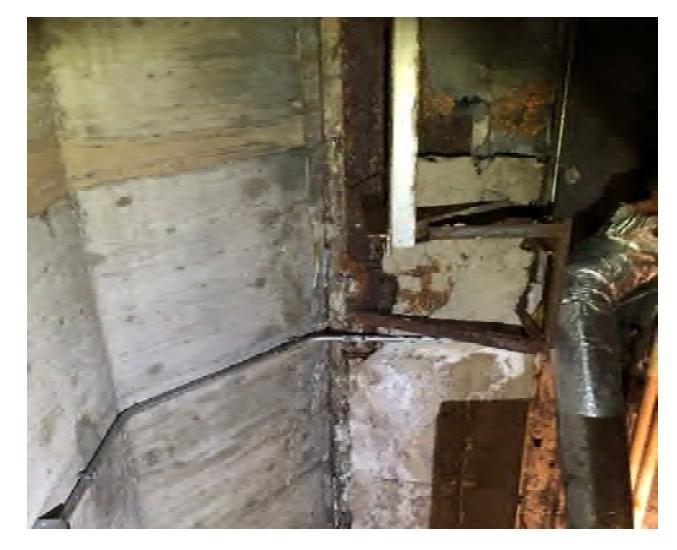
Figure – Corroded Steel Framing (0072)

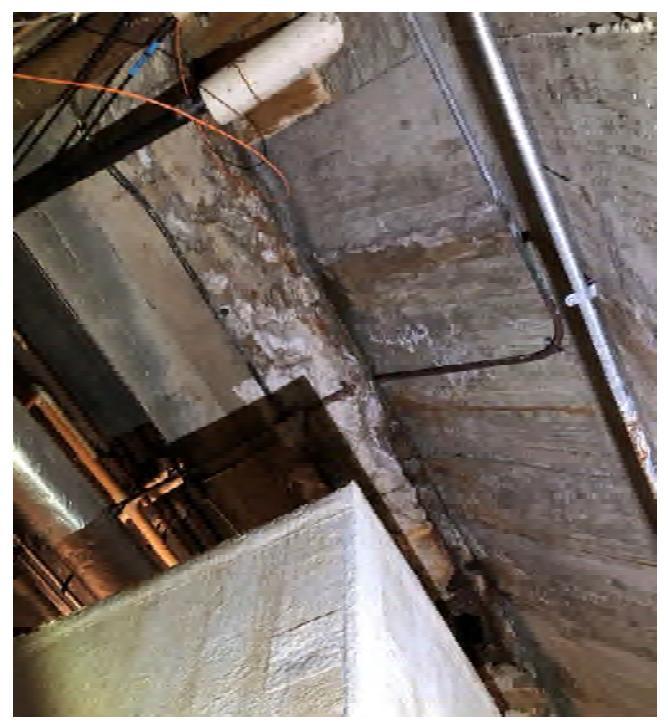
Visible efflorescence and some mild concrete spalling are visible along the eastern wall of the lower-level mechanical room. Though no moisture was present at the time of the field observation, these visible signs of past moisture presence need to be addressed. In review of the existing drawings, it seems that the street level sidewalk sits directly above this portion of the eastern building wall; it is recommended that all street level joint sealants be replaced at the interface between the sidewalk and building wall (i.e. Sikasil 728 SL or similar). Street level joint sealants will require sampling and analysis for asbestos, or to be assumed as ACM. Sampling and analysis for PCB for these sealants may be warranted.

Figure – Spalled Concrete and Efflorescence (0073)

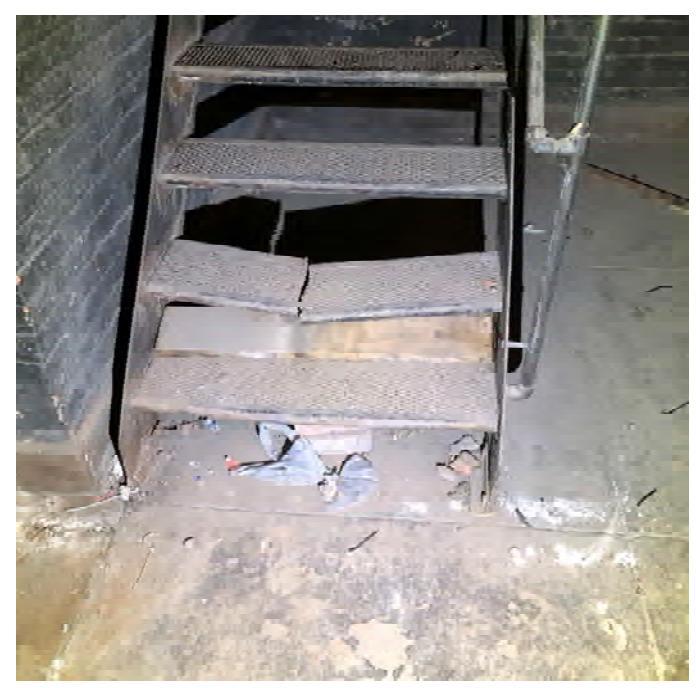
One of the steel stair treads used to access the mechanical room located at the east end of the lower level is completely broken. This stair tread should be repaired or replaced in full to restore the required maintenance access to this room.

Figure – Broken Steel Stair Tread (0069)

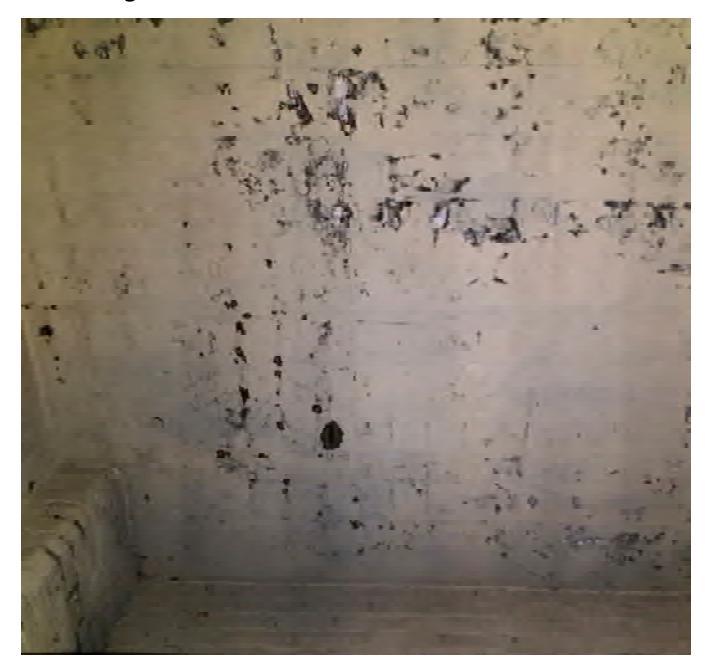
The reinforcement for the concrete slab above the fourth level mechanical room does not have adequate concrete cover and has become visible at large sections of the slab above the mechanical room. There is some spalling that is visible which has resulted in fully exposed reinforcement. Exposed reinforcing is more likely to corrode and deteriorate, thus reducing the structural capacity of the concrete slab. It is recommended that a bonding agent (i.e. Sika Armatec 1C or similar) be applied and then a concrete patch mortar product (i.e. Sika Repair 223 or similar) be applied to ensure adequate concrete cover is provided. All caulks, mortars, concrete patches, and sealants impacted by this cover repair will require sampling and analysis for asbestos or be assumed as asbestos containing.

Figure – Spalled Concrete and Exposed Slab Reinforcement (0101)

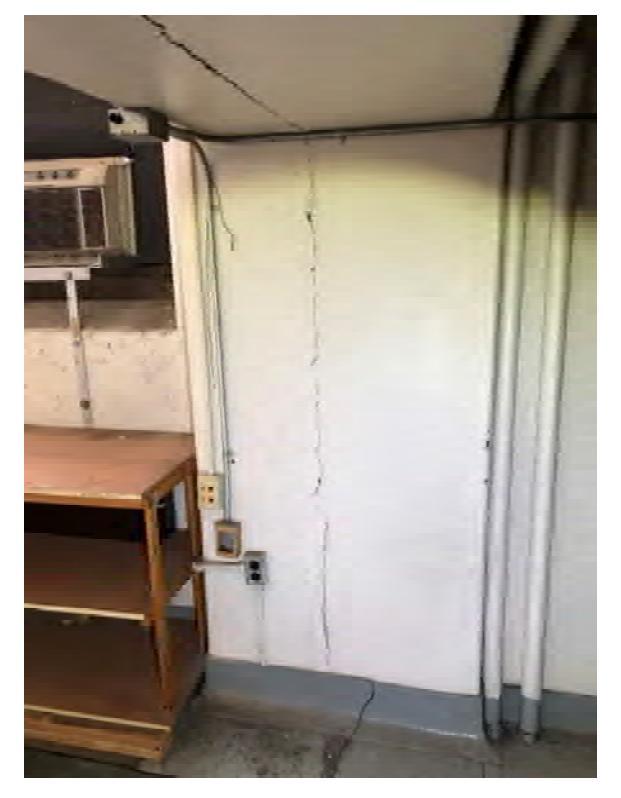
There is a crack that extends from the fifth level slab in the storage area up through the wall and column encasement and across the ceiling. This crack appears to align with the approximate location of the expansion joint that likely exists between the original 1915 construction and the 1925 addition. It is recommended that this crack be filled using an injectable mortar or epoxy repair product (i.e. Sikaflex 1C SL or similar). Crack propagation should be regularly monitored as part of annual building maintenance. All caulks, mortars, concrete patches, and sealants impacted by this crack repair will require sampling and analysis for asbestos or be assumed as asbestos containing. LBP may be present on the surface of the wall and ceiling associated with this crack.

Figure – Crack at Approximate Building Joint Location (0130)
