Phase II Environmental Site Assessment

**25-37 Canal Street
City of Rochester
Monroe County, New York**

September 2009

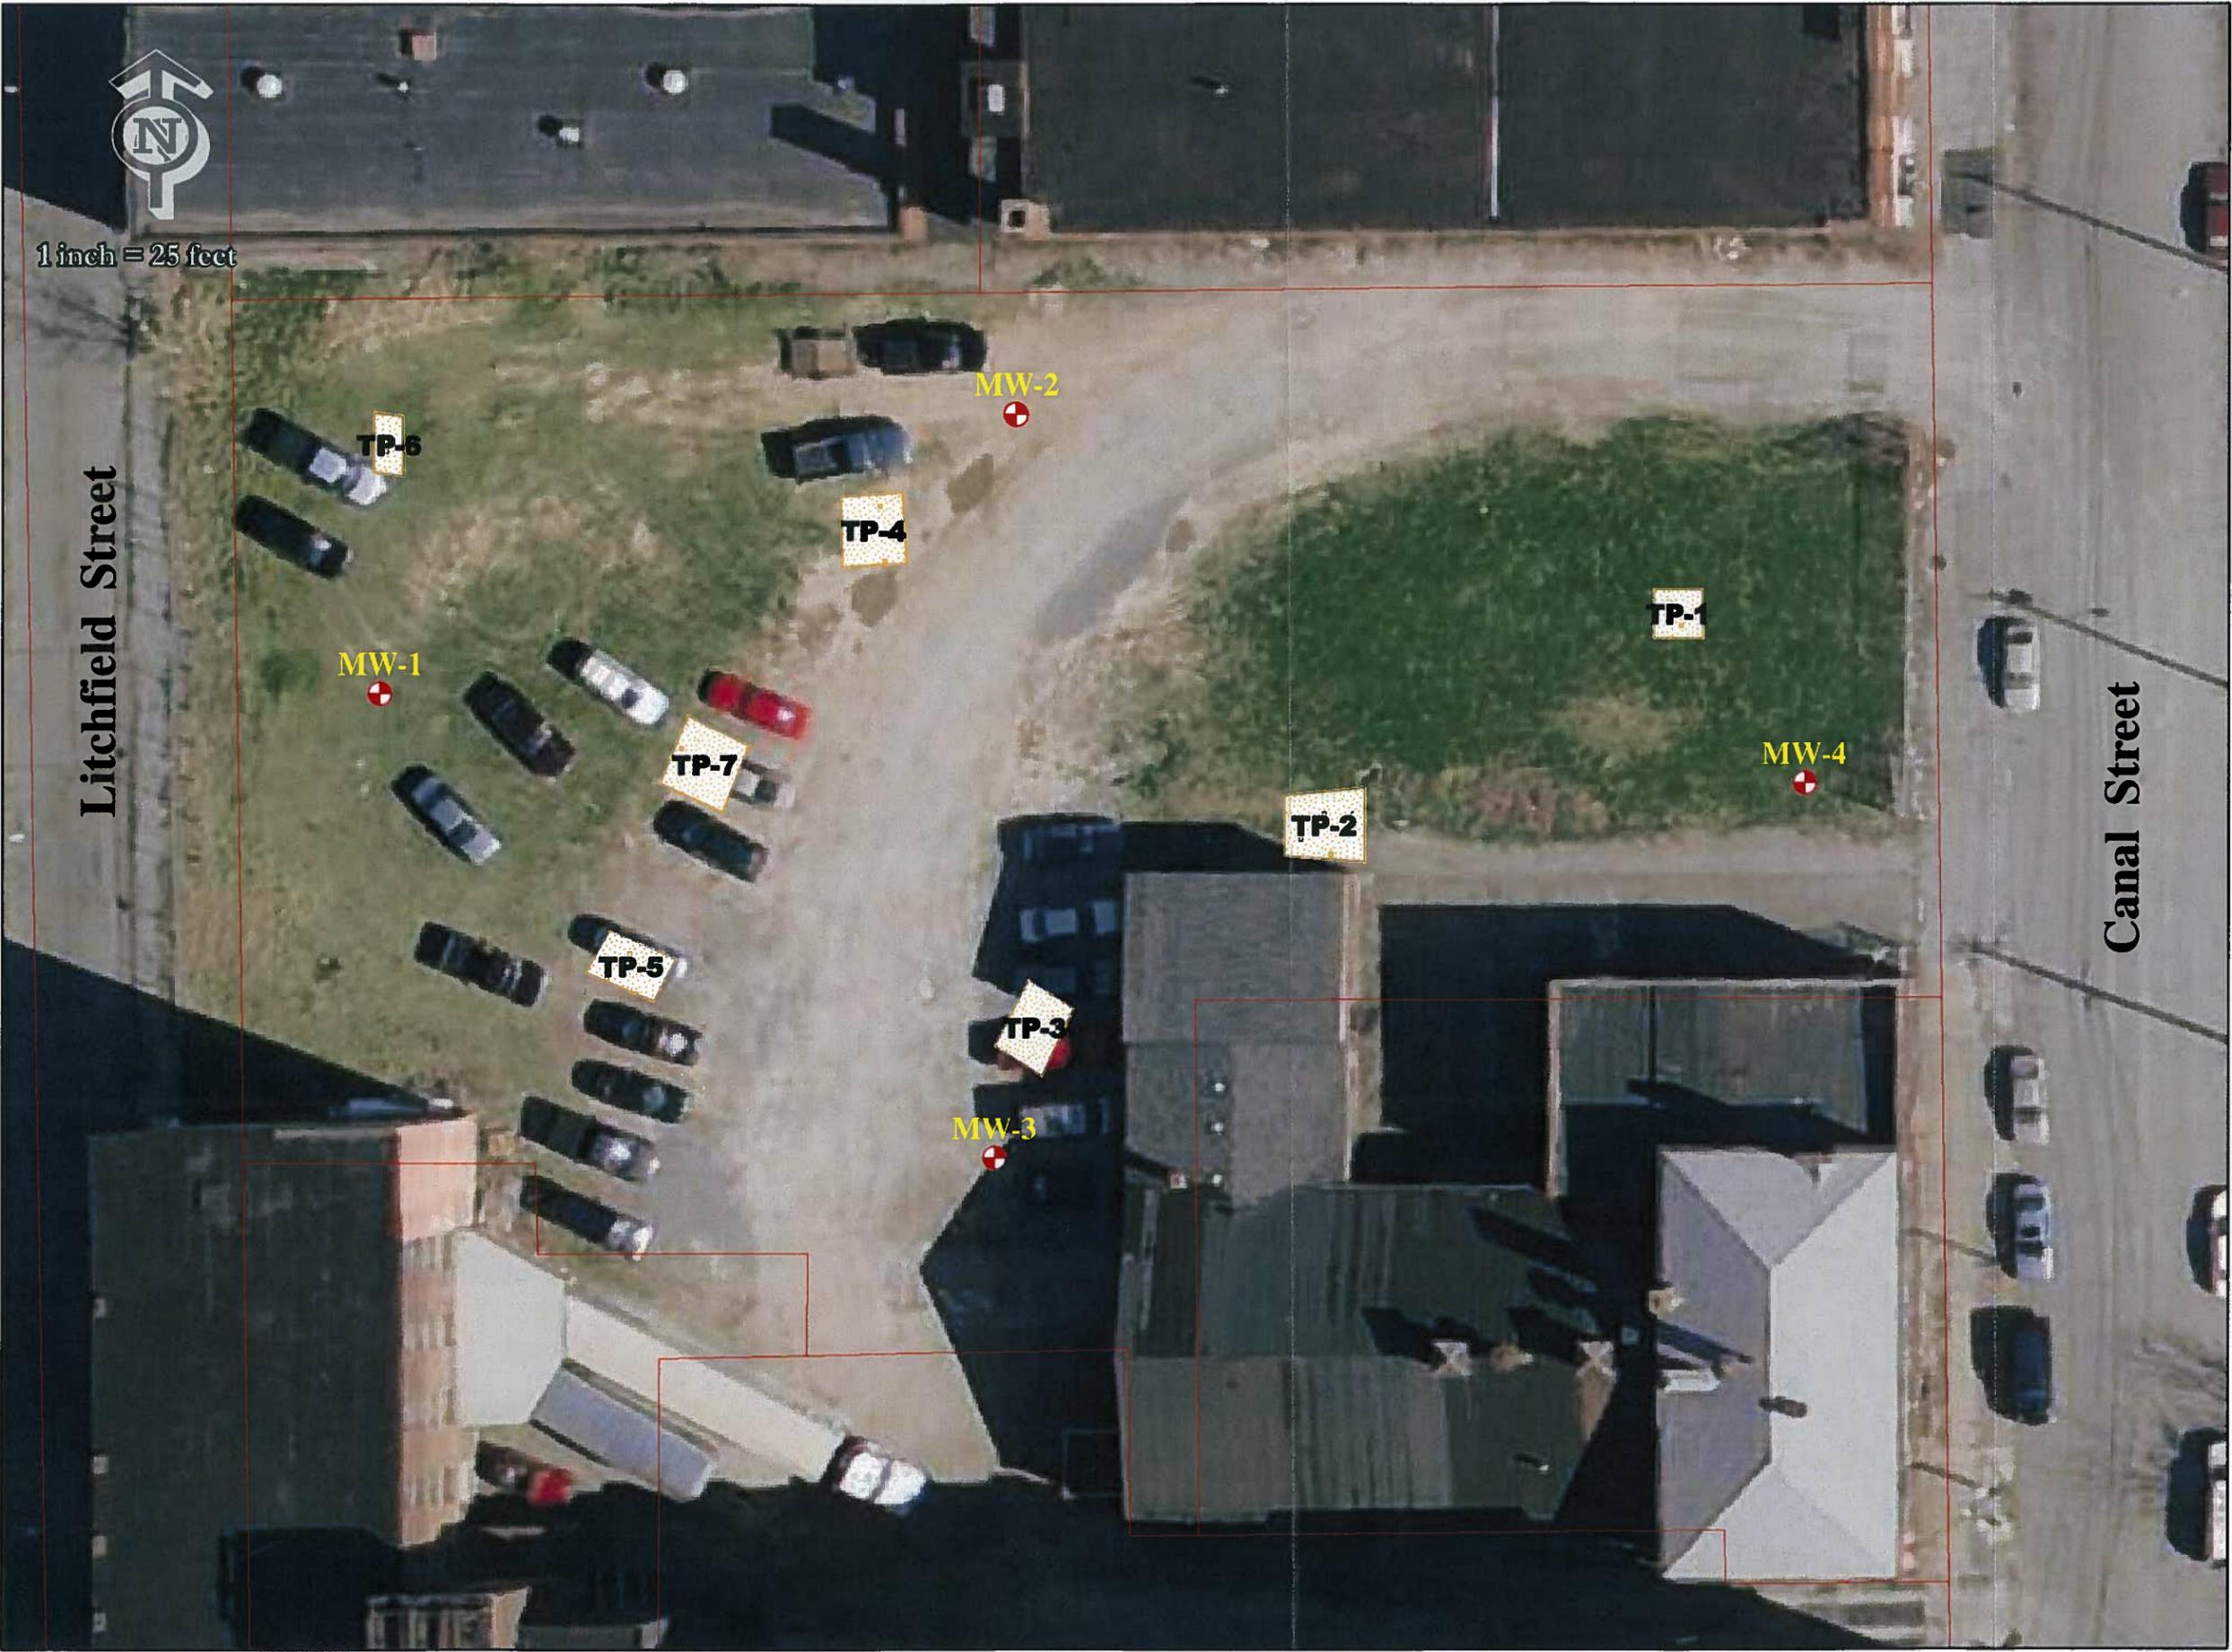
Site Plan
Figure 2

Boring Logs are included in Appendix A. Boring/monitoring well locations are shown on Figure 2. Laboratory analytical results are included in Appendix E and are discussed in Section 5.

This section describes the geologic and hydrogeologic conditions at 25-37 Canal Street, Rochester, New York. Soil boring logs and well development logs are included in Appendix A and Appendix B, respectively. Figure 2 shows the location of all existing on-Site wells.

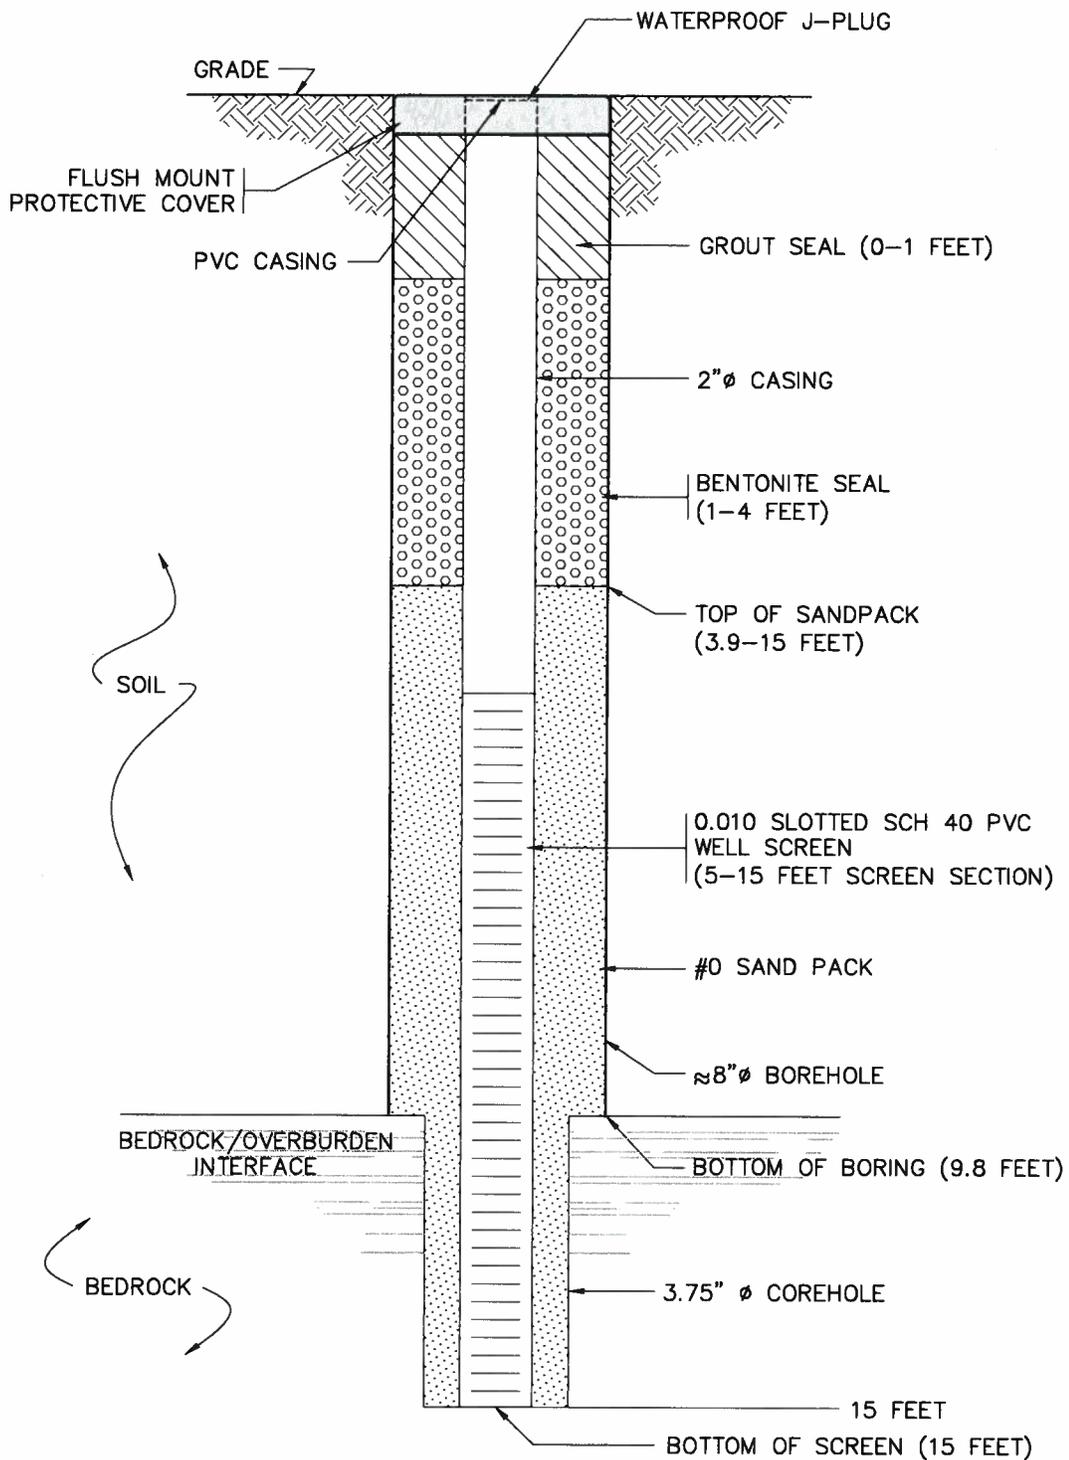
MW-01 CONSTRUCTION DETAIL
NOT TO SCALE

Well construction details are provided in Appendix B. All monitoring wells were completed flush to grade. Drill cuttings and water generated during drilling was discharged to the ground surface.

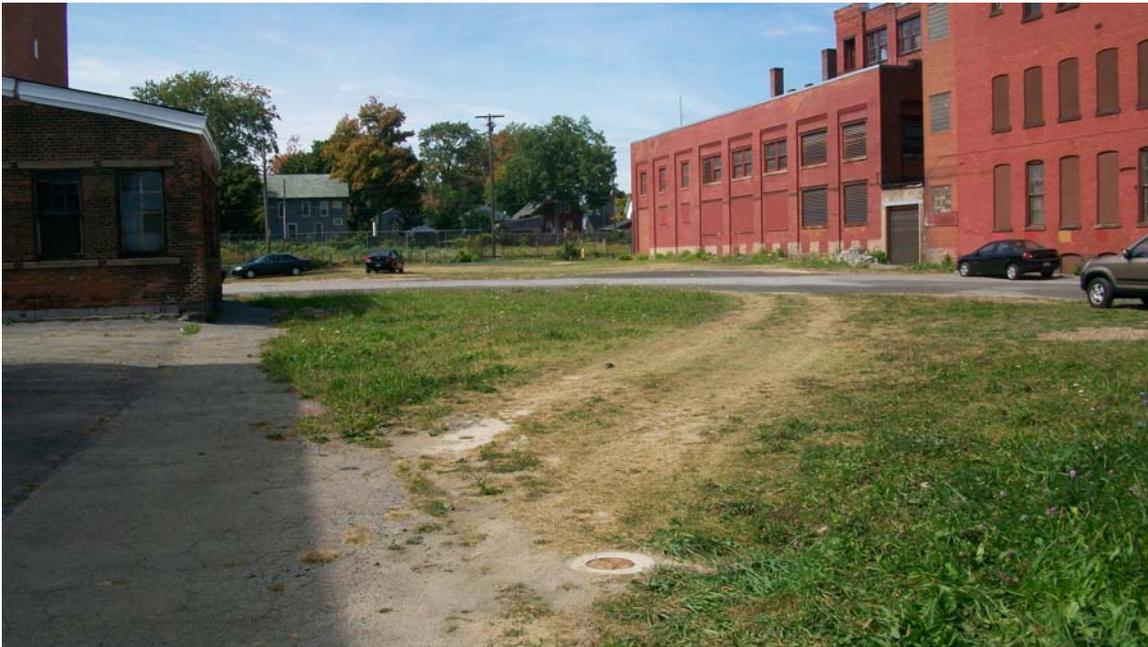
Photo No. 1. View of site from Canal Street facing west, MW-04 is visible in foreground.

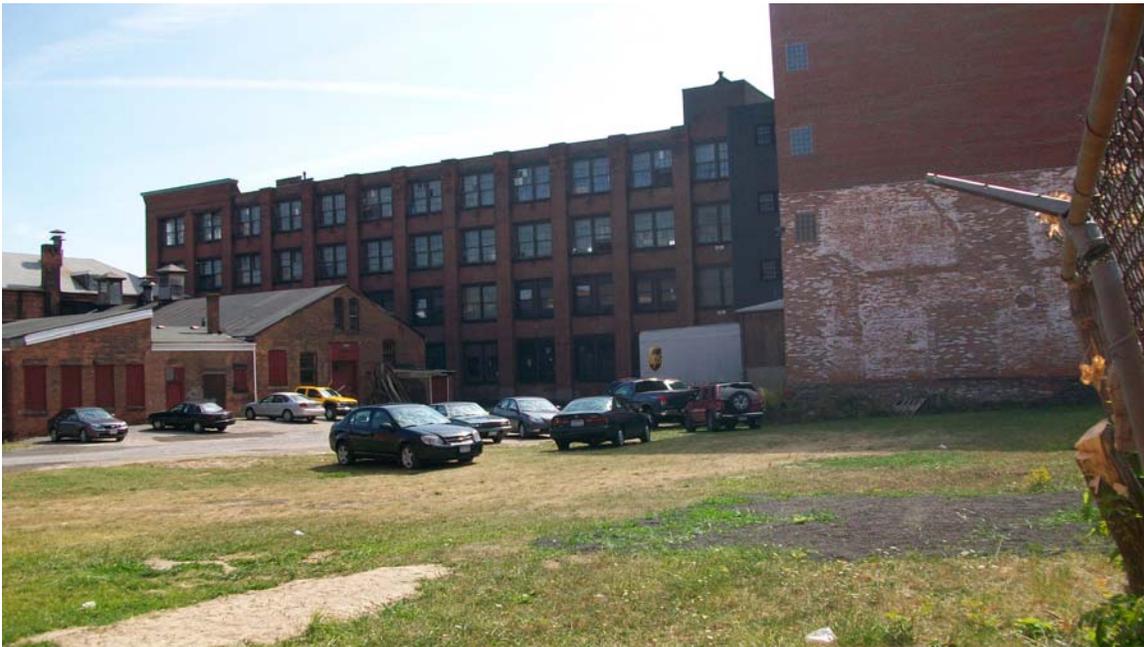
Photo No. 2. Facing south, view of center of site from northwest corner.

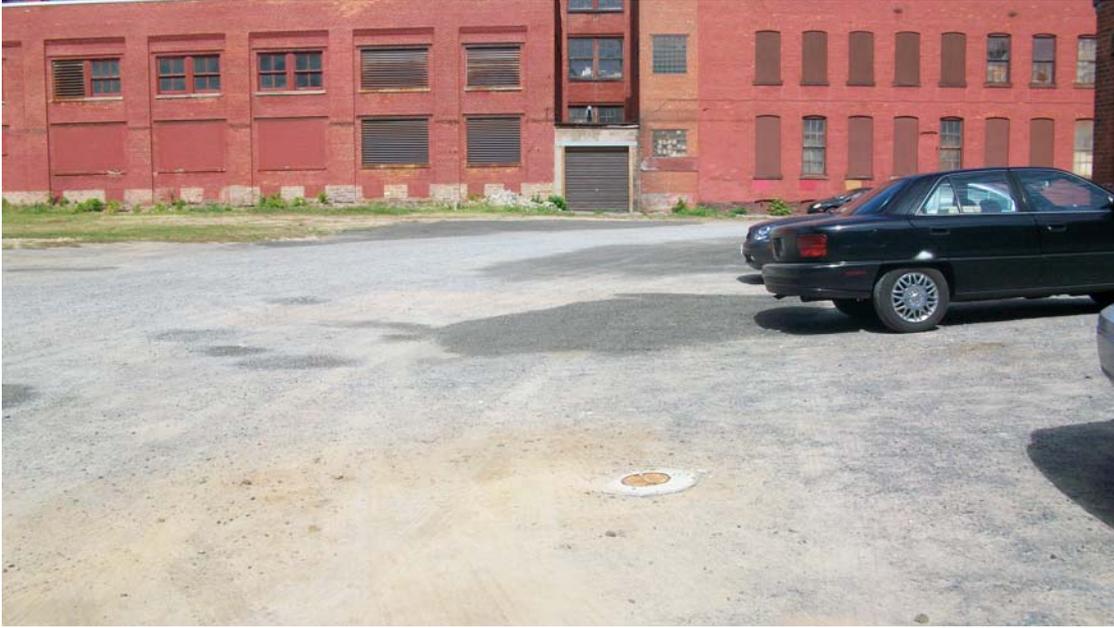
Photo No. 3. Facing north from south side of site, MW-03 in foreground.

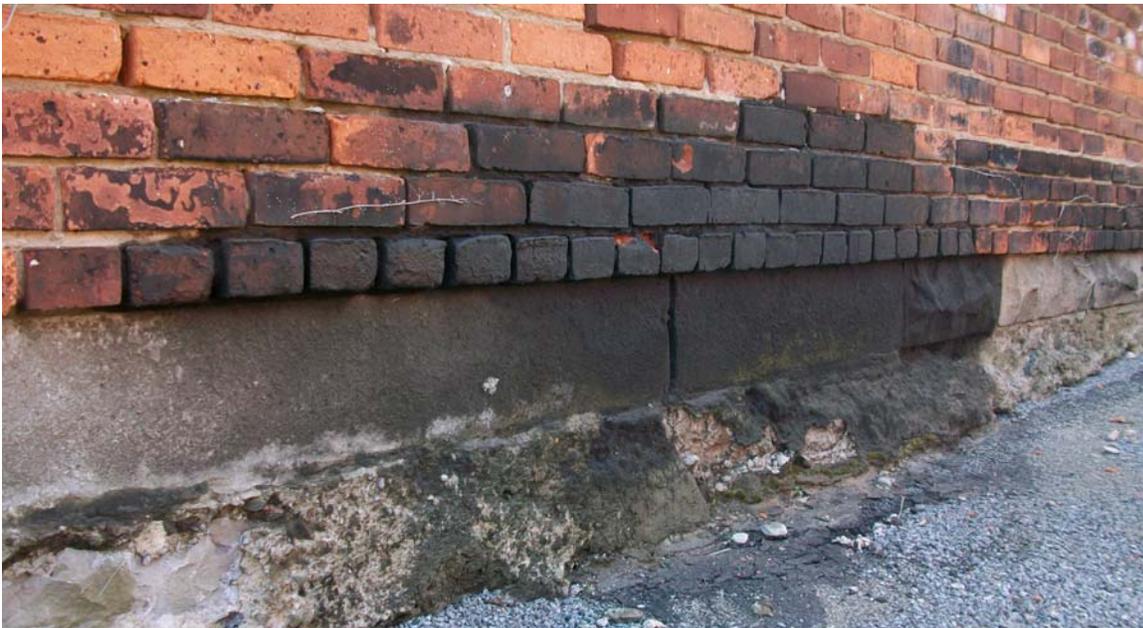
A concrete chip sample from the north side of the building encroaching on the southeastern portion of the Site was also collected for laboratory analysis at the time of the test pit investigation. This was done to evaluate staining observed at this location.

Table 4.3 indicates that soils found in TP-02 and the concrete chip samples contain lube oil. No PID readings were observed in this area and no soil staining was noted. These areas did not appear to be widespread and isolated to the southeastern portion of the Site.

Photo No. 4. View of chip sample location on north wall of building.

2. Lu Engineers also recommends that a detailed evaluation of the occurrence of PCBs be conducted. This evaluation should include the building interior. Information generated from current work in this area and data generated from additional investigation can be used to identify the most appropriate remedial alternative for this area.
