**PHASE II ENVIRONMENTAL SITE ASSESSMENT
REPORT**

**65 SULLIVAN STREET
ROCHESTER, NEW YORK**

Project No.: 5582S-19

Date: October 2019

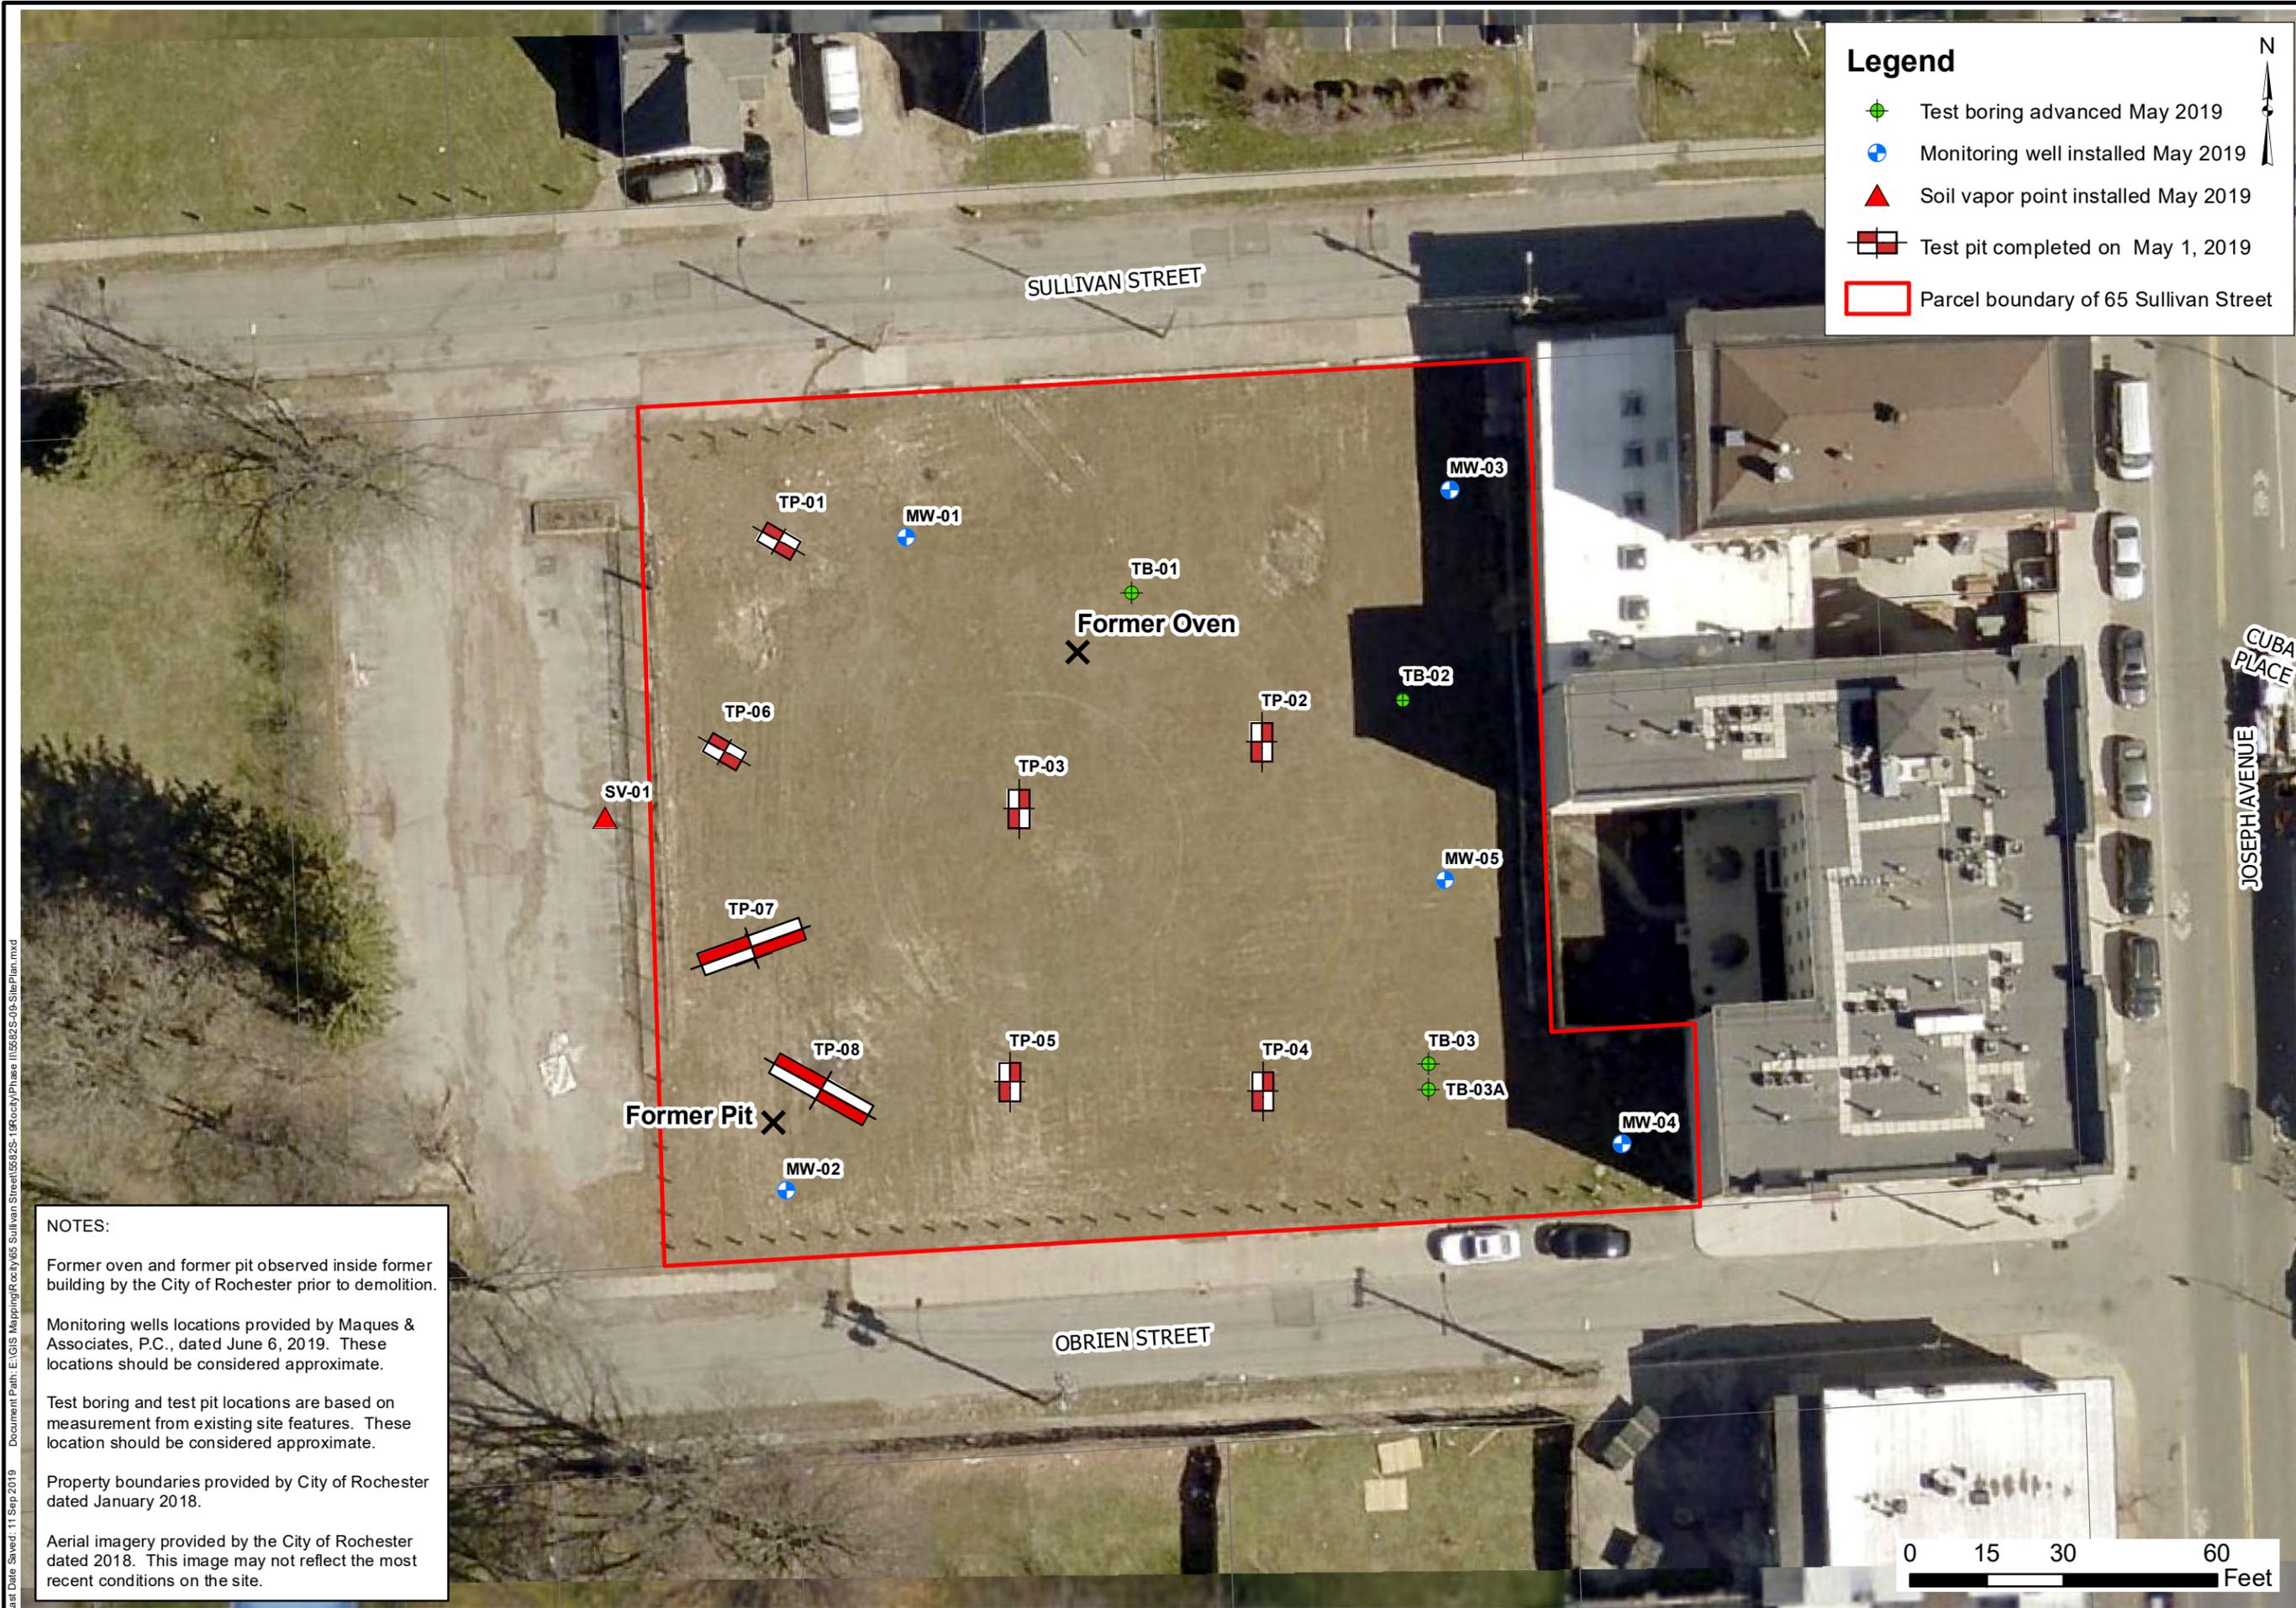
Former oven and former pit observed inside former building by the City of Rochester prior to demolition.

Aerial imagery provided by the City of Rochester dated 2018. This image may not reflect the most recent conditions on the site.

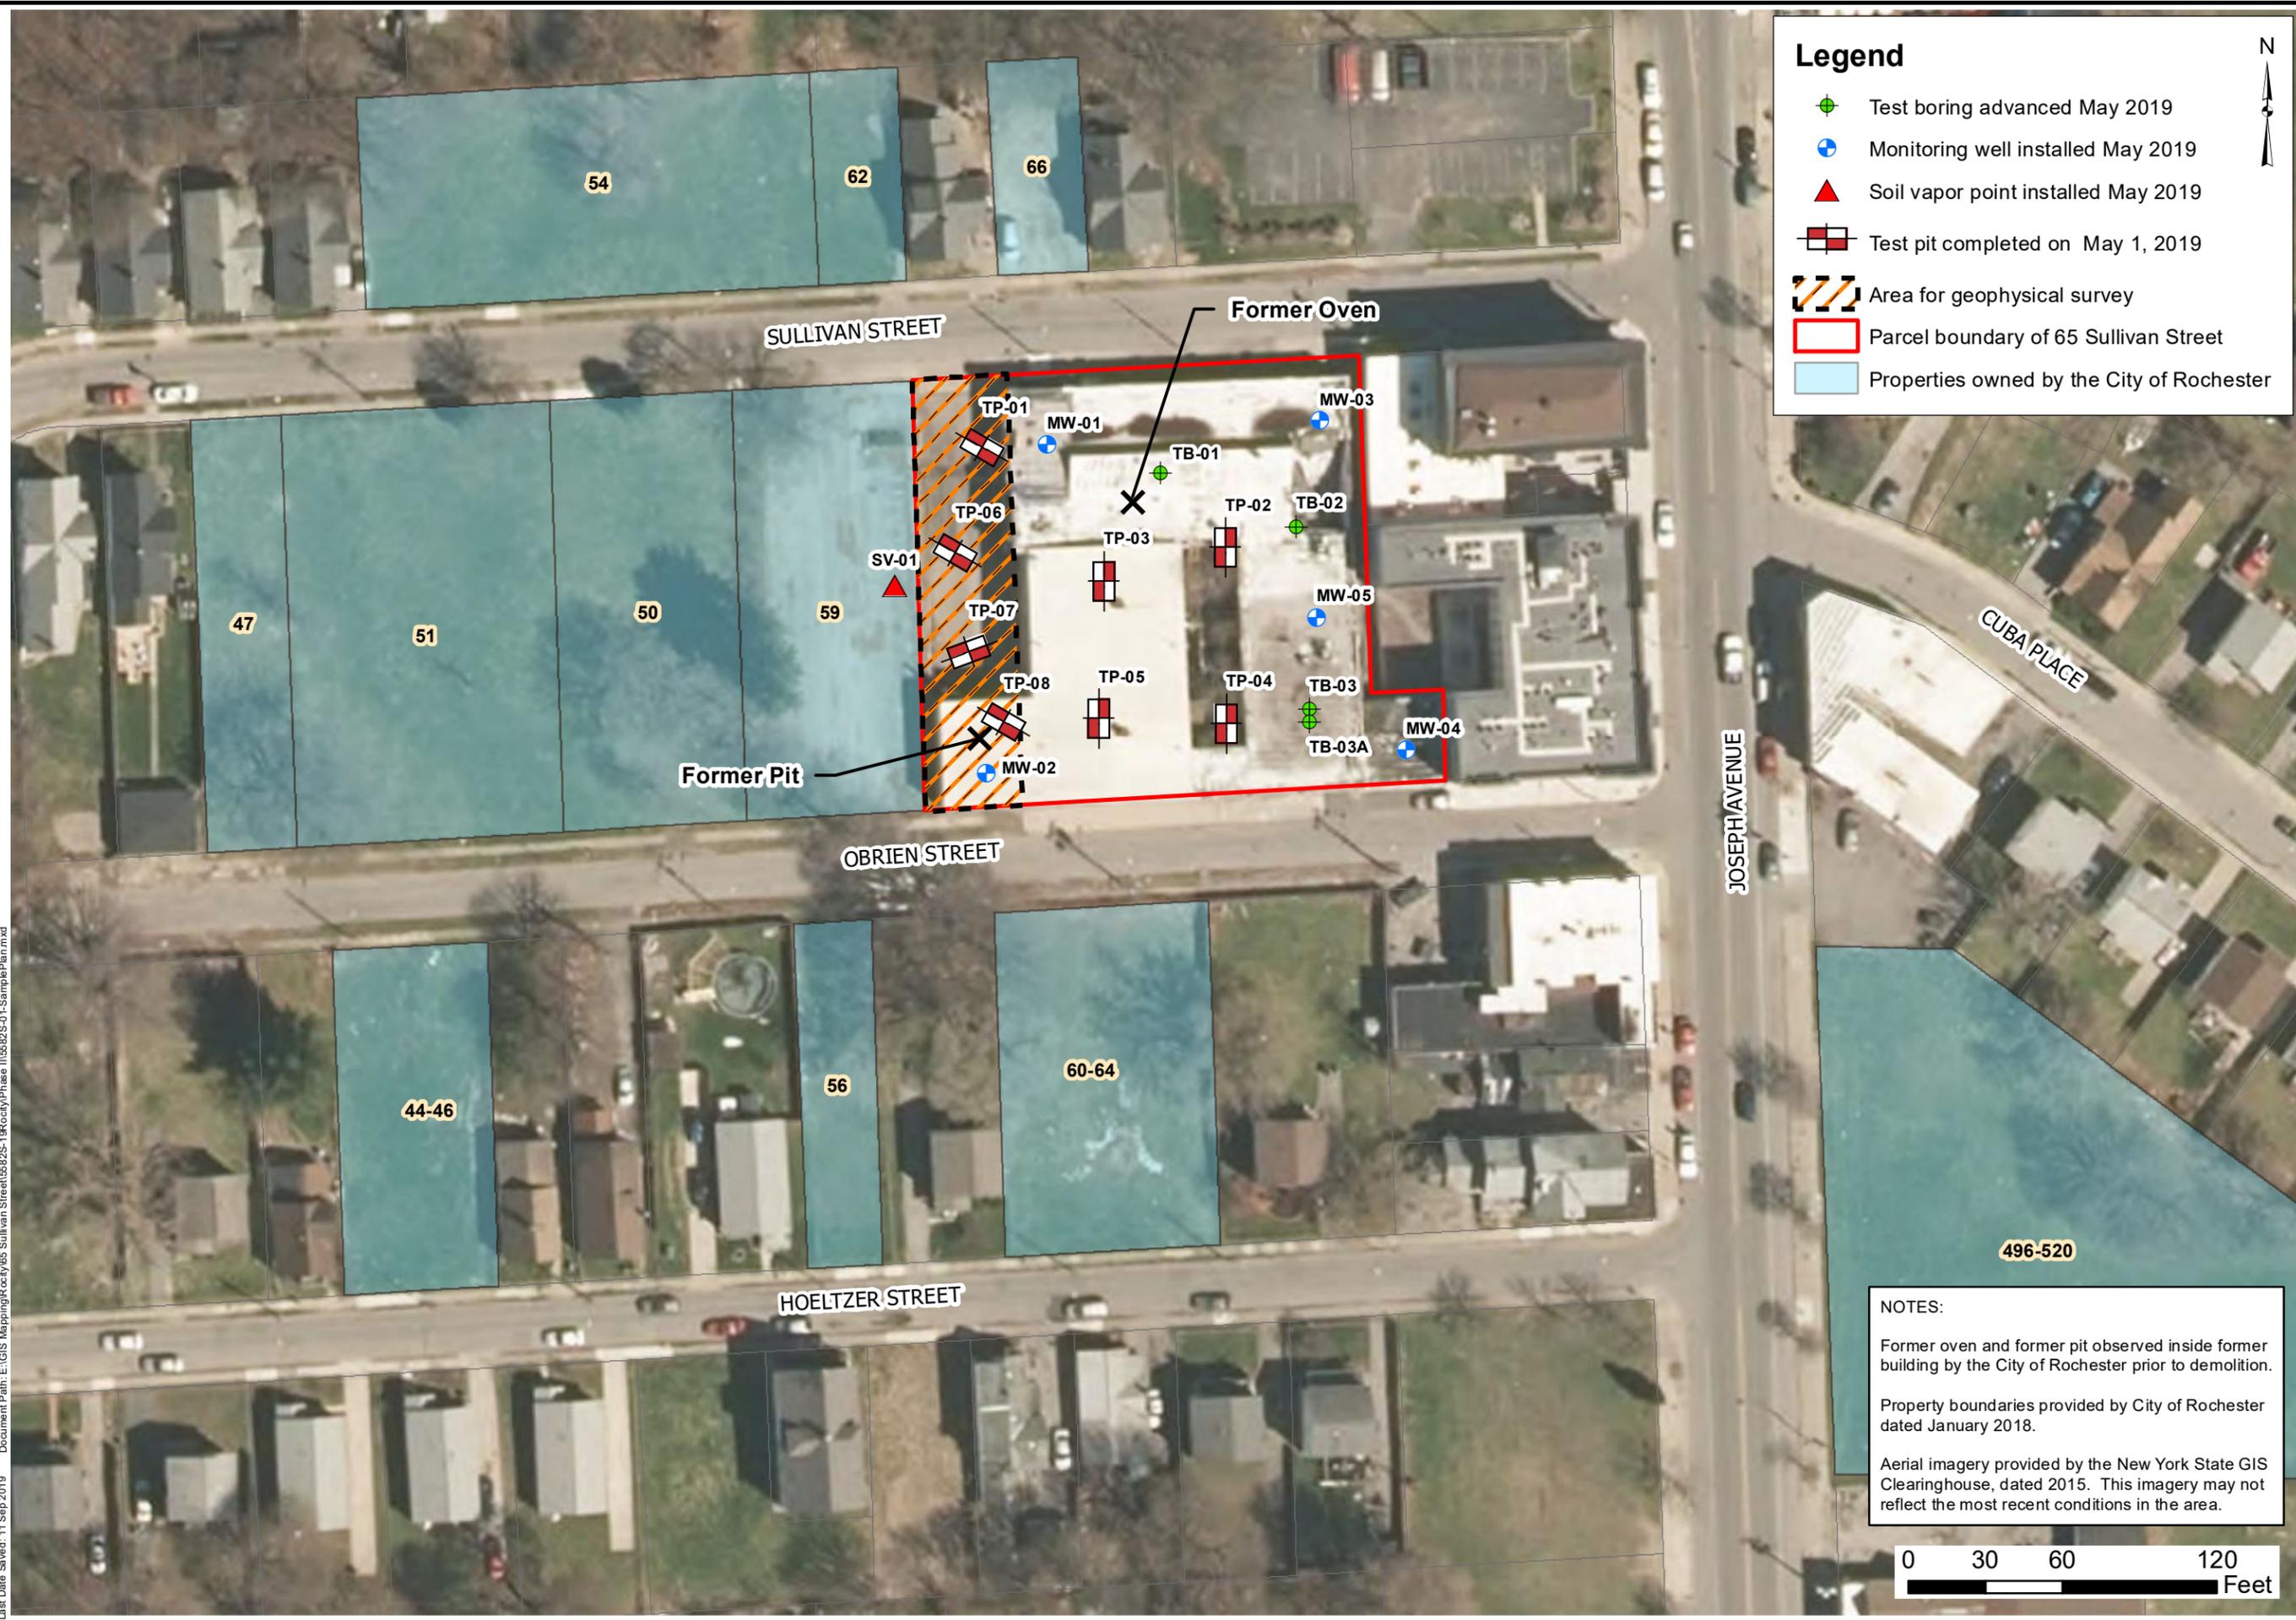
FIGURE 3

Former oven and former pit observed inside former building by the City of Rochester prior to demolition.

Aerial imagery provided by the New York State GIS Clearinghouse, dated 2015. This imagery may not reflect the most recent conditions in the area.

The following section describes the scope of work that was implemented to fulfill the objectives of the Phase II ESA. Figure 3 is a Site Plan that includes a 2015 aerial overlay showing the location of the former building in relation to the Phase II ESA test locations. Figure 3 also shows the approximate locations of a former pit and a former oven that were observed inside the former building prior to its demolition in 2016. Figure 4, Figure 5, and Figure 6 show the Phase II ESA test locations in relation to site features on 1933, 1959 and 1971 Sanborn maps, respectively. Figure 3 through Figure 6 also show adjoining and nearby parcels owned by the City (as of April 2019), some of which are associated with a developer's potential multi-parcel in-fill residential housing project. A photo log depicting various phases of the fieldwork is included in Appendix A.

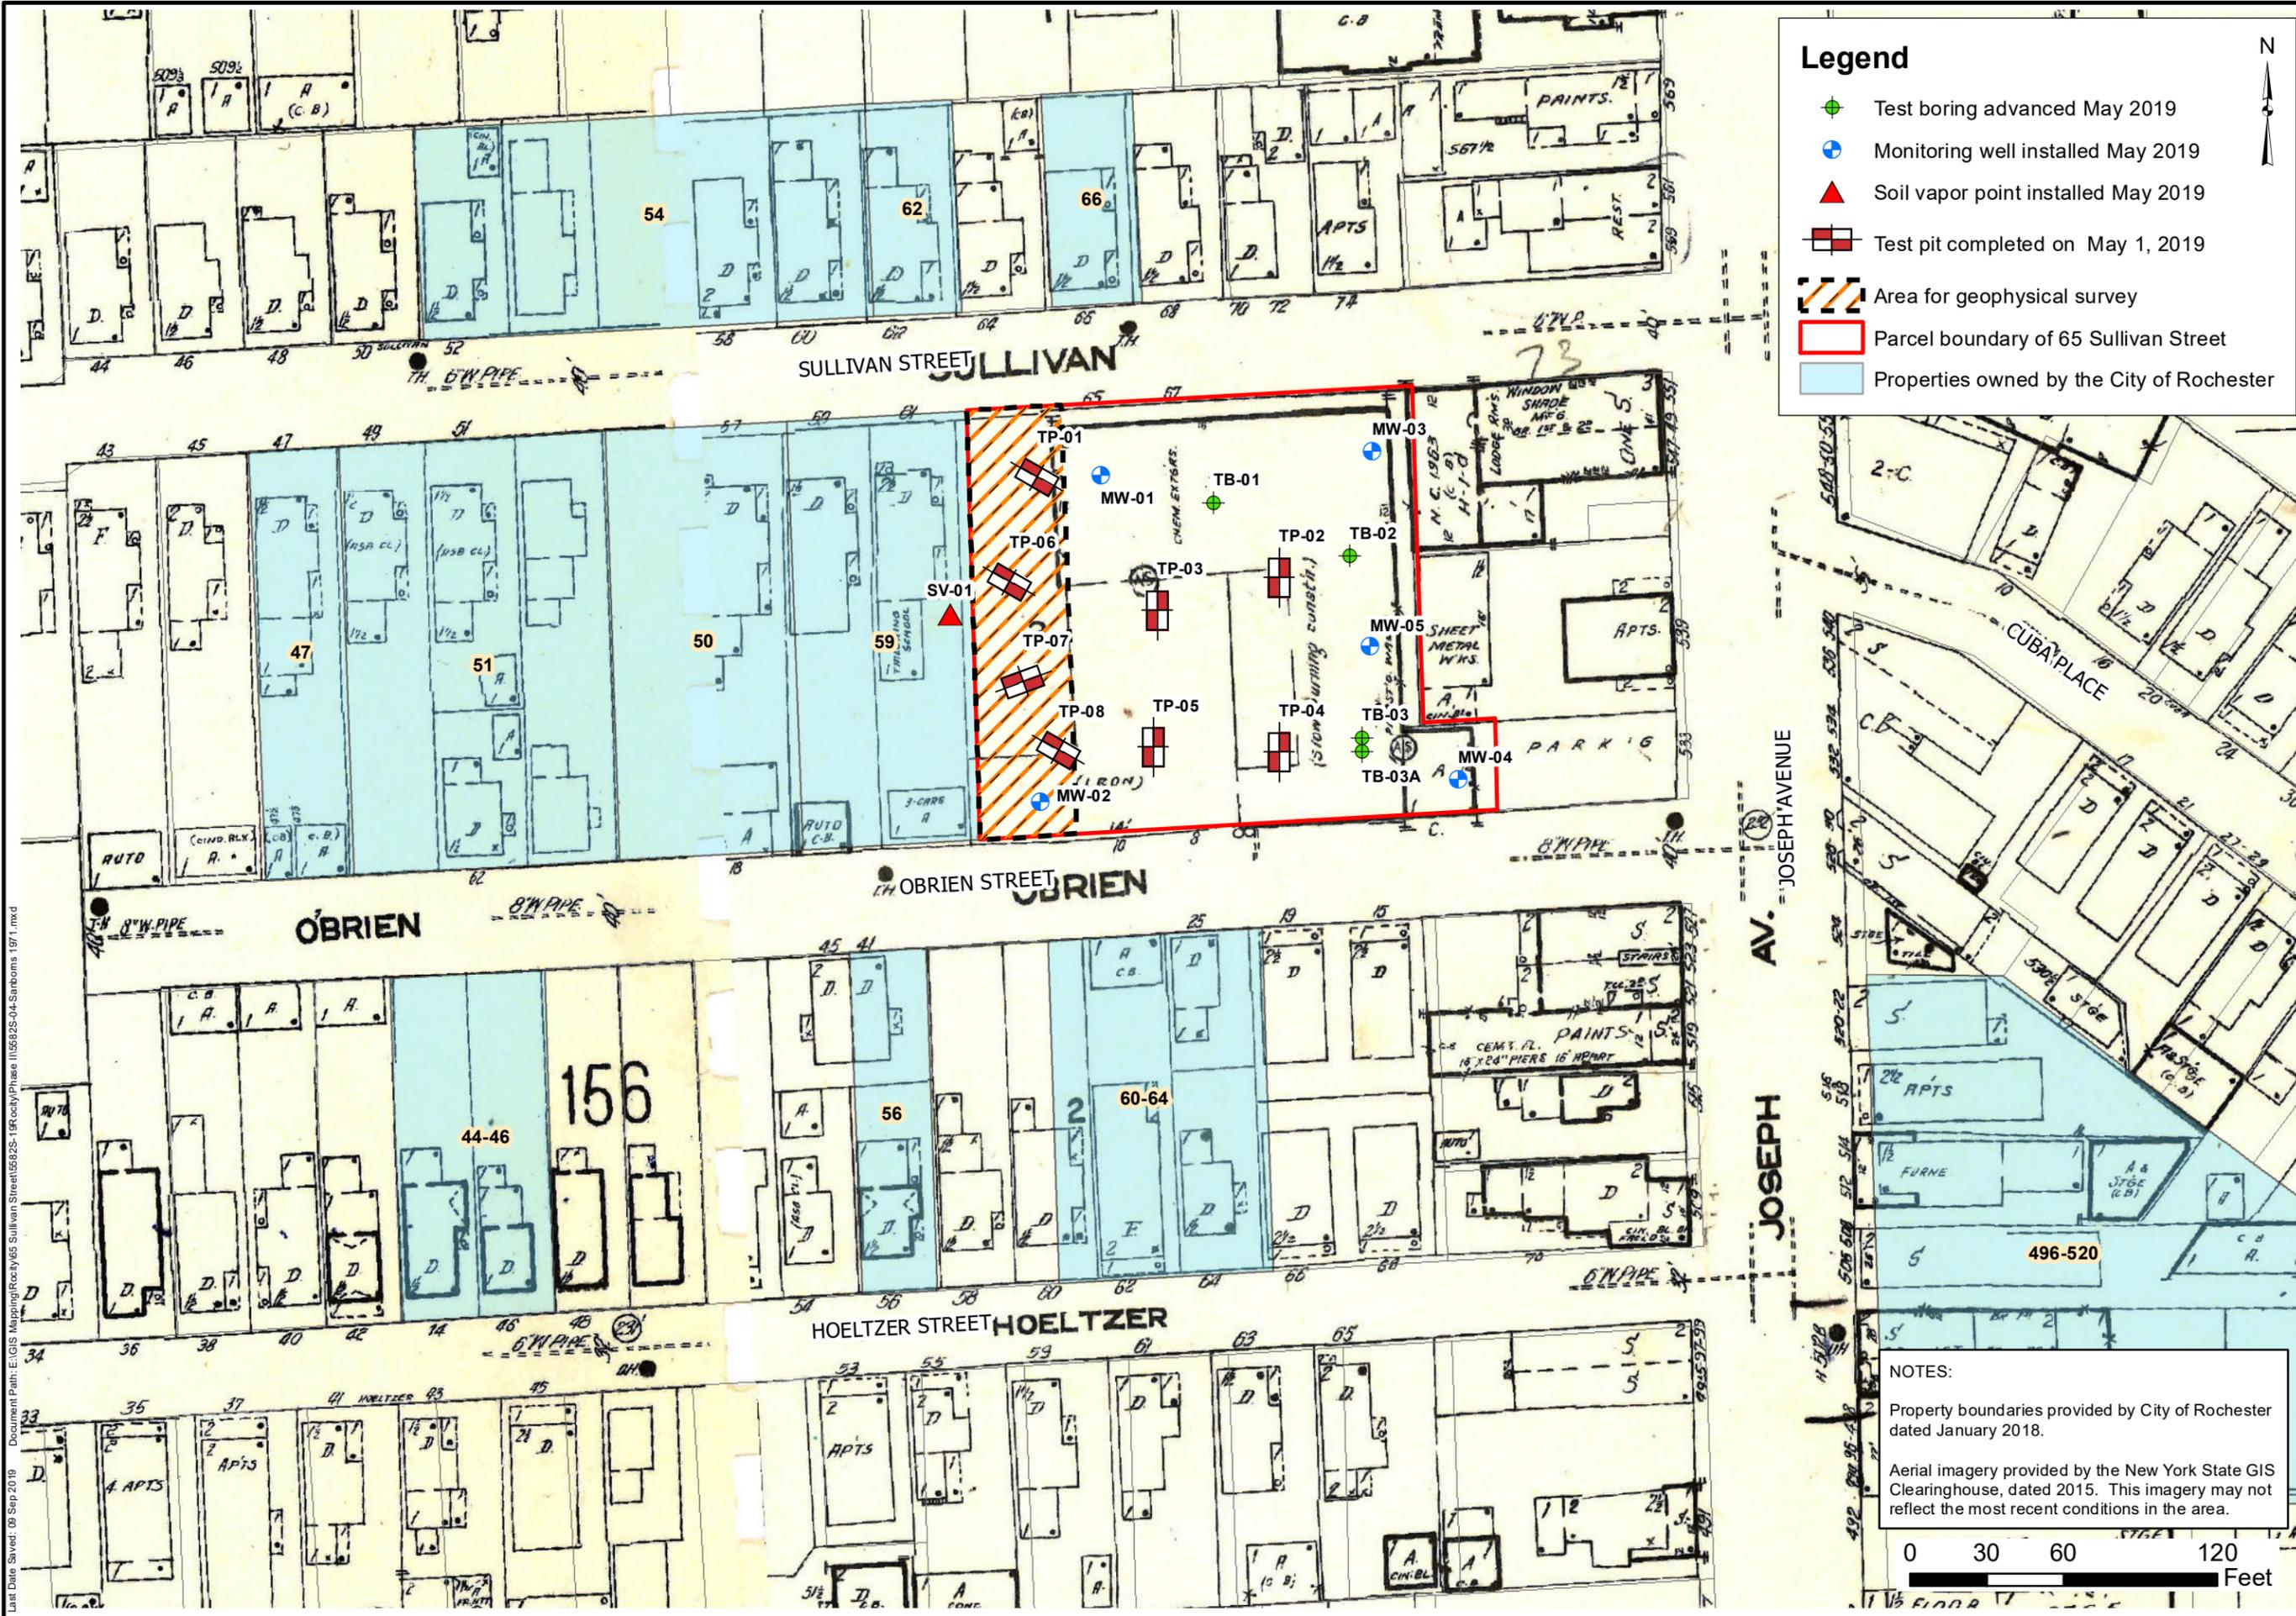
Test Location Plan with 1959 Sanborn Overlay

- ◆ Test boring advanced May 2019
- Monitoring well installed May 2019
- ▲ Soil vapor point installed May 2019
- Test pit completed on May 1, 2019
- Area for geophysical survey
- Parcel boundary of 65 Sullivan Street
- Properties owned by the City of Rochester

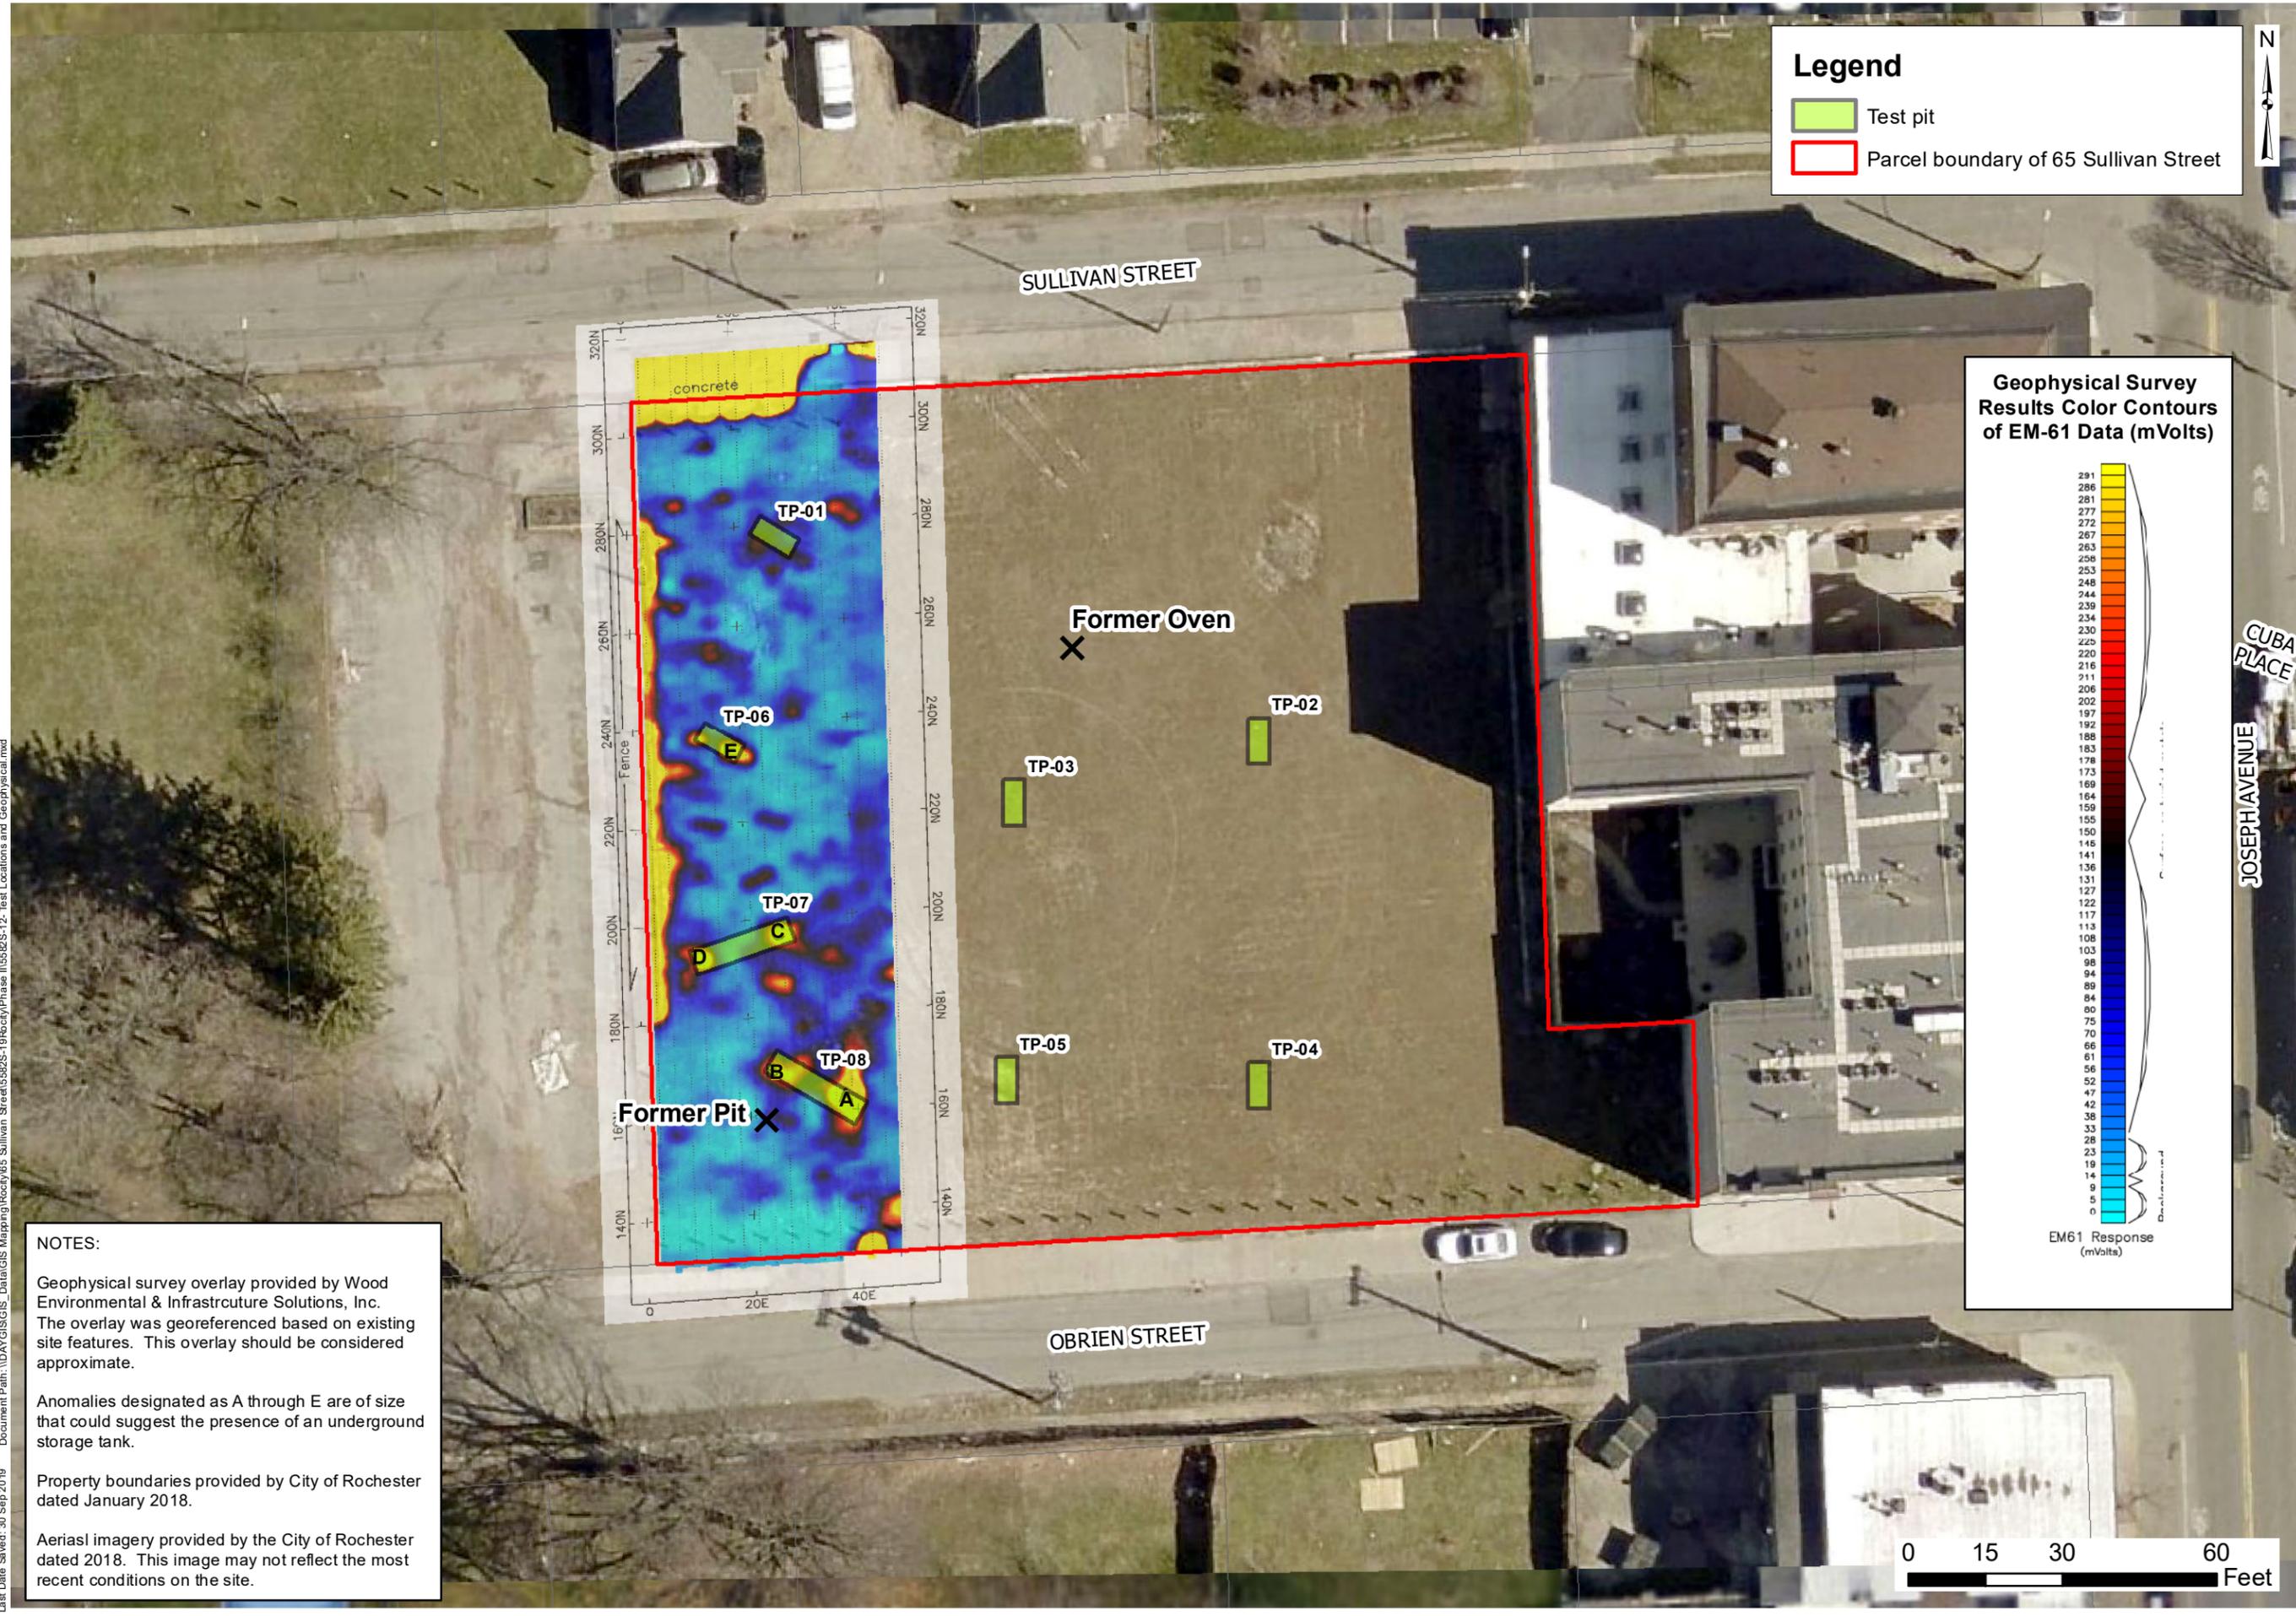
FIGURE 7

Geophysical Survey Results Color Contours of EM-61 Data (mVolts)

Geophysical survey overlay provided by Wood Environmental & Infrastructure Solutions, Inc. The overlay was georeferenced based on existing site features. This overlay should be considered approximate.

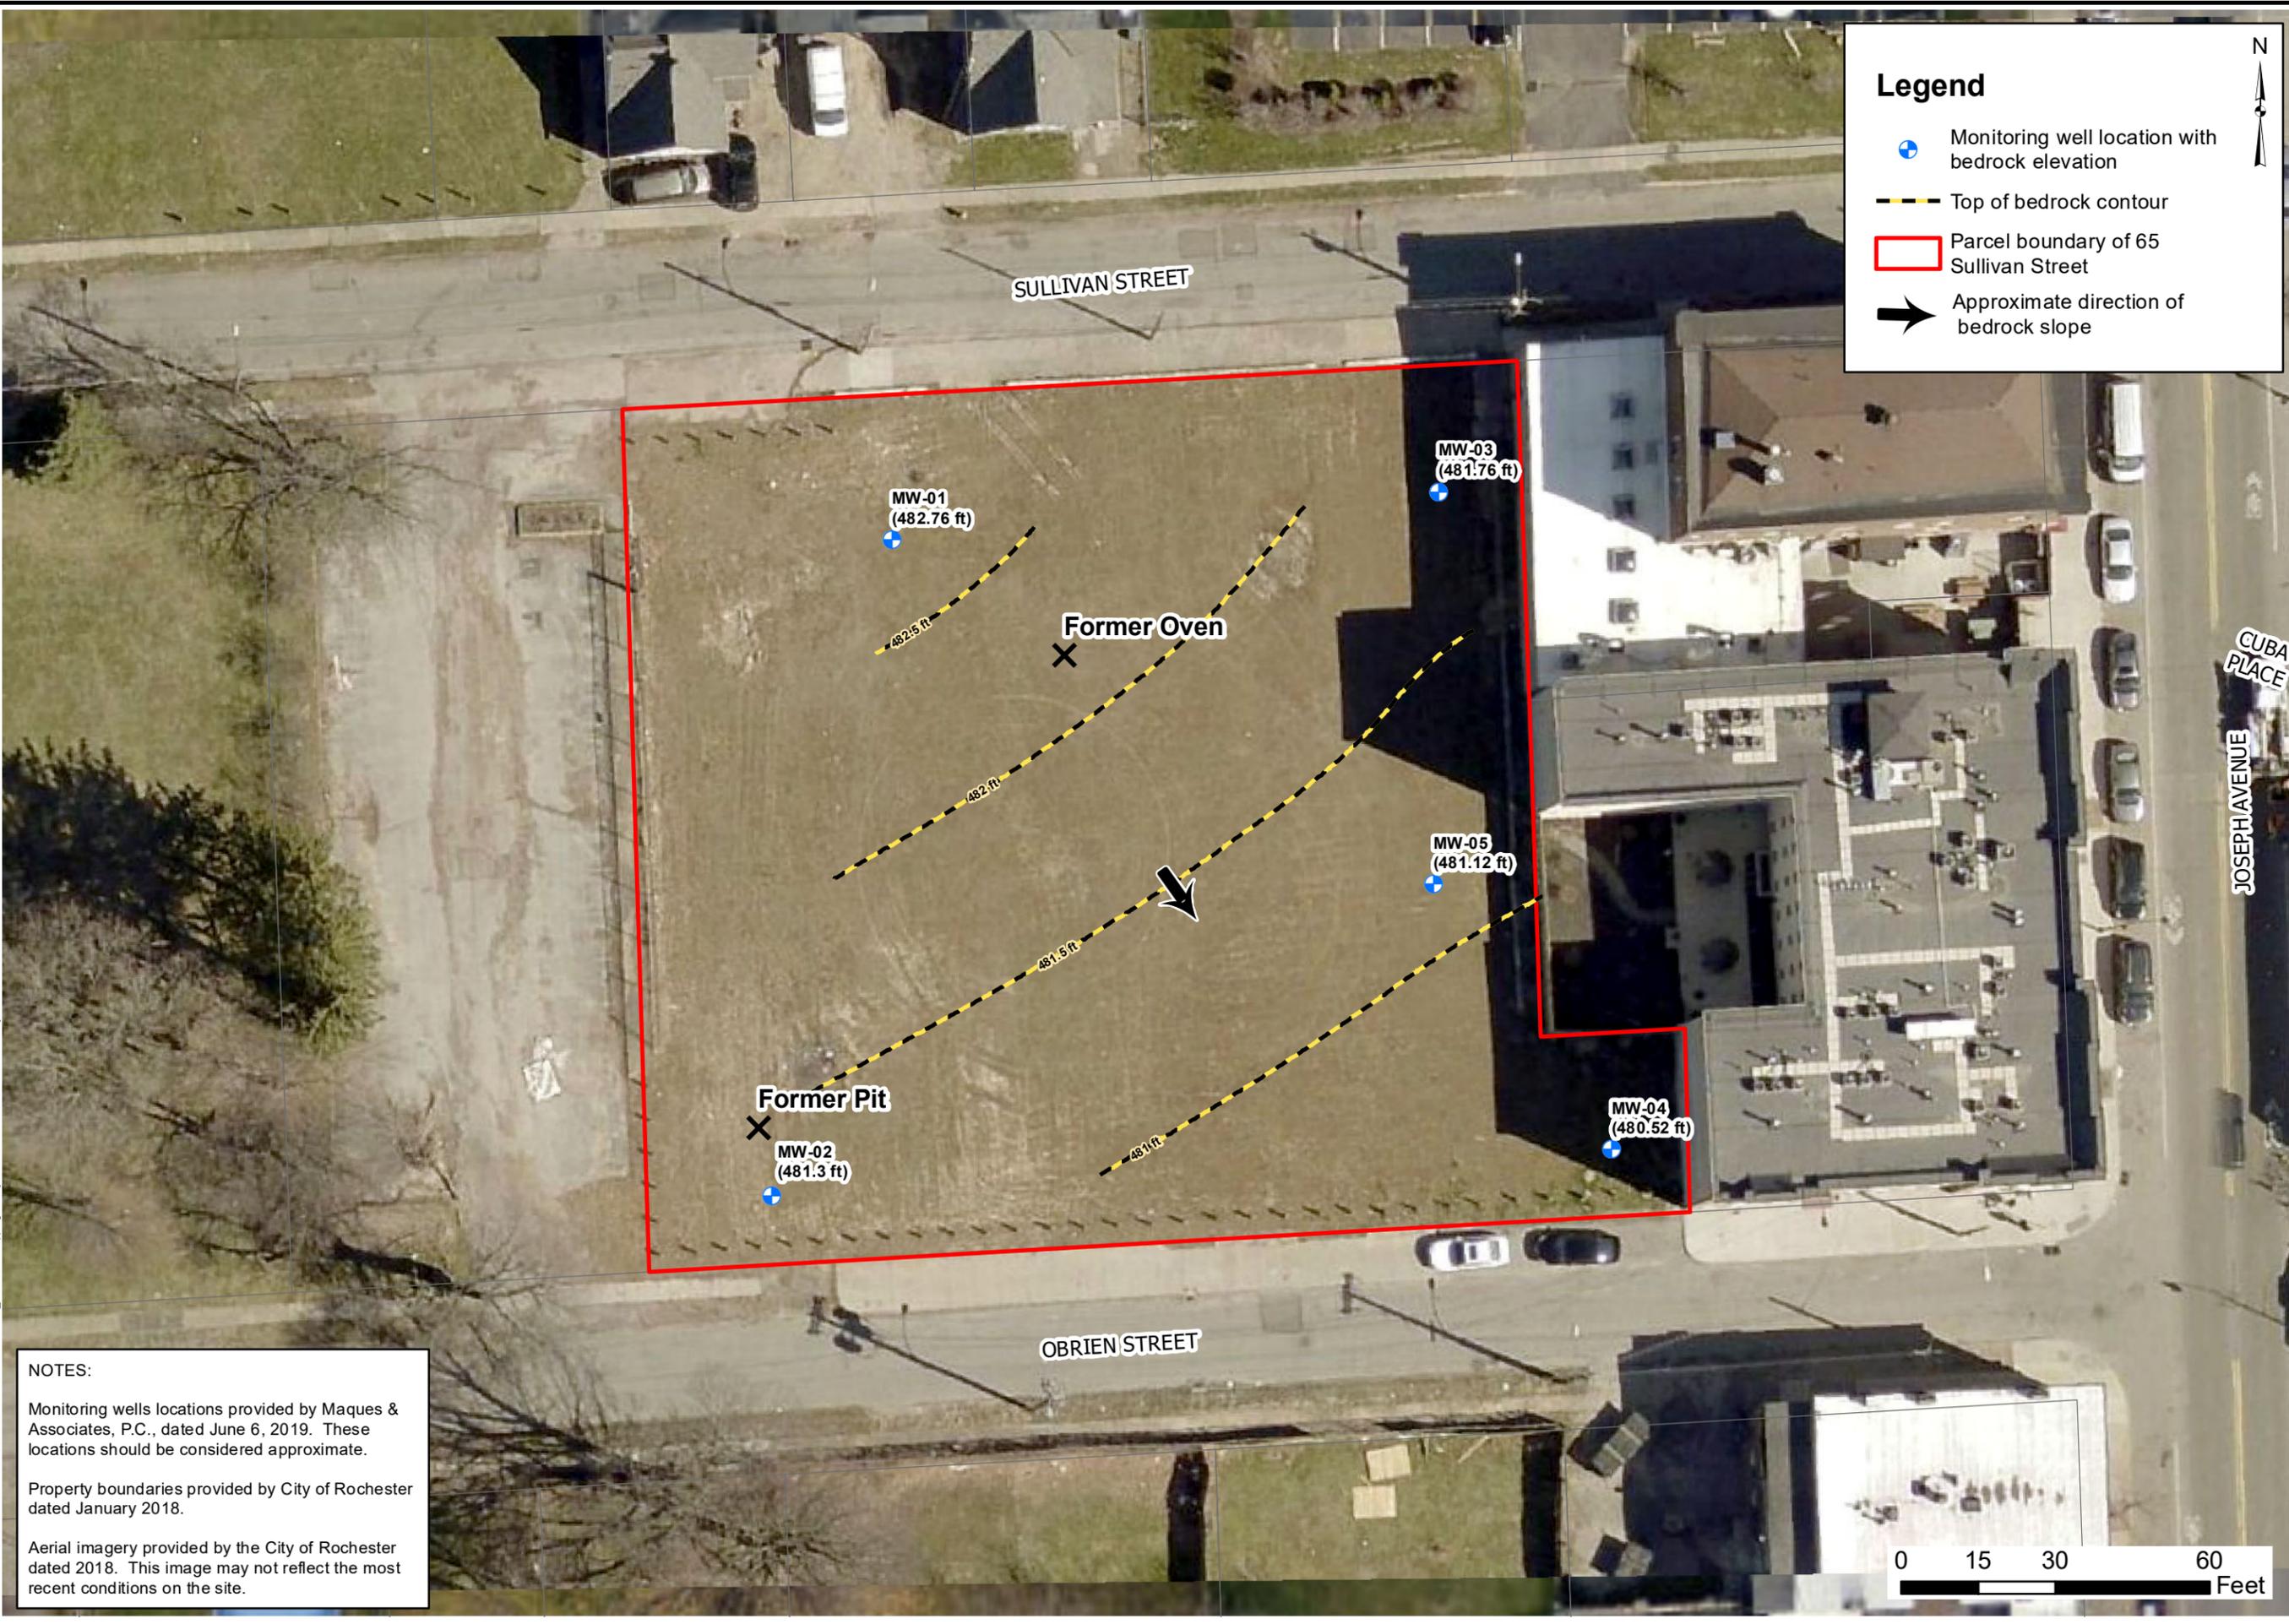
Project No.: 5582S-19
FIGURE 8

Project Title: 65 SULLIVAN STREET ROCHESTER, NEW YORK
 PHASE II ENVIRONMENTAL SITE ASSESSMENT
 Drawing Title: Bedrock Contour Map

Indigenous soils beneath the fill material generally consists of various mixtures of sand and silt that occasionally contained trace to some gravel, cobbles, boulders, fractured rock (e.g., shale or dolomite) and/or clay with lesser amounts of gravel. In some locations, the overburden soil was underlain by gray fractured Shale, which was underlain by harder gray Dolomite of the Eramosa (Lockport) Formation. At other locations, the overburden appeared to be immediately underlain by the gray harder dolomite. Based on rock cores collected from monitoring well locations MW-01 through MW-05, Rock Quality Designation (RQD) calculations ranged between 30.2% (MW-02) and 69.8% (MW-03) for the upper 4.0 to 5.3 feet of bedrock. The average RQD is 52.5%, which is indicative of weathered bedrock.
