**PHASE II ENVIRONMENTAL SITE ASSESSMENT
REPORT**

**65 SULLIVAN STREET
ROCHESTER, NEW YORK**

Project No.: 5582S-19

Date: October 2019

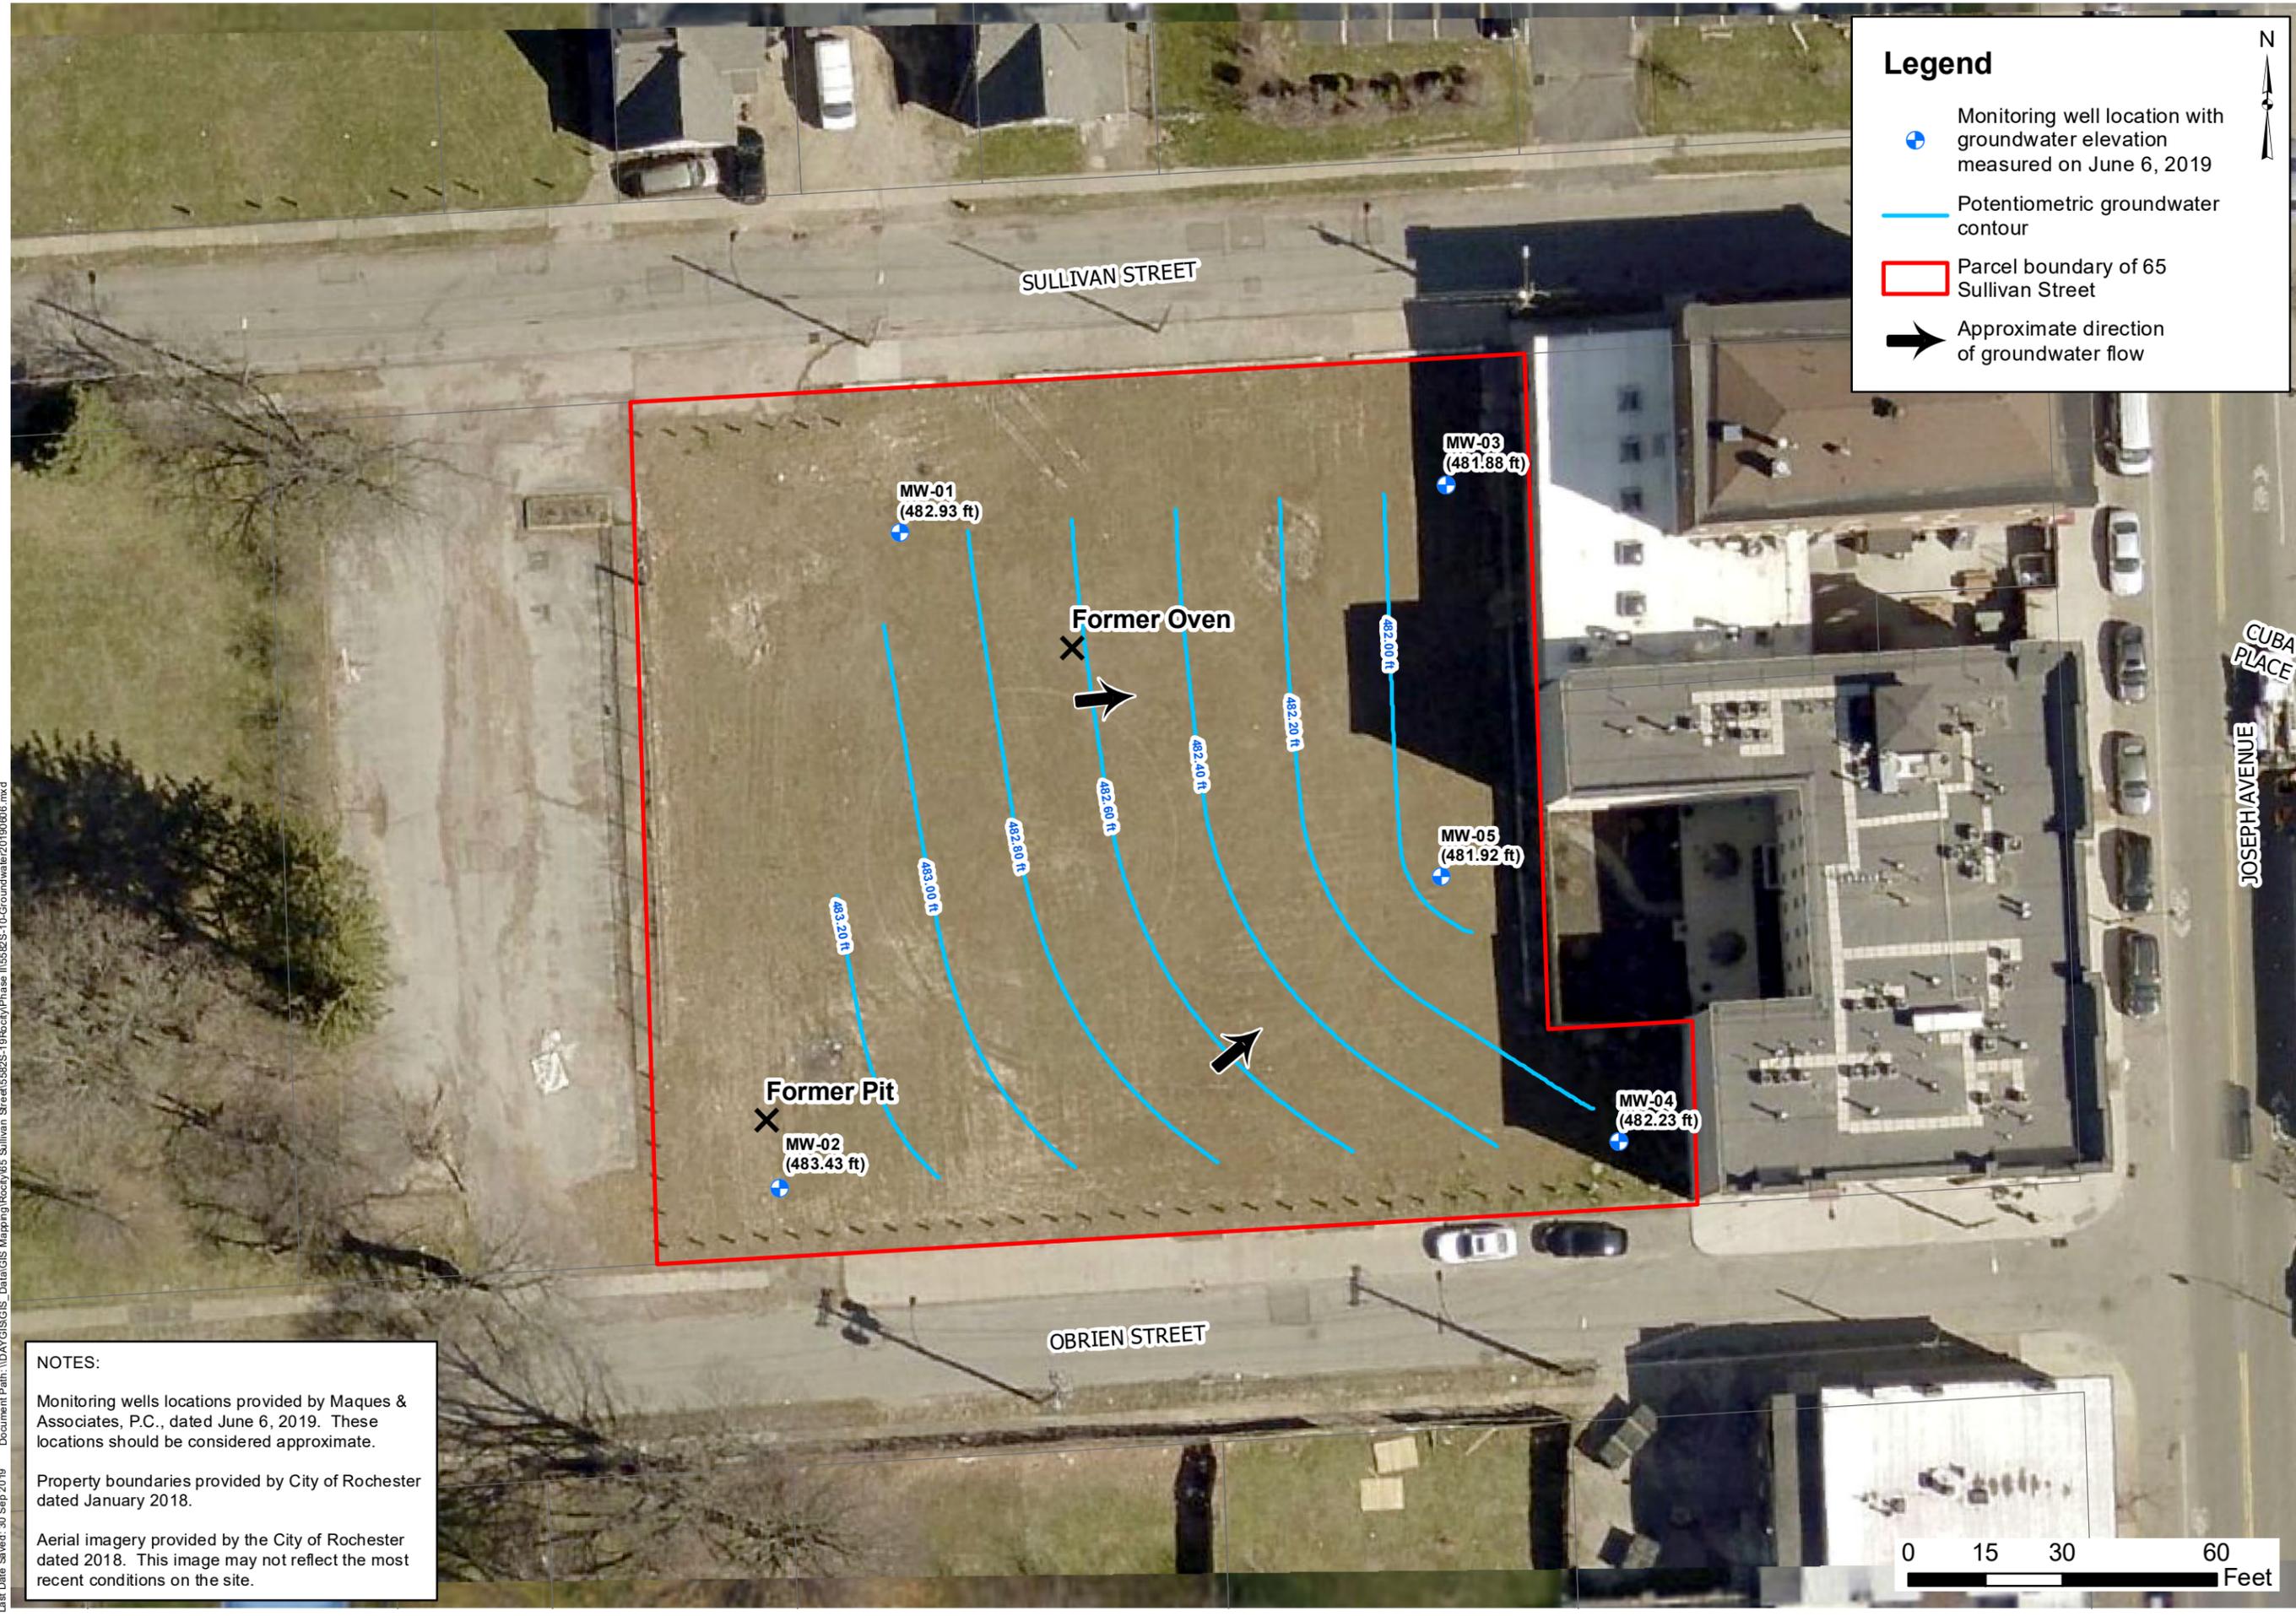
FIGURE 11

- Monitoring well location with groundwater elevation measured on June 6, 2019
- Potentiometric groundwater contour
- Parcel boundary of 65 Sullivan Street
- Approximate direction of groundwater flow

Indigenous soils beneath the fill material generally consists of various mixtures of sands and silts that occasionally contained trace to some gravel, cobbles, boulders, fractured rock (e.g., shale or dolomite) and/or clay with lesser amounts of gravel. In some locations, the overburden soil was underlain by gray fractured shale, which was underlain by harder gray dolomite of the Eramosa (Lockport) Formation. Based on the bedrock elevations measured at the five monitoring well locations, the top of bedrock at the Site appears to slope toward the southeast. Based on groundwater elevation data from the five on-site overburden/bedrock interface monitoring wells, groundwater flow on June 6, 2019 was generally to the east/northeast.

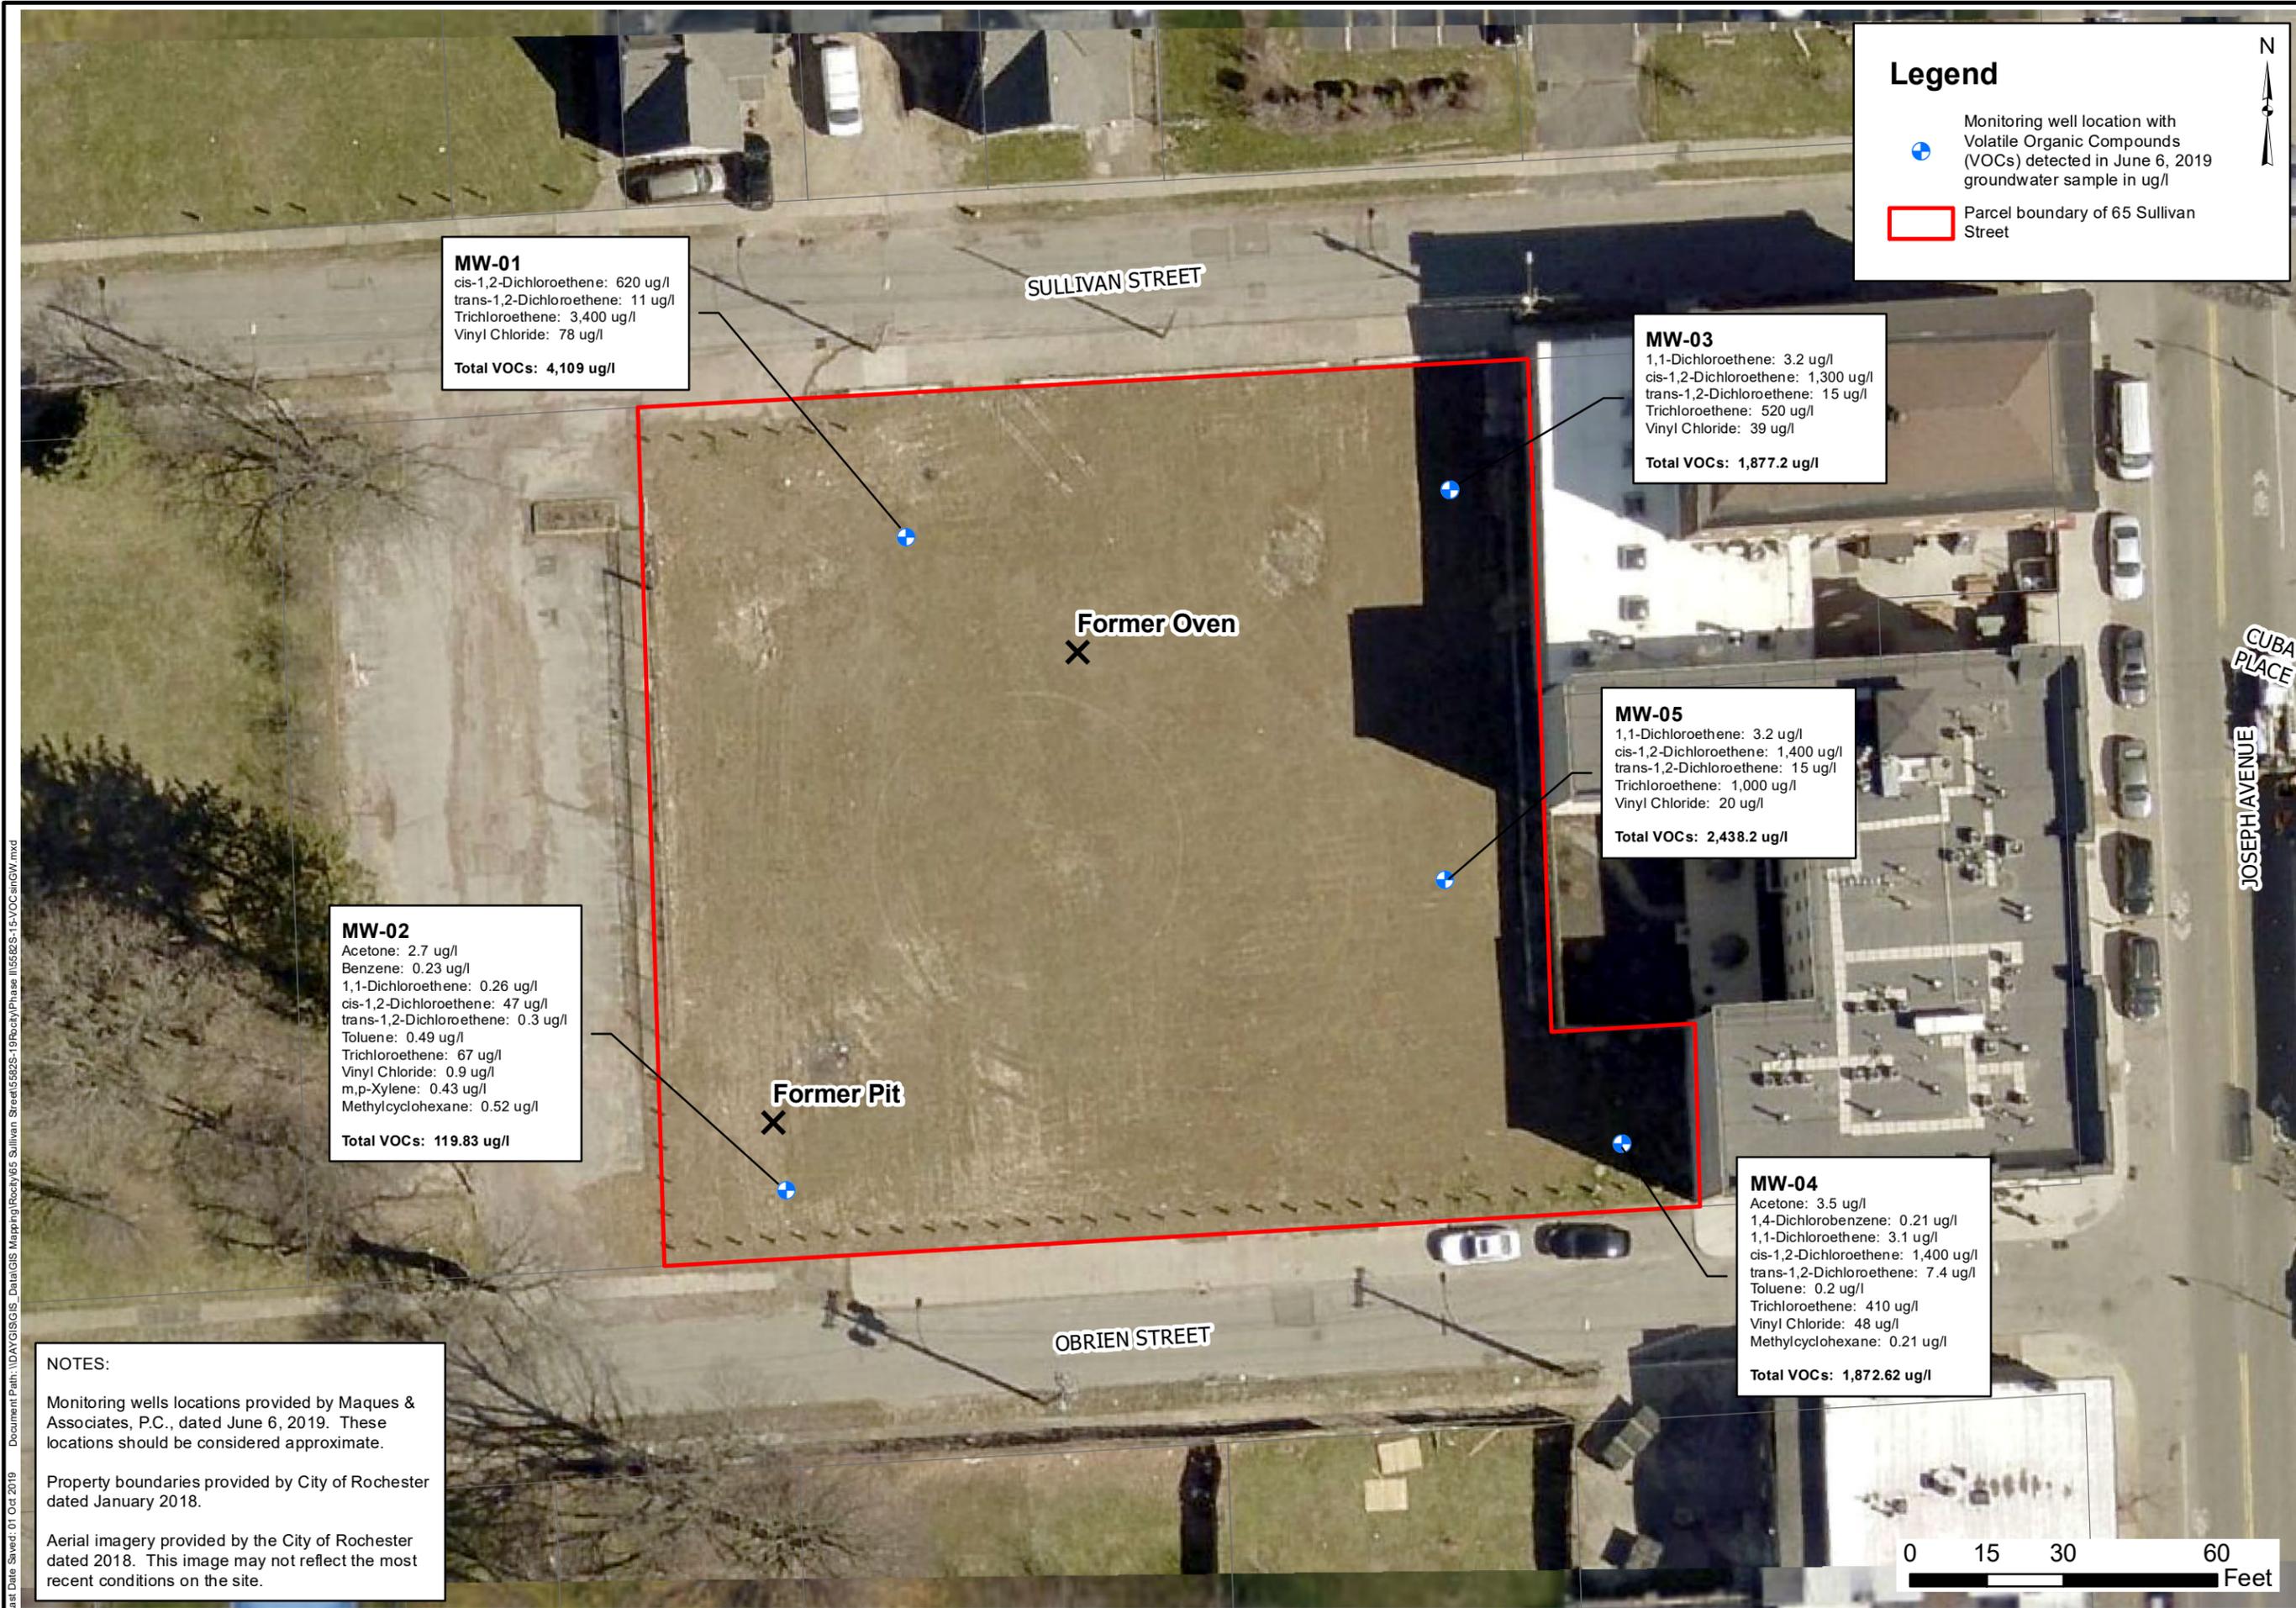
MW-01
 cis-1,2-Dichloroethene: 620 ug/l
 trans-1,2-Dichloroethene: 11 ug/l
 Trichloroethene: 3,400 ug/l
 Vinyl Chloride: 78 ug/l
Total VOCs: 4,109 ug/l

MW-03
 1,1-Dichloroethene: 3.2 ug/l
 cis-1,2-Dichloroethene: 1,300 ug/l
 trans-1,2-Dichloroethene: 15 ug/l
 Trichloroethene: 520 ug/l
 Vinyl Chloride: 39 ug/l
Total VOCs: 1,877.2 ug/l

Based on the work completed, the magnitude of total VOC concentrations in groundwater across most of the Site is generally similar, which suggests a site-wide VOC contaminant condition (i.e., VOCs in groundwater are not localized).

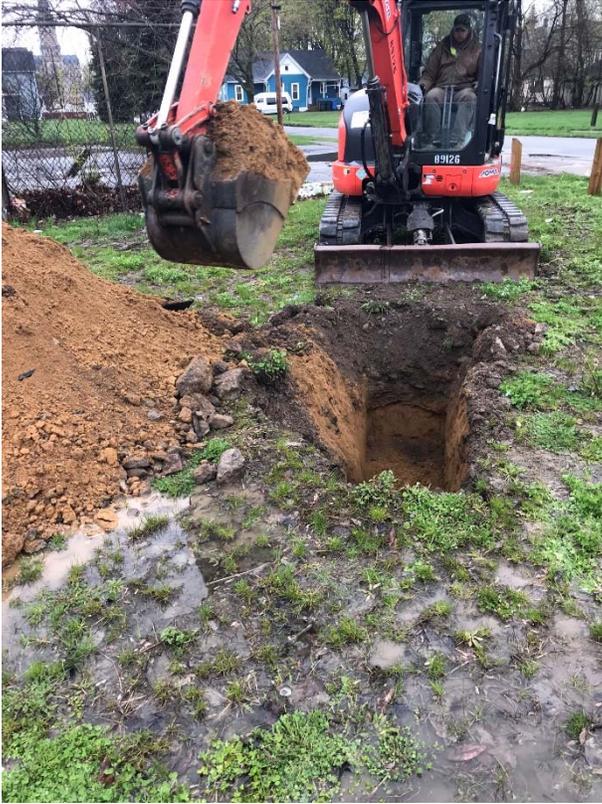
Test Pit TP-01 – looking northwest (5/1/2019)

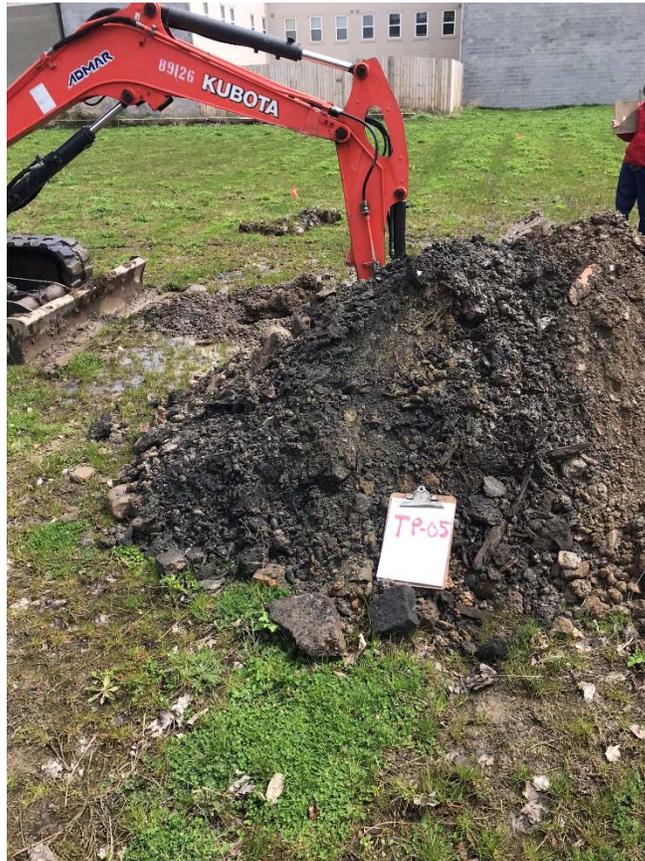
Test Pit TP-05 – looking east (5/1/2019)

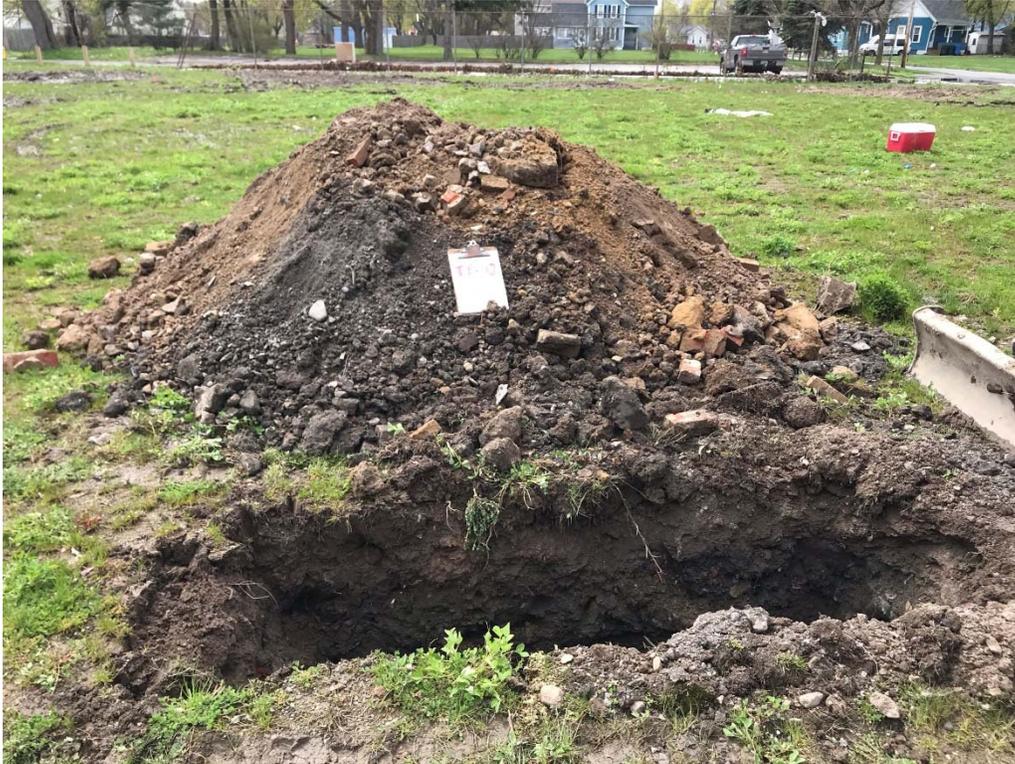
Test Pit TP-02 – looking west (5/1/2019)

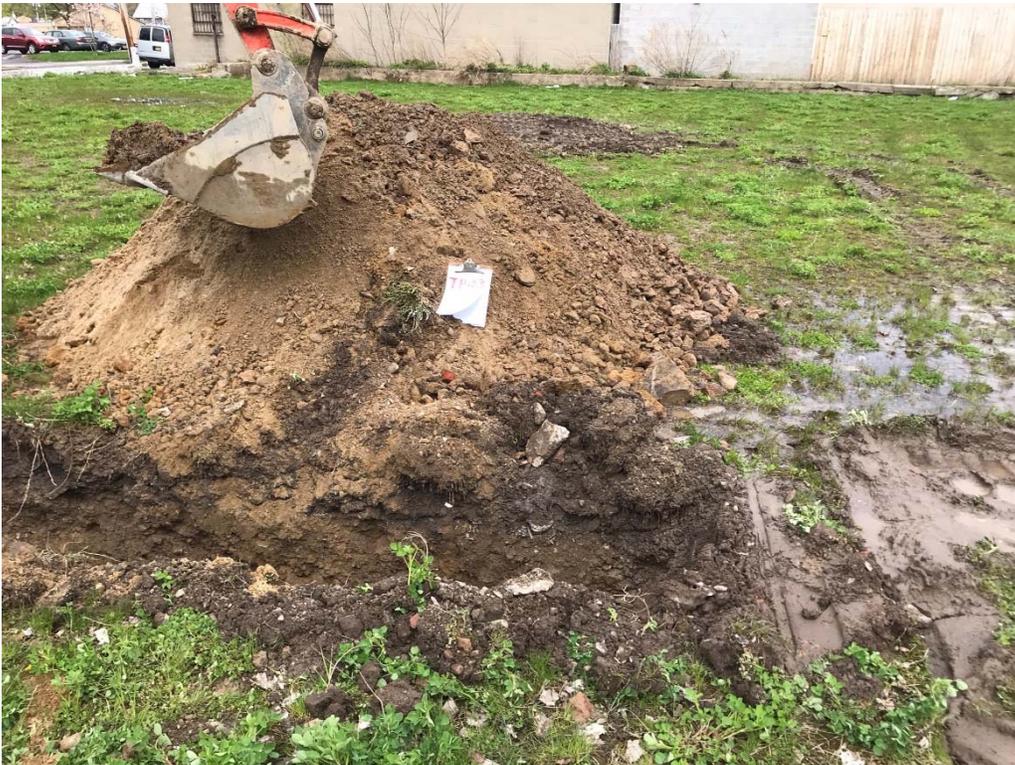
Test Pit TP-03 – looking east (5/1/2019)

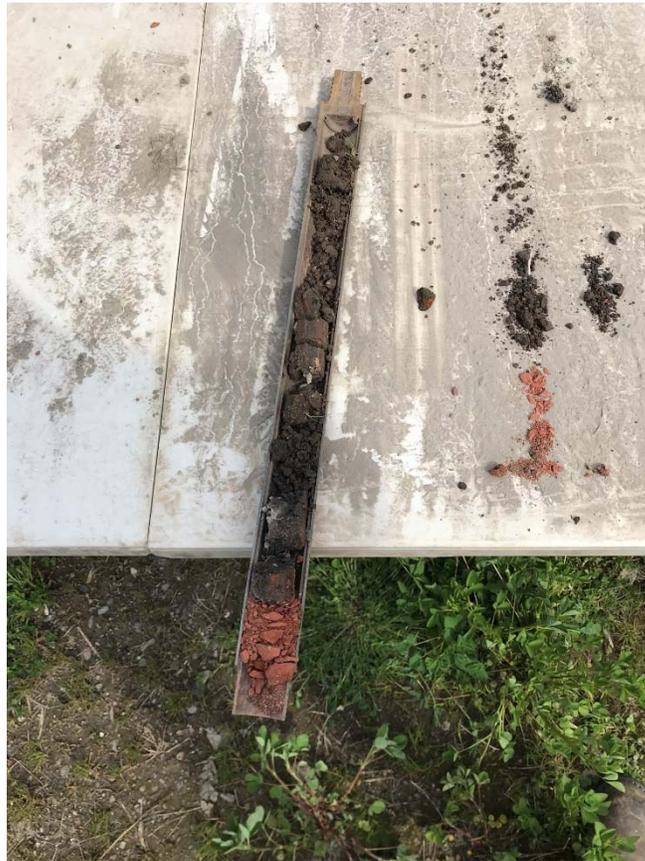
Split Spoon sample from Monitoring Well MW-01 (5/9/2019)

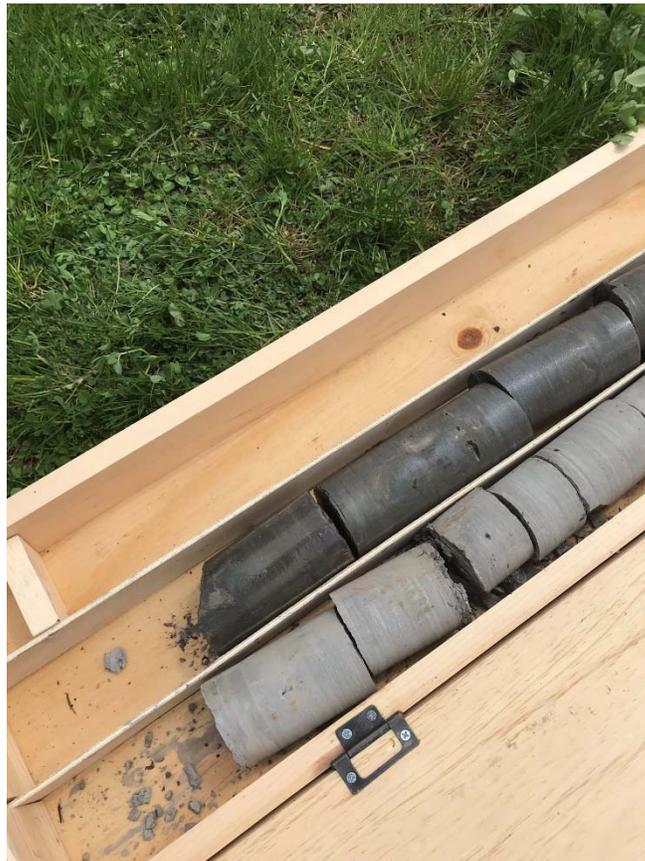
Monitoring Well MW-04 Rock Core with Sheen (5/9/2019)

Using an oil/water interface probe, LNAPL and/or DNAPL were not detected within the five on-site wells during the May 17, 2019 well development work or the June 6, 2019 groundwater monitoring event. However, a sheen and petroleum-type odors were noted on purge water from monitoring well MW-04 during the above-mentioned well development and groundwater monitoring events.

A sheen and petroleum-type odors were noted on purge water from monitoring well MW-04 located on the southeast portion of the Site, but were not noted at the other four monitoring wells. The groundwater sample from MW-04 contained petroleum-related VOCs toluene and methylcyclohexane, but at concentrations below TOGS 1.1.1 groundwater standards or guidance values. The 1933 Sanborn Map shows a gas tank (GT) on the adjoining property to the east in proximity to monitoring well MW-04; thus, the petroleum-type impacts may be attributable to an off-site source.

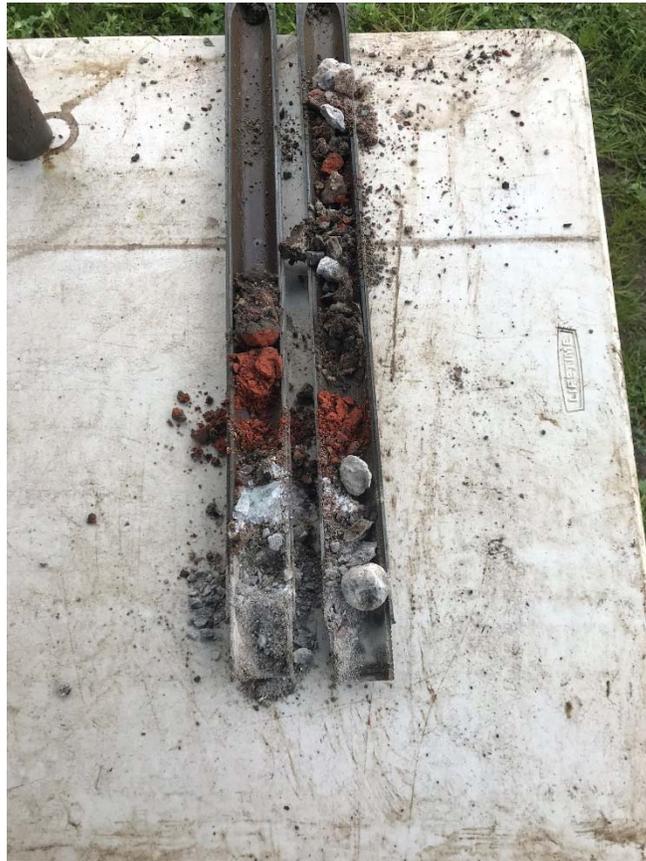
Split Spoon sample from Monitoring Well MW-05

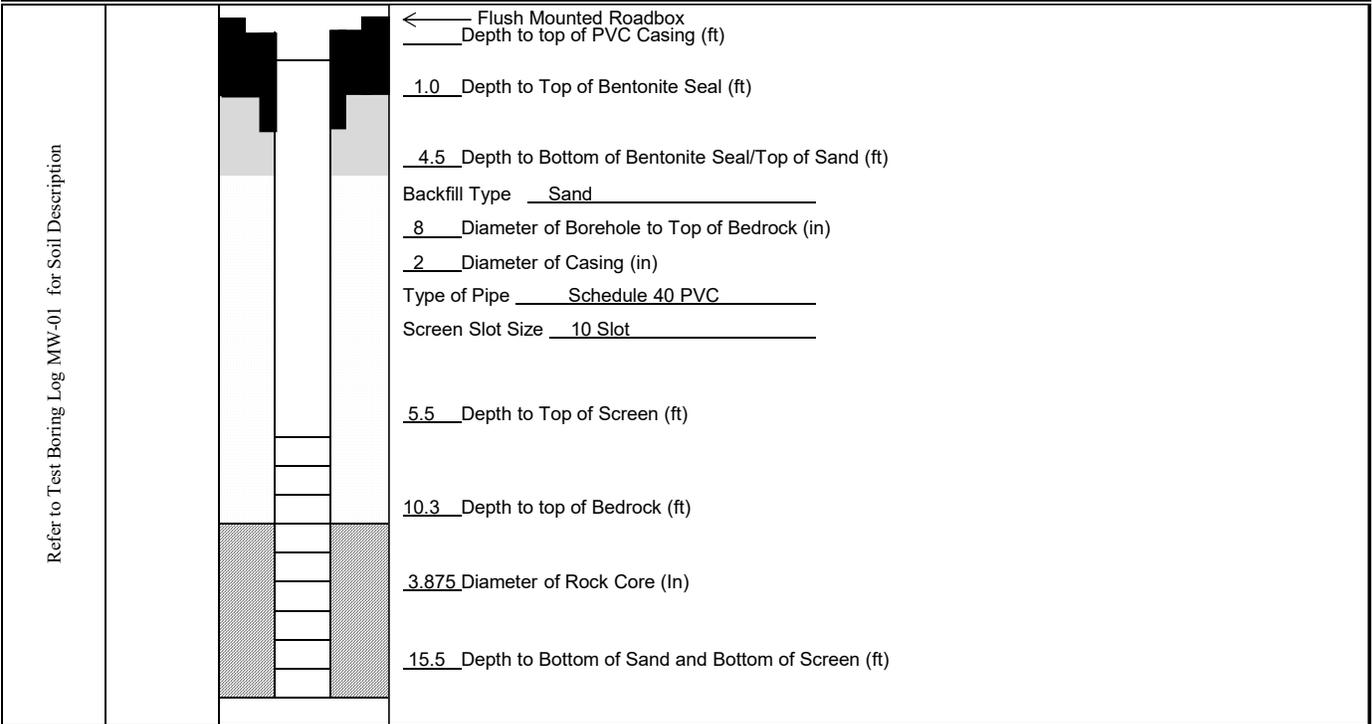
MONITORING WELL CONSTRUCTION DIAGRAM

Project #:	5582S-19			MONITORING WELL MW-01		
Project Address:	65 Sullivan Street					
	Rochester, New York	Ground Elevation:	493.06'		Datum:	NAVD88
DAY Representative:	H. McLennan	Date Started:	5/10/2019		Date Ended:	5/10/2019
Drilling Contractor:	Nature's Way	Water Level (Date):			SWL = 9.69' (6/6/2019)

Between May 8, 2019 and May 14, 2019, test borings MW-01 through MW-05 were converted to groundwater monitoring wells, refer to Figure 2 through Figure 6. Each groundwater monitoring well was constructed with a 2-inch inner diameter Schedule 40 polyvinyl chloride (PVC) screen attached to solid riser piping of the same material. The five monitoring wells were installed as overburden/bedrock interface wells where the screened intervals spanned the overburden and upper bedrock since the top of the uppermost groundwater table was generally observed at or near the top of the bedrock. Pertinent information for each monitoring well is included on monitoring well construction diagrams that are included in Appendix B.

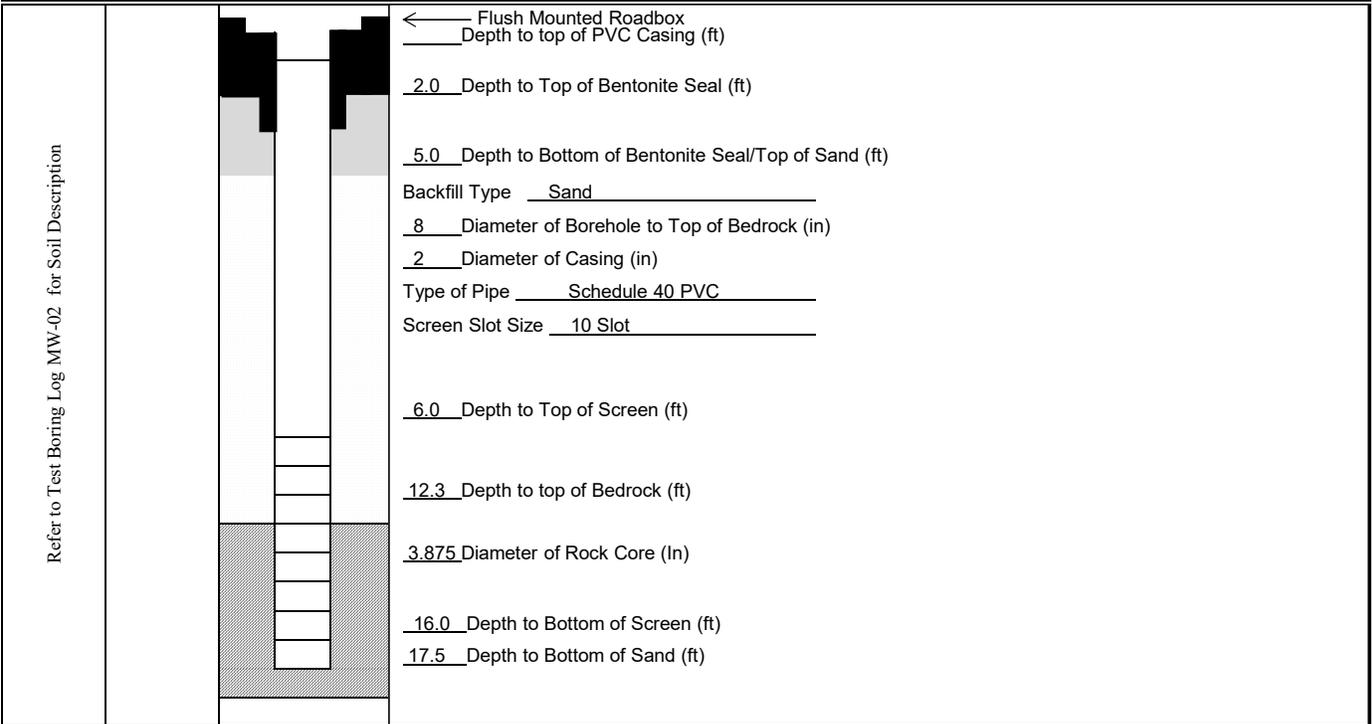
MONITORING WELL CONSTRUCTION DIAGRAM

Project #:	5582S-19			MONITORING WELL MW-02		
Project Address:	65 Sullivan Street					
	Rochester, New York	Ground Elevation:	493.60'		Datum:	NAVD88
DAY Representative:	H. McLennan	Date Started:	5/8/2019		Date Ended:	5/9/2019
Drilling Contractor:	Nature's Way	Water Level (Date):			SWL +9.63' (6/6/2019)

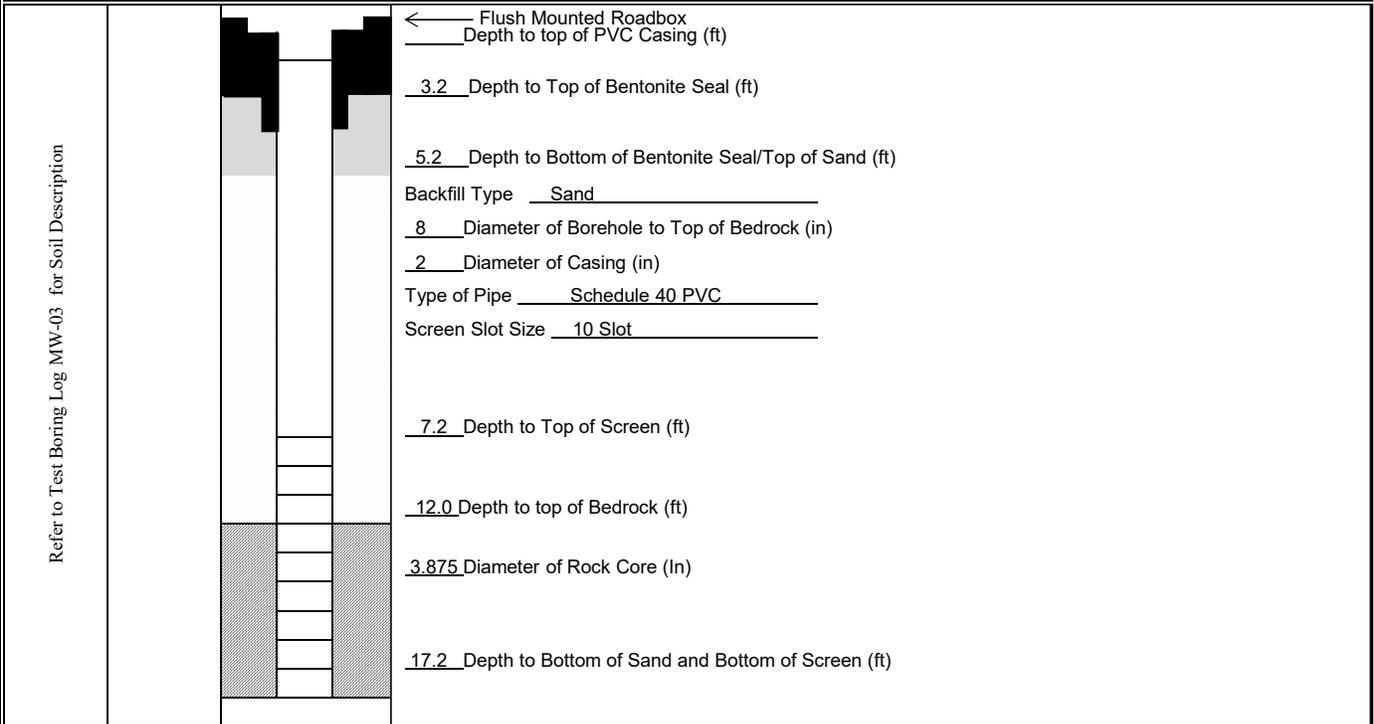
MONITORING WELL CONSTRUCTION DIAGRAM

Project #:	5582S-19			MONITORING WELL MW-03		
Project Address:	65 Sullivan Street					
	Rochester, New York	Ground Elevation:	493.76'		Datum:	NAVD88
DAY Representative:	J. Danzinger	Date Started:	5/13/2019		Date Ended:	5/14/2019
Drilling Contractor:	Nature's Way	Water Level (Date):			SWL = 11.63' (6/6/2019)

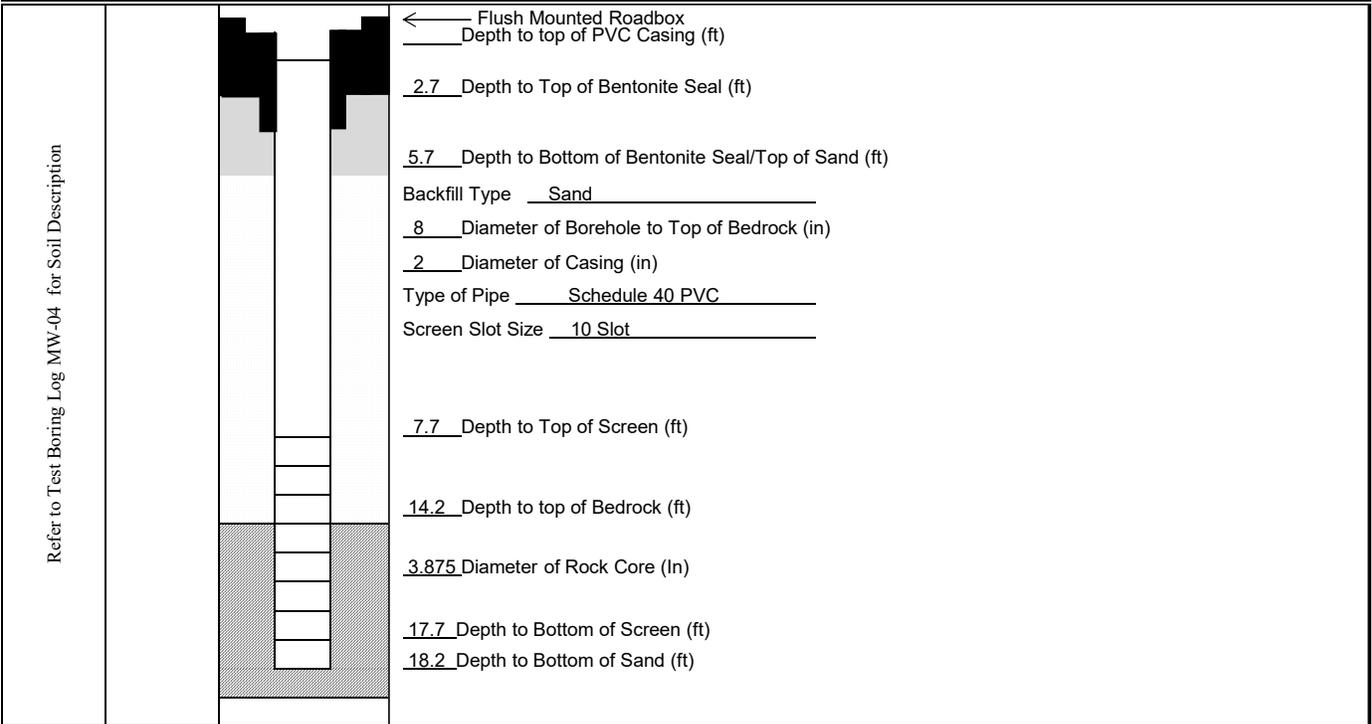
MONITORING WELL CONSTRUCTION DIAGRAM

Project #:	5582S-19			MONITORING WELL MW-04		
Project Address:	65 Sullivan Street					
	Rochester, New York	Ground Elevation:	494.72'		Datum:	NAVD88
DAY Representative:	J. Danzinger	Date Started:	5/9/2019		Date Ended:	5/10/2019
Drilling Contractor:	Nature's Way	Water Level (Date):			SWL = 12.15' (6/6/2019)

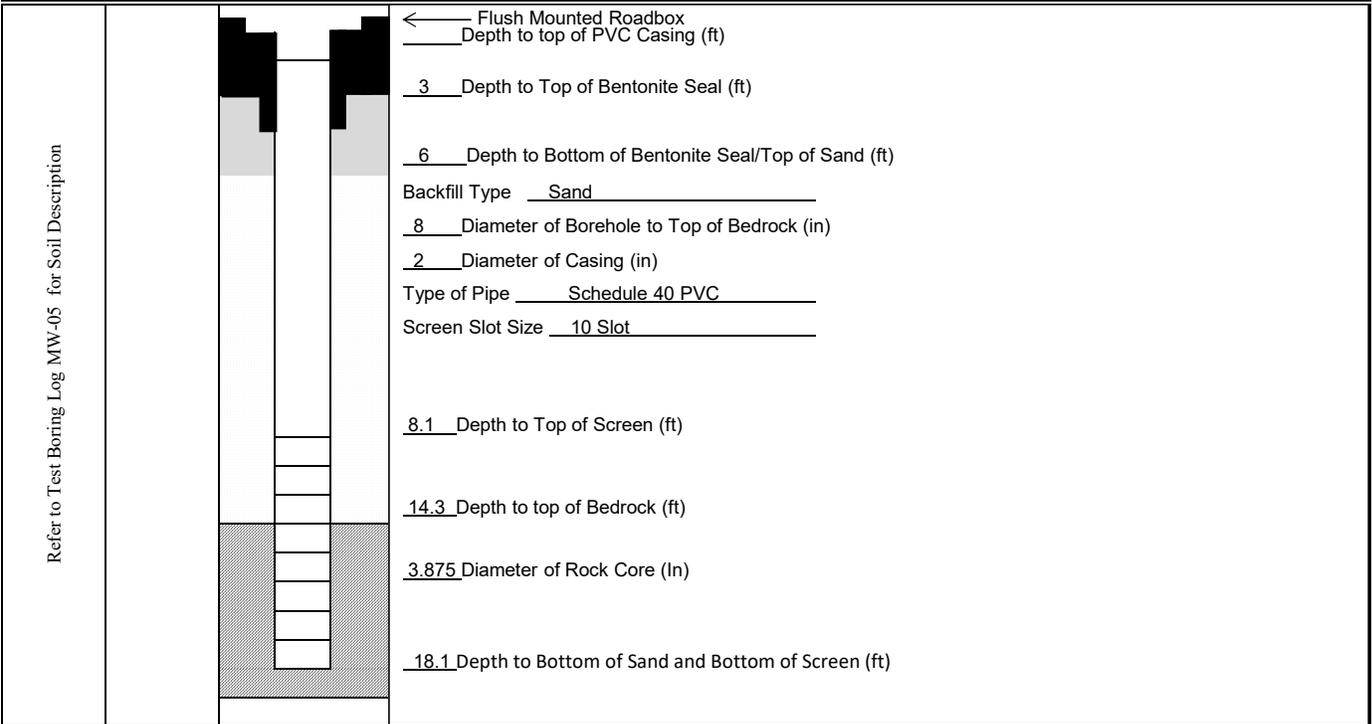
MONITORING WELL CONSTRUCTION DIAGRAM

Project #:	5582S-19			MONITORING WELL MW-05		
Project Address:	65 Sullivan Street					
	Rochester, New York	Ground Elevation:	494.22'		Datum:	NAVD88
DAY Representative:	J. Danzinger	Date Started:	5/14/2019		Date Ended:	5/14/2019
Drilling Contractor:	Nature's Way	Water Level (Date): SWL = 12.03' (6/6/2019)

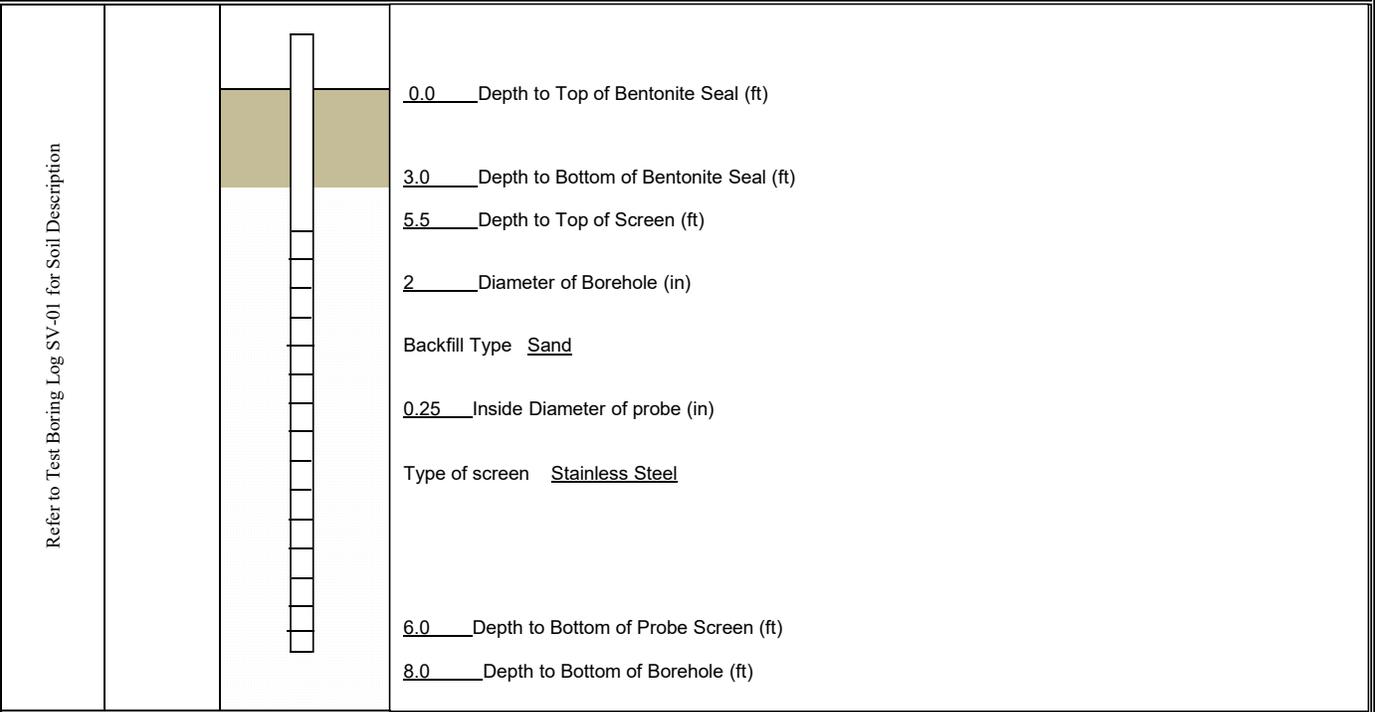
SOIL VAPOR PROBE CONSTRUCTION DIAGRAM

Project #:	5582S-19			Soil Vapor Probe SV-01	
Project Address:	65 Sullivan Street				
	Rochester, New York	Ground Elevation:	NA	Datum:	NA
DAY Representative:	A. Zobel Martino	Date Started:	5/15/2019	Date Ended:	5/15/2019
Drilling Contractor:	Nature's Way	Water Level (Date): wet soil at 7.5' (5/15/2019)

On May 15, 2019, Nature's Way used the rotary drill-rig to install a soil vapor point SV-01 on the adjoining 59 Sullivan Street parcel, which is owned by the City. The location of the soil vapor point is depicted on Figure 2 through Figure 6 show. Split Spoon samples were collected in consecutive intervals from the ground surface to a depth of approximately eight feet bgs at the soil vapor point boring. A DAY representative observed the split spoon samples retrieved from SV-01 for field evidence of contamination (e.g., staining, free product, sheen, odors), screen samples of material for total VOCs using a PID, and logged the lithology and water content conditions. This information, as well as other pertinent information, is recorded on a test boring log (copy included in Appendix B).

Nature's Way then installed a temporary soil vapor point in the boring that consisted of a 0.5-foot long screen tip fitted with a guide that was connected to solid tubing. The bottom of the screen was placed approximately six feet bgs in order to be above the groundwater table observed within the boring. The solid tubing extended above the ground surface. The annulus between the tubing and borehole walls was backfilled with clean sand, and the top of the borehole above the sand was backfilled with hydrated bentonite. Pertinent information is recorded on a soil vapor probe construction diagram (copy included in Appendix B).
