DATA PACKAGE

**ENVIRONMENTAL ASSESSMENT AND REMEDIATION SERVICES
121 AND 123 REYNOLDS STREET
ROCHESTER, NEW YORK**

NYSDEC SPILL #1103833

Project No.: 4576S-11

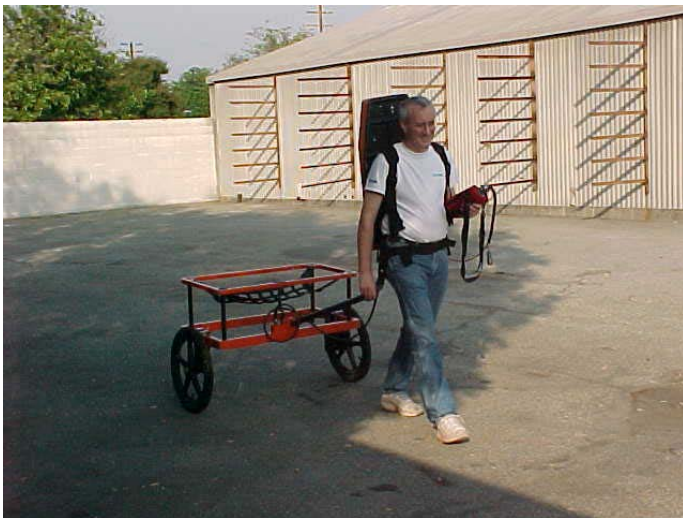
EM61 in use (photo not from this site)

Data are collected from the EM61's two receiver coils. One of the receiver coils is located coincident to the transmitter coil. The other receiver coil is located 1.31 feet (0.4 meters) above the transmitter coil. Data from the top receiver coil are stored on Channel 1 of a digital data logger. Data from the bottom receiver coil are stored on Channel 2 of the data logger. Channel 1 and Channel 2 data are simultaneously recorded at each station location. The instrument responses are recorded in units of milliVolts (mV). Data were recorded digitally by a data logger along lines spaced 3 ft apart at a rate of approximately 2 measurements per foot.

The site was geophysically surveyed using the Geonics EM61. The EM61 unit is a high sensitivity, high resolution time domain electromagnetic (TDEM) metal detector that can detect both ferrous and nonferrous metallic objects. It has an approximate investigation depth of 10 feet. The processing console is contained in a backpack worn by the operator which is interfaced to a digital data logger. The transmitter and two receiver coils are located on a two-wheeled cart that is pulled by the operator.

The device's transmitter coil generates a pulsed primary EM field at a rate of 150 pulses per second, inducing eddy currents into the subsurface. The decay rates of these eddy currents are measured by two, 3.28 foot by 1.64 foot (1 meter by $\frac{1}{2}$ meter) rectangular receiver coils. By taking the measurements at a relatively long time frame after termination of the primary pulse, the response is practically independent of the survey area's terrain conductivity. Specifically, the decay rates of the eddy currents are much longer for metals than for normal soils allowing the discrimination of the two.

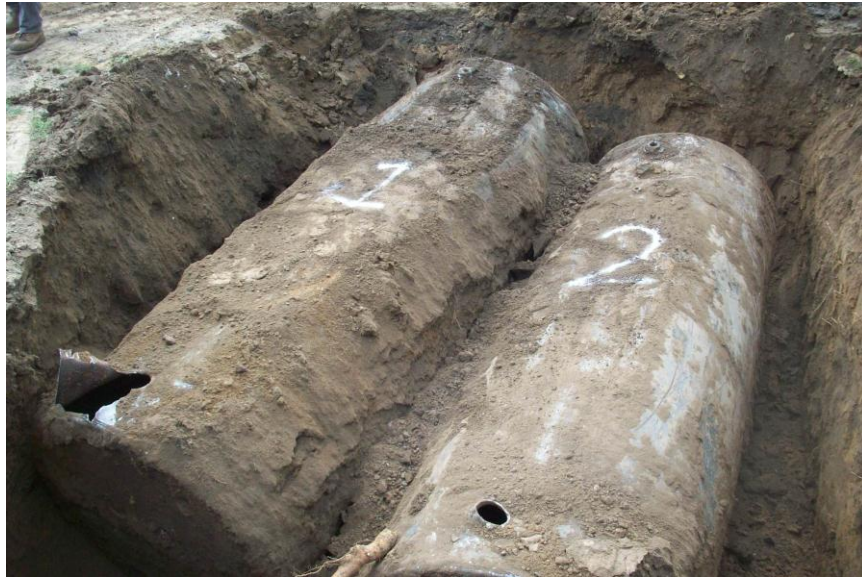
Photo 1 – Tank 1 and Tank 2 locations prior to removal (8/31/2011)

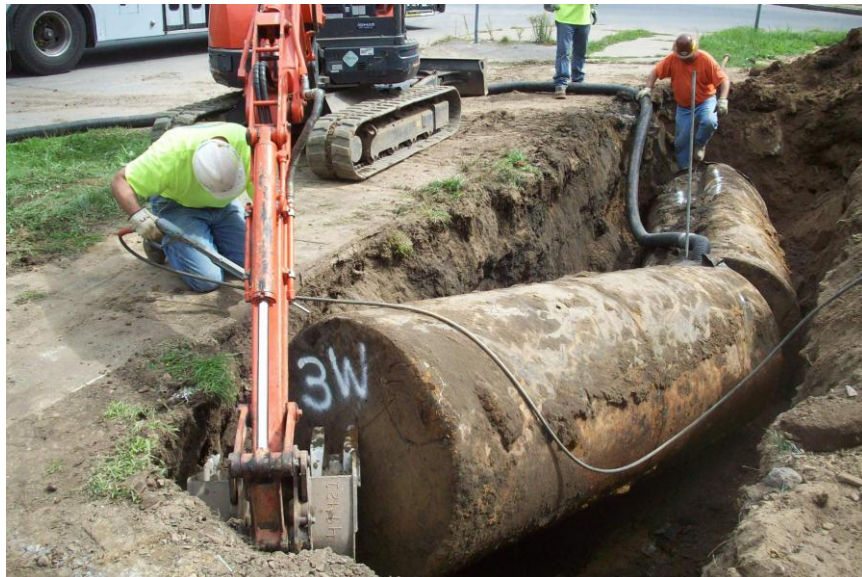
Photo 2 - Tank 3 and Tank 4 locations prior to removal (8/31/2011)

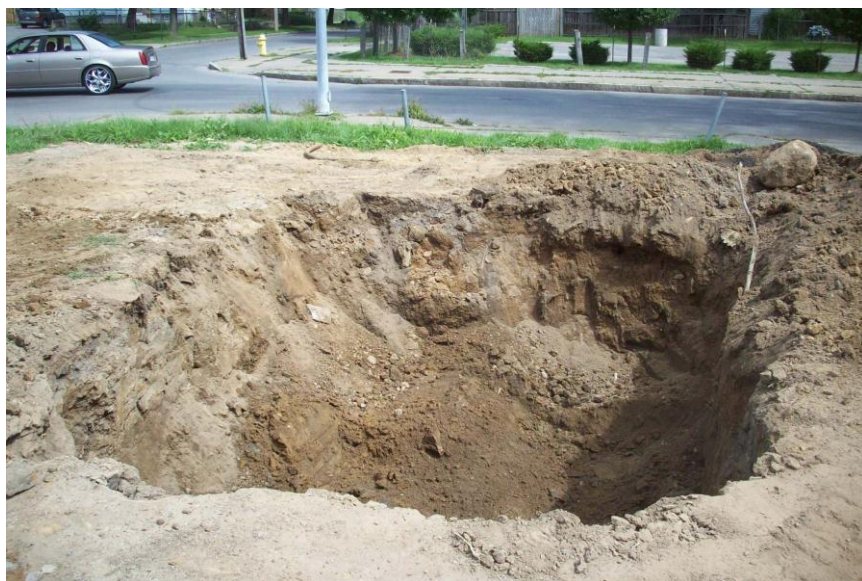
Photo 3 – Tank 1 and Tank 2 excavation subsequent to tank removal (8/31/2011)

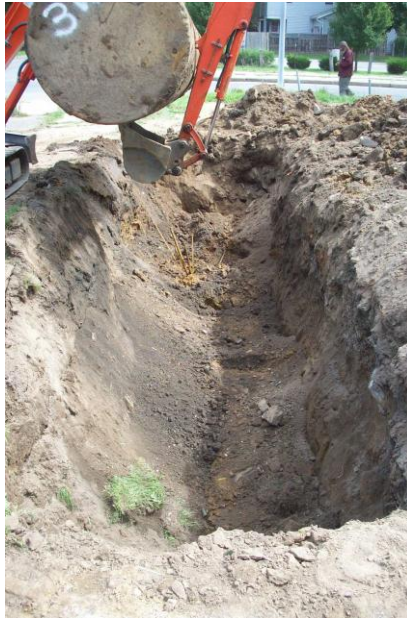
Photo 4– Tank 3 and Tank 4 excavation subsequent to tank removal (8/31/2011)

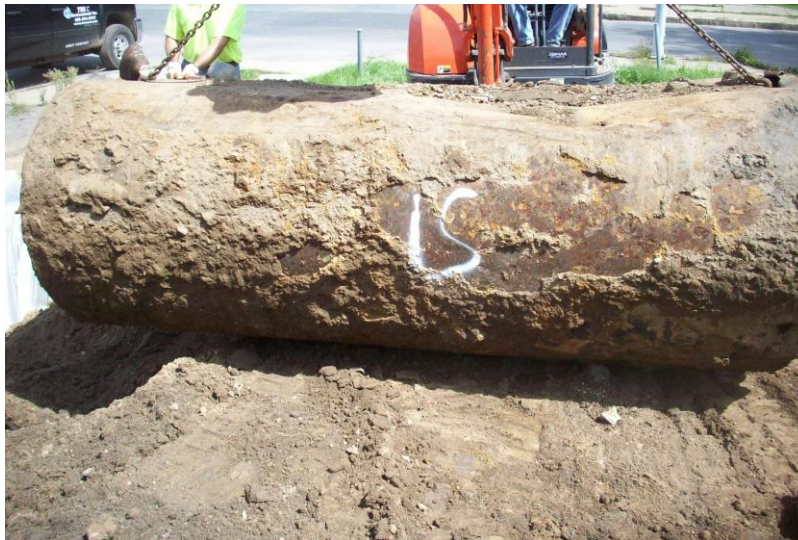
Photo 5 – View of the south side wall of Tank 1 (8/31/2011)

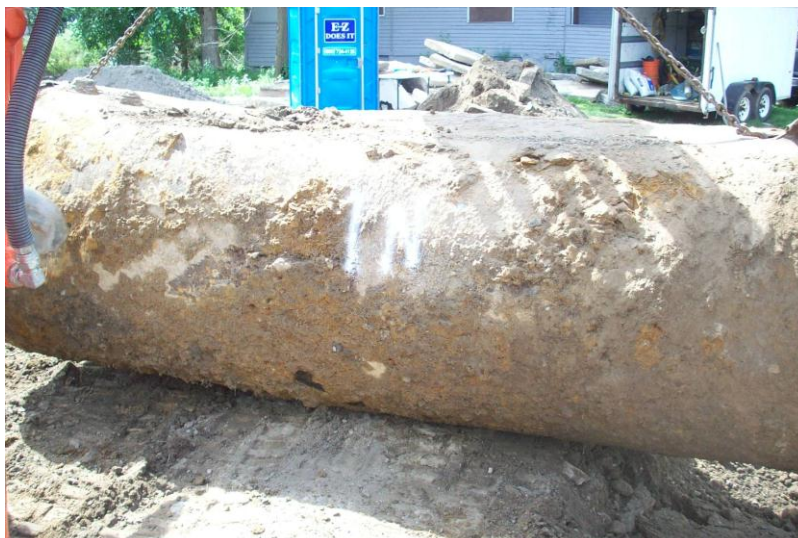
Photo 6 – View of the north side wall of Tank 1 (8/31/2011)

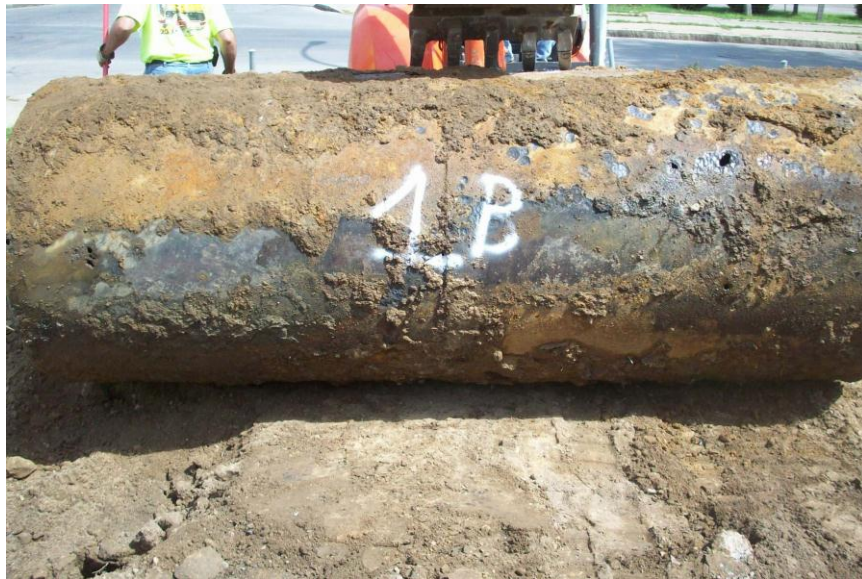
Photo 7 – View of the bottom of Tank 1 (8/31/2011)

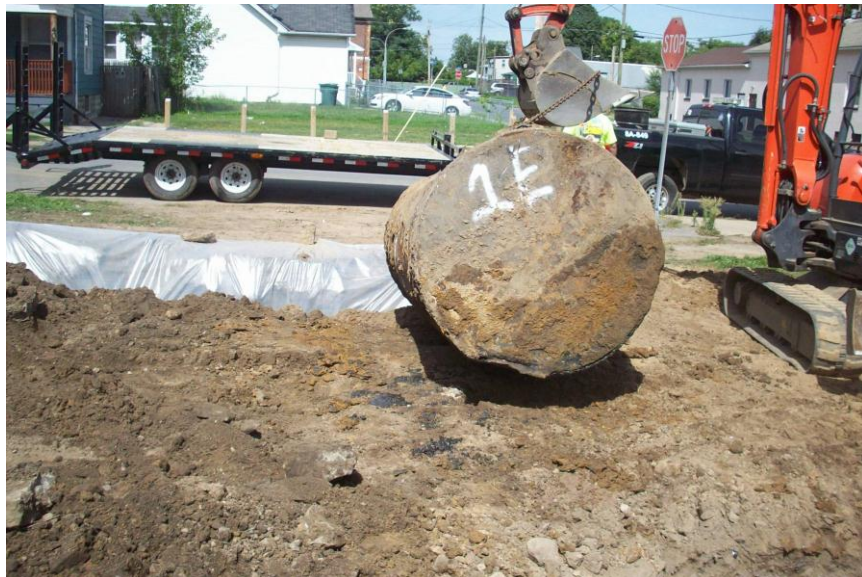
Photo 8– View of the east end wall of Tank 1 (8/31/2011)

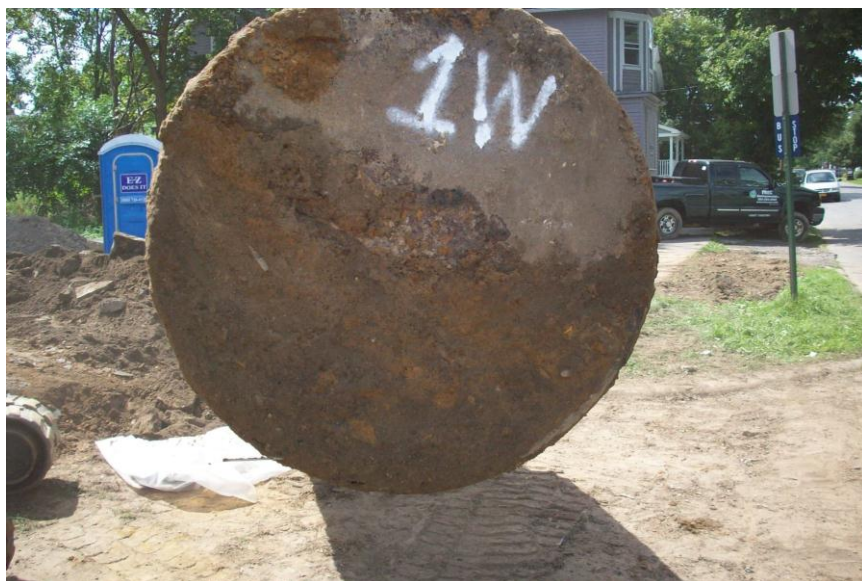
Photo 9– View of the west end wall of Tank 1 (8/31/2011)

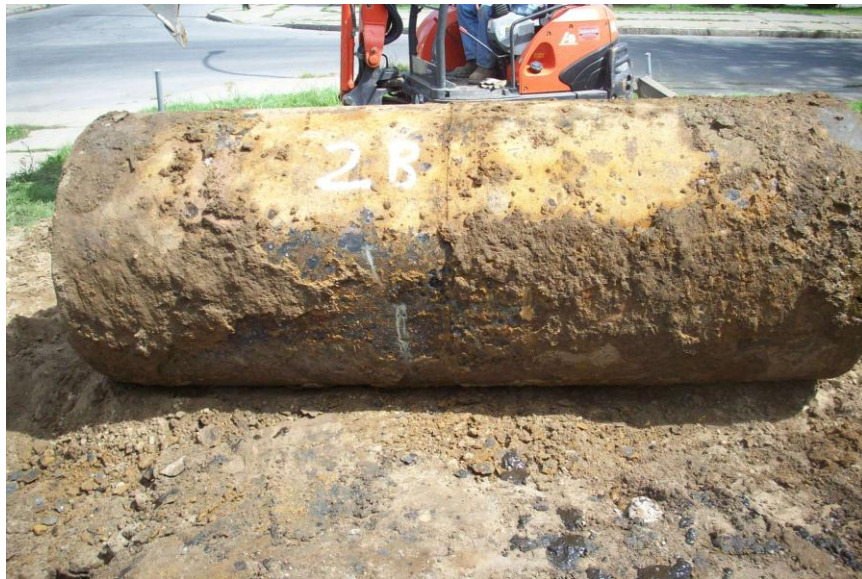
Photo 10– View of the bottom of Tank 2 (8/31/2011)

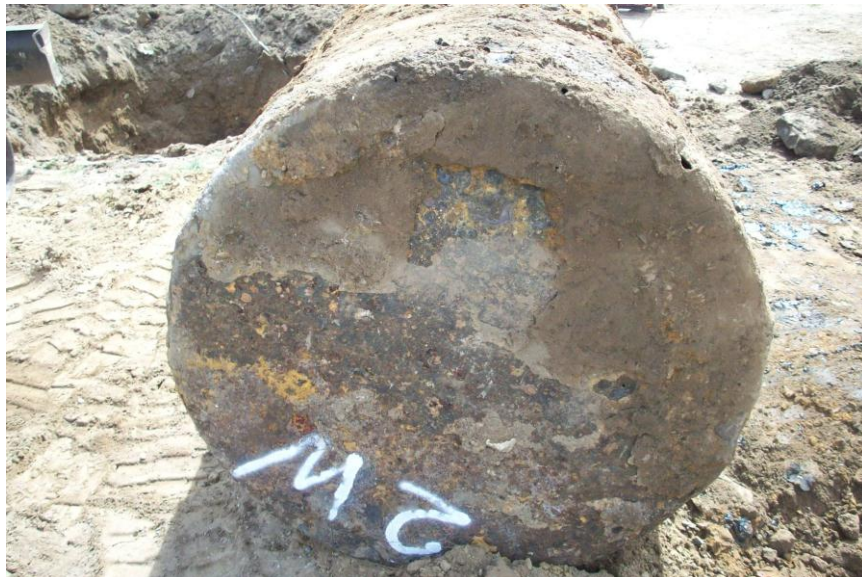
Photo 11– View of the west end wall of Tank 2 (8/31/2011)

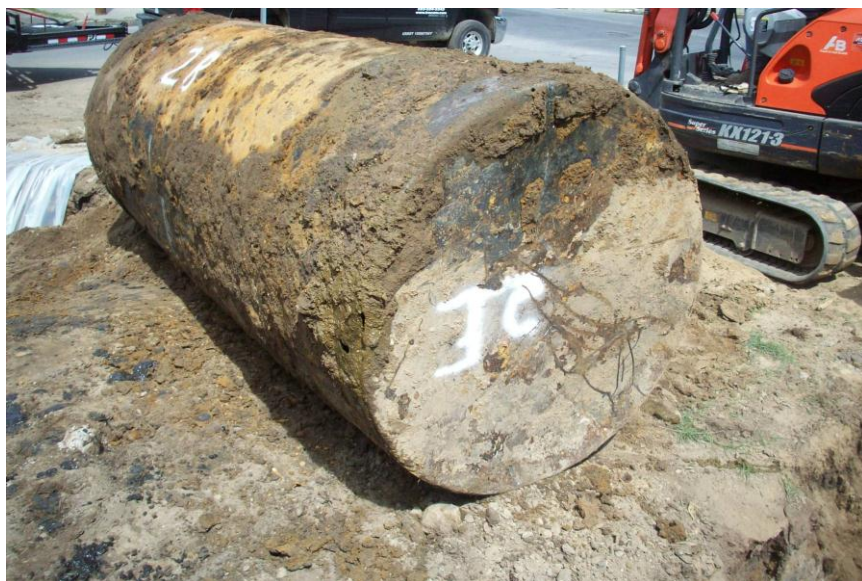
Photo 12– View of the east end wall of Tank 2 (8/31/2011)

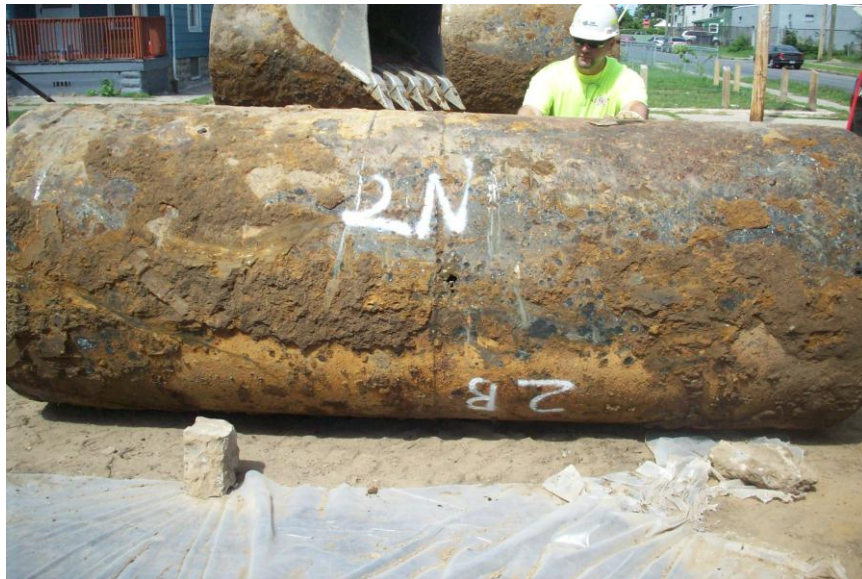
Photo 13– View of the north side wall of Tank 2 (8/31/2011)

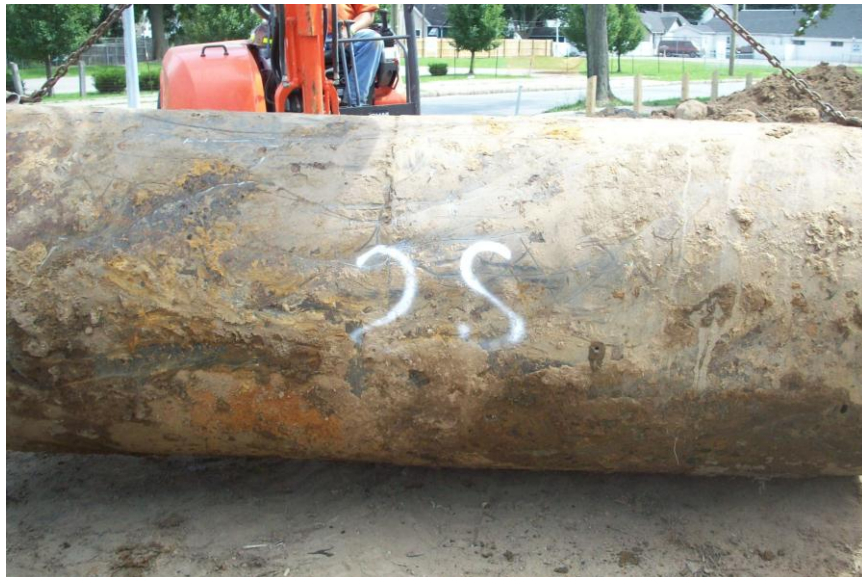
Photo 14– View of the south side wall of Tank 2 (8/31/2011)

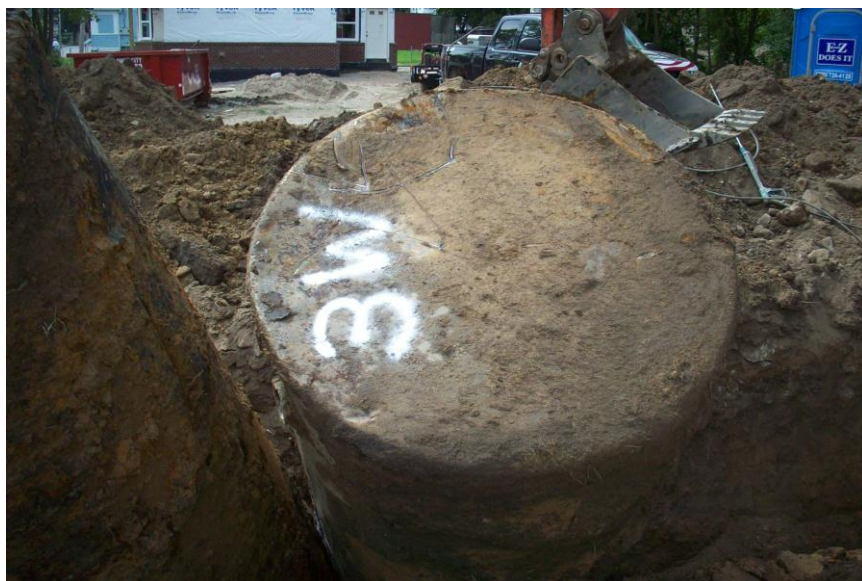
Photo 15– View of the west end wall of Tank 3 (8/31/2011)

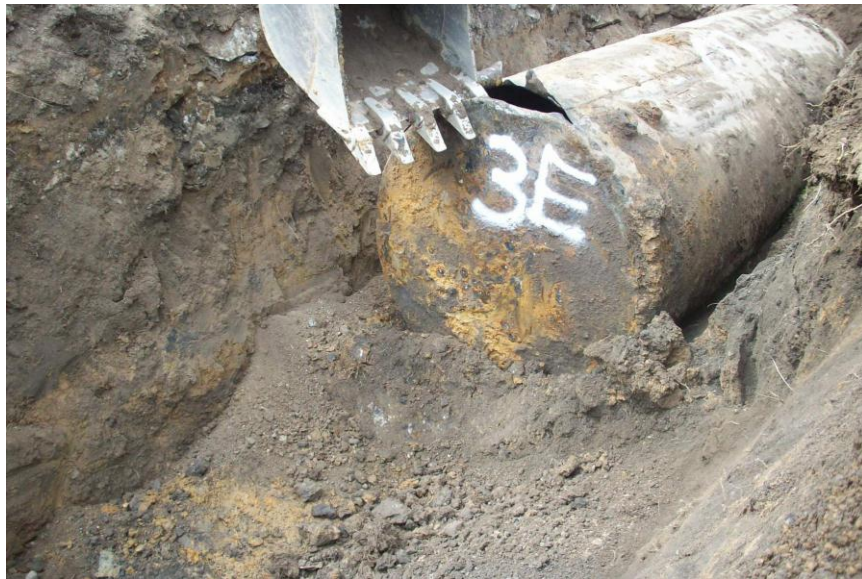
Photo 16– View of the east end wall of Tank 3 (8/31/2011)

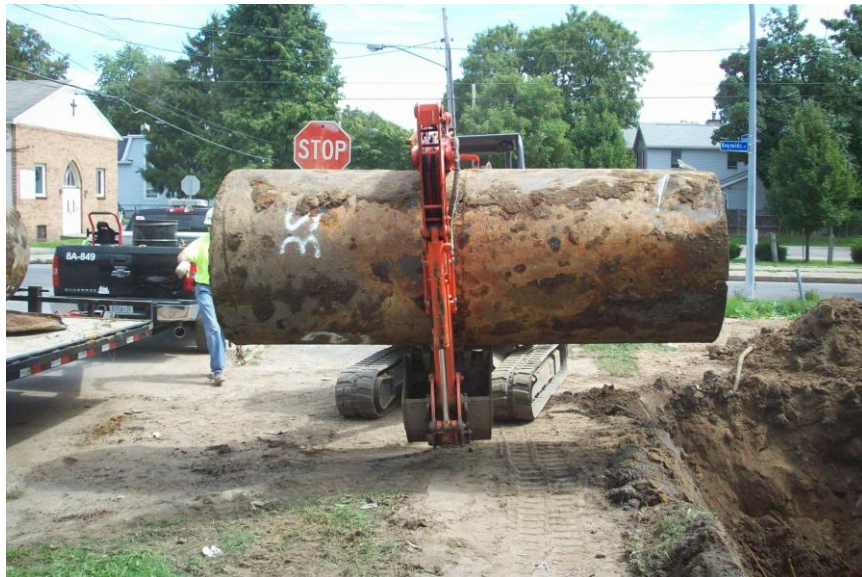
Photo 17– View of the south side wall of Tank 3 (8/31/2011)

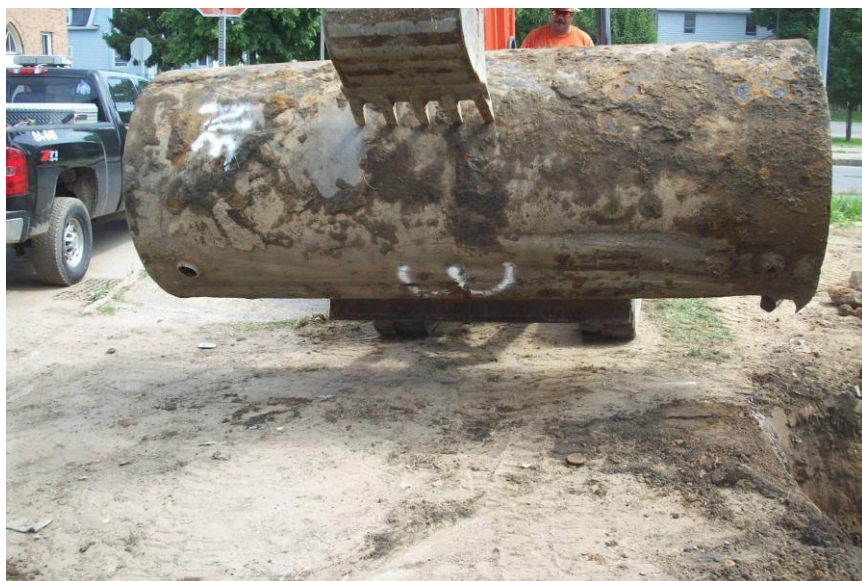
Photo 18 - - View of the north side wall of Tank 3 (8/31/2011)

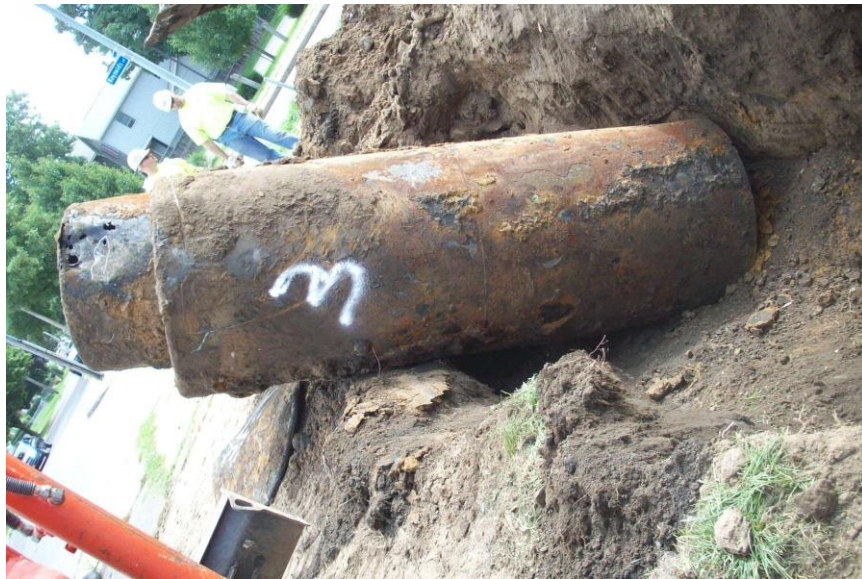
Photo 19– View of the bottom of Tank 3 (8/31/2011)

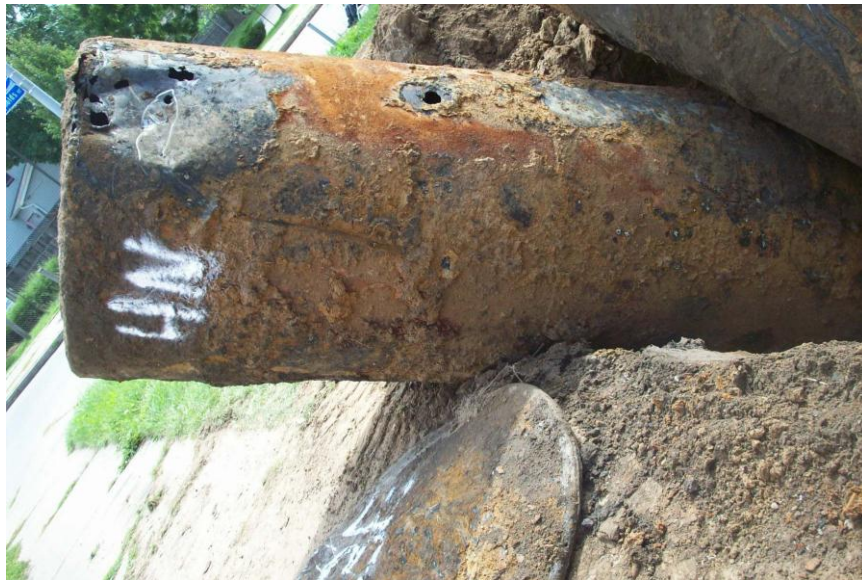
Photo 20– View of the north side wall and bottom of Tank 4 (8/31/2011)

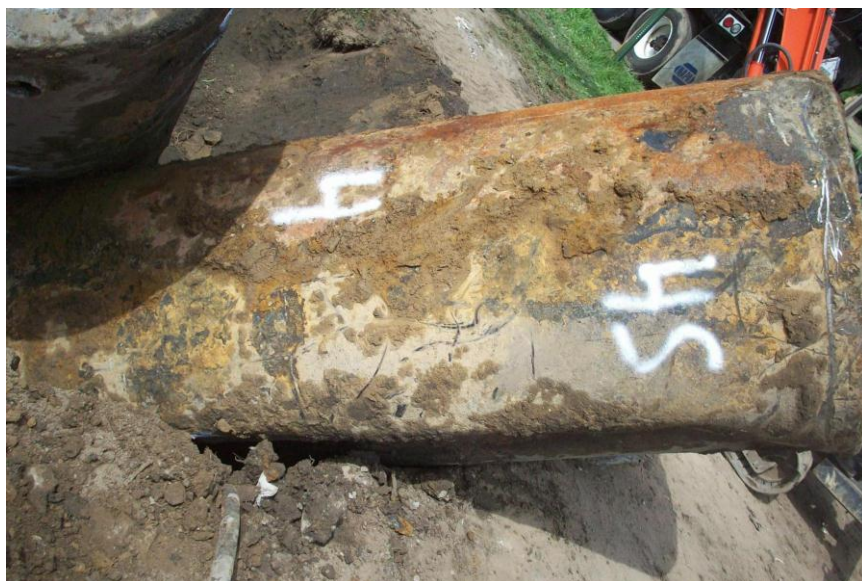
Photo 21 – View of the south side wall of Tank 4 (8/31/2011)

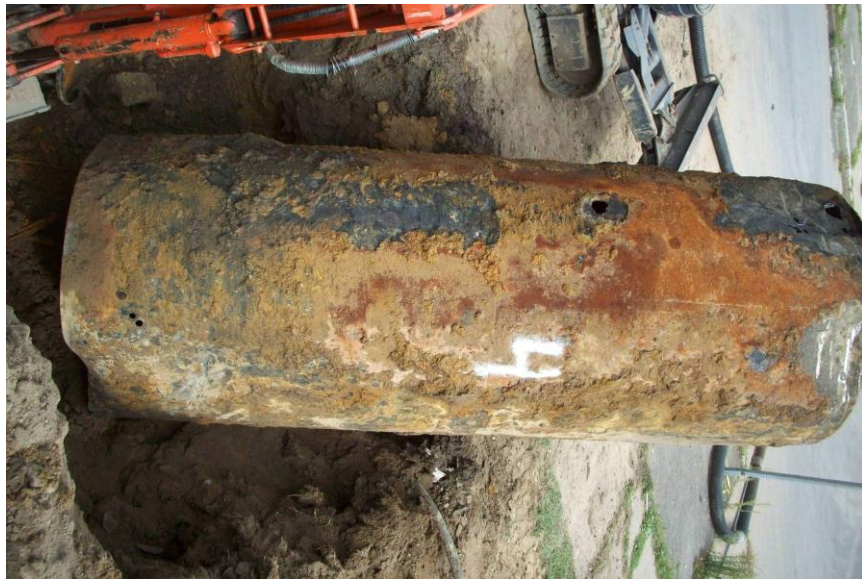
Photo 22– View of the bottom of Tank 4 (8/31/2011)

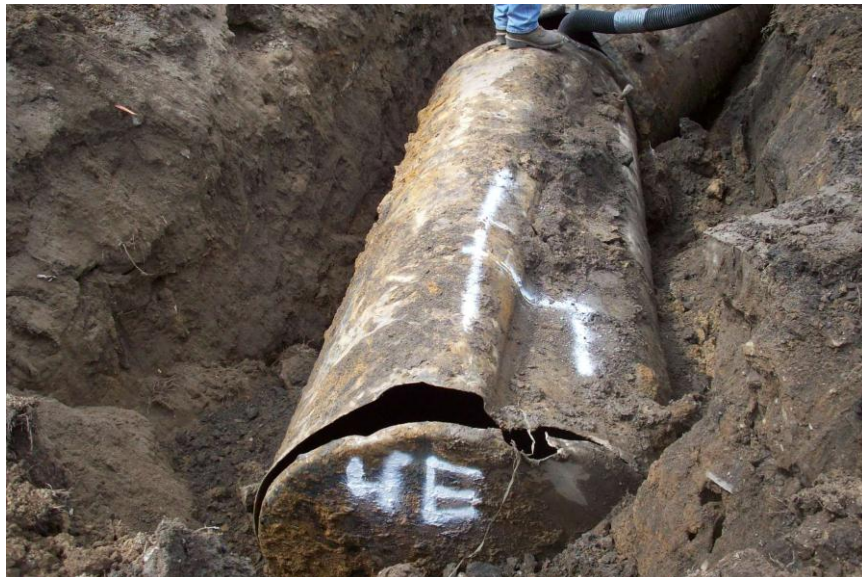
Photo 23– View of the east end wall of Tank 4 (8/31/2011)

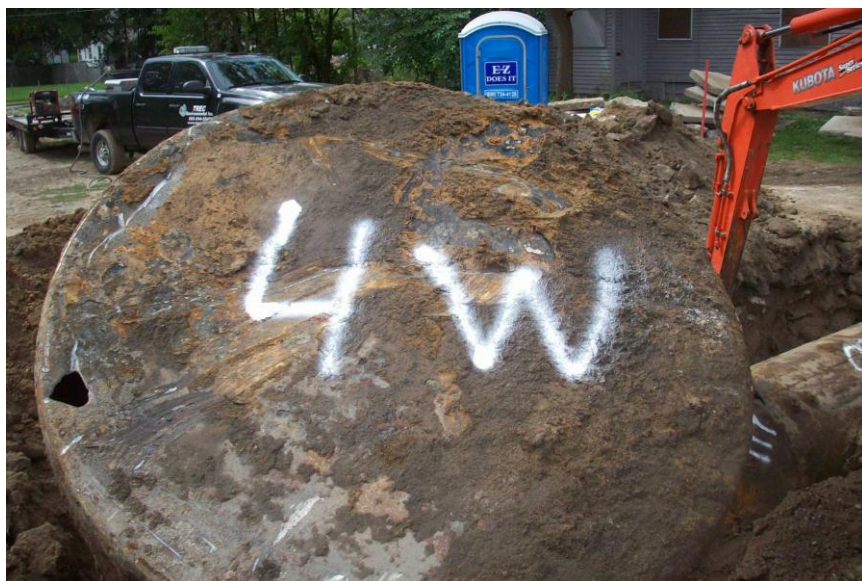
Photo 24– View of the west end wall of Tank 4 (8/31/2011)

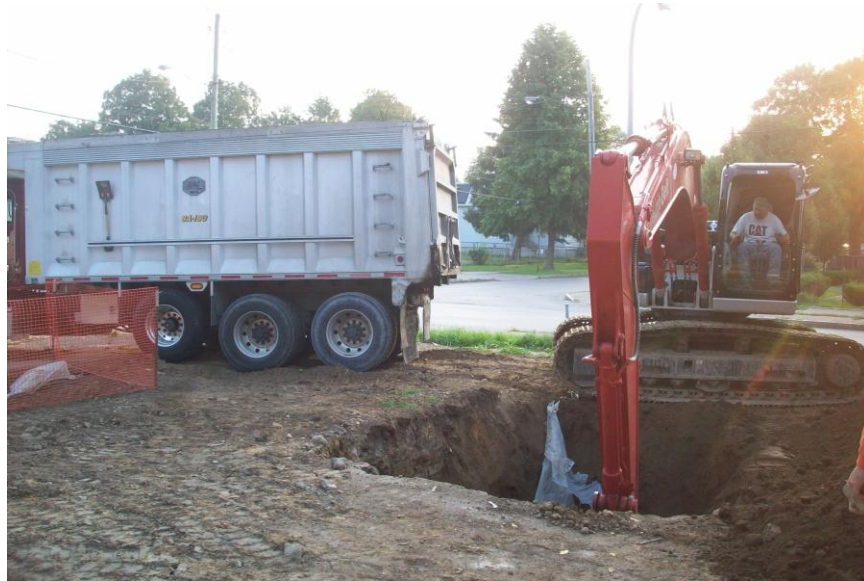
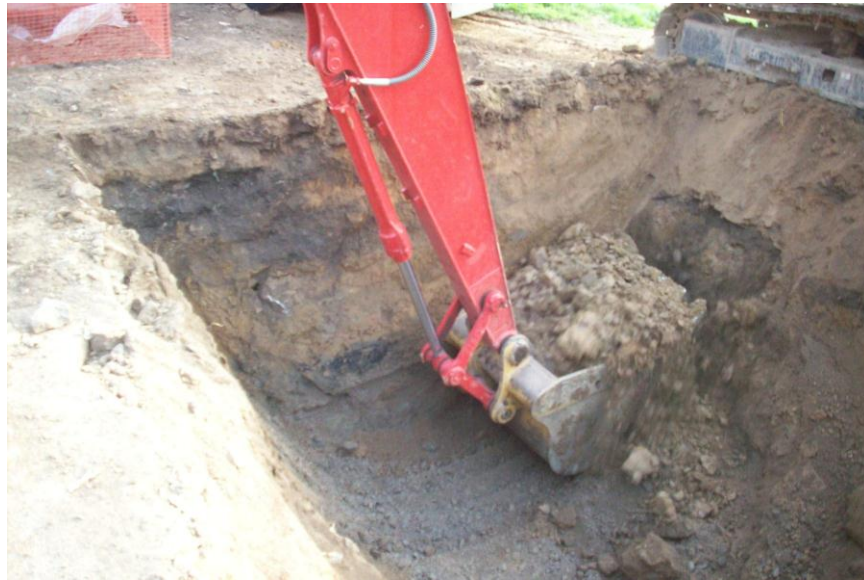
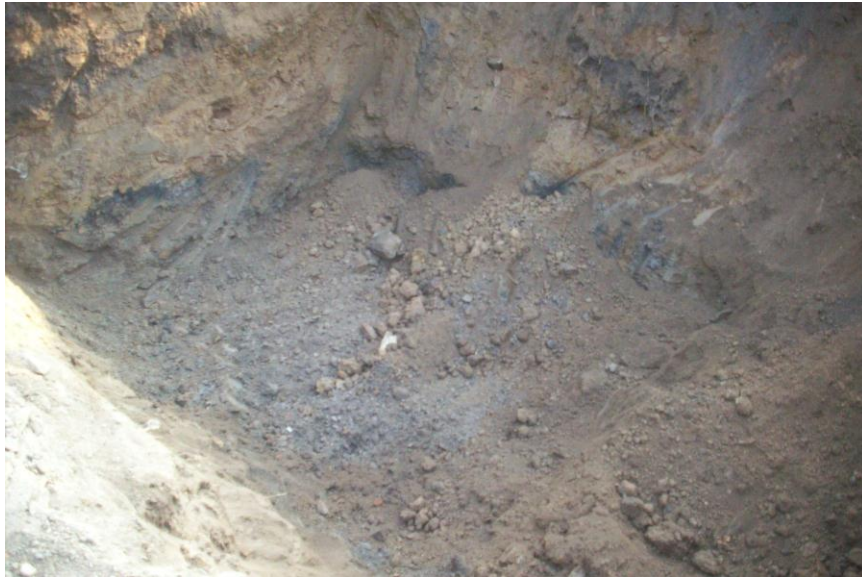
Photo 25 - Soil removal at Tank 1/Tank 2 Excavation (9/2/2011)

Photo 26 - Soil removal at Tank 1/Tank 2 Excavation (9/2/2011)

Photo 28 - Soil removal at Tank 1/Tank 2 Excavation (9/2/2011)

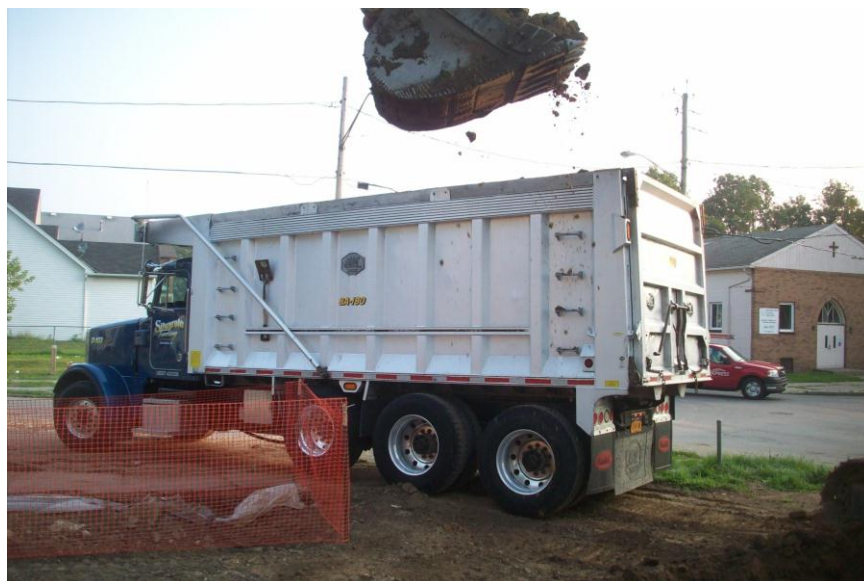
Photo 27 – Direct-loading contaminated soil from Tank 1/Tank 2 Excavation (9/2/2011)

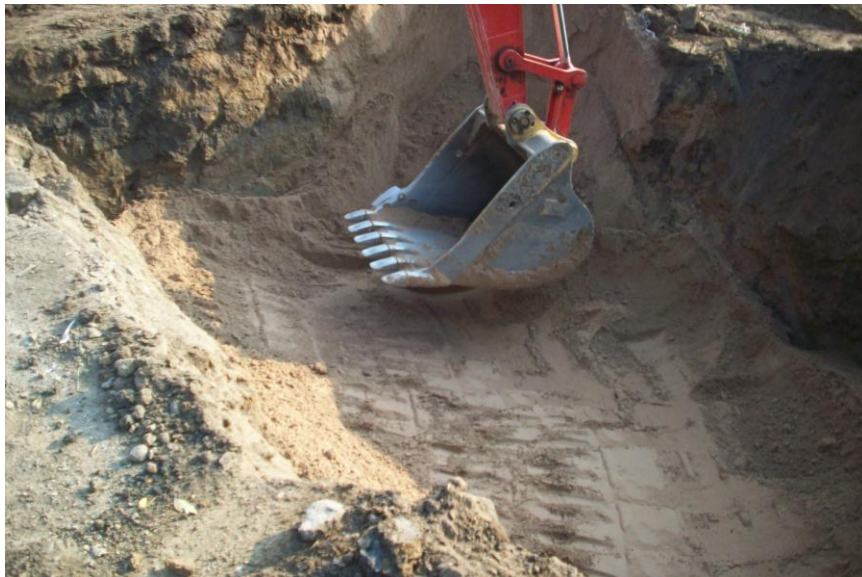
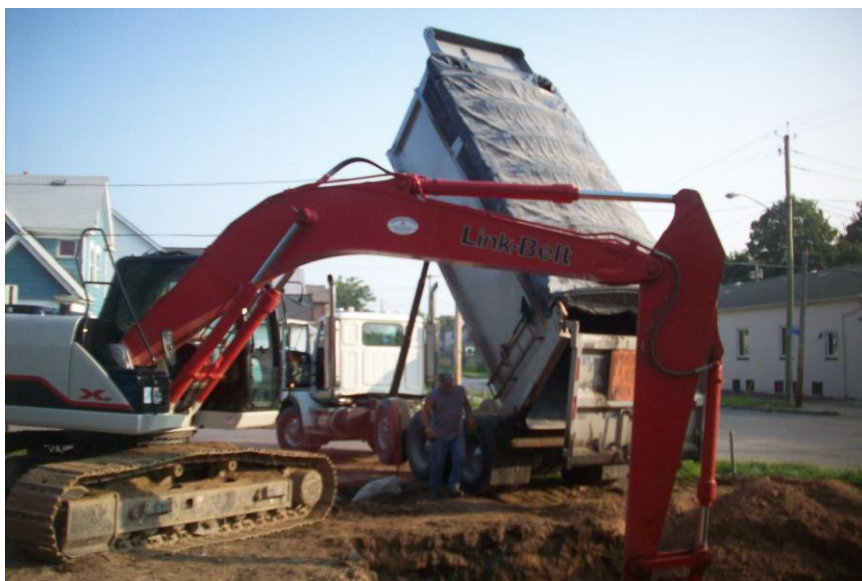
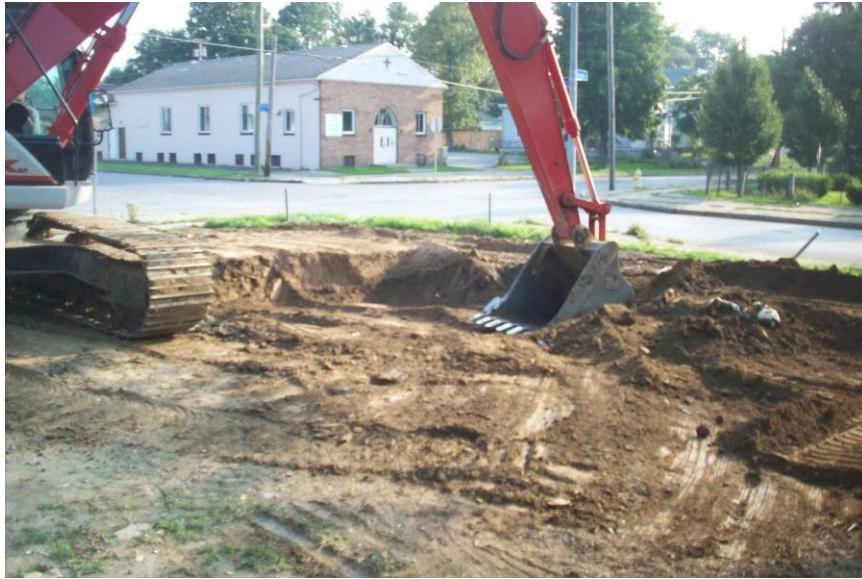
Photo 29 - Backfilling at Tank 1/Tank 2 Excavation (9/2/2011)

Photo 30 - Backfilling at Tank 1/Tank 2 Excavation (9/2/2011)

Photo 31 – Backfilling/.compacting at Tank 1/Tank 2 Excavation (9/2/2011)

On September 2, 2011, TREC backfilled the two excavations with the previously staged on-site soil, and also 133 tons of clean imported Bank Run soil transported to Site by M.J. Dreher Trucking, Inc. The Bank Run soil originated from The Dolomite Group's Ogden, NY Plant, which is a New York State Department of Transportation (NYSDOT)-permitted facility. Supporting documentation for the imported backfill is attached in the Tank Closure Report and Soil Removal Package included as Appendix D. The Site was subsequently graded, and then hydroseed was applied on September 23, 2011.

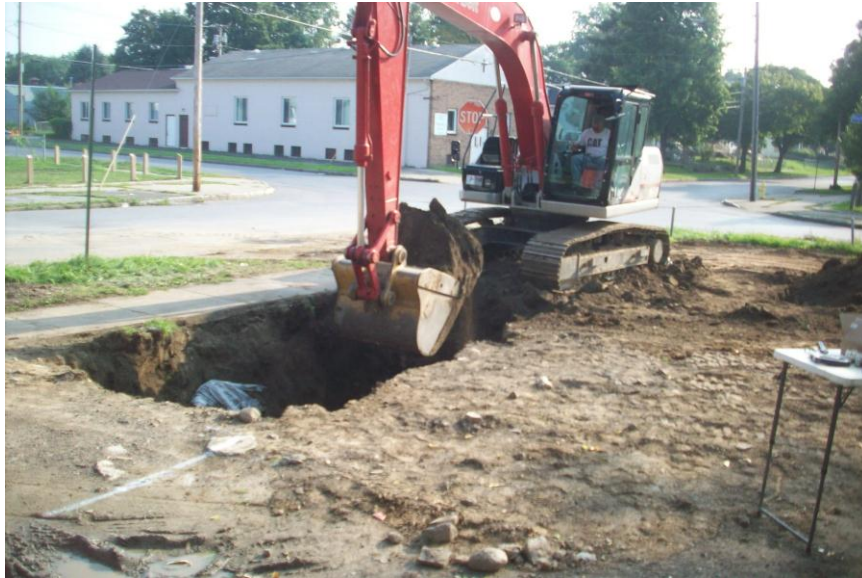
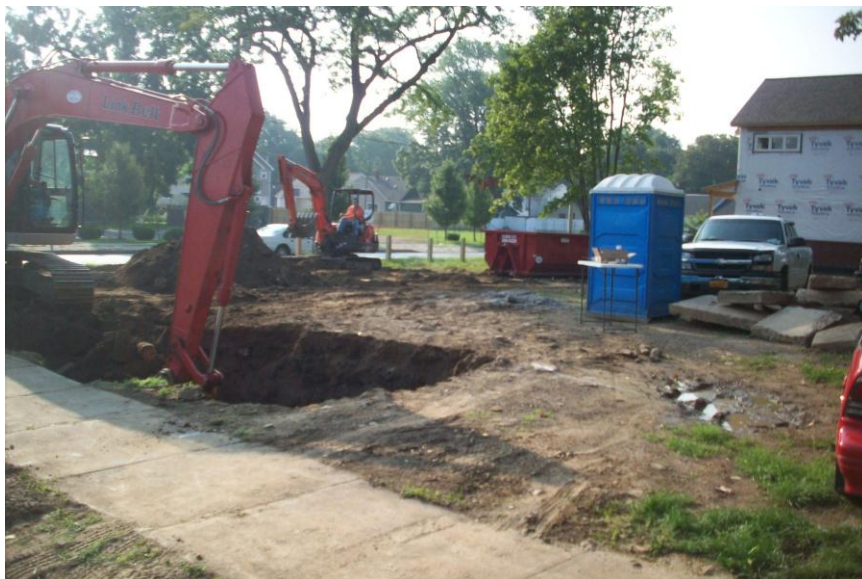
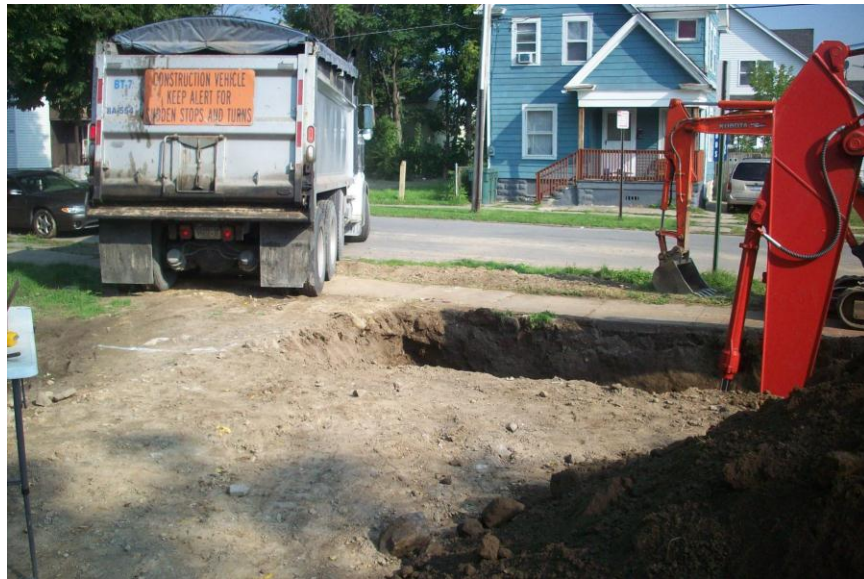
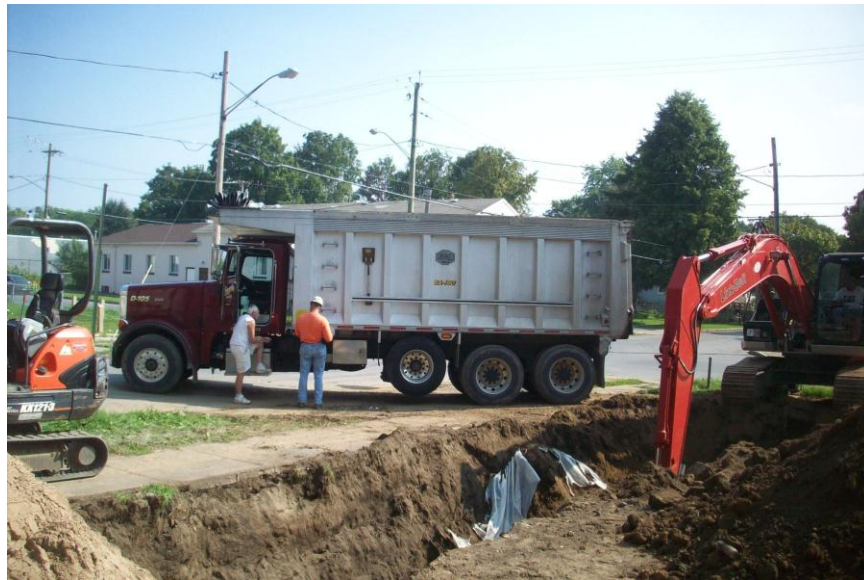
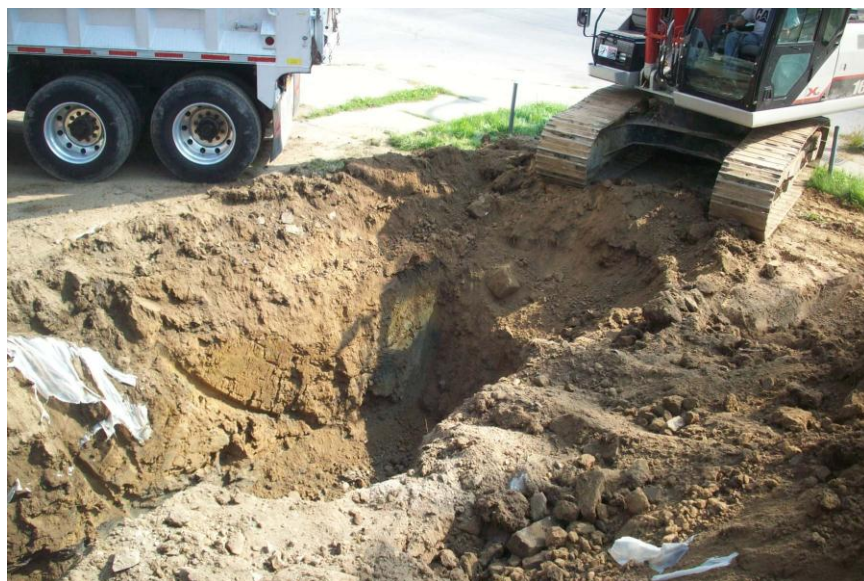
Photo 32 - Soil removal at Tank 3/Tank 4 Excavation (9/2/2011)

Photo 33 - Soil removal at Tank 3/Tank 4 Excavation (9/2/2011)

Photo 34 - Soil removal at Tank 3/Tank 4 Excavation (9/2/2011)

Photo 35 - Soil removal at Tank 3/Tank 4 Excavation (9/2/2011)

Photo 36 - Soil removal at Tank 3/Tank 4 Excavation (9/2/2011)

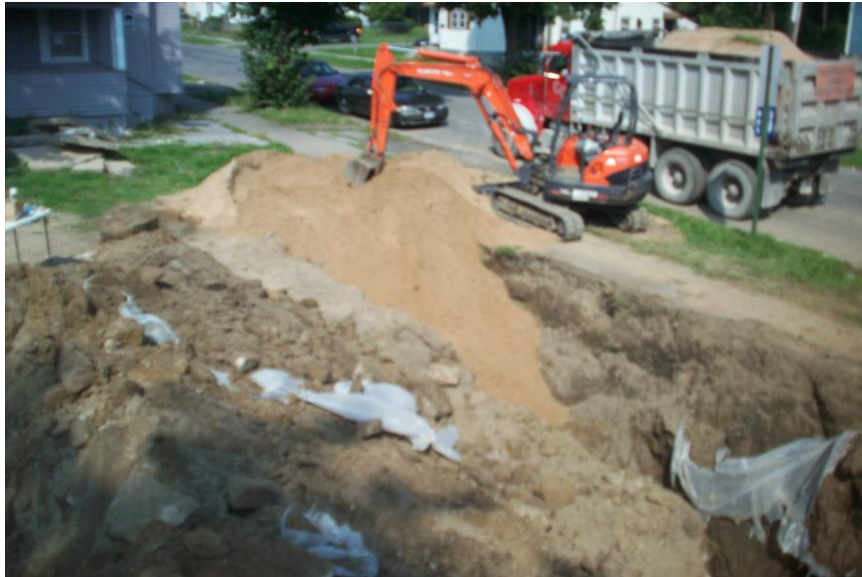
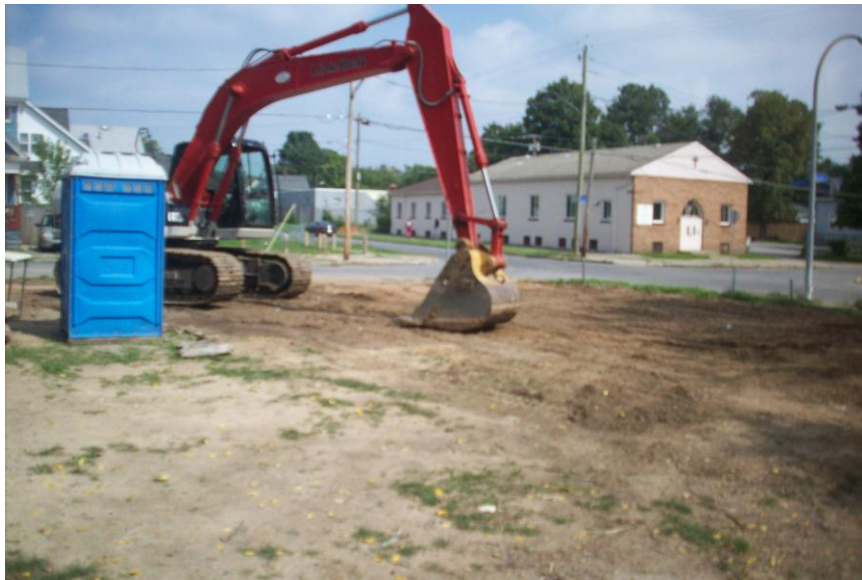
Photo 37 - Backfilling at Tank 3/Tank 4 Excavation (9/2/2011)

Photo 38 – Backfilling complete at Tank 3/Tank 4 Excavation (9/2/2011)
