**AT-GRADE AND SUB-GRADE
DEMOLITION PHASE ENVIRONMENTAL REPORT**

**300, 304-308, 320 ANDREWS STREET AND 25 EVANS STREET
ROCHESTER, NEW YORK**

NYSDEC SITE # E828144

Date: May 2011

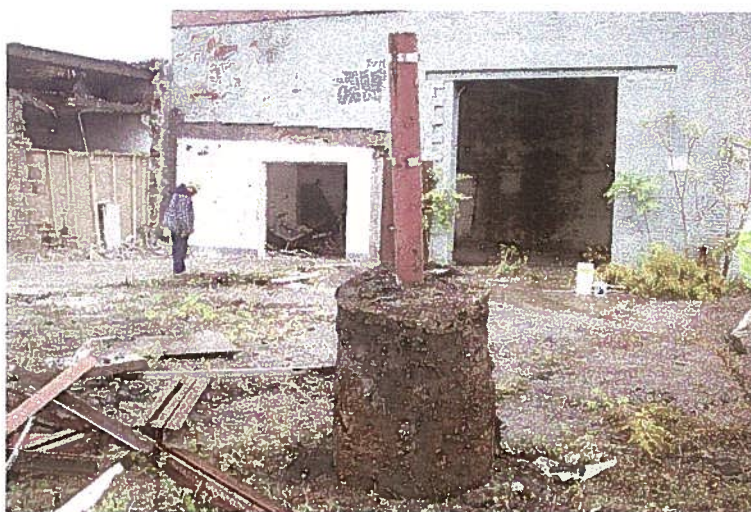
Bollard and attached footer removed from the 304-308 Andrews Street parcel (10/14/10)

- ❑ A concrete footer associated with a steel bollard was inadvertently removed from the 304-308 Andrews Street PCE Interim Remedial Measure IRM area. This structure was subsequently characterized and disposed of at High Acres Landfill and Recycling Center as a regulated non-hazardous waste in accordance with applicable regulations; and

- ❑ STR-4 consisted of a steel bollard and associated concrete footer. In an attempt to remove the above-grade portion of the steel bollard, the concrete footer was inadvertently removed. Following removal, STR-4 was staged on, and covered with, 6-millimeter reinforced plastic sheeting within the “staged material exclusion zone”. Based on the analytical laboratory waste characterization testing results, STR-4 was disposed of off-site as a regulated non-hazardous waste. Refer to Table 2 for additional waste disposal information. Refer to Section 2.5 for additional information associated with soil sample S-1, collected from the sidewall of the void created by the footer removal.

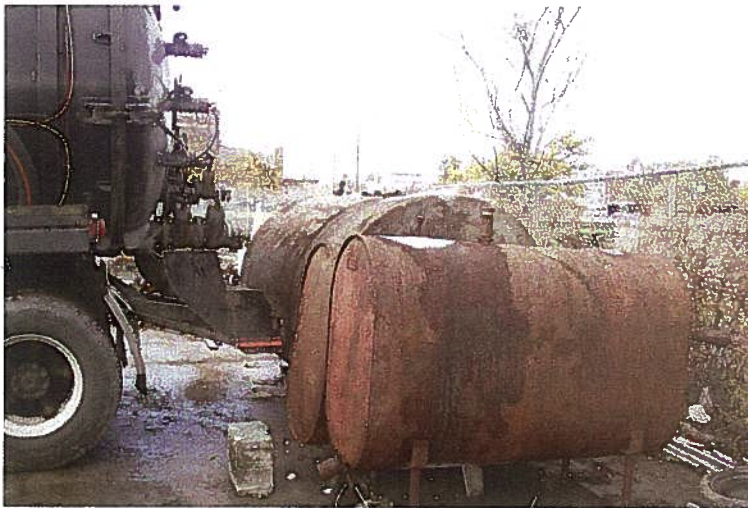
Three above ground storage tanks removed and staged for off-site disposal (10/22/10).

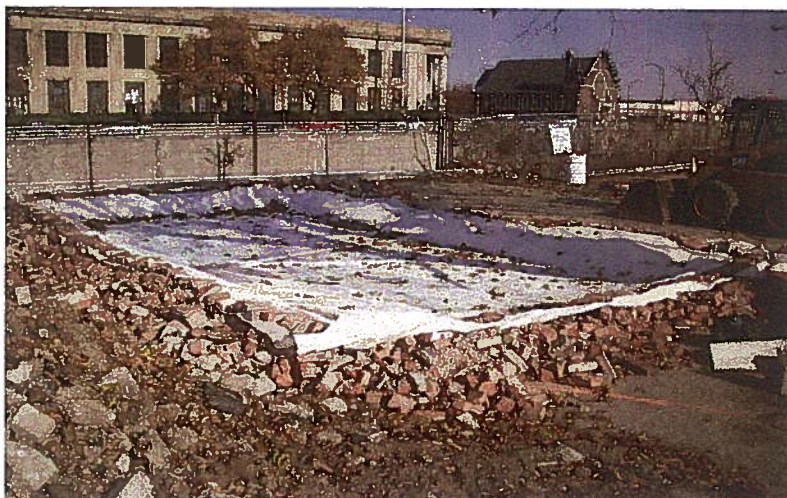
View of decontamination pad located on northern portion of Site (11/15/10).

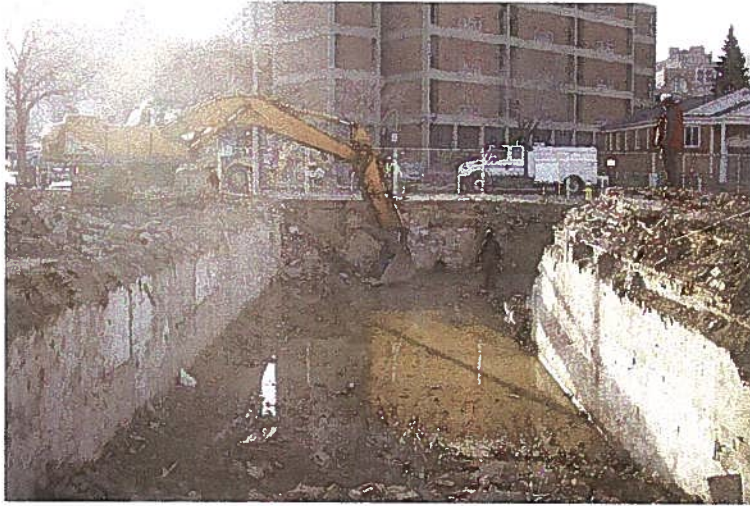
Light shaded sub-grade structures STR-2A and STR-2B in East foundation wall, facing south (11/16/10).

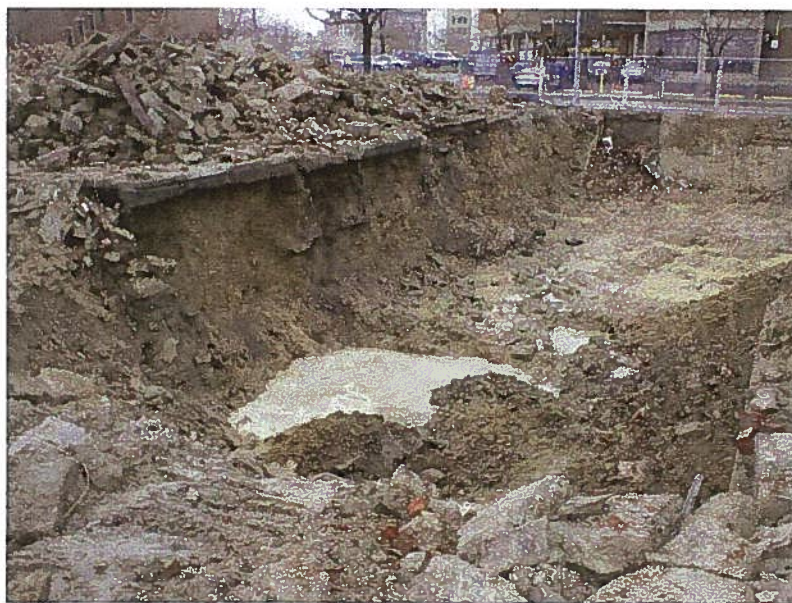
Black fill or material @ sub-grade structures STR-2A and STR-2B after west foundation wall removed, facing south (11/17/10).

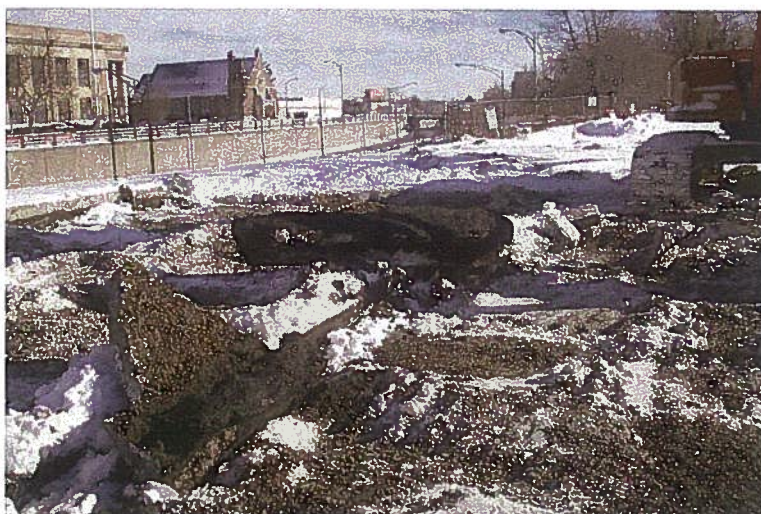
Demolition of 25 Evans Street Trench Drain looking East (1/24/11)

- ❑ Black staining and petroleum-type odors were noted on, and below, the interior trench drain. Based on the field screening results, the concrete trench drain was staged on, and covered with, 6-millimeter reinforced plastic sheeting within the “staged material exclusion zone”.

- ❑ **Trench Drain** – Hard material samples HM-24 through HM-26 were collected from the concrete trench drain following its removal on January 24, 2010 and submitted to the analytical laboratory for waste characterization testing. [Note: A 3:1 composite sample (comprised of equal portions of HM-24, HM-25 and HM-26) was created at the analytical laboratory.] Based on the analytical laboratory results, the concrete trench drain was disposed of off-site as a regulated non-hazardous waste.

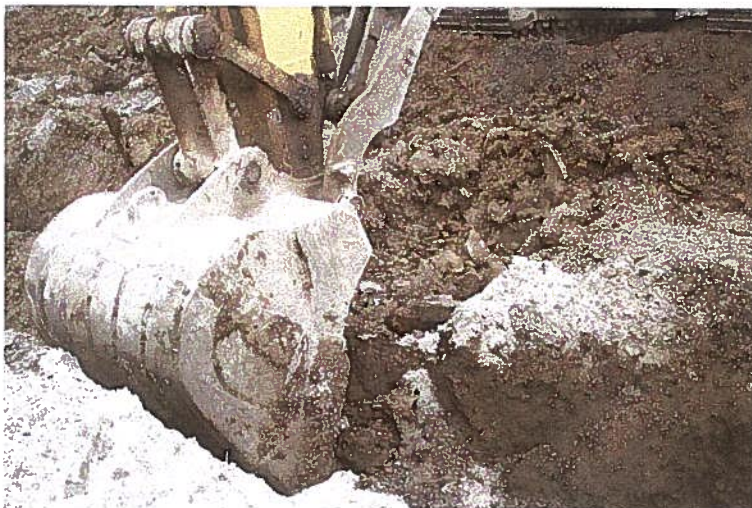
Removal of Sump/Well-2 from 25 Evans Street Parcel (1/26/11)

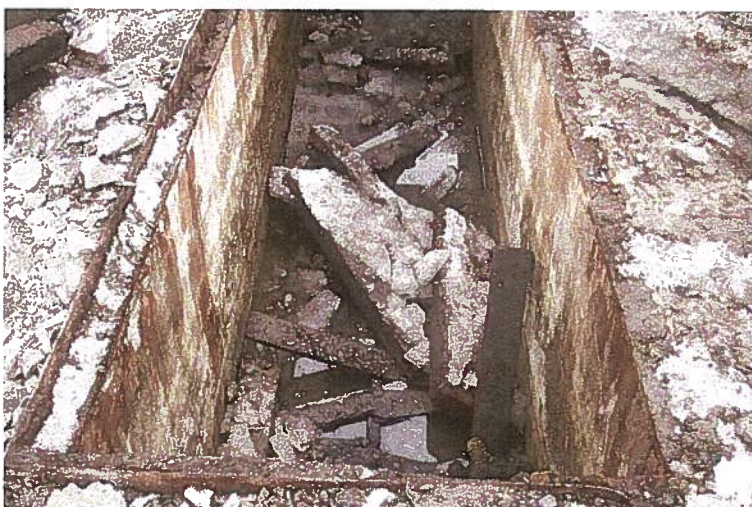
Vehicle service pit at 25 Evans Street facing south (1/31/11).

- ❑ Dark staining and petroleum-type odors were noted on the concrete bottom of the vehicle service pit and the sediments adjacent to the interior vehicle service pit bottom. Based on the field results, the impacted interior sediments were staged in a NYSDOT approved 55-gallon drum and the vehicle service pit concrete bottom was staged on, and covered with, 6-millimeter reinforced plastic sheeting within the “staged material exclusion zone”.

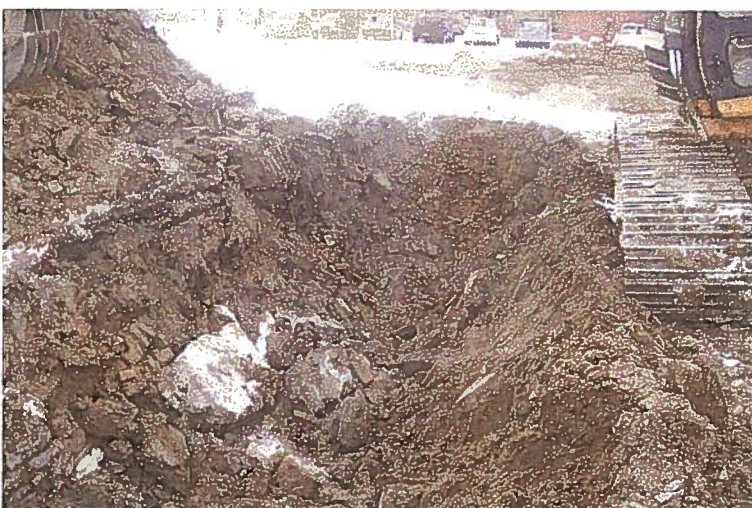
Excavation following 304-308 Andrews Street footer removal, approximate location of soil sample 046/S-34 (1/31/11)

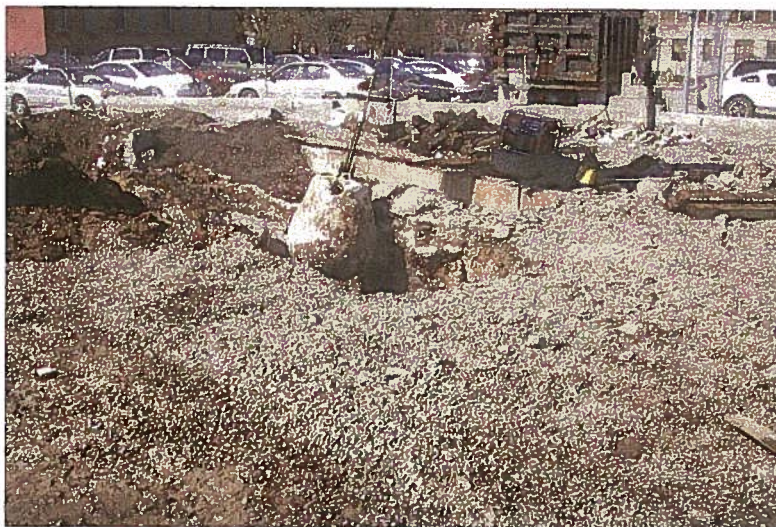
Removal of east wall of 25 Evans Street Vehicle Service Pit, looking southwest (5/5/11).

- ❑ **Vehicle Service Pit** – Hard material sample HM-27 was collected from the concrete vehicle service pit bottom following its removal on May 5, 2011 and submitted to the analytical laboratory for waste characterization testing. Based on the analytical laboratory results, the concrete vehicle service pit bottom was disposed of off-site as a regulated non-hazardous waste.

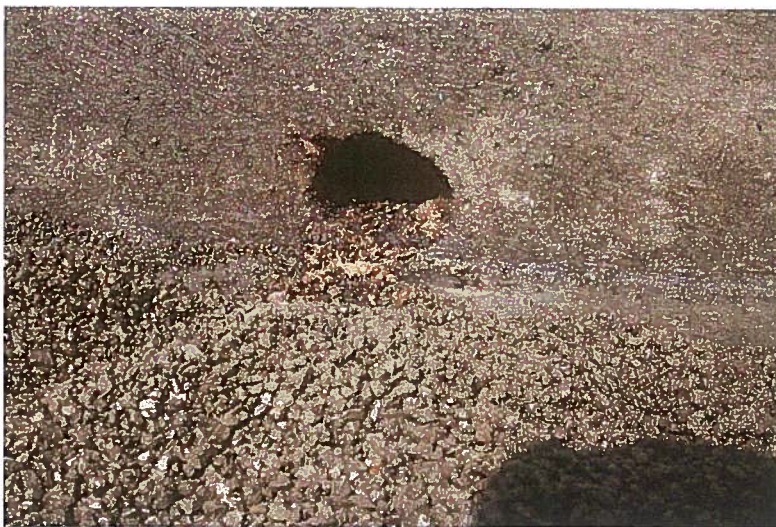
25 Evans Street Vehicle Service Pit Drain (i.e., Drain 10) prior to in-place decommissioning, looking west (5/5/11).

- ❑ STR-3 is located within the PCE IRM area, and as such was not removed. Further investigation will be performed at STR-3 in the future.
- ❑ Drain 5 is located within the PCE IRM area, and, as such, was not removed. Further investigation will be performed at Drain 5 in the future. Staining and odors were not noted on Drain 10 and PID readings above 0.0 ppm were not measured. Drain 10 was located at the bottom of the vehicle service pit and was oriented east to west in the direction of a MCPW combined sewer system. Drain 10 was decommissioned by capping with concrete. Based on the field screening results, it does not appear that further study of Drain 10 is warranted at this time.

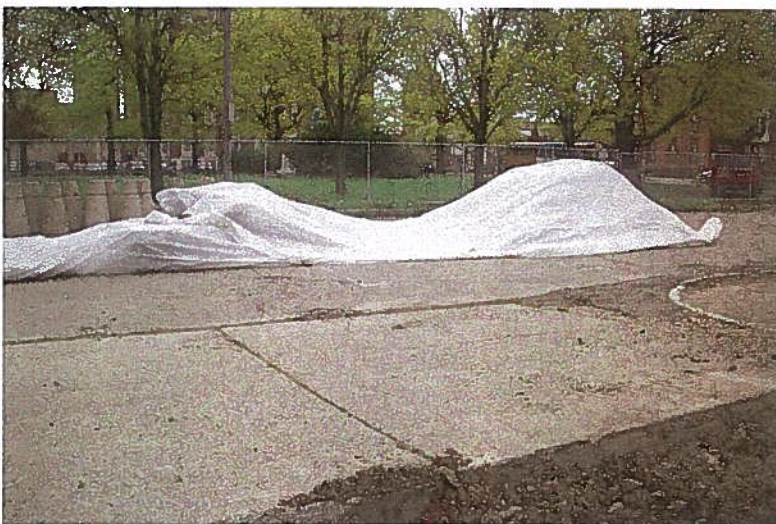
25 Evans Street Vehicle Service Pit bottom and 304-308 Andrews Street Slab within yellow dashed polygon, staged on, and covered with 6-millimeter reinforced plastic sheeting, looking east (5/6/11).

- Samples HM-23 and HM-24 were collected for analysis of additional required waste characterization parameters for the potentially impacted concrete shown as the yellow-dashed area on Figure 4. Based on the TCLP VOCs (HM-10), PCBs (HM-23) and TCLP metal (HM-23) concentrations reported by the analytical laboratory, this concrete was characterized and disposed of as a regulated non-hazardous waste. [Note: Only one sample (i.e., HM-22) was required for waste characterization testing.]
