PHASE I ENVIRONMENTAL SITE ASSESSMENT
PARKING LOT AND VACANT GRASS-COVERED AREA
101-113 FRANKLIN STREET & 106 PLEASANT STREET
ROCHESTER, NEW YORK

Prepared for: City of Rochester
30 Church Street
Rochester, New York 14614

Prepared by: Day Environmental, Inc.
1563 Lyell Avenue
Rochester, New York 14606

Date: September 19, 2018
(Revised September 25, 2018)

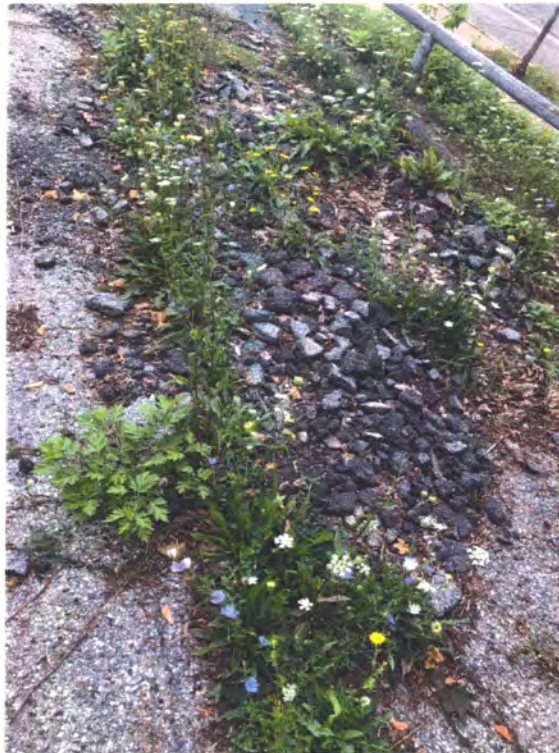
A mound of apparent asphalt along the south/central edge of the parking lot on the assessed property on 8/27/2018. (Note, this pile was removed prior to the 9/17/2018 site visit.)

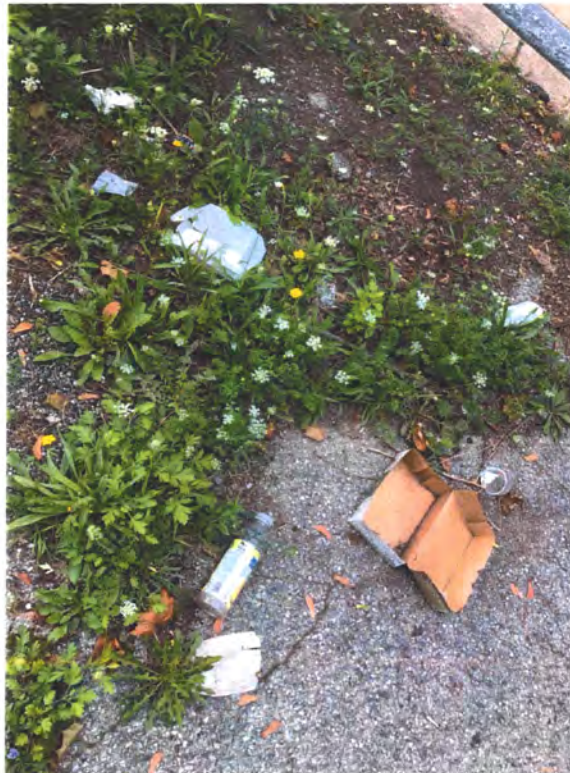
A representative view of debris observed on the southwestern portion of the parking lot on the assessed property on 8/27/2018. (Note, this debris was removed prior to the 9/17/2018 site visit.)

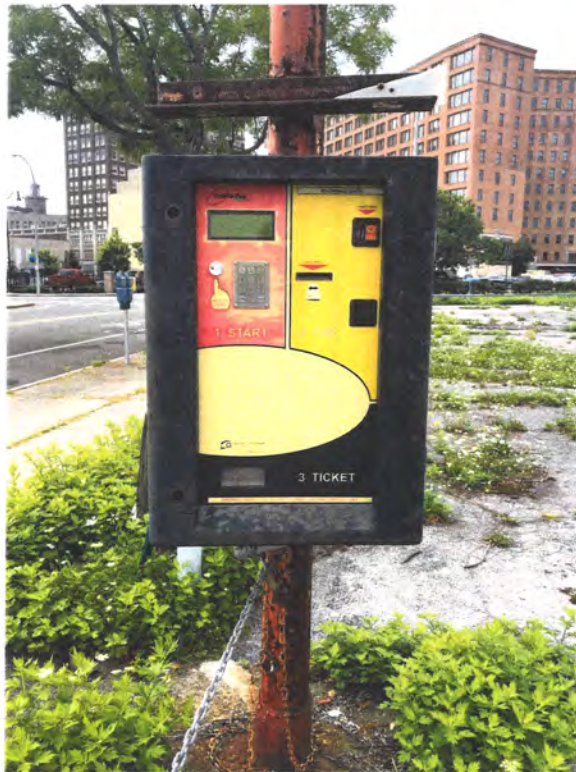
Pay station observed along the northeastern edge of the assessed property looking south.

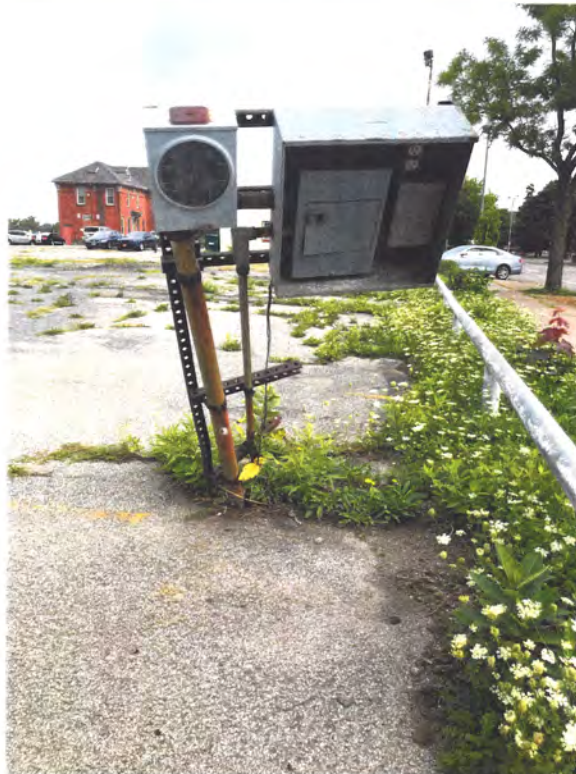
Electrical equipment located along the southeastern edge of the assessed property looking north.

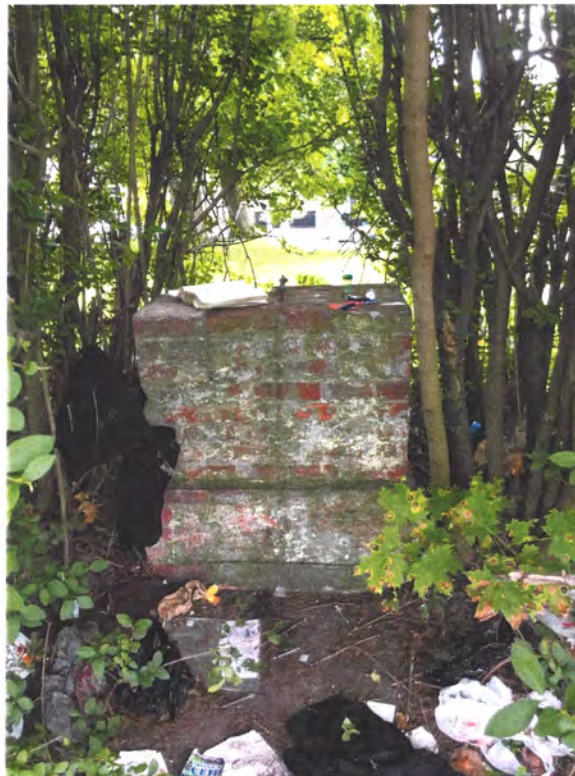
Brick monument of unknown use in treed hedgerow on the southcentral portion of the assessed property looking southwest.

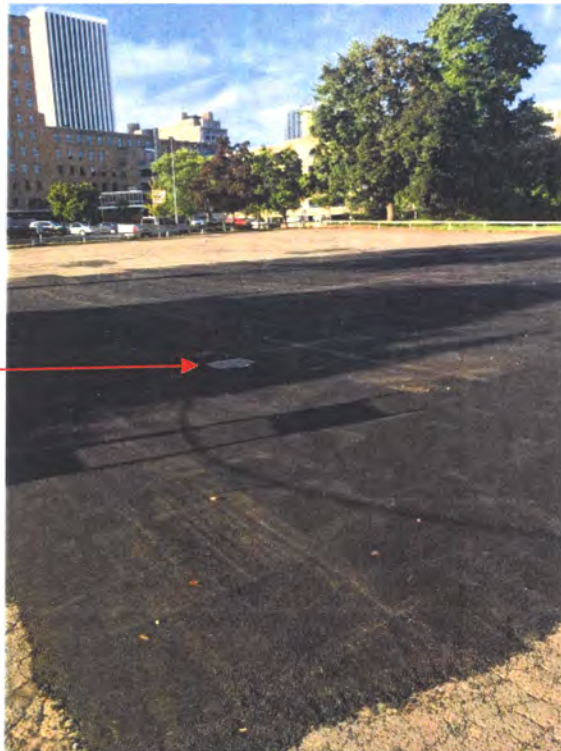
View of newly paved asphalt (observed during the 9/17/2018 site visit) in the central portion of the parking lot on the assessed property looking southwest. The catch basin is also visible.

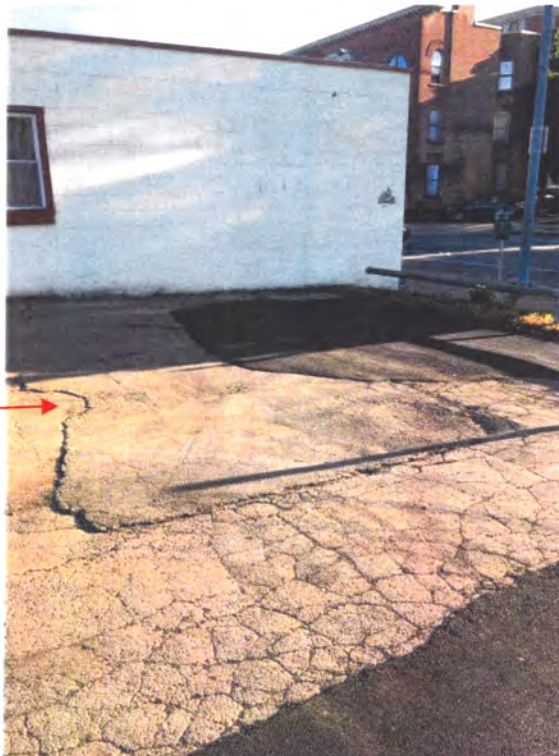
Mr. Biondolillo contacted Karen St. Aubin, City Department of Environmental Services (DES) Director of Operations, regarding asphalt patches that were observed in the parking lot portion of the assessed property by a DAY representative at the time of DAY’s September 17, 2018 site visit (refer to Section 6.3.2). Mr. Biondolillo indicated that, “Karen stated that the patches were created by DES Operations in order to make temporary improvement to the surface asphalt parking lot and that no USTs were encountered or removed”.

View of an approximate 8' x 12' rectangular-shaped asphalt patch in the parking lot on the northeastern portion of the assessed property, which could be associated with a former UST, looking northeast.

Based on the information provided by Mr. Biondolillo on September 20, 2018, the historical use of the assessed property as a Parking Station, including the documented installation of gasoline pumps on the assessed property (i.e., and the apparent installation of associated underground storage tank[s] [USTs] on the assessed property), is being identified as a recognized environmental condition (refer to Section 9.1). However, the asphalt patches observed on the assessed property at the time of DAY’s September 17, 2018 site visit are not being identified as a recognized environmental condition at this time (refer to Section 9.2).

Mr. Biondolillo stated that he contacted Ms. Karen St. Aubin, City DES Director of Operations, regarding the asphalt patch observed by DAY on the referenced property. According to Mr. Biondolillo, Ms. St. Aubin stated that the patches on the site were created by DES Operations in order to make temporary improvements to the surface asphalt parking lot, and that no underground storage tank (USTs) were encountered or removed.

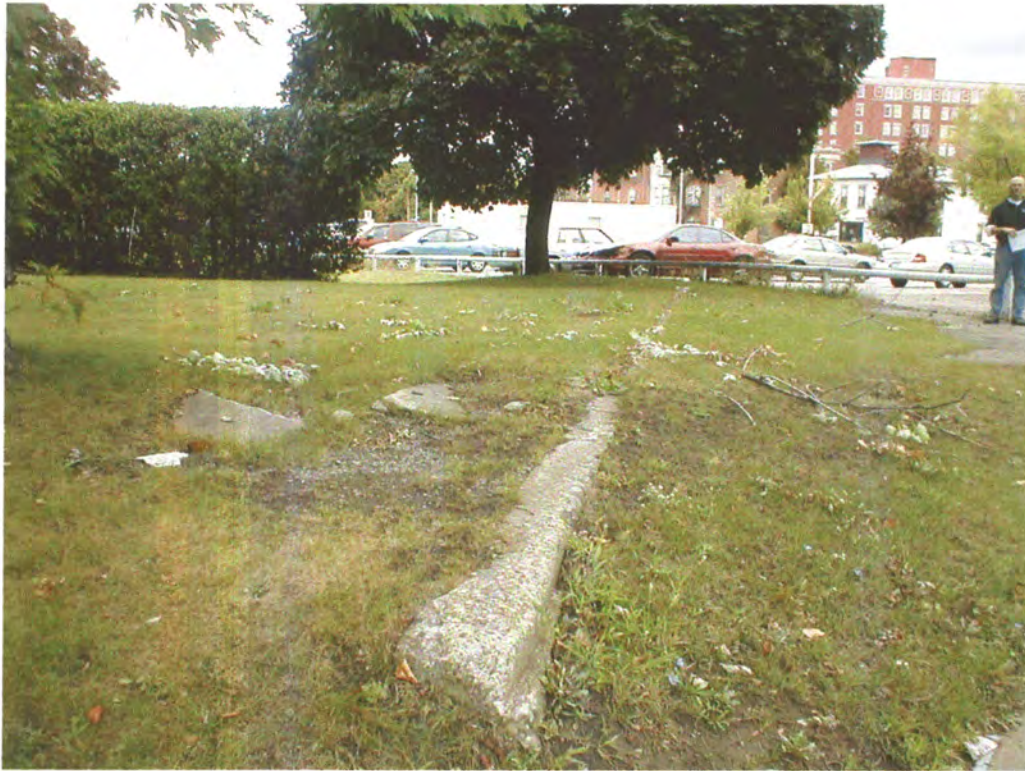
View of a visible concrete foundation on the southwest portion of the assessed property.

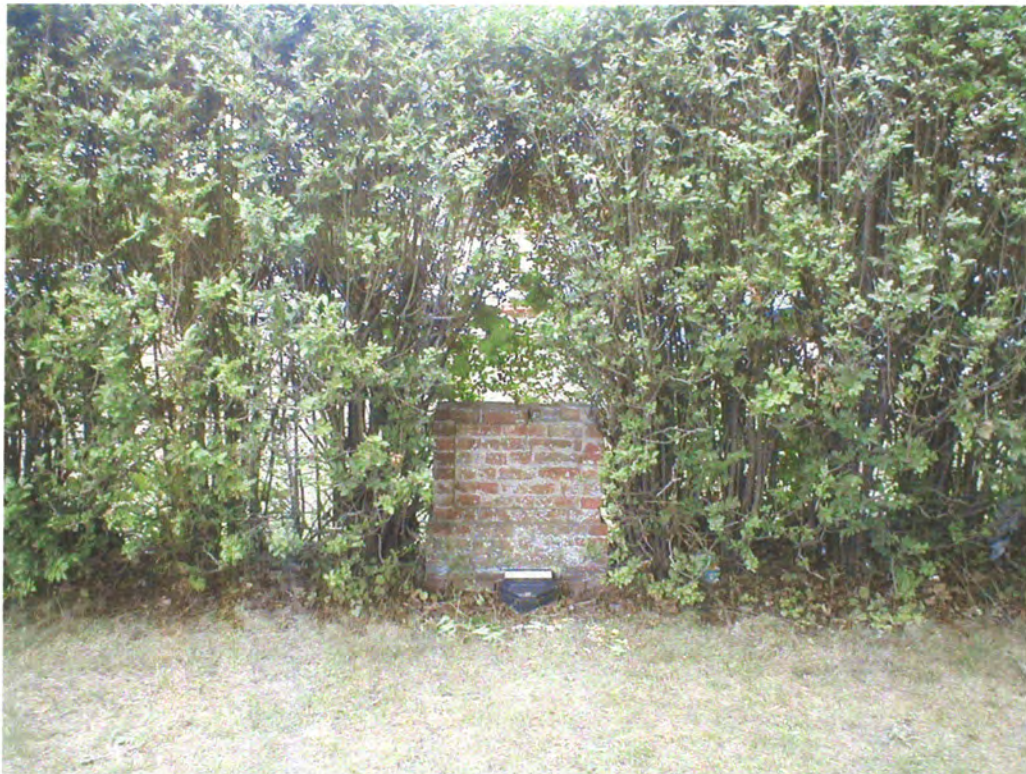
View of a brick structure located on the southwest portion of the assessed property.
