PHASE I ENVIRONMENTAL SITE ASSESSMENT REPORT

ADDRESS: 180 & 182 Exchange Street

MUNICIPALITY: City of Rochester

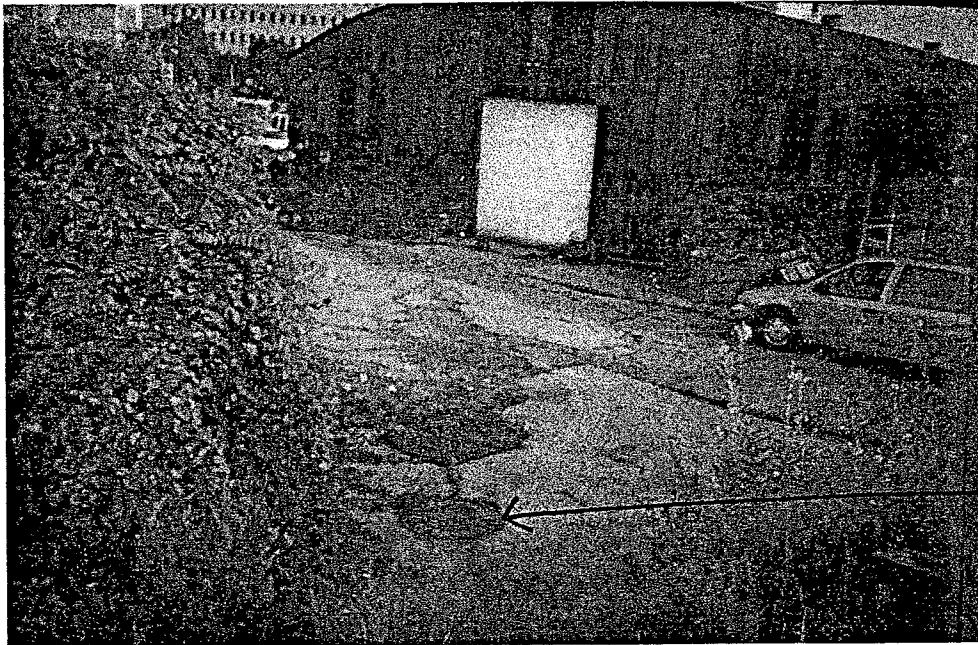
View of southeast portion of assessed property and quonset hut looking north/northwest.

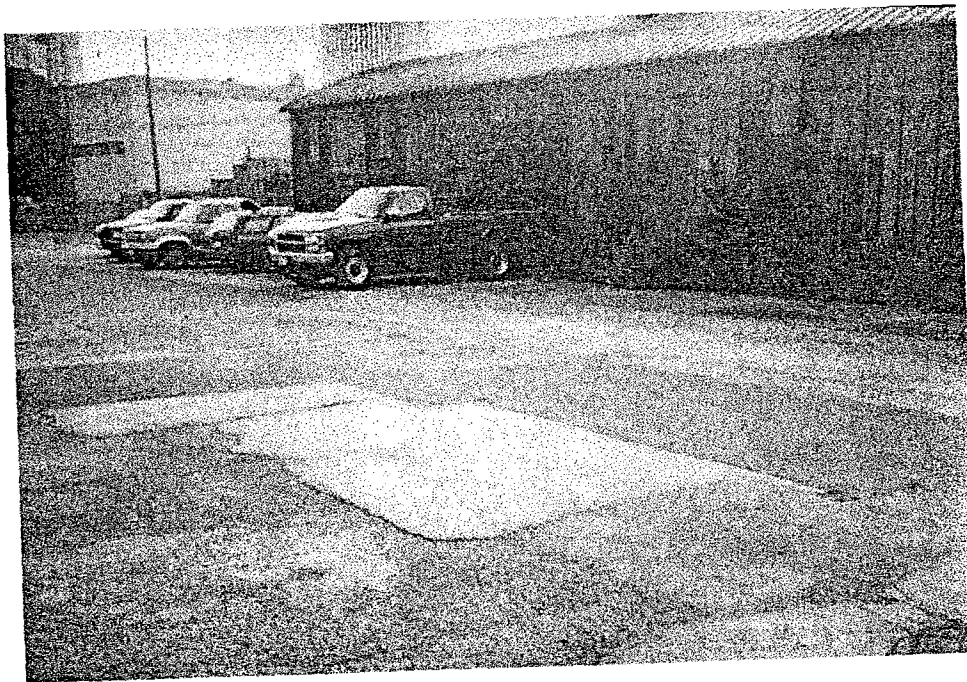
View of quonset hut and assessed property looking north/northeast.

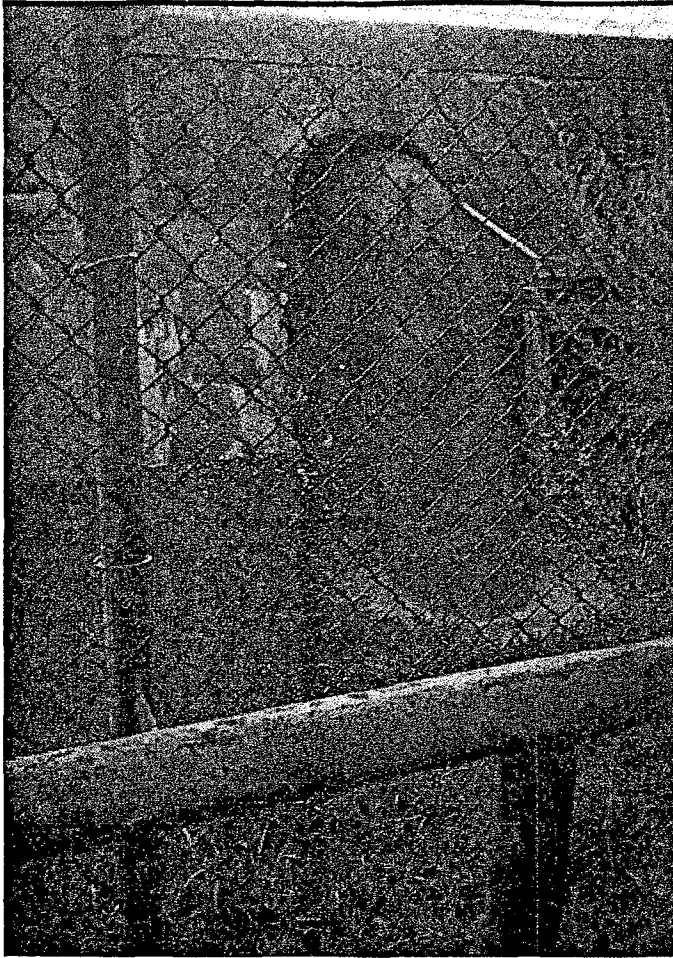
View of piping connected to Genesee River retaining wall.
