SUBSURFACE REMEDIATION REPORT

**180-182 EXCHANGE STREET
ROCHESTER, NEW YORK**

APRIL 2001

**RE: Subsurface Remediation Report
180-182 Exchange Street
Rochester, New York
NYSDEC Spill No.: 0070040**

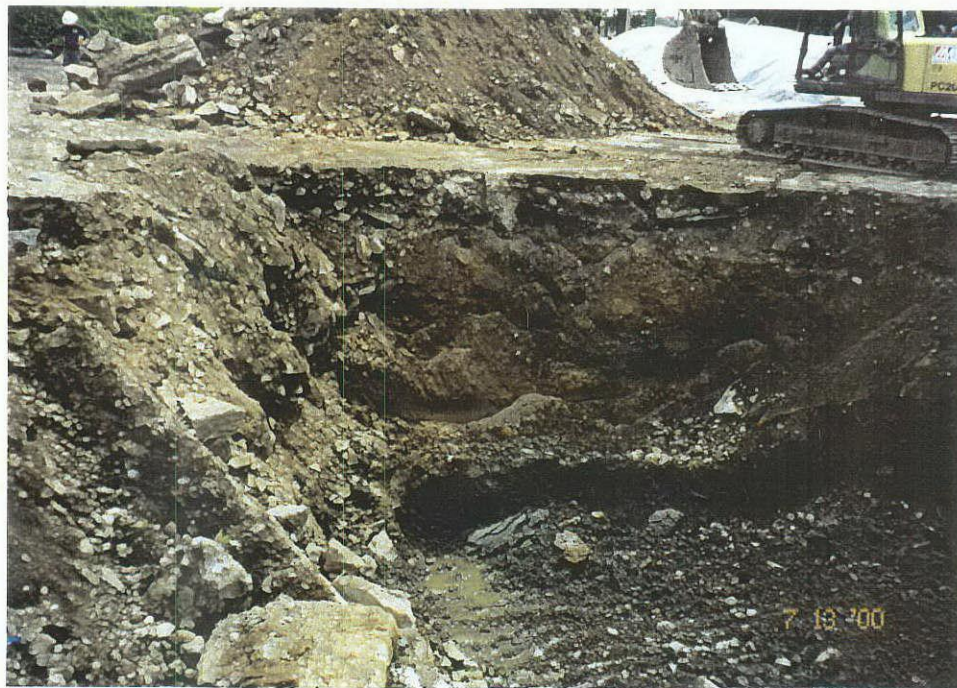
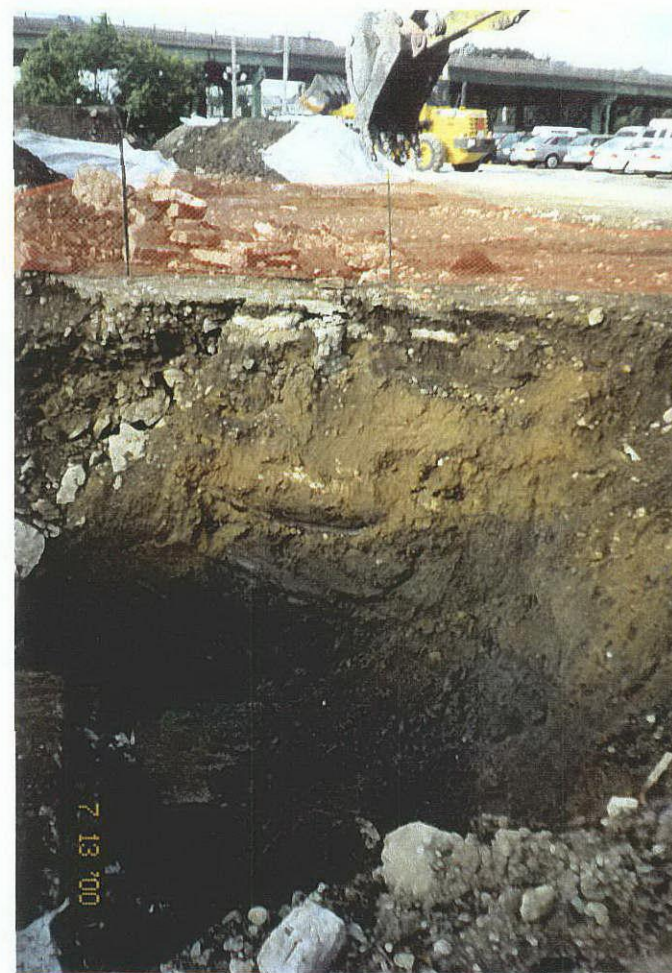
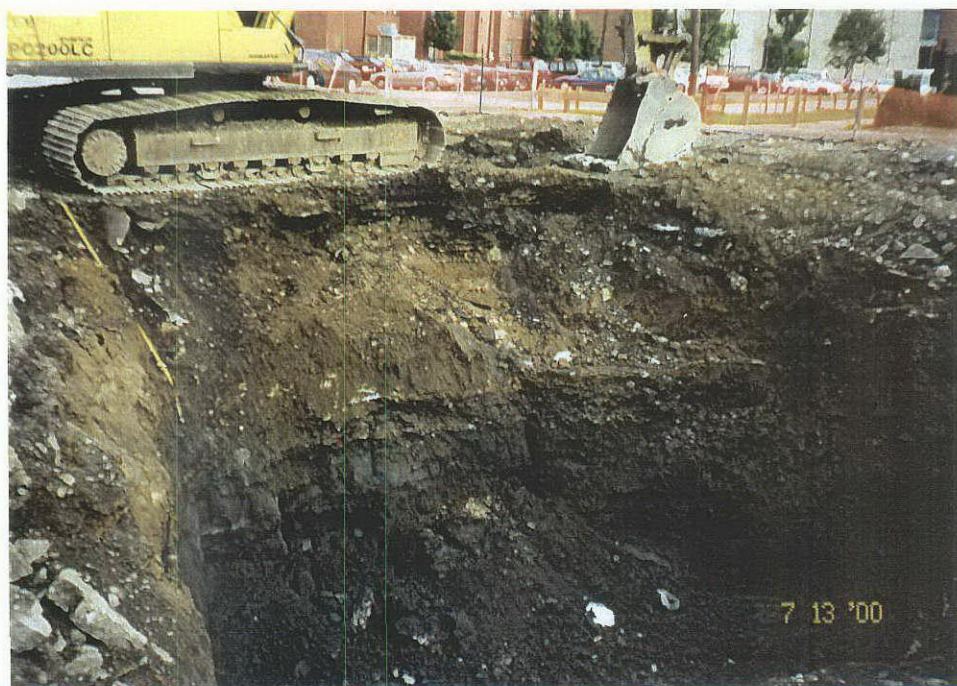
PHOTOS 1 THRU 3: SOIL EXCAVATION (2700 ft² area)

Top Left: South Wall
 Top Right: Southwest Wall
 Bottom Left: West Wall

Excavation of the affected soils proceeded in two (2) phases (Figure 3). An area of approximately 2,700 square feet (sq. ft.) was excavated to a depth of approximately 14 feet (ft.) below grade, at which competent bedrock was encountered (Photos 1 - 5). As the excavation approached the 18-inch discharge line at the northern extent of the excavation footprint, an area of approximately 440 sq. ft. was then excavated at an approximate 1:1 slope (Photo 6). During excavation of this area, a 2,000-gallon closed-in-place underground storage tank (UST) was found adjacent to the northern footing of the former quonset hut and immediately south of the 18-inch discharge line (Photo 7). The tank was removed as part of these remedial activities. Based upon the tank condition (i.e., visible holes in the tank shell) and the location of the subsurface petroleum contamination, the 2,000-gallon UST was determined to be the probable source of the release (Photos 8 - 11). Tank removal activities are summarized further below (Section 3.4).

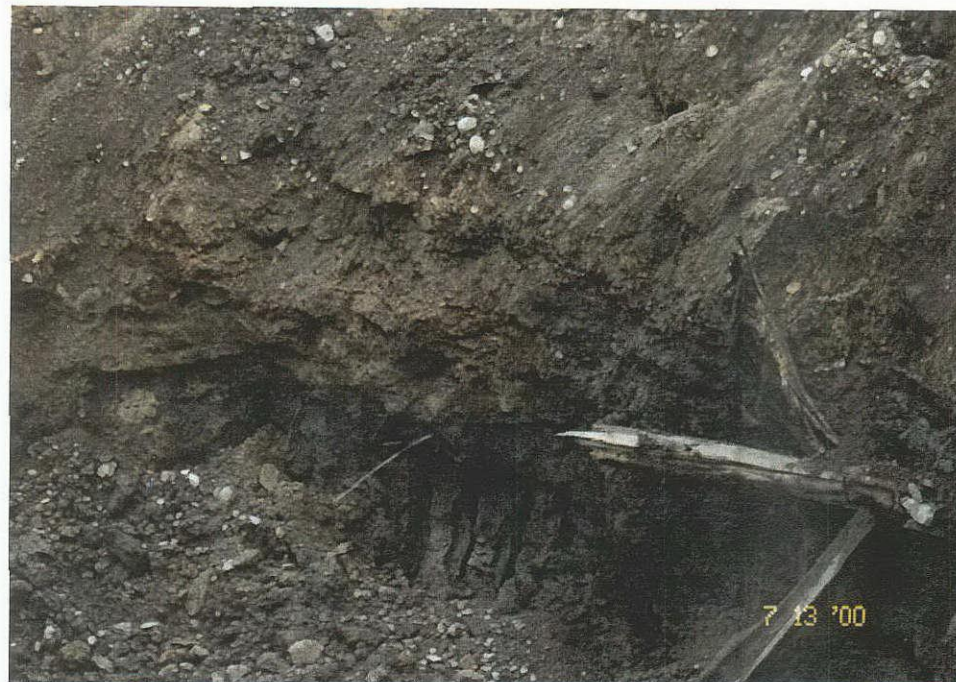
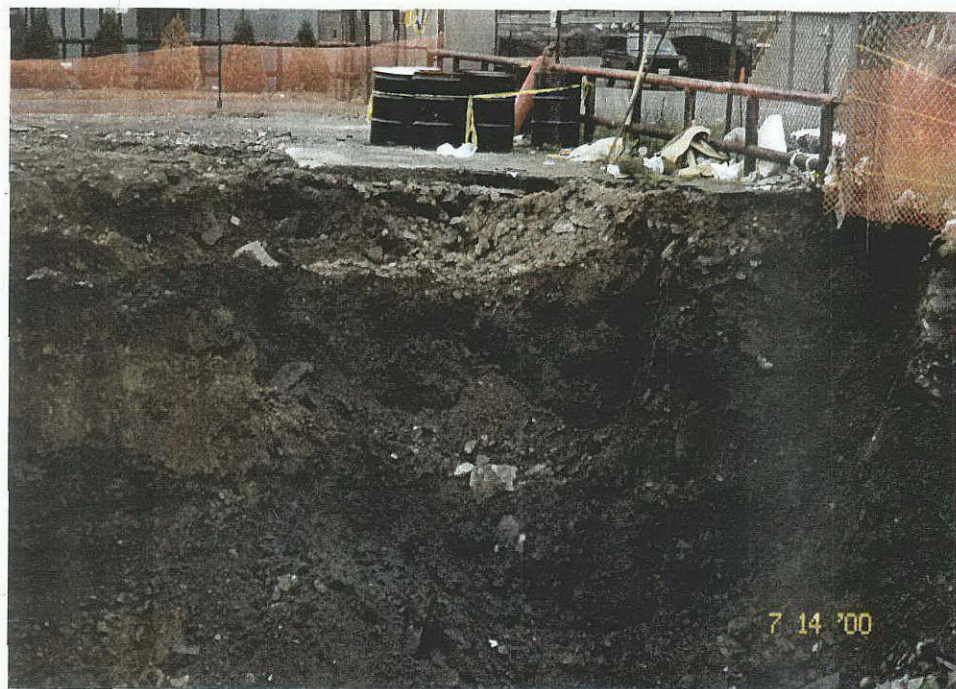
PHOTOS 4 THRU 6: SOIL EXCAVATION

Top Left: West Wall

Top Right: Northwest Wall

Bottom Right: North Wall (subsequent to removal of 2000-gallon UST)

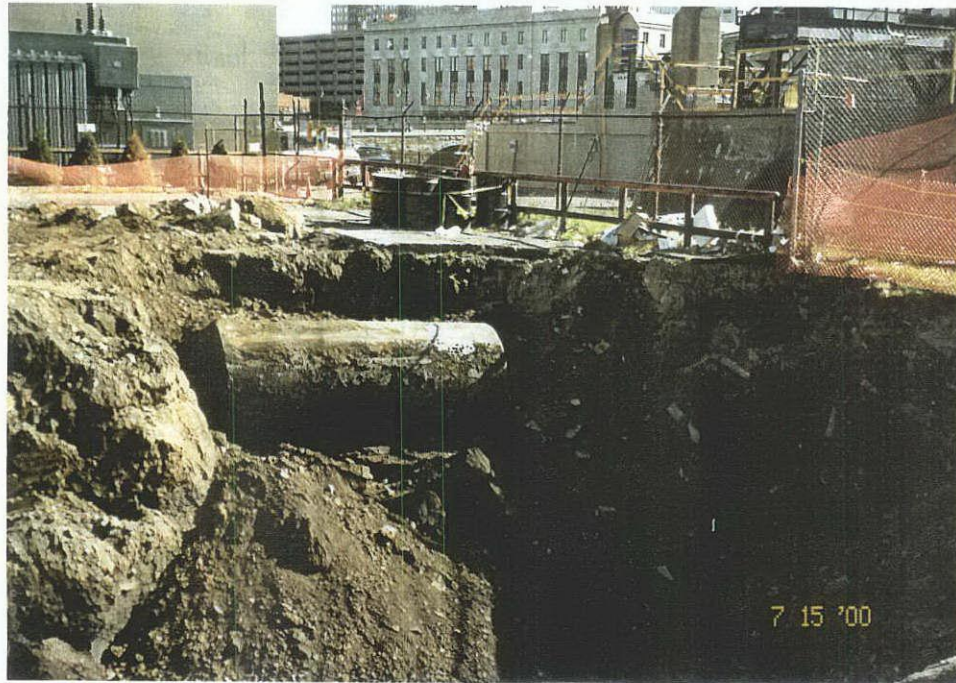
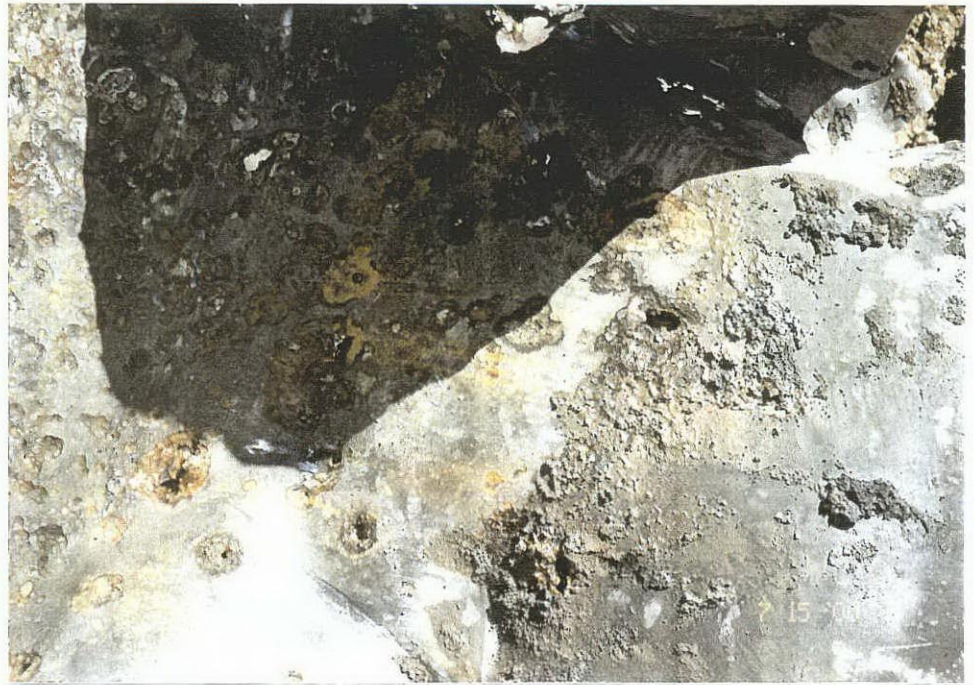
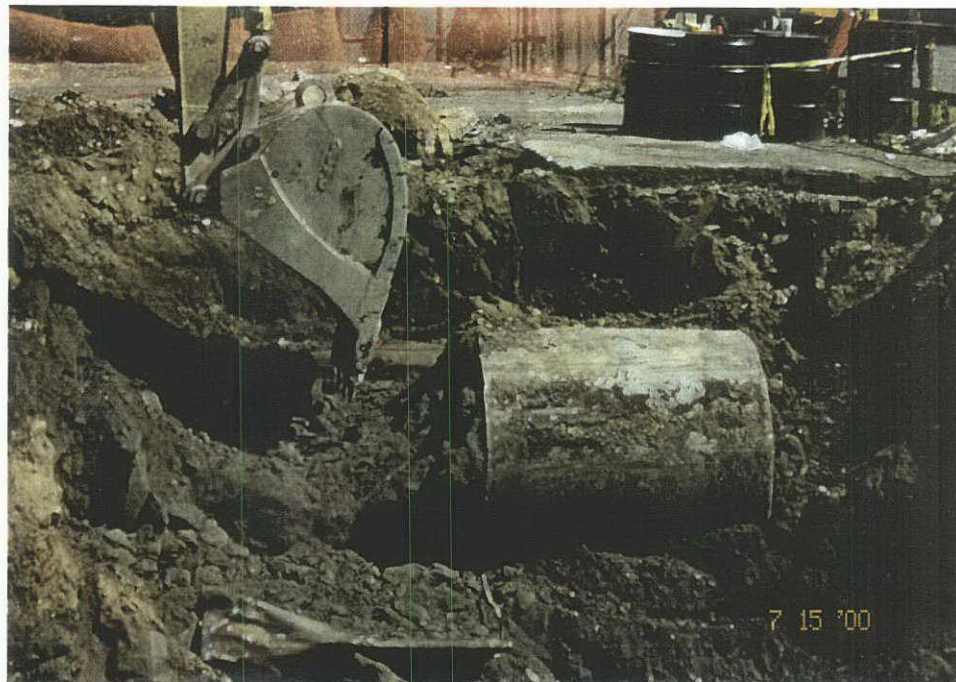
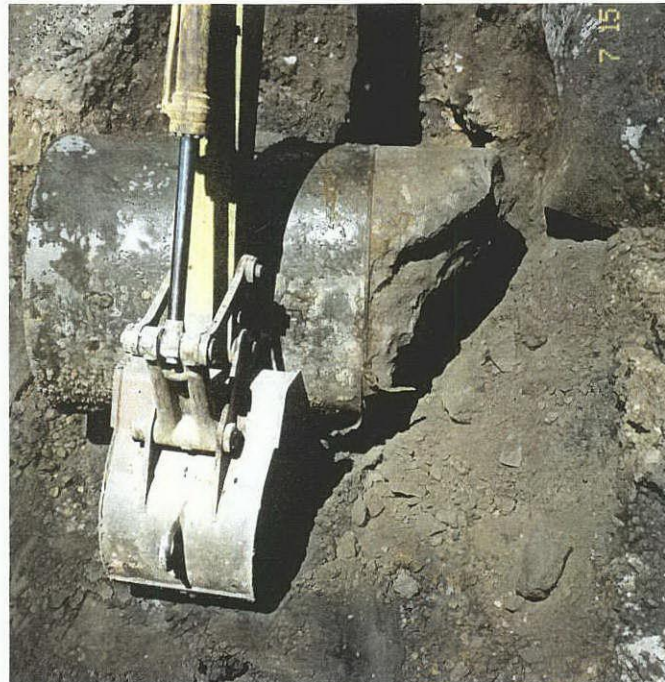
PHOTOS 7 THRU 10:
REMOVAL OF 2000-GALLON
CLOSED-IN-PLACE UST

At the time of removal, perforations/holes in the bottom of the tank were noted (Photo 8). Minimal pitting of the associated piping was also observed. Orientation and termination of the UST piping could not be determined.

During the course of the remedial excavation activities, one (1) 2,000-gallon, single-wall, steel UST and associated piping were unearthed (Photo 7). The UST was orientated longitudinally in the east-west direction, located south of the 18-inch discharge line and adjacent to the northern foundation wall of the former quonset hut. The tank had reportedly been previously closed in-place with K-Crete in the late 1980s by the former owner of the site (Monroe County). Upon approval by Lieutenant Joseph Childs of the City of Rochester Fire Department, the tank was cut open and the contents removed with the excavator (Photos 9 and 10). The contents appeared to be K-Crete, which exhibited visual indications of impacts from petroleum residual within the UST. The contents were staged and disposed of with the petroleum-impacted soils. The UST was removed from the excavation area and disposed of as scrap metal at Genesee Scrap and Tin Baling Corporation. Tank removal documentation is included in Appendix D.

Petroleum-impacted soils, as evidenced by heavy staining and discoloration of the soils, were observed along the tank pit sidewalls and bottom. Due to the proximity of the UST to the 18-inch discharge line, further excavation to the north was not performed. In addition, excavation at depths beyond the base of the tank pit (approximately 9 feet below grade) was prohibited due to the potential for undermining the discharge line. PID measurements of grab samples obtained from the undisturbed northern sidewall and bottom of the tank pit ranged from 51 ppm to 830 ppm.

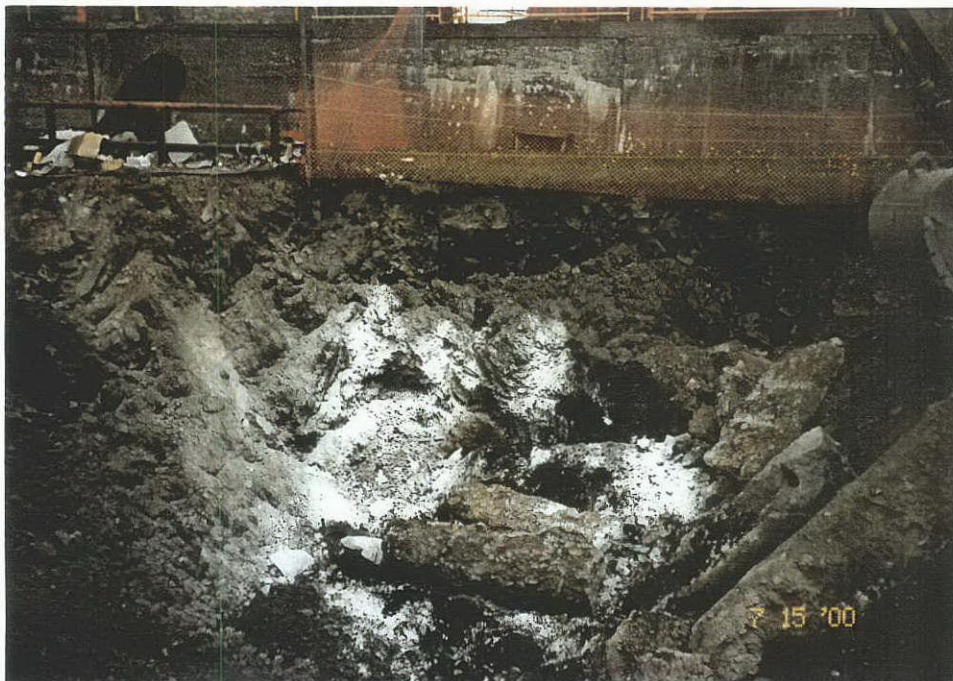
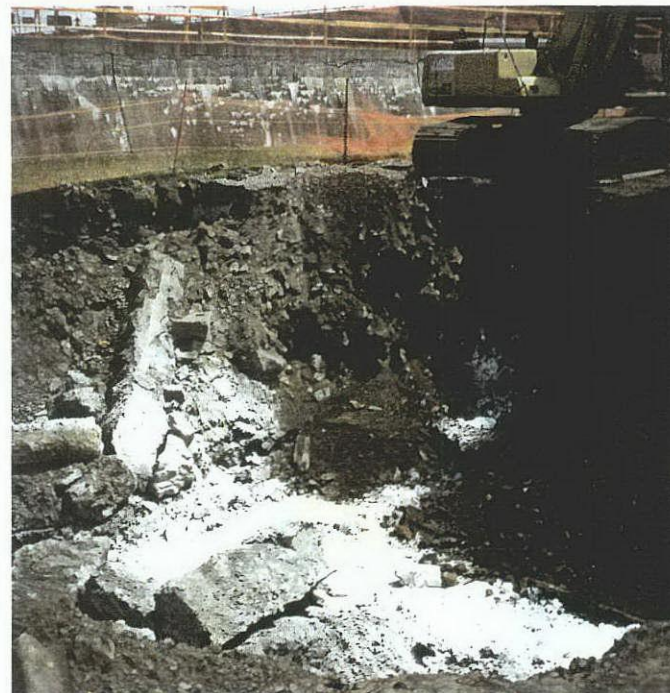
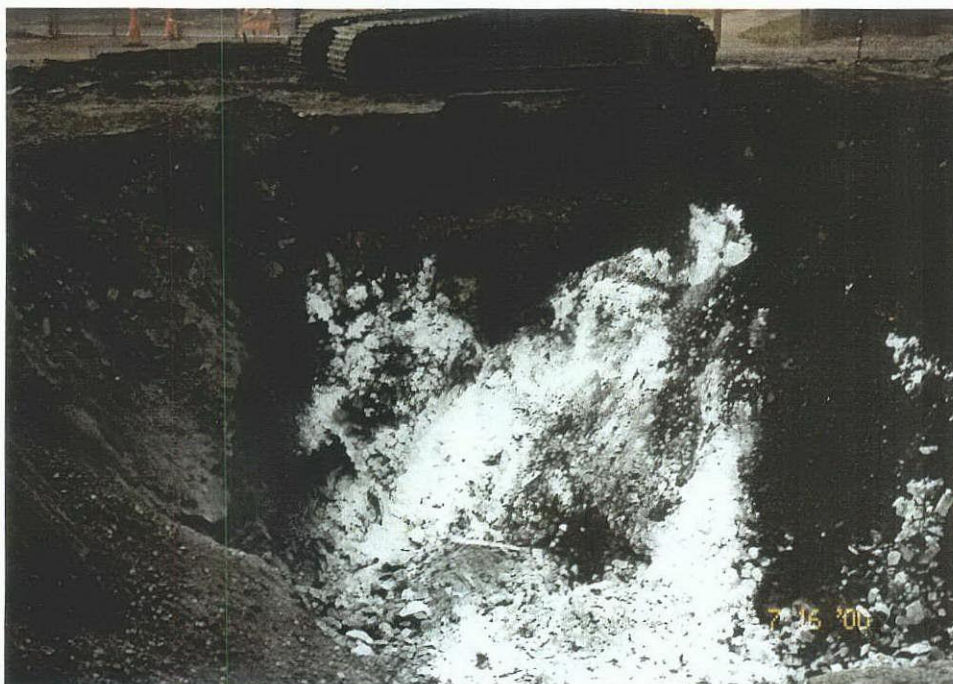
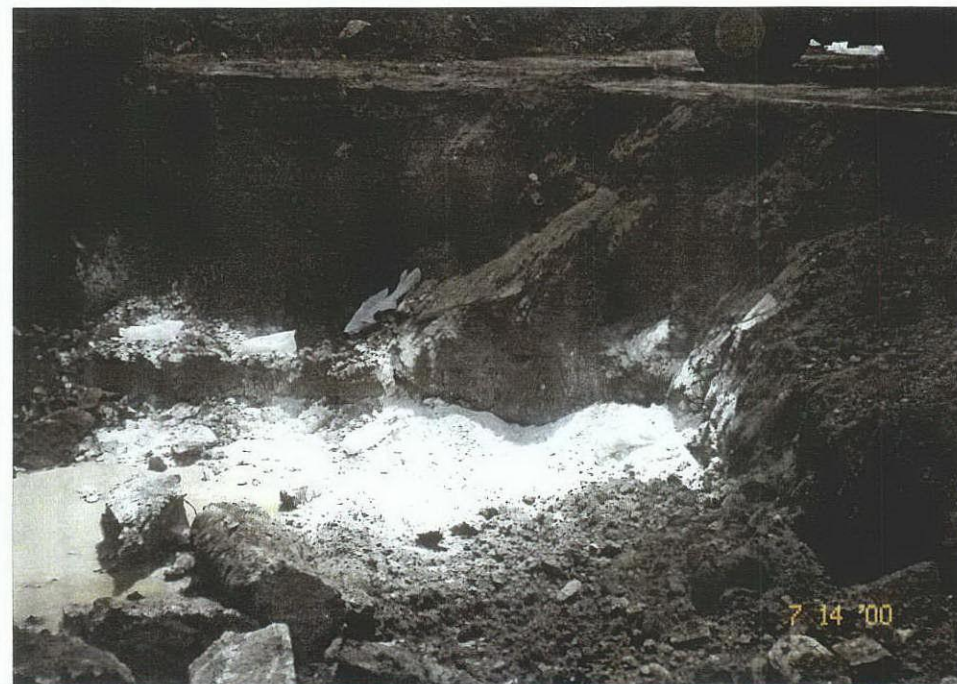
PHOTOS 14 THRU 17:

APPLICATION OF
OXYGEN RELEASE
COMPOUND (ORC)

The ORC[®] injection grid consisted of 19 points. The injection points and pounds of ORC[®] per point were concentrated in the area adjacent to the 18-inch discharge line and within the area of the former 2000-gallon UST, with consideration given to utility and proposed replacement monitoring well locations. For each point, a Geoprobe[®] Grout System GS-1000 Series Pump was used to inject a slurry of approximately 67-71% ORC[®] from the bedrock interface (13.5 – 15.5 ft. below grade) to depths ranging from approximately 4 - 8 ft. below grade. A total of 270 pounds of ORC[®] was injected into the subsurface as part of this program.
