STORMWATER POLLUTION PREVENTION PLAN

Brewery Line Trail

City of Rochester
Monroe County, New York

SWPPP Revision Date: August 23, 2021

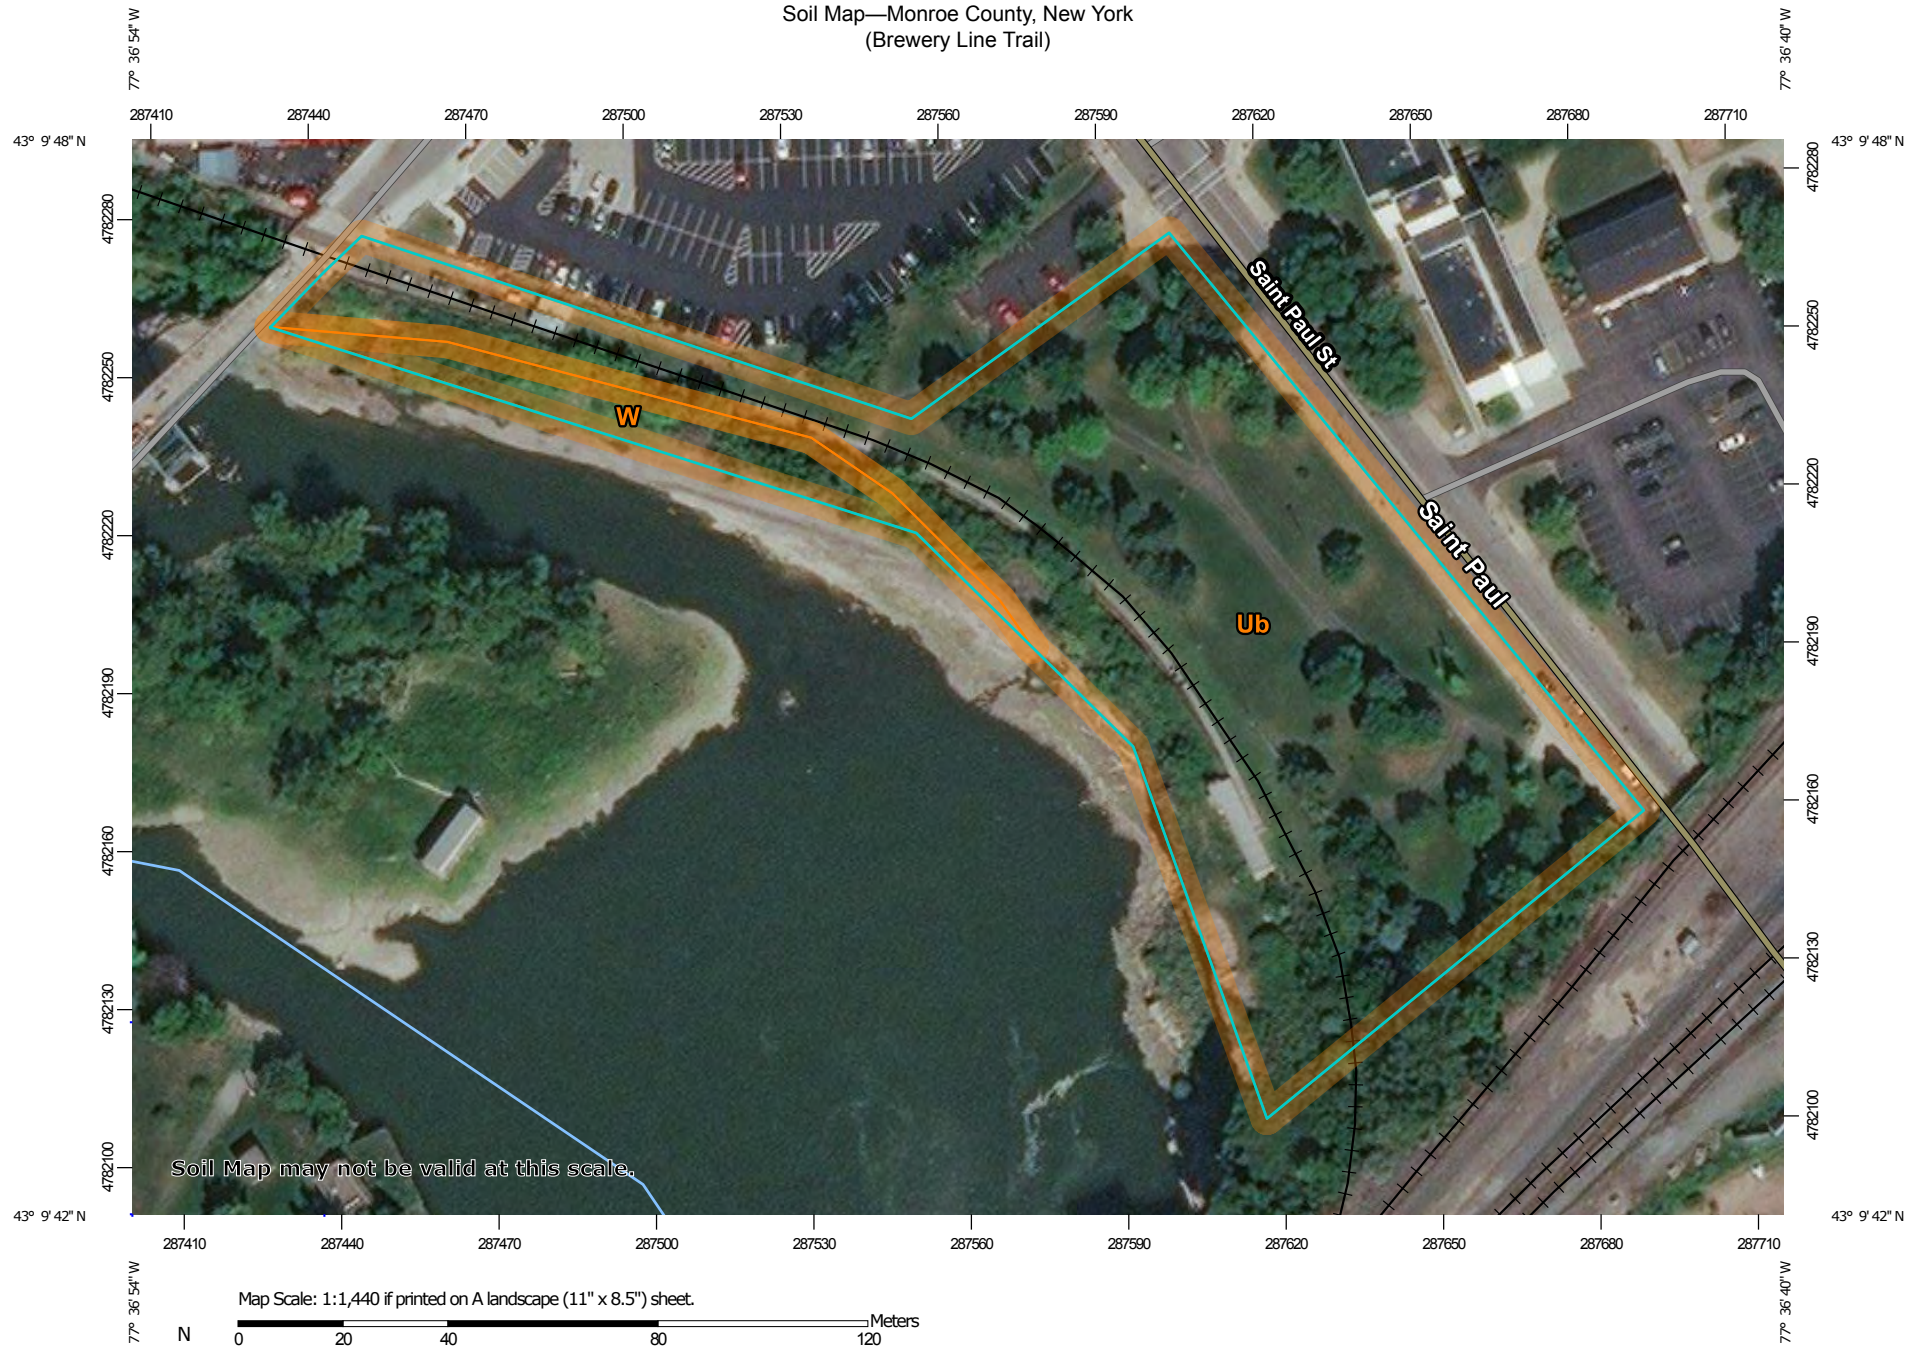
Soil Map—Monroe County, New York
(Brewery Line Trail)

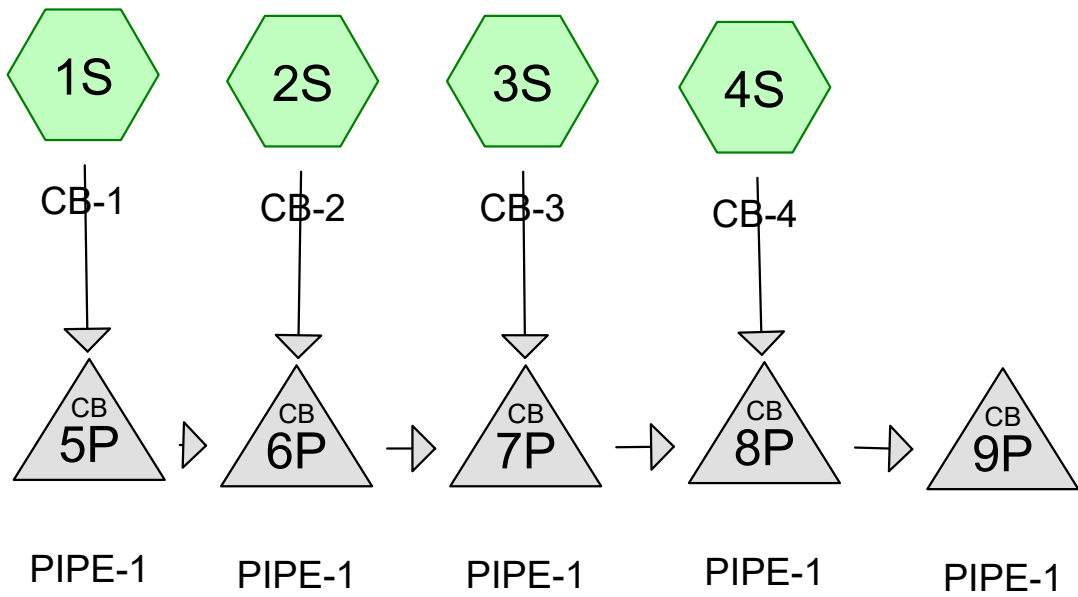
Routing Diagram for Storm Sewer

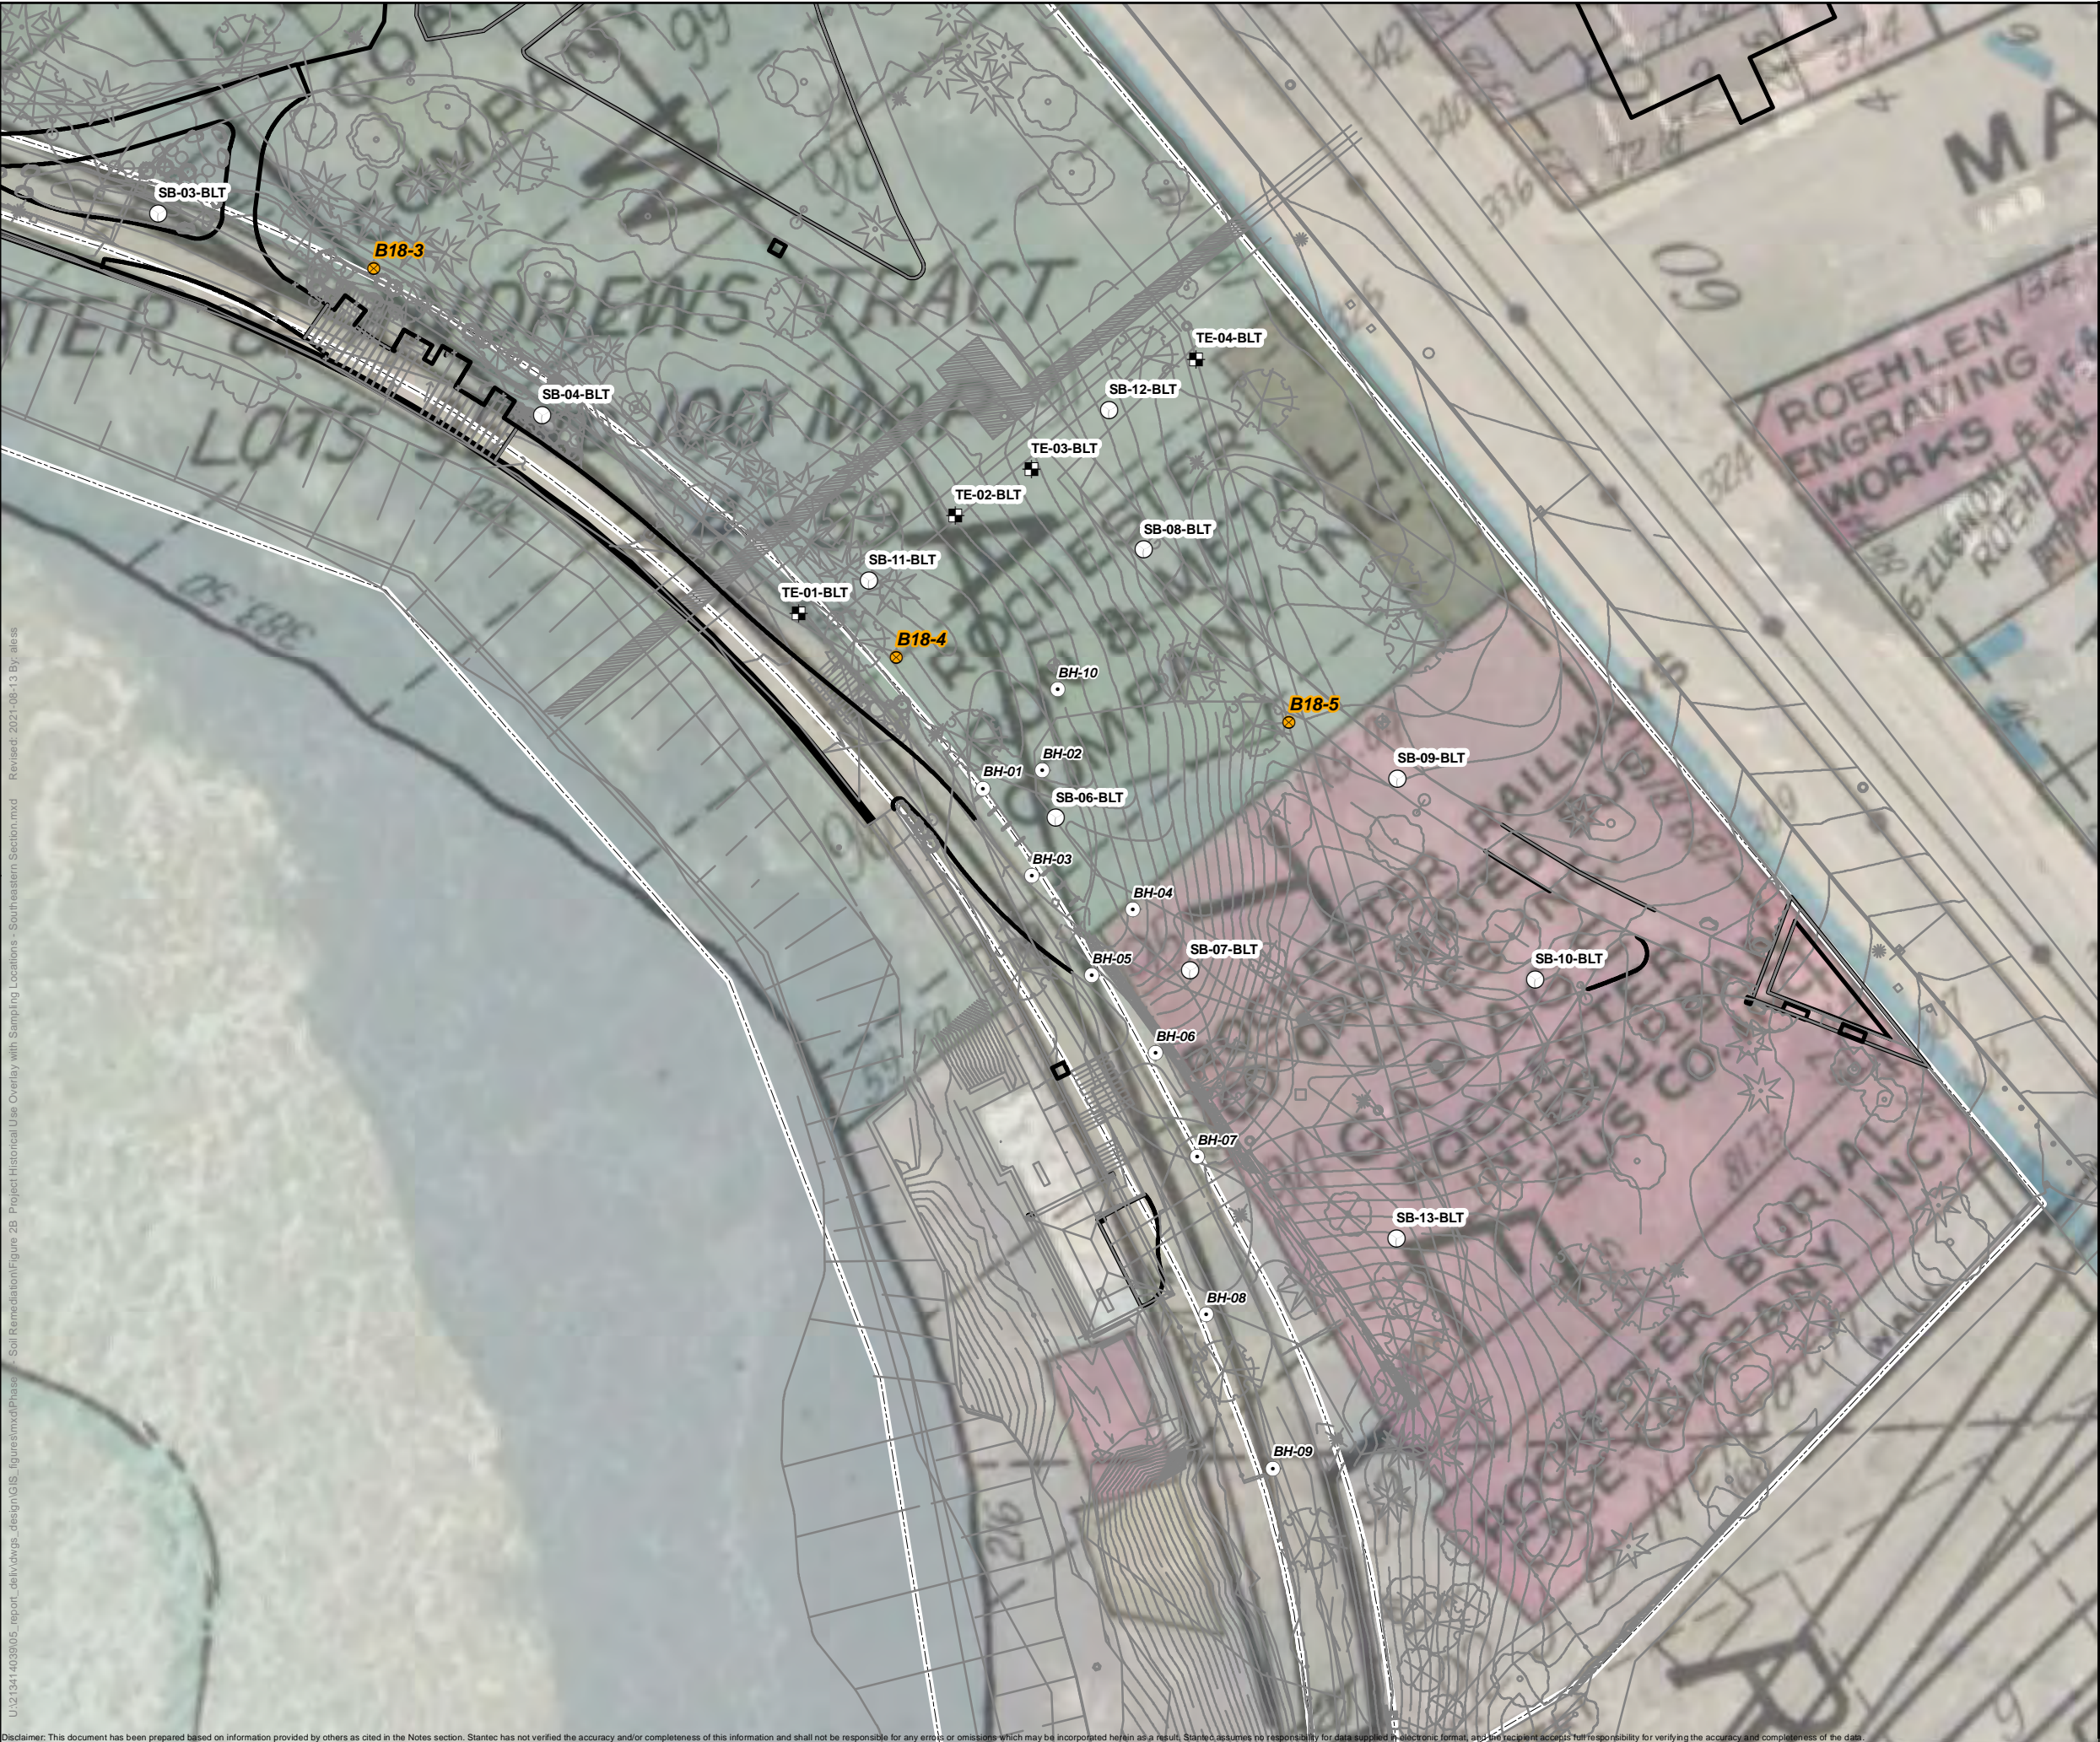
**Project Historical Use Overlay with
Sampling Locations - Western Section**

Figures 2A and 2B provide an overlay of historic site features as they relate to the proposed project design. Sampling locations from this Phase II ESA and previous soils testing completed by RELS are also included.

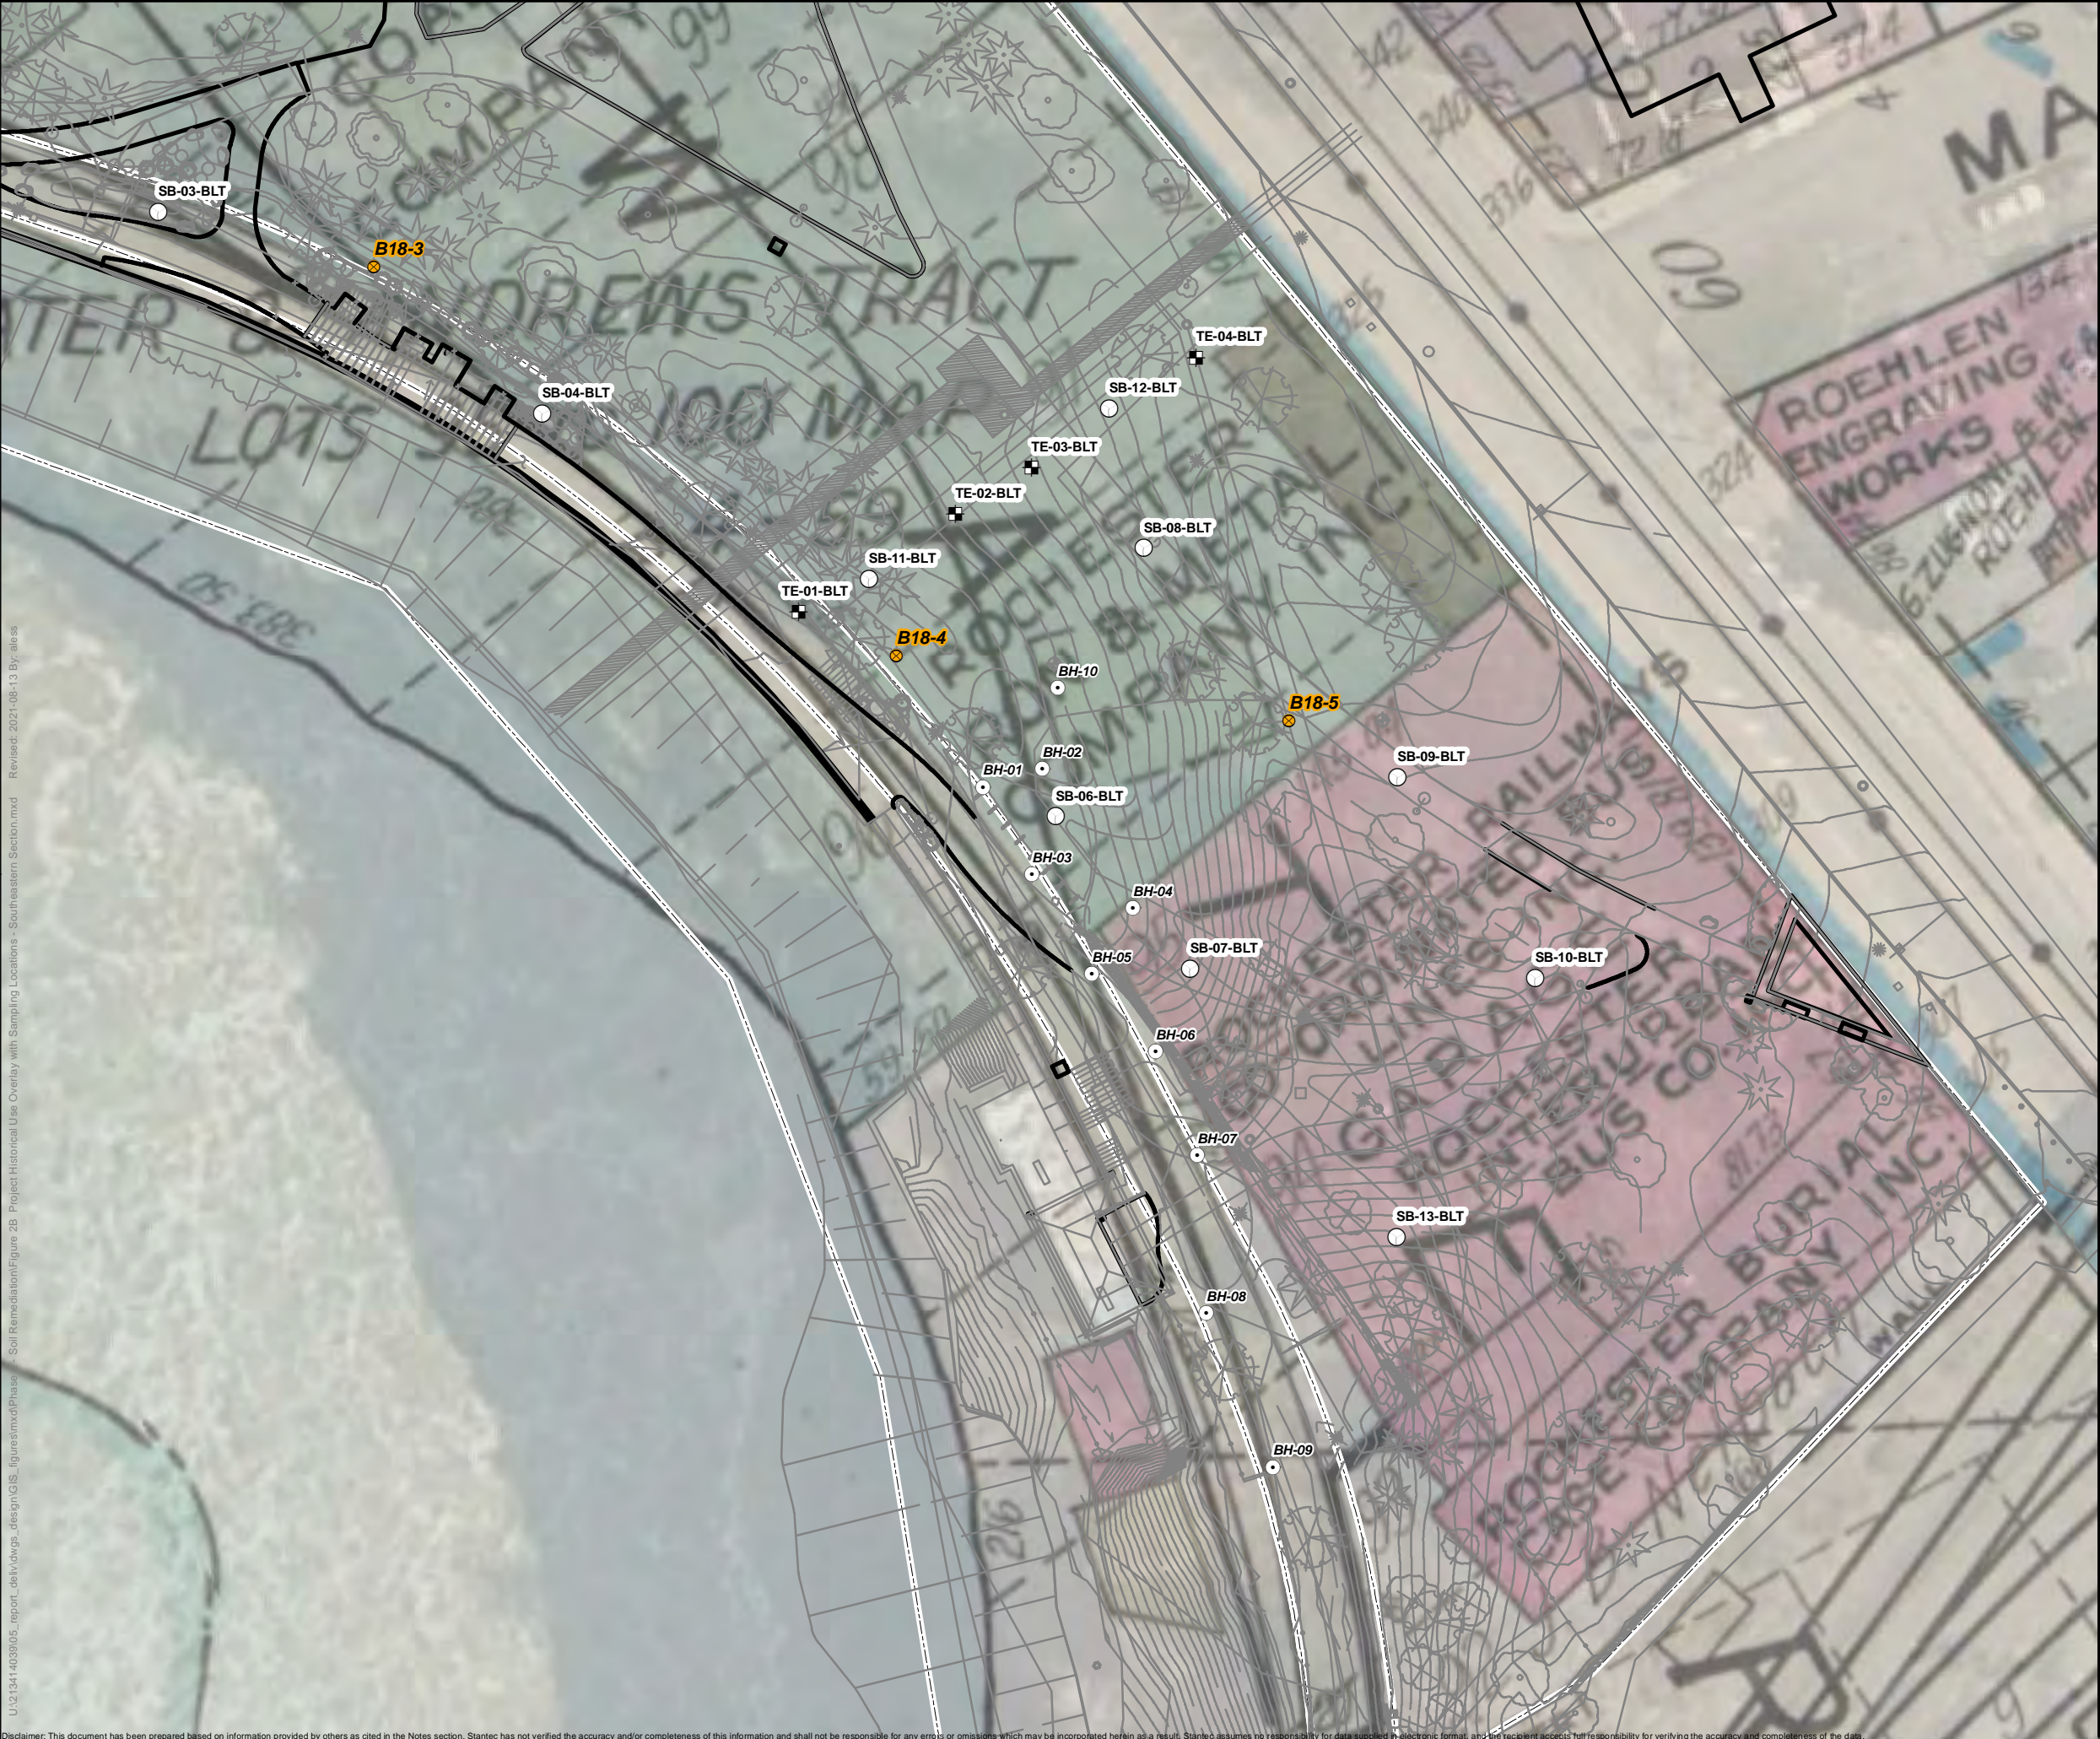
Figure No.
2B

U:\213414039\05_report_deliv\drgs_design\GIS_figures\mxd\Phase2 - Soil Remediation\Figure 2B - Project Historical Use Overlay with Sampling Locations - Southeastern Section.mxd Revised: 2021-08-13 By: aless

Figures 2A and 2B provide an overlay of historic site features as they related to the proposed project design. Sampling locations from this Phase II Assessment and previous soils testing completed by RELS are also included.
