Building Conditions and Land Use Survey Results Dewey / Driving Park Focused Investment Area

Prepared by Enterprise Community Partners
for
The City of Rochester Department of Community Development

Focused Investment Strategy - Dewey/Driving Park Area

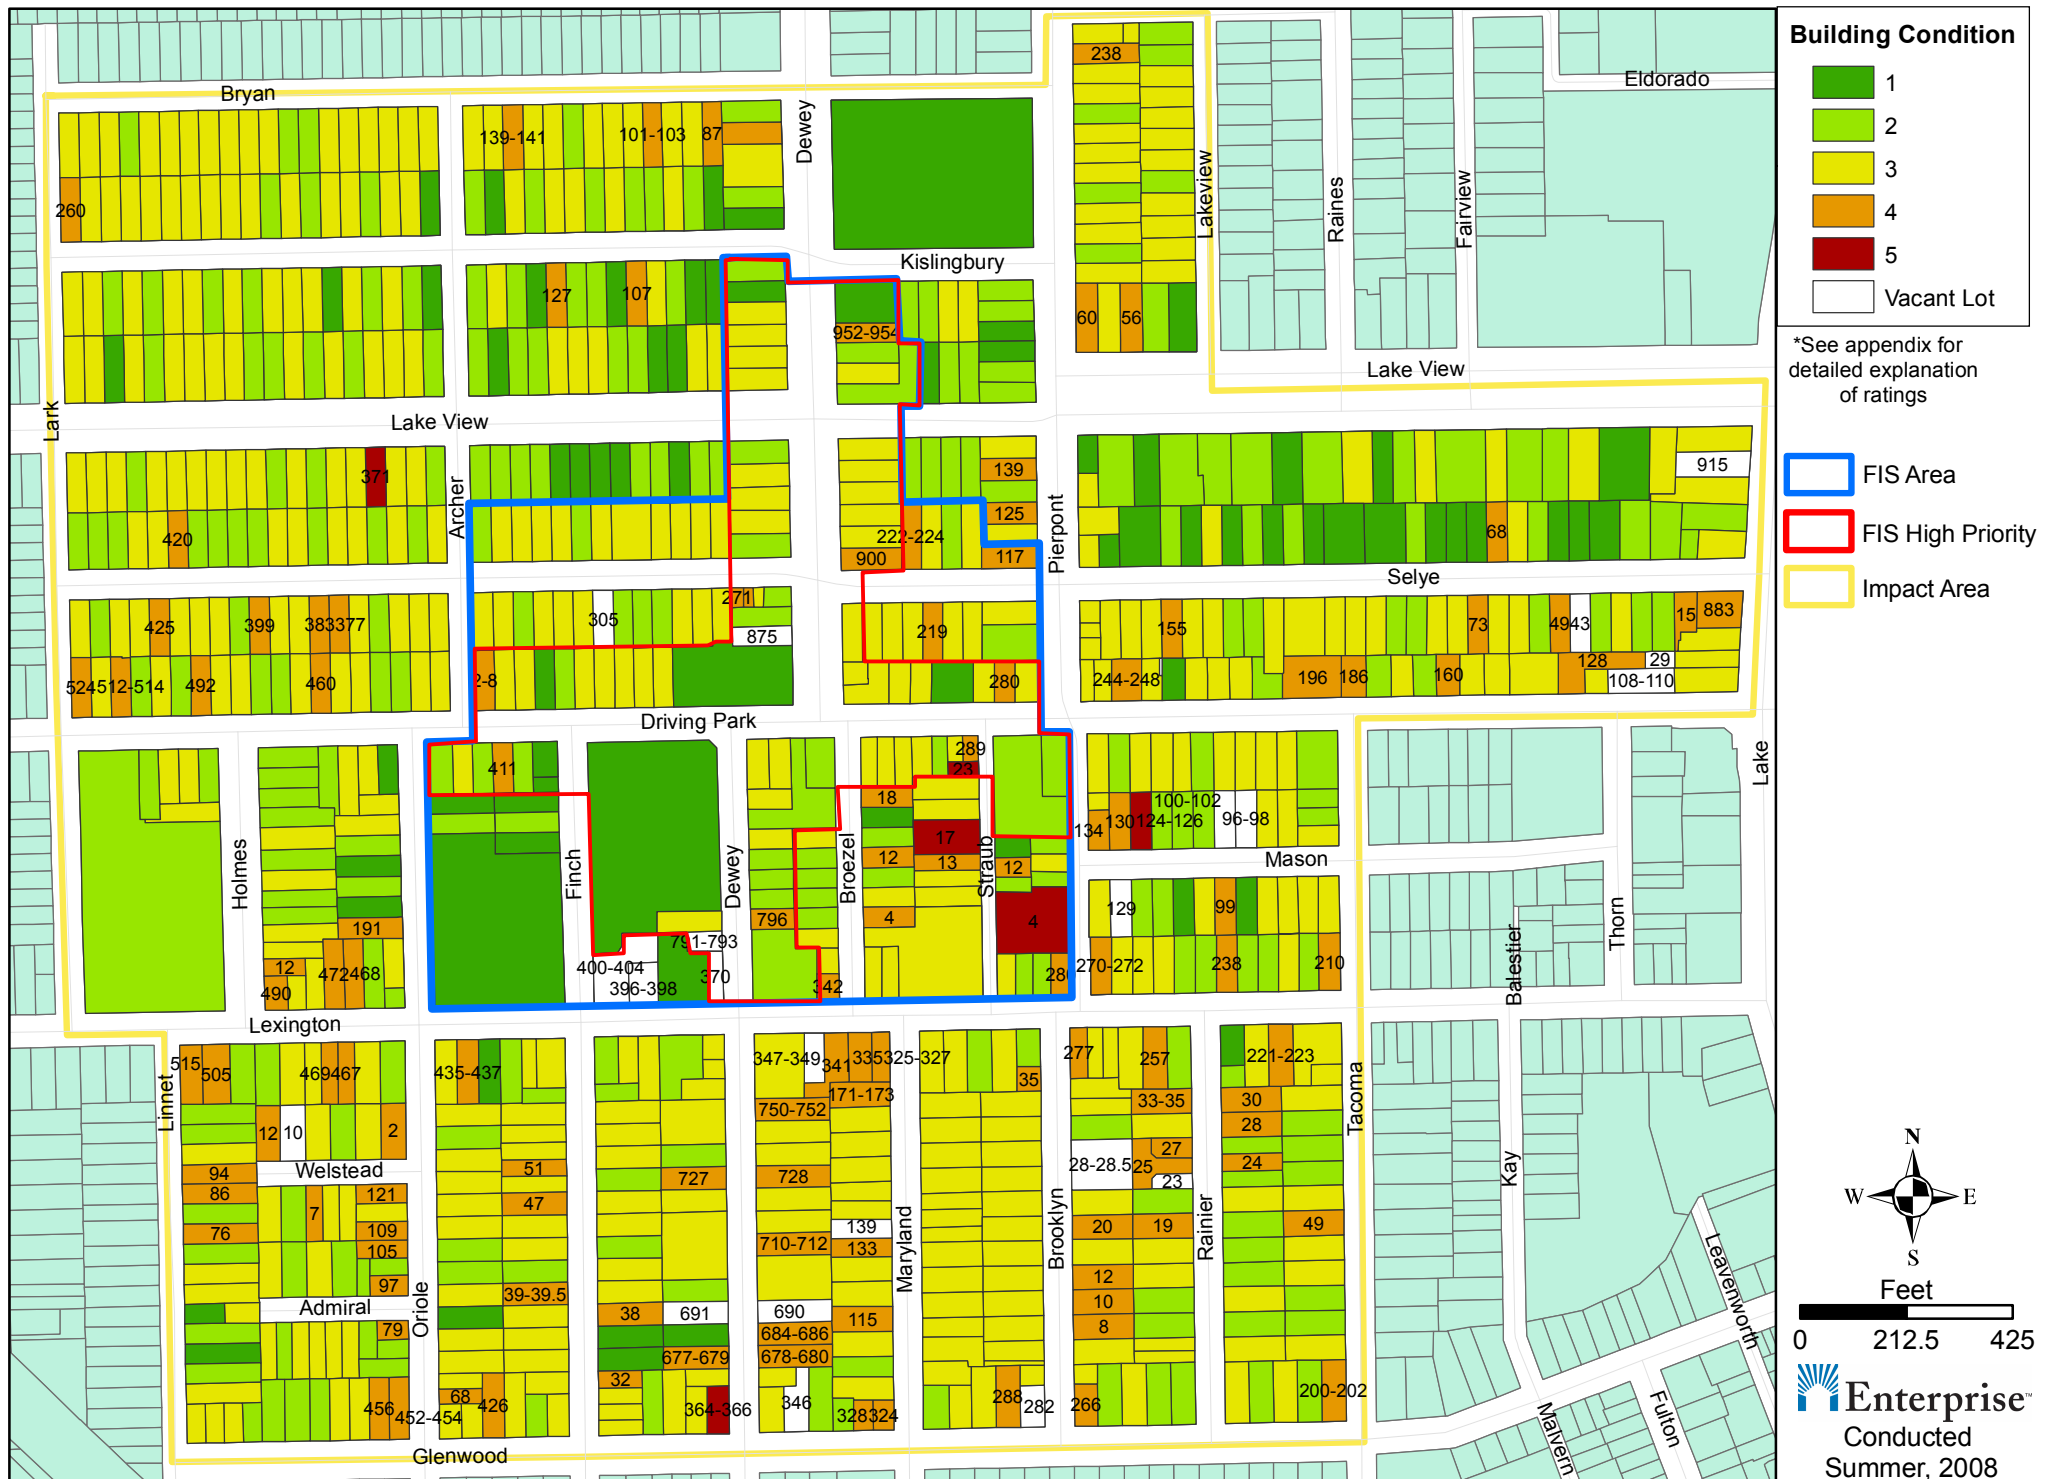
Dewey/Driving Park FIS - Building Conditions

Building Conditions

Excellent – characteristics include recently rehabilitated or remodeled, new paint, roof in very good condition.

Sound – characteristics include sound condition, good maintenance, no immediate need for repairs.

Substandard Minor – characteristics include need for basic cosmetic repairs such as painting, trim, porch and fence repair.

Substandard Major – characteristics include bulging walls, sagging foundations, broken windows and need for substantial improvements.

Dilapidated – characteristics include abandoned, fire damaged, boarded up, vacant and possibly unsuitable for rehabilitation.

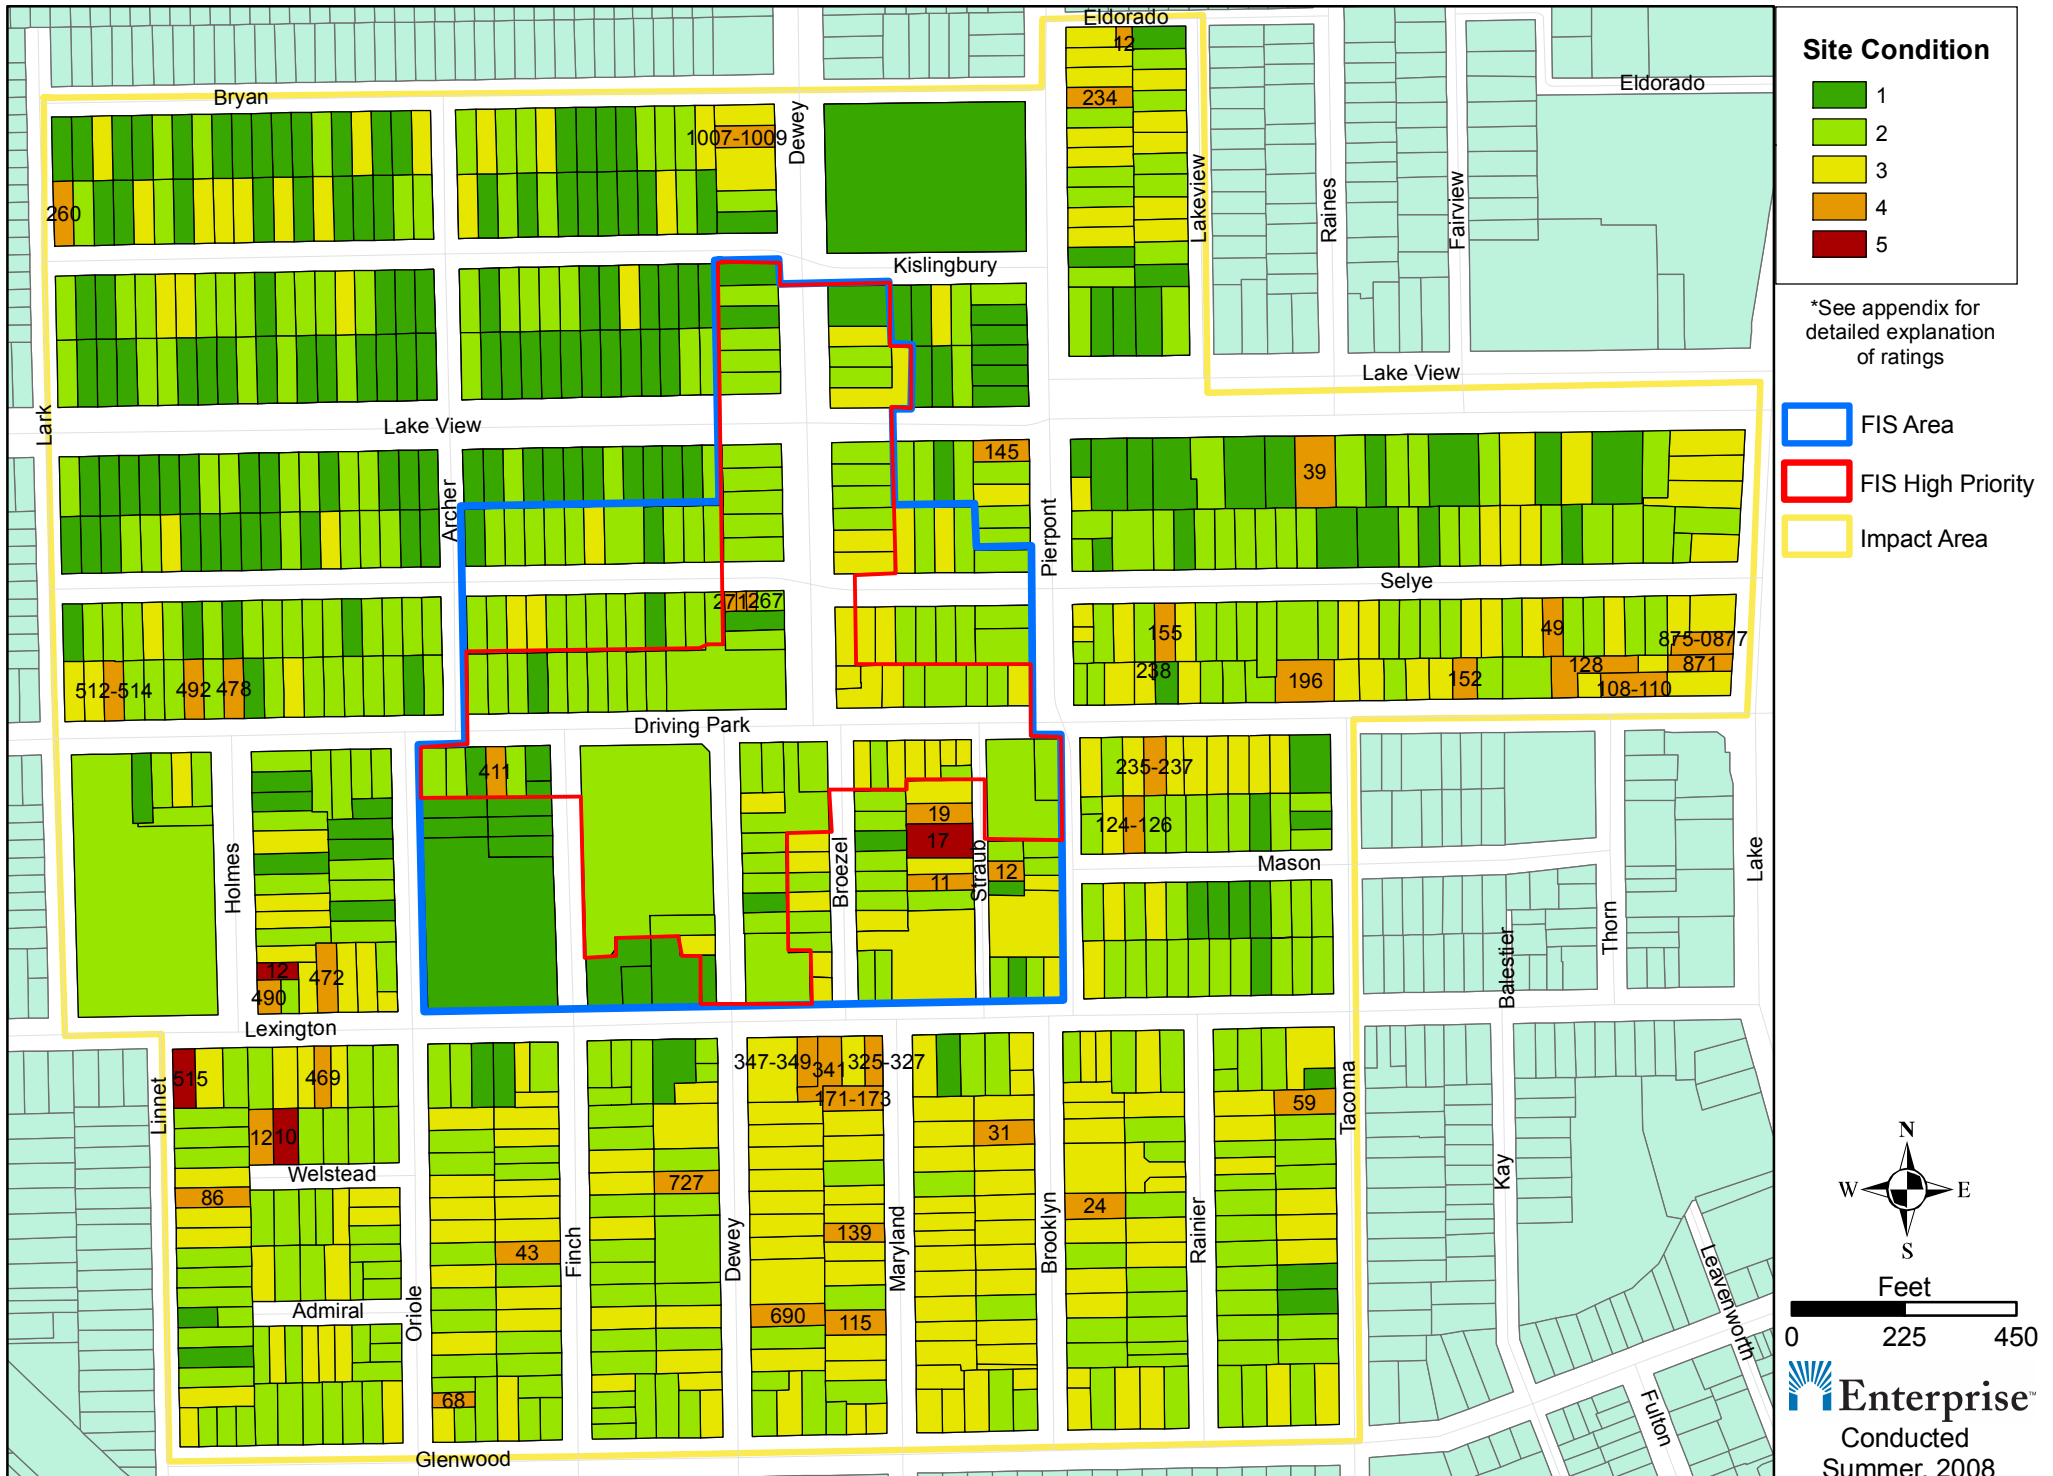
Dewey/Driving Park FIS - Site Conditions

Site Conditions

- 1) Characteristics include neatly trimmed and healthy vegetation, no trash, well-maintained walkways, no vehicles on blocks, well-maintained fencing.
- 2) Characteristics include neatly trimmed and healthy vegetation, no trash, no more than one of the following: deteriorated walkways, vehicles on blocks, deteriorated fencing.
- 3) Characteristics include some untrimmed vegetation, some trash, no more than one of the following: deteriorated walkways, vehicles on blocks, deteriorated fencing.
- 4) Characteristics include significant untrimmed vegetation, and / or trash, no more than two of the following: deteriorated walkways, vehicles on blocks, deteriorated fencing.
- 5) Characteristics include all vegetation untrimmed, significant trash, two or more of the following: deteriorated walkways, vehicles on blocks, deteriorated fencing.

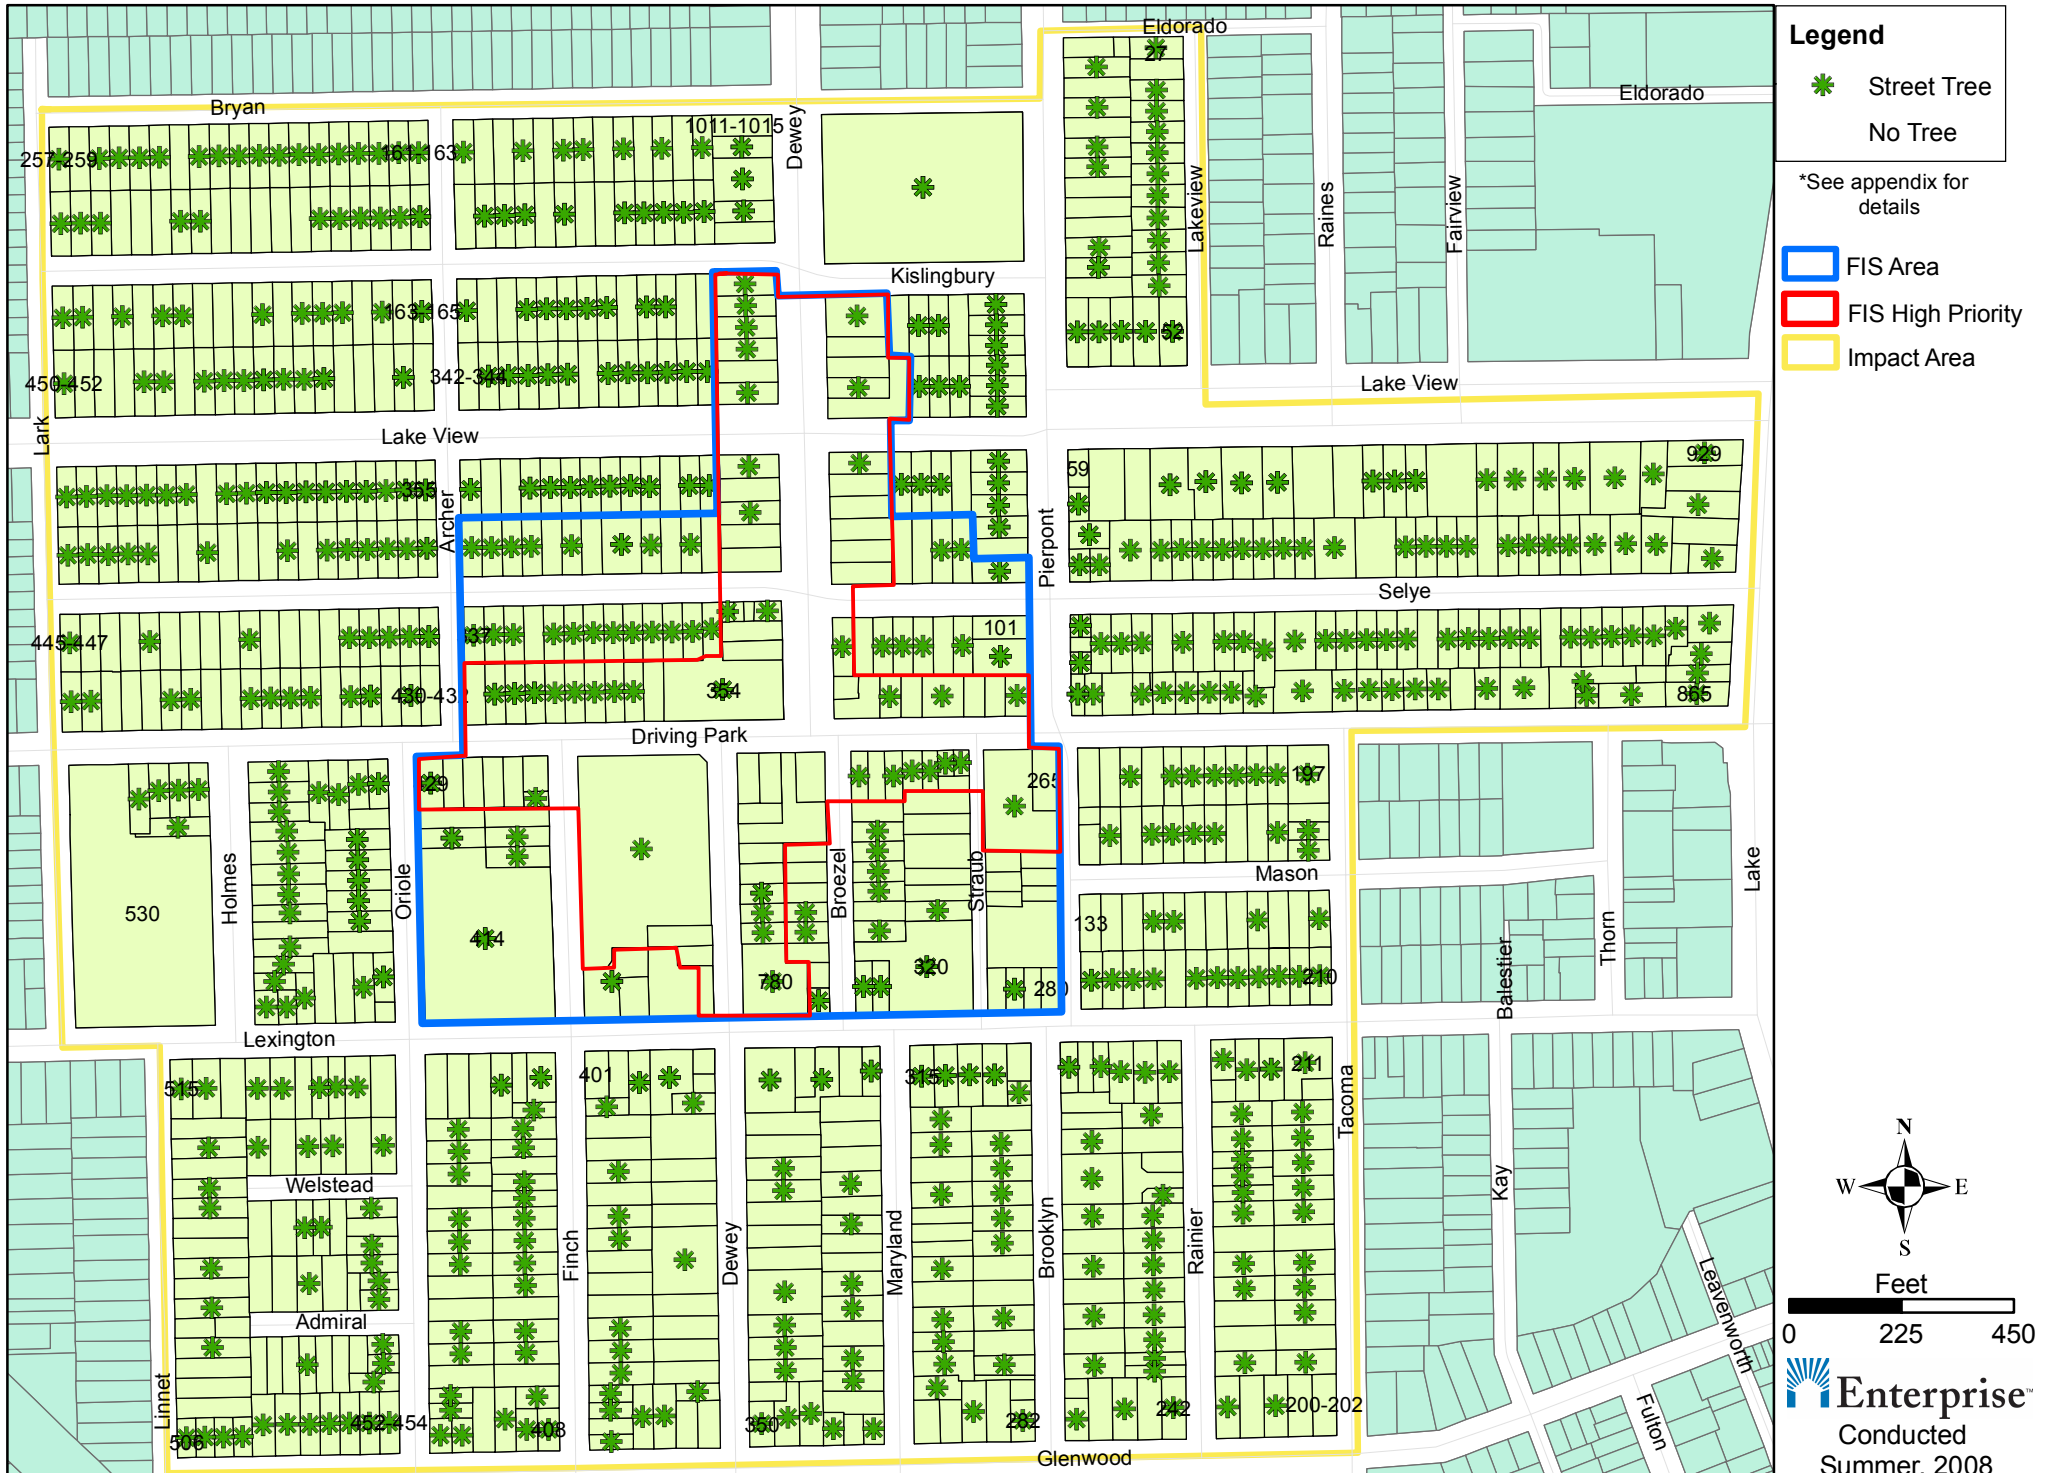
Dewey/Driving Park FIS - Street Trees

Street Trees – Existence of trees in tree lawn in front of parcel. Position on map is an approximation and does not correspond to the exact location.

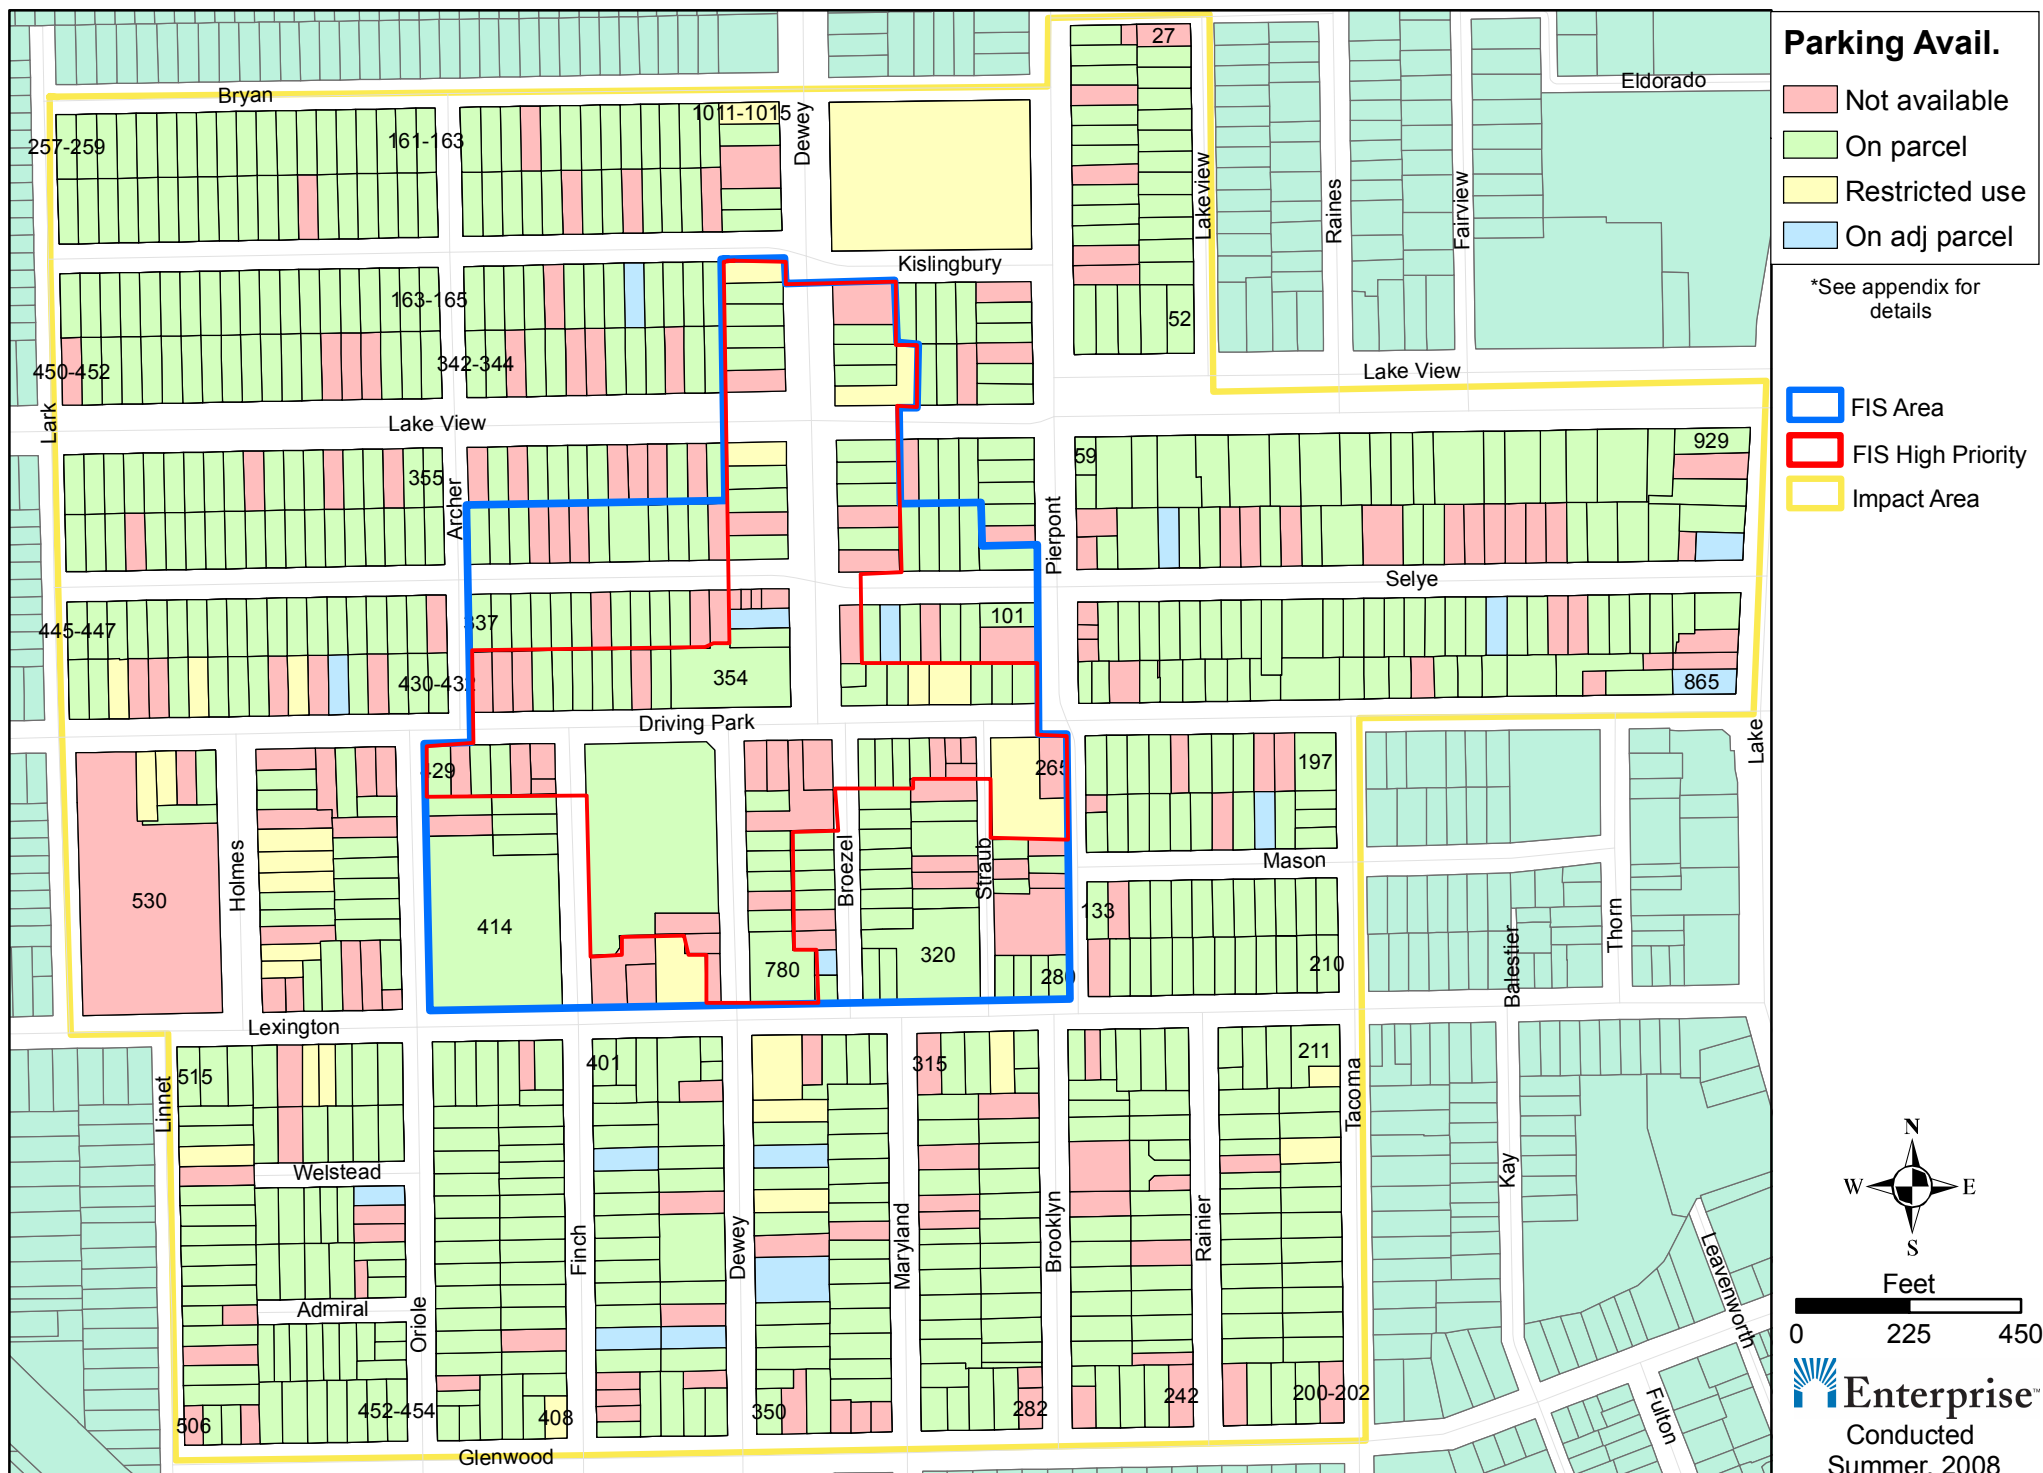
Dewey/Driving Park FIS - Parking Availability

Parking Availability

Not Available – The parcel does not have any off street parking, or the category is not applicable.

On Adjacent Parcel – Parking for this parcel exists either explicitly on an adjacent parcel, or a vacant lot is clearly used.

On Parcel, All Uses – Parking is available on the parcel and is not explicitly restricted.

Restricted Use – Parking is explicitly restricted or dedicated for a particular use only, such as for a business' customers.
