INITIAL PROJECT PROPOSAL/ FINAL DESIGN REPORT

ELMWOOD BRIDGE
PIN 475532

PROJECT NAME: Elmwood Avenue Bridge Preventive Maintenance

The project consists of completing element specific repairs to the Elmwood Avenue Bridge over Genesee River.

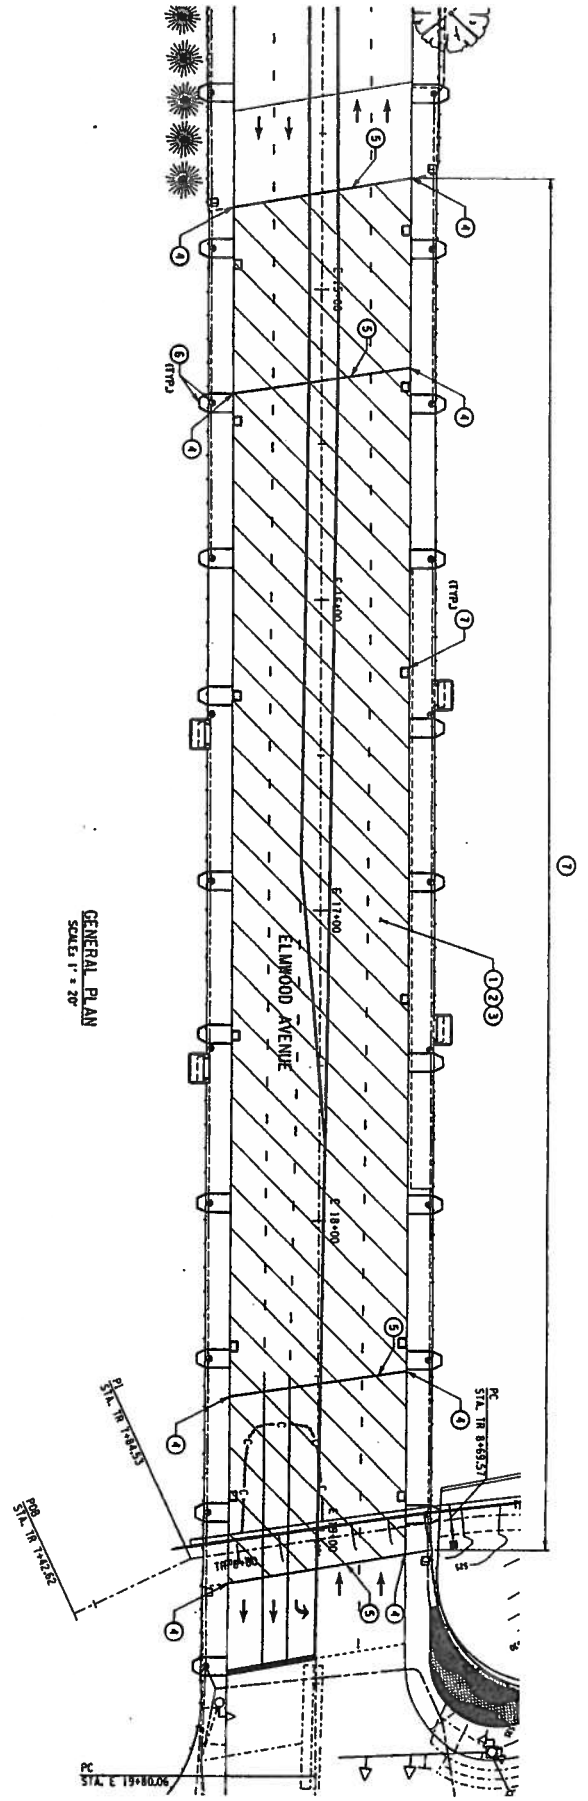
GENERAL PLAN
SCALE 1" = 20'

- DESCRIPTION OF WORK:**
- ① SCABBY EXISTING BRIDGE DECK
 - ② CONCRETE DECK REPAIRS, AS NECESSARY
 - ③ PLACE CONCRETE DECK OVERLAY
 - ④ REPLACE BRIDGE CARG AT JOINTS
 - ⑤ REPLACE EXISTING JOINT SYSTEMS
 - ⑥ RELOCATE EXISTING BRIDGE LIGHTING SYSTEM TO OUTSIDE FACE OF BRIDGE PILING
 - ⑦ BRIDGE WASHING & SCUPPER FLUSHING

- Scarify existing bridge deck
- Concrete deck repairs
- Place Concrete deck overlay
- Replace sections of failed bridge curb
- Replace existing joint systems
- Relocate existing bridge lighting system to outside face of bridge railing
- Bridge washing & Scupper flushing

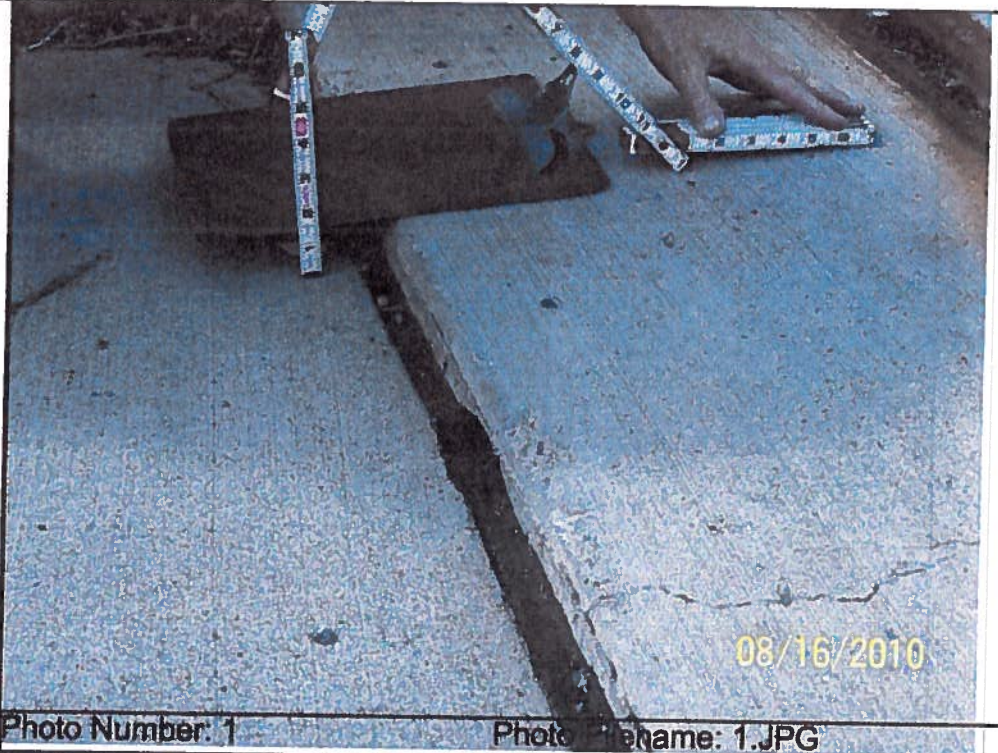
Photo Number: 1

Safety Flag No. 41100029 was issued for the end right approach sidewalk settlement condition.

**End Right Approach
Sidewalk**

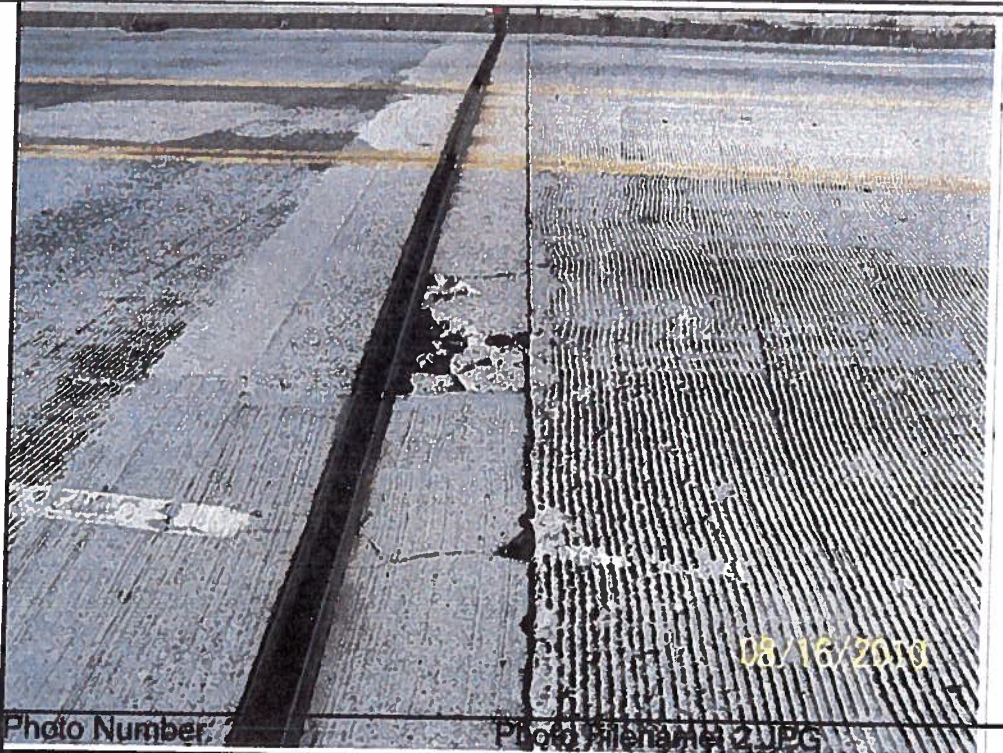
Photo Number: 2

The begin concrete approach slab left of the centerline has a 3 ft long by 1 ft wide section of broken and spalled concrete with 2 joint anchor lugs exposed along the interface of the approach slab with the joint. The remainder of this item would rate "5".

**Begin Approach
Pavement**

The existing broken and spalled concrete located at the end approach slab will be repair under the joint system replacement task. The deterioration is within the concrete header of the joint system.

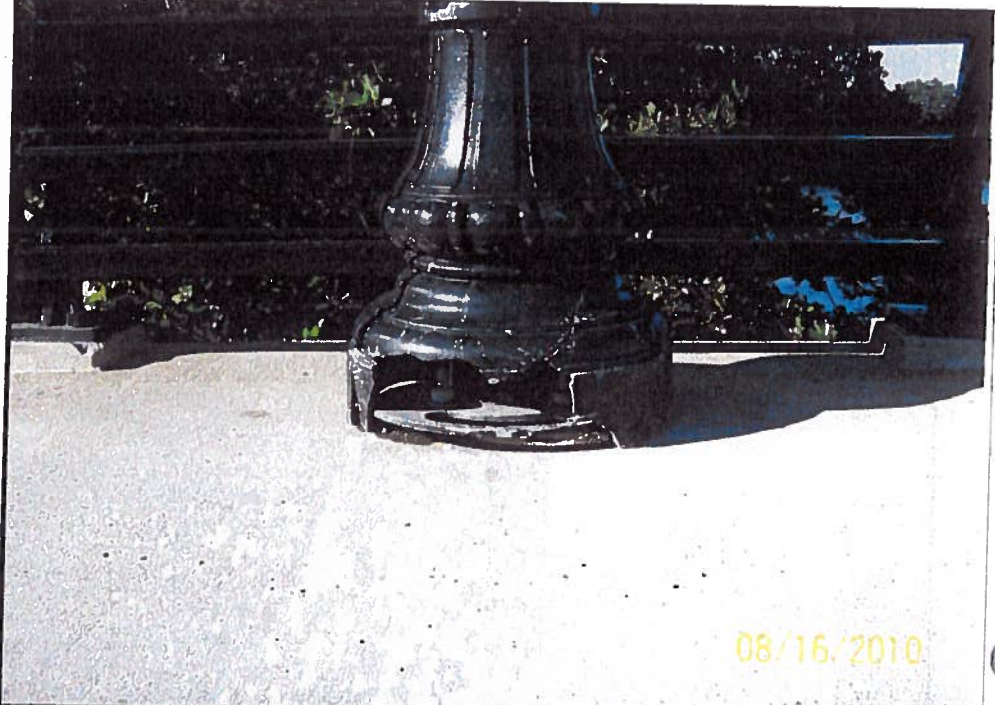
Photo Number: 3

Five light poles on the bridge have the decorative base covering broken as follows:

Span 5 Right Side Light Pole

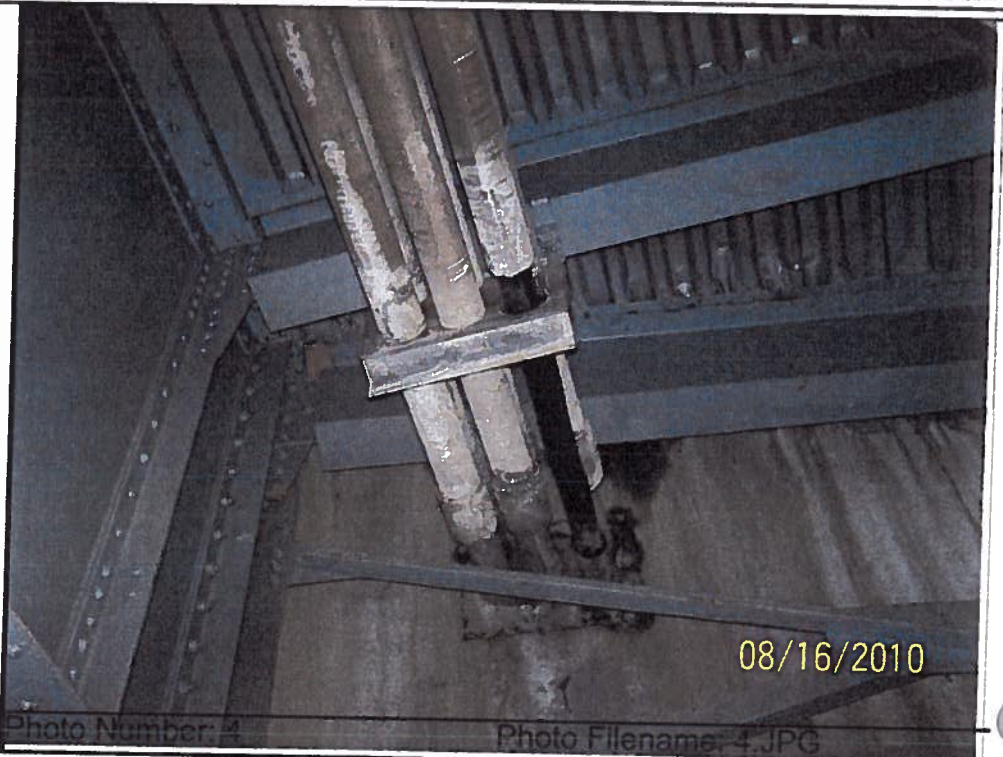
Photo Number: 4

The bottom left conduit in bay 1 is missing protective coating at the begin abutment (Photo 4).
Rollers supporting the 18" natural gas pipeline casing are missing from supports 1, 2 & 3.
Remainder of utilities are in 5-condition.

Utility Span 1 Bay 1

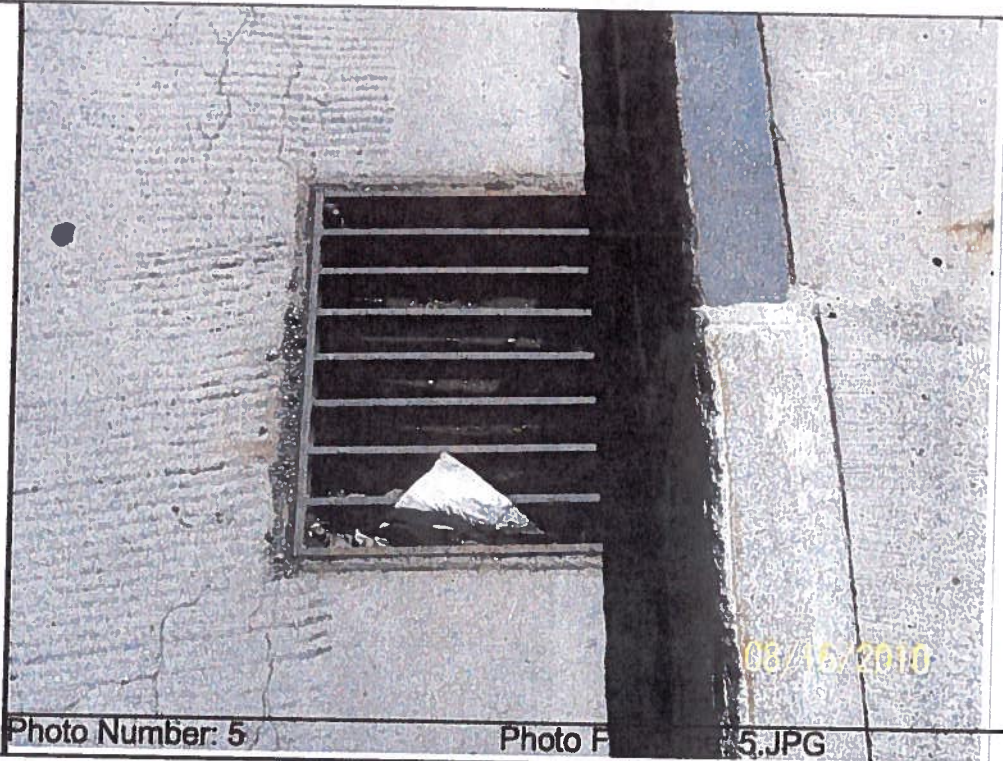
**Span 2 Right Side
Scupper**

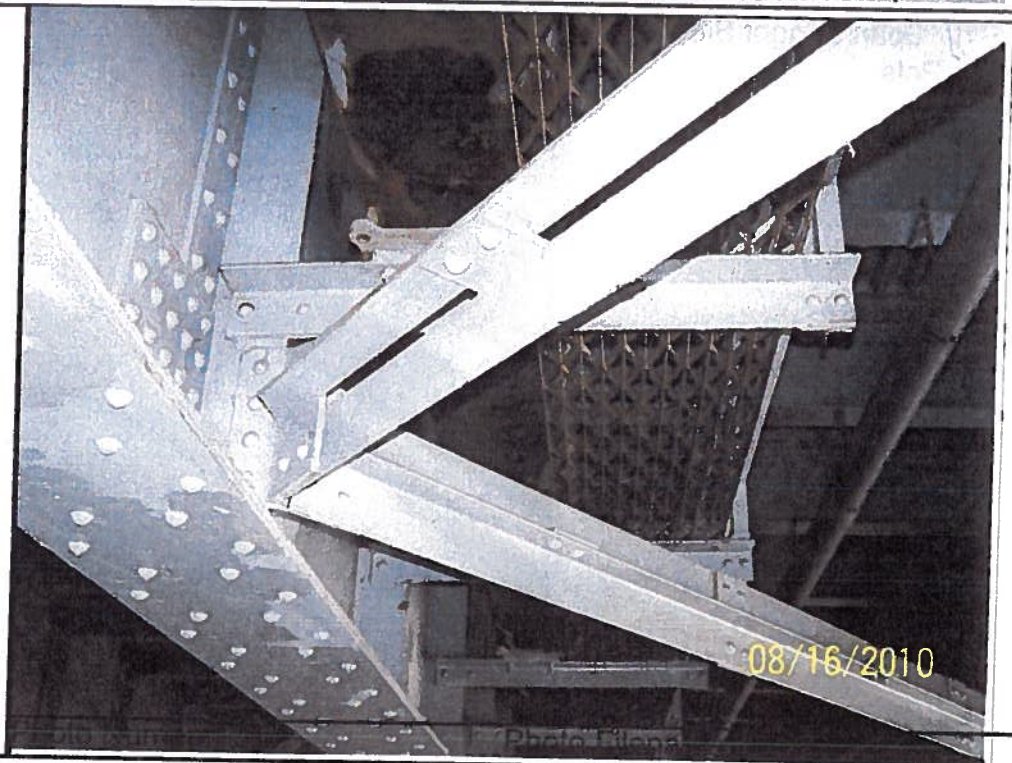
Rollers supporting the 18" natural gas pipeline casing are missing from supports 4, 5 & 6 (Photo 6).

**Span 2 Bay 4 Utility
(Typ. Spans 1 and 5)**

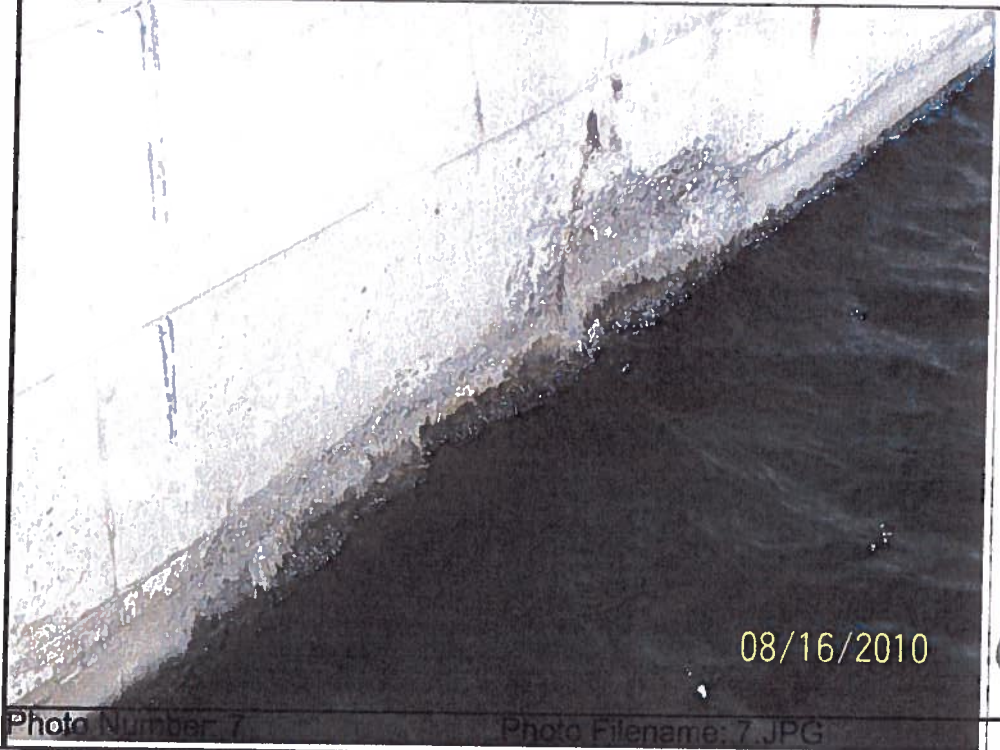
There is a 10 ft long by 2 1/2 ft max height by 8 inch max depth spall near left end of the begin face at the water level. Also, there is a 2 ft long by 1 ft max height by 4 inch max depth spall near left end of the end face at the water level.

**Pier 4 Left Side Begin
Face**

This repair is being addressed through the City of Rochester's Bridge Maintenance Program and will not be included in the scope of work for this project.

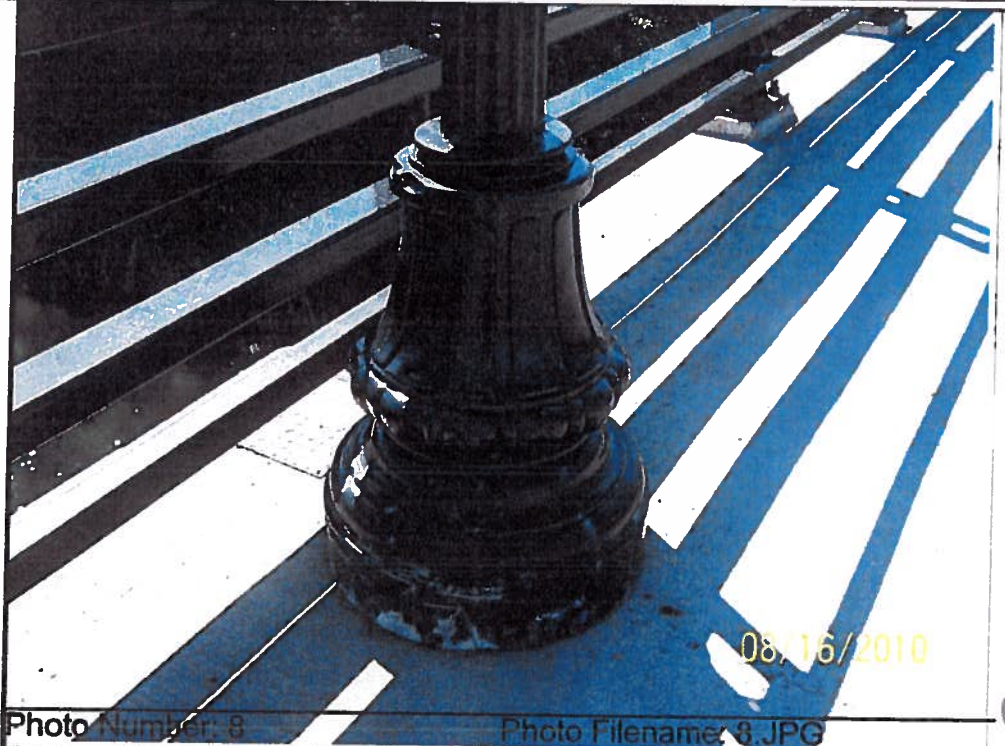
**Span 3 Right Side Light
Pole**

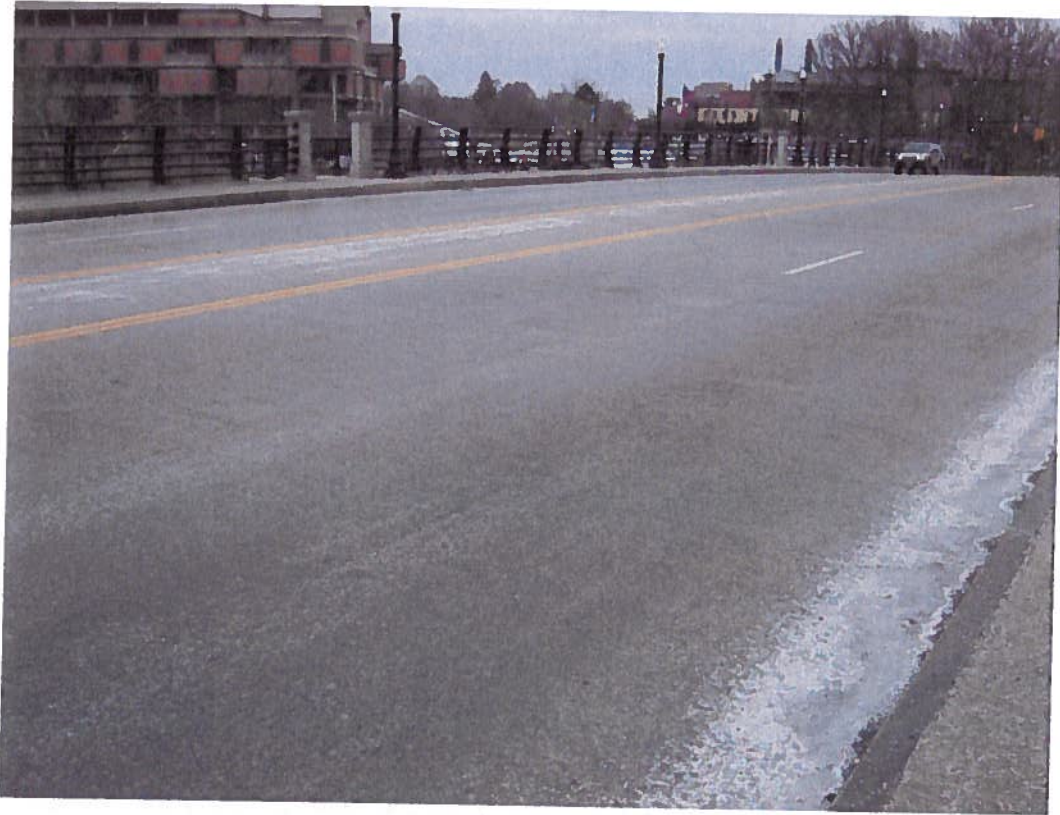
Based on a visual inspection of the deck wearing surface at the Elmwood Avenue Bridge, we disagree with the wearing surface rating (5) given in the most recent bridge inspection report. See Appendix D for photo documentation. This element should have a rating of 4. When rating a concrete wearing surface a 5 indicates the beginning of a spalling problem with no more than two or three isolated, moderate spalls or delaminations. There may be only scattered tight cracks and moderate surface wear with good riding quality. A rating of 3 indicates a more serious spalling and delamination problem with about 25% of one lane affected and poor riding quality. A wearing surface with no cracks or spalls but with well worn and polished aggregate could also be rated a 3. Based on our observations, we feel the wearing surface rating should be a 4. There is not a serious spalling or delamination problem, but the deck is scattered with cracks and the riding quality is fair. The City attempted to seal the deck 2 years ago and it took approximately 12 hours for the sealer to penetrate the deck and dry. A good portion of the deck is showing well worn and polished aggregate which we are attributing to the issue with the prolonged sealer penetration and drying. The project has been scoped based on a worst case scenario fix (e.g. scarification and overlay). Other alternative wearing surface treatments will be evaluated during preliminary design based on results of deck evaluation per the NYSDOT Bridge Deck Evaluation Manual.

1. Elmwood Ave. Bridge Deck Wearing Surface (looking east)

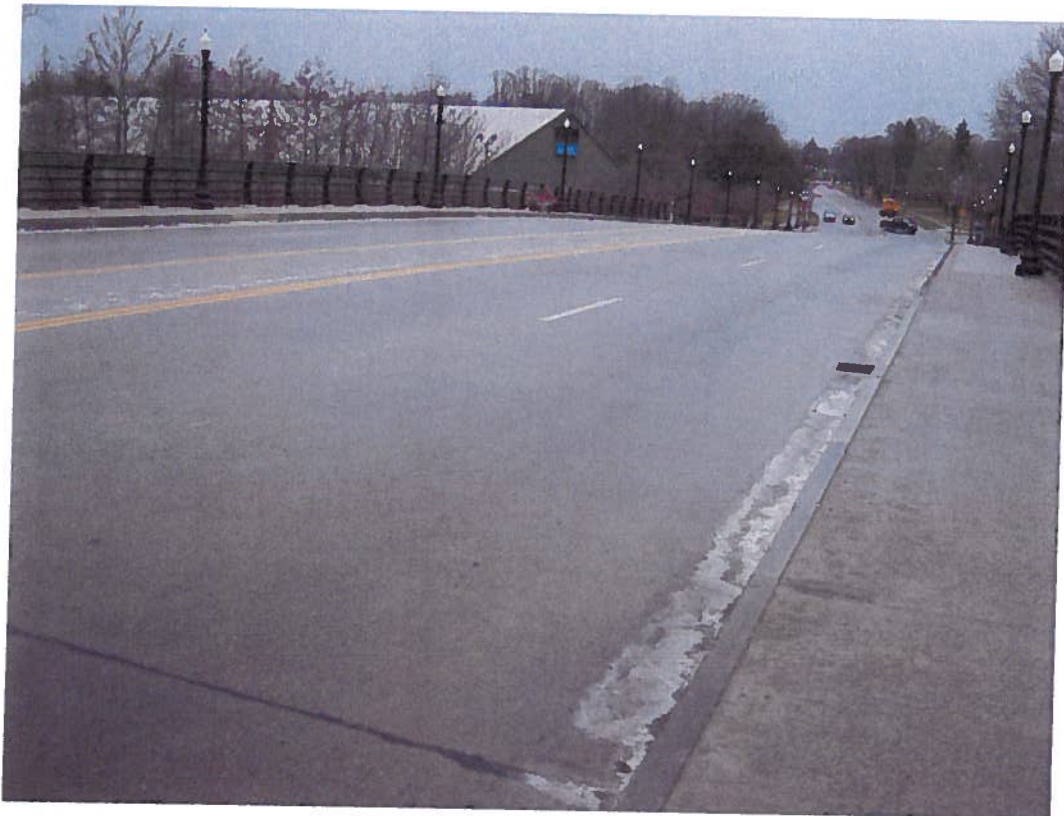
2. Elmwood Ave. Bridge Deck Wearing Surface (looking west)

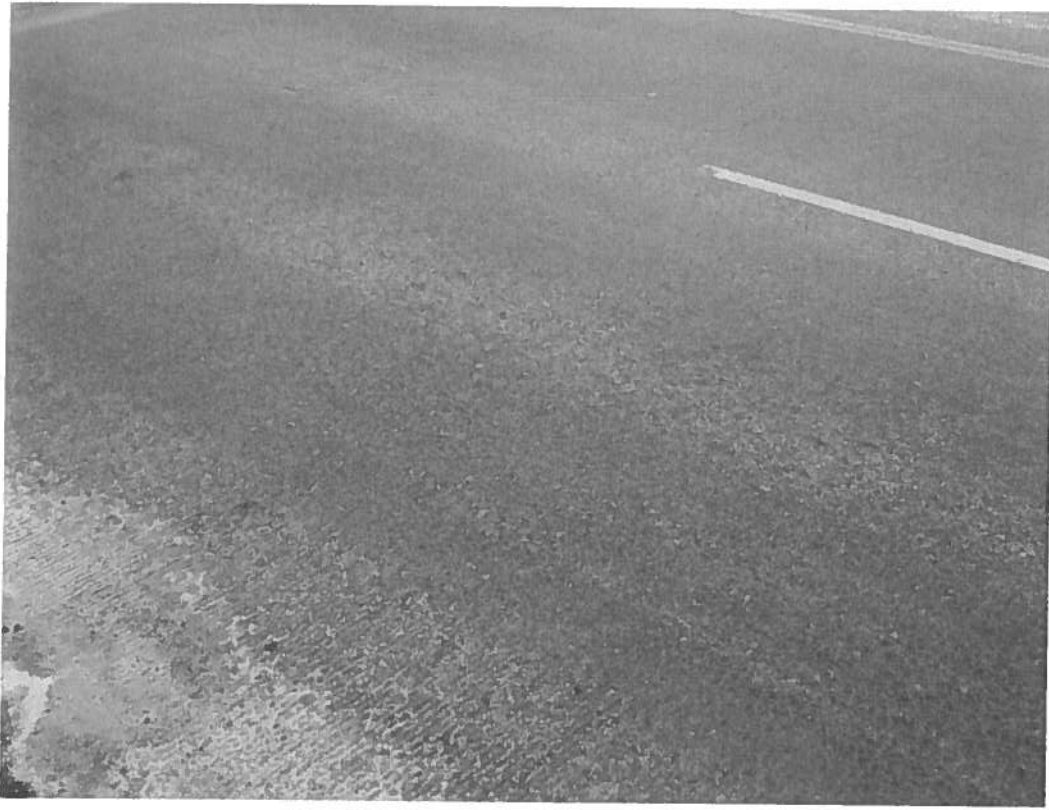
3. Well Worn and Polished Aggregate Wearing Surface

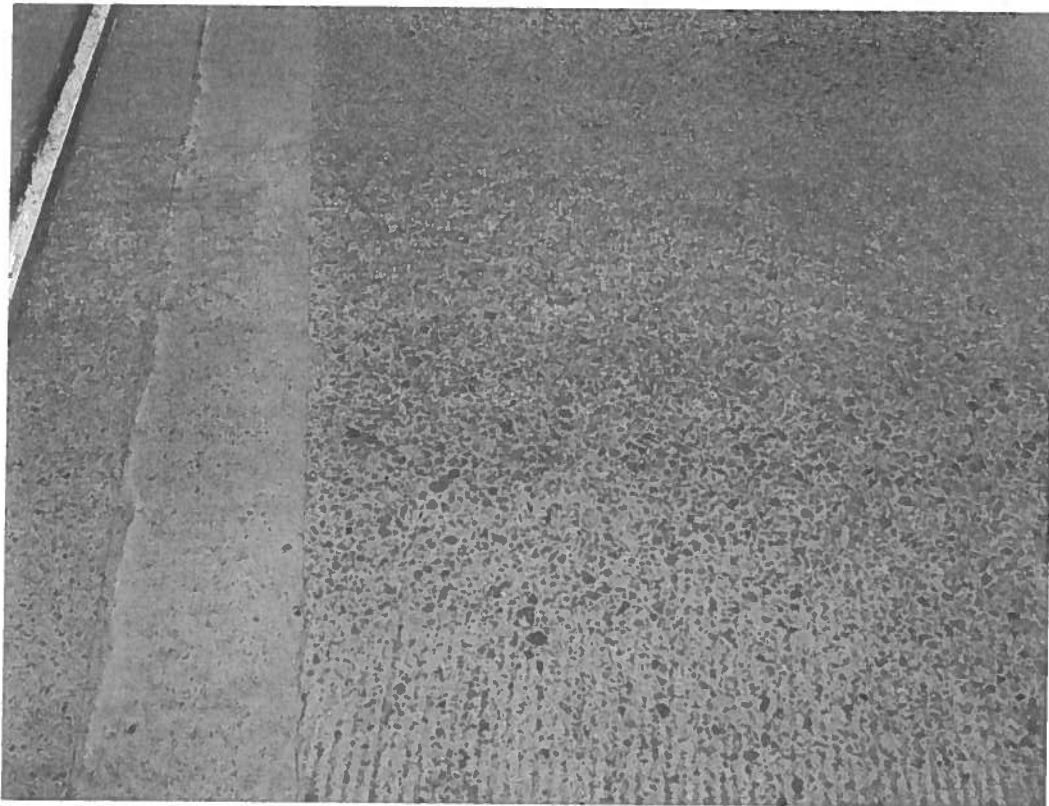
4. Well Worn and Polished Aggregate Wearing Surface
