Geotechnical Data Report

Dewey Ave. and Driving Park Ave. Realignment Project
Rochester, New York

September 28, 2016
Project No. J9165113

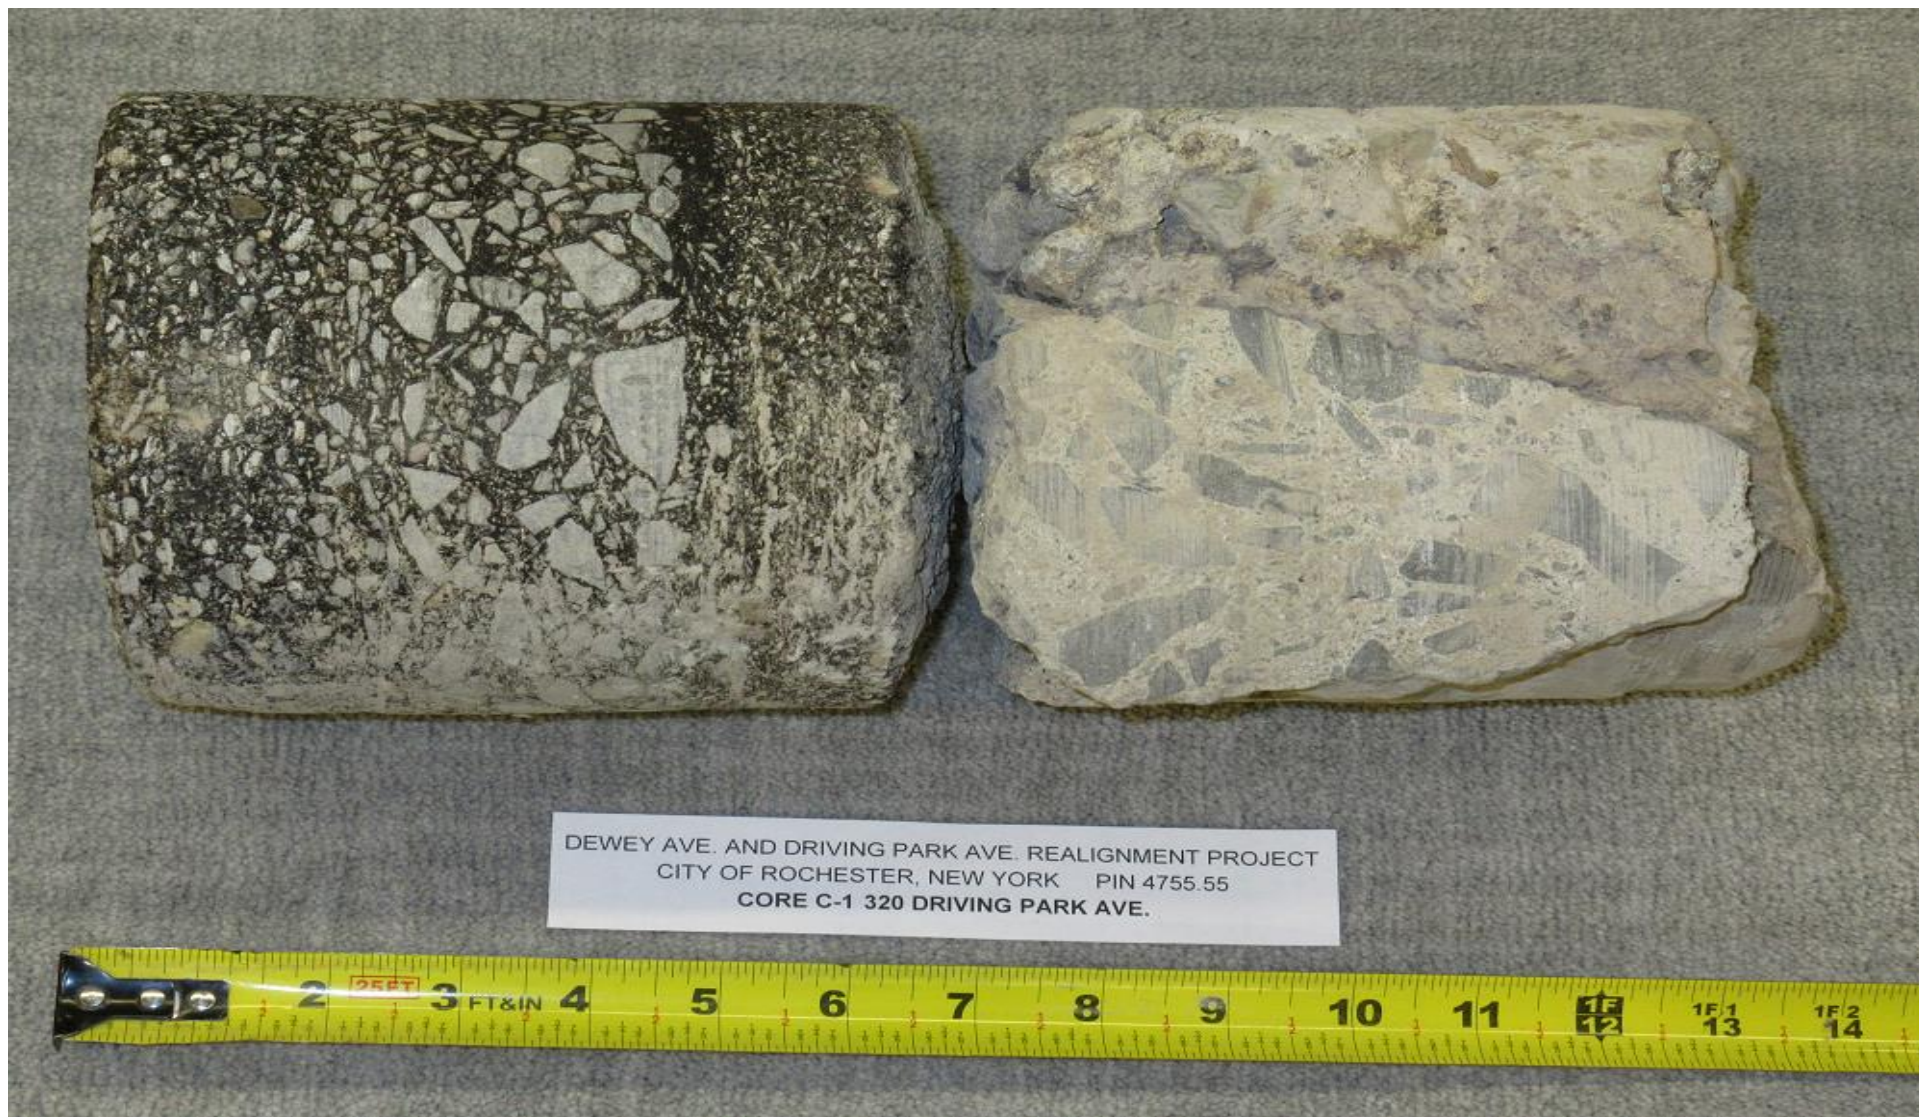
Report Number: J5165113	
	Technician:	
	Date: Sept 2106	
	Scale: Not to Scale	CORE PHOTOGRAPHS EXHIBIT A-7

DEWEY AVE. AND DRIVING PARK AVE. REALIGNMENT PROJECT DRIVING PARK AVE. ROCHESTER, NY	Site Plan:

Our scope of services included advancing three (3) exploratory soil test borings to depths of approximately 9 feet below existing grade within the area of interest. Boring Location Plans are included in Appendix A as part of this report. Logs of the test borings are also included in Appendix A. Photographs of the recovered pavement cores are also included in Appendix A.

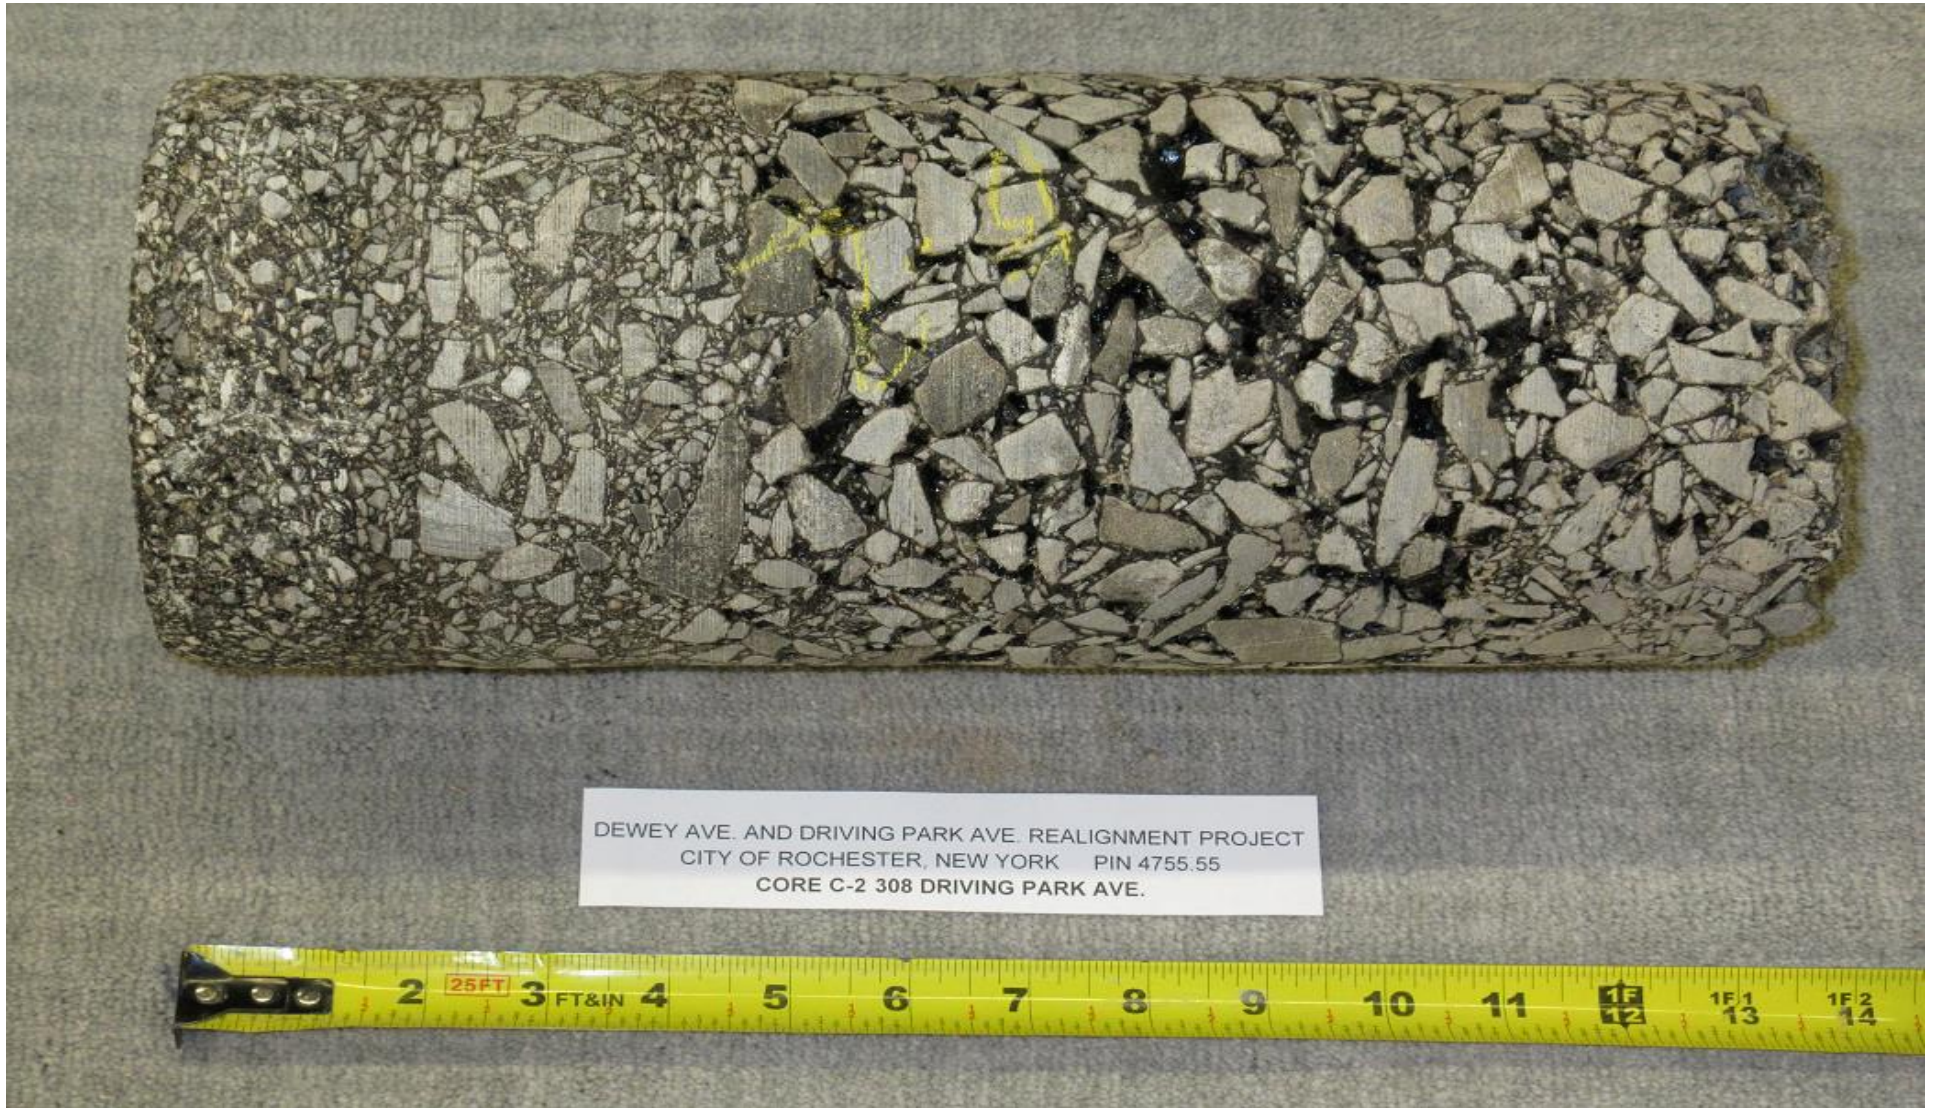
DEWEY AVE. AND DRIVIG PARK AVE. REALIGNMENT PROJECT DRIVING PARK AVE. ROCHESTER, NY	Site Plan:	Terracon CORE PHOTOGRAPHS EXHIBIT A-8
	Report Number: J5165113	
	Technician:	
	Date: Sept 2106	
	Scale: Not to Scale

DEWEY AVE. AND DRIVING PARK AVE. REALIGNMENT PROJECT
CITY OF ROCHESTER, NEW YORK PIN 4755.55
CORE C-2 308 DRIVING PARK AVE.

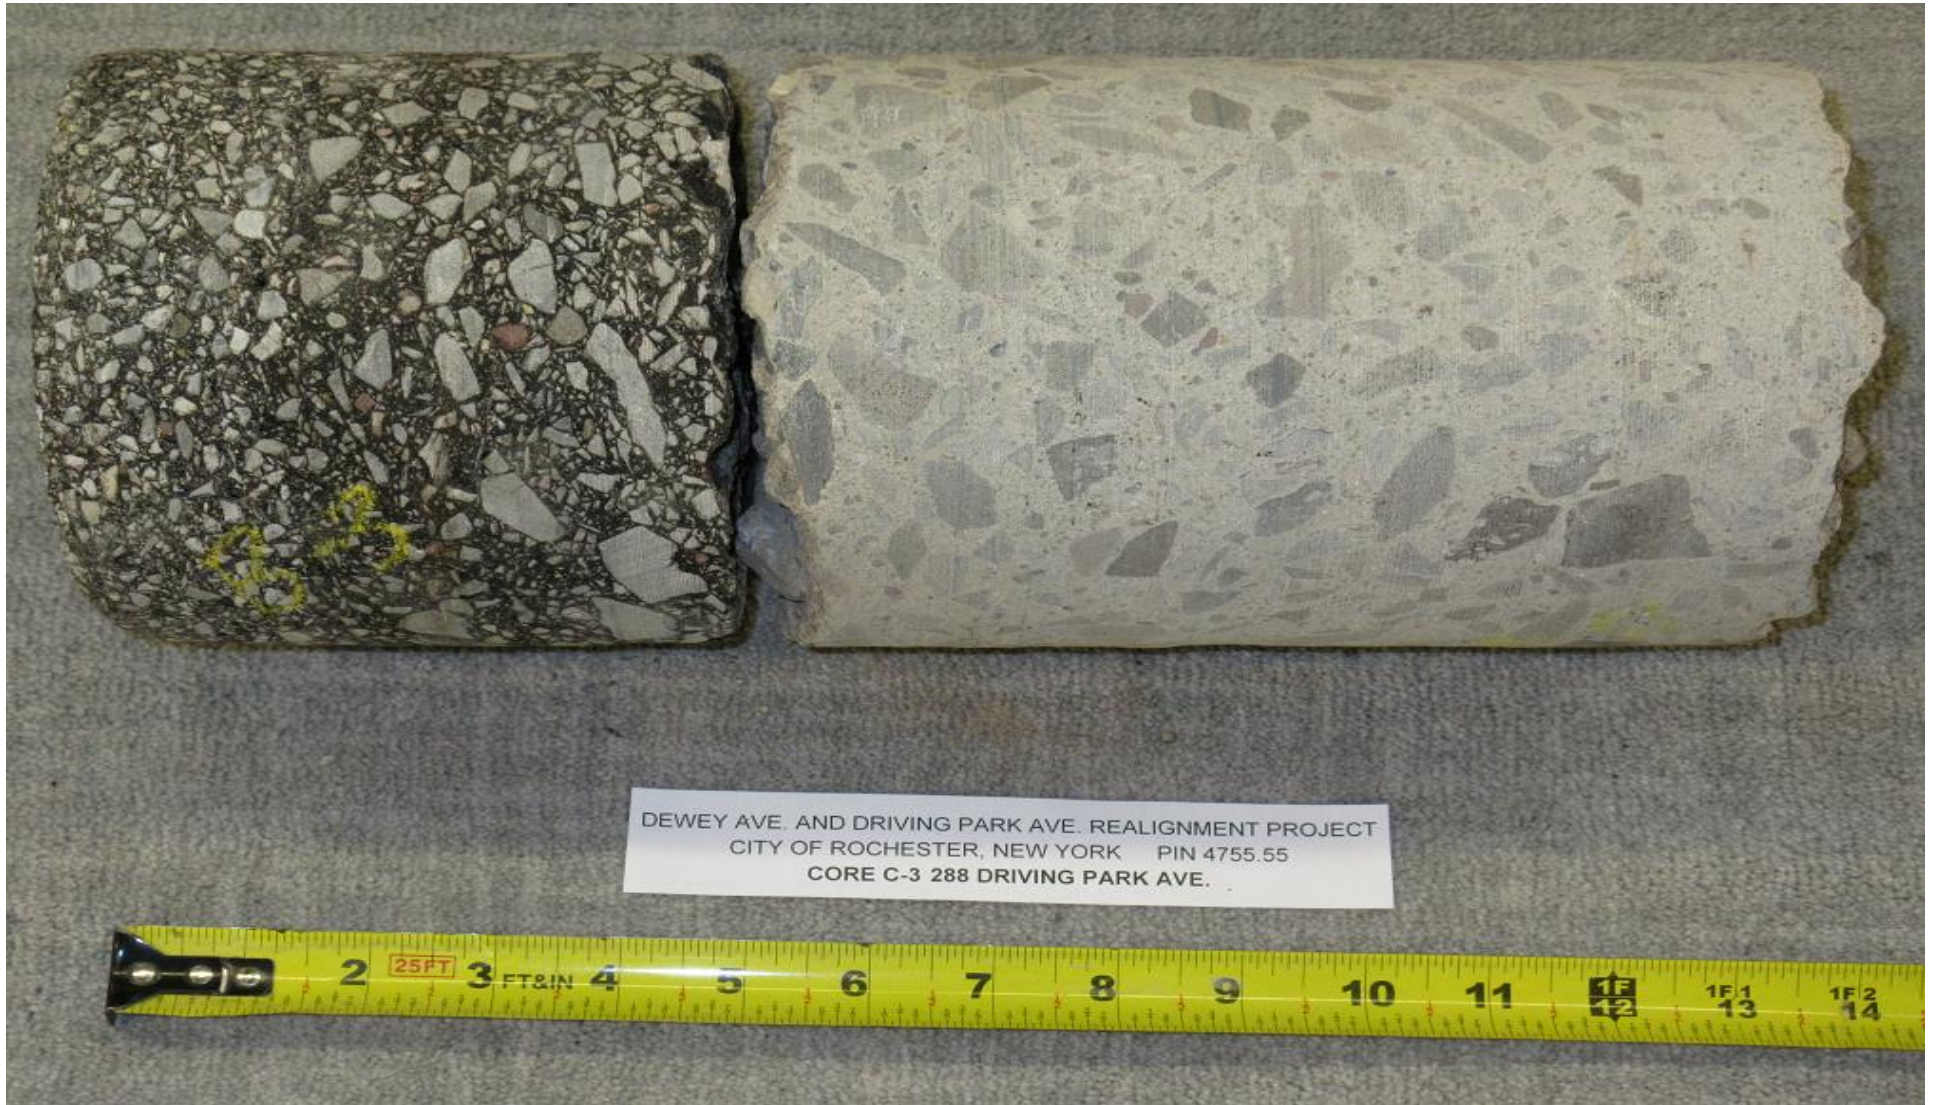
Report Number: J5165113	
	Technician:	
	Date: Sept 2106	
	Scale: Not to Scale	CORE PHOTOGRAPHS EXHIBIT A-9

DEWEY AVE. AND DRIVIG PARK AVE. REALIGNMENT PROJECT DRIVING PARK AVE. ROCHESTER, NY	Site Plan:
