CITY OF ROCHESTER
DEPARTMENT OF ENVIRONMENTAL SERVICES
30 CHURCH STREET
ROCHESTER, NEW YORK

**ASBESTOS MANAGEMENT PLAN
BUILDING INSPECTION INFORMATION**

**MUNICIPAL PARKING GARAGES, PARKING
VIOLATIONS BUREAU**

Genesee Crossroads Garage

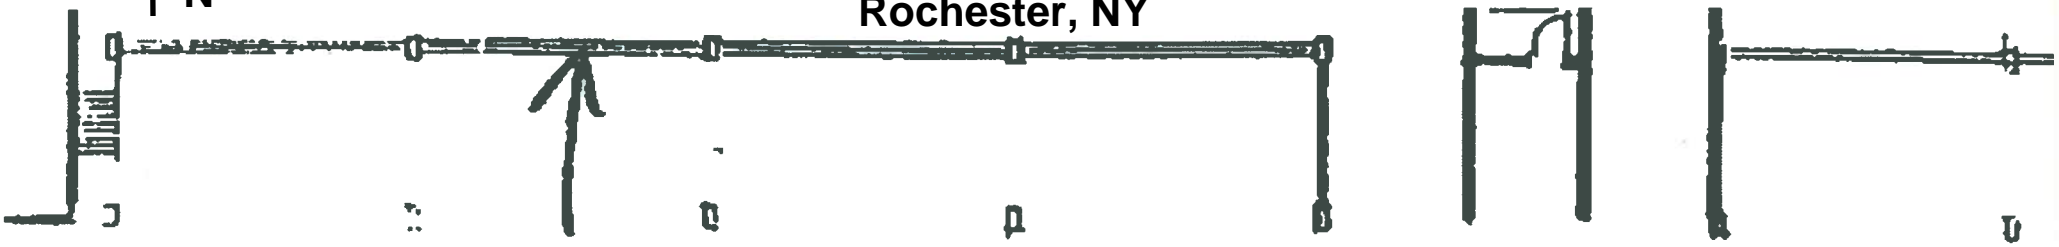
5.02N
LEVEL A

Bulk Sample Location Plan
Genesee Crossroads Garage
69 Andrews Street
Rochester, NY

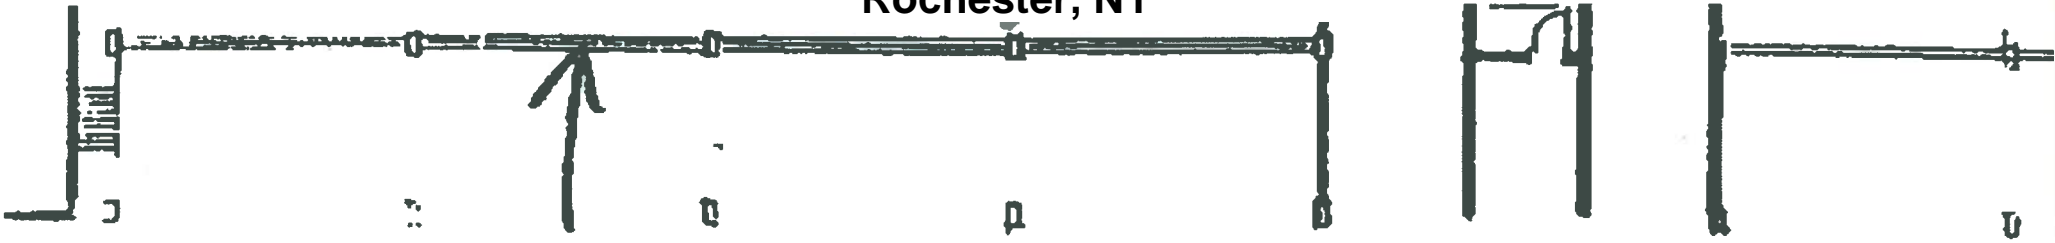
5.02N
LEVEL A

Asbestos Location Plan
Genesee Crossroads Garage
69 Andrews Street
Rochester, NY

- 1 Approximate Location of AC Tan Floor Tile
- 4 Approximate Location of AC Brown Cove Mastic
