## Midtown Tower Asbestos Survey Report

Prepared by  
David Morse  
Industrial Hygienist

June 14, 2002

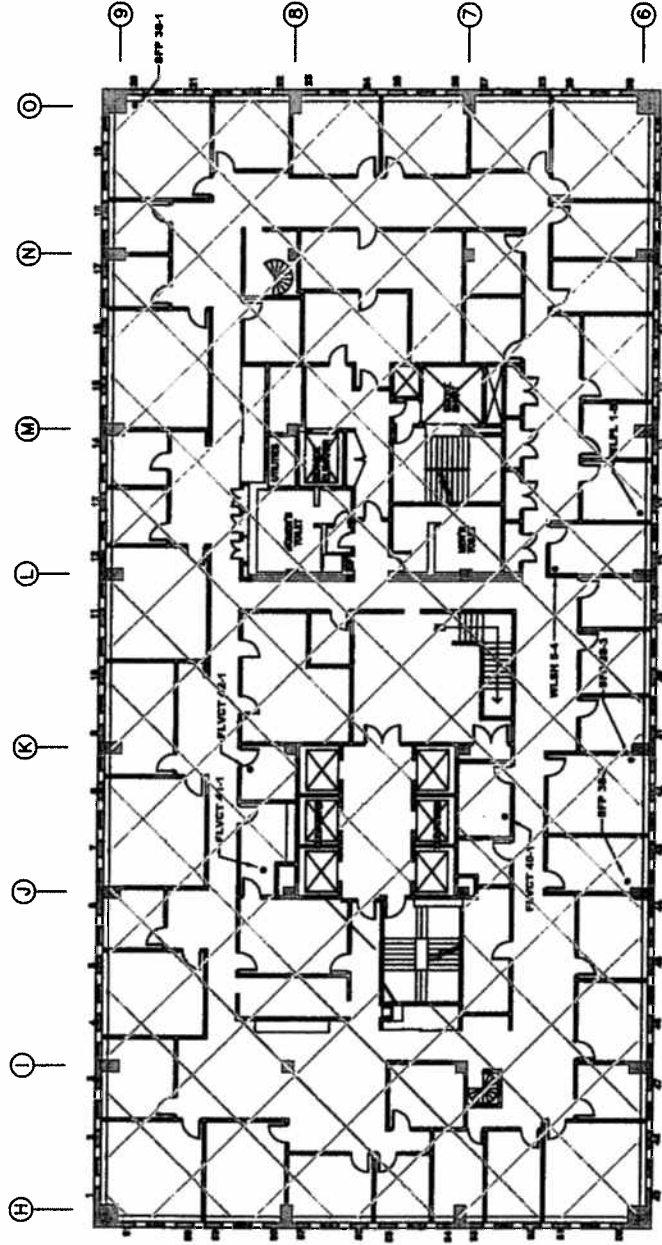
## MATERIAL SAMPLE AND LOCATION DRAWING

NOTE:  
ASBESTOS STRUCTURAL FIREPROOFING IS APPLIED TO STEEL MEMBERS INCLUDING BEAMS AND COLUMNS WITH CONCRETE OR Gypsum PACKAGES ON THE DECK AND OTHER EXISTING SURFACES WITHIN THE CEILING.

| LEGEND | ESTIMATED QUANTITY |
|---|---|
| ASBESTOS - CONTAINING STRUCTURAL FIREPROOFING | 16,890 SF |

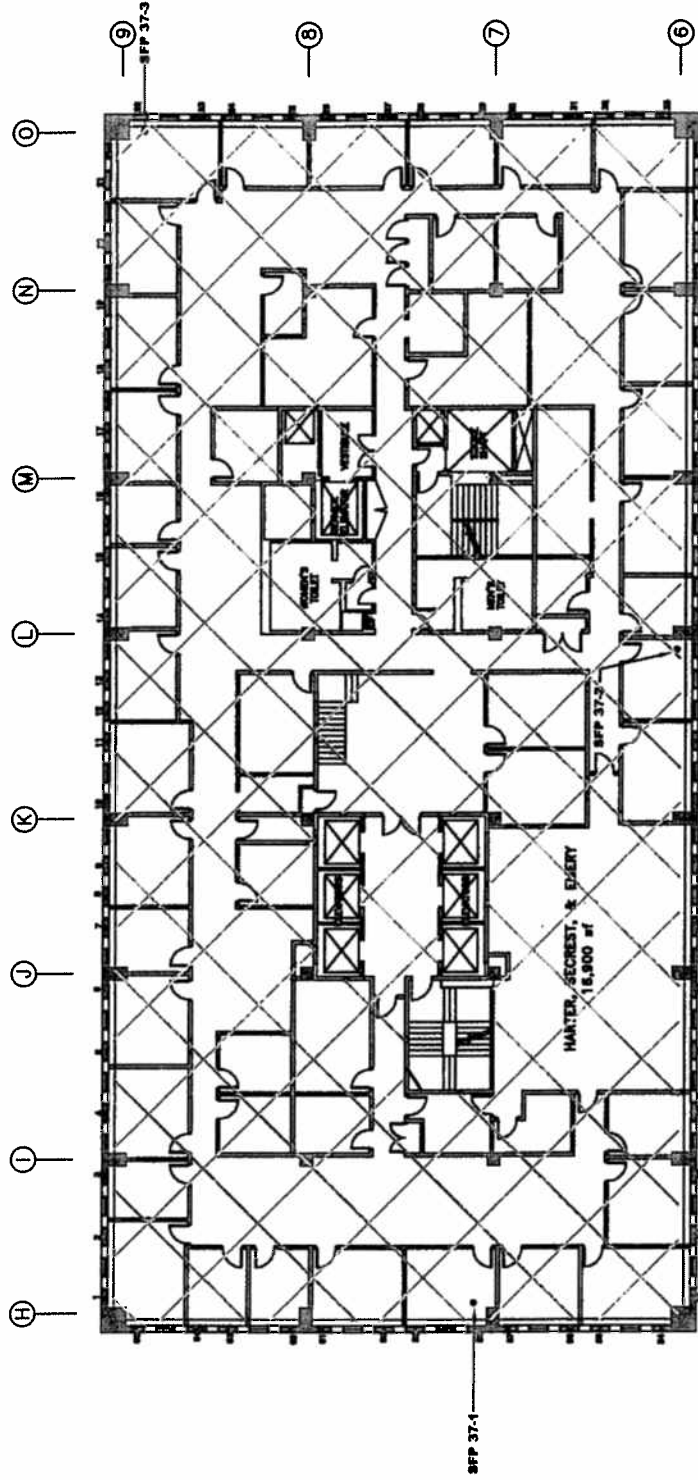
## MATERIAL SAMPLE AND LOCATION DRAWING

ASBESTOS STRUCTURAL FIREPROOFING IS APPLIED TO STEEL MEMBERS INCLUDING BEAMS AND COLUMNS WITH OVERSPRAY OF VARIOUS THICKNESSES ON THE DECK AND OTHER EXISTING SURFACES WITHIN THE CEILING.

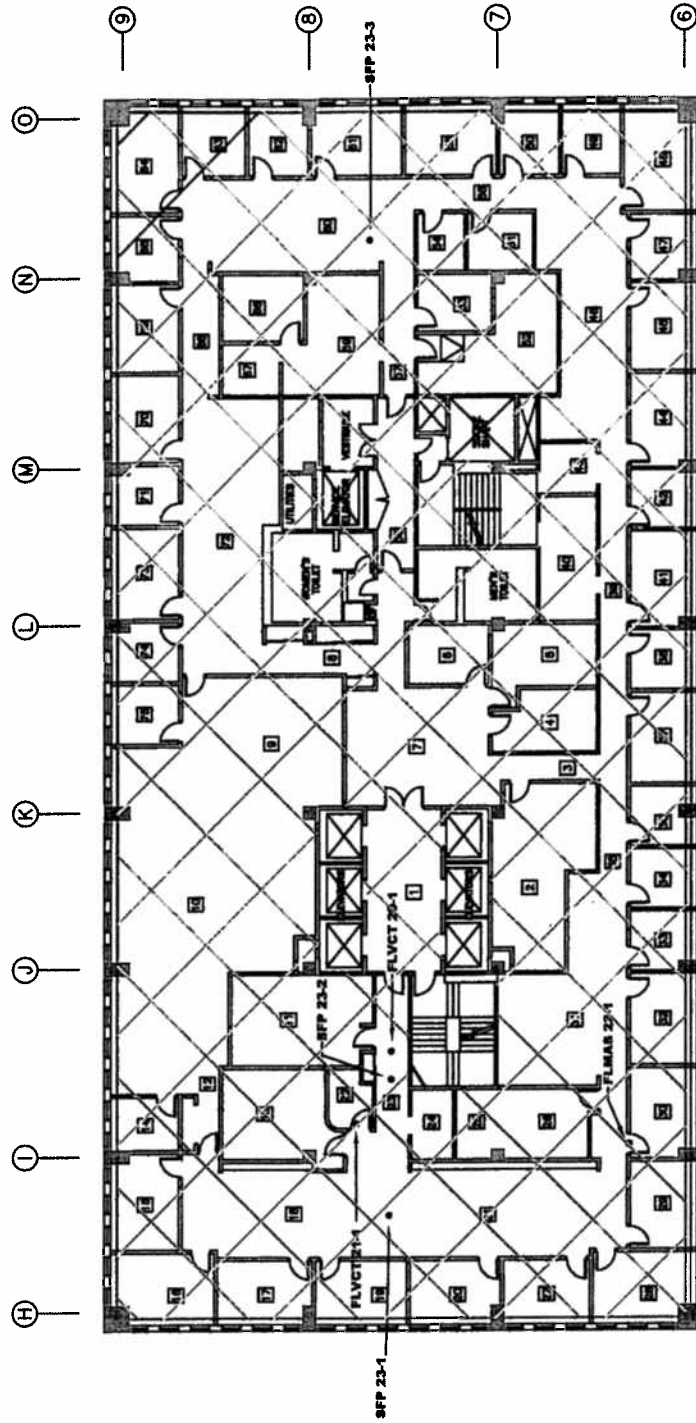
# MATERIAL SAMPLE AND LOCATION DRAWING

| LEGEND | ESTIMATED QUANTITY |
|---|---|
| ASBESTOS - CONTAINING STRUCTURAL FIREPROOFING | 10,690 SF |

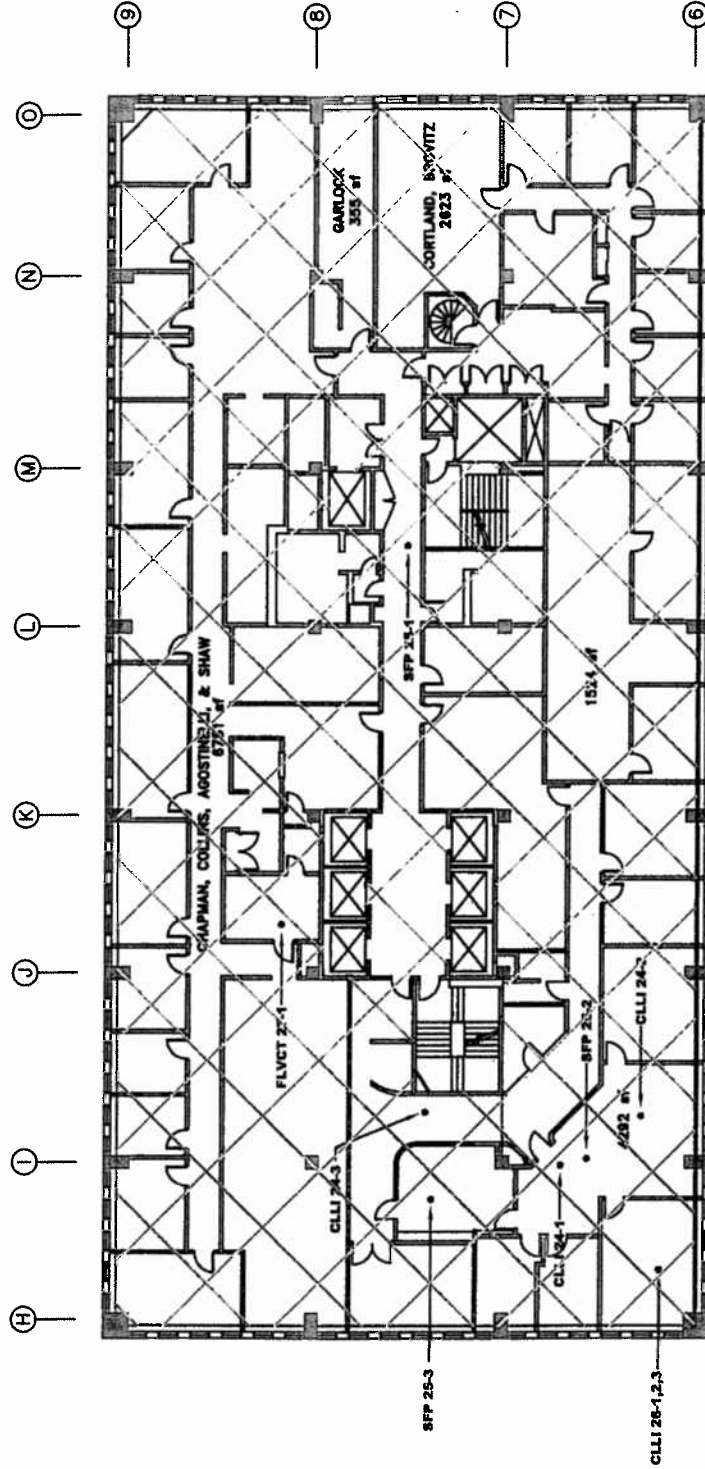
## MATERIAL SAMPLE AND LOCATION DRAWING

ASBESTOS STRUCTURAL FIREPROOFING IS APPLIED TO STEEL MEMBERS INCLUDING BEAMS AND COLUMNS WITH STEELWORK OR INSULATION EXPOSED ON THE DECK AND OTHER EXISTING SURFACES WITHIN THE CEILING.

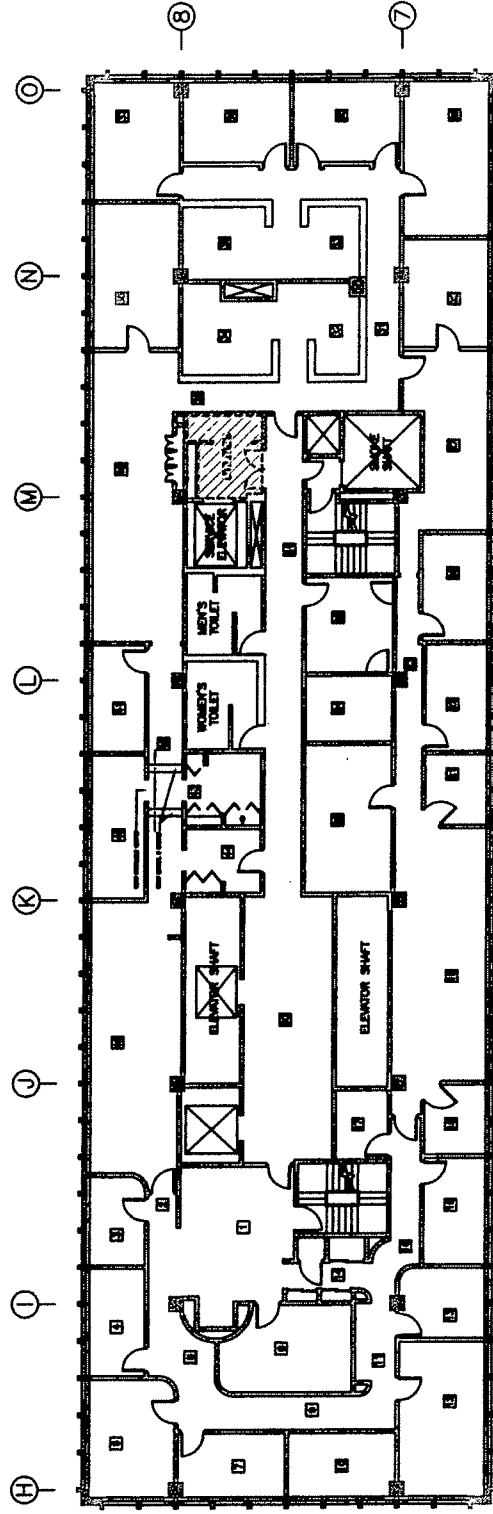
| LEGEND | ESTIMATED QUANTITY |
|---|---|
| ASBESTOS - CONTAINING CHILLER INSULATION | N/A |
| NOT SHOWN<br>ASBESTOS -CONTAINING PIPE INSULATION AND FITTING INSULATION | 100 LF |
