RUNDEL LIBRARY Parapet Monitoring – Drone Inspection

SEPTEMBER 2019

**RE: Rundel Library High Parapet Monitoring
115 South Avenue, Rochester NY
LaBella Project No. 2171916.08**

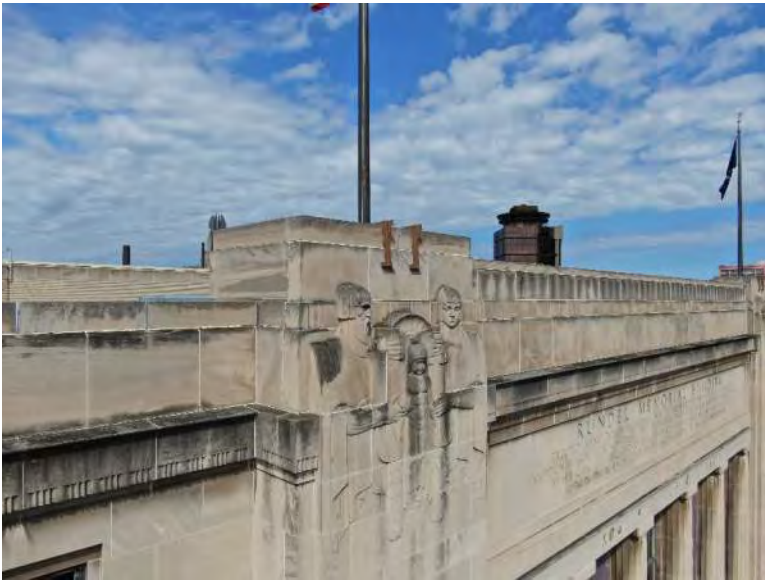
PHOTO 9
West Parapet

- Sealant deterioration and gaps are visible along the entire length of the northern portion of the west parapet in the horizontal joint between the stone façade panels and the parapet cap stones. [Photos 8 - 9]
 - These blocks do not appear to be out-of-plane or leaning away from the structure.

Sealant gaps along tops of panels

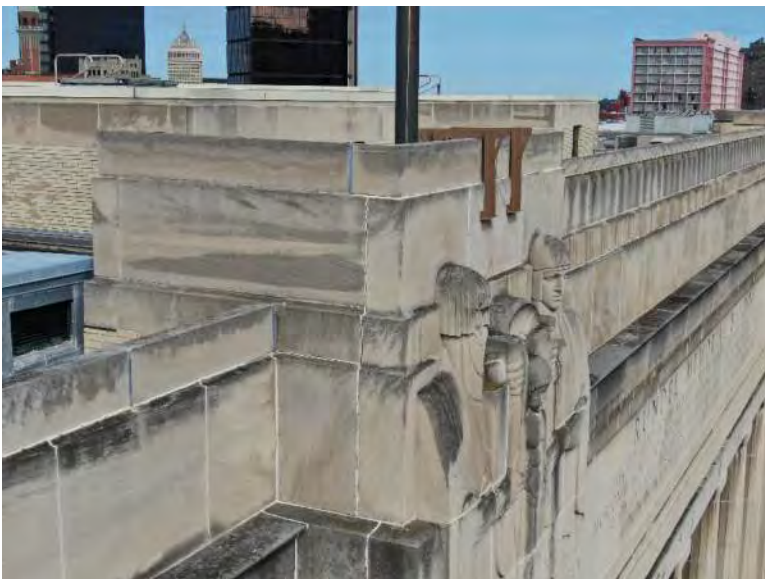
PHOTO 10

Documentation photos of the braced portions of the east and west parapets have been included in Appendix A. [Photos 10 - 21]
