B.I.N. 2211290

Feature Carried PONT DE RENNES (RED BRIDGE)

# 2012 INSPECTION

PROJECT: PONT DE RENNES PEDESTRIAN  
BRIDGE OVER GENESEE RIVER  
DETAILED INSPECTION  
BIN 2211290  
CITY OF ROCHESTER DEPARTMENT  
OF ENVIRONMENTAL SERVICES

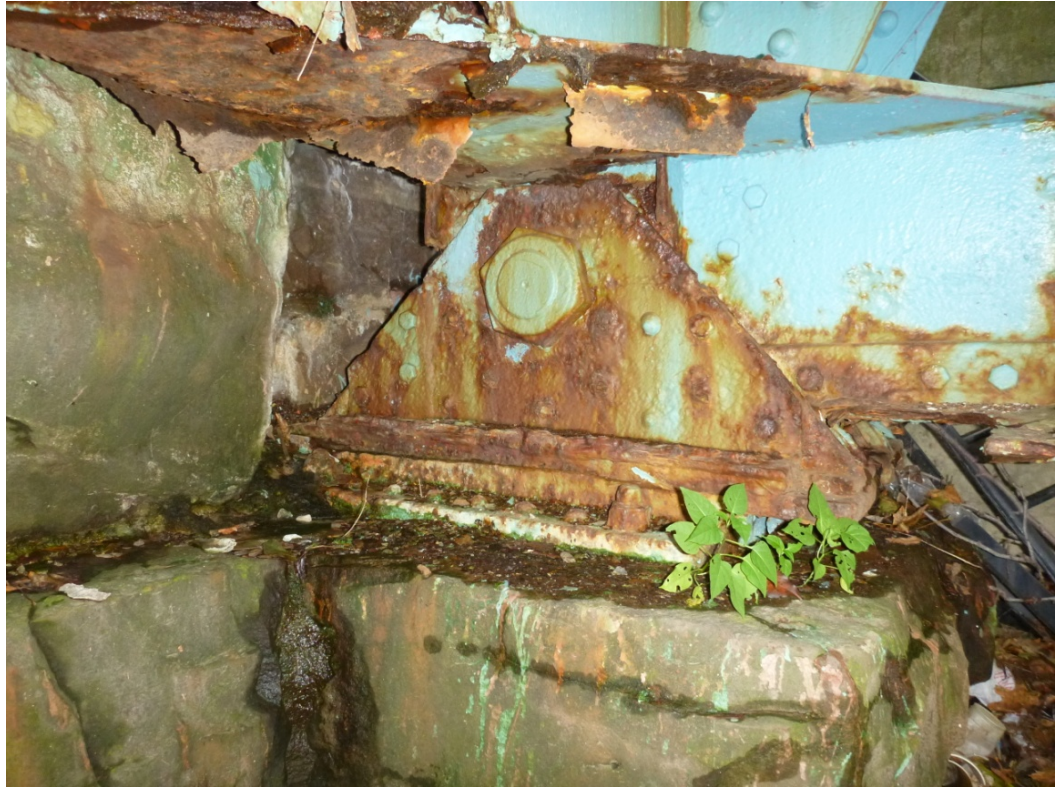
**PHOTO NO. 3****Location:**

Expansion Bearing is corroded and frozen.

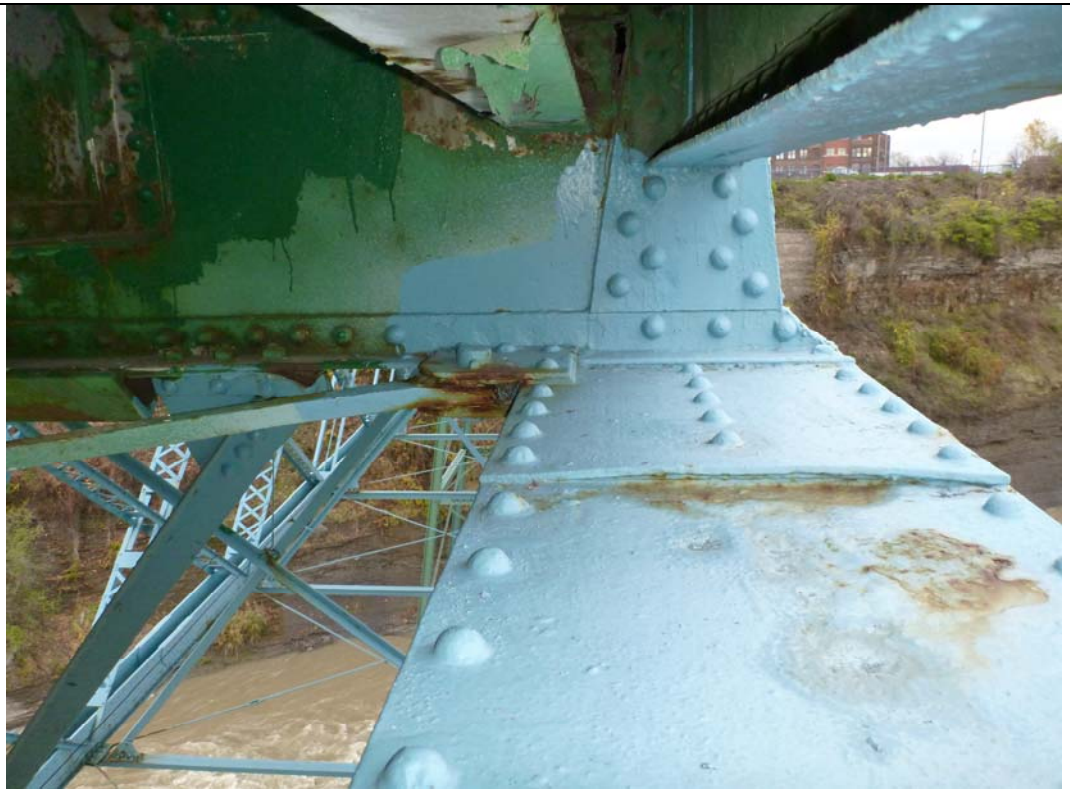
**PHOTO NO. 26****Location:**

| • Right truss at U3 – Approximately 6"x1" hole in floorbeam web near fascia stringer connection. (See Photo 26) |

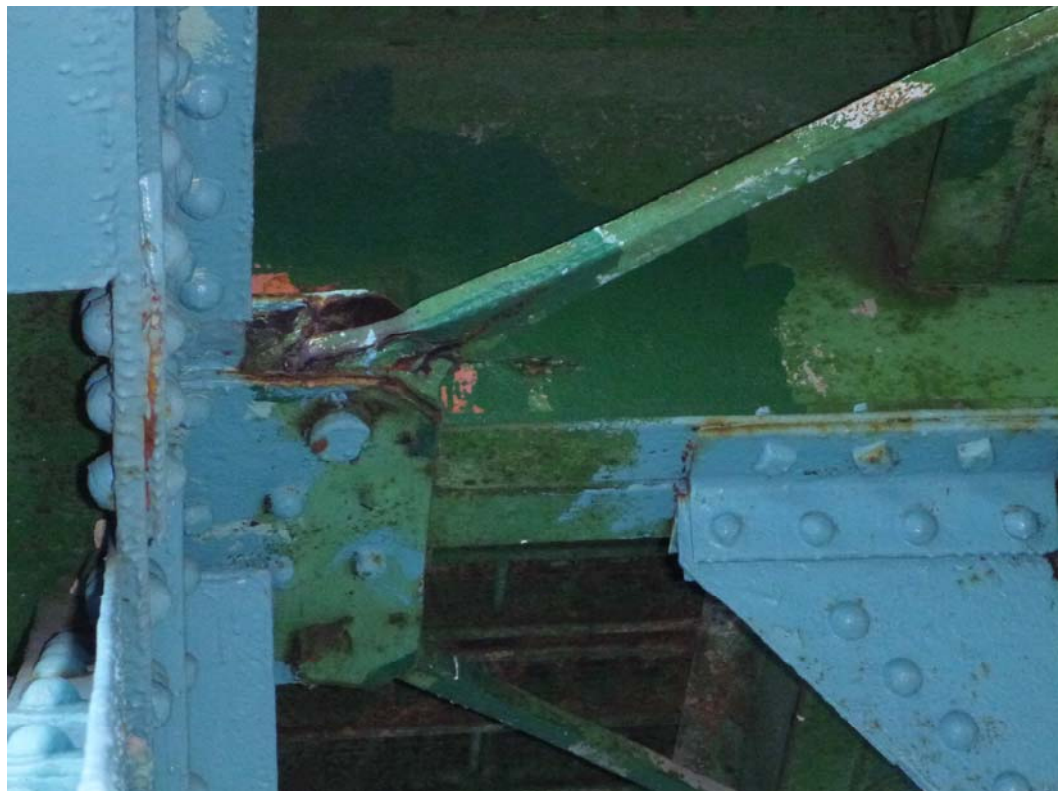
**PHOTO NO. 39****Location:**

• Right truss top lateral bracing at U7 West – Eyebar partially cracked at forging
• Right truss top lateral bracing at U7 East – Eyebar partially cracked at forging (See Photo 39)

Eyebar partially cracked and  
separated at forging.

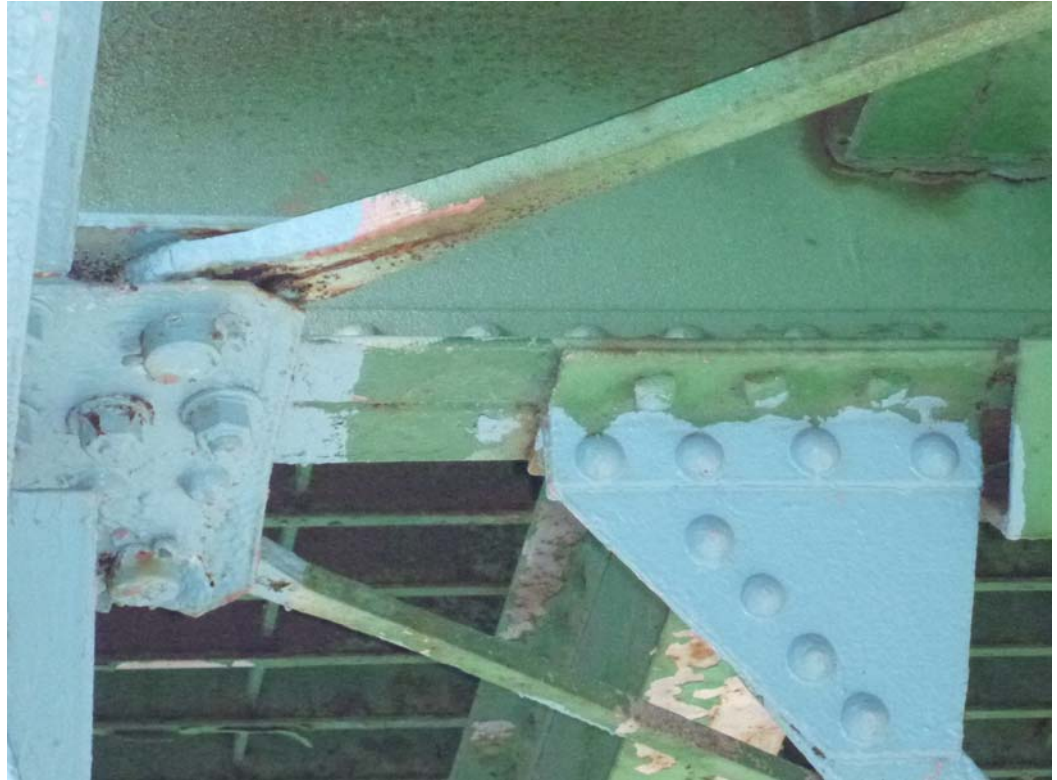
**PHOTO NO. 40****Location:**

• Left truss top lateral bracing at U1 East – Eyebar cracked at forging (See Photo 40)
• Left truss top lateral bracing at U2 West – Significant pack rust at eyebar forging, deflection in top and bottom plate of eyebar connection

Eyebar cracked and  
separated at forging.

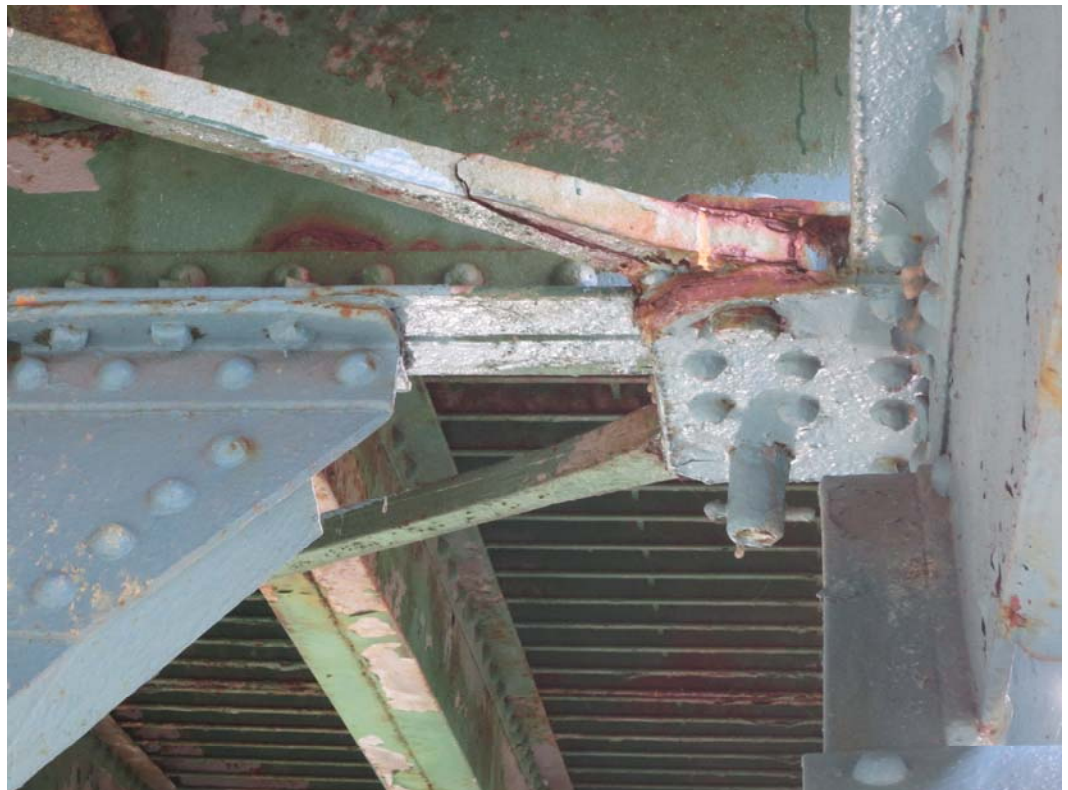
**PHOTO NO. 41****Location:**

• Left truss top lateral bracing at U8 East – Significant pack rust at eyebar forging, deflection in top and bottom plate of eyebar connection (See Photo 41)

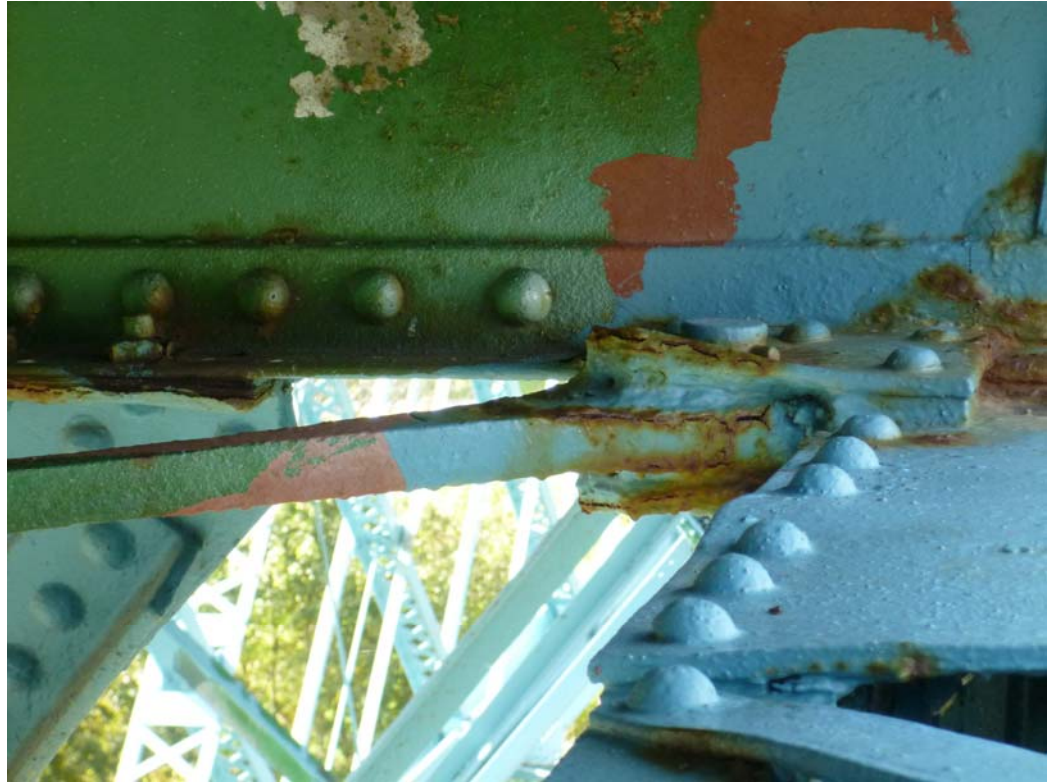
**PHOTO NO. 42****Location:**

• Left truss bottom lateral bracing at L7 East - Significant pack rust at eyebar forging (See Photo 42)
• Left truss bottom sway bar connection at L7 – Section loss on sway bar connection plate at strut

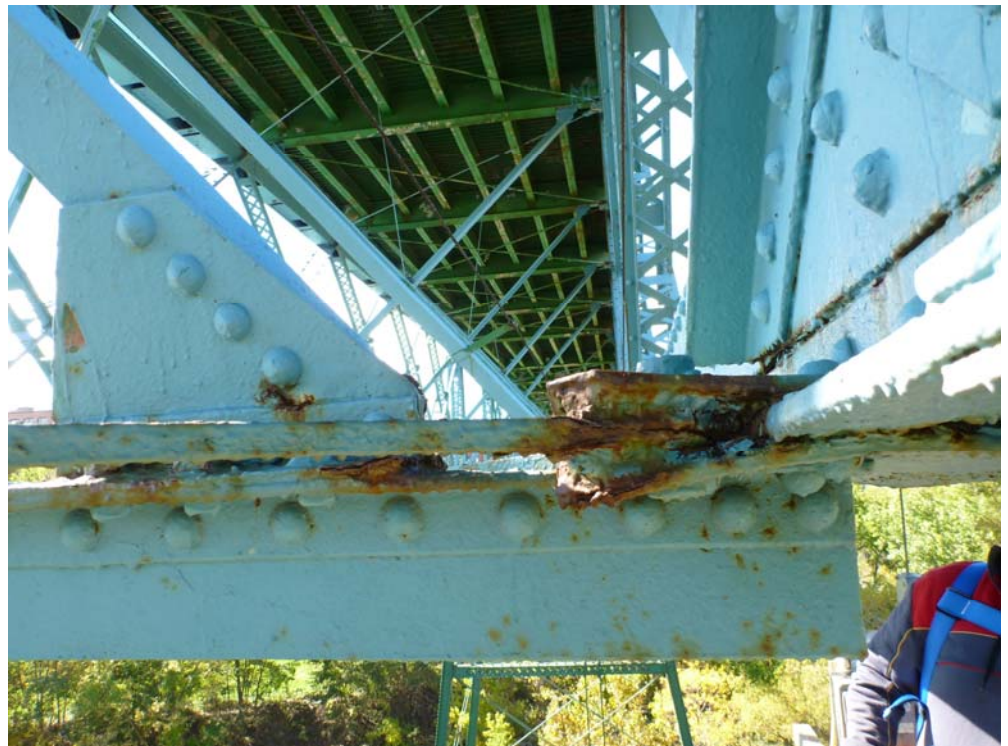
**PHOTO NO. 43****Location:**

• Left truss top lateral bracing at U5 East - Eyebar cracked at forging (See Photo 43)
• Left truss top lateral bracing at U6 West - Eyebar partially cracked at forging

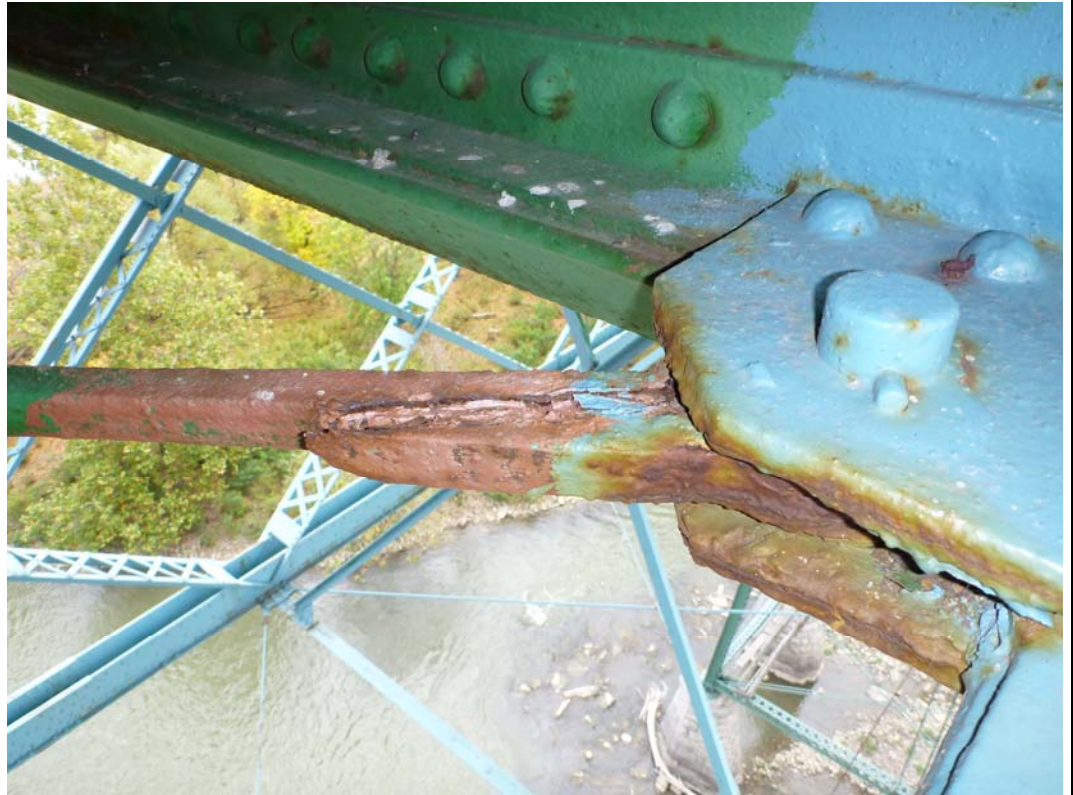
**PHOTO NO. 44****Location:**

• Left truss top lateral bracing at U8 West - Eyebar cracked at forging
• Left truss bottom lateral bracing at L1 West - Eyebar cracked at forging (See Photo 44)

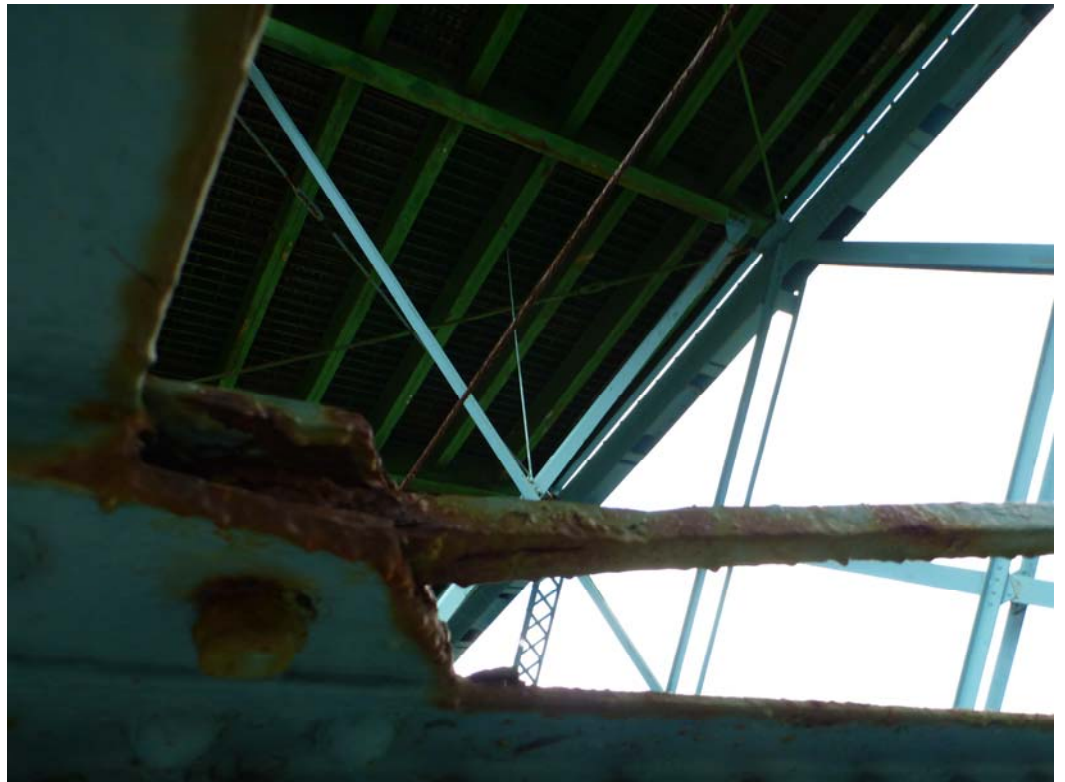
**PHOTO NO. 45****Location:**

• Left truss bottom lateral bracing at L3 West - Eyebar partially cracked at forging
• Left truss bottom lateral bracing at L4 – Hole and section loss in bottom plate of eyebar connection (See Photo 45)
