Rochester Animal Services

Masterplan and Facility Assessment Report

May 25, 2023

Purpose and Method

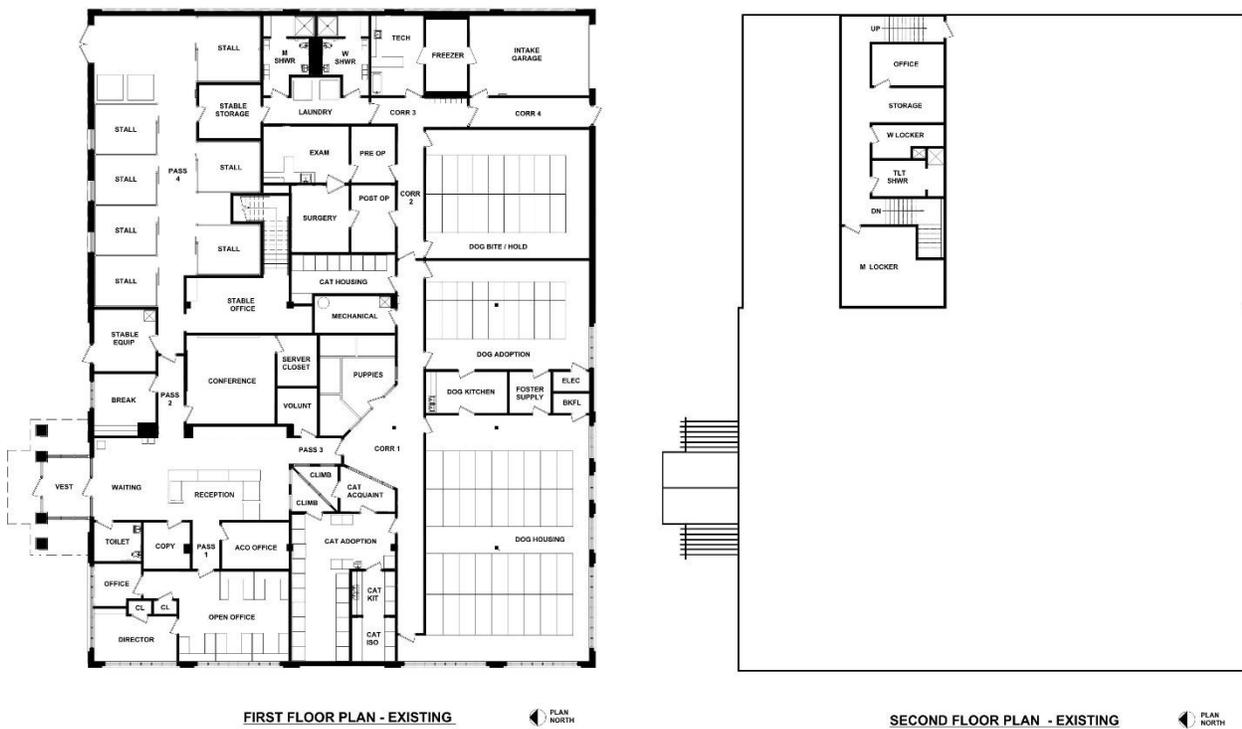
Existing two-story building, shared by Rochester Animal Services and Rochester Mounted Police.

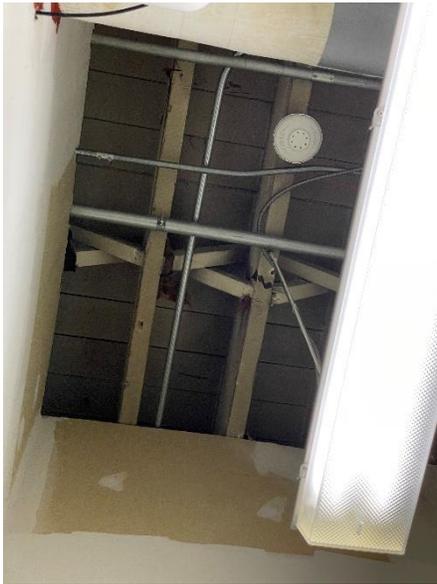
Left: Wood roof framing at original building.

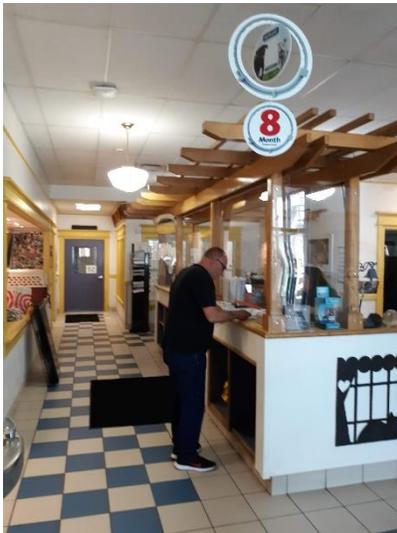
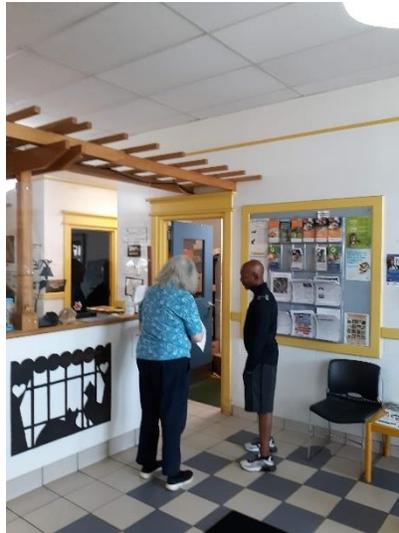
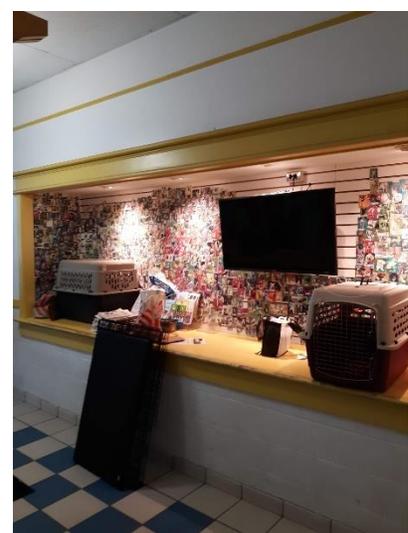
- Door: (Vestibule/Reception) Aluminum-framed storefront, w/ insulating glass – good condition.
- Flooring: 12" x 12" ceramic or porcelain tile – excellent condition.
- Wall base: 6" x 12" ceramic or porcelain tile – excellent condition.
- Walls: CMU wainscot, gypsum wall board – good condition.
- Running trim: Painted, wood chair rail and trim around metal door frames – good condition.
- Ceiling: Suspended acoustical panel, various textures – good condition.
- Plumbing: High/low accessible water cooler – excellent condition.
- Fire extinguisher cabinets: (rusting) – poor condition.

Left: Guests are received at the short side of the reception desk. Right: A recessed retail display wall opposite the long side of the reception desk has been repurposed.

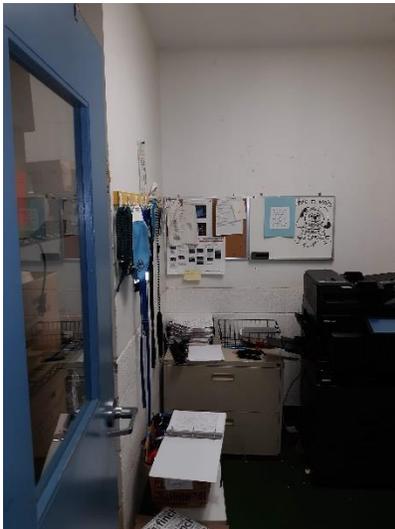
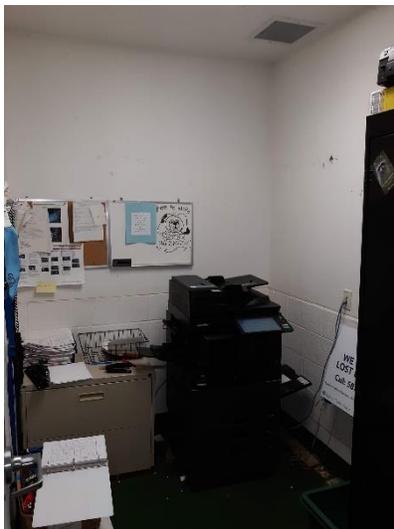
The entrance to this room is not quite behind the reception desk, and its contents are visible to the public lobby. Bins and boxes lay directly on the floor.

The entrance to this room is not behind the reception desk, and its contents are visible to the public.

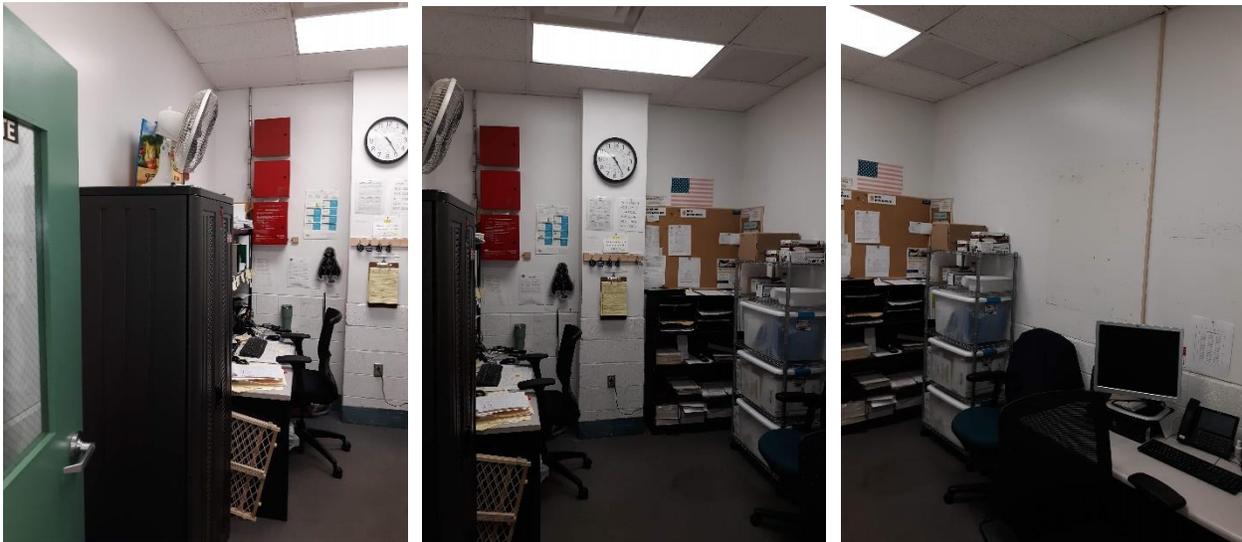
- Door: Hollow metal w/ half-lite wire glass, lever-handle lock, closer, kick plate – good condition.
- Door frame: Hollow metal with hospital stops – good condition.
- Flooring: Carpet – poor condition.
- Walls: CMU wainscot, gypsum wall board – good condition.
- Wall base: Rubber – good condition.
- Ceiling: Suspended acoustical panel – poor condition.
- Workstations: Laminated countertop – poor condition.
- Equipment: Four-drawer vertical file, wire shelving, bookshelf, tall, two-door, plastic cabinet.

This office is occupied by the Animal Control Officers (ACO's). Each has a countertop style workstation.

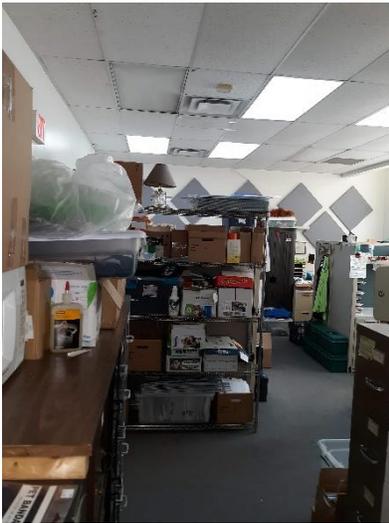
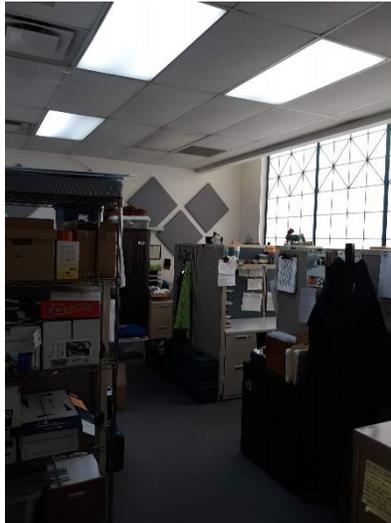
This back-of-house open-office space contains five U-shaped systems-furniture “cubicle” workstations. The cubicles themselves are efficiently arranged. There is insufficient space for the many storage cabinets, bins, shelving, and filing cabinets. Consequently, these items are poorly placed. In some cases, bins and boxes lay directly on the floor and within circulation paths.

- Door: Hollow metal, butt hinges, ½-lite wired glass, lever-handle lock – good condition.
- Door frame: Hollow metal with hospital stops – good condition.
- Flooring: Carpet – poor condition.
- Walls – north, south, and east: CMU wainscot, gypsum wall board – good condition.
- Walls – west: Gypsum wallboard - good condition.
- Wall base: Vinyl – good condition.
- Ceiling: Suspended acoustical panel – poor condition.
- Window treatments: None.

Open Office: There is insufficient space for the many storage cabinets, bins, shelving, and filing cabinets.

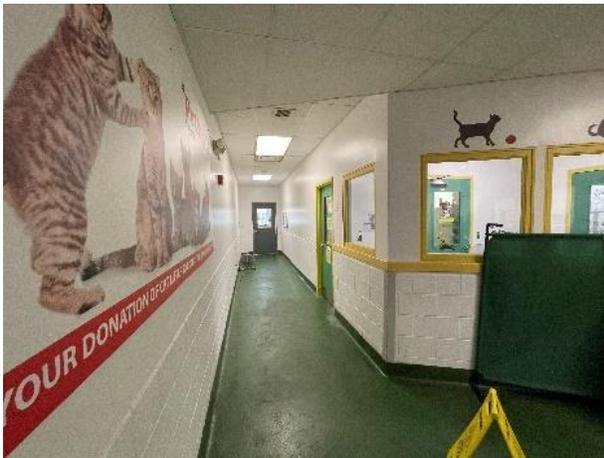
View westward

This non-secured corridor is accessed from the south end of Reception and is the primary back-of-house corridor linking animal housing, adoption, and building utility spaces. View windows provide staff an opportunity for passive observation of dog and cat adoption and acquaintance spaces. We observed the following code deficiency: West end of corridor presents a dead end exceeding 20 feet (BCNYS1020.4).

- Door: Wood, continuous-hinge, ½-lite wired glass, closer, passage set, kickplate – good condition.
- Door frame: Hollow metal with hospital stops – good condition.
- Flooring: Smooth epoxy – poor condition.
- Wall base: Integral epoxy – good condition.
- Walls: North: CMU wainscot, gypsum wall board, painted, wood chair rail – good condition.
- Ceiling: Suspended acoustical panel, various textures – good condition.
- Fire extinguisher cabinet, near Mech Room (rusting) – poor condition.

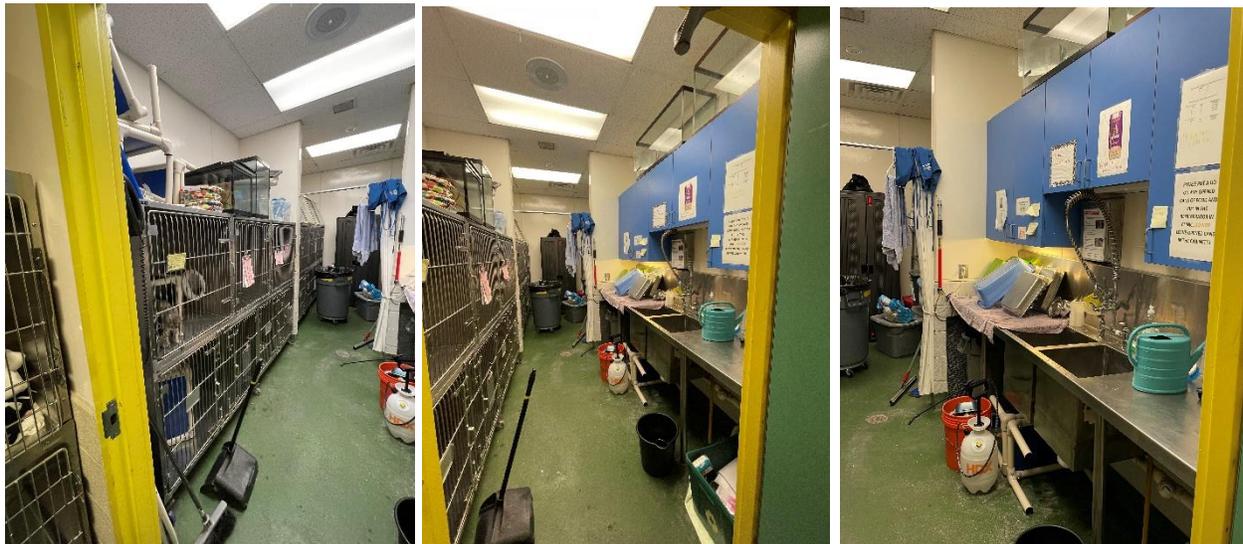
This space is accessed directly from Cat Adoption. Due to space constraints within the shelter, over-flow cat housing flanks the south wall, only a few feet opposite from where food is prepared and dishes are washed.

- Door: Hollow metal, continuous hinge, closer, passage levers, kick plate – good condition.
- Door frame: Hollow metal with hospital stops – good condition.
- Floor: Smooth epoxy – poor condition.
- Wall base: Integral epoxy – poor condition.
- Walls – north and south: CMU wainscot, wall protection panel above – good condition.
- Ceiling: Suspended acoustical panel, various textures – good condition.
- Millwork: Plastic-laminate, wall-hung cabinetry over sink area – good condition.
- Equipment: Trash cans, plastic bins, cleaning supplies, cat cages flanking the south wall.
- Plumbing: Floor drain, stainless steel counter and splash with integral deep sink, faucet w/ spray hose – excellent condition.

Views westward, overflow cat housing flanks the south wall, a few feet from food preparation activities.

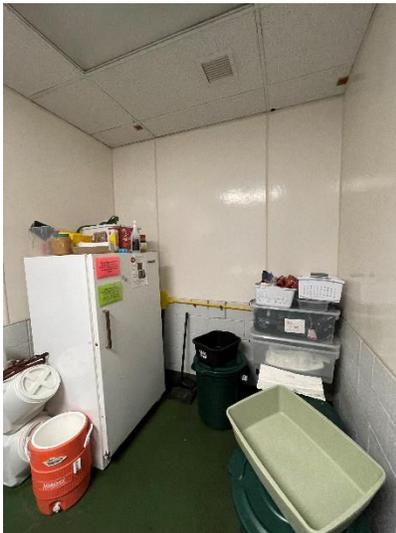
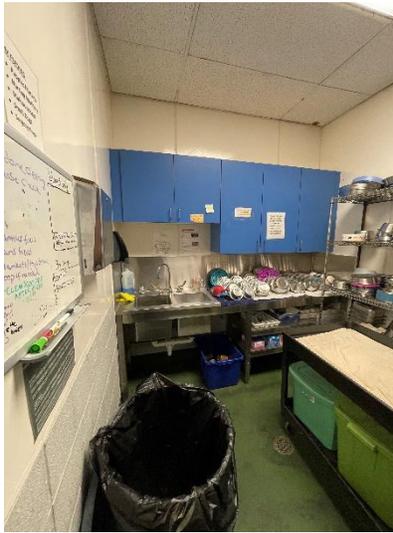
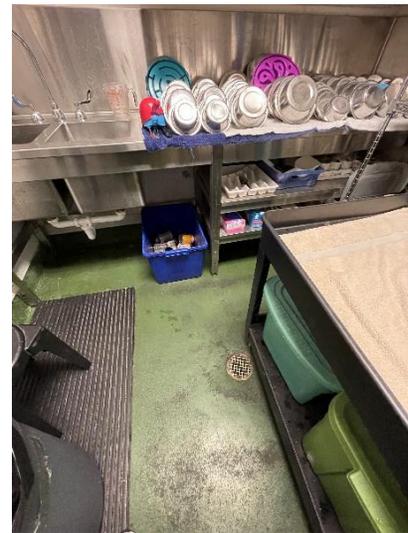
This space is between Dog Housing and Dog Adoption and may be accessed from either side. For lack of shelving or storage cabinets, some supplies are stored directly on the floor.

- Door: Hollow metal, wire glass, continuous hinge, closer, privacy lever lock – good condition.
- Door frame: Hollow metal with hospital stops – good condition.
- Floor: Smooth epoxy – poor condition.
- Wall base: Integral smooth epoxy – good condition.
- Walls: CMU wainscot, wall protection panel above – good condition.
- Ceiling: Suspended acoustical panel, rusting grid – poor condition.
- Millwork: Plastic-laminate, wall-hung cabinets – good condition.
- Equipment: Trash can, storage cans, dry-erase board, wall-hung paper towel dispensers, small recycle bin, stainless steel, wire shelving unit, plastic food-storage bins, refrigerator, broom rack, and dustpan, mobile, plastic-surface cart.
- Plumbing: Floor drain, stainless steel counter and splash with integral deep sink, faucet w/ spray hose – excellent condition.

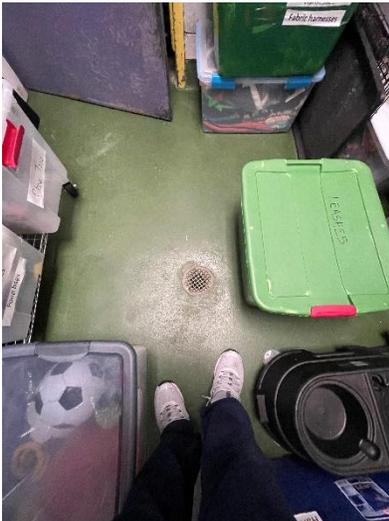
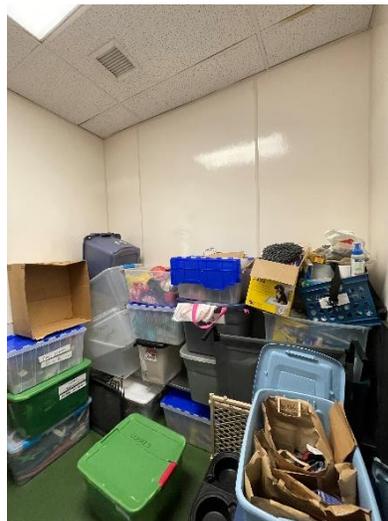
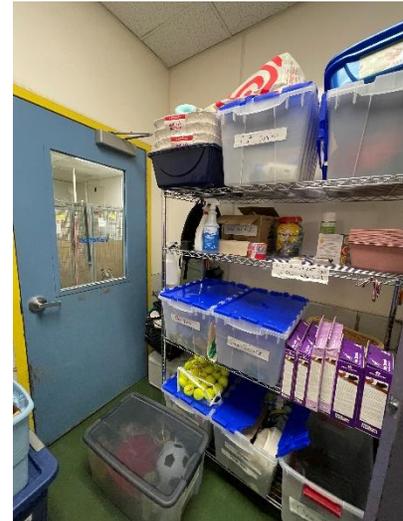
This space is between Dog Housing and Dog Adoption and may be accessed from either side. Additional shelving units might help to de-clutter this space and maximize its potential. Movement is restricted by the number of items sitting directly on the floor.

- Door: Two hollow metal doors, each w/ ½-lite, continuous hinge, closer, lever lock – good condition.
- Door frame: Hollow metal with hospital stops – good condition.
- Floor: Smooth epoxy – poor condition.
- Wall base: Integral smooth epoxy – good condition.
- Walls:
 - North, east, west: CMU wainscot, wall-protection panel above – good condition.
 - South: CMU wainscot, wall-protection panel above – poor condition.
- Ceiling: Suspended Acoustical Panel, rusting grid – poor condition.
- Equipment: Plastic-bin storage containers, stainless steel wire shelving unit.

Additional shelving units might help to de-clutter this space and maximize its potential.

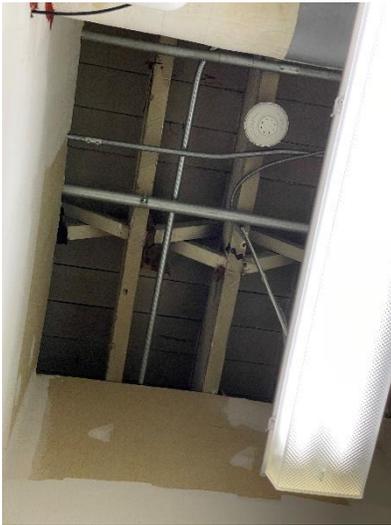
This space is where the water service enters the building. There is no finished ceiling to conceal the roof structure at this area, which is wood plank over wood joists. Unrelated supplies obstruct full access to the water service equipment, another indicator that the facility is lacking proper storage space elsewhere.

Wood roof structure above.

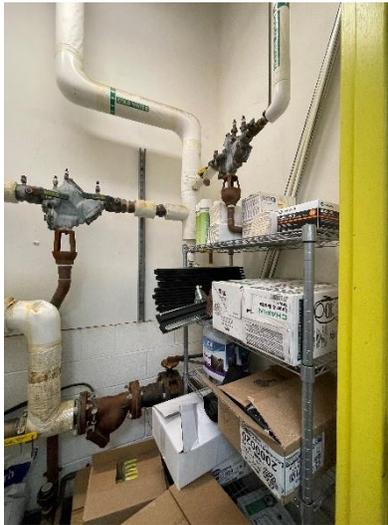
The Backflow Preventor room doubles as a supply storage space.

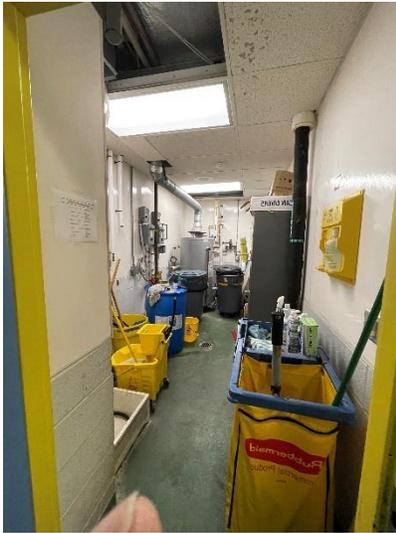
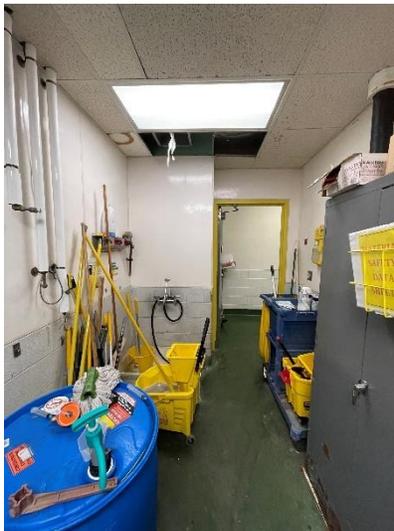
Access to this room is from the main back-of-house corridor. This room is sufficiently sized to not only house typical mechanical and electrical equipment, but also a janitor's mop sink and cleaning carts. Piping on the wall remains from an abandoned plumbing system that has been partially removed.

Piping on the wall remains from an abandoned plumbing system that has been partially removed.

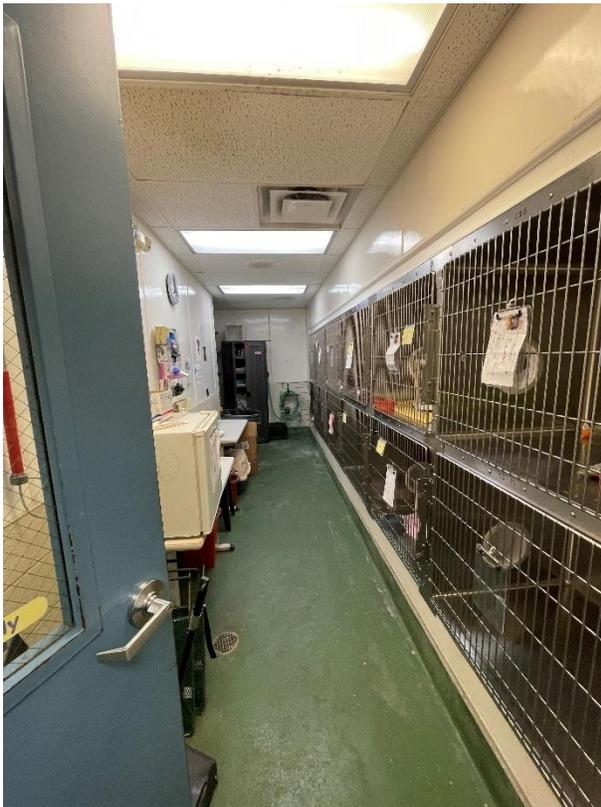
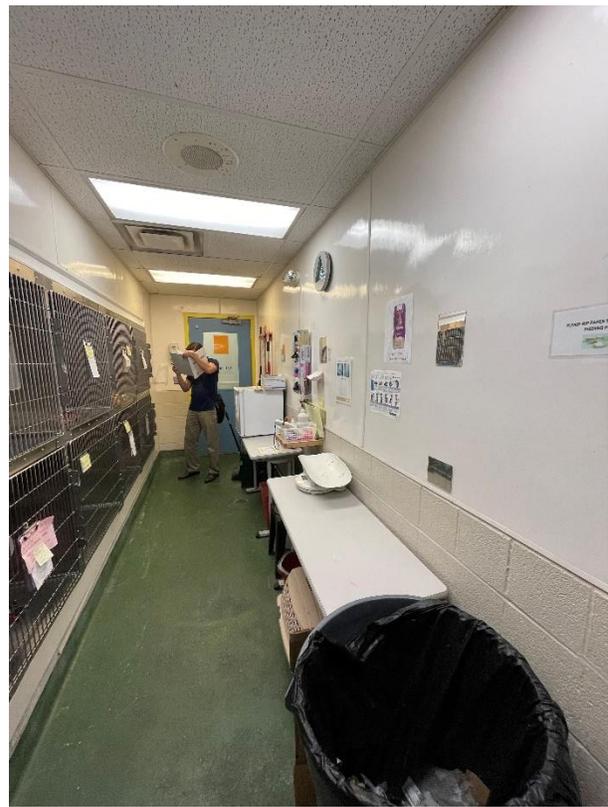
Cat Housing

Stainless steel cat cages with portals are in excellent condition.

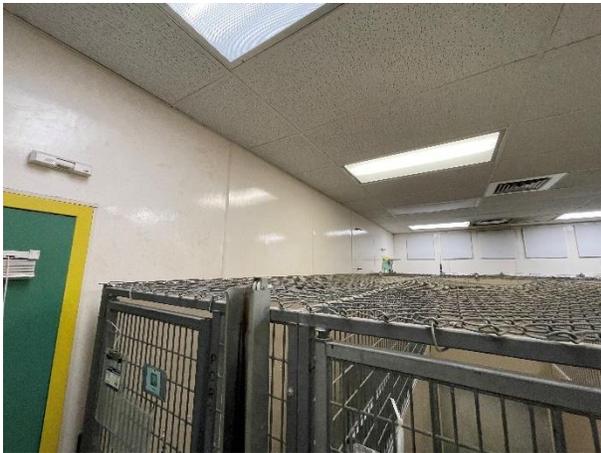
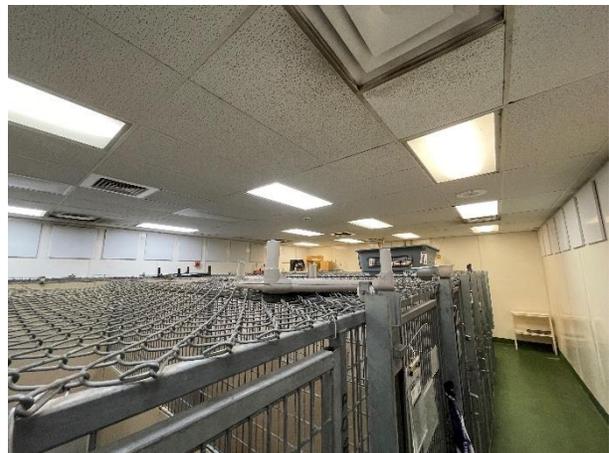
There are nine double-sided runs, each serving one dog.

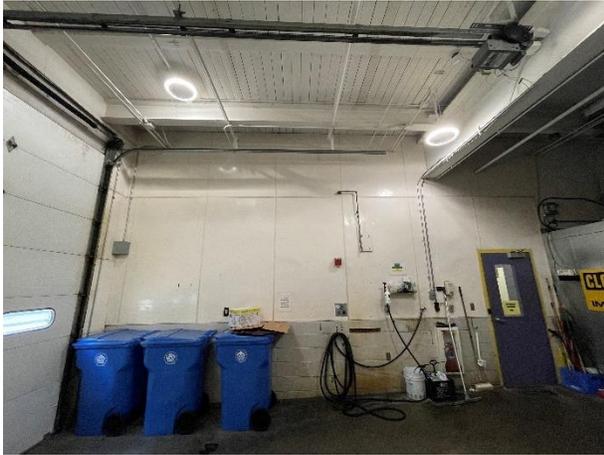
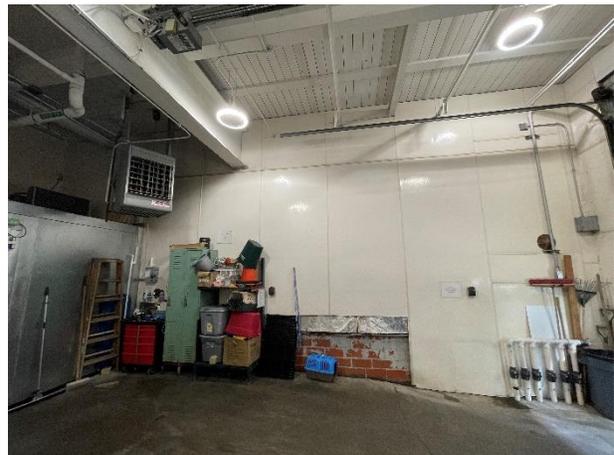
- Door: Hollow metal, ¼-lite wired glass, lever lockset, e-strike, card reader – good condition.
- Door frame: Hollow metal – good condition.
- Floor: Unfinished concrete – good condition.
- Wall base: None
- Walls:
 - North, south: Wall-protection panels – good condition.
 - East: Wall-protection panels (missing section, clay tile exposed) – poor condition.
 - West: CMU wainscot, wall-protection panels above – good condition.
- Ceiling: Exposed metal decking – good condition.
- Equipment: Three city-issued trash containers, broom, squeegee, floor cleaner concentrate, stepladder, mobile tool chest, two metal lockers, wire shelving unit with plastic storage bins and pet carriers.
- Plumbing: hose rack, floor drain.
- Fire extinguisher (west wall) is rusting – poor condition.

An overhead door at the south end of the Intake Garage opens onto Brown Street.

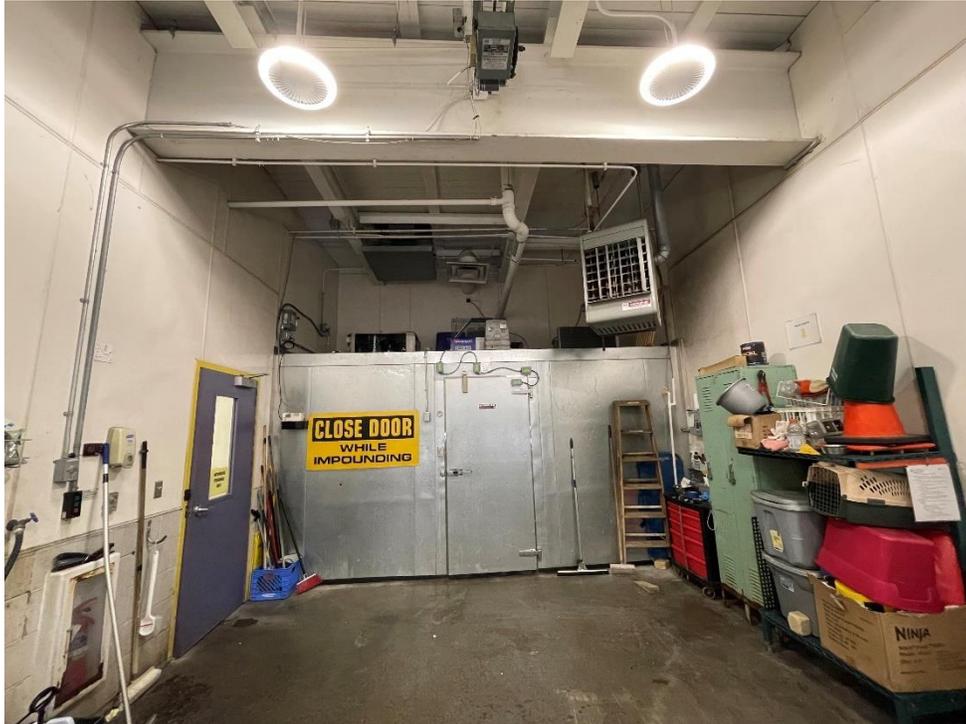
Freezer

The freezer sits within the north end of the Intake Garage and has a second door opening onto the Technician's Room. Rochester's Street Maintenance Department shares the freezer with the shelter and accesses it via the Intake Garage. Shelter staff indicated that the freezer may not be maintaining temperature exactly as it should – good condition.

The freezer sits within the Intake Garage and has a second door opening onto the Technicians Room.

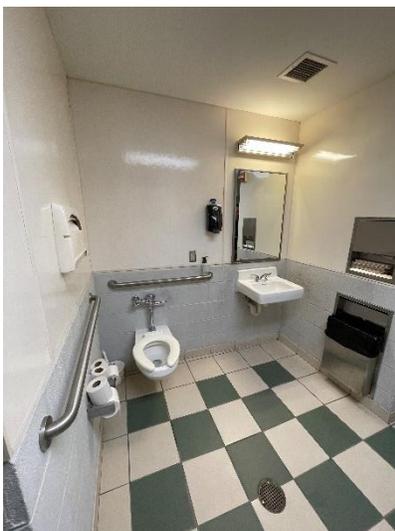
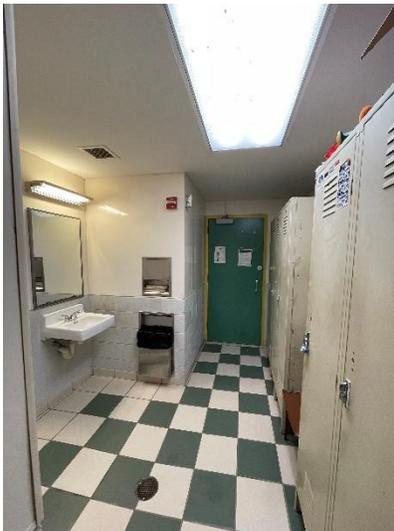
These are single-occupancy toilet rooms as the toilet is not compartmentalized for privacy. They are the only back-of-house toilet rooms for staff use. A renovation or expansion that increases the total occupant load of the building is likely to require additional toilet facilities. The shower stalls have been installed with open gaps at the sides which cannot be properly cleaned to maintain sanitary conditions. We observed the following code deficiencies: 1) The thumb-turn surface bolt that requires tight grasping and twisting of the wrist to operate is not permitted (BC 1010.1.9.1); 2) Manually operated surface bolts are not permitted (BC 1010.1.9.5); 3) Unlatching of any door or leaf shall not require more than one operation (BCNYS 1010.1.9.6).

These are single-occupant toilet rooms. Showers with gaps at the sides present an unsanitary condition.

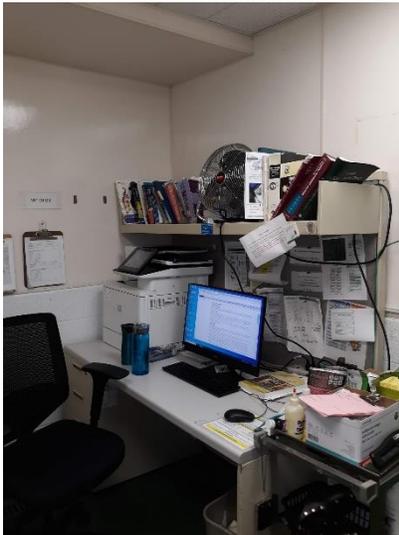
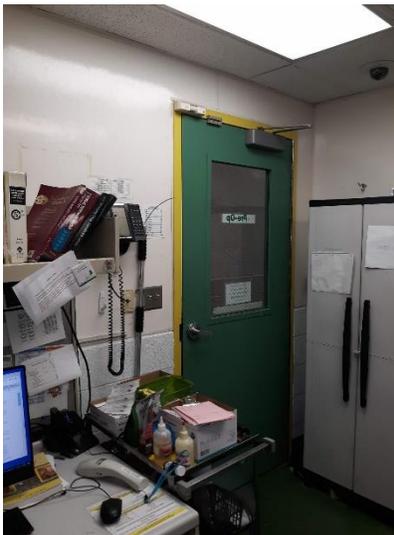
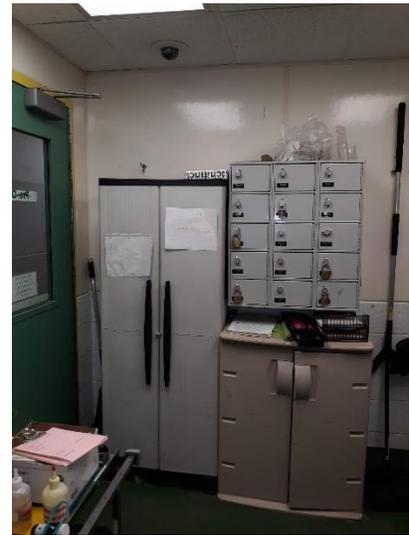
- Electrical power receptacle quantity (power strip on desk) – poor.
- Surveillance: CCTV dome cam (southwest).

Pre-Op appears to function as an office for the veterinarian.

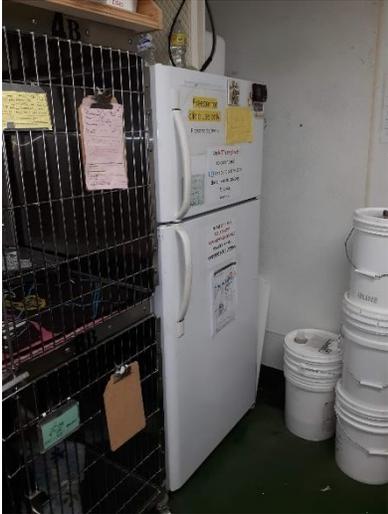
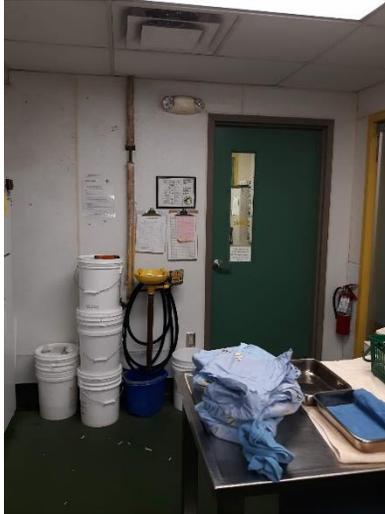
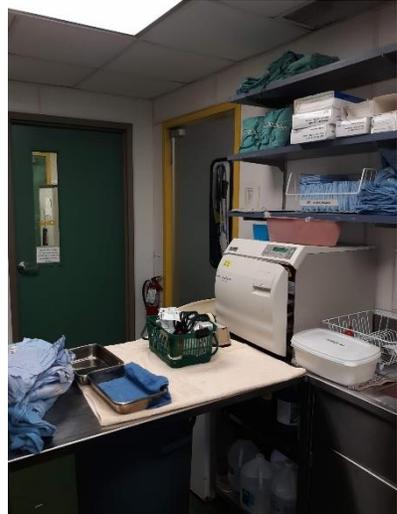
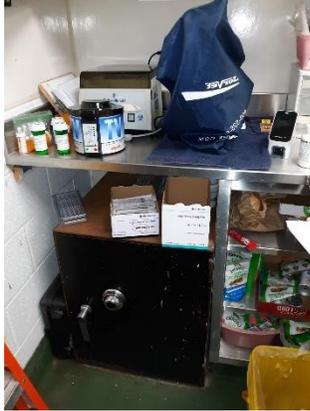
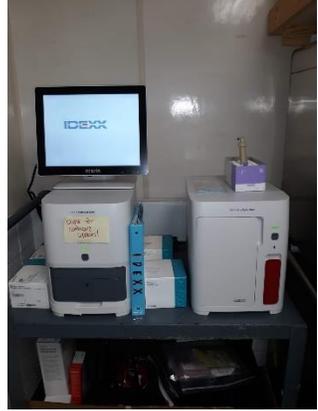
The Exam Room appears to be part lab and part pack-prep. This space is undersized for the quantity of supplies and equipment present.

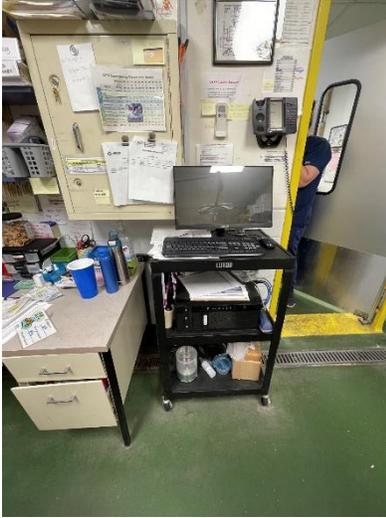
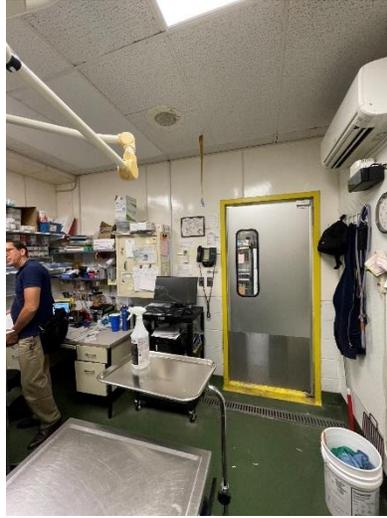
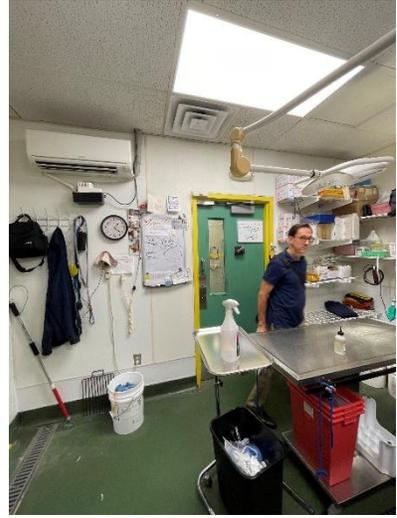
- Door (east to Exam): Stainless steel traffic door w/ narrow lite, pivots, armor – good condition.
- Door frame (east to Exam): Hollow metal frame less stops – good condition.
- Door (south to Post-Op): Hollow metal with narrow-lite wired glass, butt hinges, push plate and pull, closer, magnetic lock, electric strike, card reader, kickplate – good condition.
- Door frame (south to Post-Op): Hollow metal – good condition.
- Floor: Smooth epoxy – poor condition.
- Wall base: Smooth epoxy – poor condition.
- Walls:
 - North, east, west: CMU wainscot, wall-protection panel above – good condition.
 - South: wall-protection panel – good condition.
- Ceiling: Suspended acoustical panel ceiling (cracked, soiled, unsealed) – poor condition.
 - Mobile computer cart (east).
 - Wall phone.

Surgery: Open shelving, trench drains, porous and friable ceilings, and HVAC air flow are not conducive to infection control.

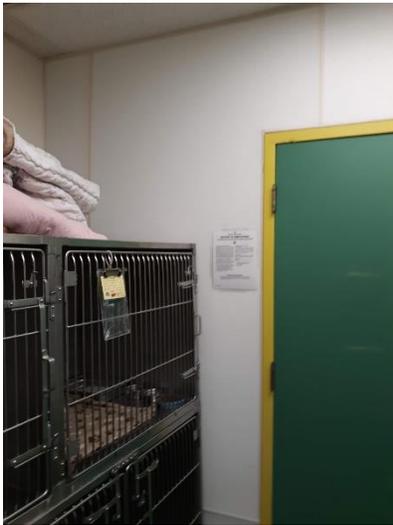
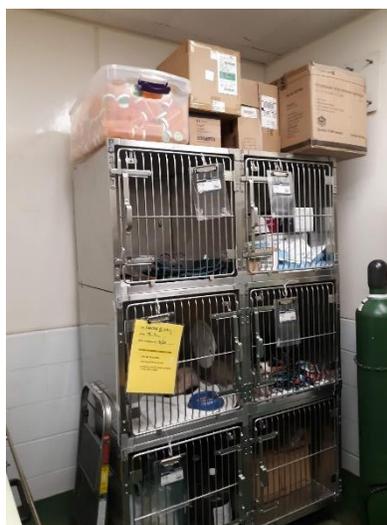
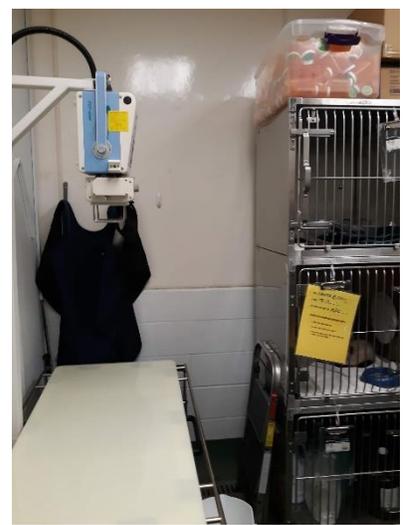
Post-Op lacks proper storage space as evidenced by boxes of sponges and other supplies sitting directly atop the cages. The X-ray table is not ideal to this setting and indicates a lack of space in the facility for a dedicated X-ray room to serve the treatment suite.

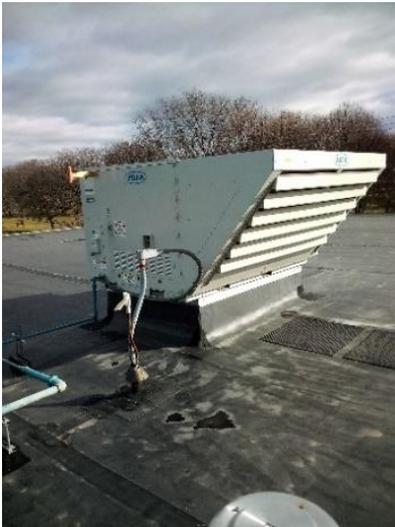
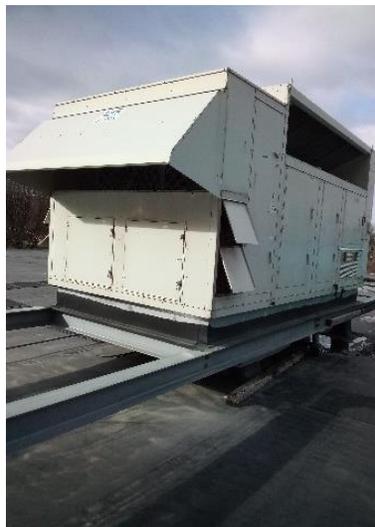
Two rooftop units serve the Rochester Animal Shelter.

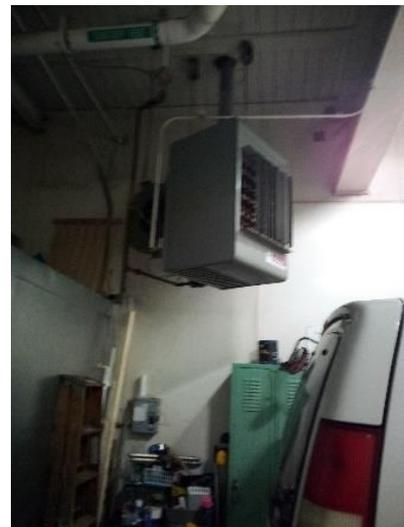
Suspended unit at Garage.

Wall-mounted electric heaters are present in Toilet/Locker Rooms but proper unit functionality is questionable. A natural-gas-fired unit heater is suspended in the Intake Garage and appears operational.

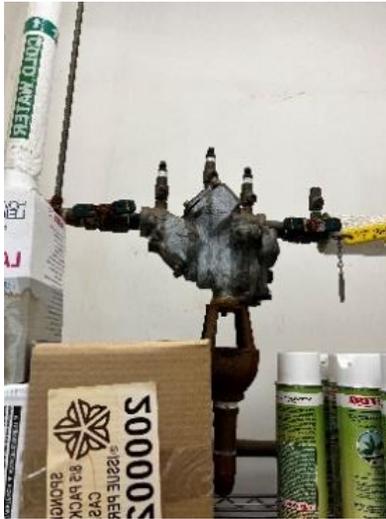
Domestic water service

The domestic water service is 4" ductile iron into the building and is reduced in size to 2" to serve the building. The building is protected from backflow via a 2" RPZ backflow preventer that discharges into a floor drain. There is also a ¾"-RPZ backflow preventer that serves the washdown system for the kennels. The domestic water piping is type-L copper. The domestic water system appears to be in satisfactory condition.

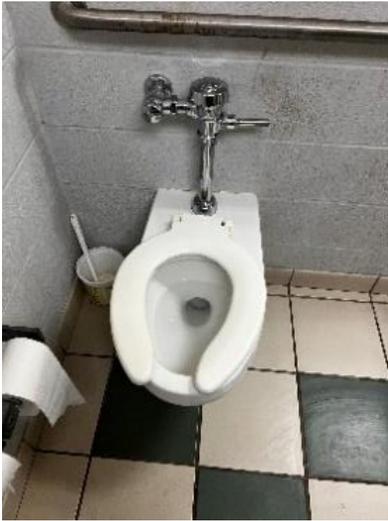
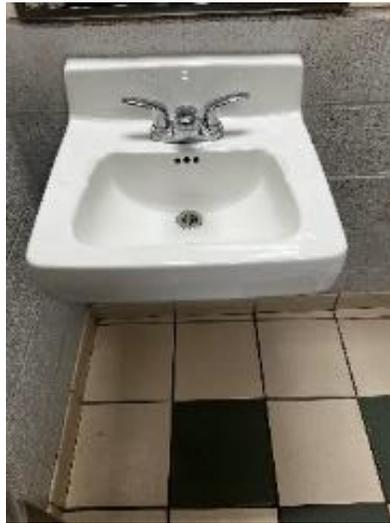
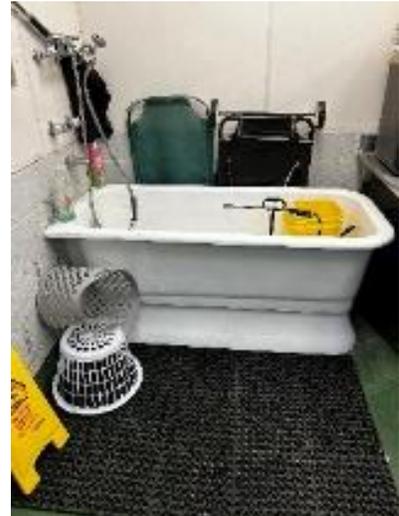
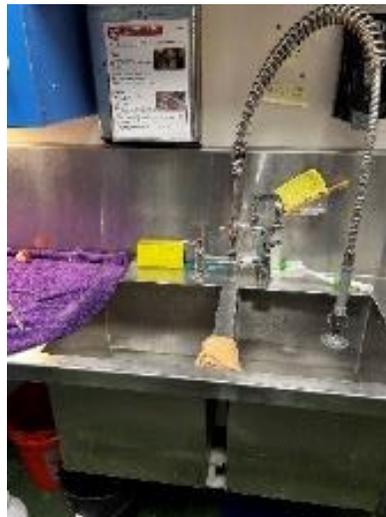
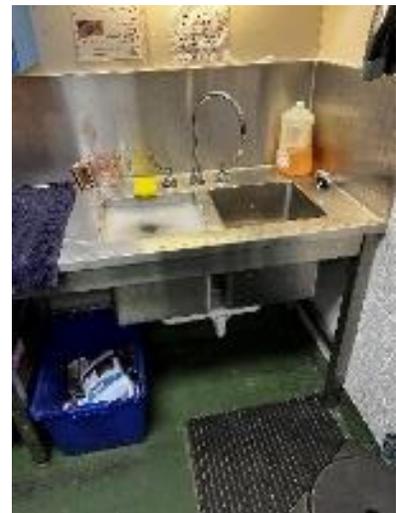
Plumbing fixtures are clean and functional. The building features a single-occupant toilet room with flush-valve water closet and a lavatory with blade handles. The lavatory is not code compliant as the flow exceeds 0.5 GPM and doesn't have an ASSE 1070 approved mixing valve. There are also some stainless steel sinks and a bathtub in the building. The plumbing fixtures are in satisfactory condition.

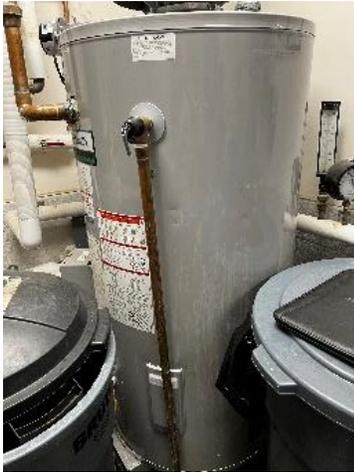
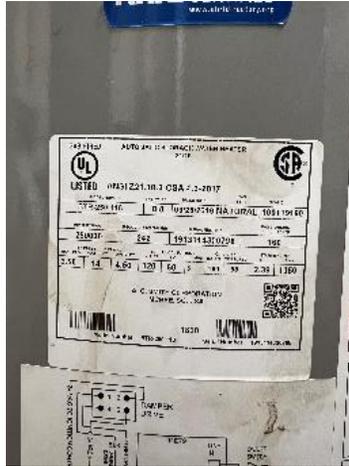
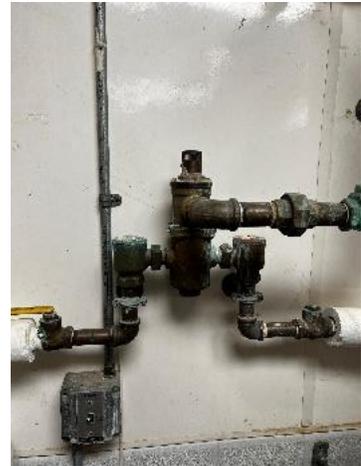
Domestic Water Heating

Domestic hot water is produced by a 100-gallon, gas-fired, tank-type water heater. The water heater is 250,000 btus and has a one-hour recovery rate of 242 gallons. The heater was built in 2019 and has a few years of life left. Hot water produced by the heater is regulated with a master mixing valve. The domestic hot water system appears to be in satisfactory condition. Domestic hot water serves both the Rochester Animal Services and the Rochester Mounted Police.

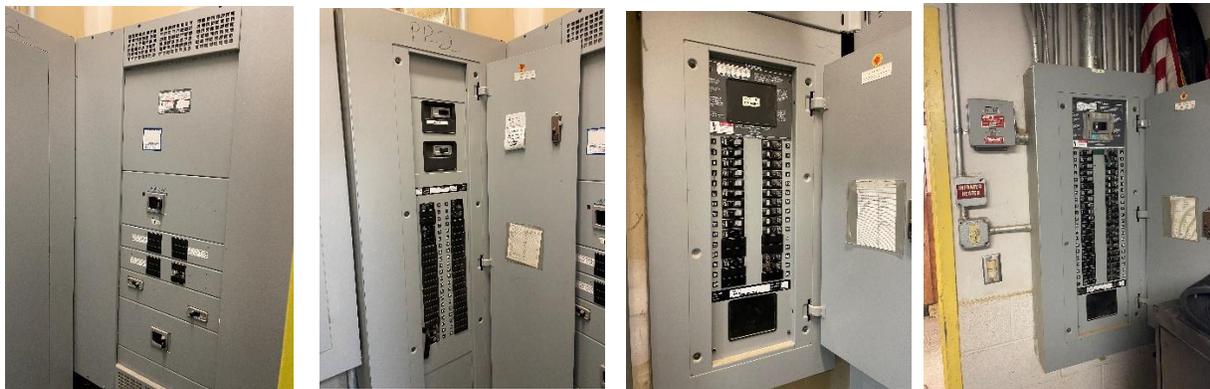
Panel 'LP-1' is fed from the MDP with a 100-Amp, 3-pole circuit breaker. There is limited space available for future loads.

The panel that is located within the Rochester Mounted Police area is also identified as 'PP-2'. This panel is fed from the MDP with a 225-Amp, 3-pole circuit breaker. The panel is also metered with a 'EMON DMON' unit to measure the electrical usage. There is no space available for future loads.

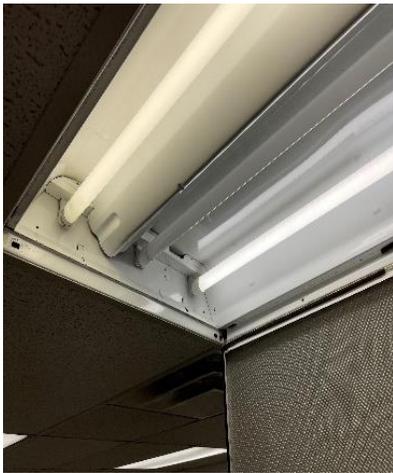
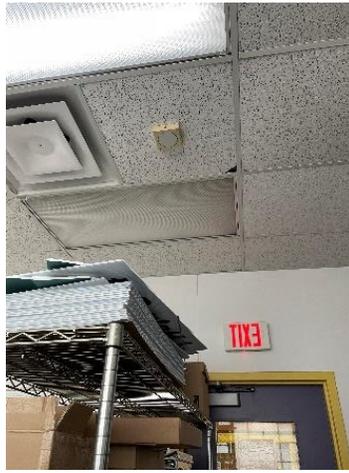
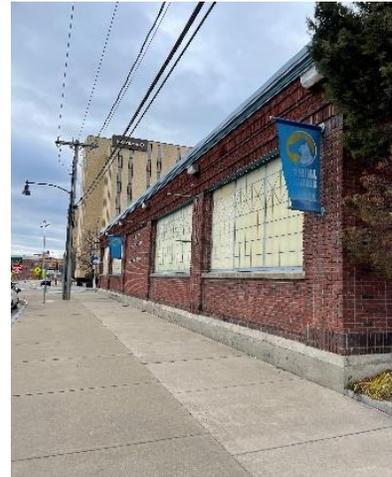
Lighting

The lighting appears to be 1997 vintage. The majority of the lighting throughout the building utilizes T8 lamping. As lamps have failed, they have been replaced with LED lamps. In the main lobby there are pendant mounted 'schoolhouse'-type fixtures that have replacement LED-type lamps in them. The emergency battery operated lighting appears to have adequate coverage. The exit lighting also appeared to provide adequate coverage. In general, the lighting levels appear to be sufficient. Automatic lighting controls were not observed in many of the spaces.

The exterior lighting consists of wall packs that have primarily been re-lamped with LED lamps.

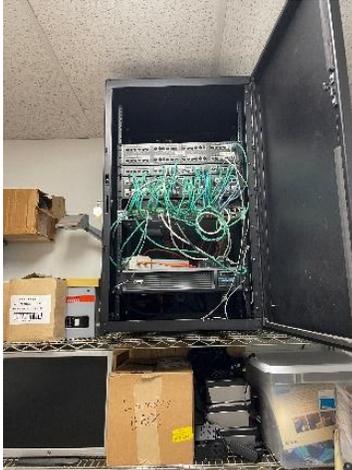
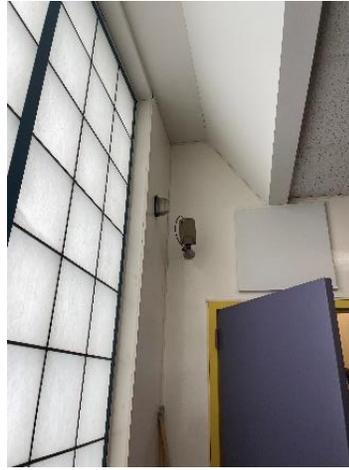
There is a closed-circuit television (CCTV) system which appears to be antiquated. There are some cameras that were pointing directly to the floor with what appeared to be corrosion on the mounting brackets. There are some cameras that appear to be newer models which tie into the data system.

There is no ductless split unit in this room for temperature control.

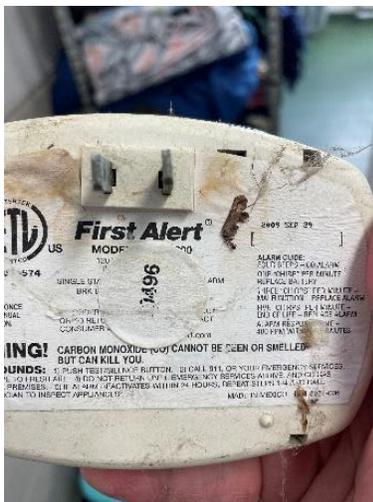
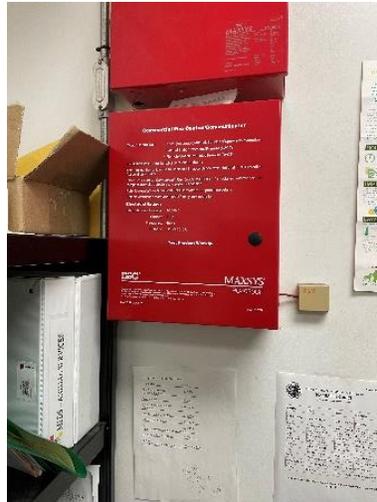
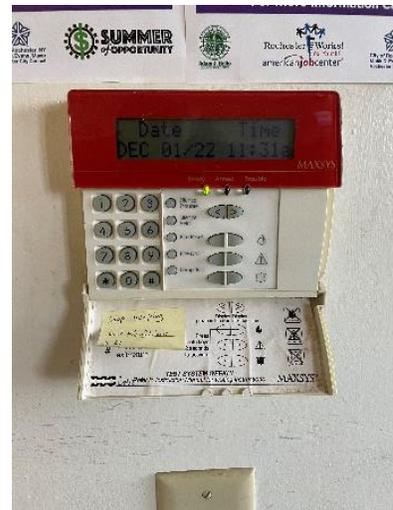
Fire Alarm System

The existing fire alarm system is manufactured by Maxsys PC4020CF which is also integrated as part of the security system. The fire alarm system is a conventional type of system and is beyond its life expectancy. The typical life expectancy is 15 to 20 years. The spacing of notification appliances in corridors appeared to provide inadequate coverage. Devices are more than 15 feet from the ends of corridors.

There was no CO detection observed in the intake garage. There was one stand-alone CO detector observed plugged into an outlet in DOG HOUSING. This device is beyond its useful life and should be replaced immediately.
