**PHASE I ENVIRONMENTAL SITE ASSESSMENT
REPORT**

The City of Rochester
City Hall
30 Church Street
Rochester, New York 14614

200 East Avenue / 62-64 Scio Street

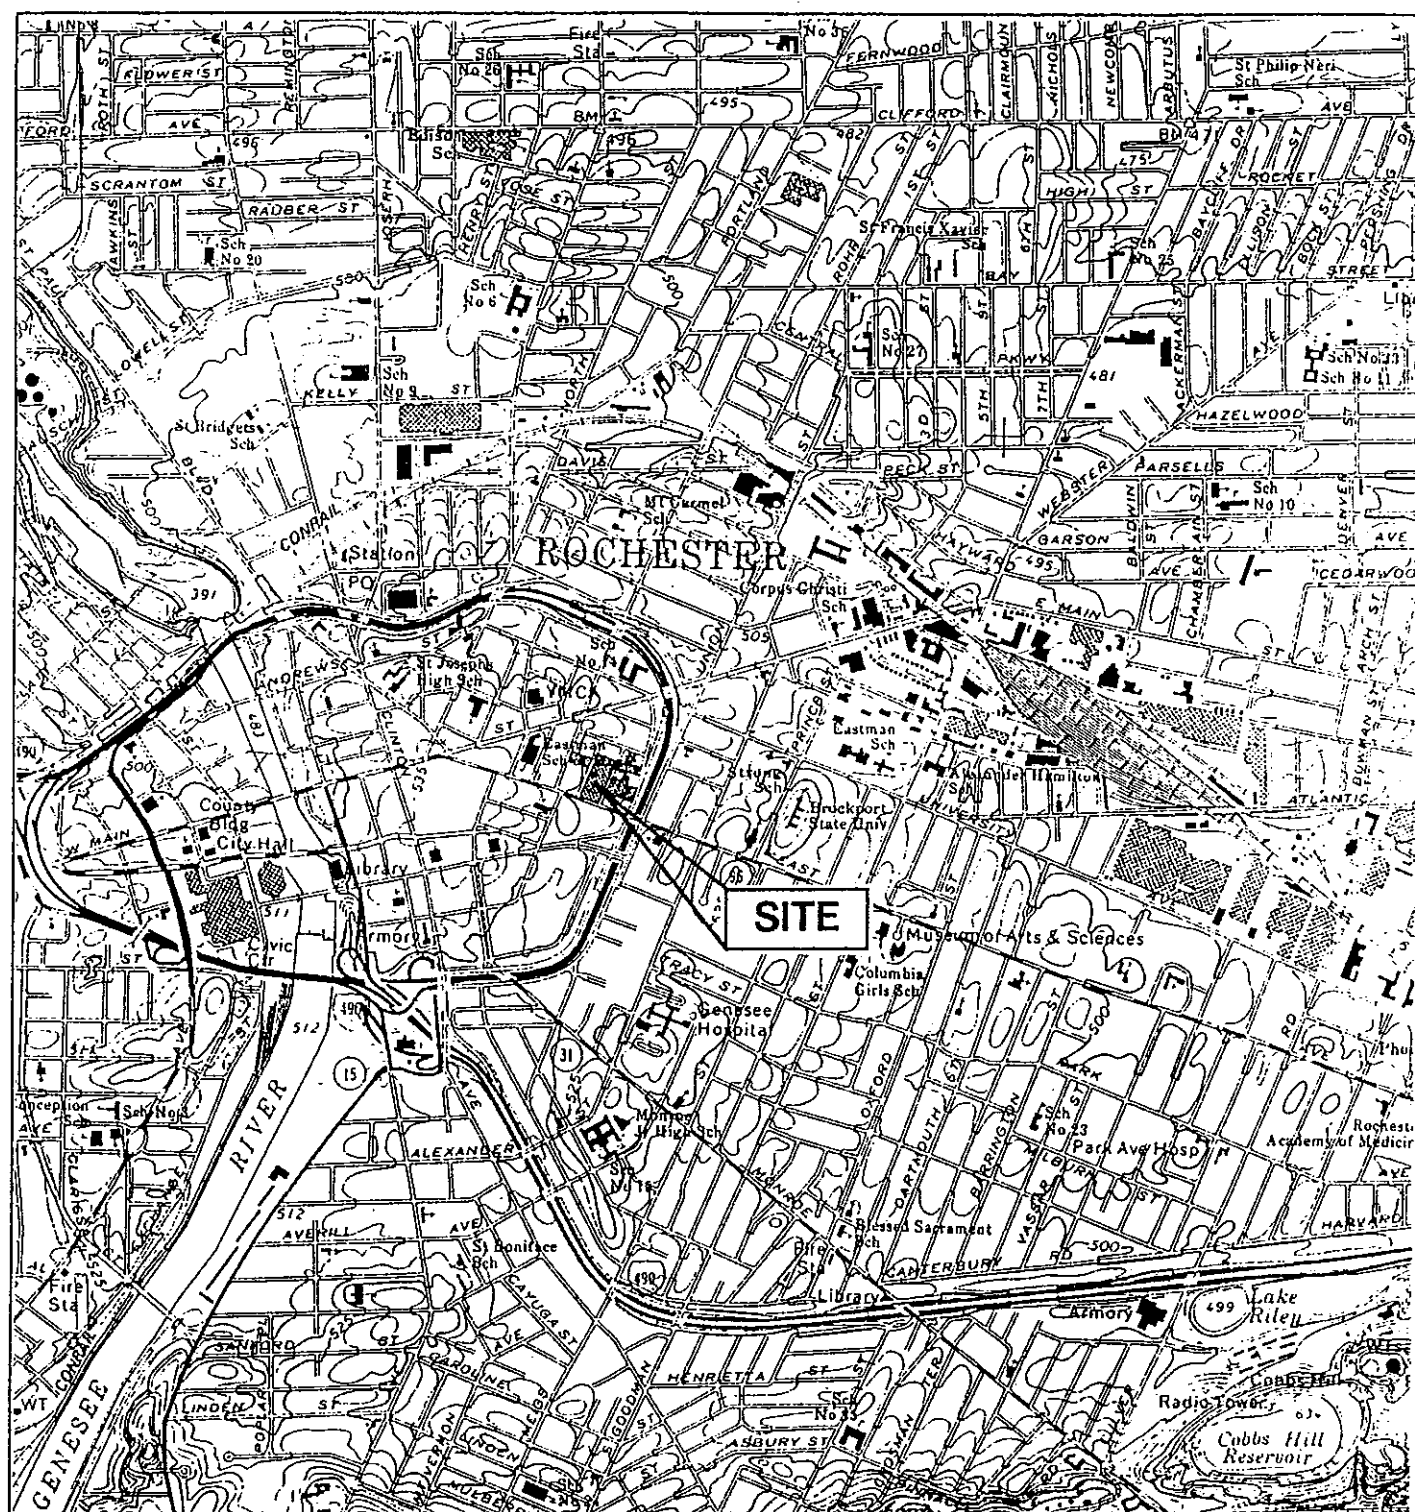
Base Map: USGS Topographic Map
Rochester East Quadrangle

The Site location is shown in Figure 1, and a Site Plan is shown in Figure 2.

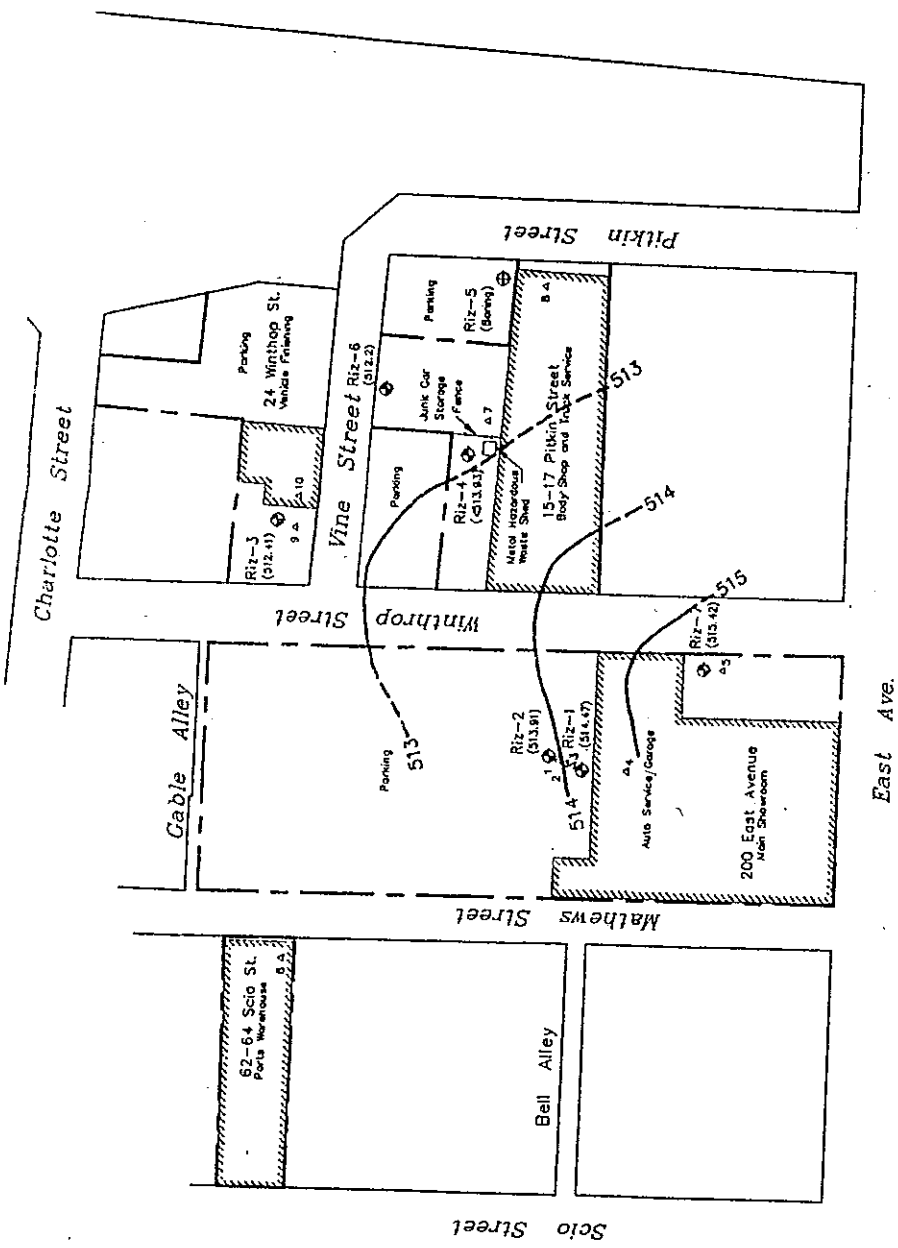
Figure 2 :
Site Plan With Monitoring Well Locations

Seven soil borings were advanced on the Site for monitoring well installation on May 13 and 14, 1993 by Pennsylvania Drilling, Inc. of Rochester, New York. Soil boring and monitoring well construction were conducted under the direction of Rizzo Associates personnel following the standard protocols outlined in Appendix B. The borings were advanced using an Acker AD-2 truck-mounted drill rig with 4.25-inch-inside-diameter hollow-stem augers. Boring logs and monitoring well construction diagrams for the wells are included in Appendix C. The locations of the monitoring wells are shown on Figure 2.

Monitoring well locations were selected to address specific areas of potential contamination on the Site. Well locations were selected based on the assumption that groundwater flow generally mimics the slope of surface topography on the Site and would flow to the north or northeast. RIZ-1 was installed beside the north wall of the automobile maintenance portion of the main showroom building to evaluate the groundwater downgradient from tank No. 4 and from the garage work area. RIZ-2 was installed north of the three motor oil USTs (No. 1, No. 2, and No. 3 on Figure 2). RIZ-3 was installed north of tanks No. 9 and No. 10 near the vehicle finishing building (24 Winthrop Street). RIZ-4 was installed north of the metal shed beside the body shop building where waste petroleum naphtha was accumulated for disposal. RIZ-5 was a soil boring not completed as a monitoring well because of bedrock refusal above the water table. RIZ-5 was advanced at the northeast corner of the body shop building, as near to tank No. 8 as was feasible. RIZ-6 was advanced north of the waste oil tank along the north side of the body shop building; however, because of the junk cars in the lot, the boring was 85 feet from the tank. RIZ-7 was installed 12 feet north of tank No. 5 located southeast of the showroom building.

The results of the groundwater elevation survey are presented graphically as potentiometric surface contours on Figure 2. The potentiometric surface indicates that groundwater flow at the Site is northerly on the western portion of the Site and northeasterly on the eastern portion of the Site.
