Cornerstone Park Improvements

Preliminary Investigations Report

PREPARED BY MCCORD SNYDER LANDSCAPE ARCHITECTURE, PLLC
 NOVEMBER, 2013

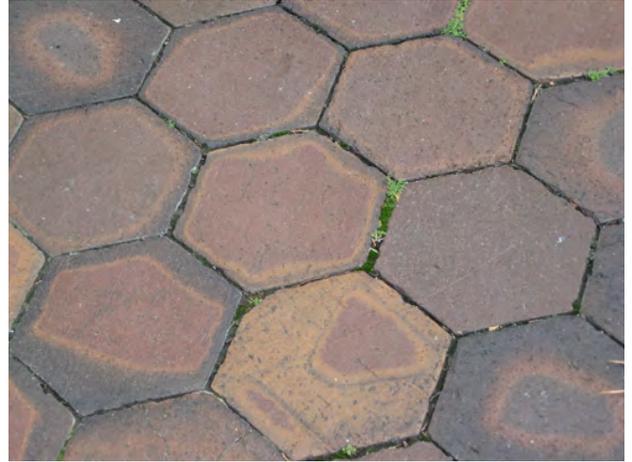
Figure 3 - Existing fired brick hexagonal pavers.

Pavement. Sidewalks surrounding the park on 3 sides and within the right-of way and along the entrance to the South Avenue Garage, are standard concrete in generally good condition and have been well-maintained. Sidewalks within the site are primarily paved with hexagonal, fired brick pavers (Figure 3) that have heaved in many locations to an unacceptable extent either individually or in larger groups of pavers, due to frost heave, roots, and other factors (Figure 4). These pavers are only 1.25" thick and, as such, are more like tiles and they cannot function to interlock as can more modern, thicker pavers and bricks. It is suggested these pavers be completely removed and disposed of. The broken areas of sidewalk are an impediment to access by the disabled.

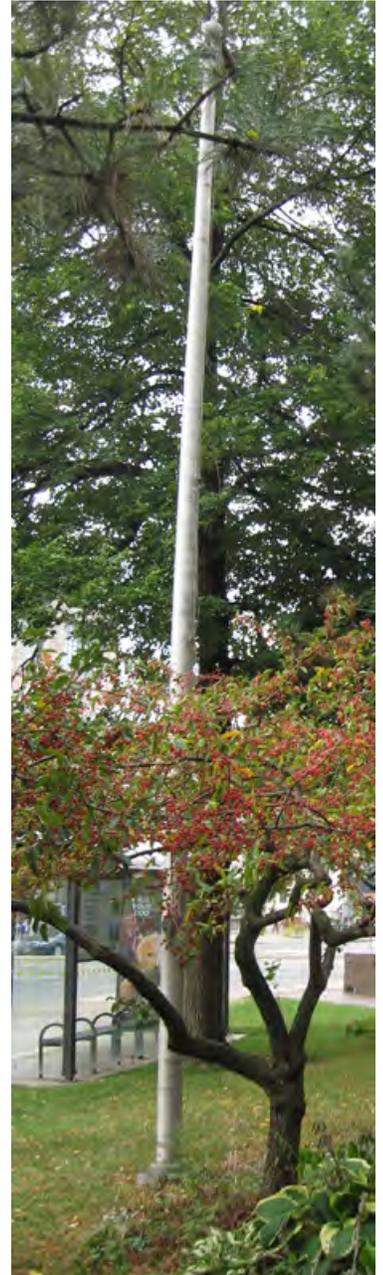
An aluminum flagpole (Figure 10), estimated to be 20 ft. in height is located centrally along the Broad Street frontage and next to the bus stop shelter. It has not been observed in use throughout the investigative phase of this project. We surmise it has not been used for quite some time.

Figure 10 - Existing flagpole.

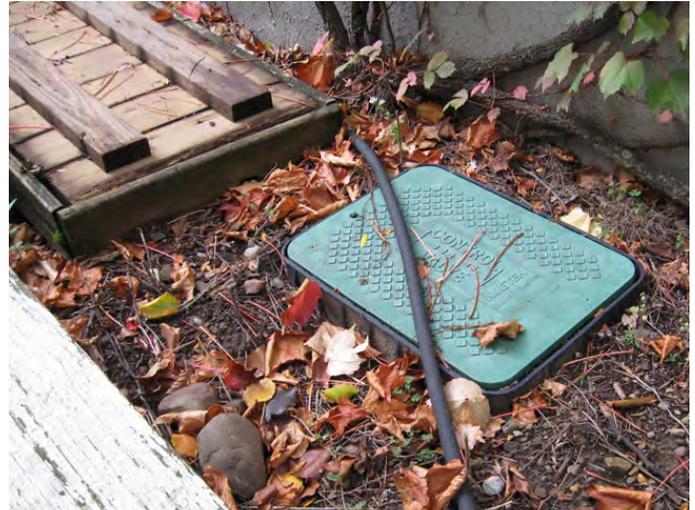
Figure 12 - An existing irrigation system valve box and check-valve hand-hole are located along the north wall behind the retaining wall.

An irrigation system (Figure 11) was installed and presumably functional at some point but has since fallen into disrepair and is no longer used. There are numerous pieces of the system still visible in landscape areas including spray heads, drip pipes, black pipe, and connectors. The entire system should be removed and disposed of.

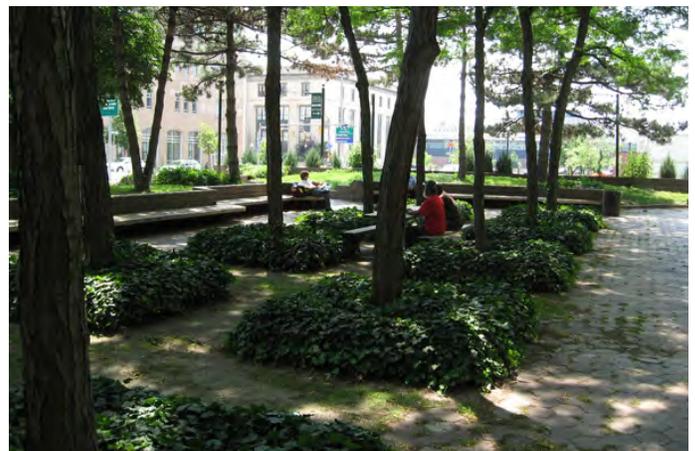
A formal grove of twelve (12) honeylocust trees (Figure 13), all in good condition is located in the central portion of the site adjacent to the former waterfall feature. They are each surrounded with a small 6'x6' planter, about 8" high. Any effort to save these trees as part of a new park design will need to consider the elevation of earth in proximity to the trunks of these trees and special efforts that will be required for root protection.

Figure 13 - Grove of 12 honeylocusts 6" to 12" DBH

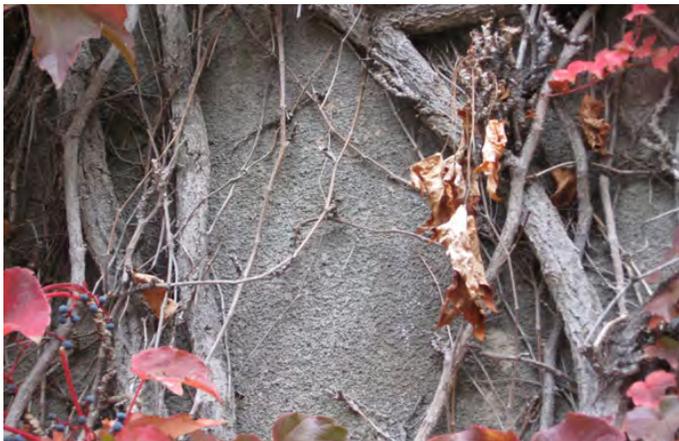
Figure 16 -The textured (stucco) south wall of 63 Stone Street appears to be in good condition.

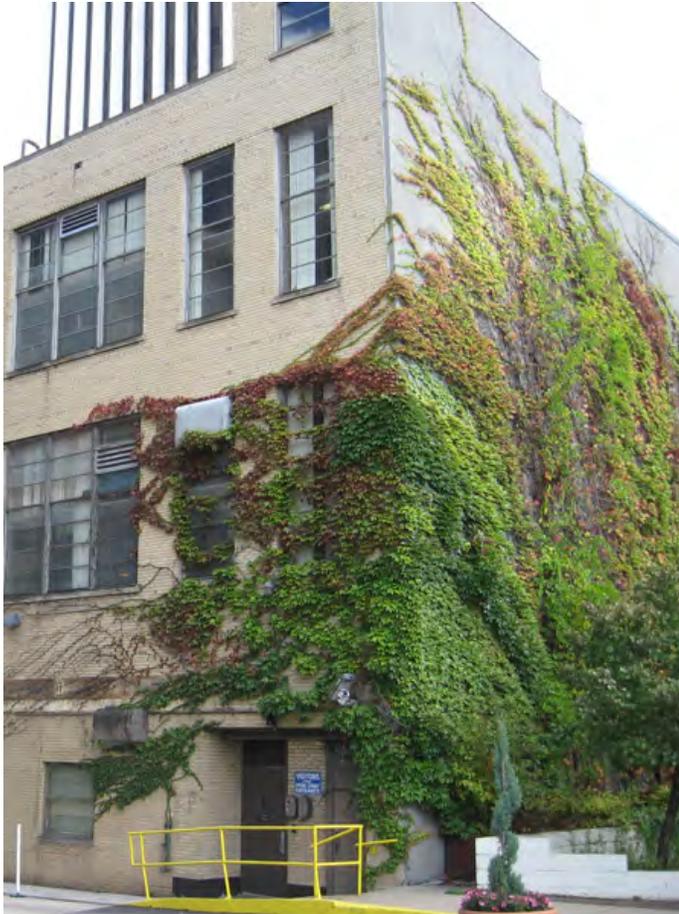
Wall vines are primarily Boston (Japanese) Creeper (*Parthenocissus tricuspidata*), with some wild vines (Poison Ivy, Wild Grape), one invasive species (Oriental Bittersweet, *Celastrus orbiculatus*) and other landscape varieties intermixed all growing up onto the light grey stucco-style wall. cursory examination of the wall reveals that the wall and stucco material appear to be holding up very well (i.e. no cracking or missing pieces noted). Vines have spread, perhaps undesirably, to the east and west sides of the Frontier building, partially covering windows and doorways. The original agreement with Frontier places maintenance of wall vines as their responsibility.

Figure 18 -Vines have spread to the front (east) and rear (west) sides of the Frontier Building (63 Stone Street).

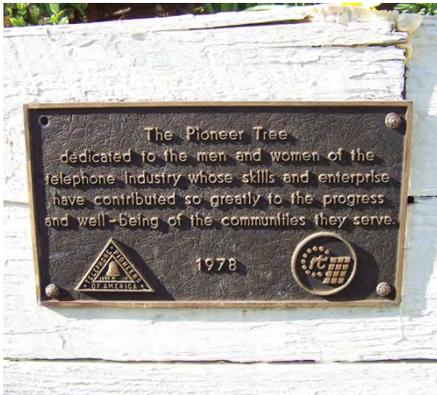
Figure 20 -Bronze "Pioneer Tree" plaque - has since been removed.

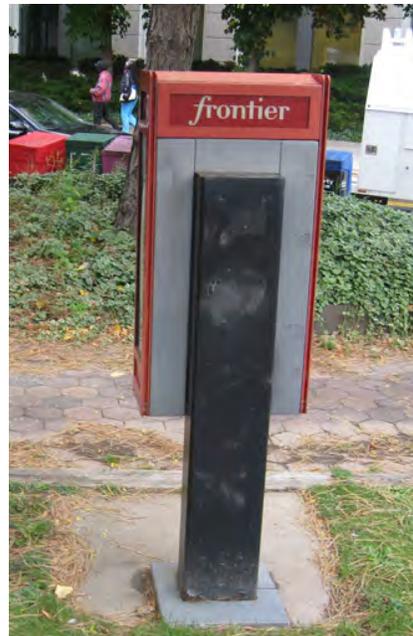
Telephone Booth: The free-standing, Frontier telephone booth near the southeast entrance to the park appears to be in good condition. It is still functional, however given the prevalence of cell phones these days, it is recommended it just be removed and returned to the owner (Frontier Telephone)

Figure 23 - Existing Public Telephone Located At The Southeast Entrance To The Park.

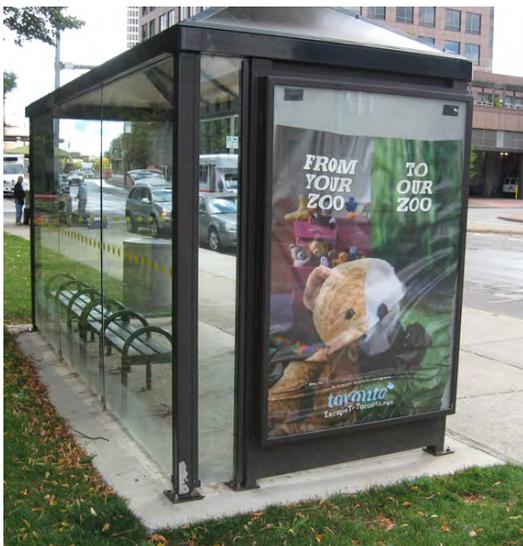
A bus stop operated by RGRTA is located on site with a typical covered shelter structure in place. The shelter is in good condition and appears to be maintained on a regular basis, advertisement signs are present that are up to date. The shelter can stay or be replaced depending on the needs that arise from design schemes for the park and on the desires of RGRTA, the presumed owner of the shelter. The Broad & Stone bus shelter location averages 100 customers per day (80 boarding, 20 alighting).

Figure 24 - Existing RGRTA Bus Stop Shelter.

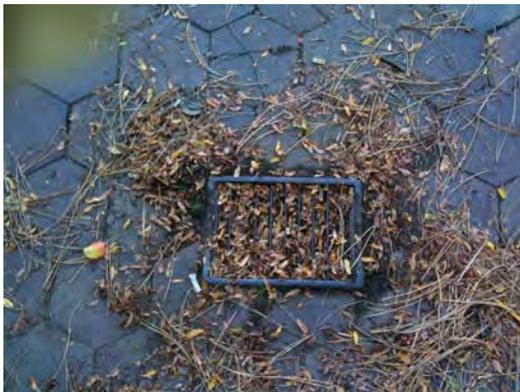
The existing storm drainage system in the Park is minimal, and includes 8"x12" surface drains located in the paver area between the two rows of locust trees and planters. Although construction plans of the Park indicate four (4) of these units, we could only locate two (2). These inlets were clogged full of leaves and debris at the time of our topographic survey, and the grates were not able to be removed to clean them out or verify the size and inverts of the outlets. Original drawings show area drains located throughout the park, however this area no longer has pavers and has been covered in crushed stone, so it is unknown if the drains and/or the piping leading to the utility main have been removed.

Figure 25 - Existing Surface Drain

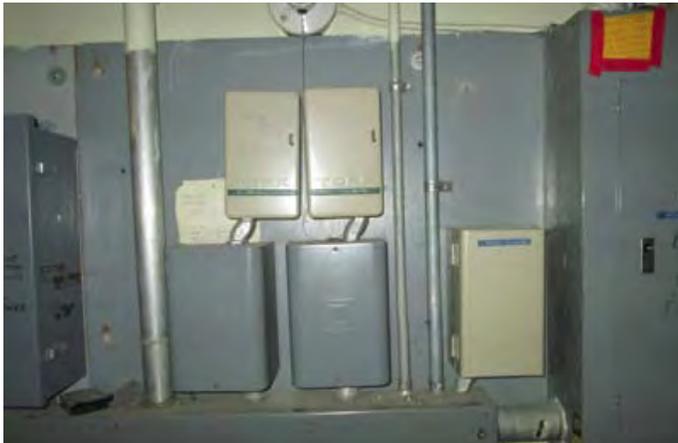
Power for the electrical equipment and devices located in Cornerstone Park is currently paid for, and supplied by, a dedicated 225 amp, 120/208 volt, 3 phase, 4 wire panelboard located inside the adjacent Frontier building. Along with the panelboard, associated lighting and pump controls, consisting of time clocks, contactors, and pump controllers are located to the left of the Frontier power distribution panel (painted panel in the picture shown). All equipment is in good condition and appears to be well maintained.

Figure 27 - Time Clocks And Contactors

Existing outdoor electrical systems and equipment are approaching the end of normal, useful service life and should be completely removed. Considering the level of landscape changes, maintaining any part of the electrical systems will hamper and possibly limit landscaping options. Removal and replacement of the outdoor and underground electrical systems, wiring and equipment will allow the area electrical needs to keep pace, and expand with, the park upgrade and revitalized appearance.

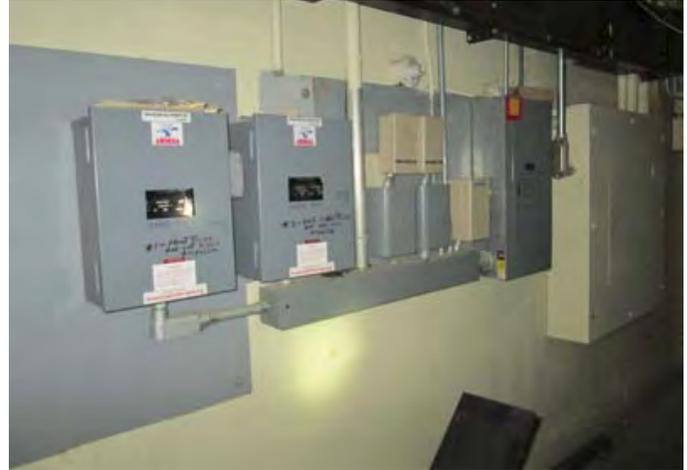
Figure 26 - Existing Electrical Equipment

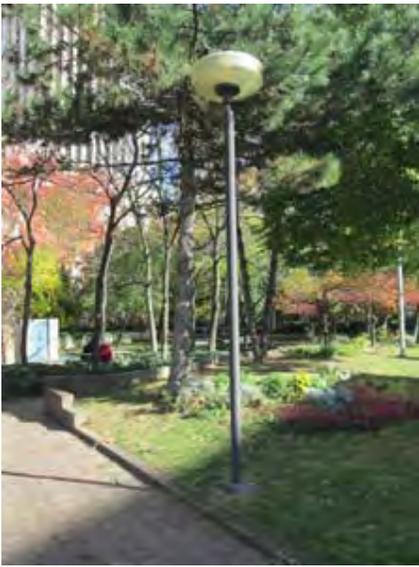
In the park area, landscape and pole lights are installed. For the most part, the landscape lighting fixtures have been removed. However, wiring, junction boxes and outlets remain. Originally, six (6) area lighting poles were installed. Today, the poles remain, with only four (4) operational and having light fixtures in place. The remaining two (2) poles, located along the South Avenue parking ramp garage driveway, have had the light fixtures previously removed. Lighting system components are operational, however, show age and weathering, and are energized continuously.

Figure 30 - Area Light Pole With Fixture Area Light

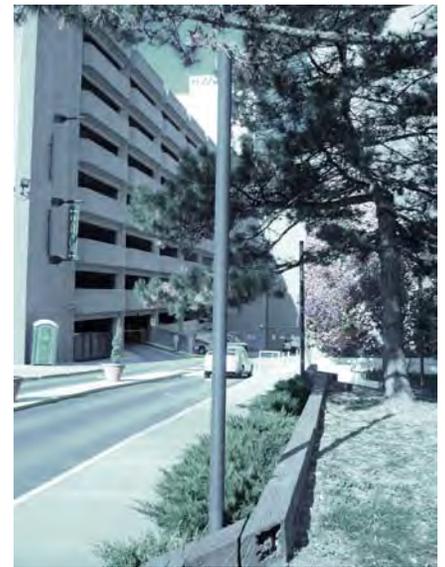
Figure 31 - Pole With Fixture Previously Removed

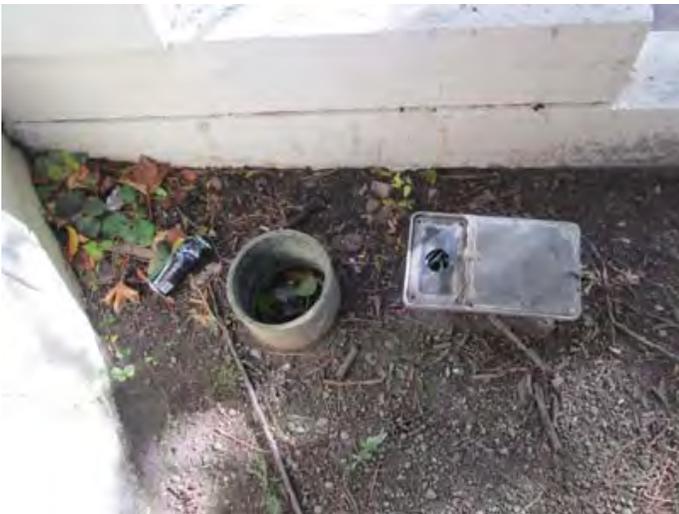
Figure 32 - Lighting Outlet and Junction Boxes

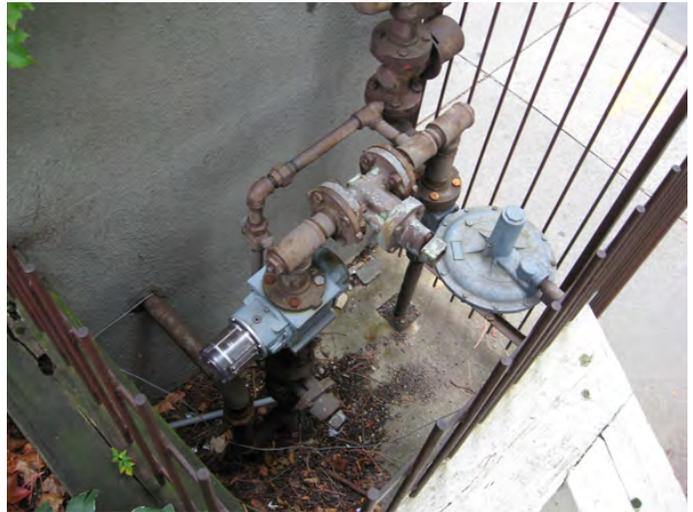
An existing gas service to the neighboring building to the north (63 Stone Street) appears to be at least partially located on City (Cornerstone Park) property. The 1992 maintenance memo (page 4) notes that this is located in an approximate 3'x4' easement.

Figure 36 - Existing gas valve and meter serving 63 Stone Street, at the northeast corner of the park site.

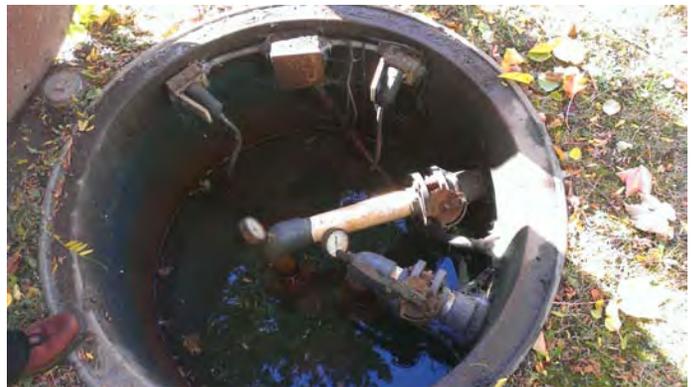
It appears, originally, a 15 HP pump, located in the Frontier building supplied water to the park fountain / water feature. This pump is now totally disconnected. Currently, two (2) submersible pumps for the fountain / water feature are located in a manhole to the east of the fountain / water feature. Actual pump sizes are unknown. Based on the circuit breaker size, the pumps are estimated to be no larger than 5 HP each. Water level in the manhole is maintained by a float switch connected to a solenoid valve in the Frontier building. Equipment appears to be operational.

Figure 37 - Water Level and Pump System

Existing plumbing systems and equipment are approaching the end of normal, useful service life and should be completely removed. Considering the level of landscape changes, maintaining any part of the plumbing systems will hamper and possibly limit landscaping options. Removal and replacement of the outdoor and underground plumbing systems and equipment will allow the area plumbing needs to keep pace, and expand with, the park upgrade and revitalized appearance.

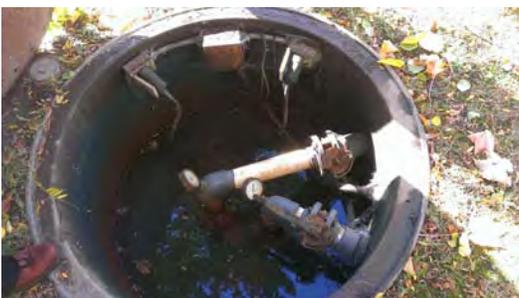
In the park area there is an abandoned Level Maintenance Sump Pit that used a series of sump pumps to maintain the pool's water depth. There is also an abandoned irrigation system which has an unknown source of water. All fountain feature piping has been disconnected from the indoor pump but still remains. There is a wall hydrant that no longer has a cover and appears to have been neglected over the years. An abandoned filter station is also located on the north side of the fountain.

Figure 45 - Level Maintenance Sump Pit

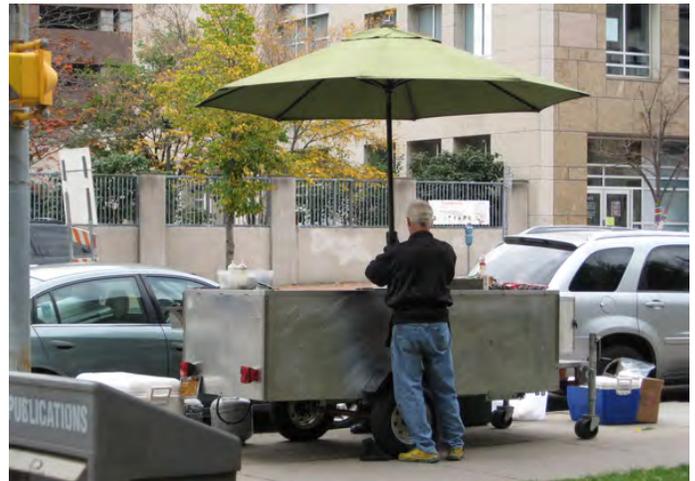
A "hots and sausage" vendor has been located on the sidewalk for lunch time at the southeast corner of the site (the northwest corner of Broad and Stone Streets). The owner of this cart has a permit from the City to operate in that specific area only. Any move would need to be cleared through the proper channels within the City. An alternative location might be at the same corner but just inside the boundary of the park. A paved pad could be installed to accommodate that new location.

Figure 48 - A lunch-time vendor has been located at the southeast corner of the park for many years.
