# Rundel Library

115 South Avenue  
Rochester, NY  
Building ID No. 7.11

**CITY OF ROCHESTER**  
**ASBESTOS CONTAINING MATERIALS**  
**BUILDING ID NO. 7.11**  
**RUNDEL LIBRARY - 115 SOUTH AVENUE**

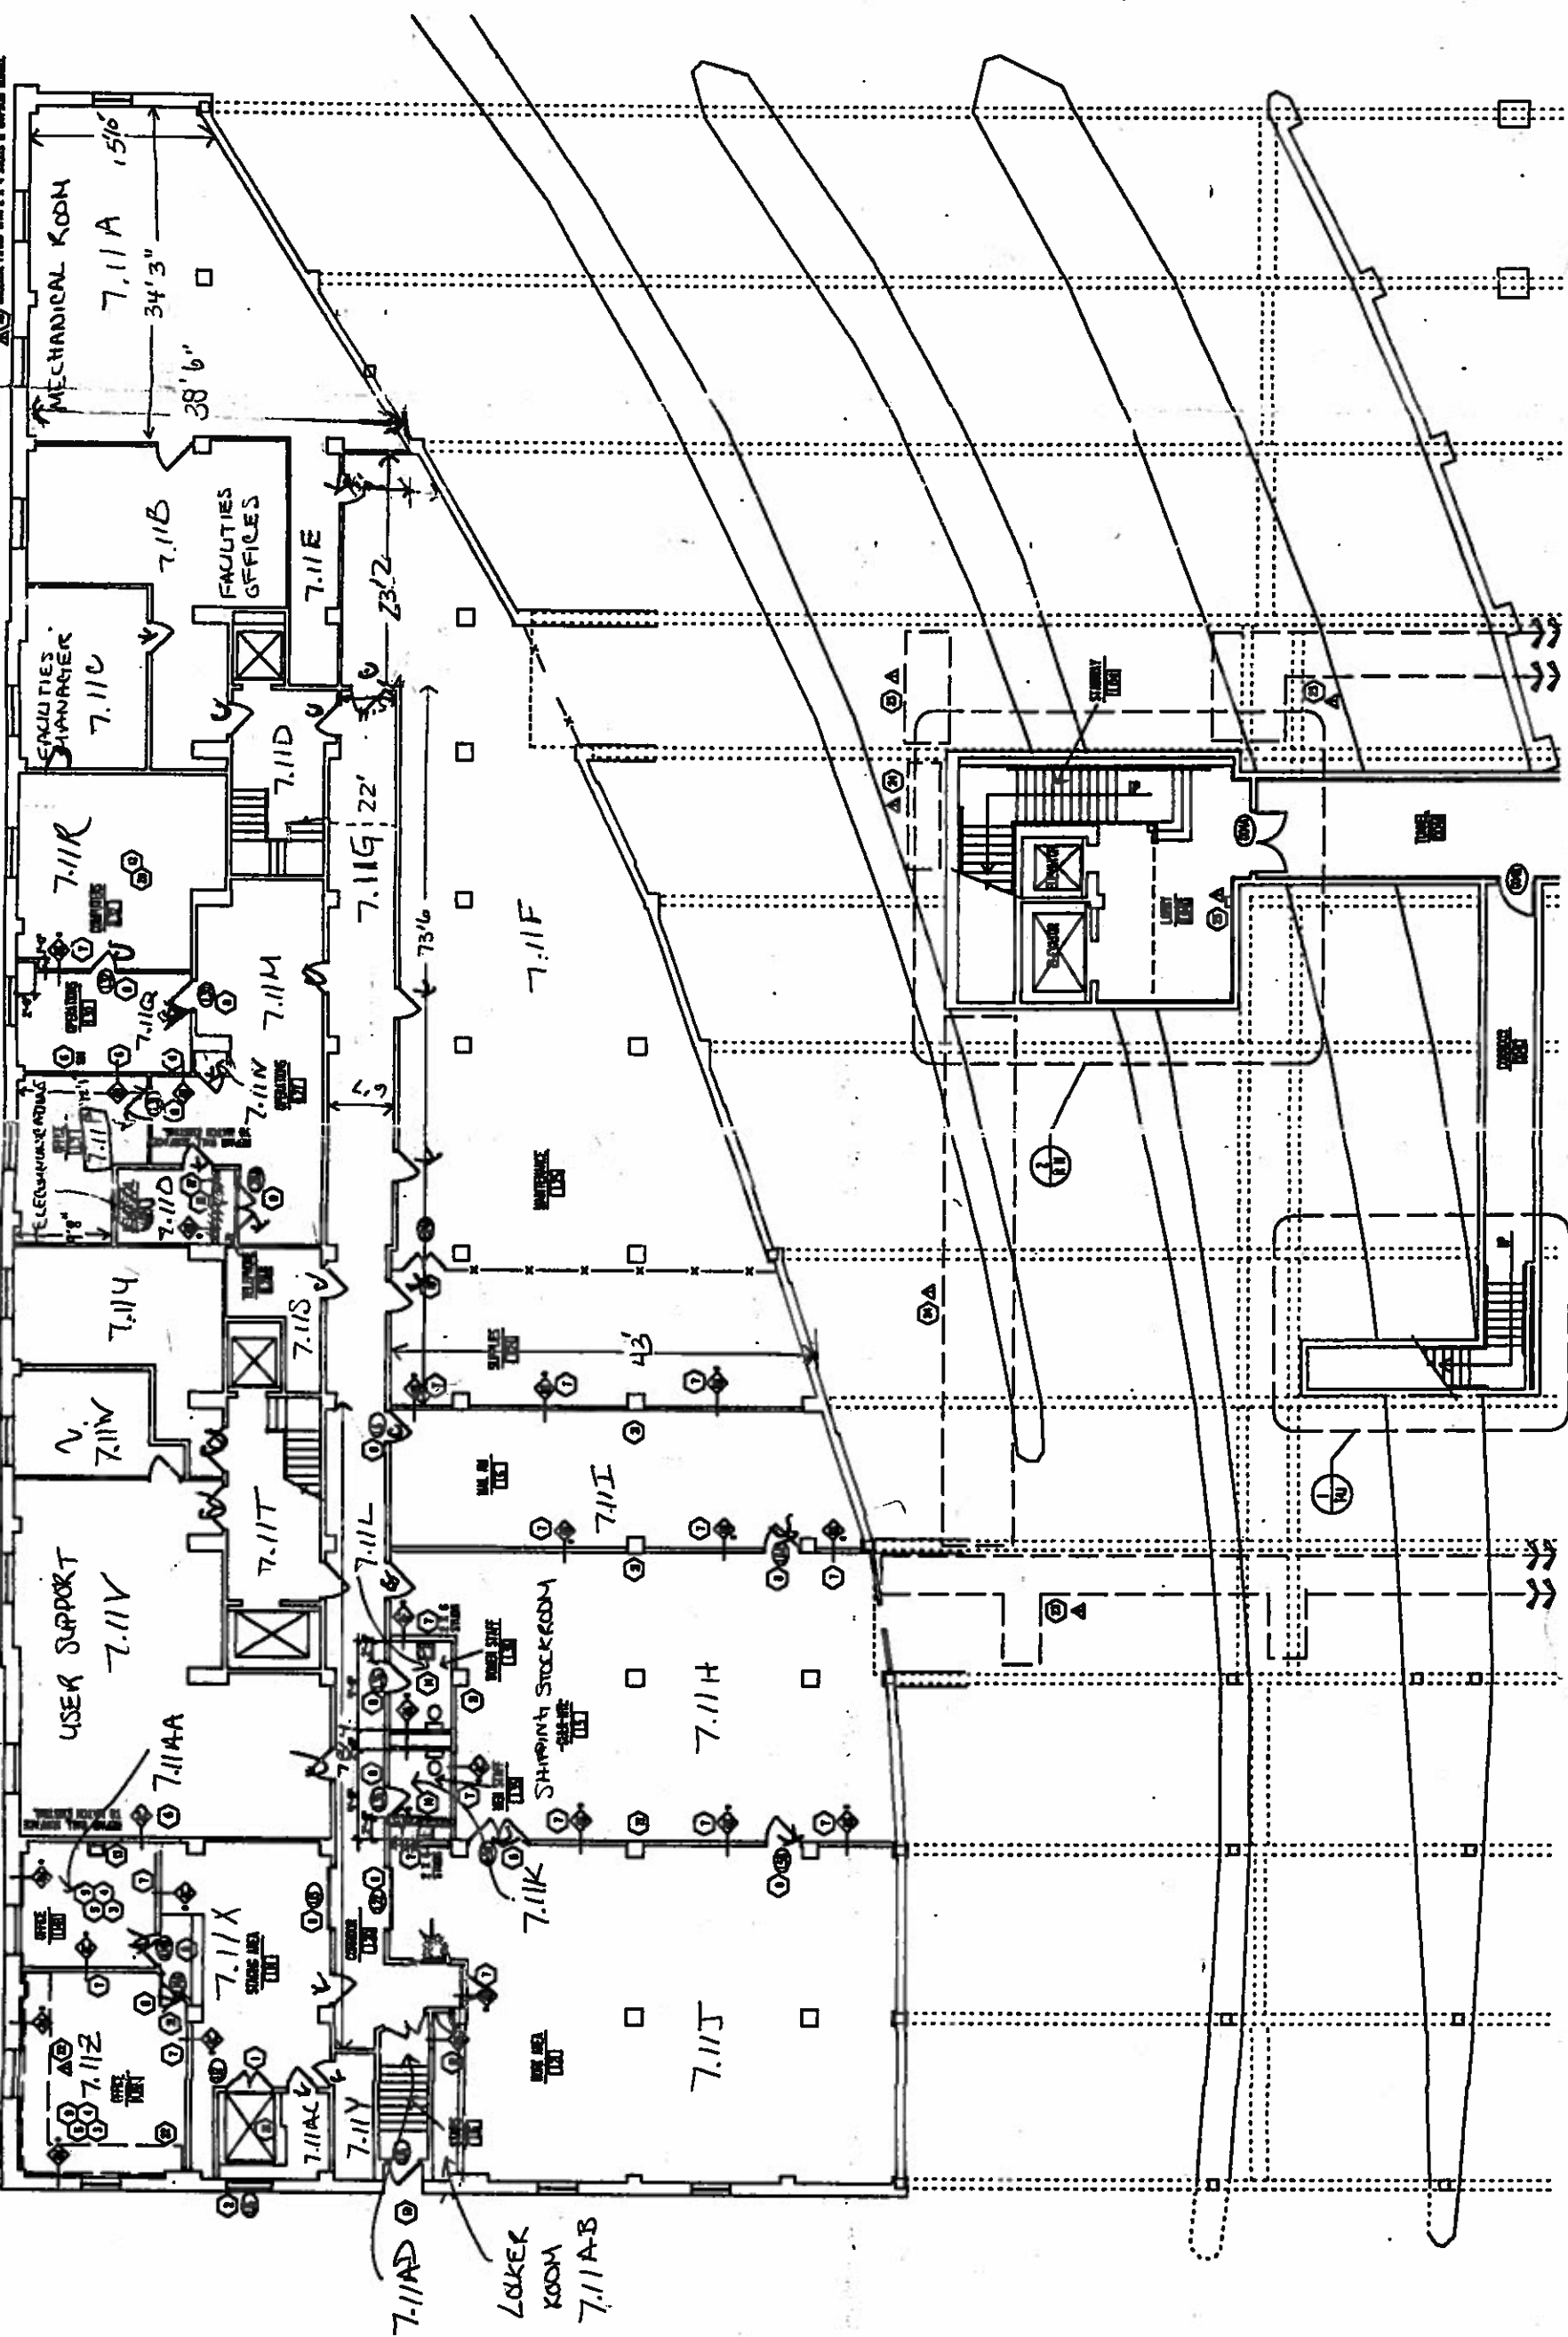
# EXISTING RUNDEL MEMORIAL BUILDING LOWER STACKS REMODELING FLOOR PLAN

SCALE: 1/8" = 1'-0"

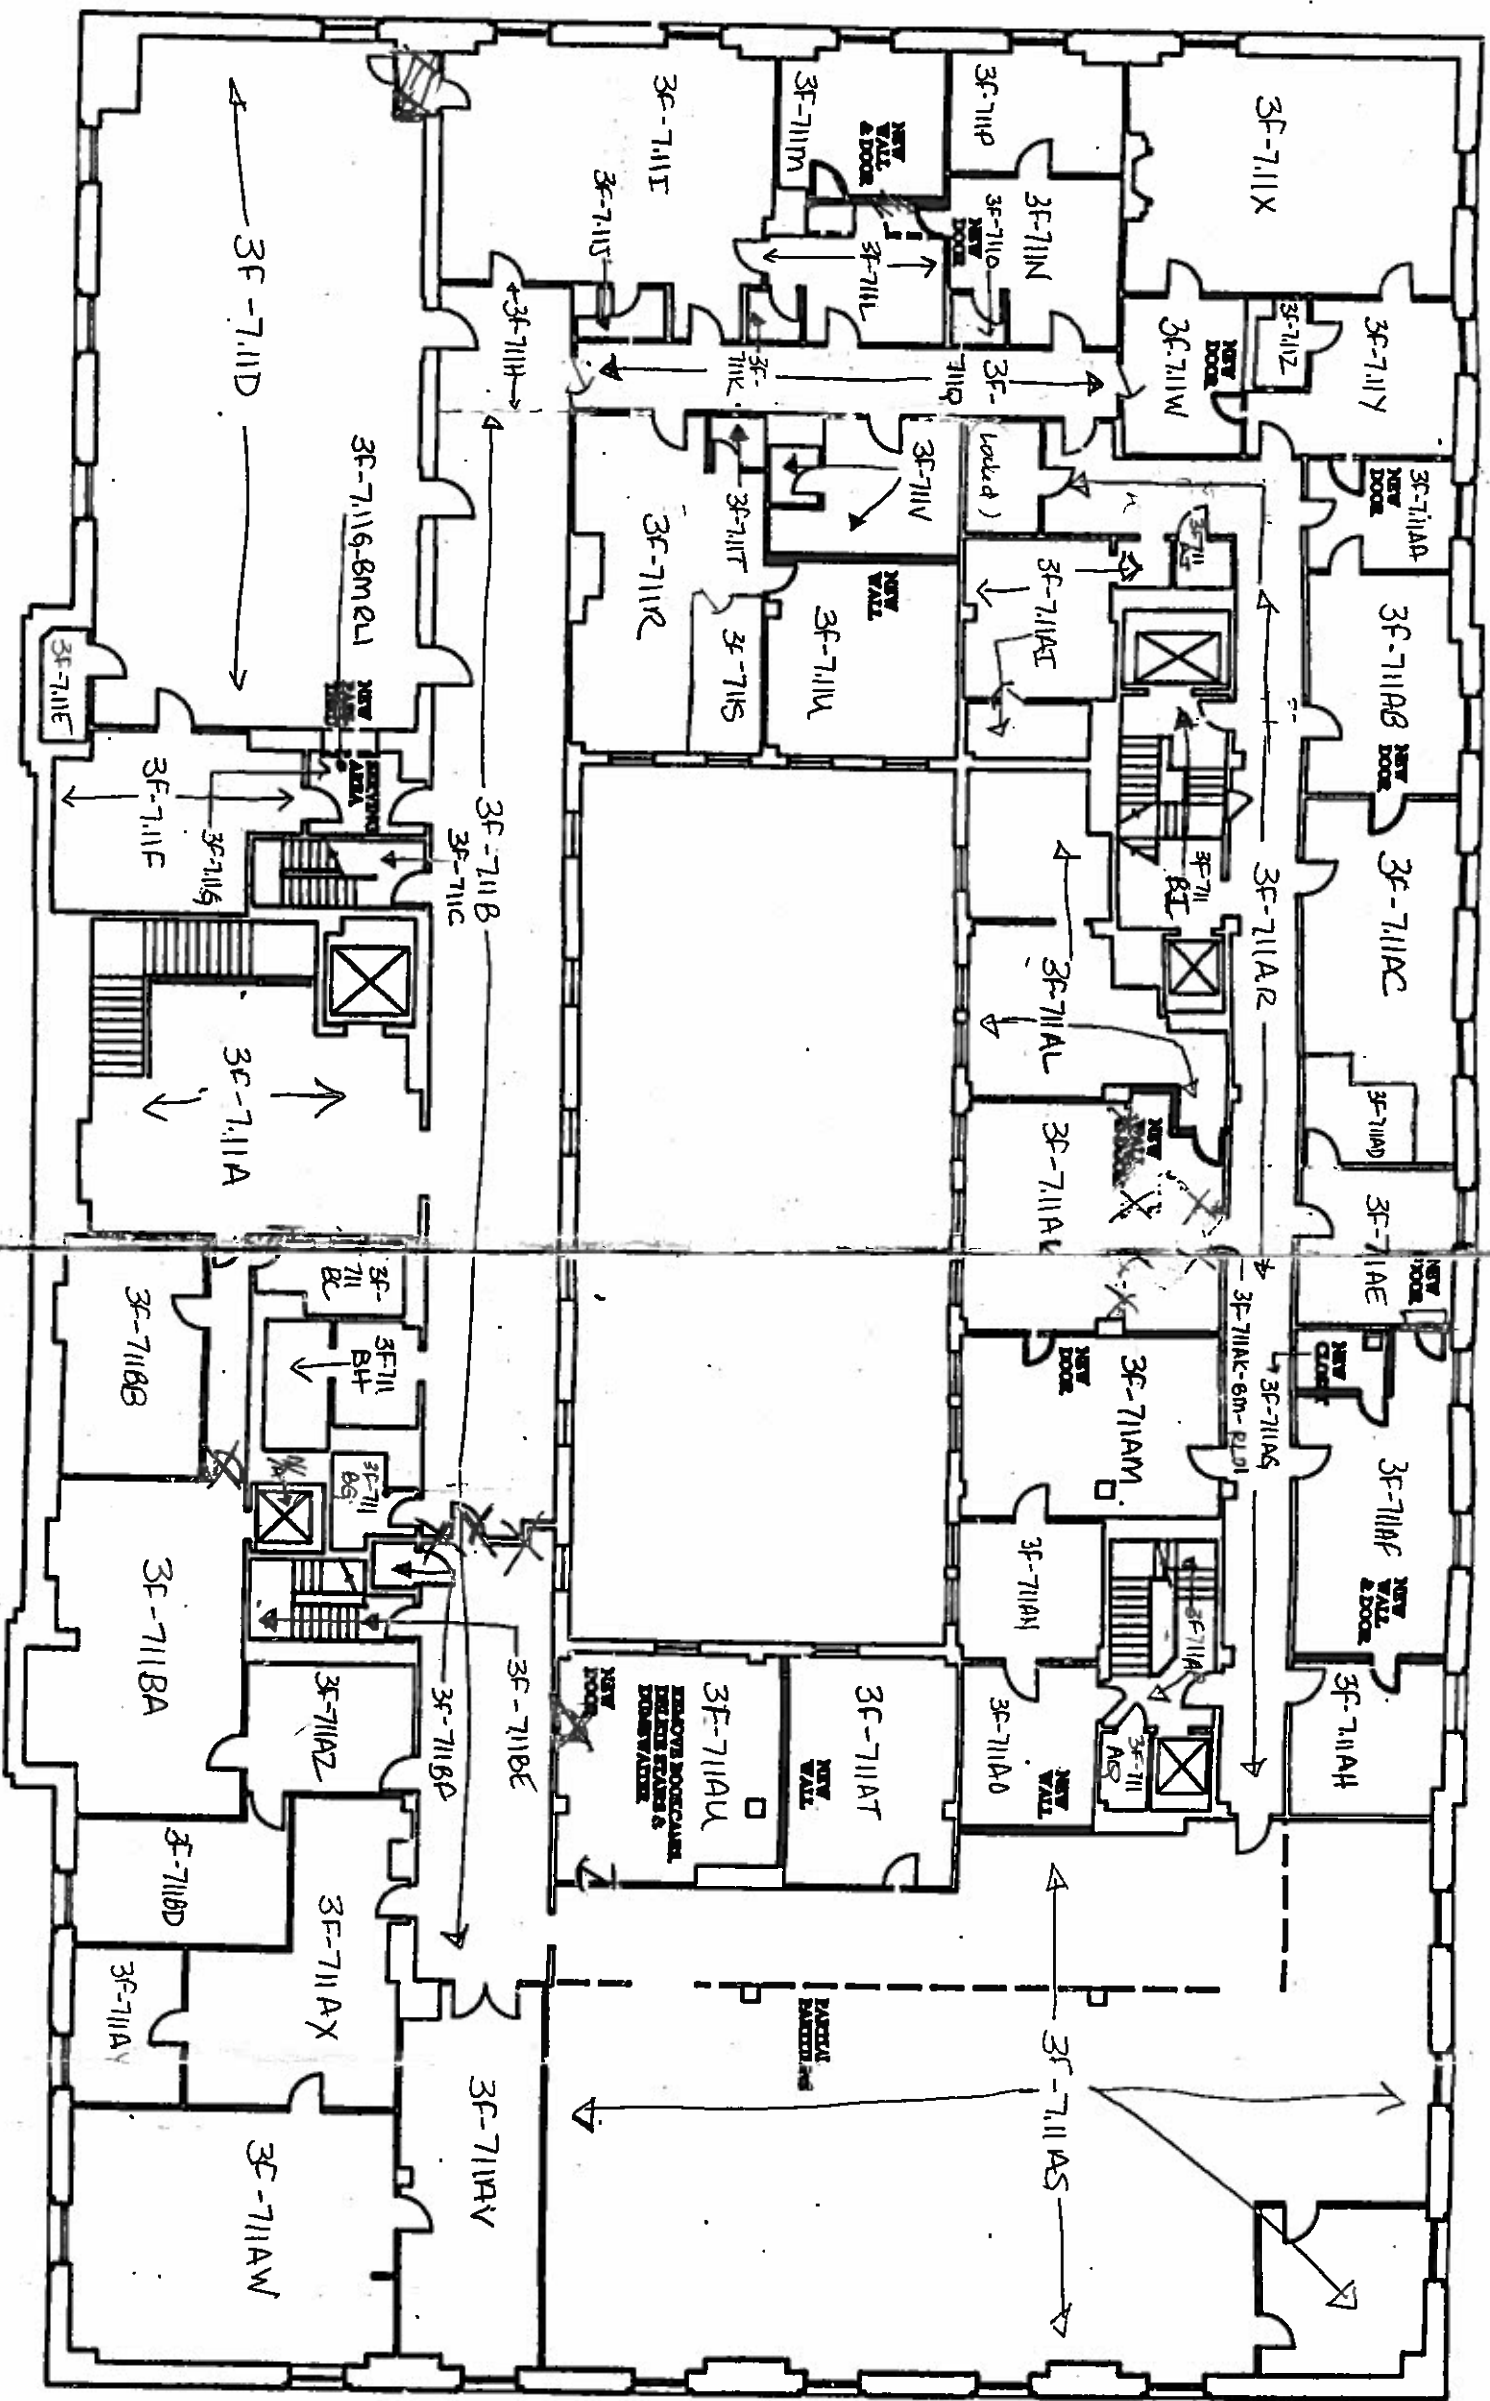
### **THIRD LEVEL PLAN**

**SCALE: 15-14** **Transit 10 AUGUST 1977**
