ASBESTOS ASSESSMENT REPORT

Dewey Avenue and Driving Park Avenue Realignment Project
City of Rochester, Monroe County, New York

PIN 4755.55

Project No. 40-14-035

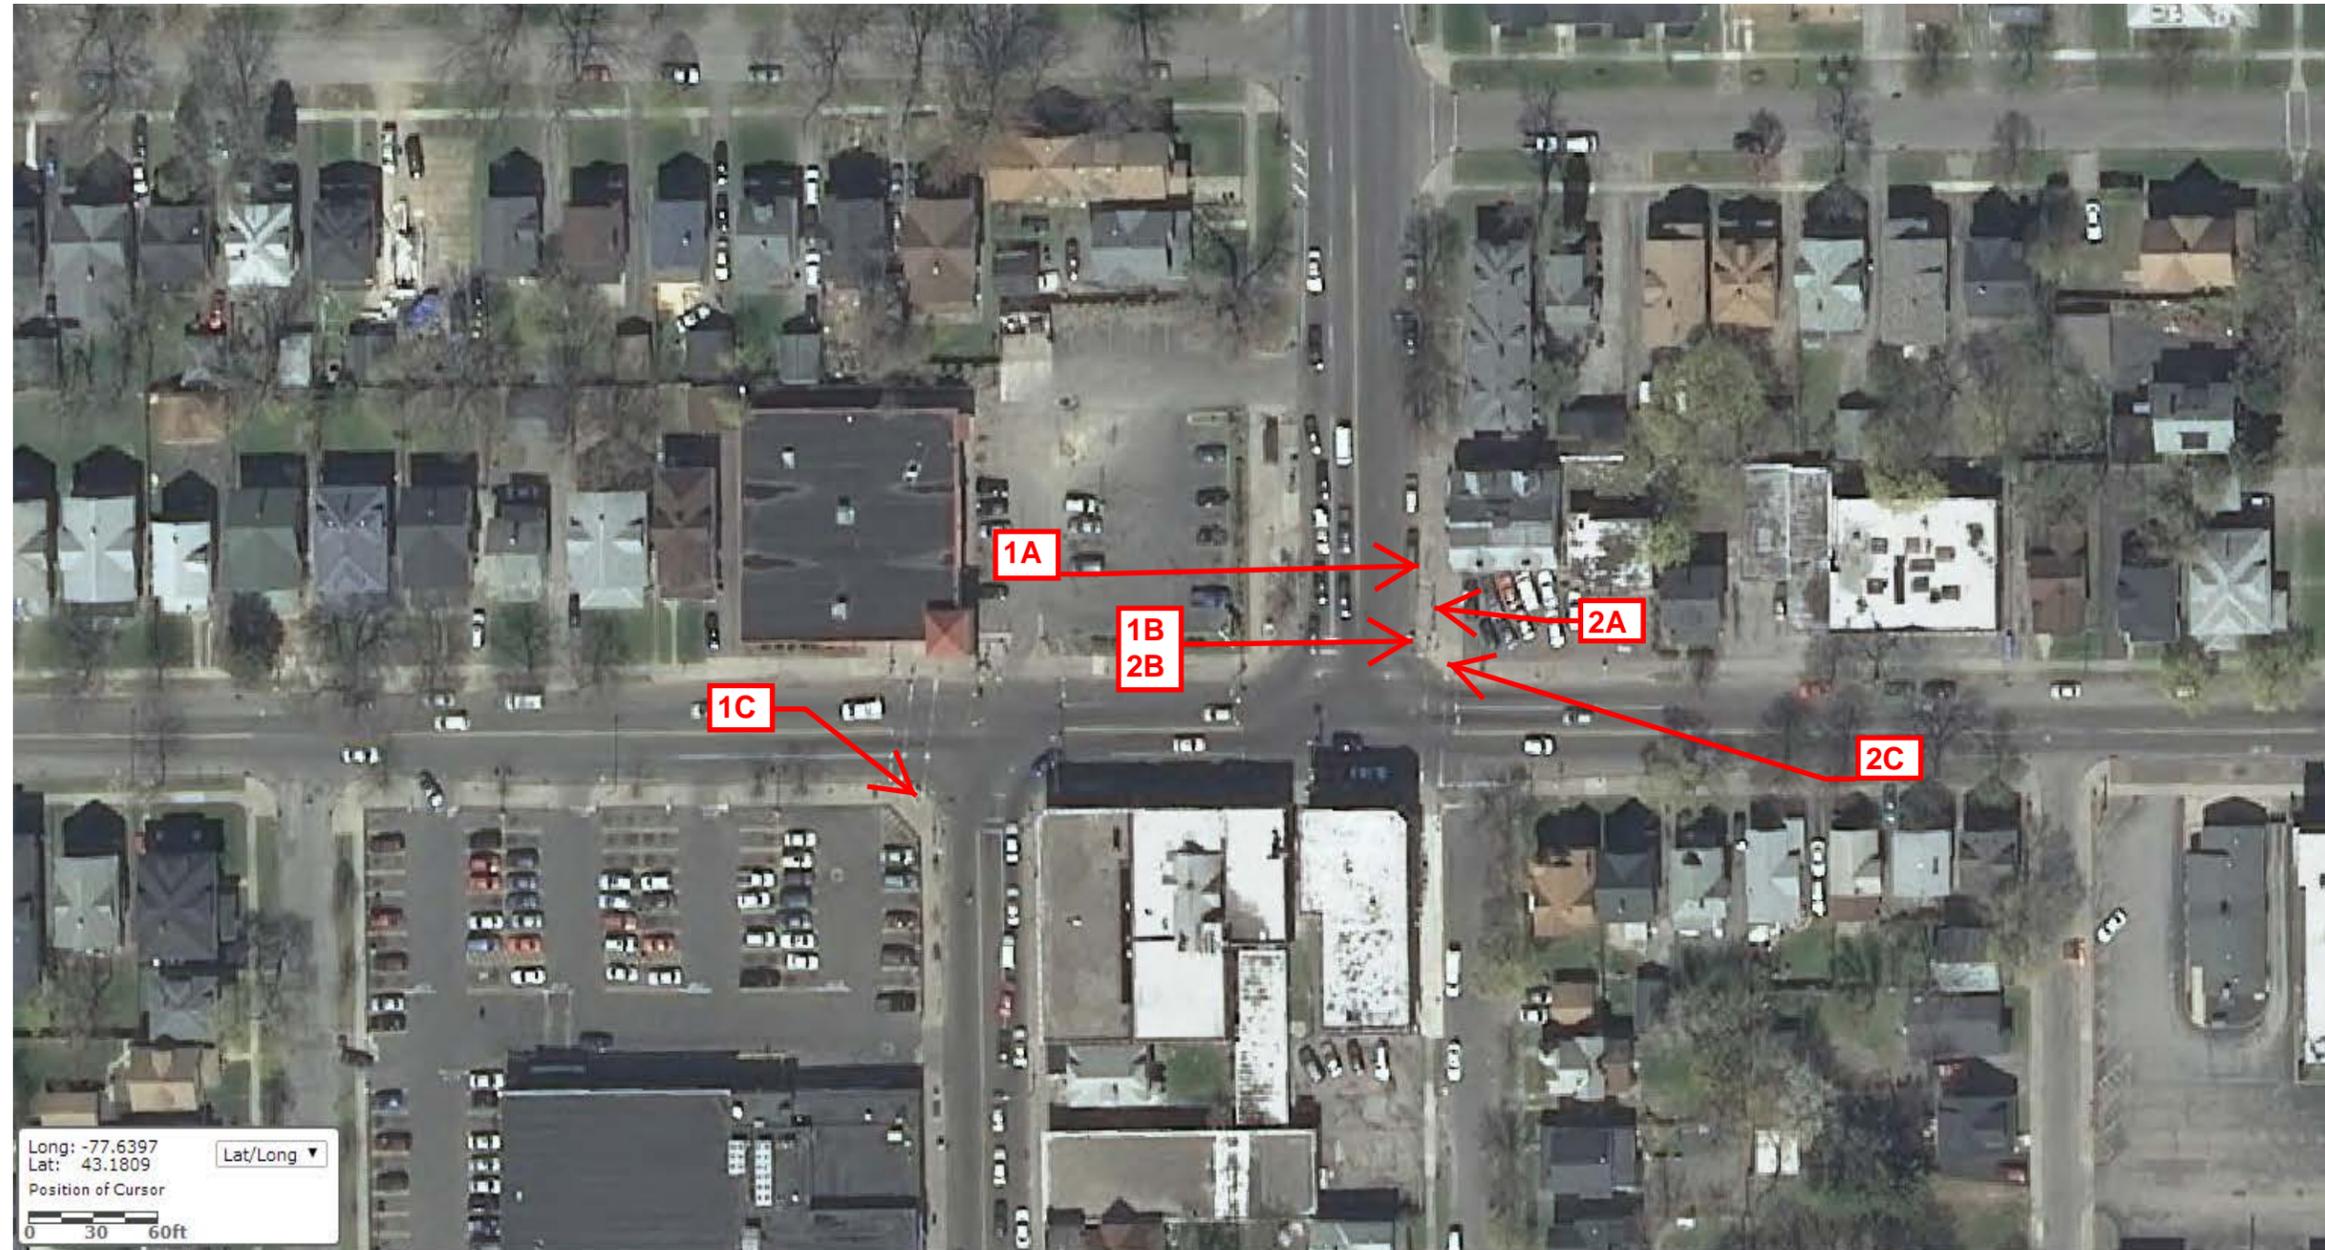
ATTACHMENT C: BULK SAMPLE LOCATION PLAN

SAMPLE RESULTS			
Homogeneous Area No. (HA)	Description	Sample Number	Asbestos Content and Type of Analysis
1	Gray curb grout	1A 1B 1C	None Detected-PLM None Detected-PLM None Detected-PLM
2	Brown sidewalk expansion joint	2A 2B 2C	None Detected-PLM <1.0% Residue Remaining, PLM and TEM Not Required <1.0% Residue Remaining, PLM and TEM Not Required

As indicated by the above table, no asbestos concentrations above one percent exist in any of the materials sampled during this assessment.
