# Midtown Parking Garage

Condition Survey

December 2010

**LABELLA**  
Associates, P.C.

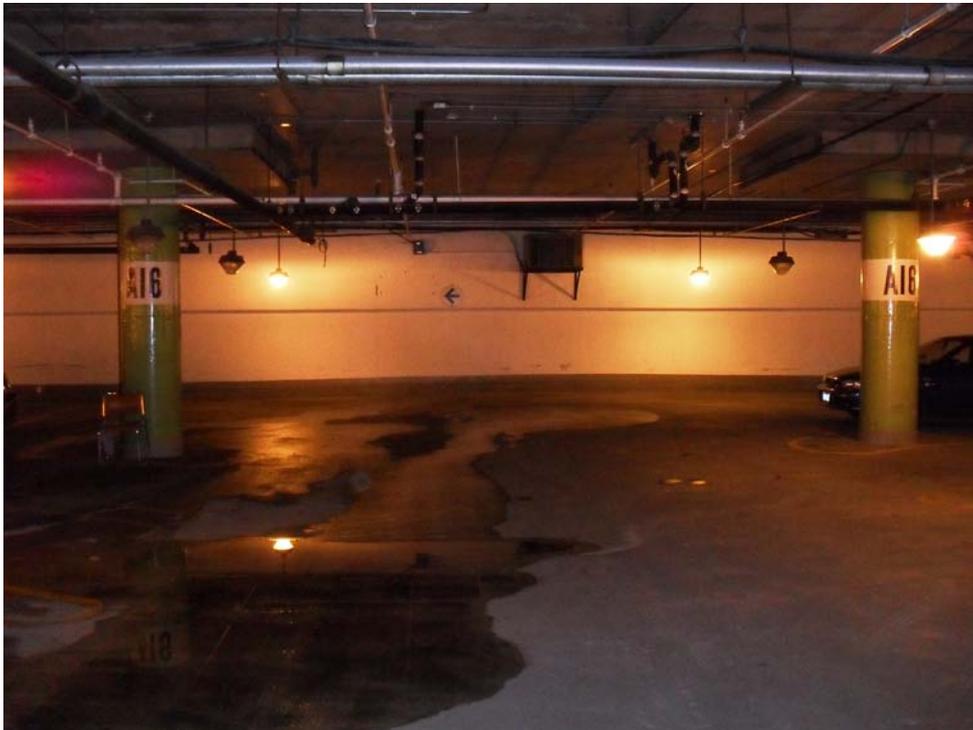
2. Level A: Ponding Water

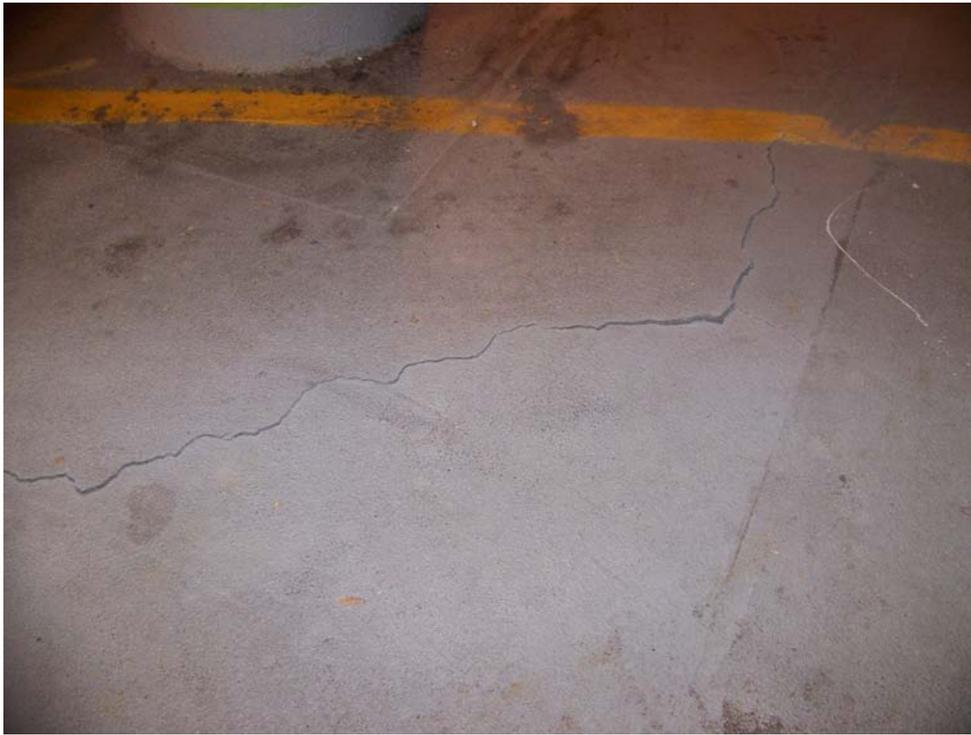
3. Level A: Crack in Traffic Membrane

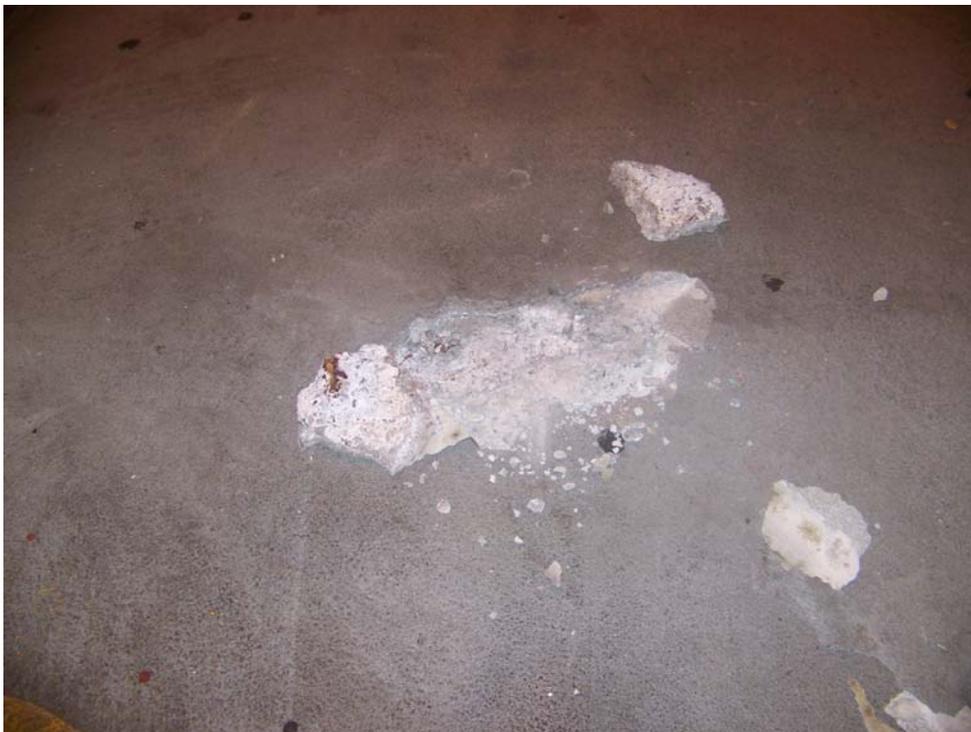
4. Level A: Debonding in Traffic Membrane & Deterioration in Concrete Overlay

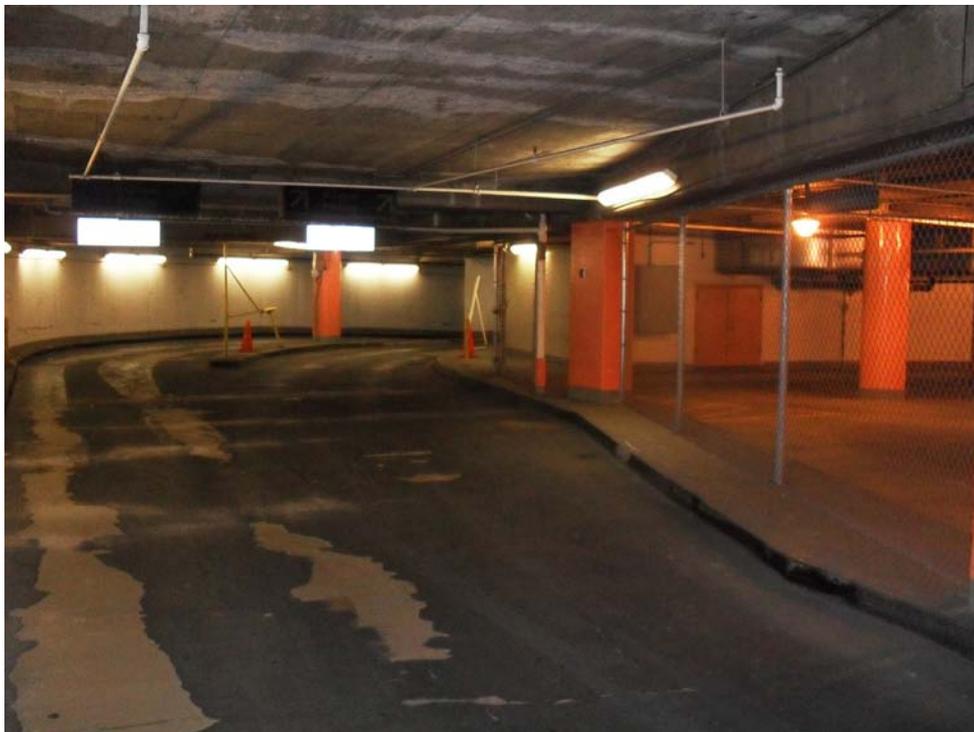
8. Level B: Worn Traffic Membrane in Recirculation Aisle

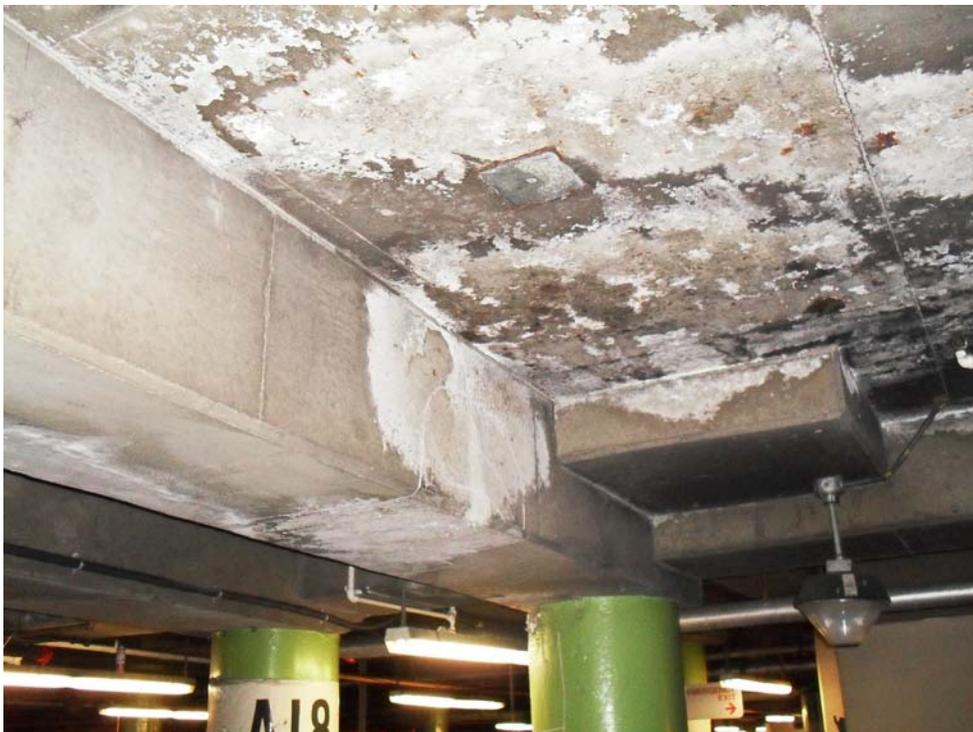
10. Level A: Ceiling and Beam Deterioration

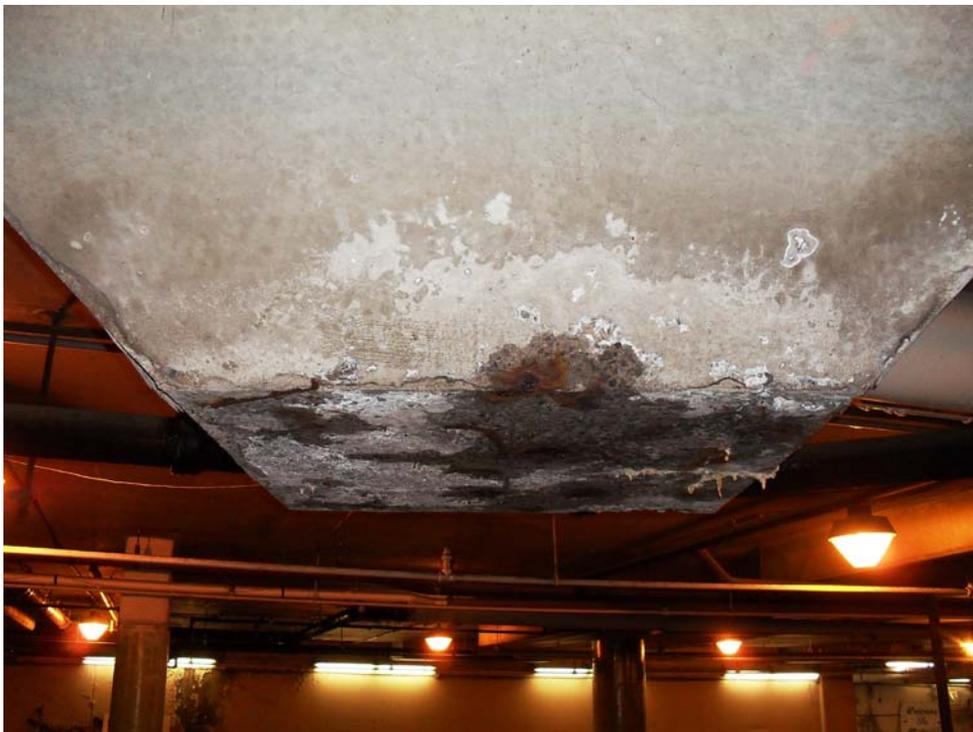
13. Level A: Bottom of Broad Street Catch Basin

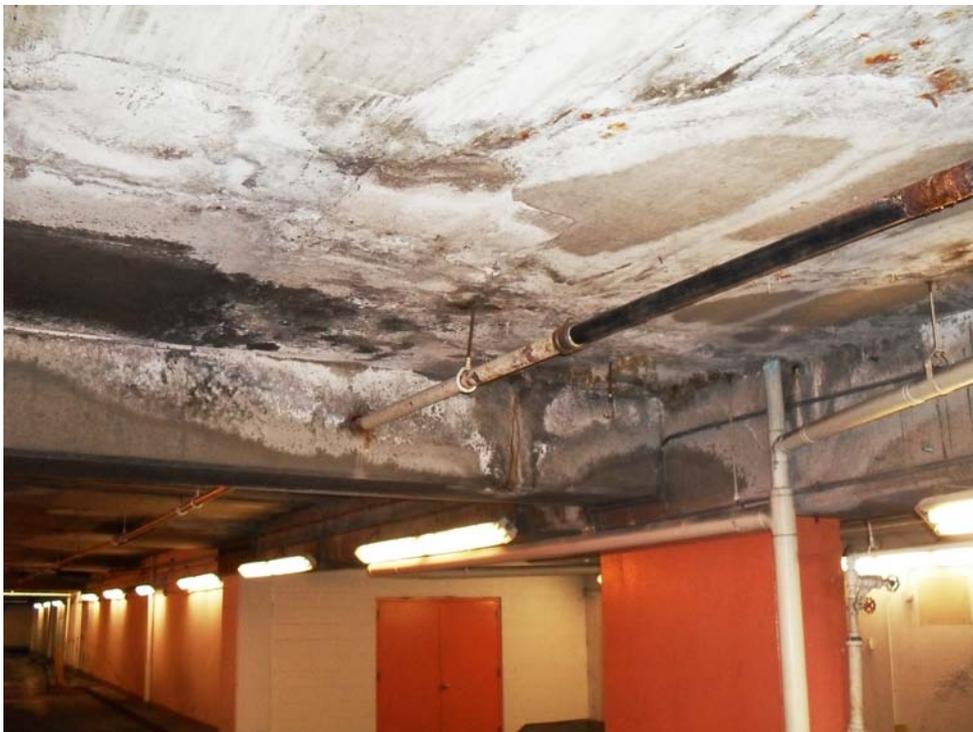
15. Level B: Ceiling Deterioration

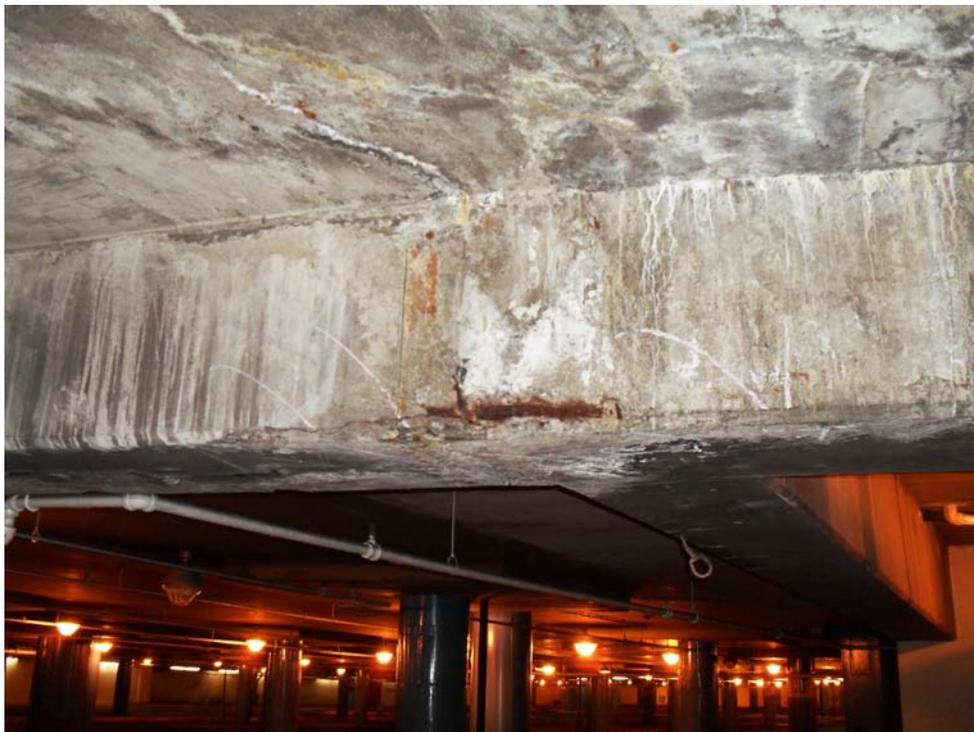
20. Level C: Ceiling and Beam Deterioration

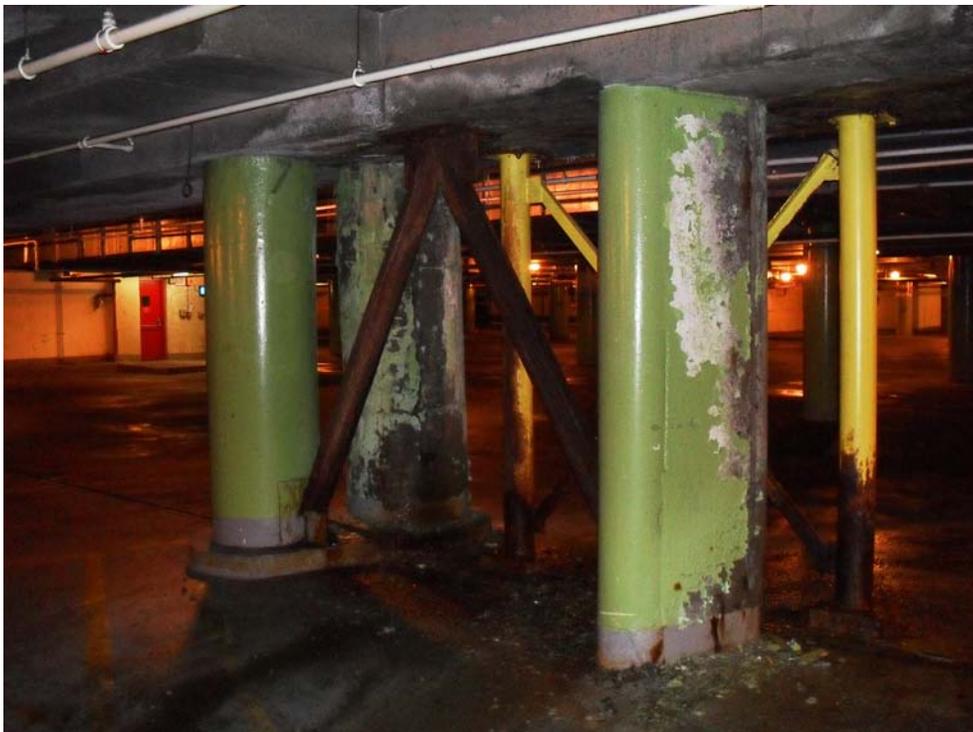
24. Level A: Columns 5-H and 5.4-H.1 Deterioration at Leaking Expansion Joint

The proposed joint replacement requires removing a 5-foot wide strip of existing concrete fill and waterproof membrane over the depressed Mall Level slab, repairing the slab corners at the joint opening as necessary, installing a “Silicoflex” joint system by R.J. Watson (or equivalent), installing a sheet-applied waterproofing membrane within the limits of the removed strip, and replacing the concrete fill up to the proposed asphalt concrete roadway reconstruction for Broad Street and Atlas Street Extension. The opinion of probable construction cost for the replacement of the two expansion joints is \$155,000.

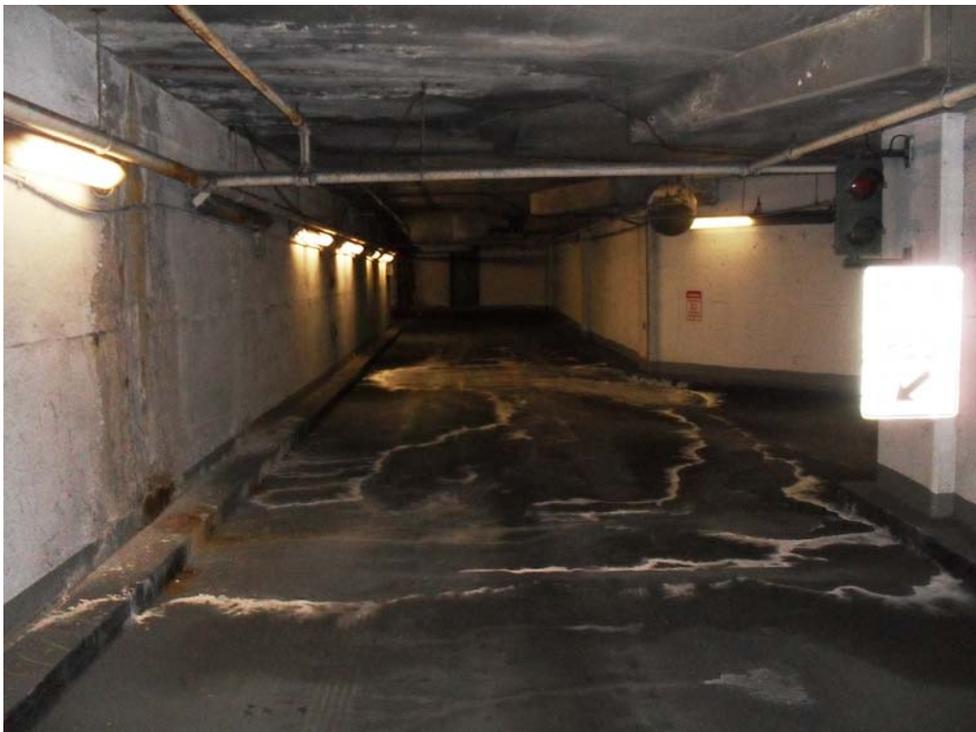
29. Level A: Exit to Court Street Efflorescence Buildup on Floor

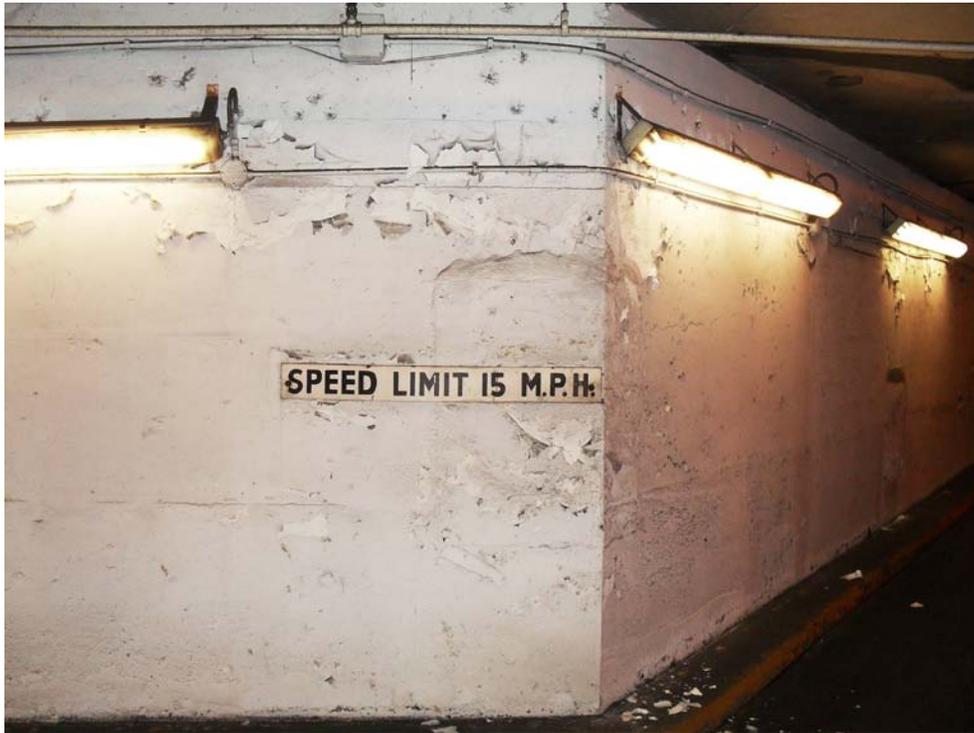
34. Level C: Typical Wall Coating Condition

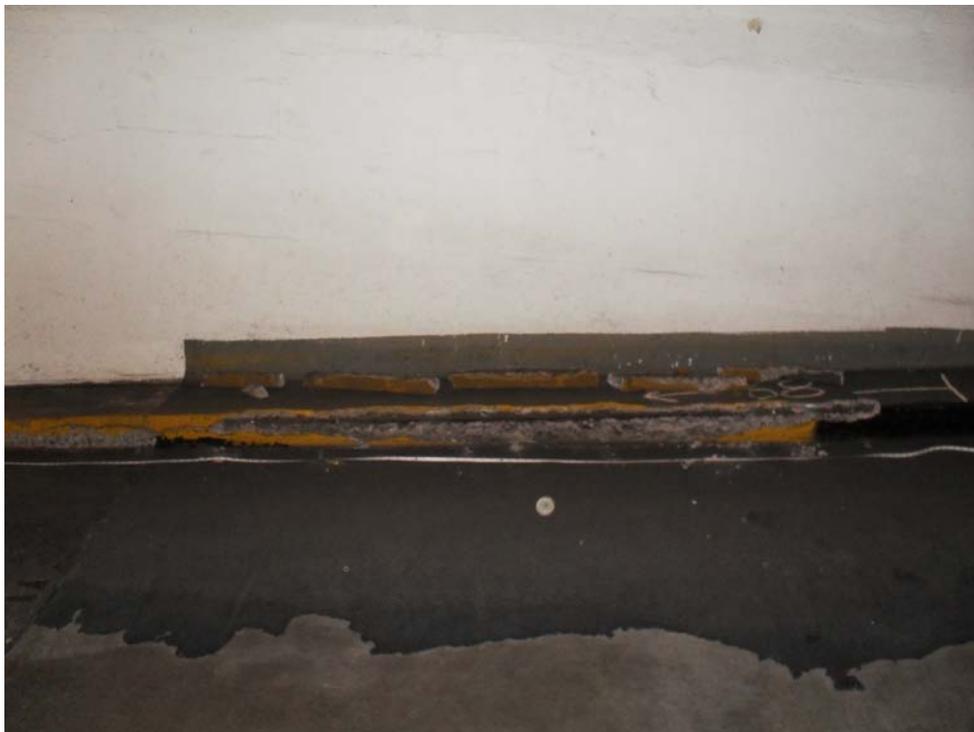
35. Level B: Curb Spall with Exposed Rebar

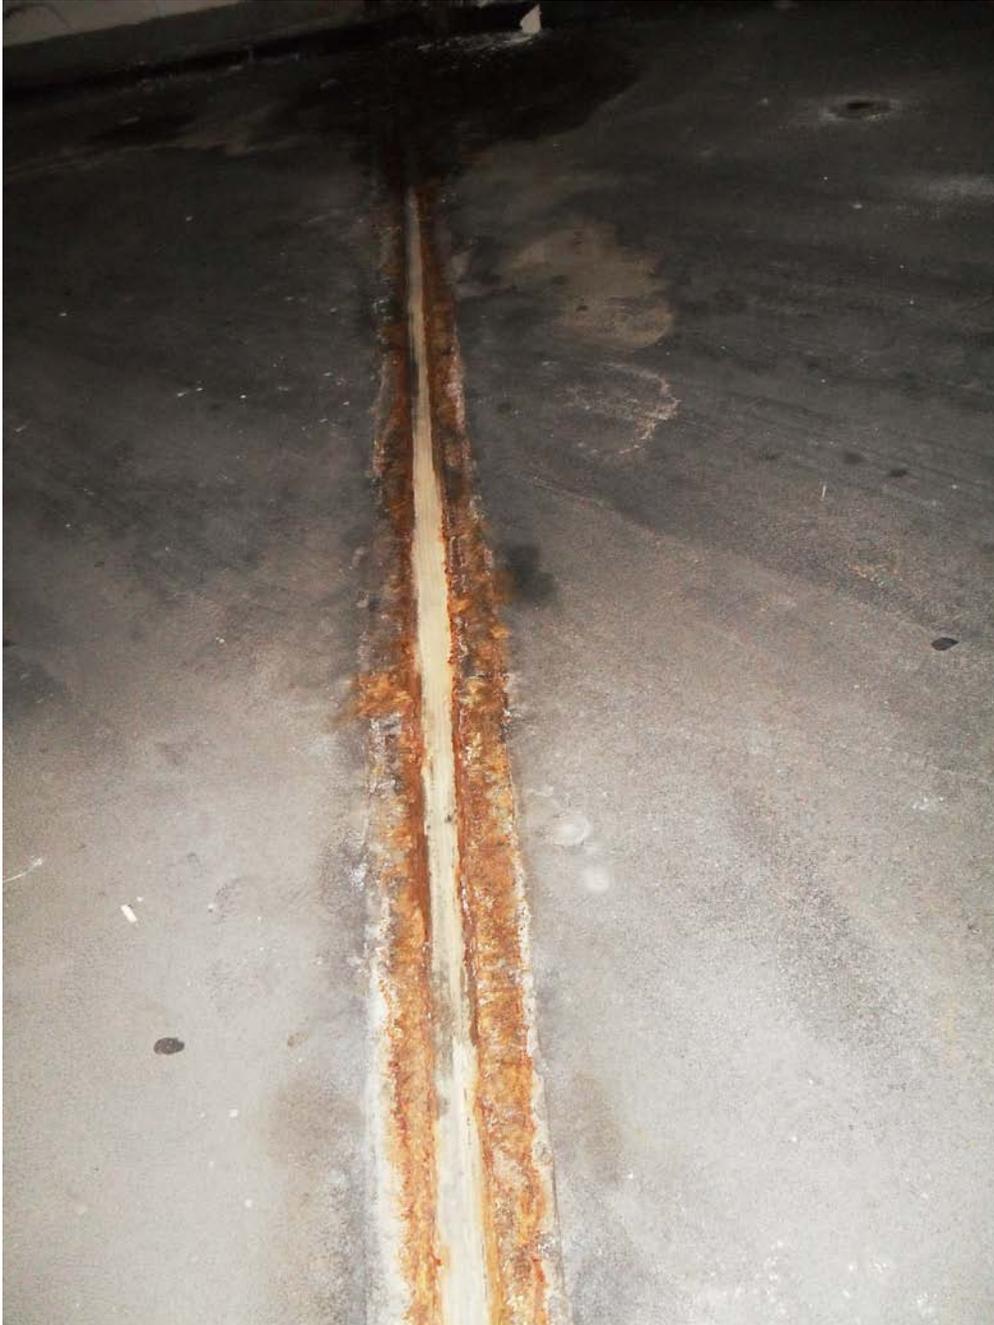
40. Level A: Expansion Joint at Exit Ramp to Court Street

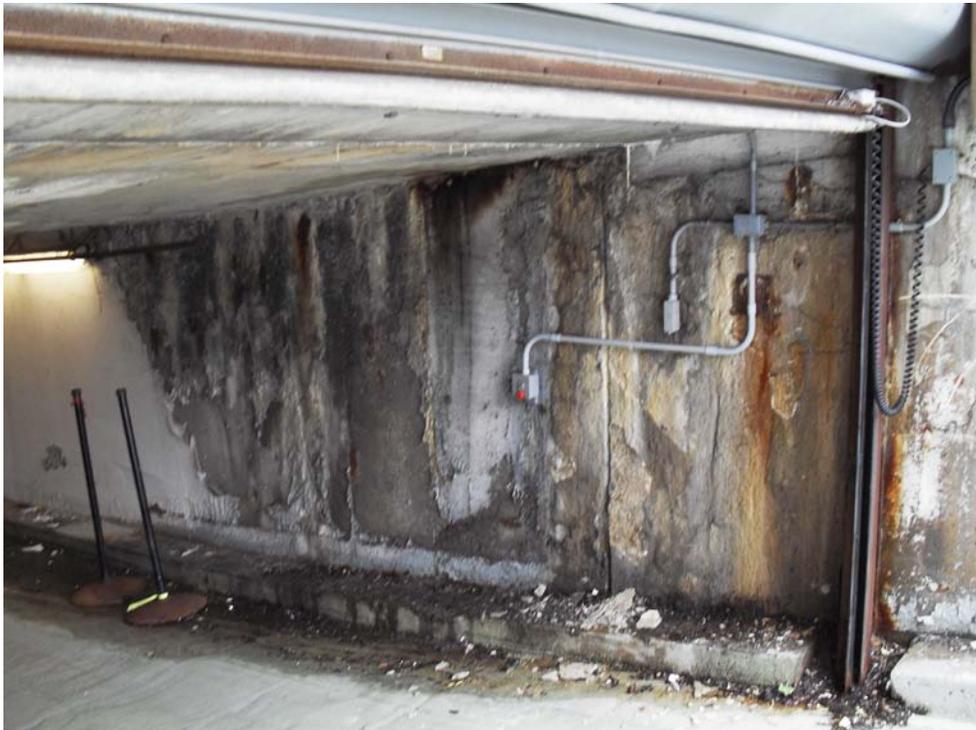
42. Clinton Avenue Entry: Wall and Ceiling Deterioration

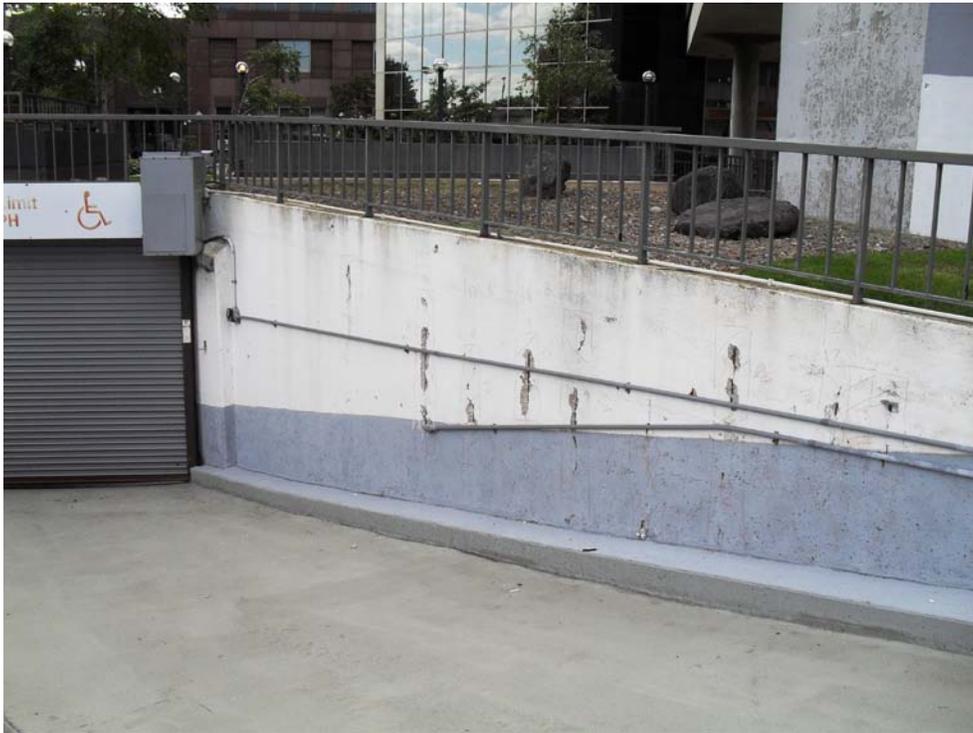
43. Broad Street Entry: Retaining Wall Isolated Spalls

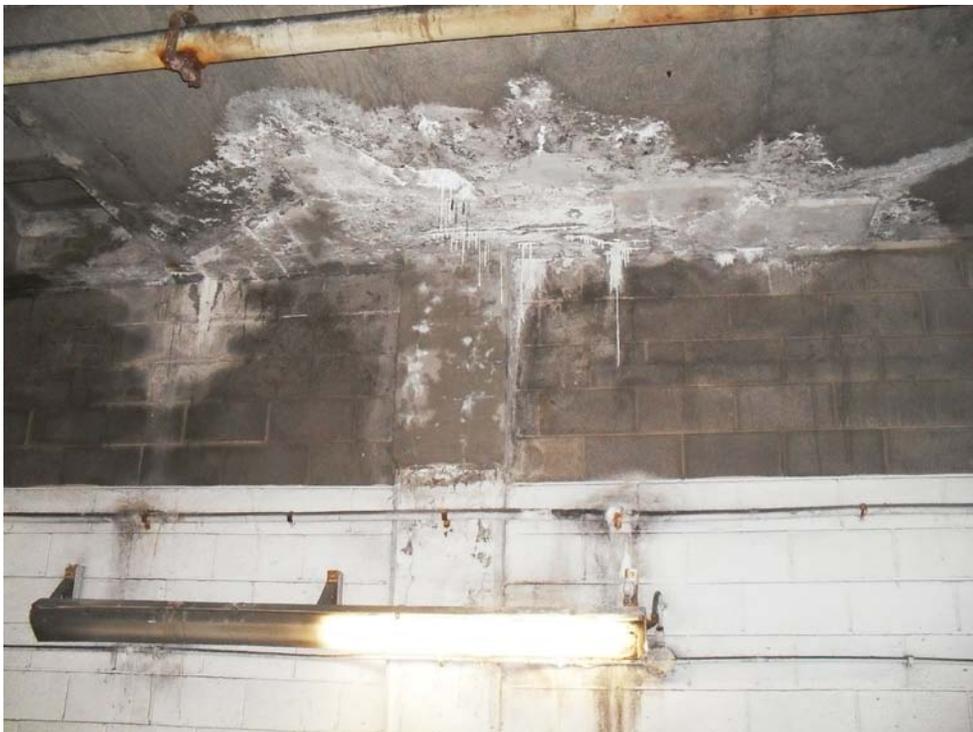
44. Exit to Court Street: Ceiling Deterioration and Column Cracking

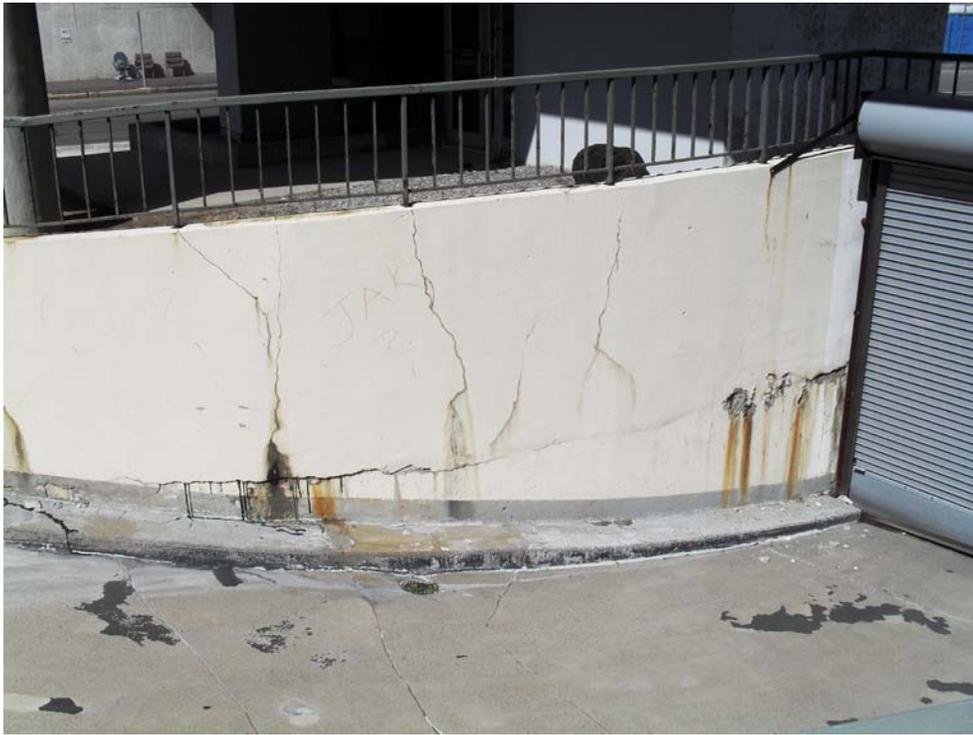
45. Broad Street Exit: Retaining Wall Cracks at Railing Posts

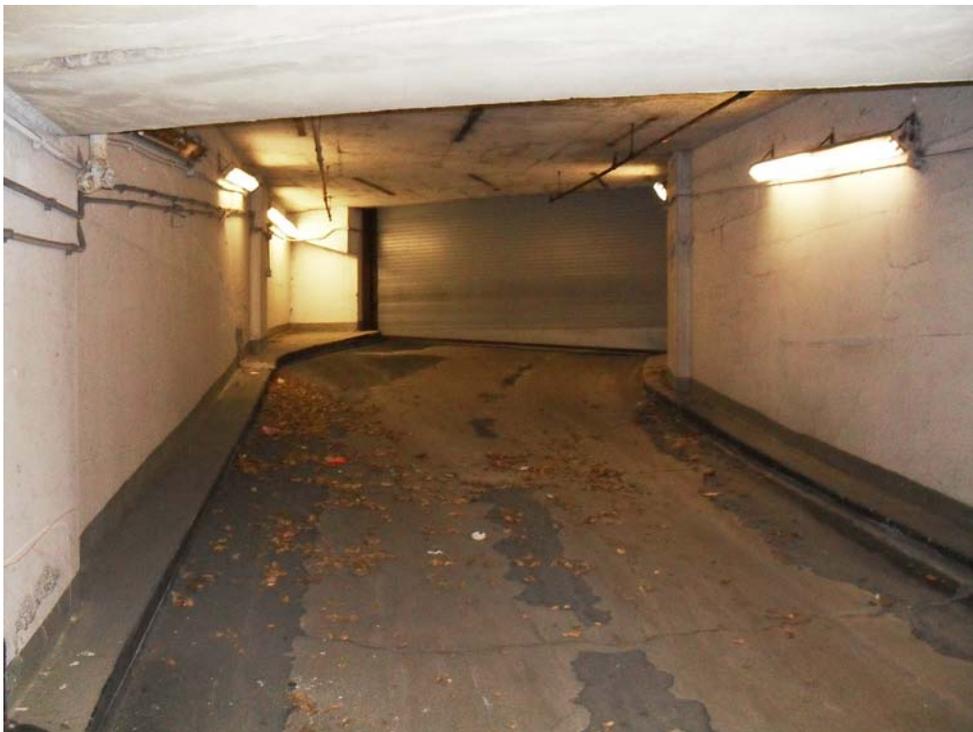
46. Broad Street Exit: Worn Traffic Membrane and Transverse Floor Crack

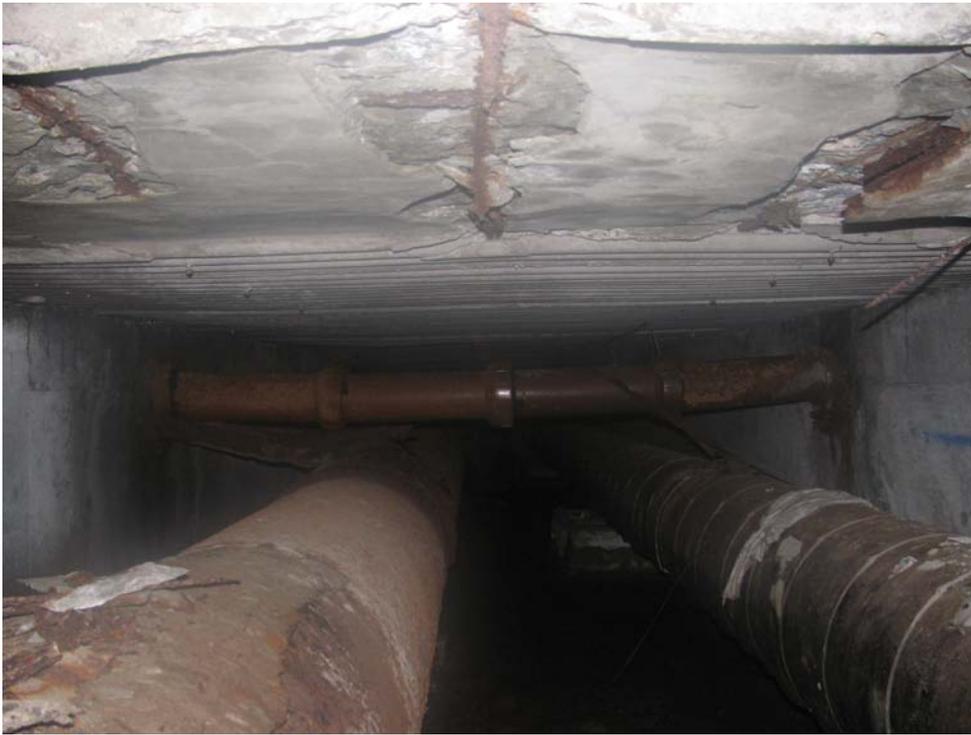
47. Level C: Utility Tunnel Roof Slab Deterioration

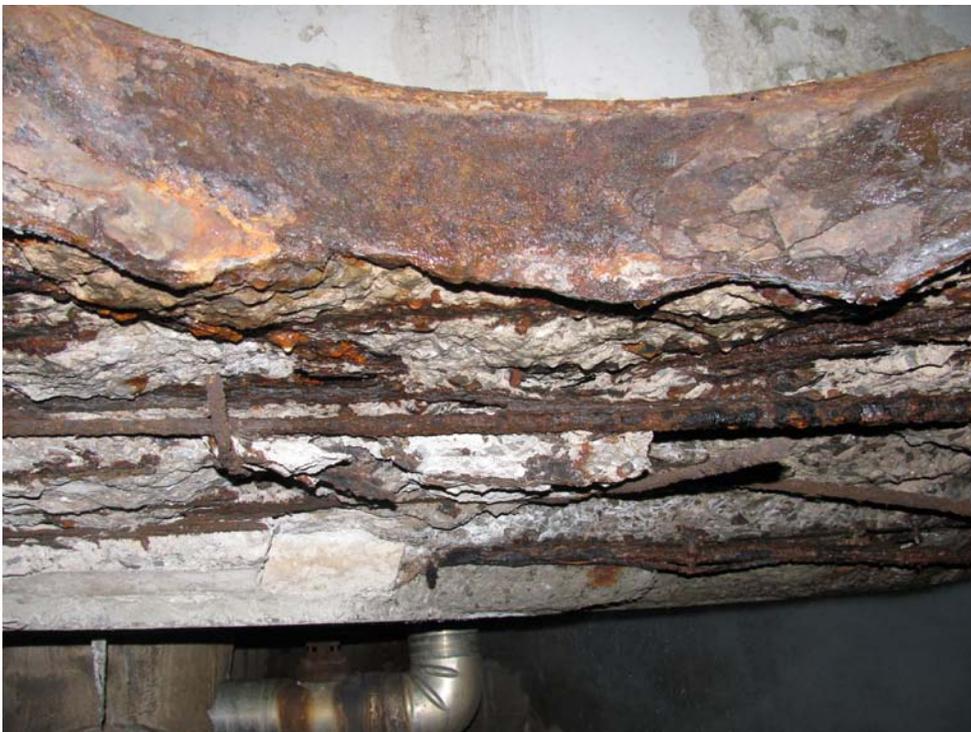
48. Level C: Utility Tunnel Roof Slab Deterioration
