Vacuum Oil - Brownfield Opportunity Area

Building Assessment Report

5 Flint Street

December 2014

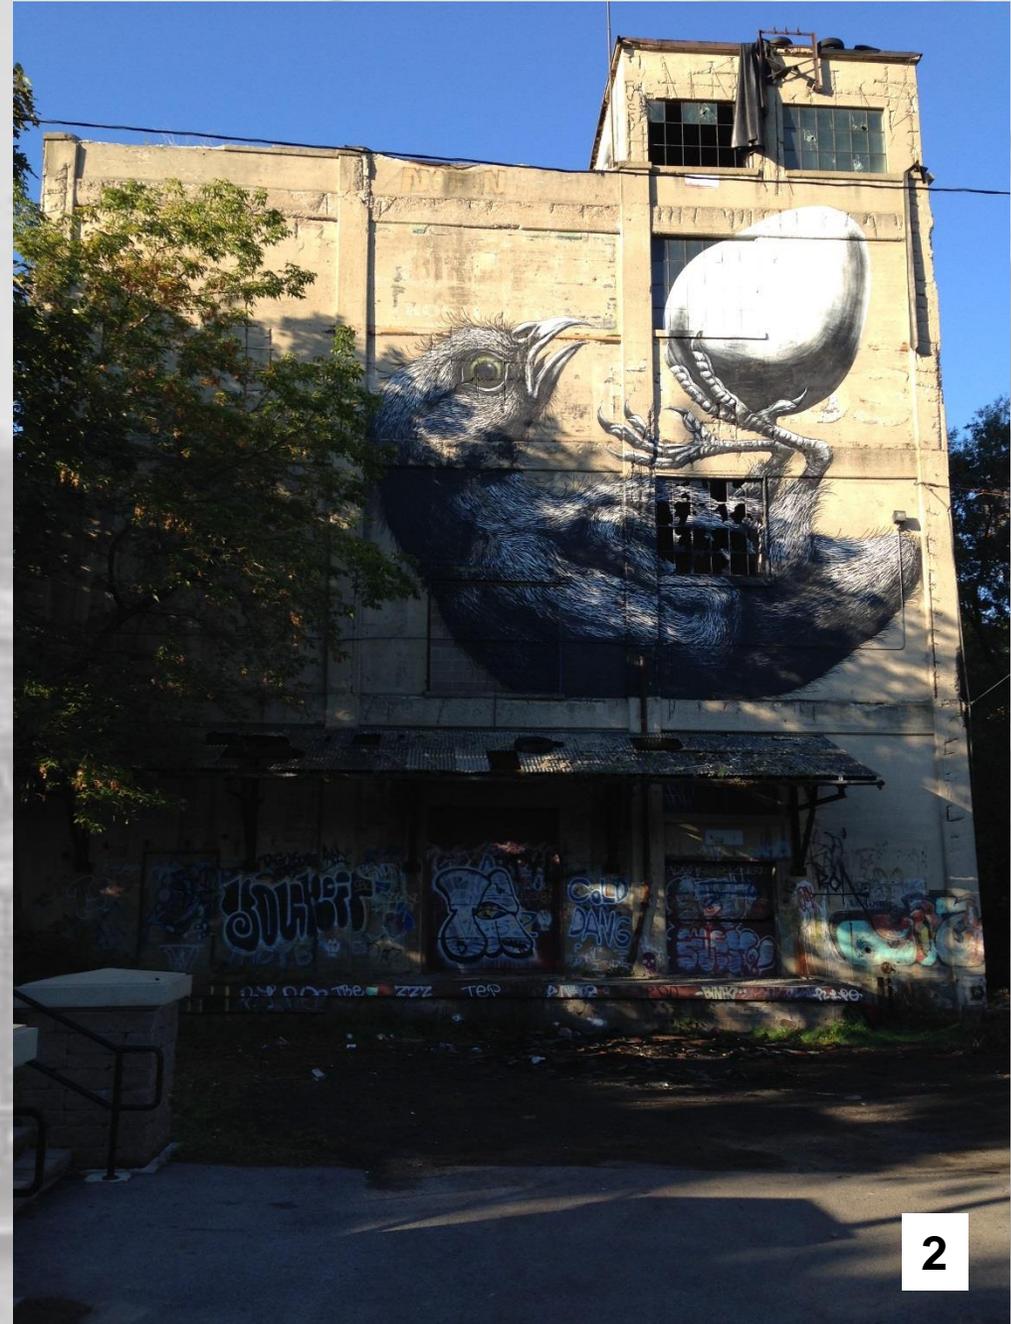
North Façade
• Loading Dock

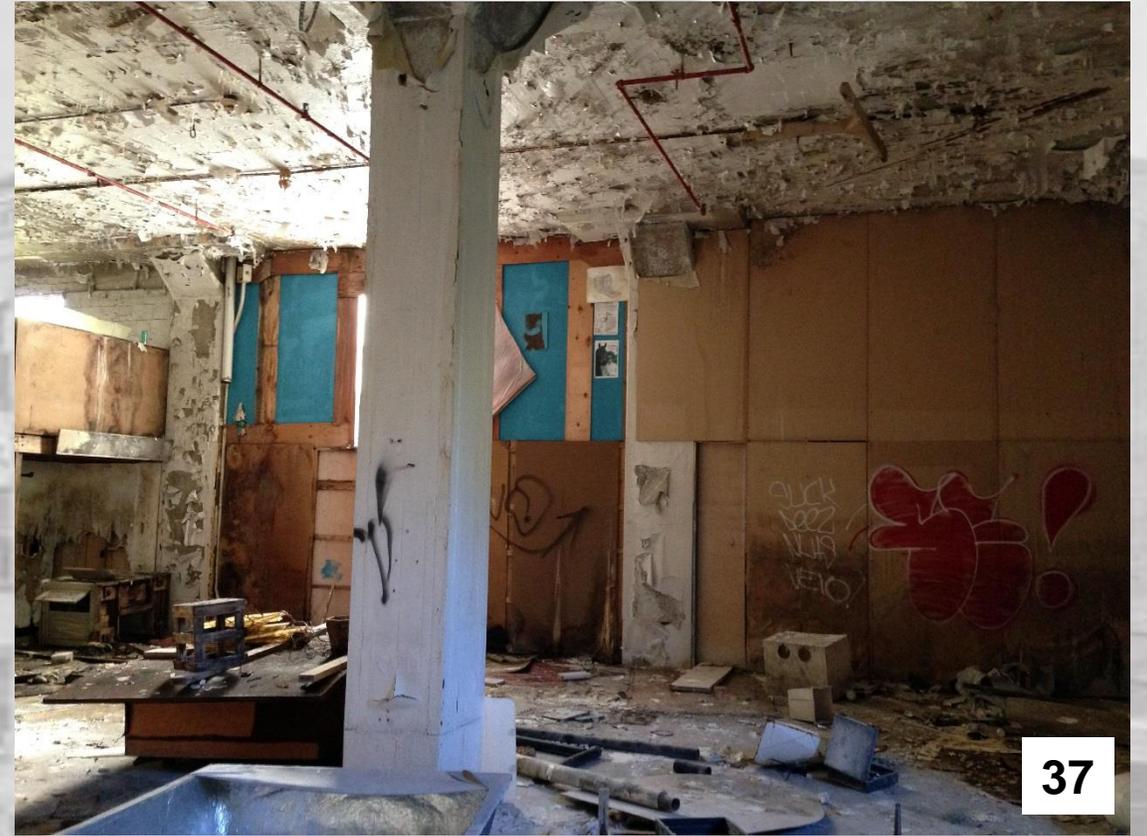
Second Floor looking East

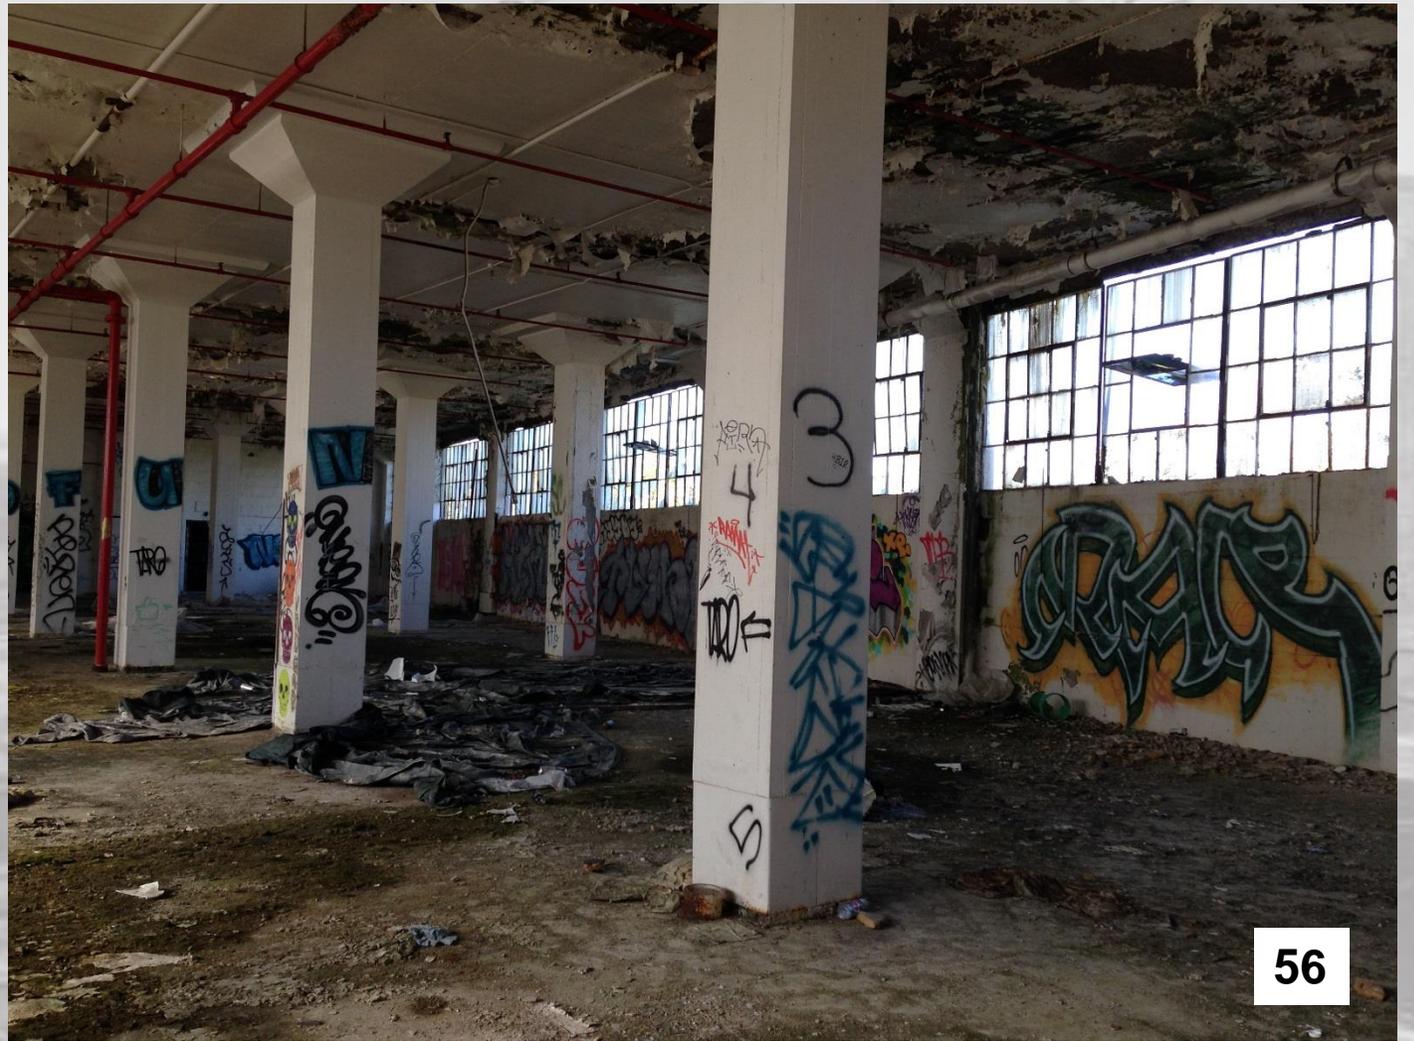
56

Third Floor looking South West

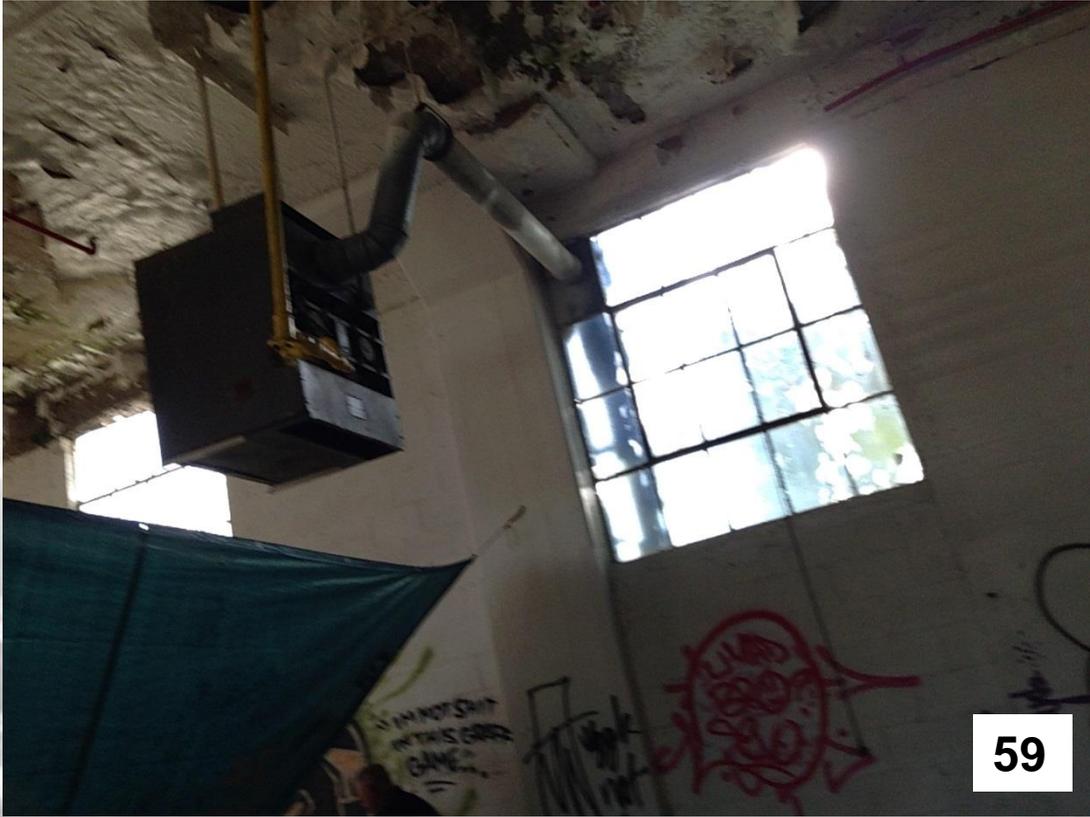
59

Third Floor typical heating unit

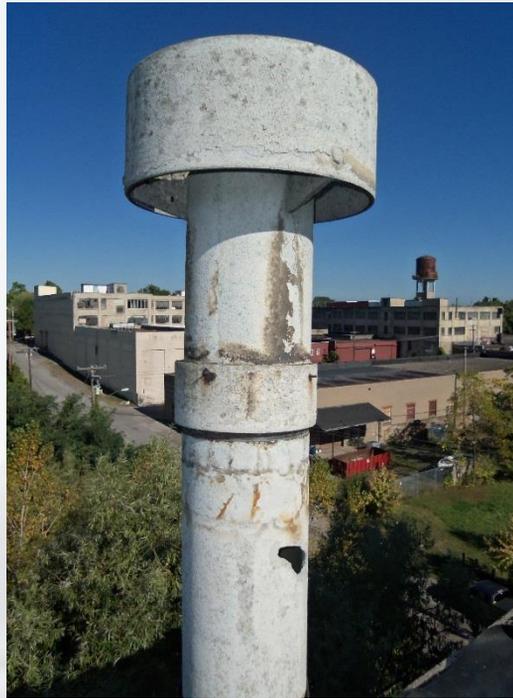
Vent Cap for Exterior Wall Vent

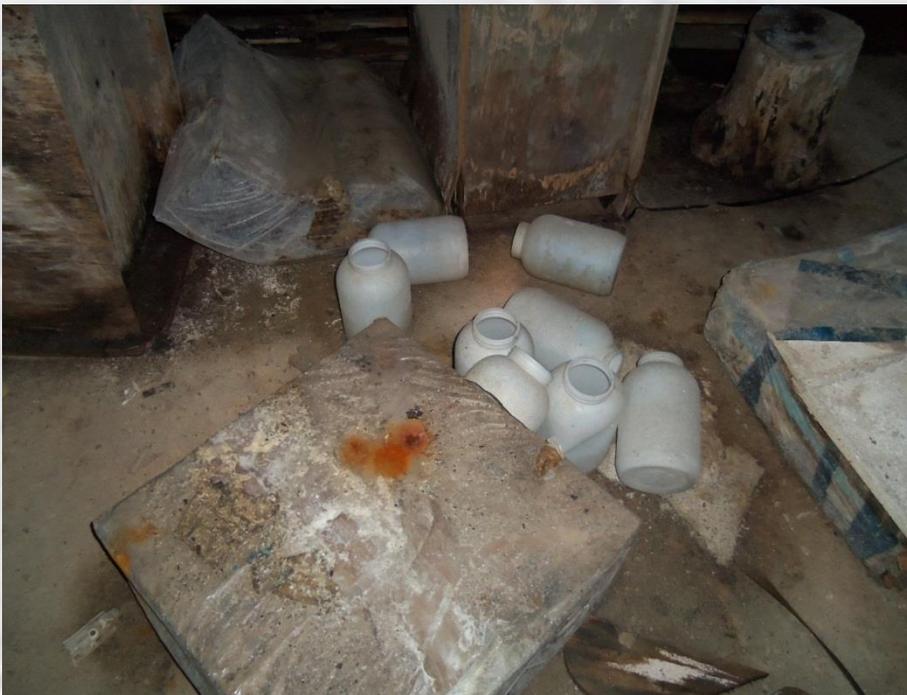
Empty containers in piles within the building

Hazardous materials and containers should be properly removed and disposed according to federal, state, and local regulations prior to building demolition.

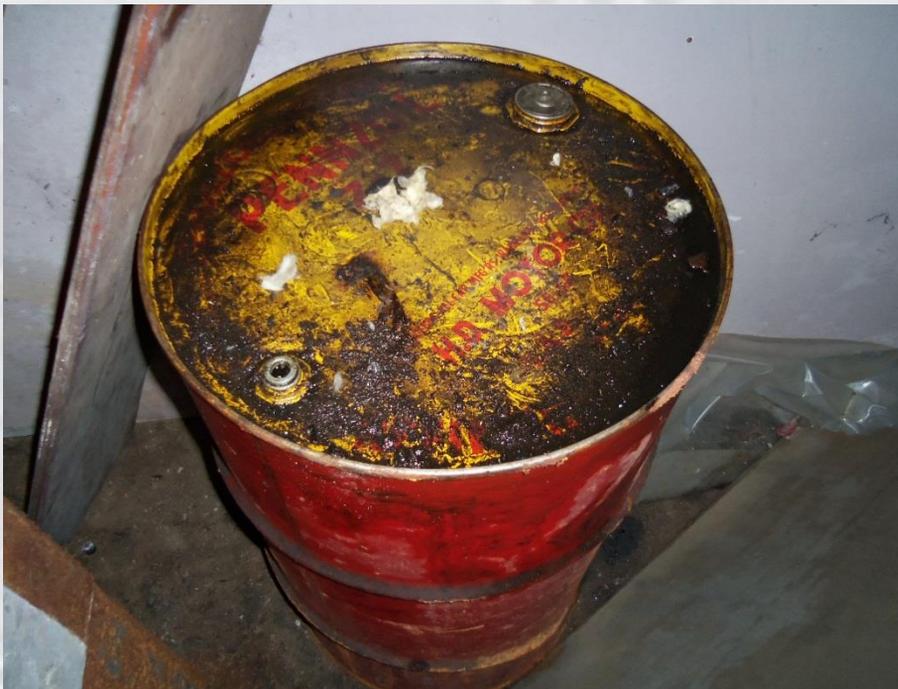
- One (1) 55-gallon steel drum labeled Pennzoil on the top. The drum appeared to be full. Due to the staining on the top of the drum, suspect waste motor oil.
- Fluorescent light bulbs within lighting fixtures, on floor and within boxes.
- Five-gallon buckets labeled joint compound, driveway seal, stain and paint. The buckets are a mix of empty and partially full containers. Some buckets appeared to contain water with residual material in the bottom. Additional buckets were labeled generically with a home improvement store name. The contents of these buckets is unknown.
- An empty automotive fuel tank.
- Miscellaneous containers in quart, gallon and two-gallon sizes labeled to contain: Gear oil, kerosene, antifreeze, motor oil, and windshield washer fluids.
- Empty and partially empty spray paint cans.
- Miscellaneous empty plastic containers.

1st Floor Drum, may contain waste oil

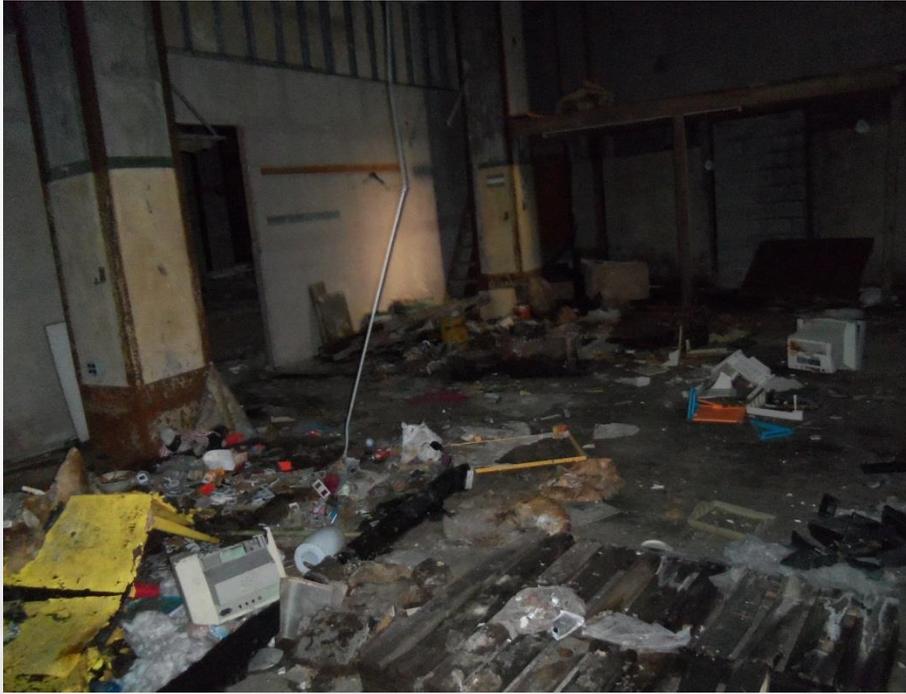
Floor surfaces within the structure were entirely covered in a majority of areas with litter and debris. No visual observation of floor drains, pits, vaults or additional staining would be likely until cleanup of the debris present on floor surfaces is complete.

Typical debris covered floor

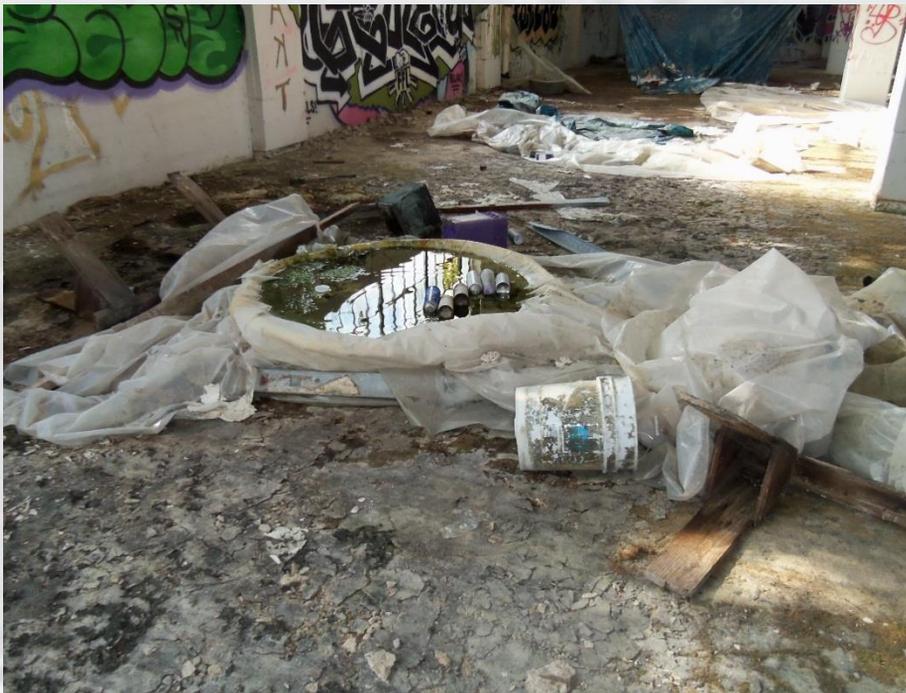
1. Miscellaneous 5-gallon buckets with what appears to be water.
2. Empty and partially empty spray paint cans.
3. Five-gallon rusty steel tar bucket. Tar leaked onto the floor surface.
4. Kiddie pools and plastic filled with what appears to be water.

Kiddie pool and plastic
